THE CORPUS CHRISTI TORNADOES OCTOBER 24, 2002

Joseph E. Minor, P.E.

Consulting Engineer

November 15, 2002

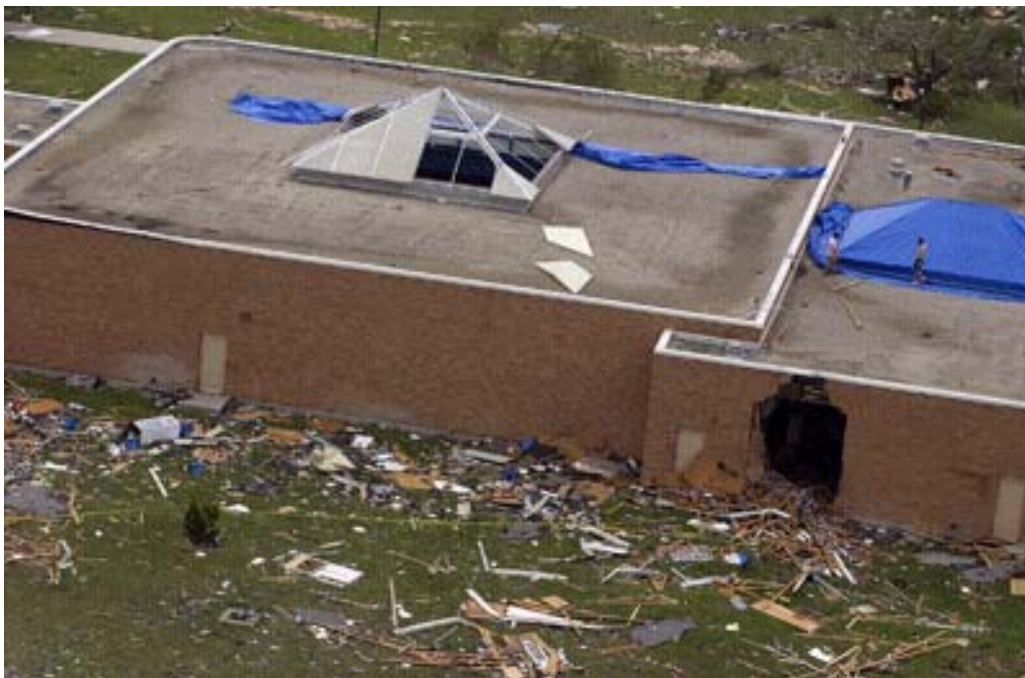
Damage caused by Tornado 2 at Del Mar College West Campus
(*Caller-Times* Photo/David Pellerin 10.25.2002)

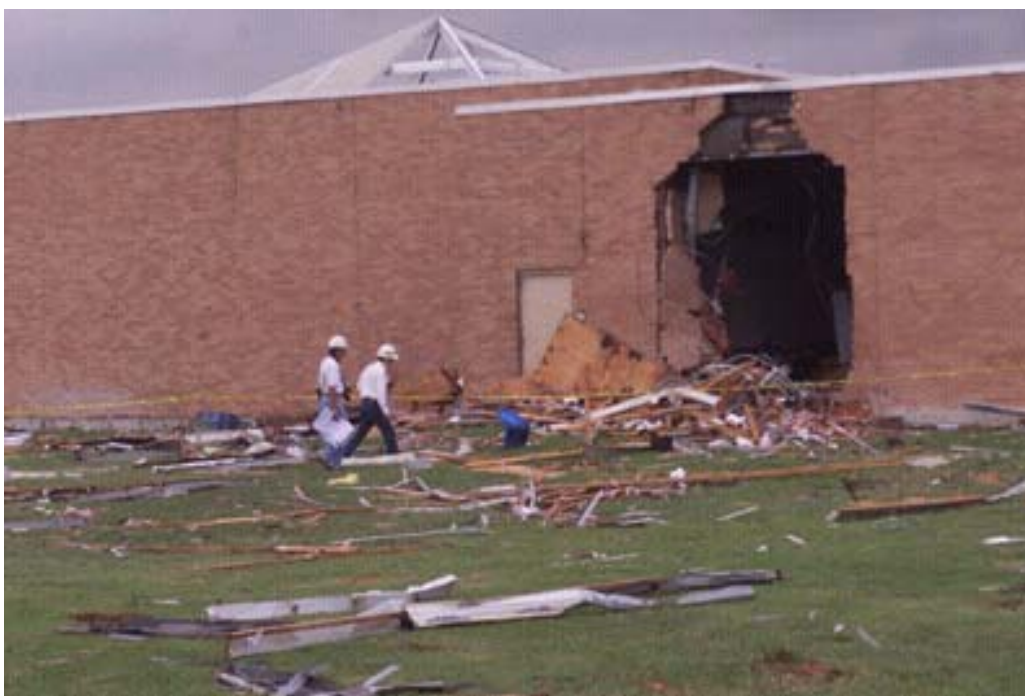
Damage to brick veneer wall at Del Mar College West Campus caused by Tornado 2
(*Caller-Times* photo/Joey Cruz 10.25.2002)

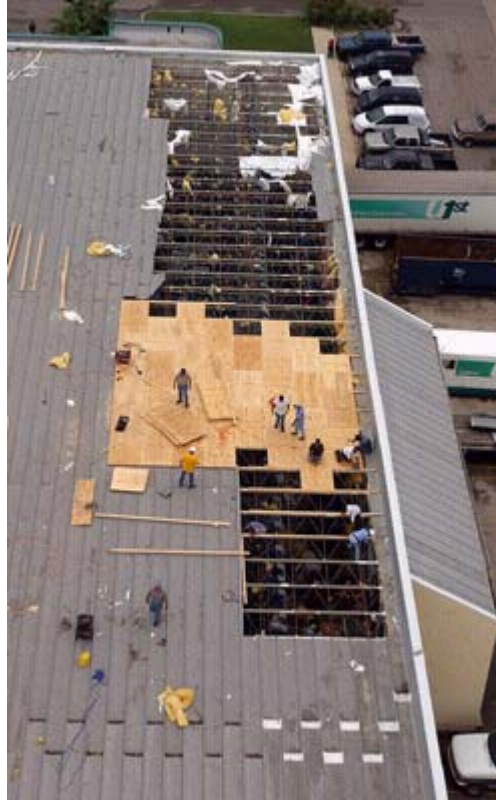
Roof Damage at the UniFirst Building near the Del Mar College West campus caused by Tornado 2 (*Caller-Times* photo/David Pellerin 10.25.2002)

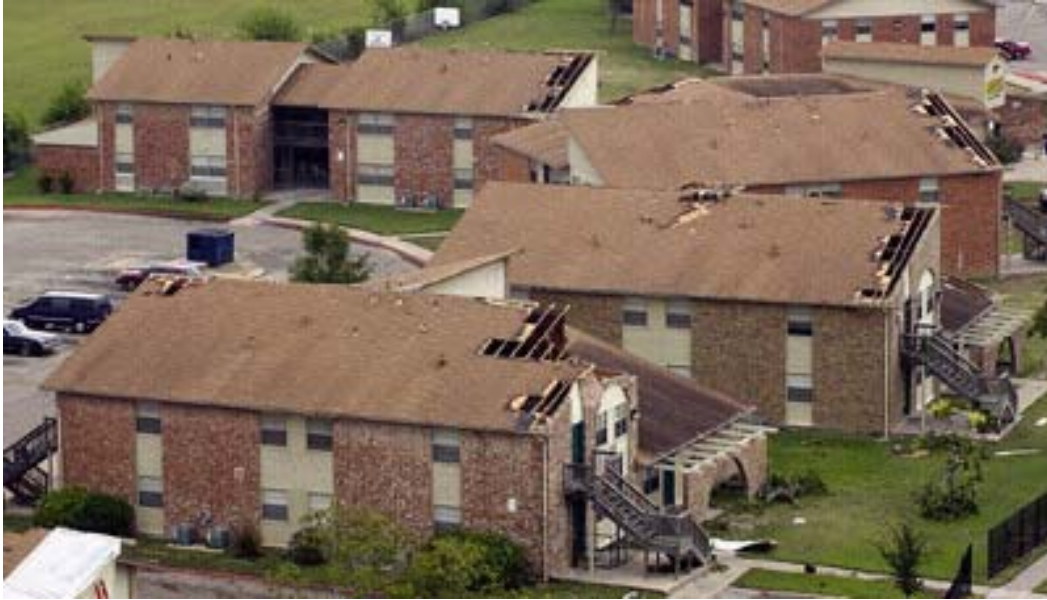
Tornado 3 caused eave-line damage to apartment houses with monoslope roofs
(*Caller-Times* photo/David Pellerin 10.25.2002)

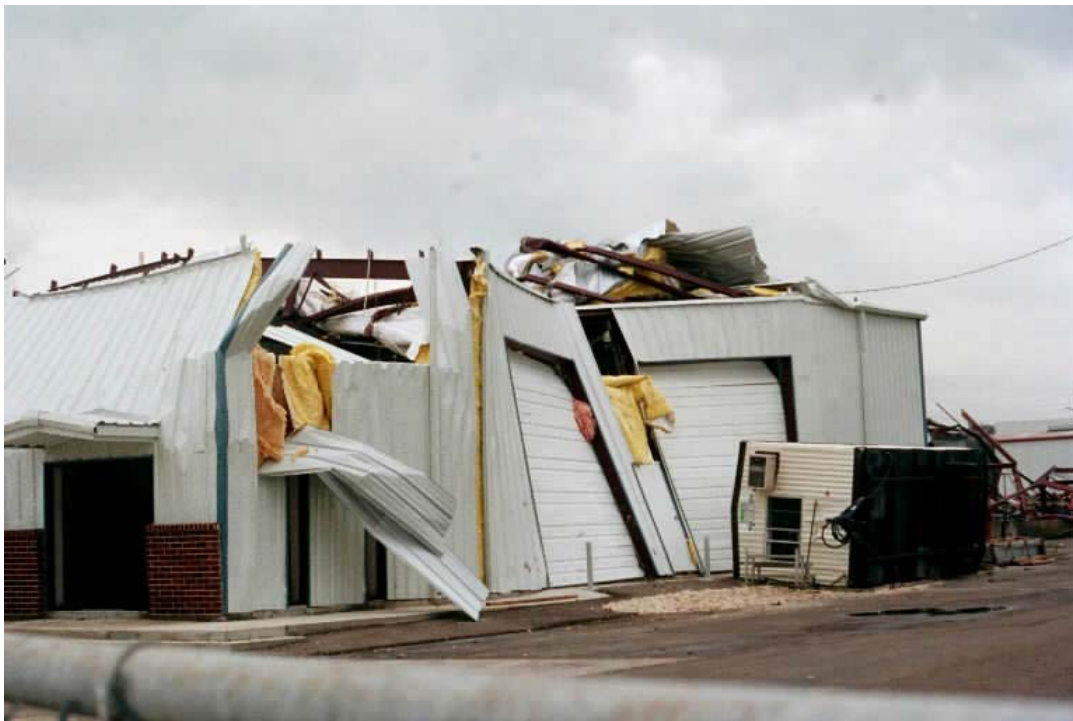
Purlins were removed from bolted connections on the first interior frame (from left) and pulled the second interior frame upward, causing wall with doors to move inward
(Photo by Joseph E. Minor)

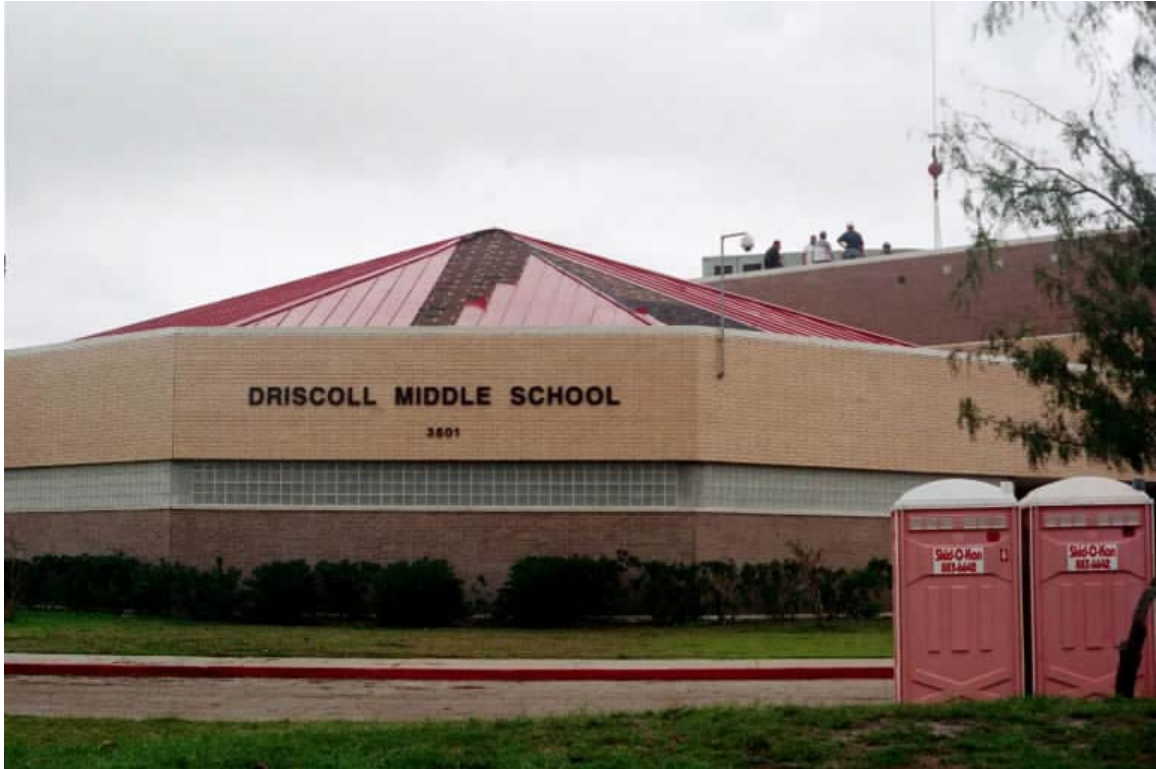
Metal sheathing removed from hip roof on Driscoll Middle School
(Photo by Joseph E. Minor)

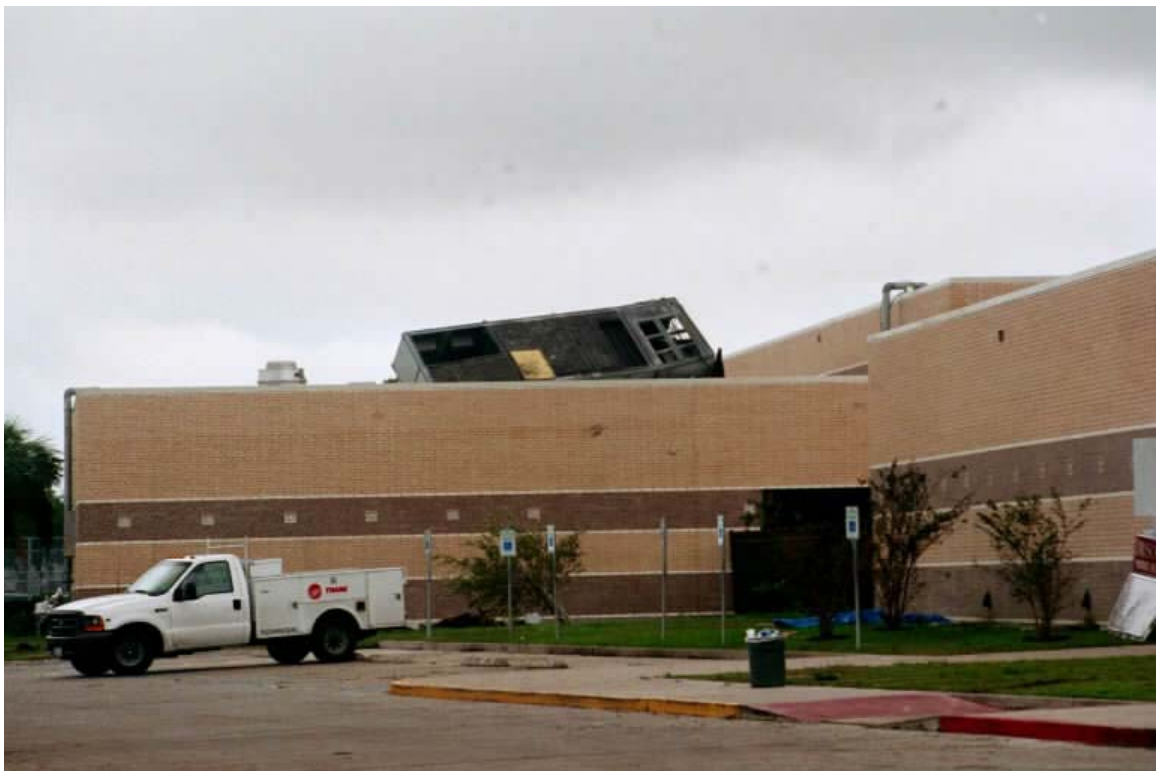
Mechanical equipment overturned on roof of Driscoll Middle School
(Photo by Joseph E. Minor)

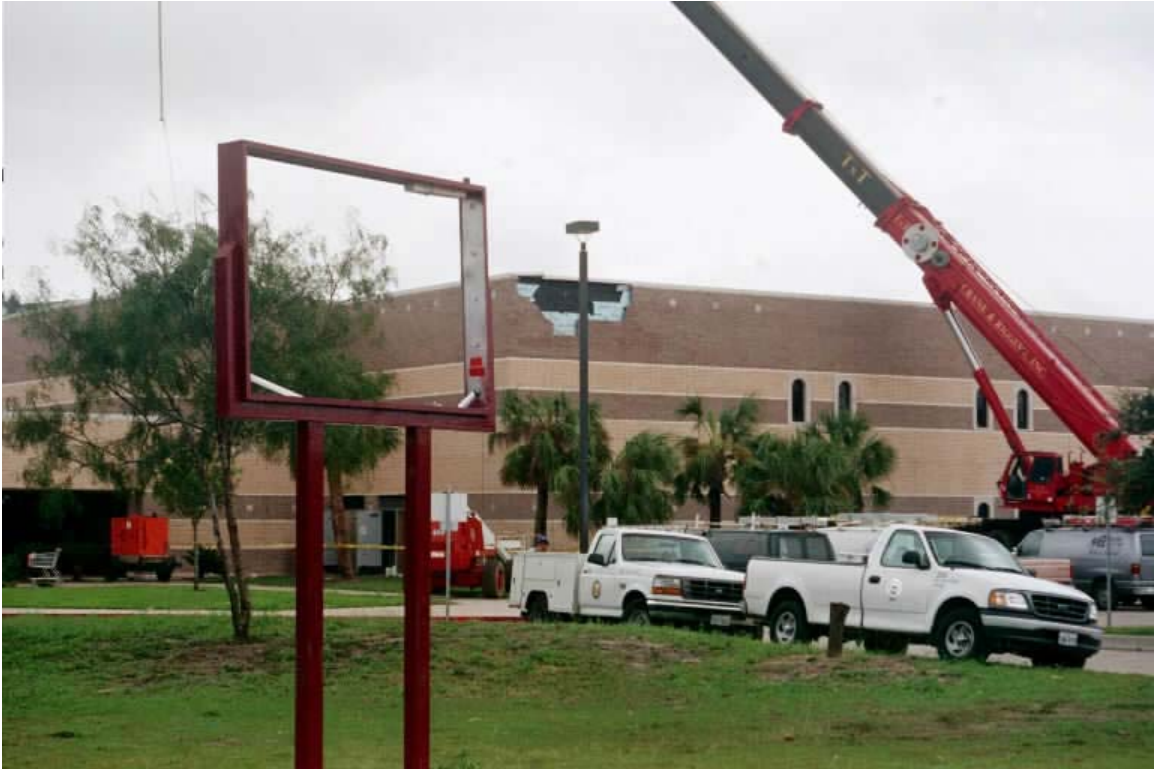
Failure of non-reinforced masonry at corner of walls, Driscoll Middle School
(Photo by Joseph E. Minor)

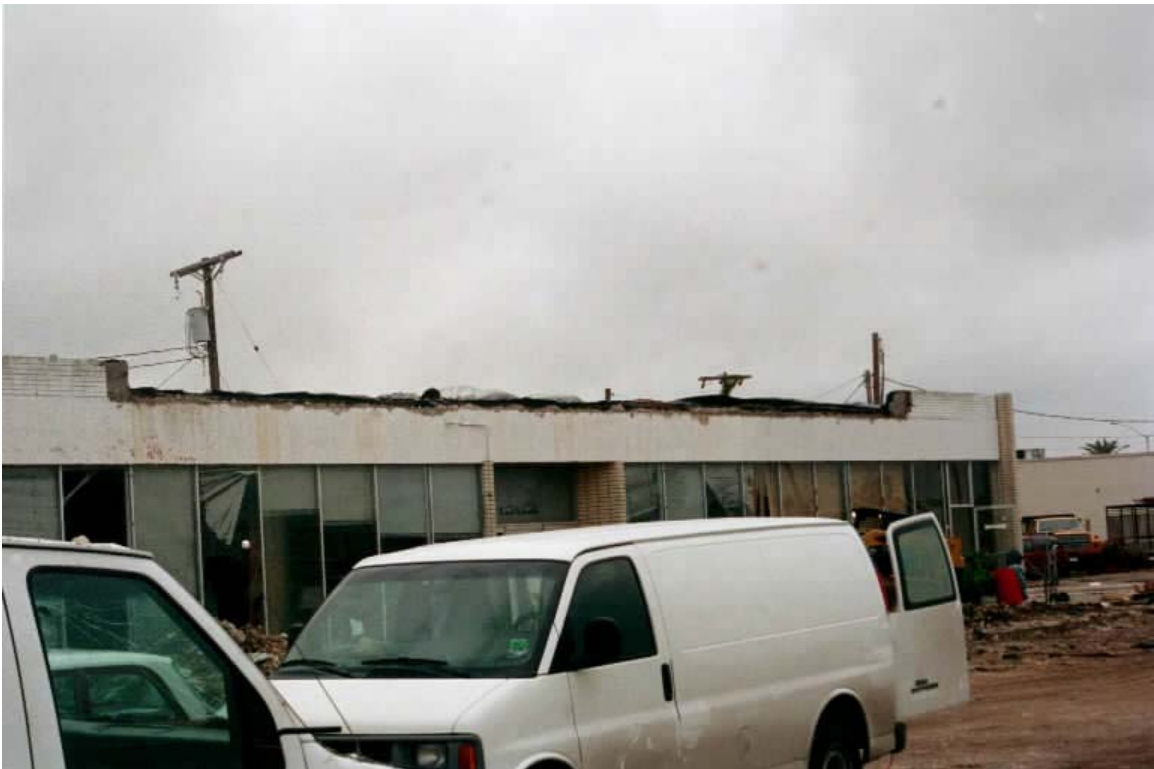
Failure of leeward parapet (two CMUs high)
(Photo by Joseph E. Minor)

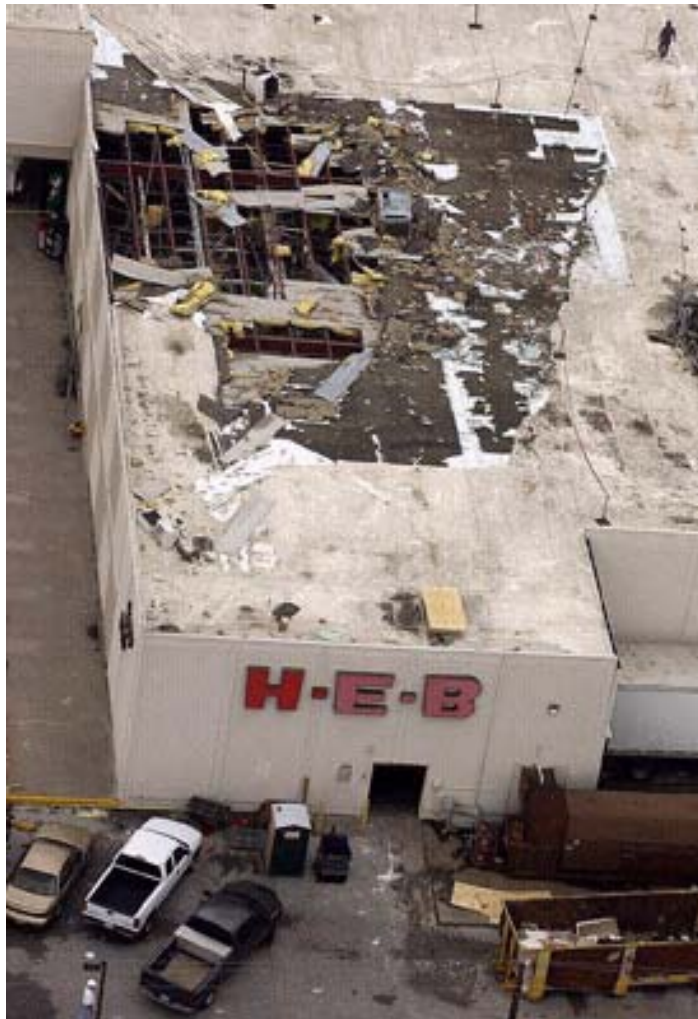
Roofing system failure on HEB Food Store
(*Caller-Times* photo/David Pellerin 10.25.2002)
