DAMAGE SURVEY OF THE TORNADOES NEAR ALTUS, OKLAHOMA ON MAY 11, 1982

James R. McDonald and Timothy P. Marshall

Institute for Disaster Research
Texas Tech University
Lubbock, TX
July 1983

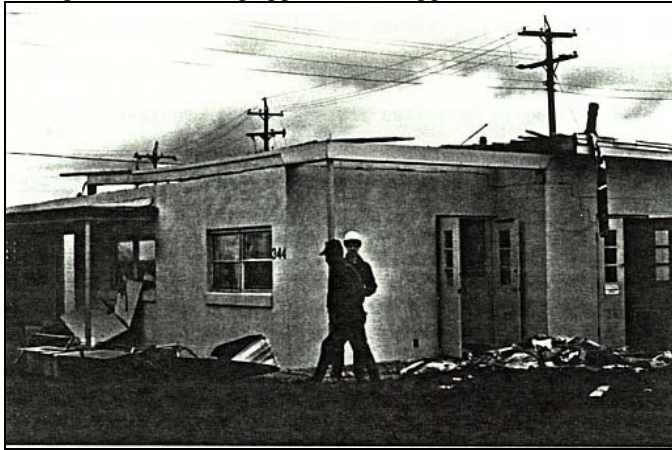
The veterinary clinic is a reinforced concrete masonry building with a flat timber roof (Figure 6). It was located about 200 feet to the right of the tornado center. As the tornado passed, portions of the roof on the windward (south) side were uplifted and transported as far as a hundred feet toward the east. The roof joists were toenailed to a 2x8 plate anchored to a bond beam at the top of the wall. The bond beam was reinforced with two #5 bars. As the roof lifted, horizontal cracks formed in the mortar joint just below the bond beam. These cracks were observed around the perimeter of the building. Based on the loss of roof and minimal damage to the reinforced concrete block walls, damage to the building appears to be upper F2 or lower F3.

Figure 6. Southeast elevation view of the Veterinary Clinic. The cracks in the mortar joint below the bond beam occurred as the roof was uplifted.

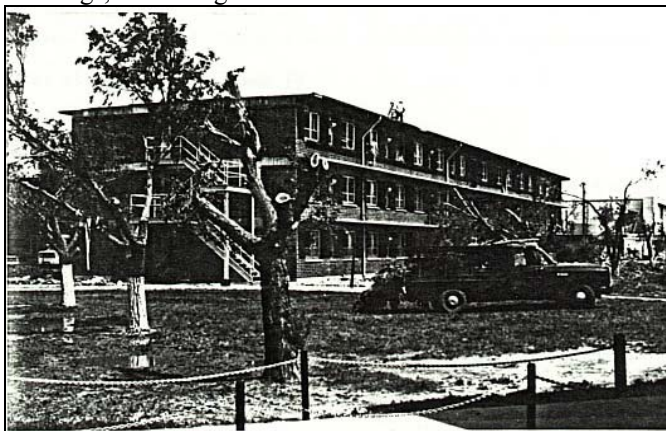
These three-story dormitories have reinforced concrete frames with non-loadbearing brick walls (Figure 7). Each building is oriented in a northwest to southeast direction and is located just left of the tornado centerline. The longest side of each building was normal to the strongest tornadic winds. Most of the damage caused by the tornado was superficial with some broken windows and loss of roofing material. Based on superficial damage to the buildings, the damage was estimated to be F2.

Figure 7. Windward side of dormitory building #315. The steel-reinforced concrete structure had non-loadbearing masonry walls. Damage was limited to the roof covering and windows.

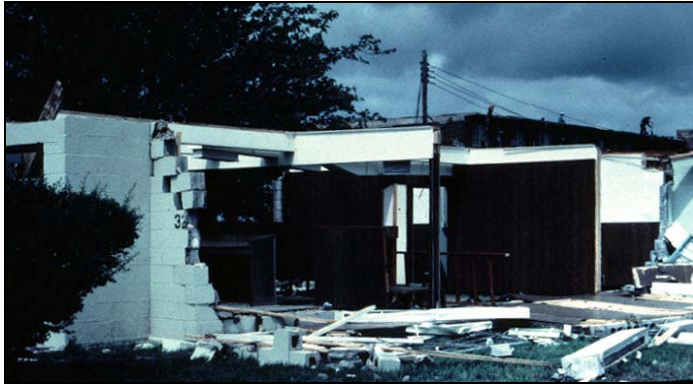
The base lawyer's office is a single-story concrete masonry building and was 100 feet to the right of the tornado centerline. As the tornado passed, the window panels on the back wall failed inward, the timber roof was uplifted, and the front wall fell outward (Figure 8). The top course of each wall was a bond beam. Each bond beam was reinforced with two #5 bars. The bond beam, located on the back wall, traveled in a northeasterly direction nearly 200 feet before striking a pickup and a car (Figure 9). Also, a 12-foot long timber missile sliced through four CMU

blocks on the back wall. Based on the roof damage and missile present, the damage was estimated at upper F2 to lower F3.

Figure 8. Front CMU wall of lawyers office fell outward and roof was uplifted exposing the inner steel-framed structure.

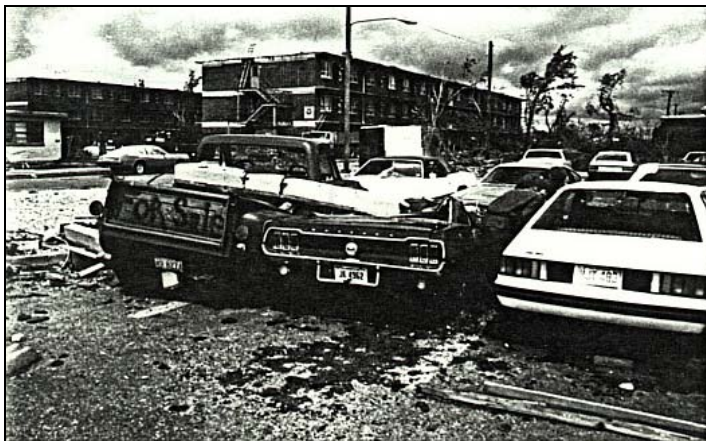
Figure 9. Concrete masonry bond beam missile traveled from the lawyers office northeastward approximately 200 feet before striking these vehicles.

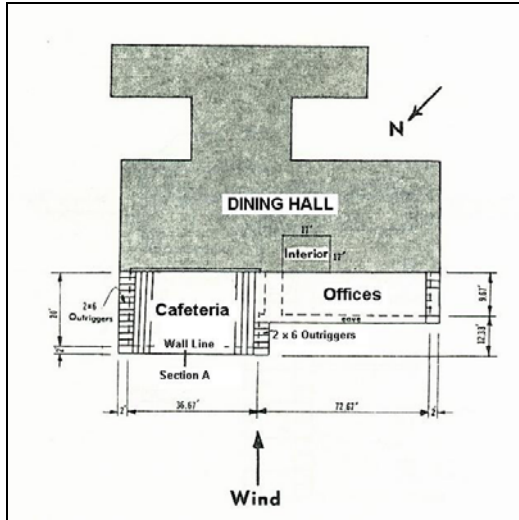
The dining hall is a single story masonry building with a timber roof. The center of the tornado passed 200 feet to the south of the building. Roof damage was observed along the entire length of the windward (north) wall (Figure 10). A closer view of the damage to the cafeteria roof is shown in Figure 11. The roof consisted of 2x 10 inch wooden joists spaced at 12 inches on center. The joists were secured with 10d nails that were toenailed to a wooden plate at the top of the wall. As the tornado passed, part of the roof, including the roof joists, was removed and one precast concrete bond beam was lifted up and slightly displaced. Based on the damage to the roof, the damage was estimated to be F2.

Figure 10. Roof plan diagram of the dining hall. The northwest section of this roof was uplifted (not shaded). The roof was relatively flat and composed of wooden joists supported by steel beams and masonry walls.

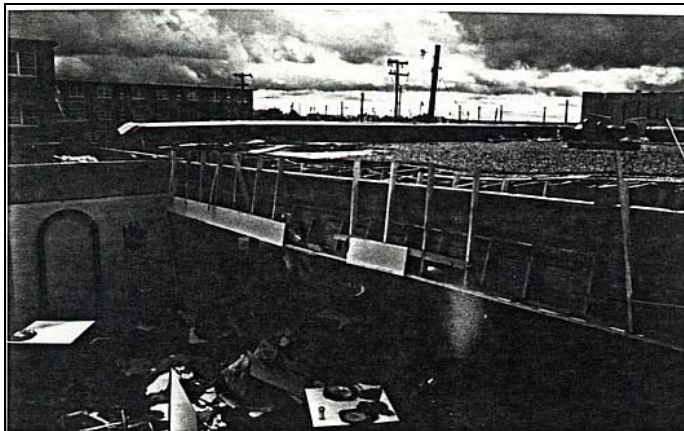
Figure 11. Flat roof section removed from dining hall. Roof was built-up type supported by wooden joists that spanned between steel I-beams and perimeter masonry walls.

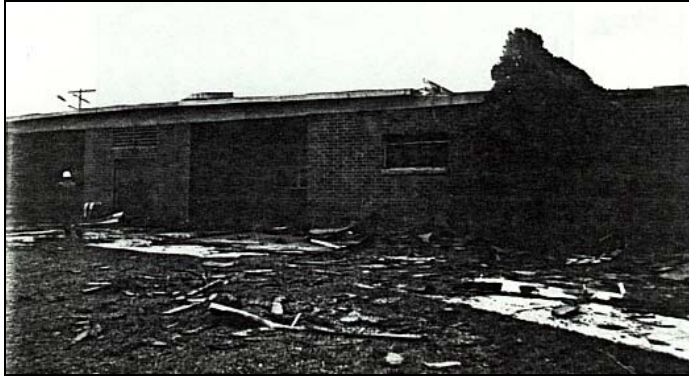
The Recreation Building is adjacent to the Dining Hall and similarly constructed. It is a single story masonry structure with a flat timber roof (Figure 12). Most of the damage occurred at the northwest corner of the building next to the windward side. A portion of the roof was uplifted and window glass was blown inward (Figure 13). The roof joists remained in place but the wood decking was removed. An exterior metal door in the windward wall was damaged by an impact of several timber missiles. Based on the damage to the roof corner and the presence of the missile, the damage was rated F2. Trees in the area sustained light damage and some utility poles were snapped near the ground. However, none of the utility poles were transported by the winds.

Figure 11. Roof corner was removed on recreation building. Roof was built-up type supported by wooden joists that spanned between steel I-beams and perimeter masonry walls.

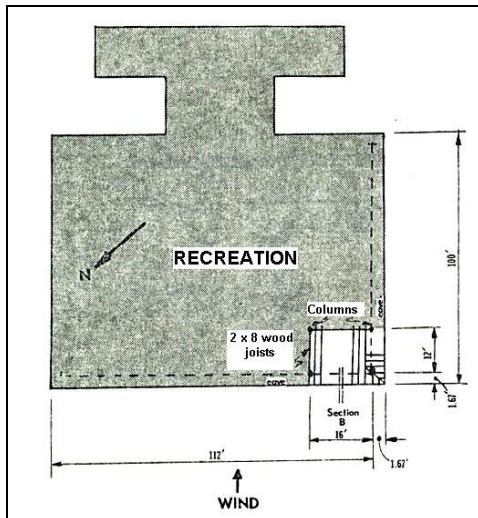
Figure 13. Roof plan diagram of the recreation building. The northwest corner of this roof was uplifted (not shaded). The roof was relatively flat and composed of wooden joists supported by steel beams and masonry walls.

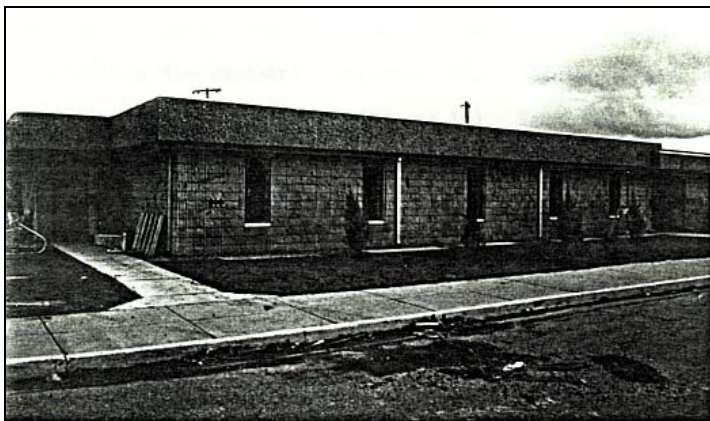
The Contracts Office has masonry walls and a mansard-type timber roof (Figure 14). It was located just left of the tornado centerline. Damage to the building was superficial with broken windows and damage to its fascia from impact of small timber missiles. Several cars in a nearby parking lot were damaged by flying roof gravel, other small missiles and hail. Windows broke in some cars and allowed roof gravel and mud to collect inside. Two compact vehicles overturned but most of the cars remained in place. Based on superficial damage to the building, overturned cars in the parking lot and the observed missiles, the damage was rated F2.

Figure 14. Front elevation view of the Contracts office building. This building only had superficial damage and was just left of the tornado center.

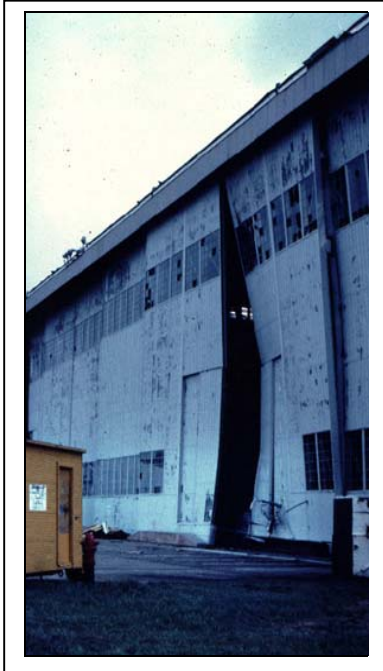
A large hangar 500 feet wide by 600 feet long and 80 feet tall was damaged by the tornado. The damage was confined to the siding, doors and roof on the windward (southwest) side. As the tornado passed, the hangar doors were blown inward (Figure 15). Each door section is 65 feet high and 20 feet wide. The doors are suspended from the top of the hangar and are guided on tracks at the bottom. A closer view of the hangar doors revealed that the lower edge of the center door was pushed about four feet inward. The hangar was approximately 600 feet to the right of the tornado centerline, on the periphery of the tornadic winds. The roof is constructed with 30 in. wide by 8-ft long sheets of 18 gage metal deck. The deck is 1.5 in. deep and has ribs spaced 6 in. apart. One-quarter inch diameter spot welds at the ends of each rib attached the deck to the roof framing system. Several of the sheets were uplifted and then fell back into the building.

Asbestos siding was removed from portions of the walls at the corners. The siding was removed after it cracked and allowed the anchor bolt to slip through the crack. Based on damage to the hangar doors, the partial roof uplift and loss of siding at wall corners, the damage was rated F1.

Figure 15. Large hangar door buckled inward from wind.

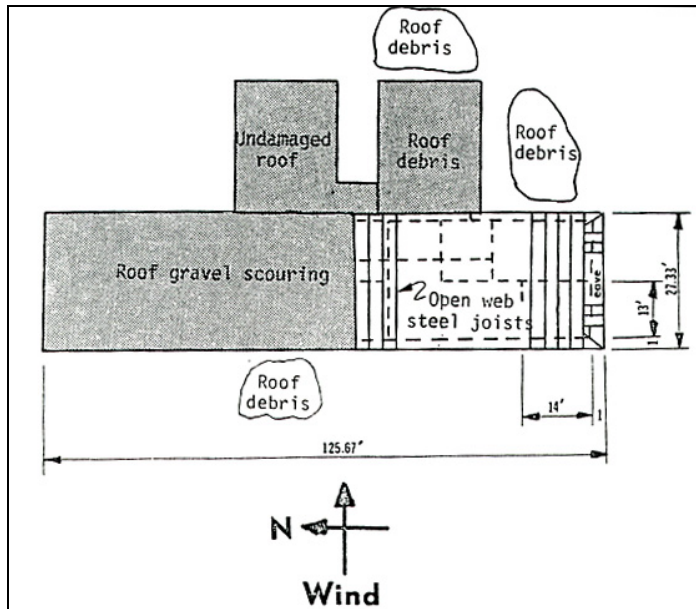
The Communications Building is a single story concrete block building with a lightweight concrete roof. The building has a long, rectangular shape and is oriented in a north-south direction (Figure 16). As the tornado passed by, roof sections on the south half of the building were uplifted whereas the northernmost half of the roof remained in place. This observation supports the contention that the center of the tornado passed directly over the building. The roof consists of a 2-in. thick perlite (lightweight) concrete slab poured over a fabric-backed wire mesh. The mesh is laid in 8-ft wide strips. It is secured to the steel joists with twisted galvanized wire. The open web steel joists are spaced 30 in. on center and are anchored to a bond beam with two half-inch diameter bolts. The somewhat unusual construction of the roof is the result of the building being designed to resist blast. As the tornado passed by, the twisted galvanized wires failed and the perlite slabs were lifted and rolled off the roof (Figure 17), but the steel joists remained in place. Based on damage to the roof and the surroundings, the damage was assigned a rating of F-3.

Figure 16. Roof plan diagram of the Communications Building. The damaged area of the roof is not shaded. Flat roof was comprised of lightweight concrete deck that was tied to open web steel joists.

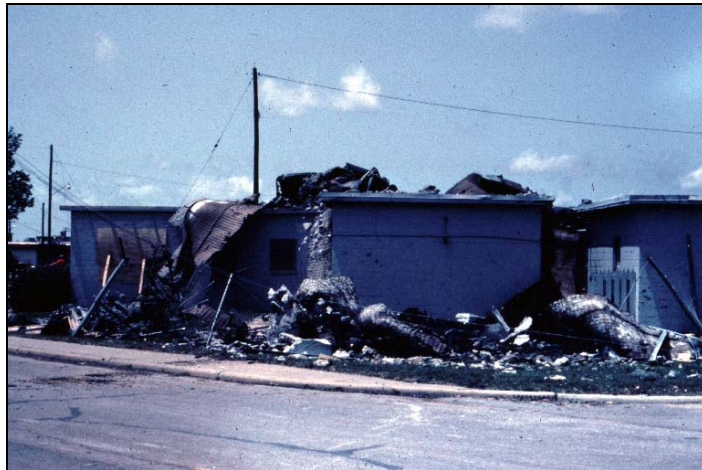
Figure 17. Lightweight concrete roof rolled off Communications building. The reinforcing mesh in the roof slab was secured with small wire twisted to open web steel joists.

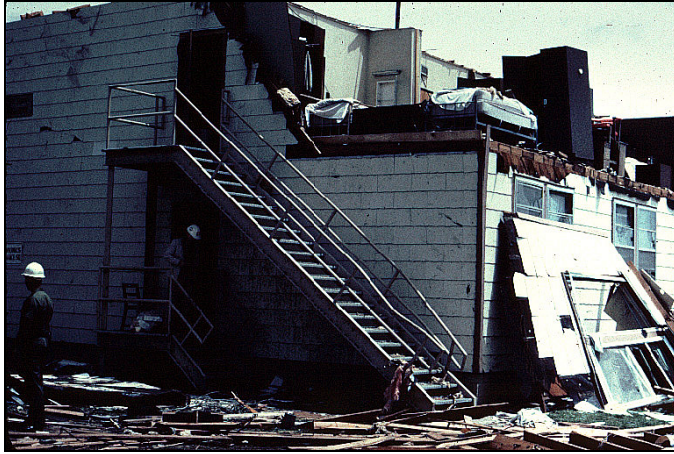
A series of five two-story wooden barracks were heavily damaged by the tornado. Sections of the roofs were removed and second story walls collapsed (Figure 18). Not all the roofs failed in the same manner. Some of the roof failures were attributed to anchorage of the roof to the wide. Roof joists that were toenailed to plates on top of the walls pulled loose. In other cases, the wood joists split horizontally along their entire length. When the roof joists were removed, the top of the walls were left unsupported and in many cases the walls collapsed. The damage was estimated to be F2 or F3 based on damage to the wooden roof system.

Figure 18. Removal of roof and portion of second story exterior walls on wooden barracks. This damage was rated F-3 on the Fujita scale.

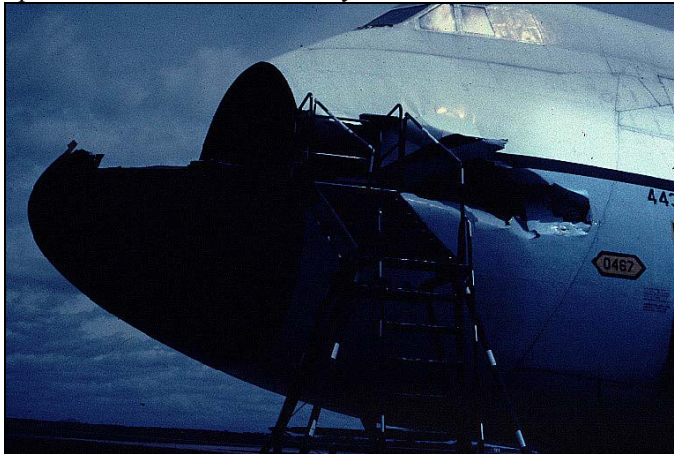
Two C-5 Galaxy aircraft and one C-141 sustained major damage while four C-5s had minor damage. The aircraft were parked in a north-south row facing west before the tornado (Ref. Fig. 5). As the tornado passed over the aircraft, one C-5 Galaxy pivoted 90 degrees toward the south (Figure 19). The nose of the aircraft came in contact with the wing of another. The aircraft that pivoted was located on the northern (left) periphery of the tornado. Specifications of the C-5 Galaxy aircraft are listed in Table 3 in the Appendix.

Figure 19. Damage to the nose of a C-5 aircraft. The aircraft pivoted 90 degrees and struck the wing of an adjacent C-5 as the tornado passed.

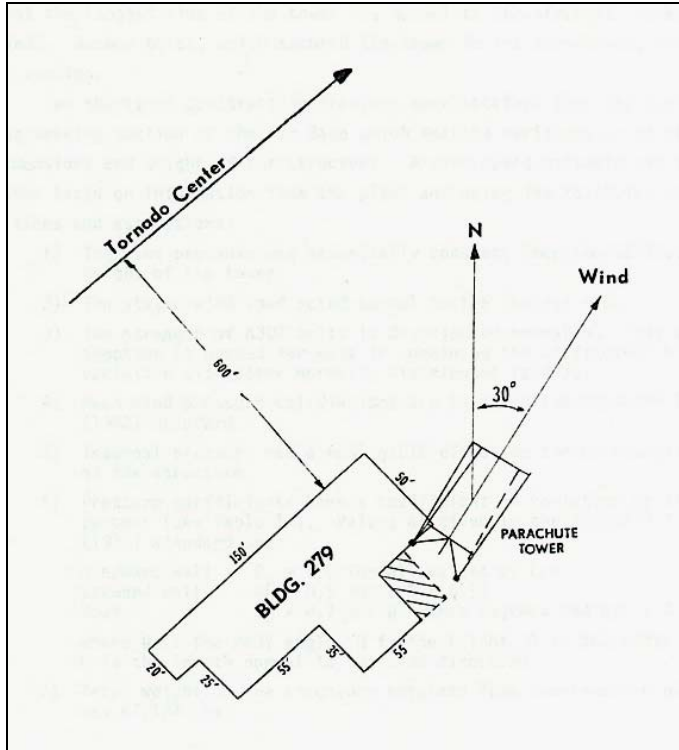
The Parachute Drying Tower was located on the right side of the tornado path approximately 650 feet from the tornado center (Figure 20). The rectangular tower measured 28'-6"x15'-6" in plan and was 62'-4" high. It was anchored to concrete footings with four 5/8" diameter A307 anchor bolts at each corner. As the tornado passed, the tower pivoted about a line through the two corner columns on the leeward (northeast) side of the tower (Figure 21) and fell toward the northeast. The anchor bolts failed in tension. Based on the collapse of the tall, rather fragile tower, the damage was rated F1.

Figure 20. Plan view diagram of the parachute drying tower at Building 279. The tower toppled to the northeast as the tornado passed by to the northwest.

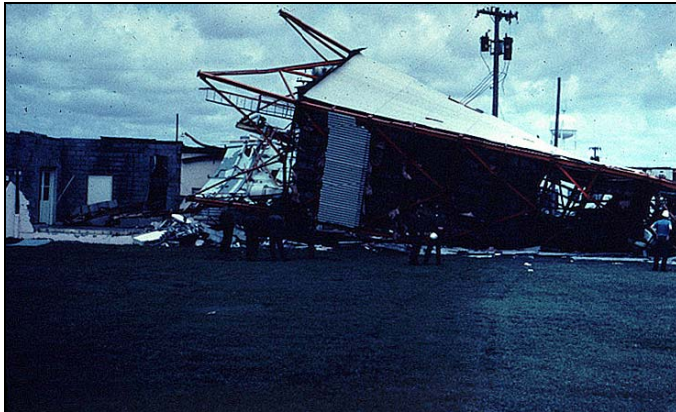
Figure 21. Overturned parachute drying tower. Failure initiated when anchor bolts securing the two corner columns had failed in tension.

The failure modes for the structural analyses were primarily due to connection and anchorage failures. The Parachute Tower overturned when anchor bolts in two of the corner columns failed in tension. Roof failure at the Dining Hall and Recreation buildings occurred when the wood joists, which were toenailed to the plate at the top of the wall, uplifted. Uncertainties in the pullout strength of toenailed connections are reflected in the rather wide confidence bands. In the case of the Parachute Tower, structural calculations predict an expected value that is 25
