**Storm Observations and Damage Survey
of the Tornado Outbreak Near
Pampa, Texas on May 19, 1982**

Timothy P. Marshall
James R. McDonald, P.E.

Institute for Disaster Research
Texas Tech University
Lubbock, TX

June 1983

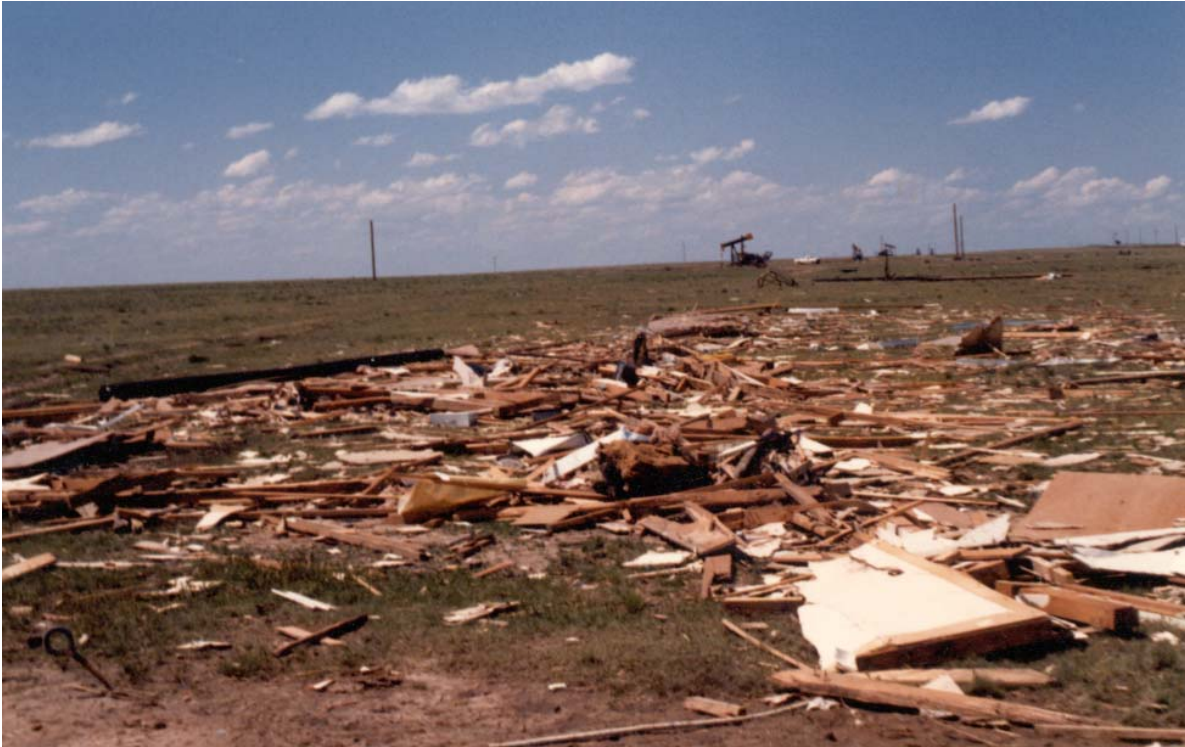
The damage survey revealed that the tornado traveled only two miles during the twenty-two minutes it was on the ground. The damage path extended northeastward and then curved back towards the northwest where a building was demolished. The entire building was moved more than 100 yards toward the west with debris scattered northwestward (Figure 10). Closer inspection revealed that the building was not anchored to its foundation. Trees in the area were stripped of large branches and telephone poles were snapped off at the ground. Several large oil tanks were damaged by flying debris and covered with mud. Based on damage to the building and the surroundings, the second tornado was rated an F3.

Figure 9. View looking north of the remains of a wooden building which was not anchored to its foundation.

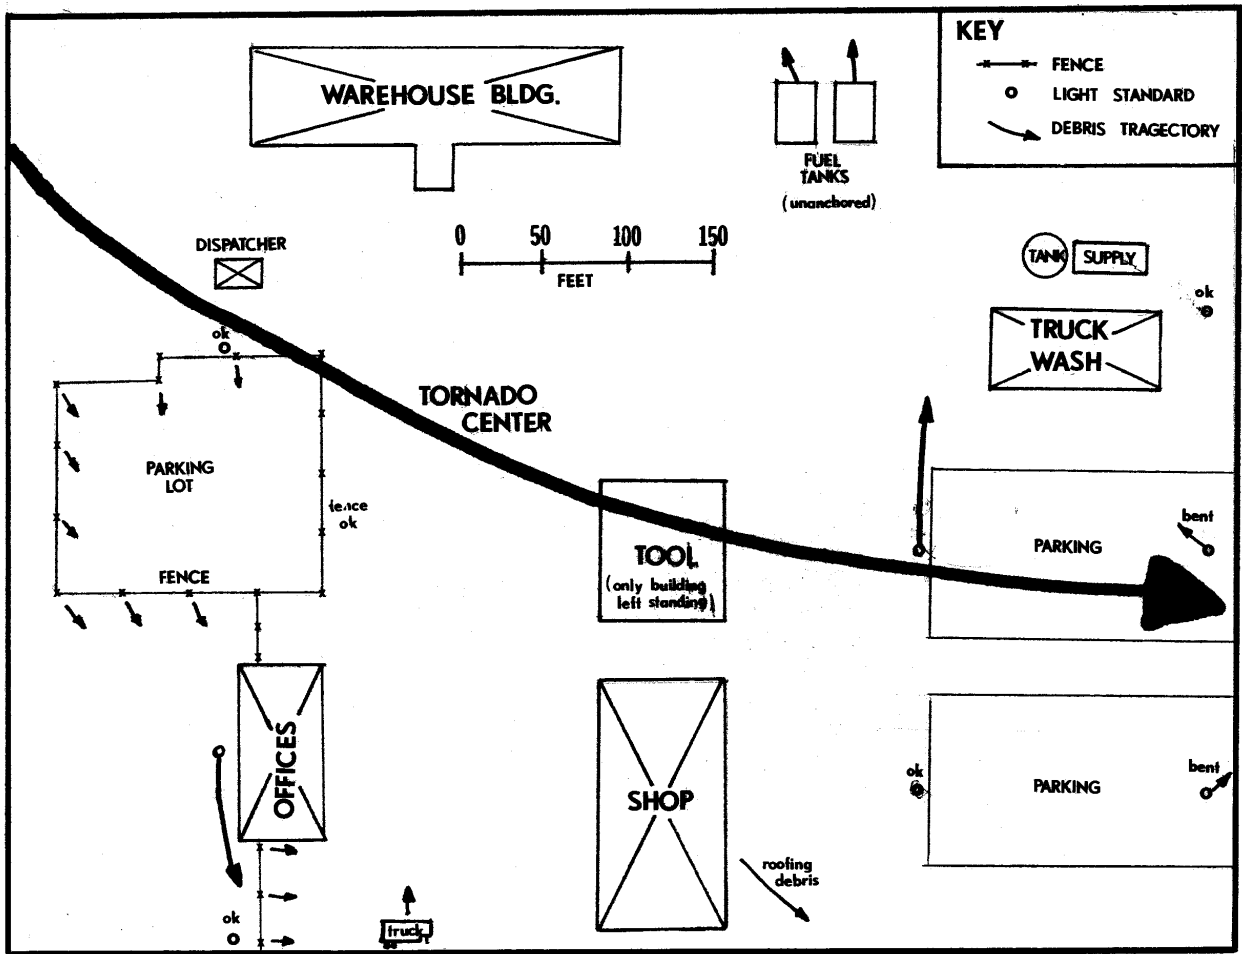
The tornado traveled across the complex from the northwest to southwest direction. All but two buildings were totally destroyed. Damage at Halliburton Services was carefully documented by photographs and tape recorded comments. A summary of the damage caused to each building is presented here. Based on damage to Halliburton Services and the surrounding area, the damage intensity was rated F3.

Figure 10. Plan view of the path of Tornado #4 through Halliburton Services.

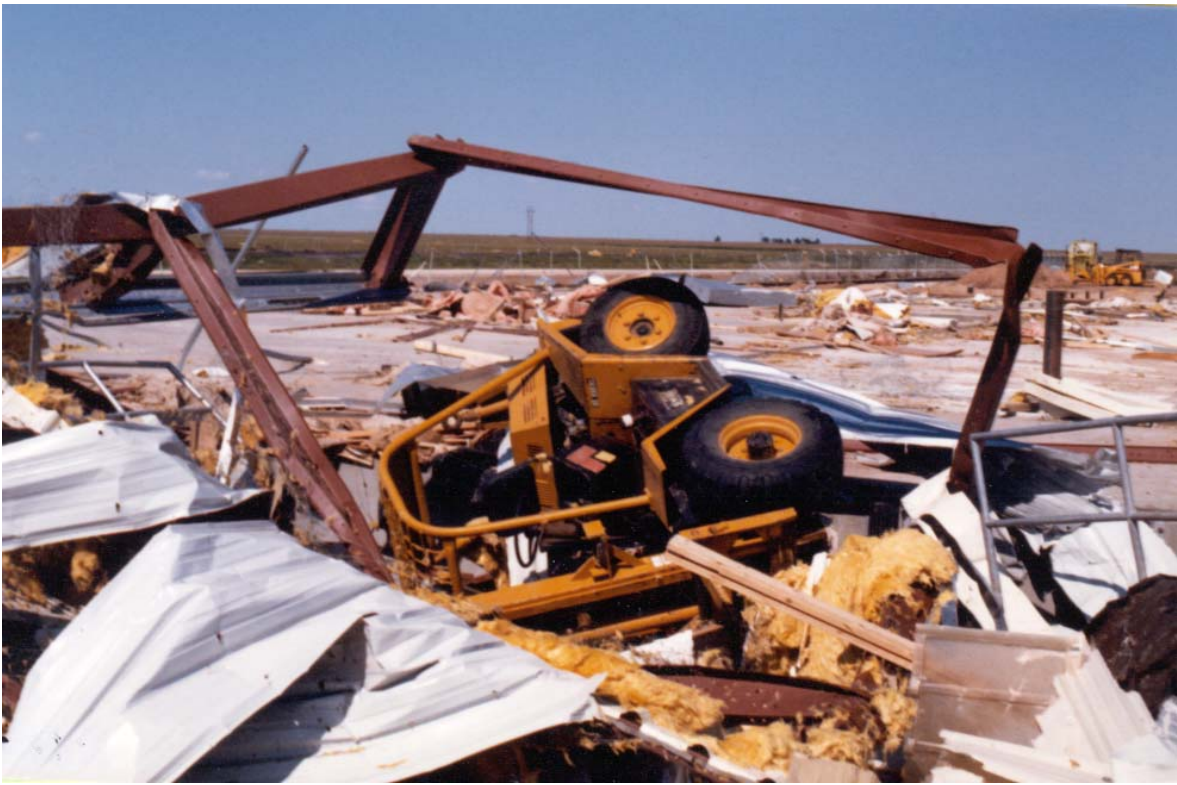
The Warehouse-Admixture building was the largest building on the complex. It had a rectangular shape and measured 220' x 60' x 21' tall. Columns were evenly spread at 20' on center. Figure 11 shows all that was left of the building. Block masonry walls were located at the ends of the building and were horizontally reinforced. As the tornado passed, the building appeared to be laterally displaced toward the west. The masonry walls failed and the building collapsed. Figure 12 is a view of the building after it was rebuilt in the same manner as before the tornado.

Figure 11. Remains of the Warehouse-Admixture building which was totally destroyed by the tornado

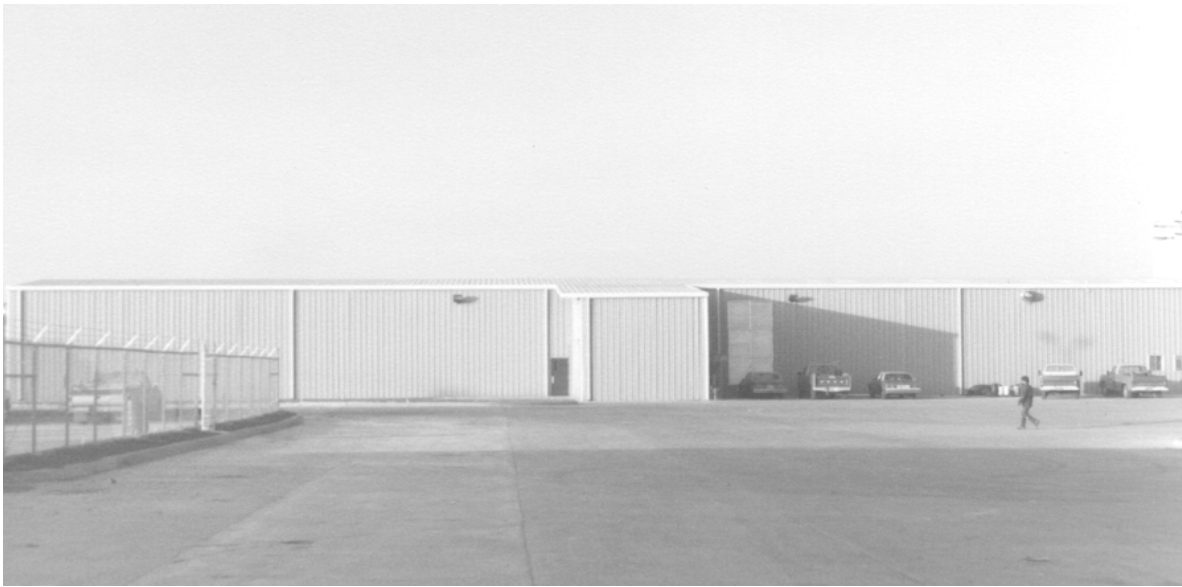
Figure 12. View looking north of Warehouse-Admixture building as rebuilt.

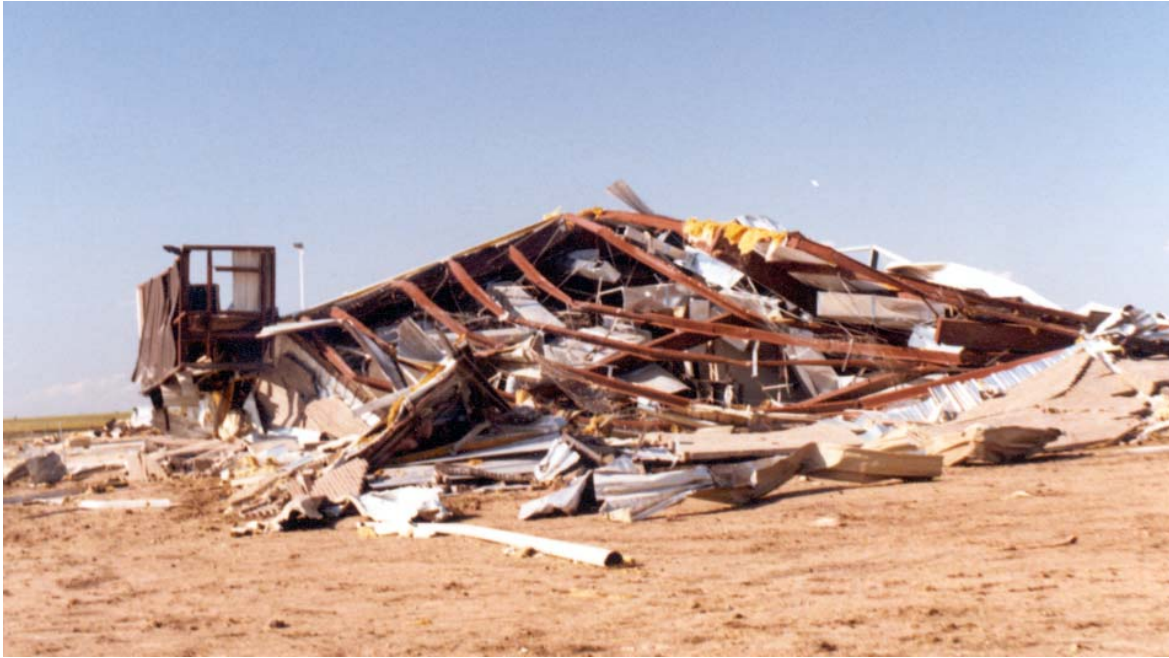
The office building also has a rectangular shape which measures 100' x 50' x 14' tall. Unreinforced face brick veneer was placed on the exterior of the building perimeter. As the tornado passed, the building was laterally displaced toward the south (Figure 13). Columns buckled and the building collapsed. A 30' light standard initially located in front of the building broke off at the base and was transported southward approximately 100 feet. Figure 14 shows the Office building as rebuilt.

Figure 13. Damage to the Office building looking north. Note position of light standard.

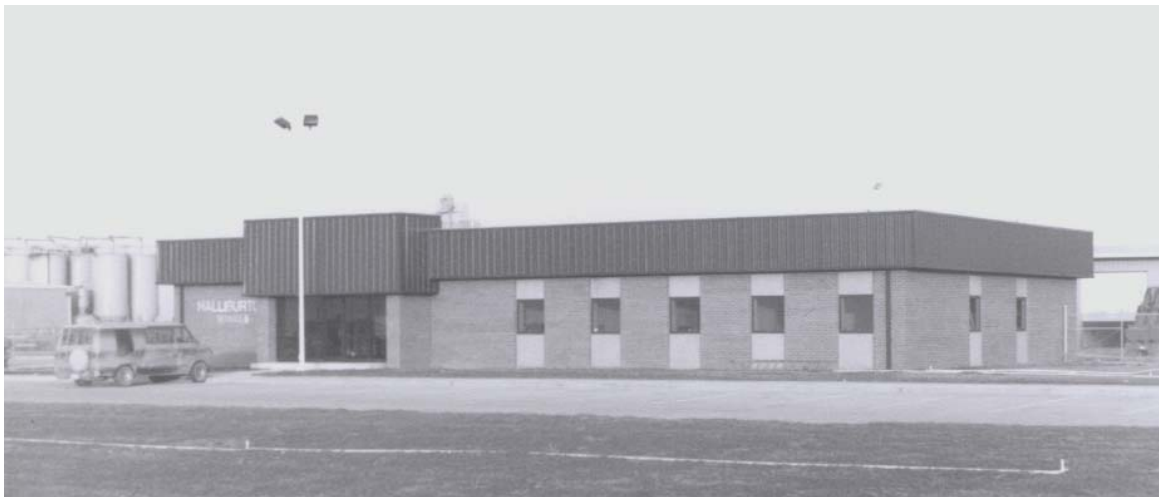
Figure 14. View looking northwest of the Office building as rebuilt.

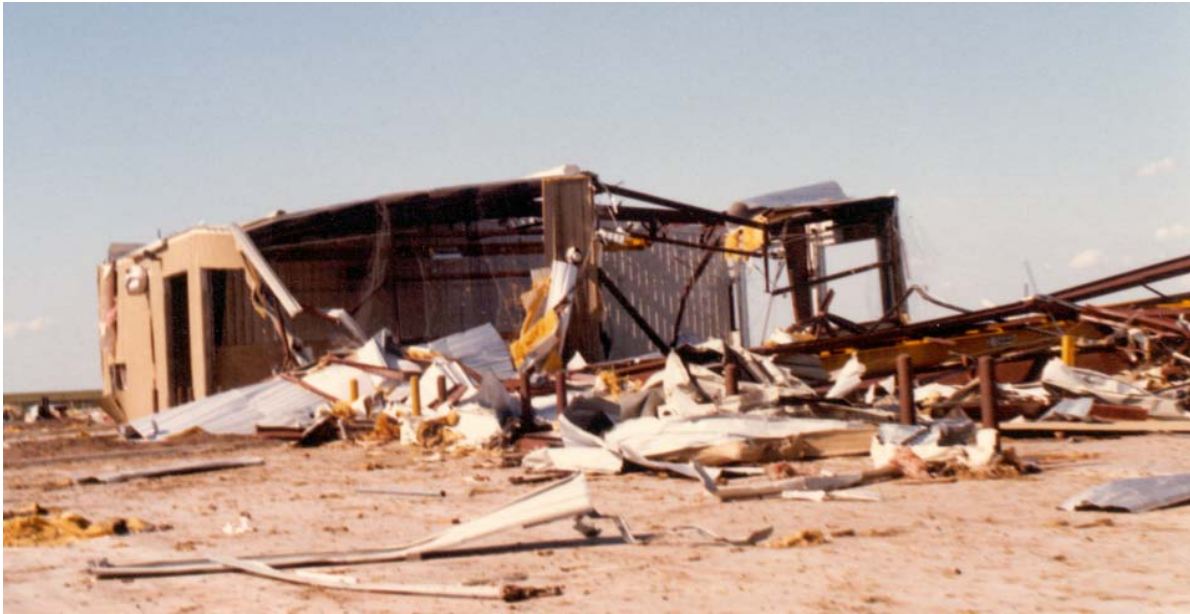
The Tool building was almost square-shaped measuring 80' x 70' x 25' tall. As the tornado approached, the west side of the building became the windward face. Several punctures in the short metal wall resulting from flying debris were noted. The overhead debris on the west side buckled inward allowing the wind to enter the southern portion of the building (Figure 15). Subsequently, the south wall fell outward and the overhead doors on the east side of the building buckled outward. Figure 17 is a view of the Tool building after it was rebuilt.

Figure 15. The Tool building was the largest building left standing after the tornado. View is looking north.

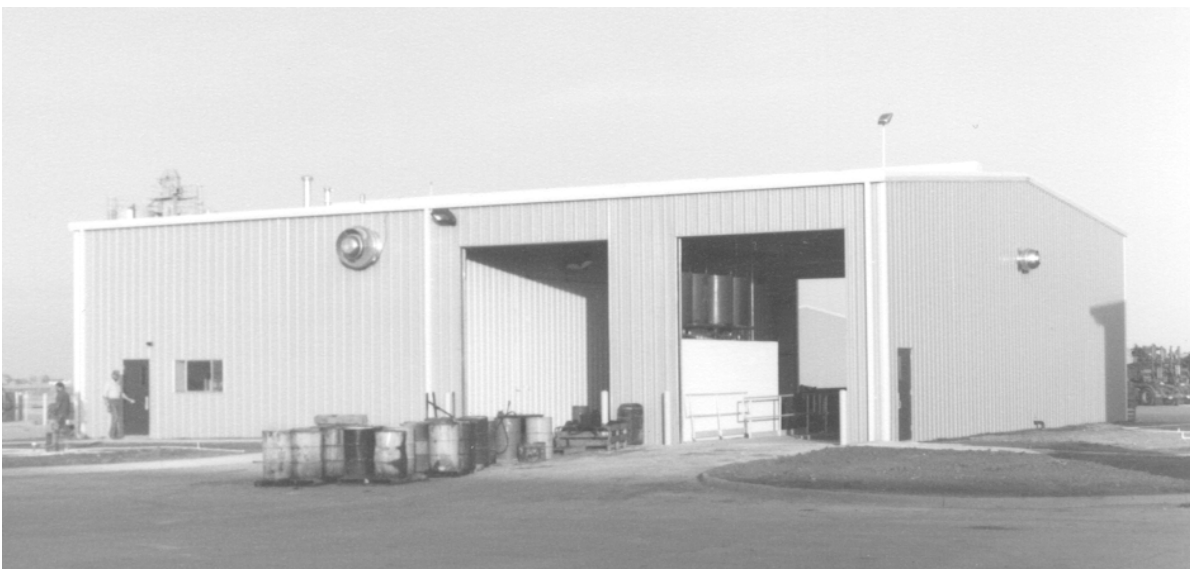
Figure 16. View looking northeast of the Tool building as rebuilt.

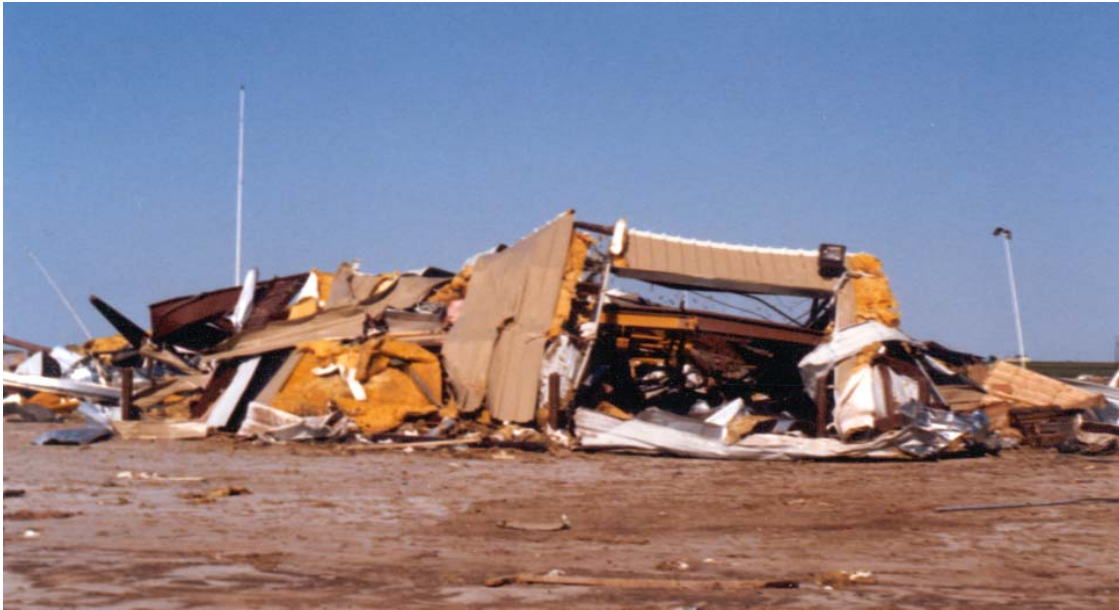
The Shop building was a rectangular shape, measuring 160'x 70'x 26' tall. As the tornado passed, the building was laterally displaced toward the east (Figure 17). Seven overhead doors along the west wall buckled inward. It appeared that the beams buckled out of plane as the column anchorages failed.

Figure 17. View looking east of the remains of the Shop building.

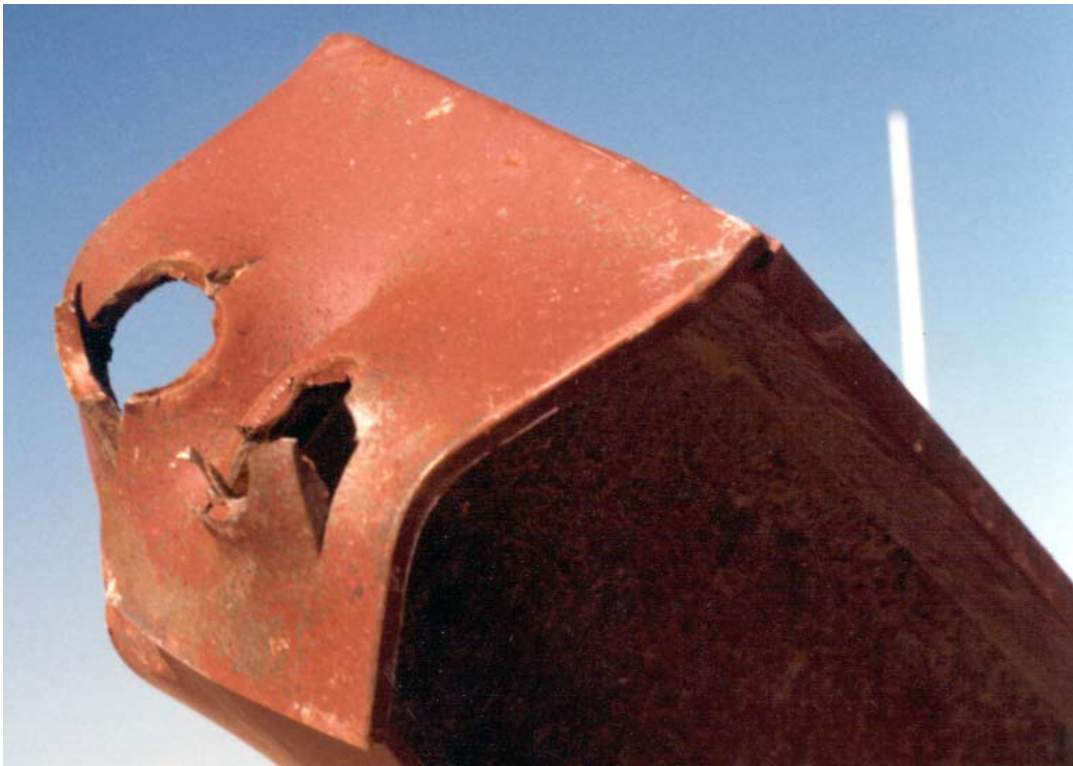
Two types of column anchorage failures were most common. Either the 7/8 inch diameter anchor bolts were pulled through the 1/4 inch column base plates (Figure 18) or the column base plate tore (Figure 19). Failure of the anchorages in this manner allowed the building to displace eastward and collapse.

Figure 18. Example of column anchorage failure in the shop building. The anchor bolts pulled through the column base plate as the column was uplifted.

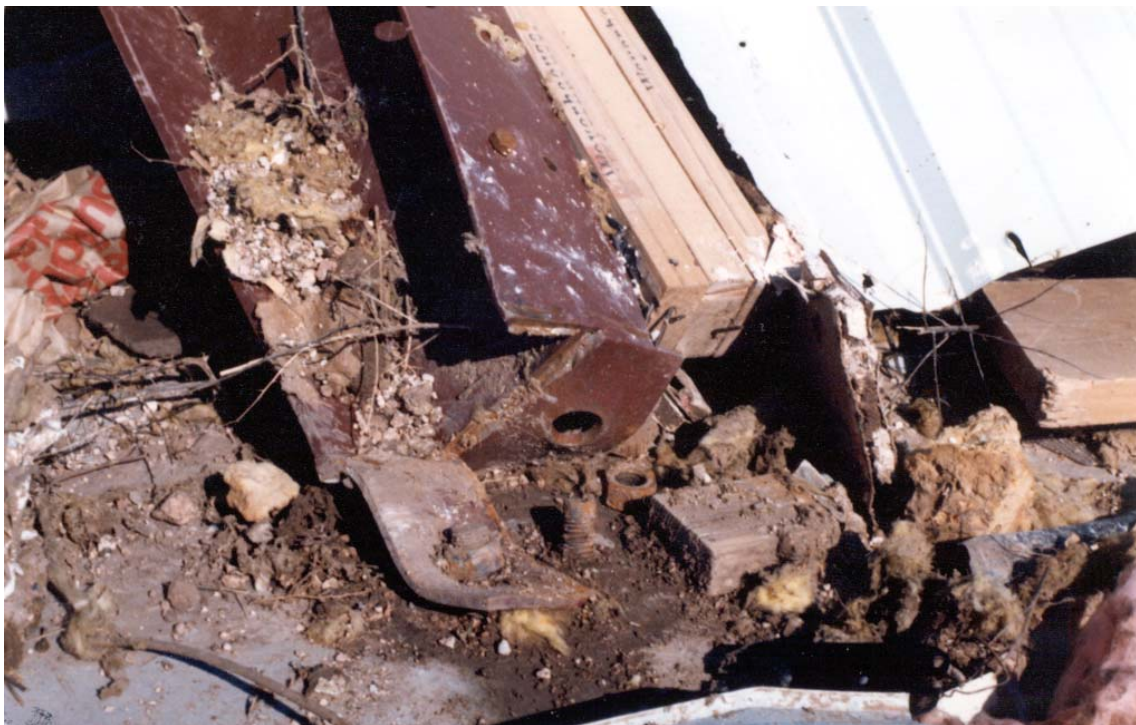
Figure 19. Example of column base plate tearing in the Shop building

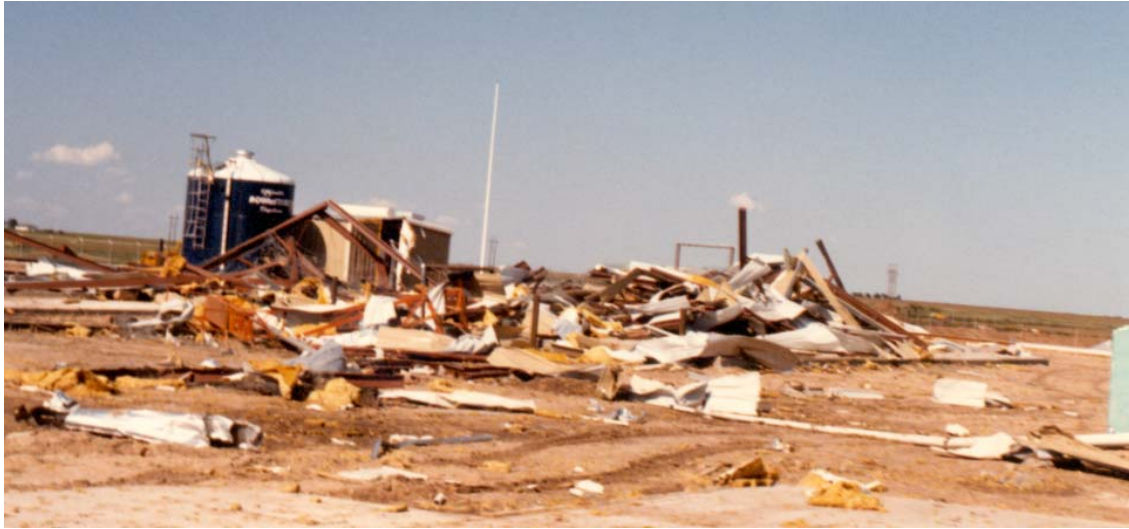
The Truck Wash building was rectangular in shape, measuring 100'x 44'x 27' tall. Results of the damage survey show that the building was on the northern side of the tornadic winds. As the tornado passed, the building was displaced northward (Figure 20). An empty tank and supply building which were adjacent to the Truck Wash building had minor damage. A light standard found in front of the building was displaced from approximately 100 feet away. Figure 21 is a view of the Truck Wash building after it was rebuilt.

Figure 20. View looking east of damaged Truck Wash building.

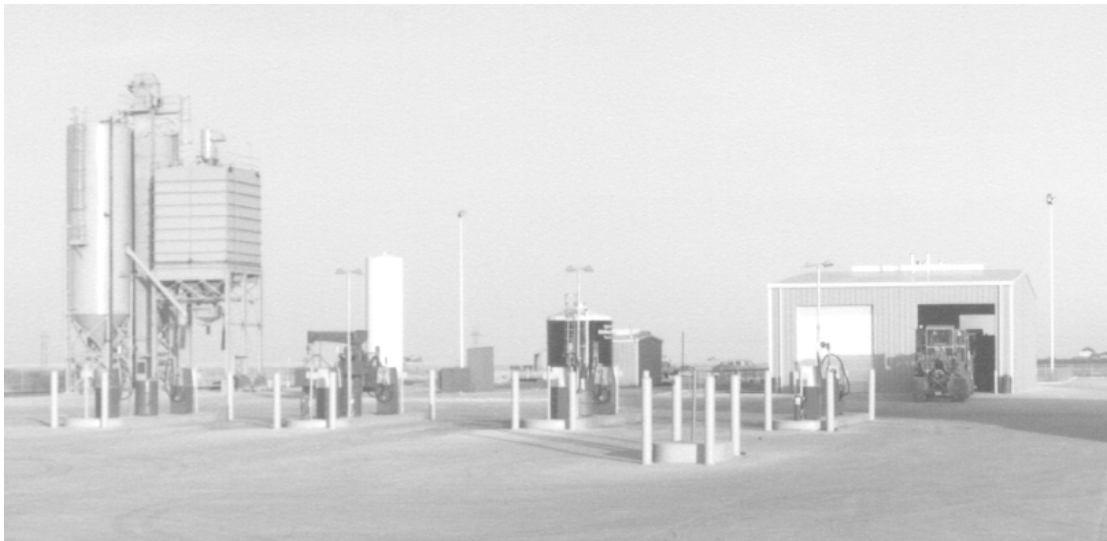
Figure 21. View looking west of Truck Wash building as rebuilt.
