May 20, 2013 Moore, OK Tornado Shelter Performance Report
Larry J. Tanner, Pataya L. Scott, Joseph Dannemiller, Daan Liang

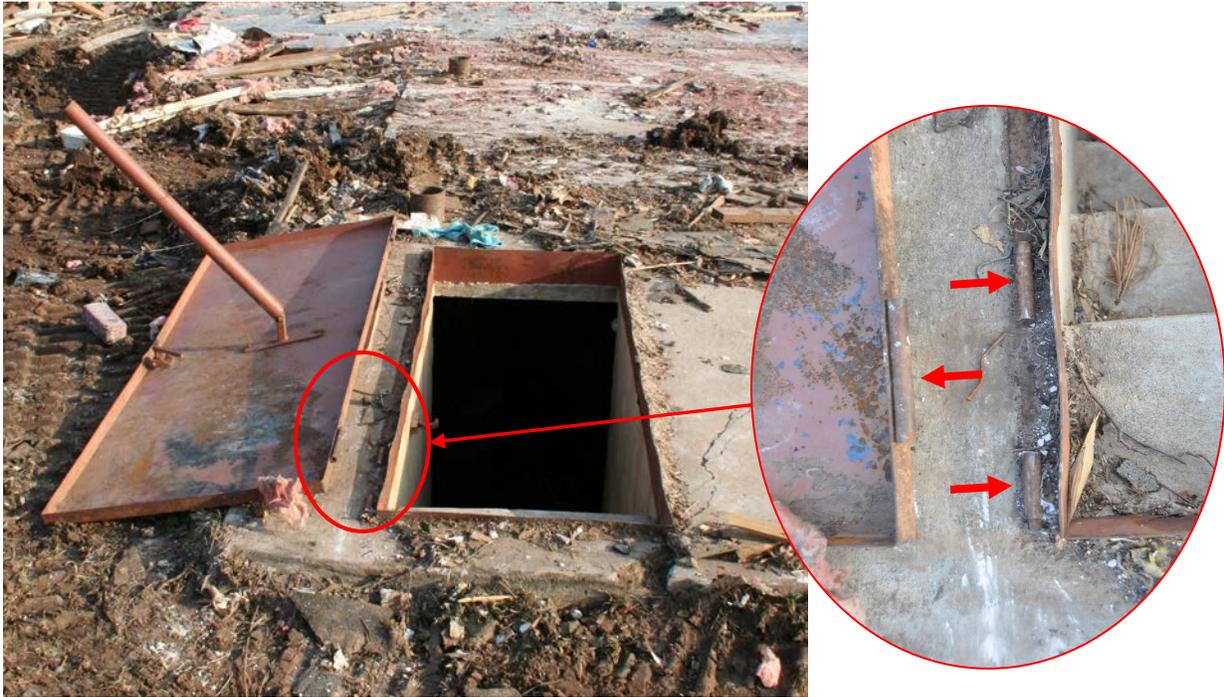
The team documented eight flush-to-the-ground shelters, all of which had hinged swinging doors. One shelter (No. 47) sustained a significant failure as the door was blown off due to rusty hinge pins with sheer failure (seen in Figure 7). The door of another shelter (No. 14) was stuck shut and the homeowner, an elderly man, opted to take shelter in an interior bathroom of his home with his pets. Additional deficiencies with shelters of this type were related to door thickness, locking systems, hinges, stairs, and drainage. Many of such shelters were not properly designed with beveled edges slightly above-ground to allow water runoff to flow around the opening, and as the result had been flooded with 6 inches to 4 feet in depth of water. Flooding was a common complaint among homeowners. Many homeowners were under the impression that they were safer in below ground shelters even though most of the units were not tested per building standards.

Figure 7. Door failure when accessing shelter with only a single lock point (No 47).

- d. Outdoor shelters must be maintained annually with rust removal and repainting.
 - e. Additional locking systems should be added to the existing shelters that only have one lock.

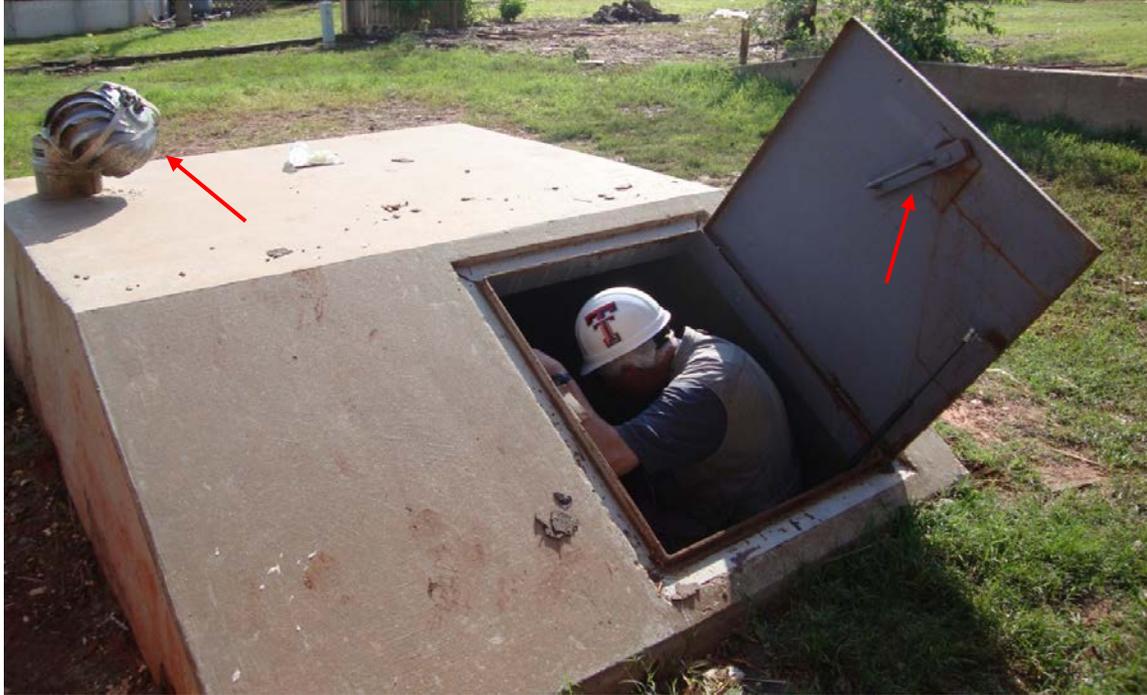
Fifteen clam shell shelters were documented with no observed major failures. However, deficiencies were found consistently in doors and ventilators. Many doors had only one locking latch and an insufficient number and inadequate type of hinges. As with below In Figure 8 a clam shell shelter (No. 3) was designed with only one lock, two hinges, and sustained vent damage at an EF-2 rated location. In Figure 9 a clam shell shelter with a tested door that included three locks and three hinges was documented at an EF-4 rated location. A flat-top clam shell shelter (No. 17) was documented in an EF-2 rated location, as seen in Figure 10. Performance of these types of shelters was good. Accessibility to the shelters can be an issue because this type is always located outdoors and the distance people must travel to take shelter needs to be considered when deciding placement. One shelter was located about 100 feet from the house which could pose a greater threat to potential occupants if they need shelter quickly. Standing water of several inches was also commonly observed.

Figure 8. Clam shell shelter with an insufficient locking system and damaged vent at an EF-2 rated location (No. 3).

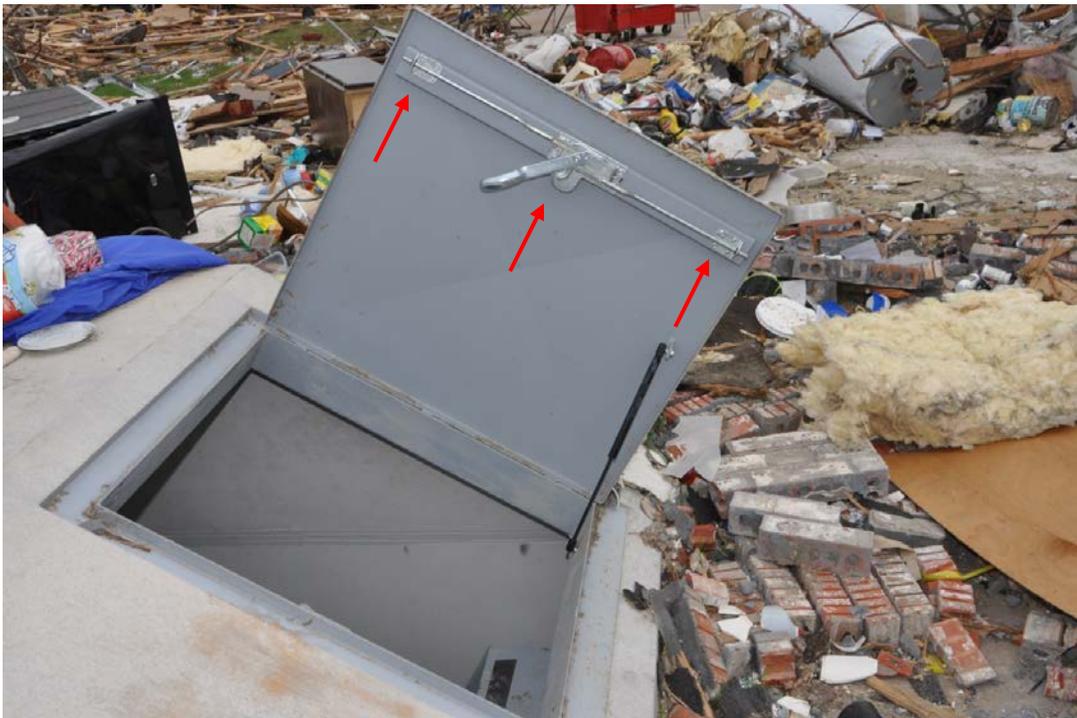
Figure 9. Clam shell shelter with a tested door that has three locks and three hinges at an EF-4 rated location (No. 28).

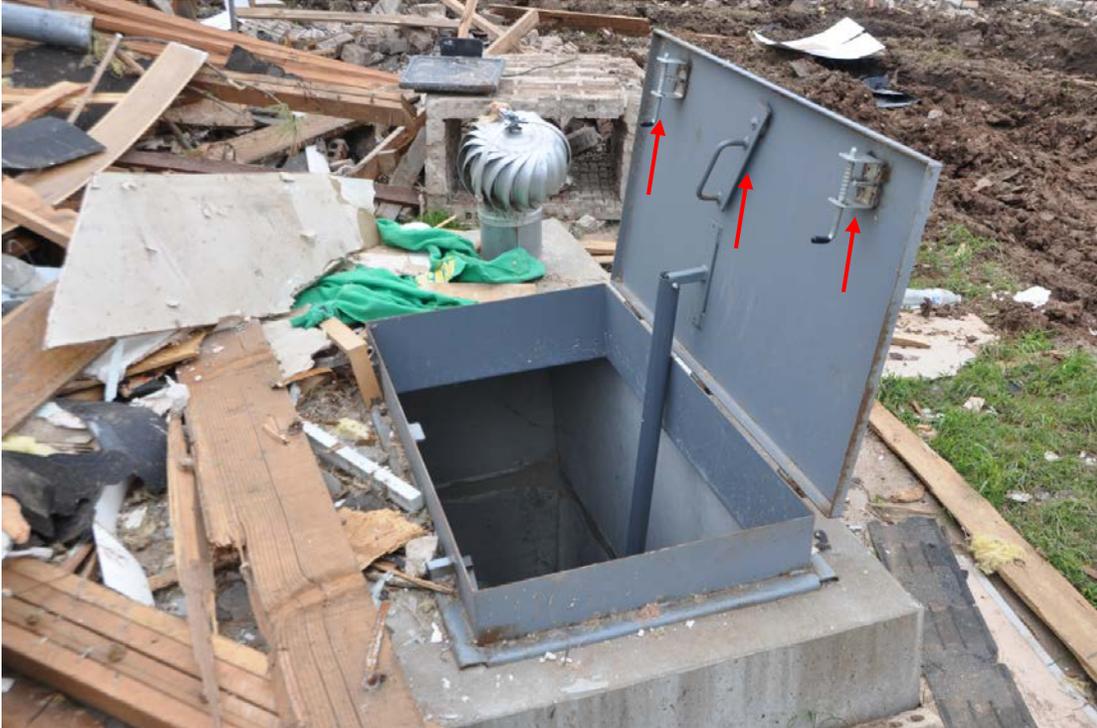
Figure 10. Flat top clam shell shelter with three locks at an EF-2 rated location (No. 17).

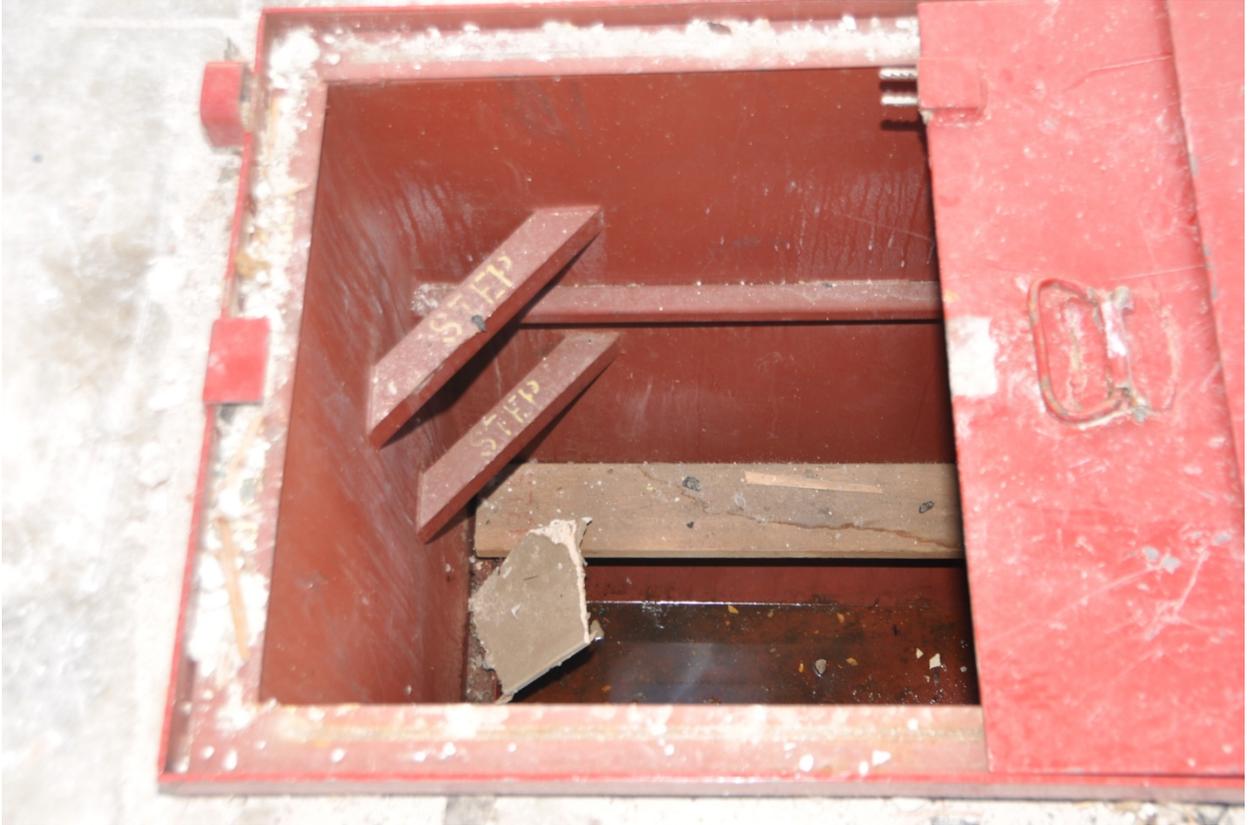
Twenty in-garage floor shelters with heavy sliding doors were documented. All appeared to have performed reasonably, with no major failures. Figure 11 shows a shelter (No. 12) with a stair entry that would not allow for easy access, an inadequate locking system, and some flooding at its bottom in an EF-3 rated location. Other issues were similar to exterior below ground shelters such as door thickness, locking systems, roller bearings, stairs, and drainage. Figures 12 and 13 are tested shelters (No. 9 and 61) that performed very well in an EF-4 and EF-0 rated locations respectively. Homeowners indicated they preferred the in-garage style shelter because it was cheaper, installation was quick, it did not take up any space, and again they felt safer in a below ground shelter.

Figure 11. In-garage storm shelter with inadequate stairs, locking system, and flooding in the bottom at an EF-3 rated location (No. 12).

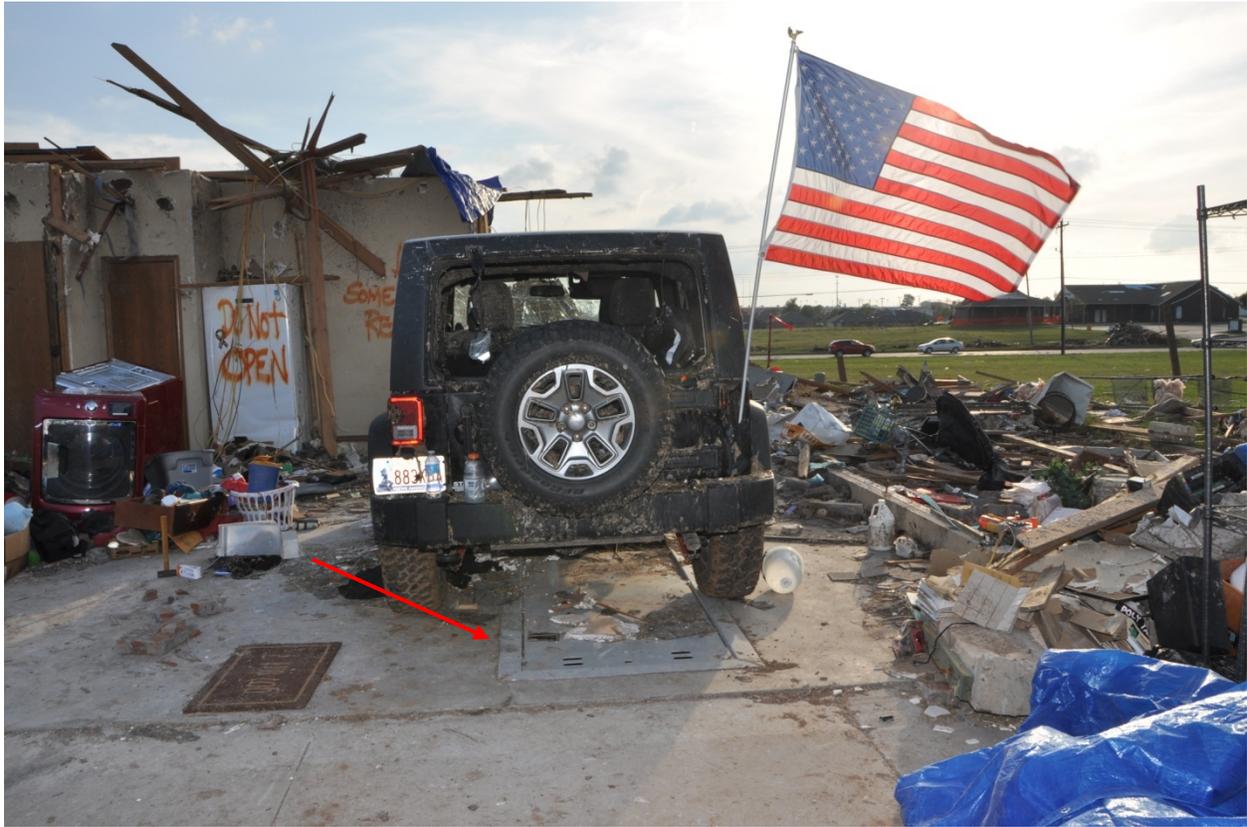
Figure 12. Tested shelter at a location assigned an EF-4 rating (No. 9).

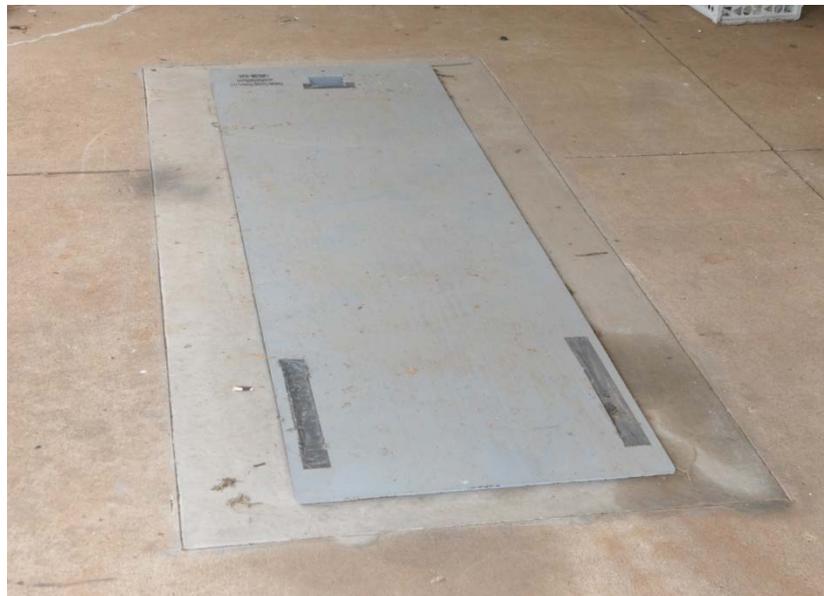
Figure 13. Tested NSSA shelter at a location assigned with an EF-0 rating (No. 61).

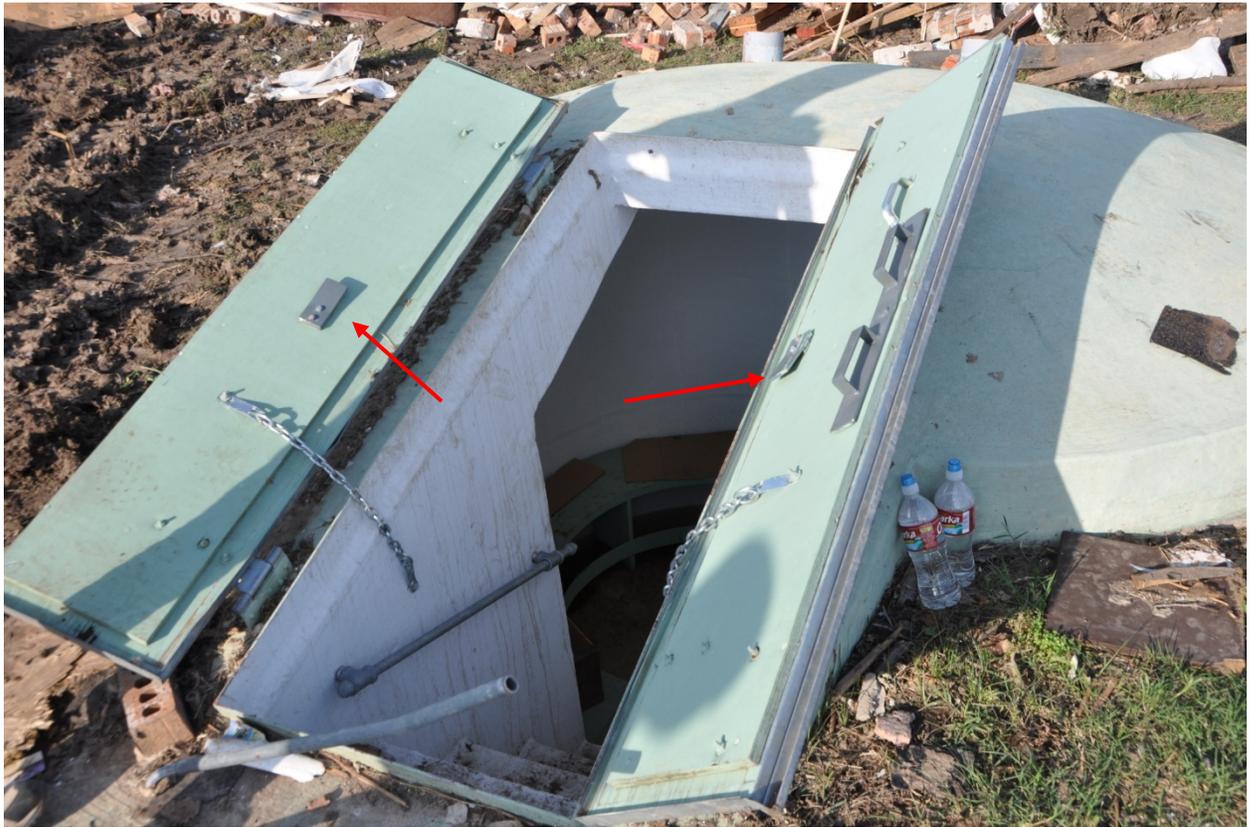
Two dome style shelters were inspected. The shelter pictured in Figure 14 (No. 43) was cast in place concrete with double plywood doors with 18 or 20 gauge steel skin cladding, one lock, and two hinges per door. The shelter was observed at an EF-3 rated location. This shelter also had a few inches of standing water in the bottom. The other dome shelter the team documented had 3 heavy gauge locks with an 1/8 inch steel door. It was partially above-ground, located in an EF-4 rated location, and can be seen in Figure 15 (No. 40). Both appeared to have survived the storm with no major failures, although the construction of the door of the first dome shelter was inadequate.

Figure 14. Dome shelter with an inadequate door system that included a plywood and light gauge sheet metal clad door, single locking point, and ventilator removed at an EF-3 rated location (No. 43).

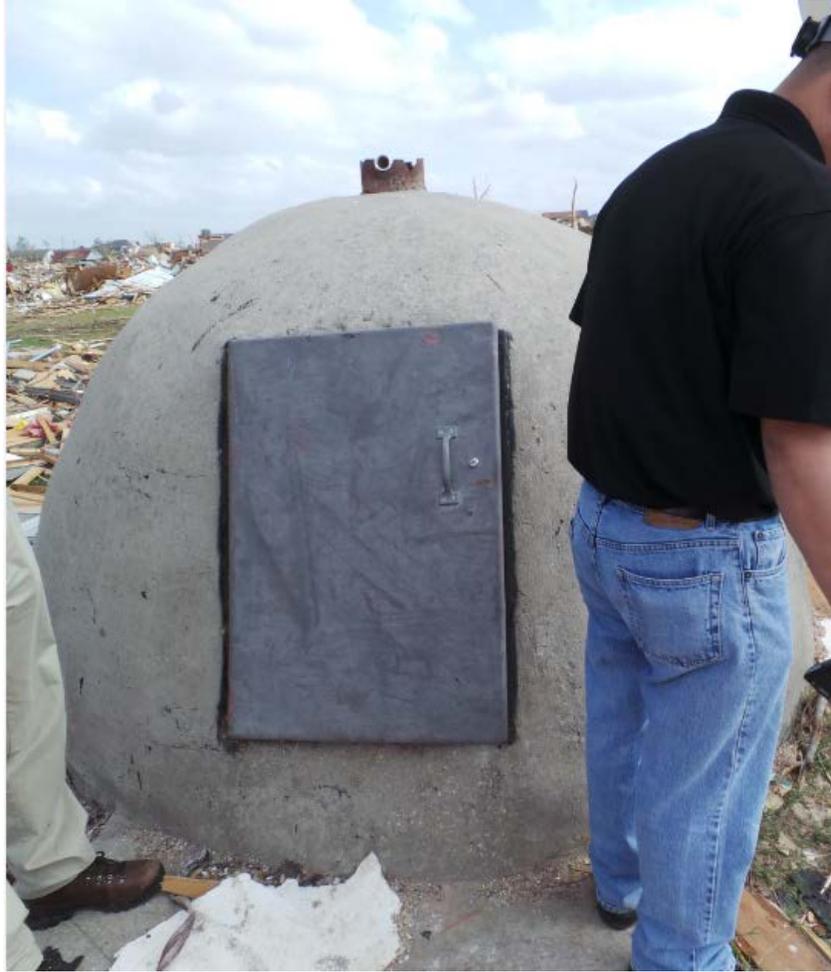
Figure 15. Dome shelter partially above-ground located in an EF-4 rated location (No. 40).

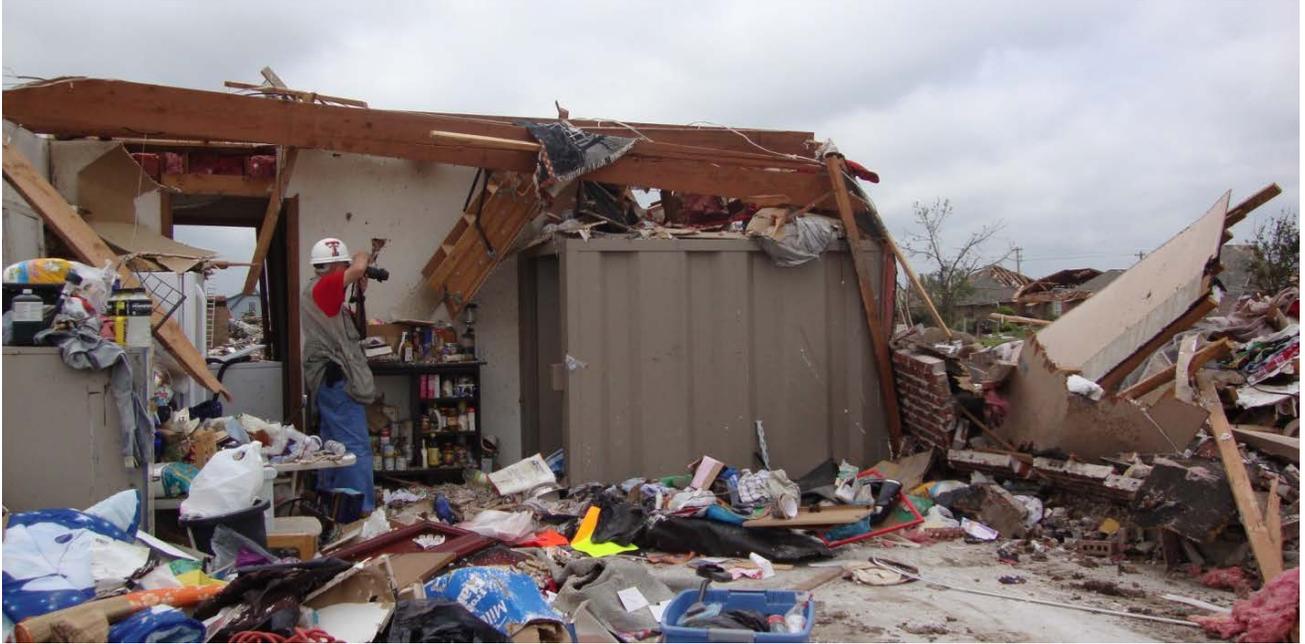
Eight above ground safe rooms were documented. Six had been tested, and it was noted that most of these safe room manufacturers proudly displayed their company name on their products. Figure 16 is an untested above ground storm shelter (No. 25) that was in the garage of the home in an EF-4 rated location, and survived without any failures even though the rest of the home was destroyed. The other two safe rooms that were not tested were located on the same street of a fairly new, well built neighborhood. These were builder installed walk-in closets made of concrete. The concrete portions of the shelters had been tested, however, the doors did not appear to be tested units. One of these shelters (No. 49) is shown in Figure 17. Figure 18 shows a tested steel shelter (No. 46) that performed very well. Some above ground safe room owners still questioned if they were safe because they were not below ground.

Figure 16. An above-ground tested safe room that survived EF-4 wind speeds (No. 25).

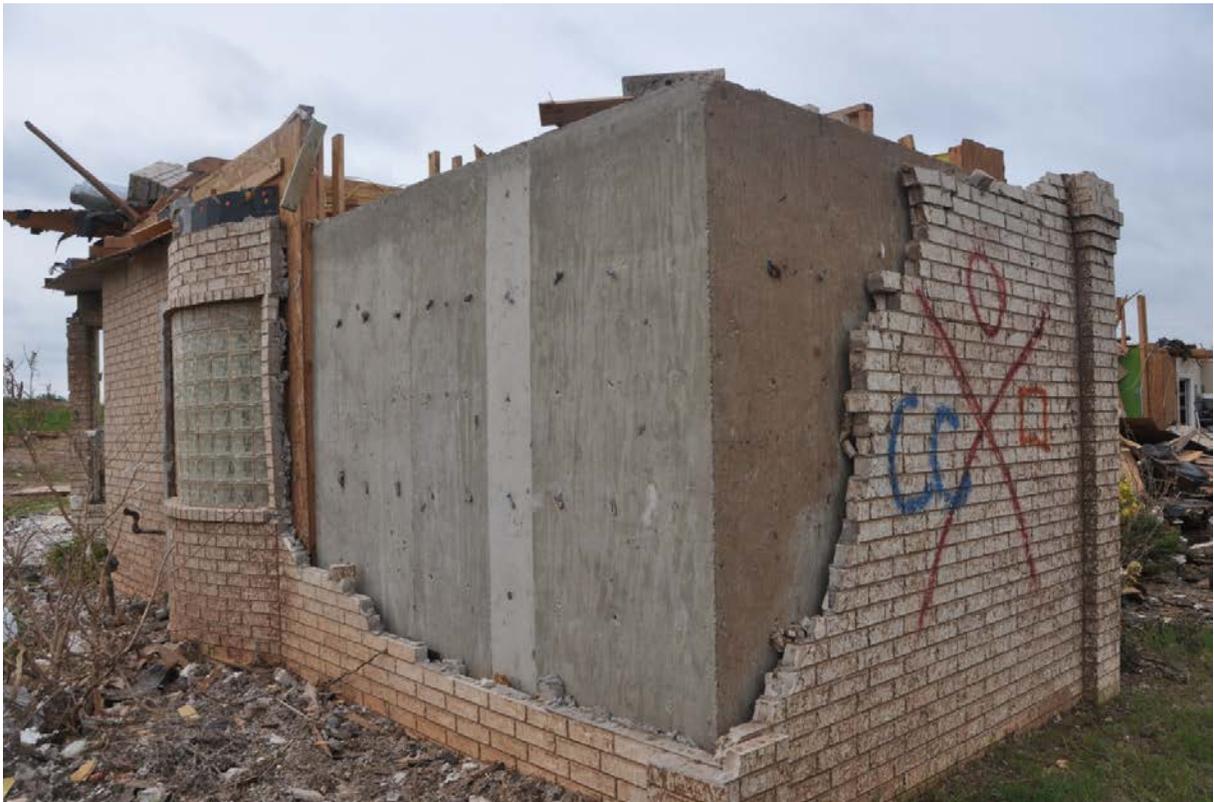
Figure 17. An above-ground, concrete safe room that also served as a walk-in closet at an EF-2 rated location (No. 49). The concrete was tested, but the door was not.

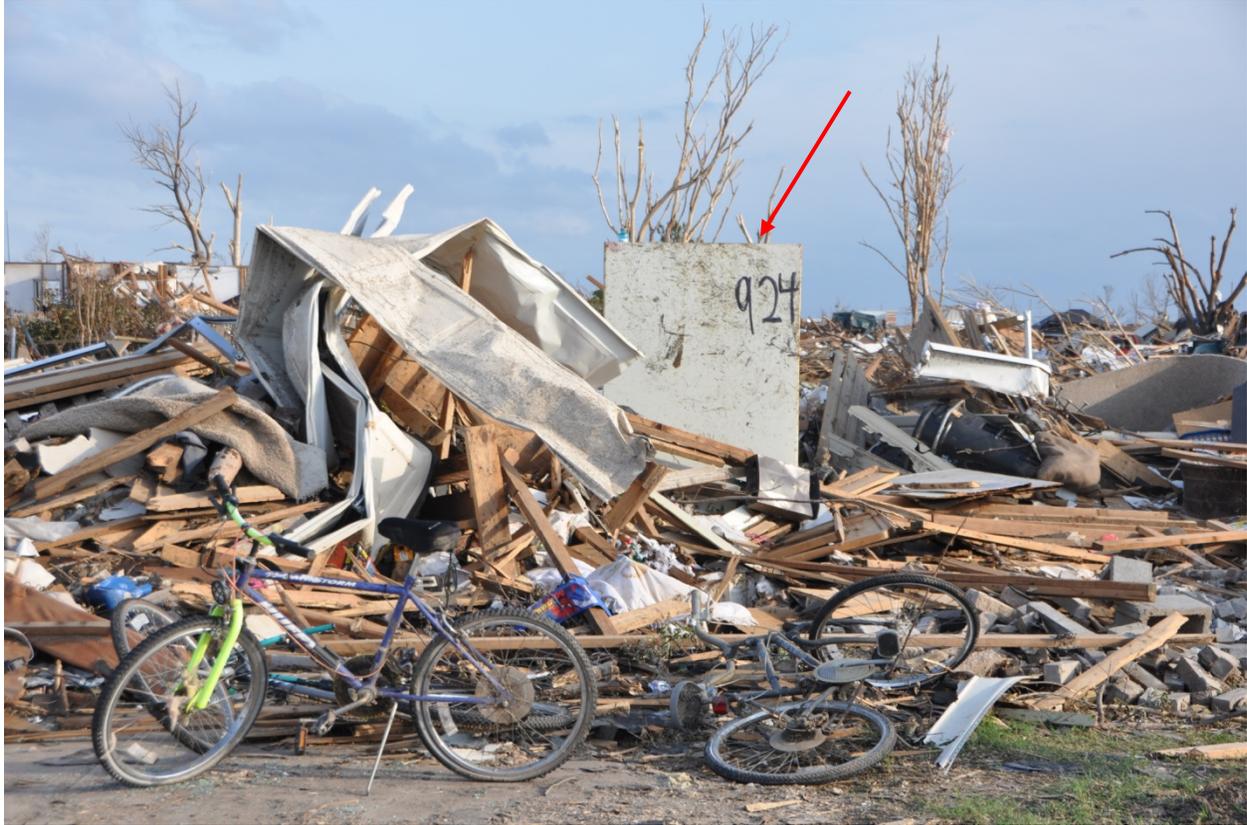
Figure 18. Above-ground tested steel shelter that performed very well in an EF-3 rated location (No 46).
