# Pressure and Impact Test Performance of Above-Ground Non-Complying Tornado Shelter Doors

A NSSA/NWI DIF Sponsored Project

<sup>1</sup>Larry J. Tanner and <sup>2</sup>Ernst W. Kiesling

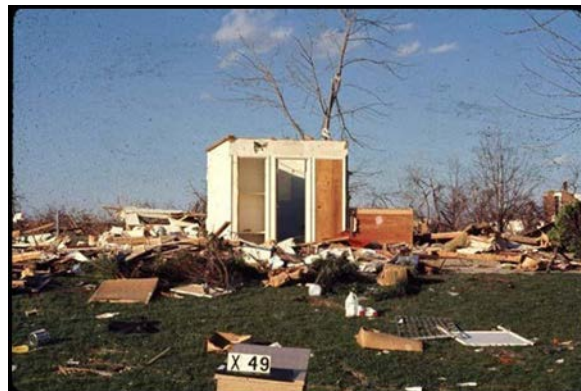
During their early research, these Tech professors routinely found surviving small structures among the destruction, and the surviving structure in *Figure 1* from the 1974 Super Outbreak reinforced the above-ground shelter concept.

*Figure 1: Surviving Structure, Xenia, Ohio Tornado, 1974.*

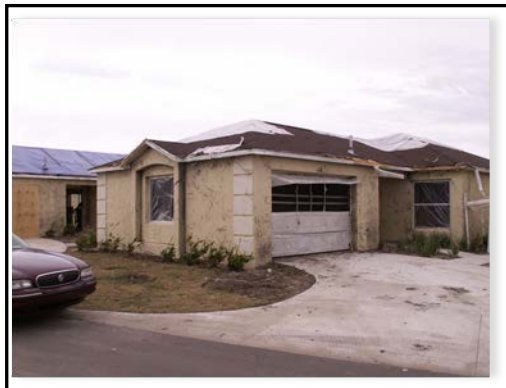
Door systems are particularly vulnerable to pressures and debris impacts, as seen in the photographs from numerous storms below. *Figure 2*, from the 2007 Central Florida Tornadoes, illustrates negative pressure exerted on a garage door. *Figure 3*, from the 1999 OKC Tornadoes, shows a typical residential entry door and sidelight perforated by storm debris. *Figure 4*, also from 1999 OKC Tornadoes, shows a solid core wood door located in an interior corridor at Kelley Elementary with multiple debris impacts. *Figure 5* is from the Moore, OK 2003 Tornadoes and shows a second floor outswing steel exit door knocked inward by debris impacts.

*Figure 2: Negative pressure on OHD.*

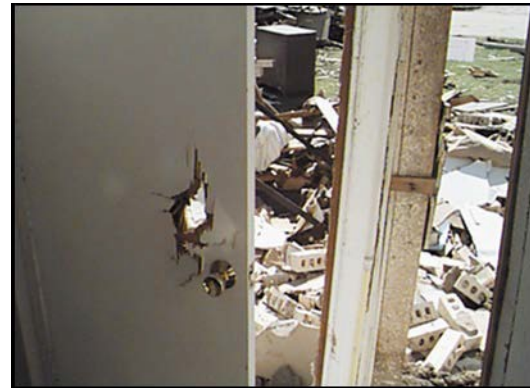
*Figure 3: Residential entry debris*

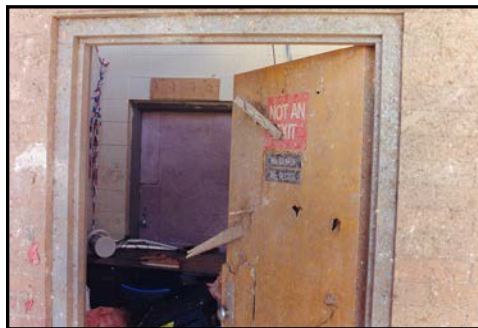
*Figure 4: Multiple impacts on interior door.*

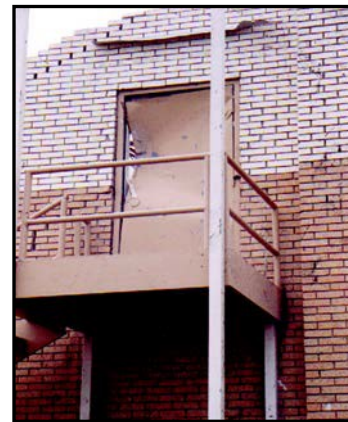
*Figure 5: Exterior HM door impacted.*

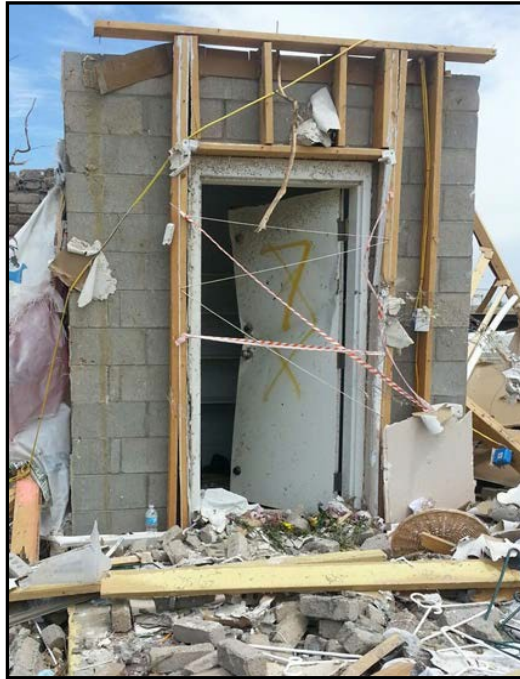
*Figure 6: Mayflower, Arkansas, Shelter.*

No deaths were reported in above-ground shelters until April 27, 2014, when a woman in Mayflower, Arkansas, was killed when her shelter door failed when impacted by storm debris, as shown in *Figure 6* (KARNTV4 2014). With the assistance of the NSSA, researchers from the NWI DIF at TTU obtained the door and performed a complete dissection and analysis of the actual door and hardware to better understand why it had failed. It was determined that the light duty hollow metal (HM) door and frame with residential hardware was not designed or intended for tornado safe room installations (Tanner2014).

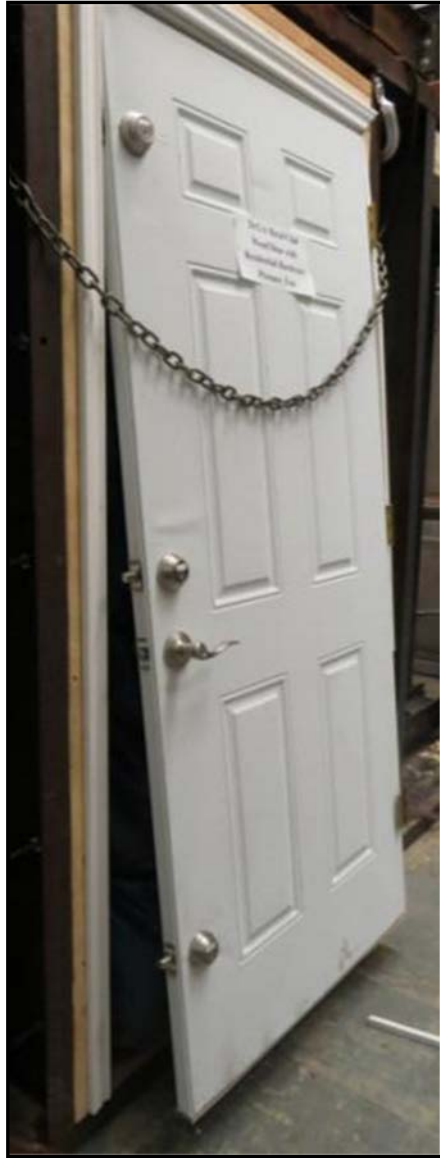
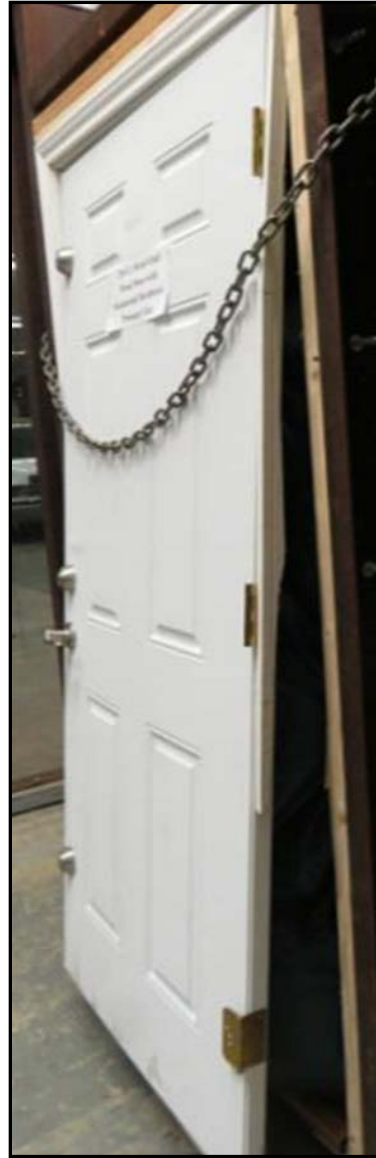
- a. The Series 1 Metal Clad wood frame door and the Series 2 Solid Core Wood door failed to hold the required pressure. The Series 1 door frame cracked vertically along the door edge, along the lock line allowing the residential deadbolts to bend past the frame strikes. The hinge jamb was split which released the entire door and half of the jamb frame. (See *Figures 12 & 13.*)
- b. The Series 2 door failure was the result of excessive bending of the bottom two residential deadbolts which were withdrawn from the strike boxes in the HM frame. (See *Figures 14-17.*) The Series 3-7 doors each held the required pressure for 10 seconds, per ASTM E330.

*Figure 12: Series 3 Pressure Failure.*

*Figure 13: Series 3 Hinge Jamb Split.*

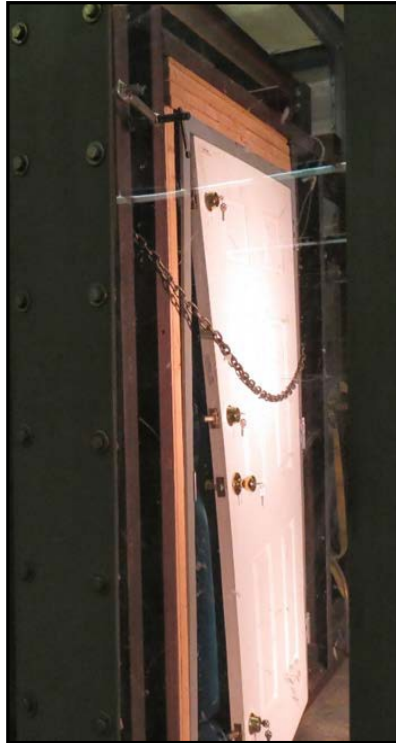
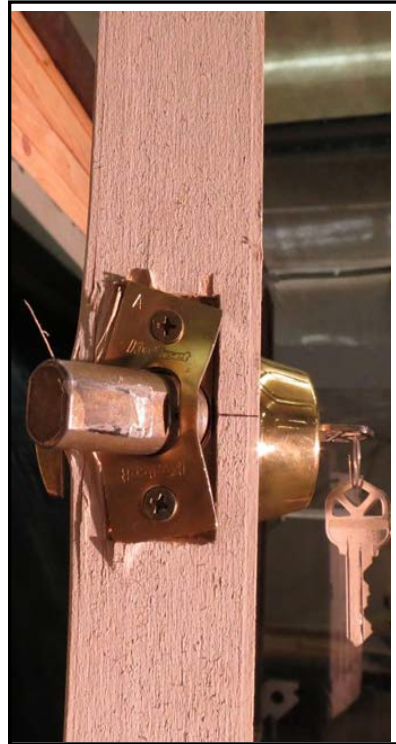
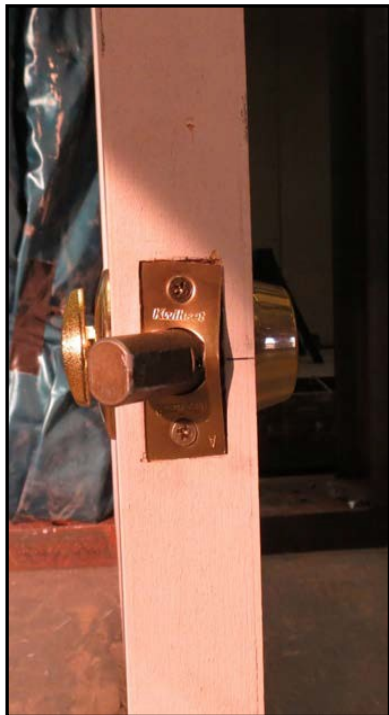
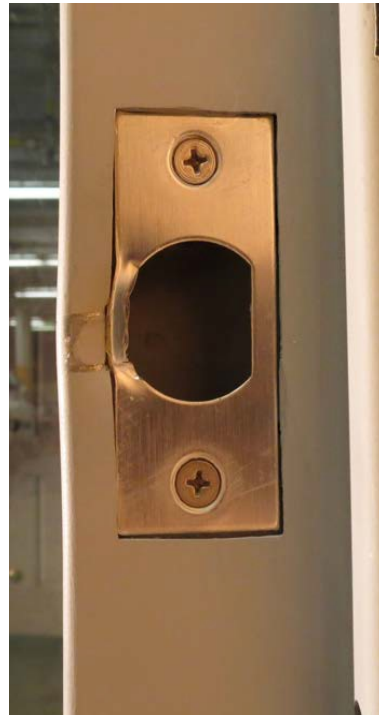
*Figure 14: Series 2 Pressure Failure.*

*Figure 15: Upper Deadbolt Failure.*

*Figure 16: Lower Deadbolt Failure.*

*Figure 17: Deformed Deadbolt Strike.*

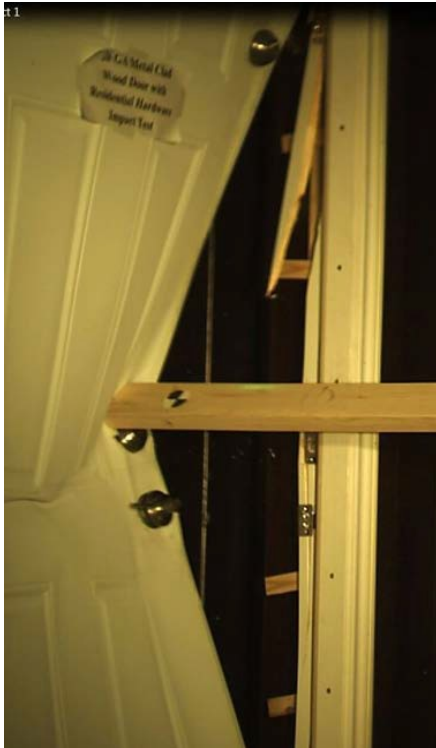
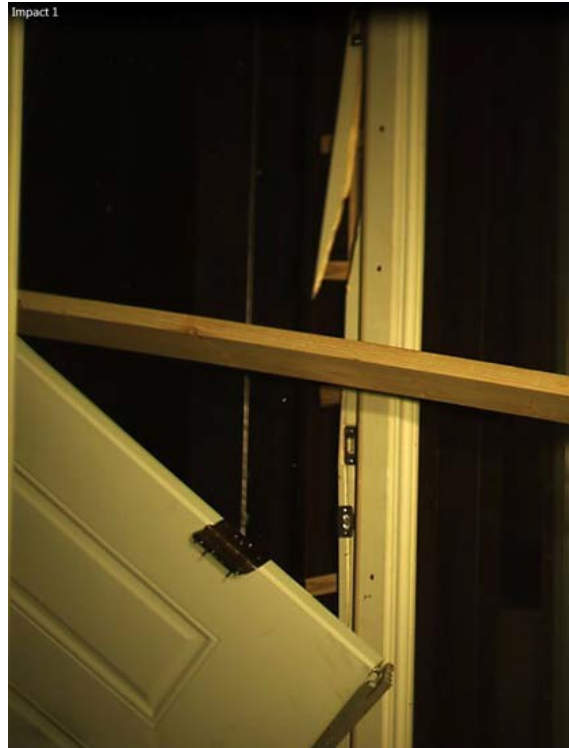
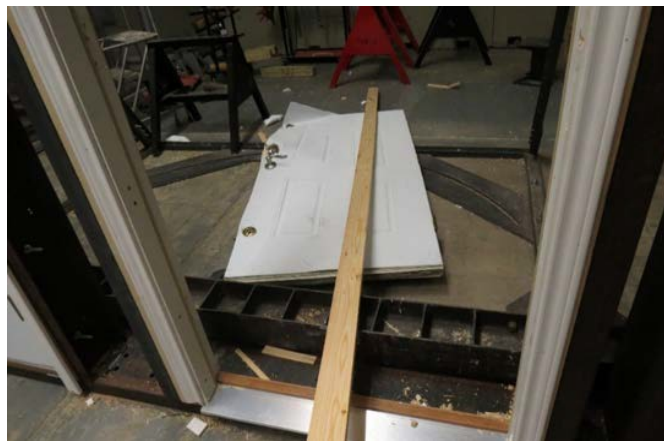
- a. Impact 1 on the Series 1 Metal Clad door produced a catastrophic failure by knocking the door from its hinges and lock strikes and twisting it 180 degrees, as seen from photographs taken from high speed video in *Figures 18 & 19*. *Figure 20* shows the door condition produced by the impact.

*Figure 18: Series 1 impacted.*

*Figure 19: Series 1 door twisted 180 degrees by impact.*

*Figure 20: Series 1 door knocked from frame and twisted by first impact.*

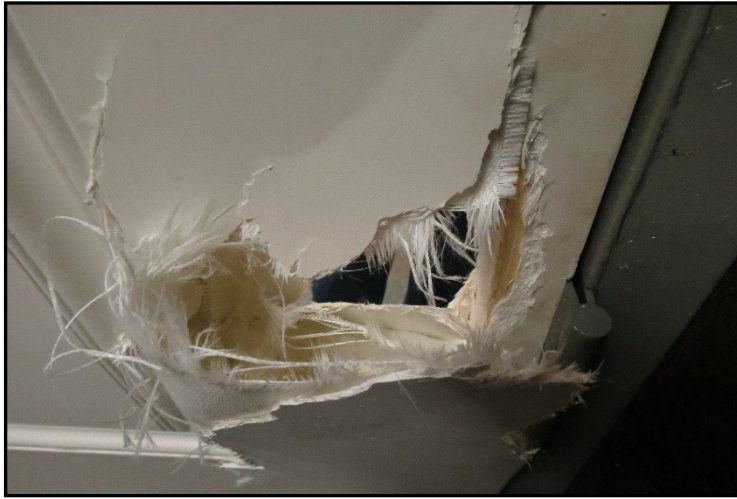
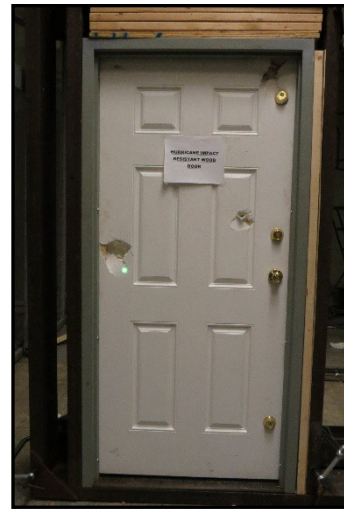
- b. All three impacts on the Series 2 Wood Solid Core Hurricane Impact Resistant Door passed through the door face, see *Figures 21 & 22*.

*Figure 21: Perforation at center hinge.*

*Figure 22: Door perforated by 3 impacts.*

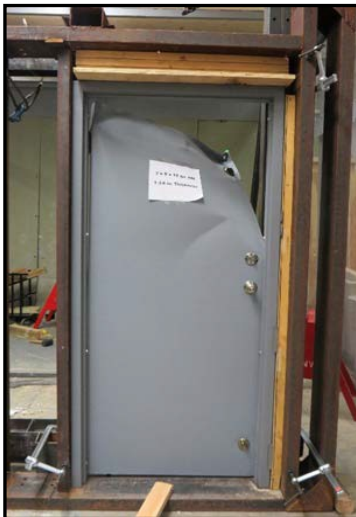
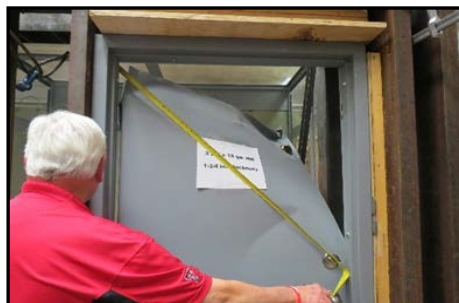
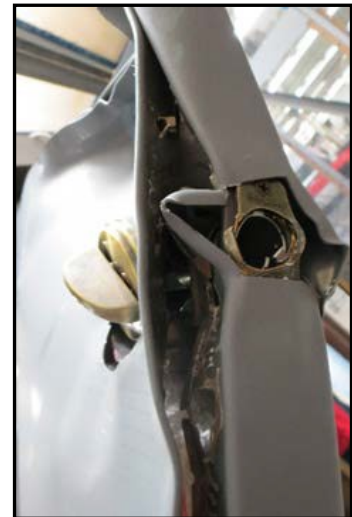
- c. The failure of the Series 3 18 ga. HM door was similar to the Mayflower shelter door. The Mayflower door had a cardboard honeycomb core, which is somewhat stiffer than the Series 3 open cell Styrofoam core. However, the Series 3 door was fitted with Residential Grade 1 hardware, which should have been superior to the Mayflower residential hardware. The mode of failure of the Series 3 door was similar to that of the Mayflower door, but the prescribed standard sequence of impacts (1-near top lock, 2-near center lock, and 3-near center hinge) initially bent the top lock corner over, separating it from the frame 48-in. and extracting the top deadbolt, see *Figures 23-25*.

*Figure 23: Series 3 Impact 1.*

*Figure 24: Door folded over 48-in.*

*Figure 25: Deadbolt extracted.*

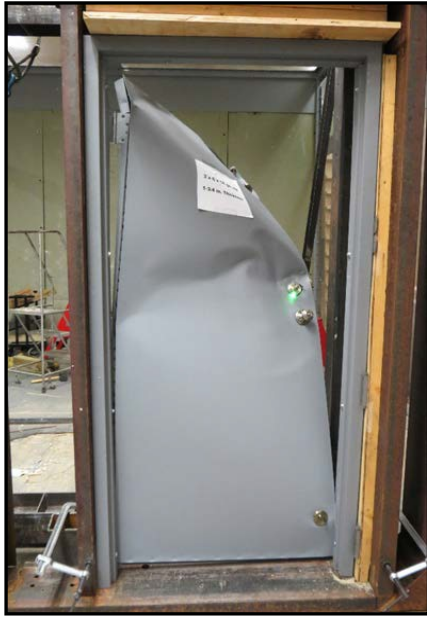
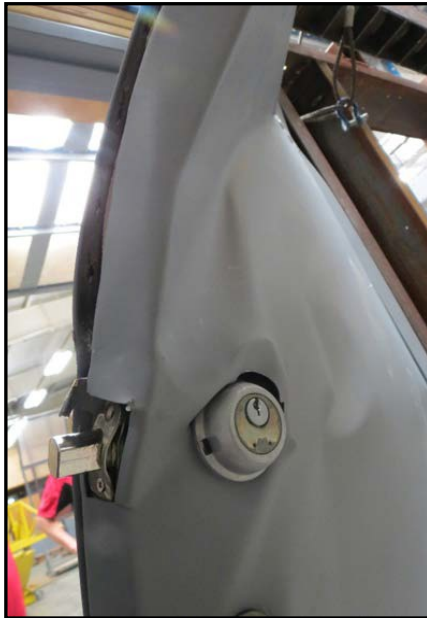
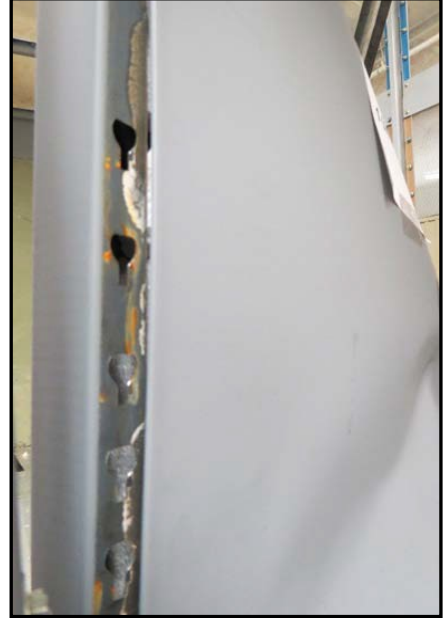
- a. Since two deadbolts remained engaged, the door was impacted a second time near the center deadbolt. This impact removed the deadbolt from the strike and bellied the door in the middle, similar to the Mayflower door impact, and then delaminated the face sheet from the edge channel, see *Figures 26-28*.

*Figure 26: Series 3 Impact 2. from frame.*

*Figure 27: Deadbolt withdrawn*

*Figure 28: Series 3 door bellied and delaminated.*

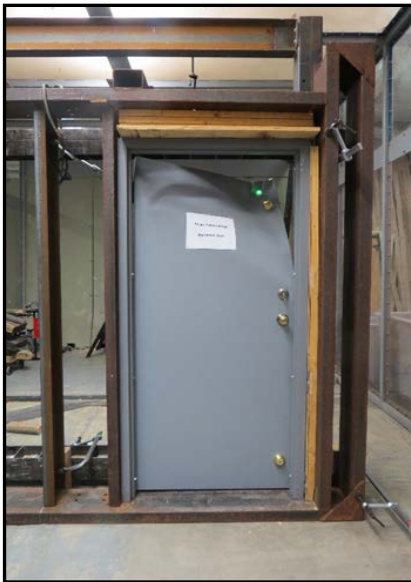
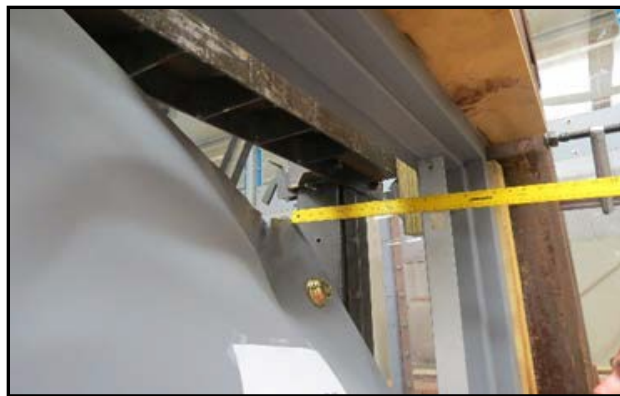
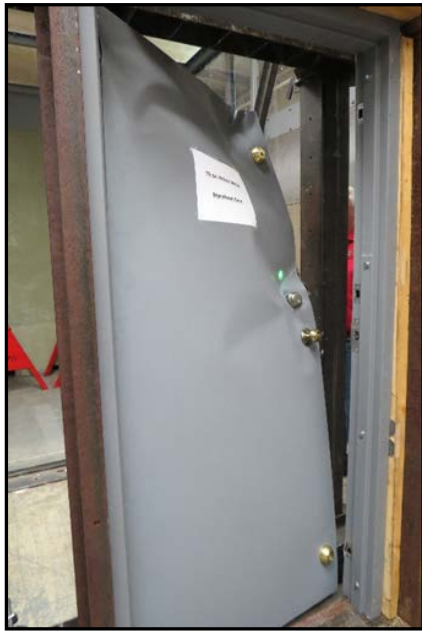
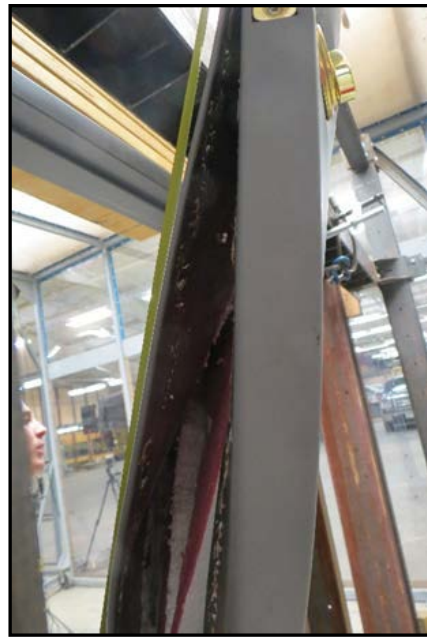
- b. Series 4 door was constructed the same as the Series 3 door, but was faced with 16 ga. face sheets, and the Residential Grade 1 hardware was also the same. Modes of failure were basically the same as the Series 3 assembly, but extents of deflection and deformation were less due to the increased door stiffness produced by the stronger face sheet. Impact 1 near the top lock produced bending of 12-in. and withdrew the deadbolt, see *Figures 29 & 30*. Impact 2 produced delamination of the impacted face sheet and withdrew the middle and bottom deadbolts, see *Figures 31 & 32*.

*Figure 29: Series 4 Impact 1.*

*Figure 30: 12-in. door corner deflection.*

*Figure 31: Bottom two deadbolts withdrawn.*

*Figure 32: Delamination of face sheet.*

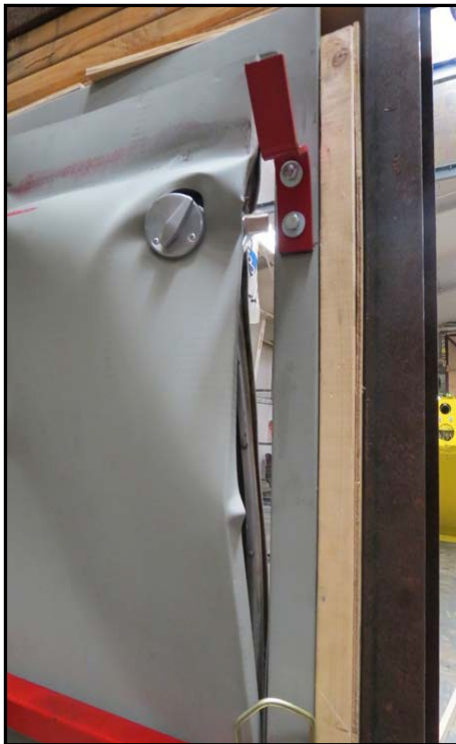
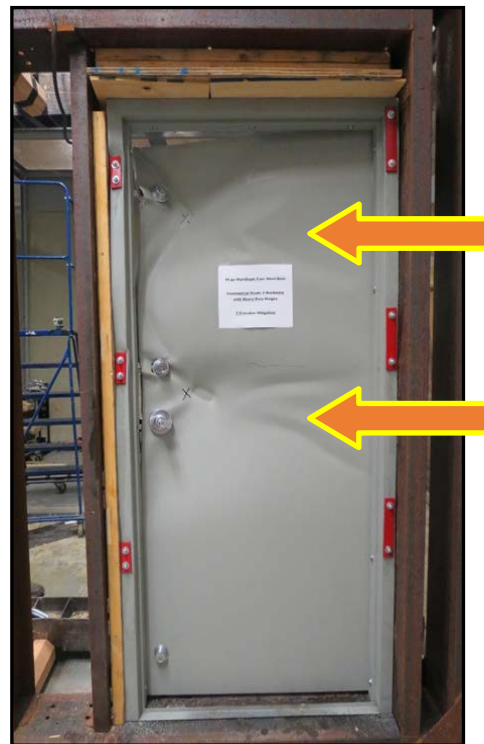
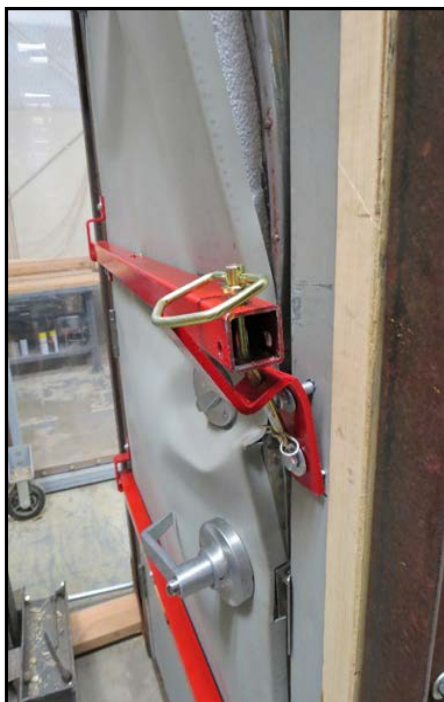
- c. The Series 5, 16 ga. HM door was vertically steel stiffened, locked with Commercial Grade 2 deadbolts, and had mitigations installed to control door deflections and lock failures. The mitigation included (3) 1 ½-in. x 1 ½-in. x 3/16-in. HSS tube steel hung on ¼-in. x 2-in. hangers bolted through the frame. The tube steel was further pinned with 3/8-in. shear pins. Safety pins were available for insertion into the shear pins, but left off, with the assumption that a panicked occupant might forget to install the pins. (See *Figures 33 & 34.*) The first impact near the top lock withdrew the shear pin and the crossbar, see *Figure 34*. A safety pin was installed in the shear pin on the center cross bar for the second impact. The safety-pinned center cross bar held the second impact. (See *Figures 35-37.*)

Figure 35: Cross bar removed by Impact 1

Figure 36: Impacts 1 & 2 on Series 5

Figure 37: Impact 2 on Crossbar w/ shear & safety pin

- a. There were numerous options considered for the mitigation and retrofitting of non-tested safe room door installations. The crossbar option was considered to be an easy and inexpensive installation with through bolting of the hangers and utilization of tube steel crossbars with the crossbars located at the most critical points across the door exposure, and ¼-in. steel selected for the hangers, bar loops, and bolt cover plates. Though cold bending of steel maintains the integrity of the steel properties, the hangers tested were heat bent in the laboratory. Two thicknesses of 1 ½-in. x 1 ½-in. tube steel was tested with the 3/16-in. thickness being the most desirable for its weight and ease of installation and used for the Series 5 test. The stronger and heavier ¼-in. thick tube steel was reserved and tested for Series 6. Displacement of the crossbar from the loop and hanger was a major concern, and thus 3/8-in. shear pins were utilized for both series of tests. Safety pins to lock the shear pins in place were considered to be a nuisance to shelter occupant and likely to be overlooked by an occupant in a state of panic. After the failure of the top crossbar on Series 5 without the shear pin/safety pin, safety pins were installed and impacts were successful without further loss of crossbars. All shear pins were secured by safety pins for the Series 6 tests. However, the first and the second impacts sheared the safety pins and displaced the crossbars. It is considered that the improved performance of the lighter HSS crossbar in Series 5 with the safety pin is due to the ability of this bar to bend more freely than the ¼-in. HSS crossbar, thereby absorbing more energy.

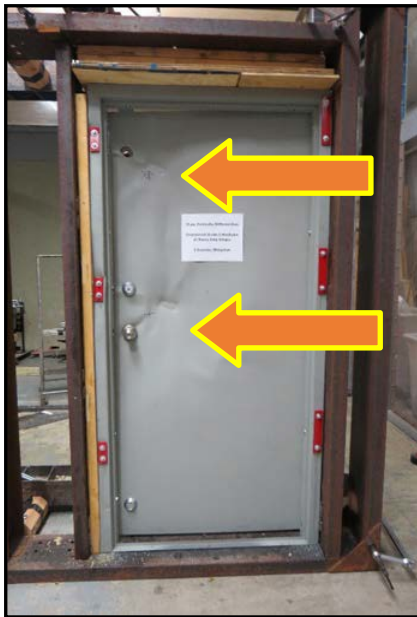
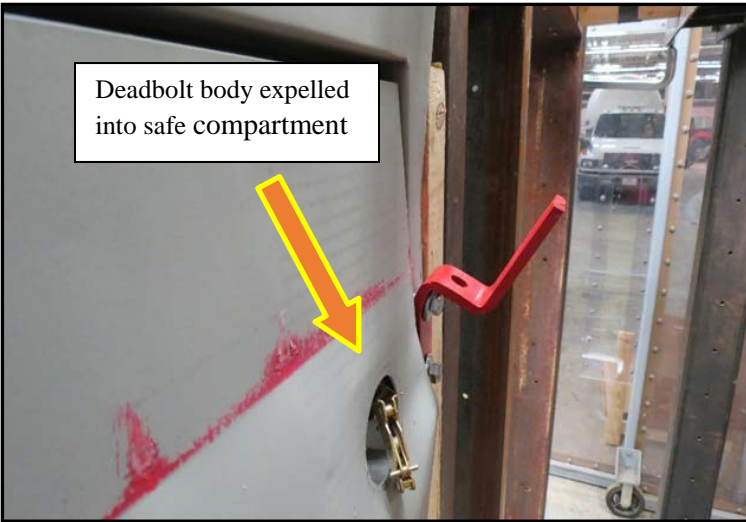
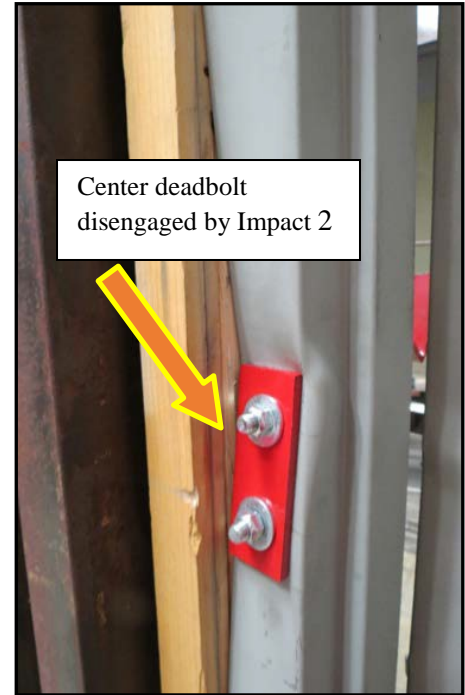
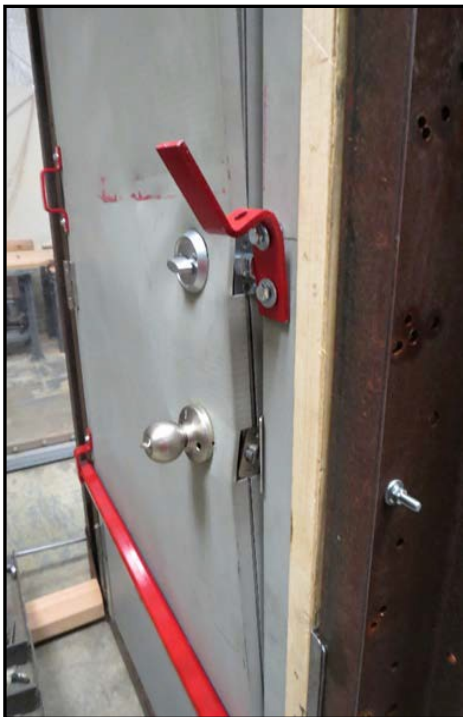
- d. The Series 6 was the same type of 16 ga. HM door and was a vertically steel stiffened door and locking hardware as Series 5. Mitigations were installed to control door deflections and lock failures. The mitigation included (3) thicker HSS (1 ½-in. x 1 ½-in. x 1/4-in.) tube steel hung on ¼-in. x 2-in. hangers bolted through the frame. The tube steel was further pinned with 3/8-in. shear pins which were restrained from withdrawal with safety pins. These mitigations represented the stronger of the two mitigation installations. Impact 1 sheared the safety pin and allowed the shear pin to withdraw and the crossbar to fall. Impact 2 produced the same behavior. (See *Figures 38-43.*)

**Figure 40: Impacts 1 & 2 on Series 6.**

*Figure 41: Series 6 top crossbar knocked loose by Impact 1.*

*Figure 42: Frame crushed by hanger plate*

*Figure 43: Center crossbar knocked loose by Impact 2.*

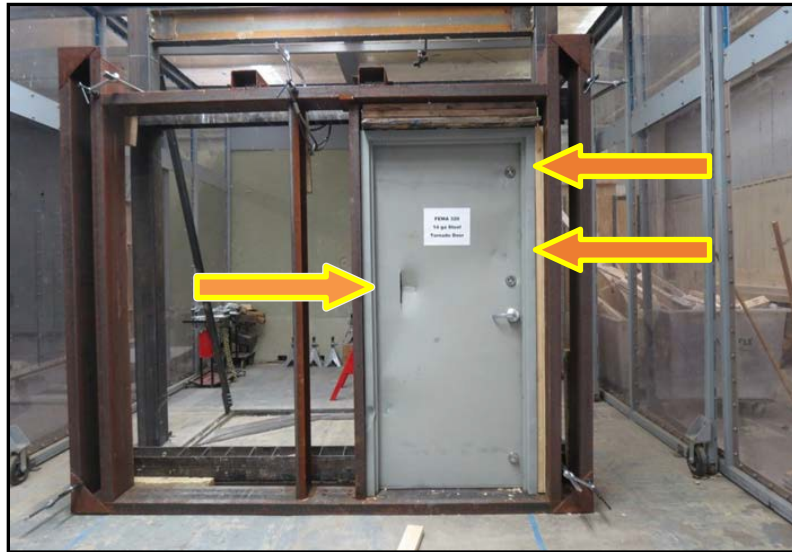
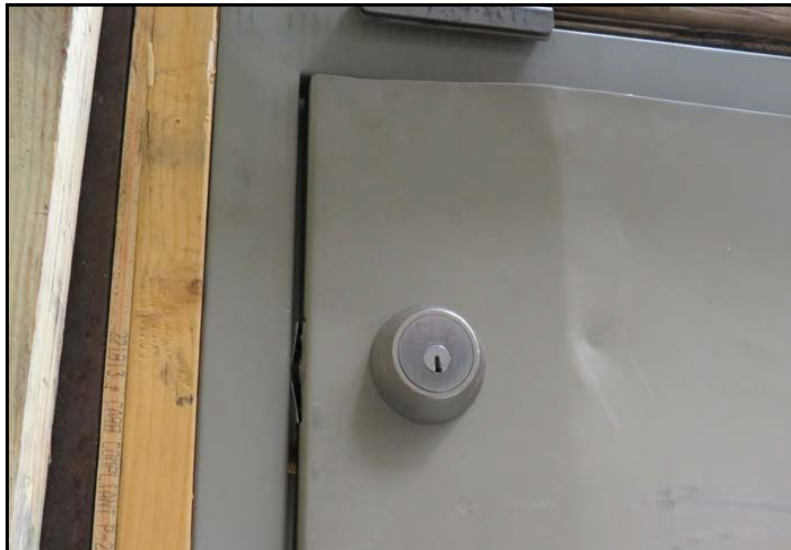
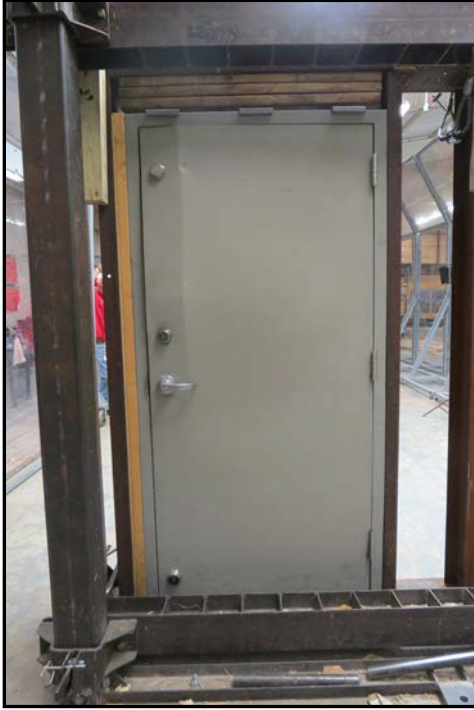
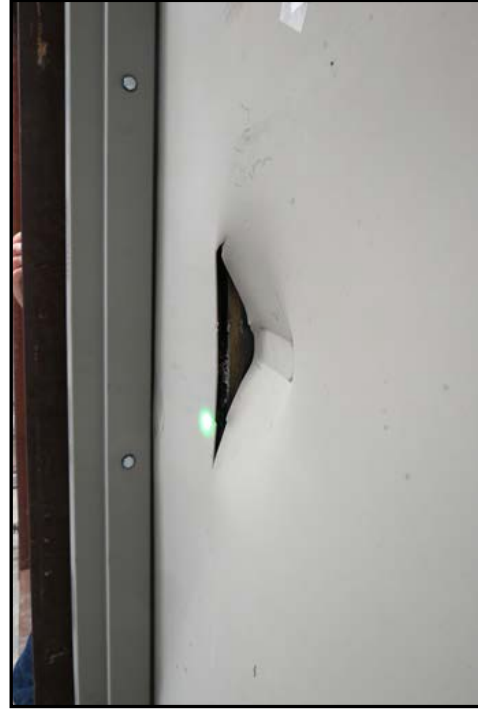
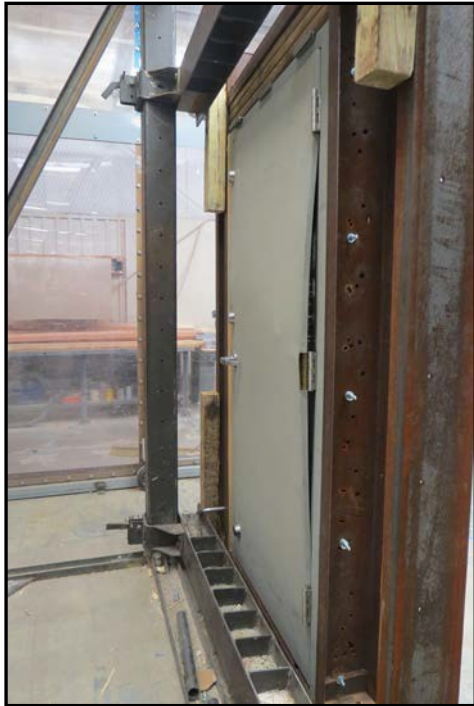
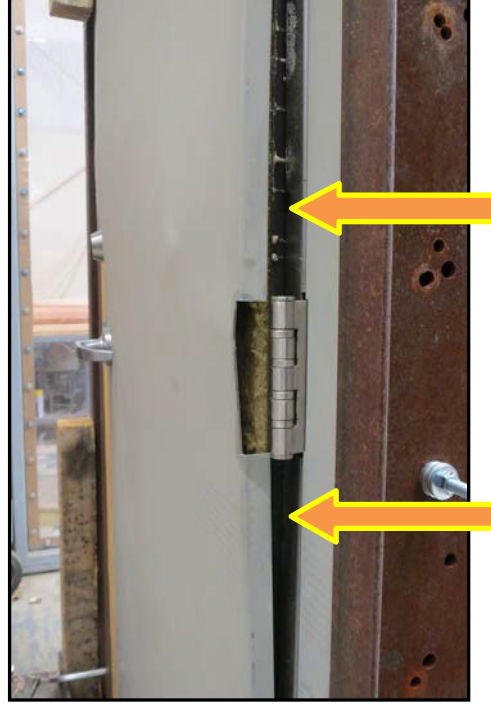
- e. The Series 7 door was 14 ga. HM, vertically steel stiffened, and was hung in an 18 ga. HM frame with reinforced strike and lock boxes. All hardware was Commercial Grade 1. Though not affecting the test results, the deadbolt hardware was installed with the thumb turns on the impact face and the keyway side on the shelter side of the door. Three protocol impacts were conducted on the door (*Figure 44*). Damage from the first two impacts included imprinting a vertical internal stiffener on the back face sheet (*Figure 45*), and bending of the center deadbolt, which remained engaged (*Figure 46*). The third impact directed near the hinge tore the face sheet at a vertical stiffener (*Figure 47*). The most notable damage was separation of the back face sheet along the hinge side (*Figures 48 & 49*).

*Figure 44: Series 7 door after three impacts.*

*Figure 45: Backside damage after Impact 1.*

*Figure 46: Vertical stiffener imprint after 2 Impacts.*

*Figure 47: Sheet tear by Impact 3.*

*Figure 48: Sheet separation produced by Impact 3.*

*Figure 49: Delamination of back face sheet.*
