Analysis of the Above Ground Shelter Door Failure

April 27, 2014 Tornado, Mayflower, Arkansas

Larry J. Tanner and Ernst W. Kiesling

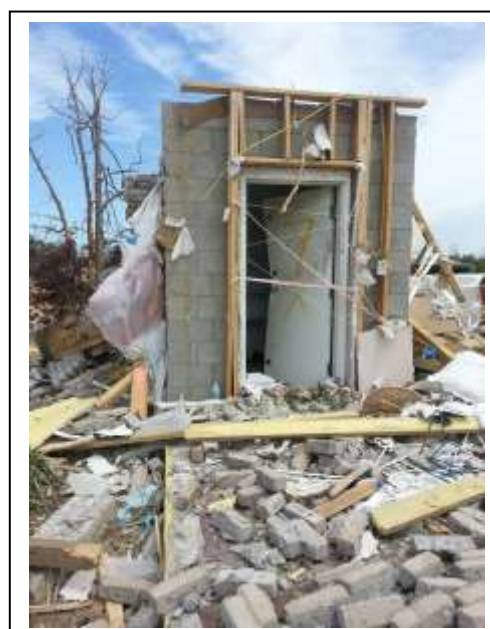
One death in Mayflower occurred when the storm door on the home above ground residential shelter was impacted by storm debris. According to the surviving homeowner, all three dead bolts were engaged initially. A missile of unknown weight and speed struck the center of the door which resulted in the door bending and failure of the center dead bolt and the shearing of the top dead bolt leading to the death of one of two occupants.

Surviving above ground shelter with failed door

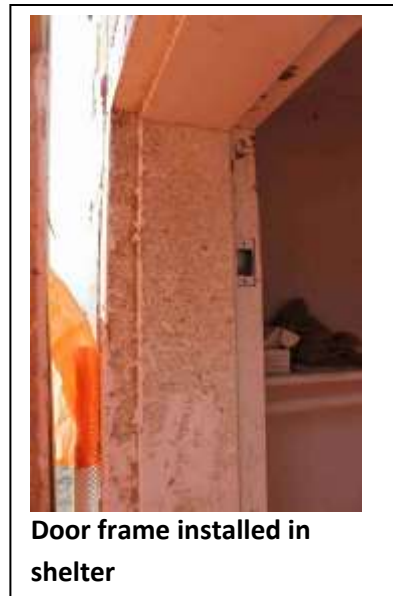
The door frame was installed as a “wrap-around” of the 8-in. concrete masonry, grout filled, without any apparent wall anchorage. The frame measured 8 ¾-in. wide, with a 2-in. face, a 1 15/16-in. door rabbit, a 5 ¼-in. soffit, and 18 ga. in metal thickness. The frame further contained 10 ga. hinge reinforcements, and 22 ga. strike mud boxes.

Door frame installed in shelter

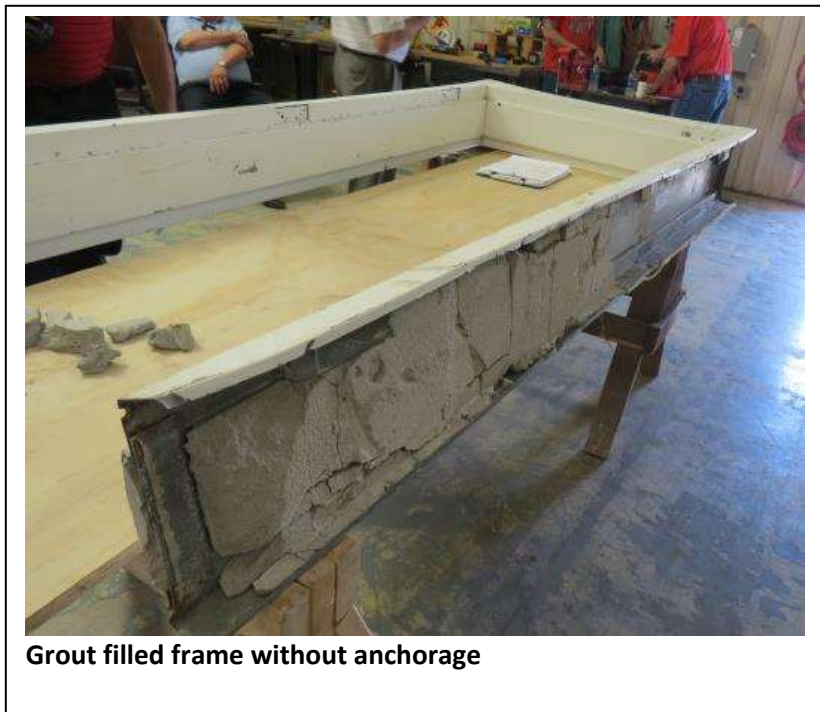
Grout filled frame without anchorage

Safe Room Door frames are required by FEMA P-320 and ICC-500 to have the equivalent shear strength of (5) 3/8-in. bolts in each jamb and (3) 3/8-in. bolts in the door head.

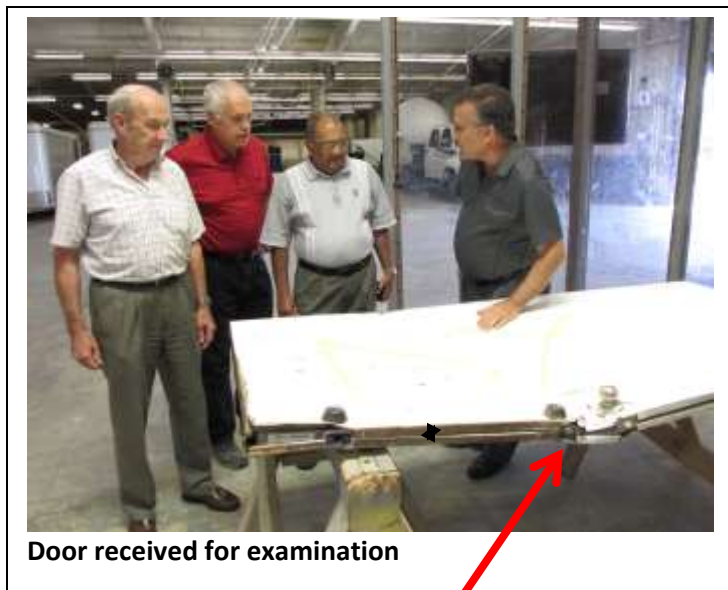
Using bar codes on the door, the manufacturer of the door was determined to be Republic Doors & Frames, DM Series, SDI 100 Grade 2 and Model 1 (Heavy Duty, minimum 18 ga., hollow steel composite).

Republic Doors and Frames manufacture FEMA 320 & FEMA 361 Tornado Doors (DE Series). The DM Series is not intended for use as an above ground safe room door.

Door received for examination

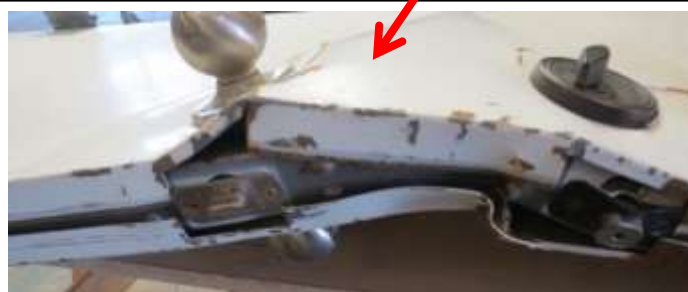
Door edge separation at latch and deadbolt location
(door shown upside down to expose severe damage)

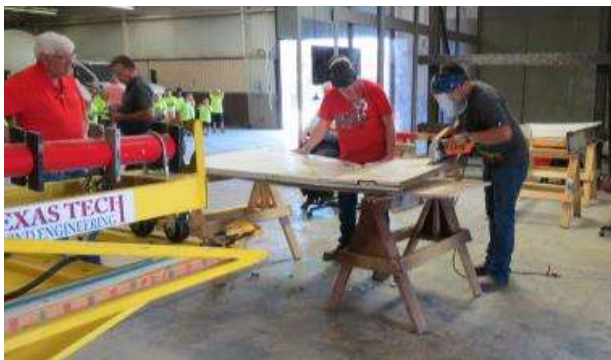
It was sliced in three locations to investigate the internal construction. The edge channels were 1 11/16-in. x 5/8-in. x 16 ga. with door skins projection welded at 2 1/2-in. centers along the top and bottom channels and 5-in. centers along the edge channels. Numerous projection welds were discovered to have failed.

Door Sliced for internal investigation

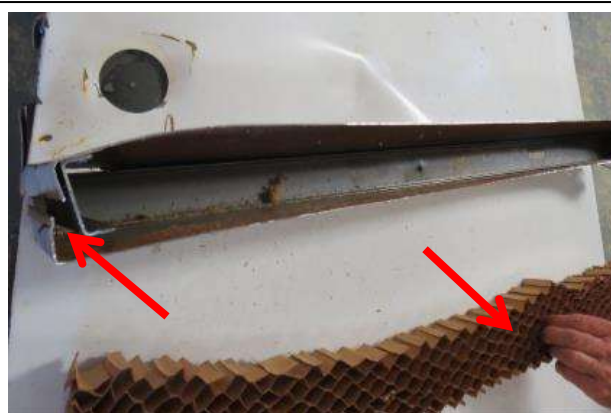
Hinge reinforcement was 4 1/2-in. x 1 1/2-in. x 11 ga. The hardware reinforcement consisted of 16 ga. partial boxes, tack welded to the edge channel. The door core was a standard 3/4-in. x 3/4-in. honeycomb. No vertical steel stiffeners were included in the door construction.

16 ga. Edge Channels and honeycomb core

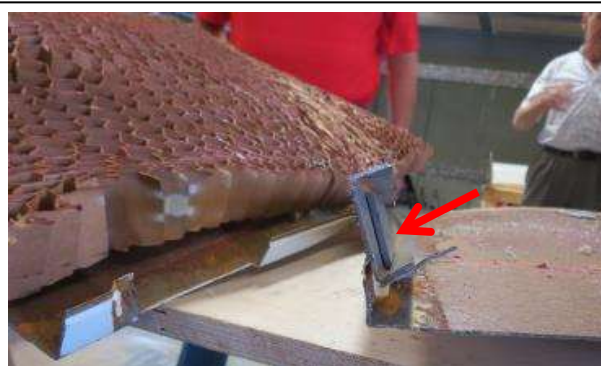
11 ga. Hinge reinforcement

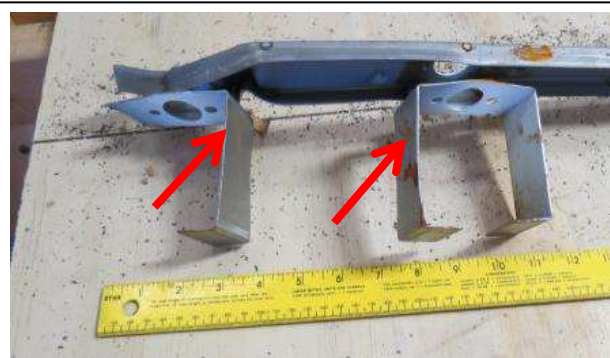
Lock/Latch and Deadbolt reinforcement - 16 ga. partial lock box

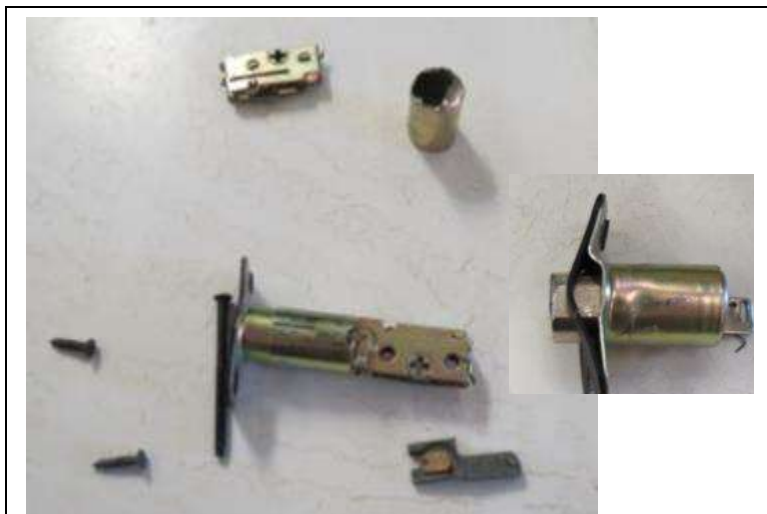
The attached door hardware included (3) Residential Grade deadbolts and a latch/lock, all were branded Design House. Hinges were 4-in. x 4-in. x 0.130 (5-knuckle) standard duty, branded Cal-Royal.

Damaged Deadbolts and Latch Bolt

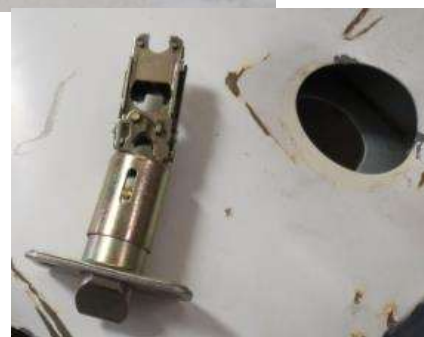
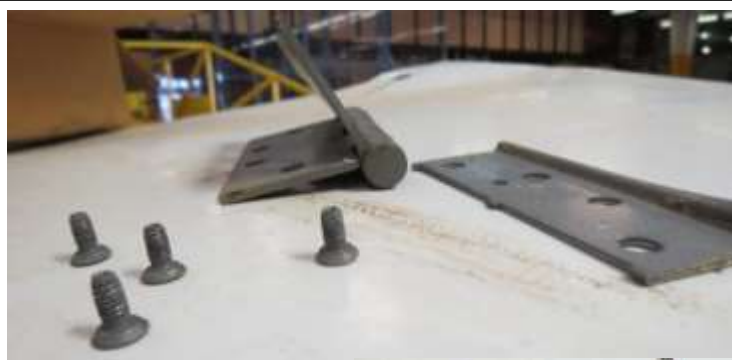
Damaged Hinges and Screws

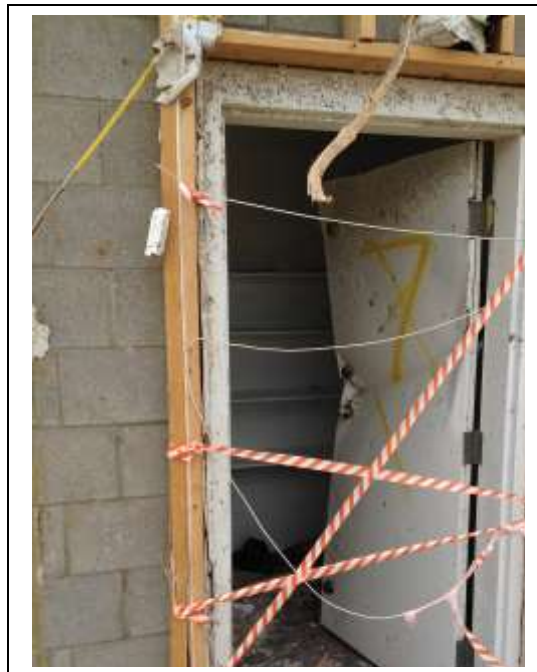
The crease on the door face and the material deposits on it would appear to be caused by a sheet material, possibly a piece of plywood or OSB roof decking. The performance of bodies impacted by another body is best described by formulas for Momentum ($p = \text{mass} \times \text{velocity}$) and Kinetic Energy ($K_e = \frac{1}{2} \text{mass} \times \text{velocity}^2$). Momentum is a vector with magnitude and direction, whereas, Kinetic Energy is scalar with only magnitude. Momentum best indicates penetrability of the impacted subject, whereas Kinetic Energy describes the channeling of energy across the face of a subject to all the connecting points (locks and hinges). In the case of the Mayflower door, the door was not sufficiently stiff to be penetrated by the Momentum of the assumed OSB sheet. However, the door was sufficiently flexible to catastrophically bend and damage the hardware indicating that Kinetic Energy was instrumental in the door failure. Similar failures of sub-standard door assemblies have been documented in the DIF Laboratory. It therefore appears that the door was not impacted by some astronomical object traveling at a high rate of speed. Door failure resulted from the improper usage of a door, frame, and hardware not intended for tornado safe rooms. Just because it was a steel door did not qualify it to be a tornado safe room door.

- Site constructed tornado safe rooms should be constructed in strict accordance to FEMA P-320
- Safe Room doors should be FEMA 320 "Tested Door and Hardware Assemblies"
- For tested door assemblies, refer to the NWI website:
<http://www.depts.ttu.edu/nwi/research/DebrisImpact/Reports>
- Door manufacturers should provide notices to resellers and wholesalers of the dangers of selling non-tested door products for tornado safe rooms.
