**National Wind Institute**  
**Debris Impact Facility- Texas Tech University**  
P.O. Box 43155  
Lubbock, Texas 79409-1023

**Report No. \_20140604A**  
**Specimen No. \_\_\_\_\_2\_\_\_\_\_**  
**Test Date: \_June 4, 2014\_**

- 2.0 PRODUCT TYPE:** **Series 1-FEMA 320/361 & ICC 500, Utility Brick Veneer Wall**  
**Series 2-FEMA 320/361 & ICC 500, Modular Brick Veneer Wall**
- 2.1 MODEL NUMBER:** N/A
- 2.2 CONFIGURATION:** See Article 3.0 Test Unit Description
- 2.3 SAMPLE SIZE:** See Article 3.0 Test Unit Description
- 2.4 DOOR ASSEMBLY:** See Article 3.0 Test Unit Description, see installation photos, pages 5-14.
- 2.5 DRAWINGS:** See Appendix B Drawings.

**4.1 SCOPE:** Conduct impact tests for two brick veneer wall configurations.

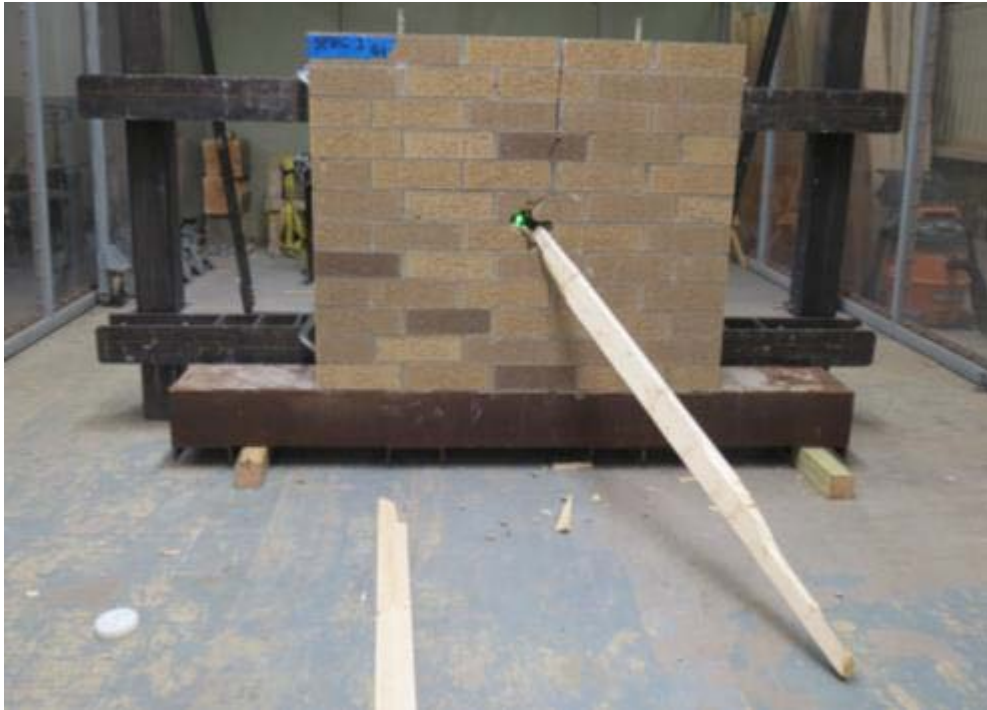
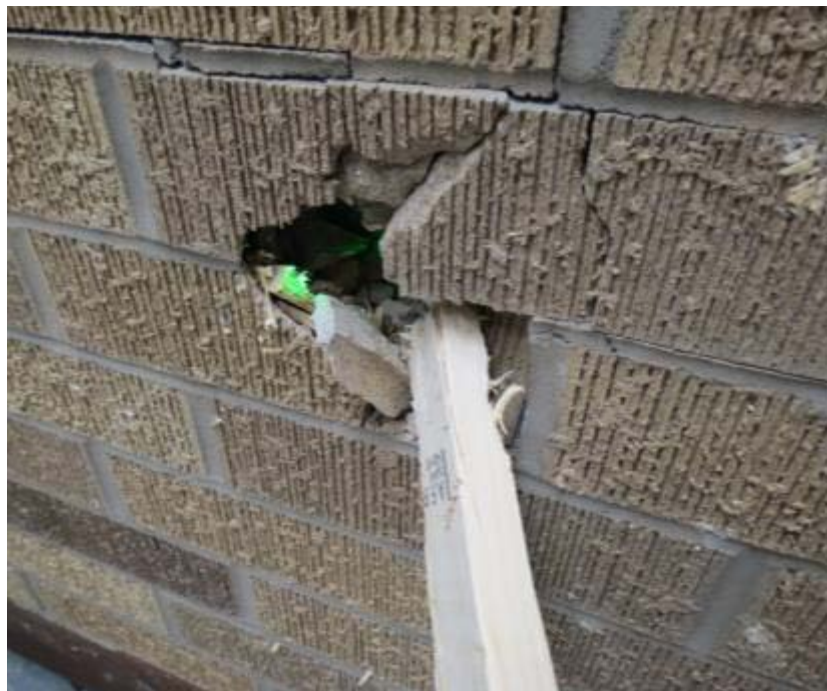
### Series 1 Impact 1

Series/Impact	Velocity (mph)	Location	Results
1/1	100.0	Panel center.	Vertical crack from top to bottom and missile perforation of brick. No damage to CMU, front or back; see photos, pages 15-18.
1/2	100.2	Lower right over reinforced column.	Opening of vertical crack to 3/4-in. and brick destruction at impact area. No penetration of CMU; see photos, pages 19-22.
1/3	101.0	Lower left beside grouted cell.	Failure of left lower corner brick. No backside damage; see photos, pages 23-27.
2/1	102.3	Panel center.	Brick perforation with diagonal shear cracks at 22-in.; see photos, pages 28-31.
2/2	101.0	Lower right over grouted cell.	Destruction of brick at impact point; see photos, pages 32-33.
2/3	103.3	Upper left beside grouted core.	Cracking of corner; see photos, pages 34-39.

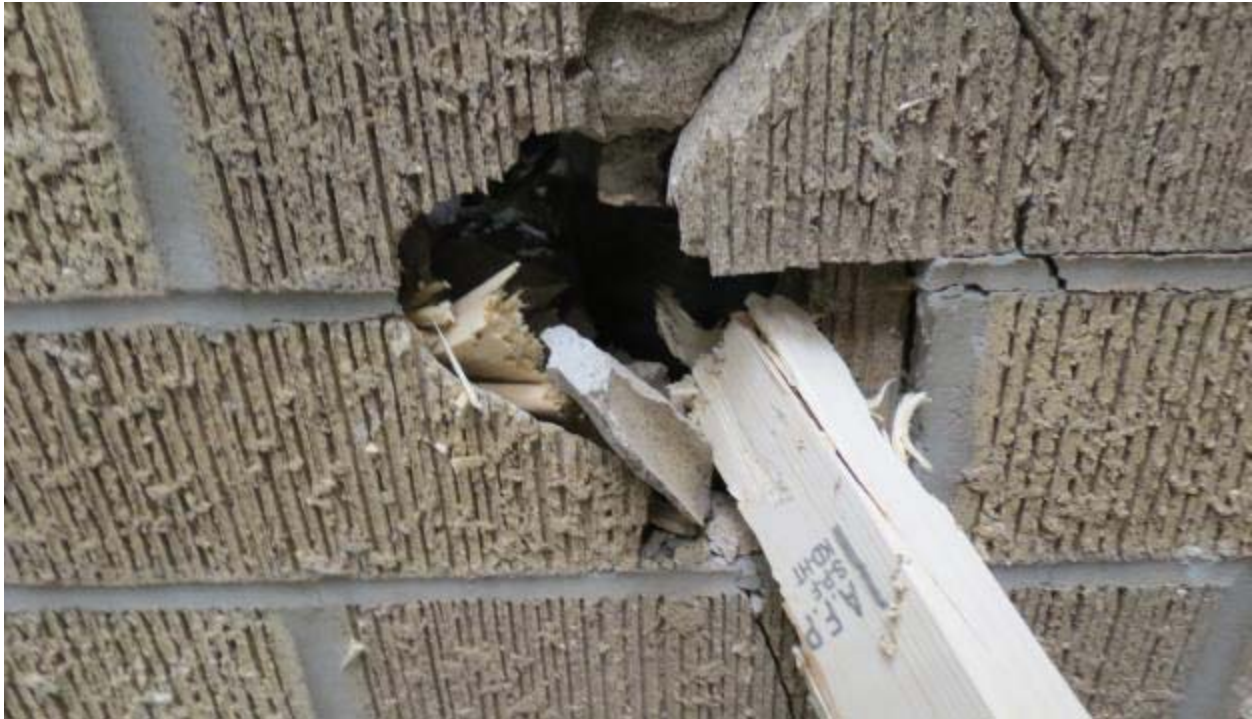
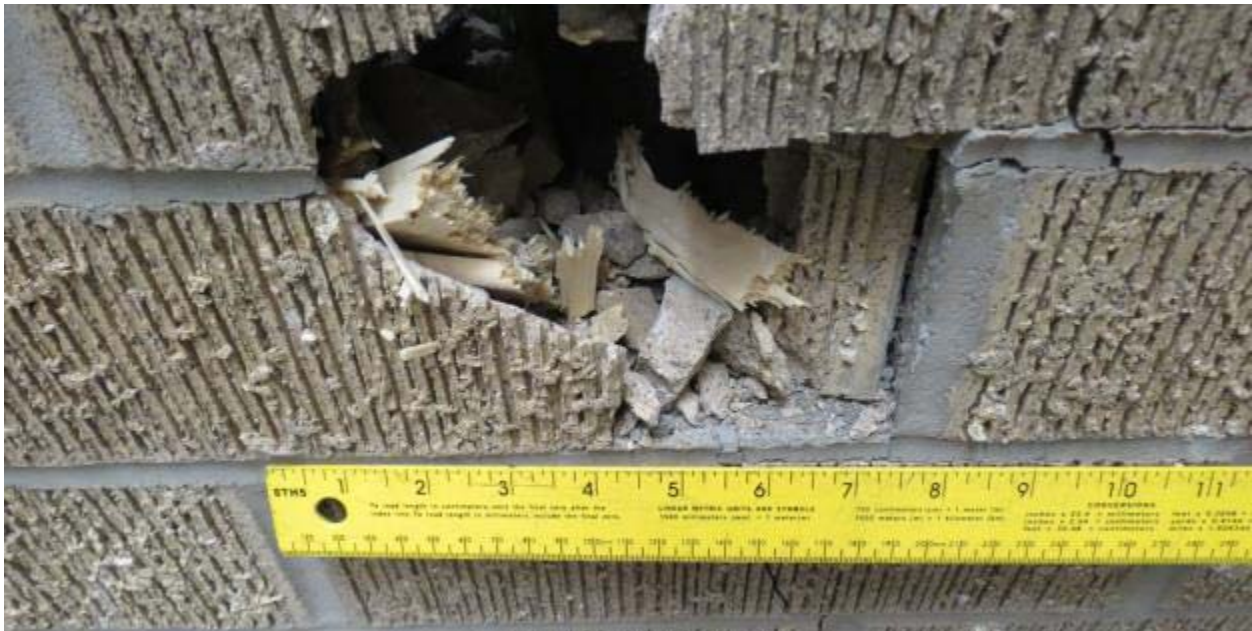
### Series 1 Impact 1 Horizontal Width of Impact

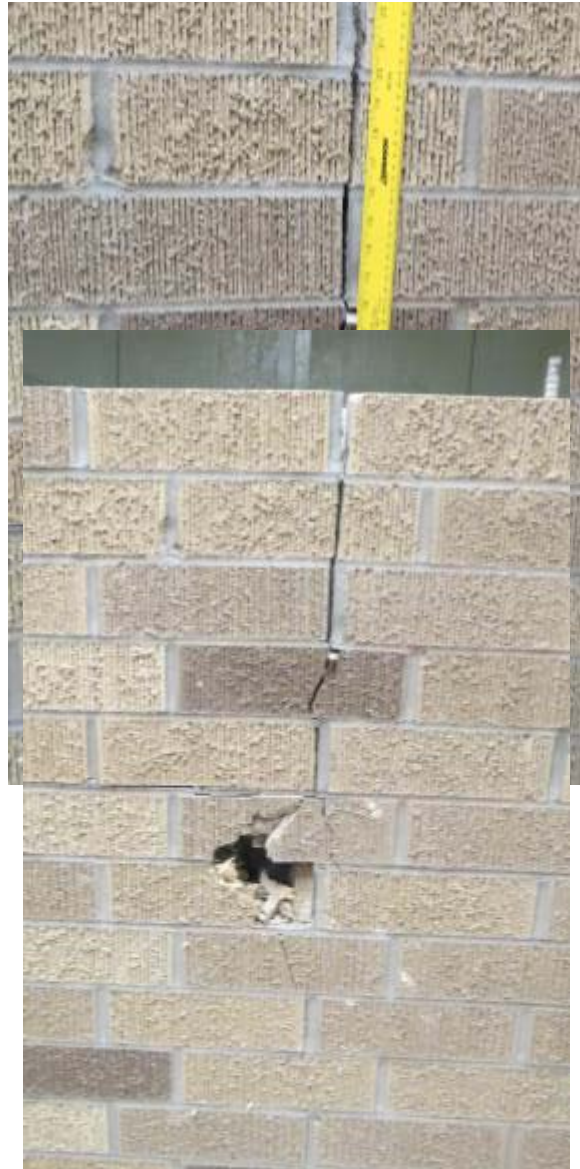
### Series 1 Impact 1 Vertical Crack

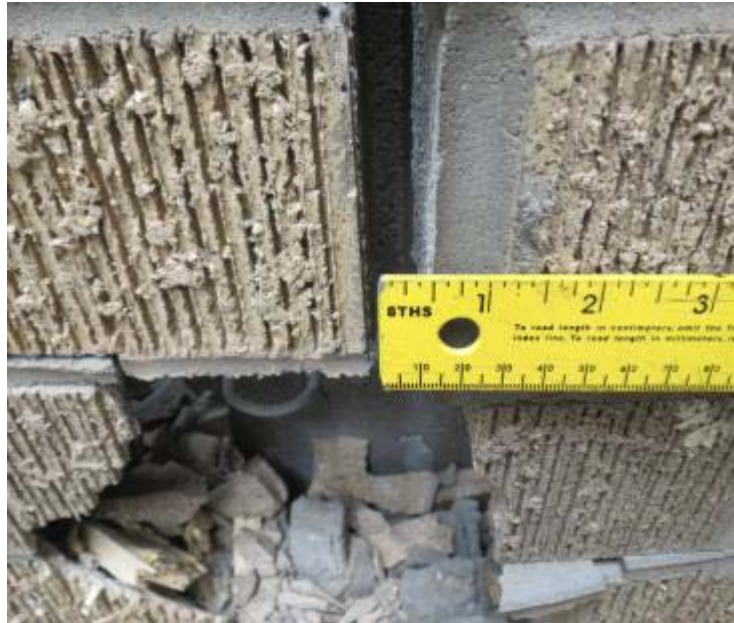
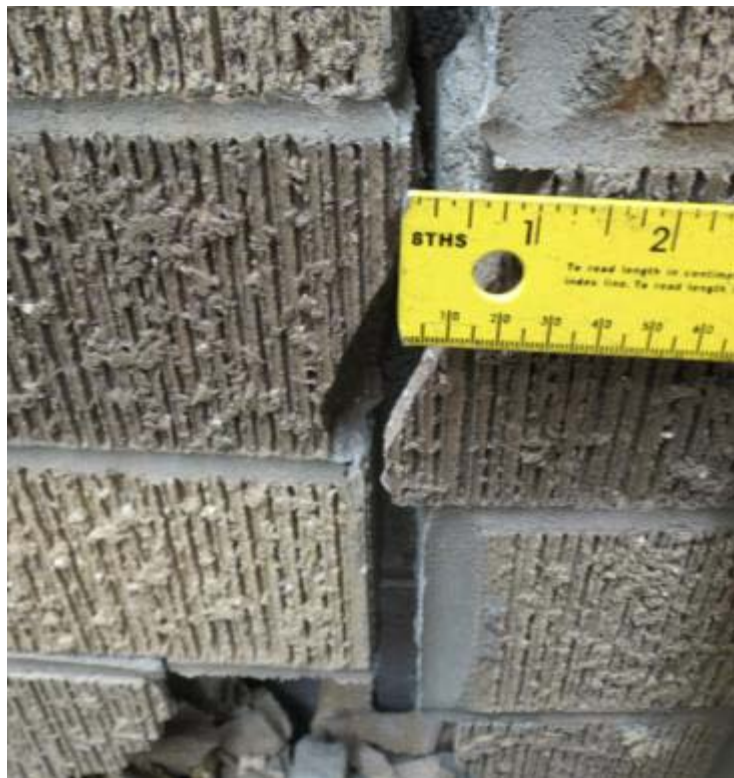
### Series 1 Impact 2 Vertical Crack Separation

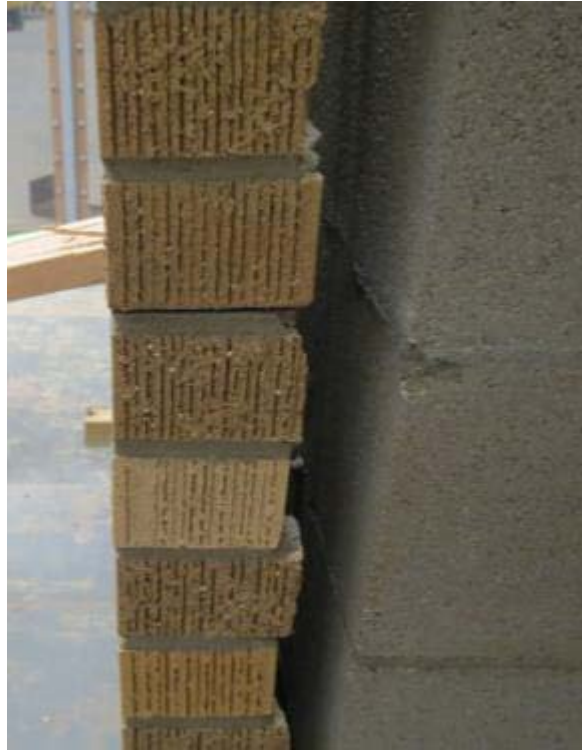
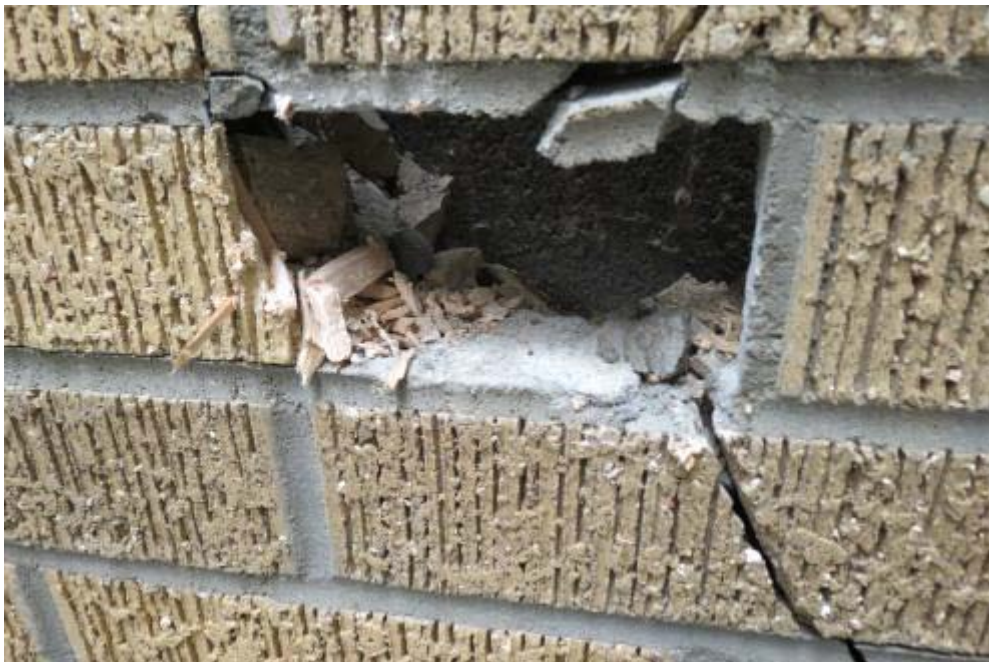
**Series 2 Impact 1 Side Crack and Close Up**

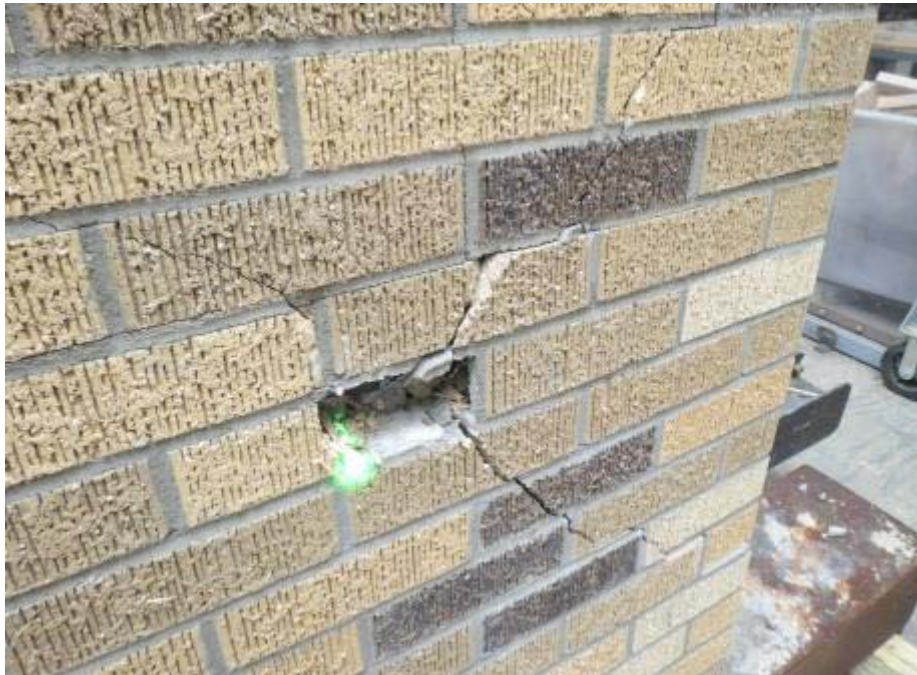
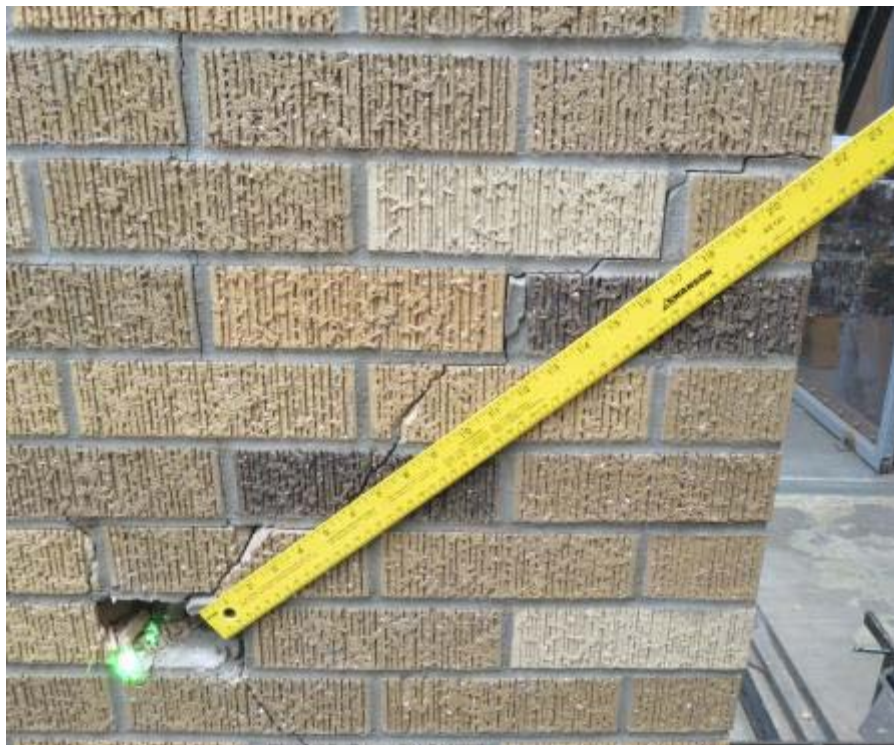
### Series 2 Impact 1 Close Up of Diagonal Crack

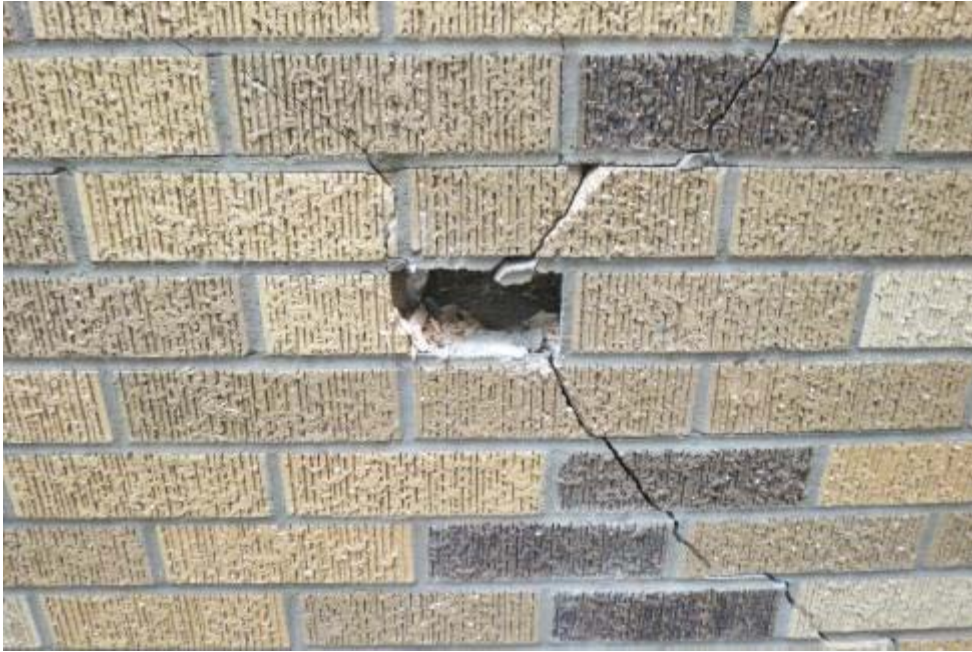
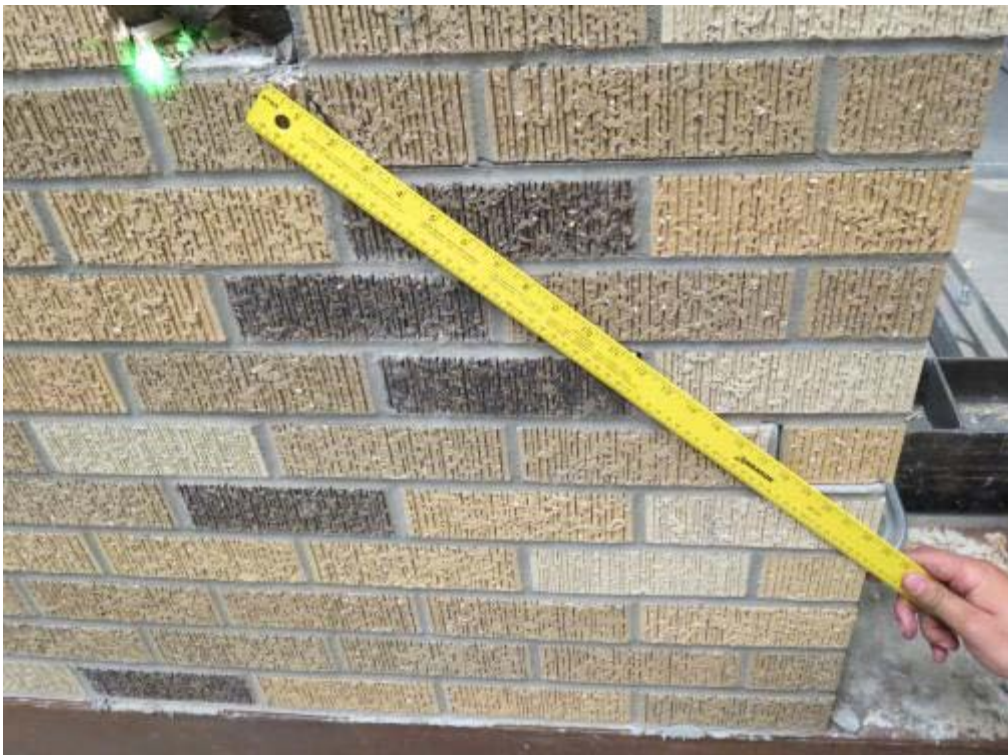
### Series 2 Impact 1 Close Up of Diagonal Crack

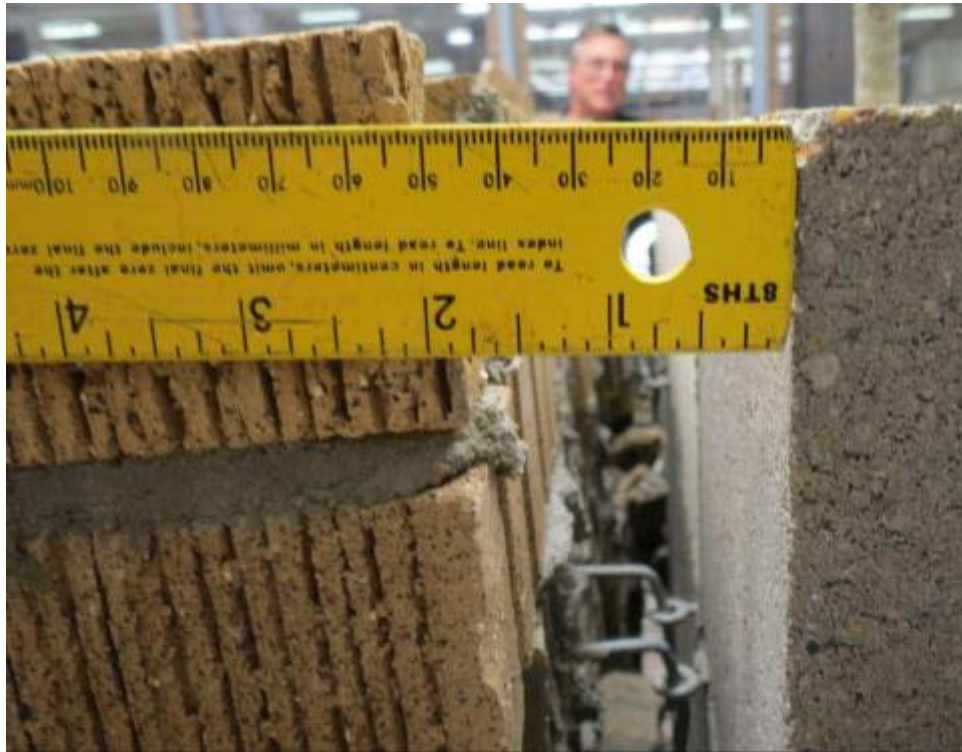
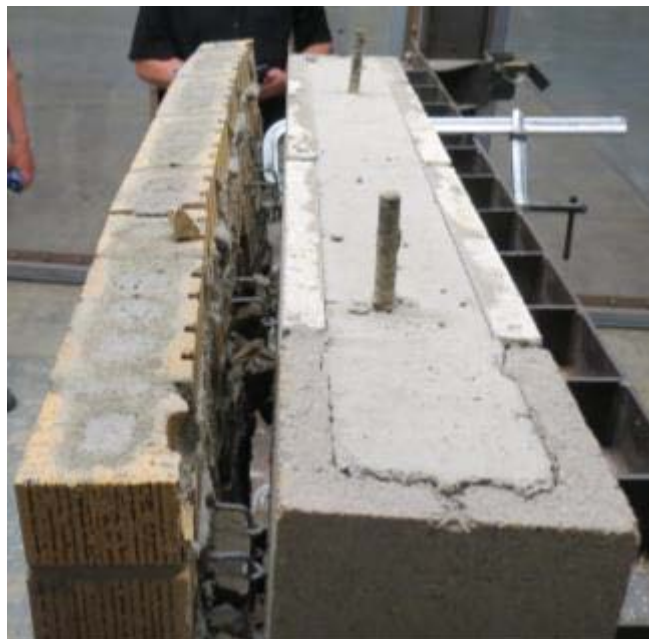
### Series 2 Impact 3 Separation and Top View
