TEXAS TECH UNIVERSITY  
**National Wind Institute™**

**MAY 20, 2013 MOORE, OK, TORNADO INVESTIGATION REPORT**

November 2014

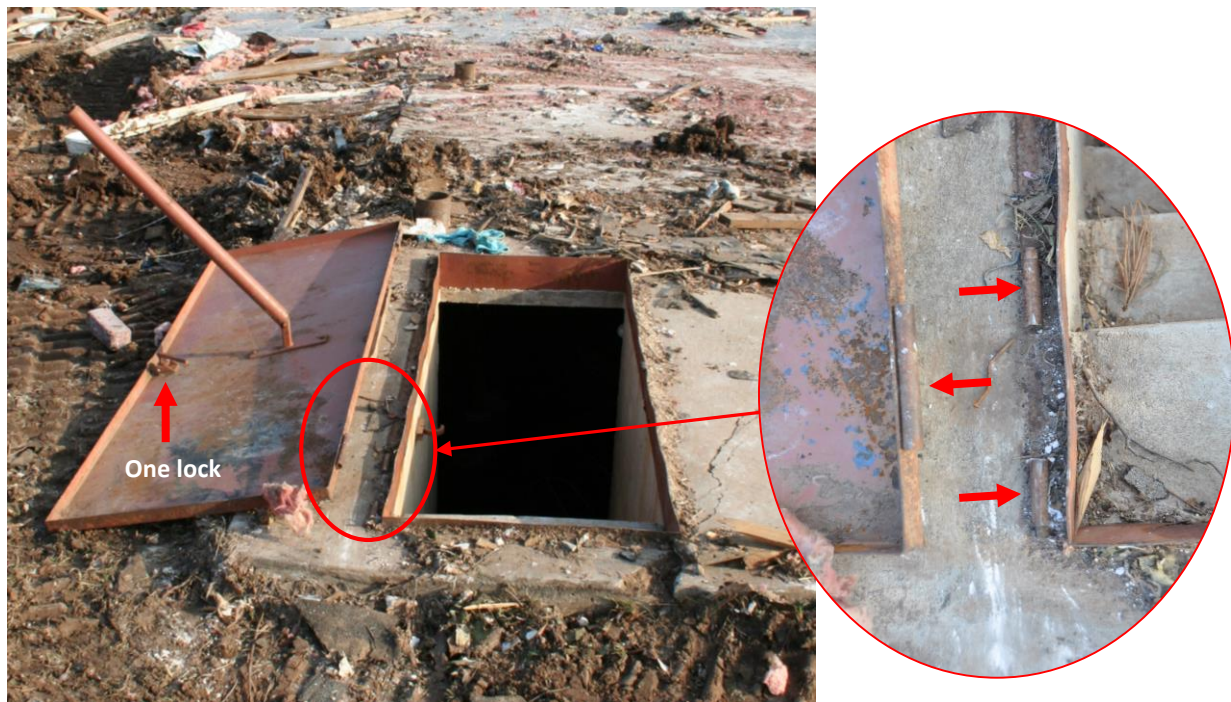
The team documented eight flush-to-the-ground shelters, all of which had hinged swinging doors. One shelter (No. 47) sustained a significant failure as the door was blown off due to sheer failure of rusty hinge pins (seen in *Figure 7*). The door of another shelter (No. 14) was stuck shut and the homeowner, an elderly man, opted to take shelter in an interior bathroom of his home with his pets. Additional deficiencies with shelters of this type were related to door thickness, locking systems, hinges, stairs, and drainage. Many of such shelters were not properly designed with beveled edges to allow water runoff to flow around the opening, and had been flooded with 6 inches to 48 inches of water. (Flooding was a common complaint among homeowners.) Many homeowners were under the impression that they were safer in below-ground shelters and were unaware of shelter installation and testing guidelines.

**Figure 1.7.** Door failure of shelter with only a single lock point (No. 47).

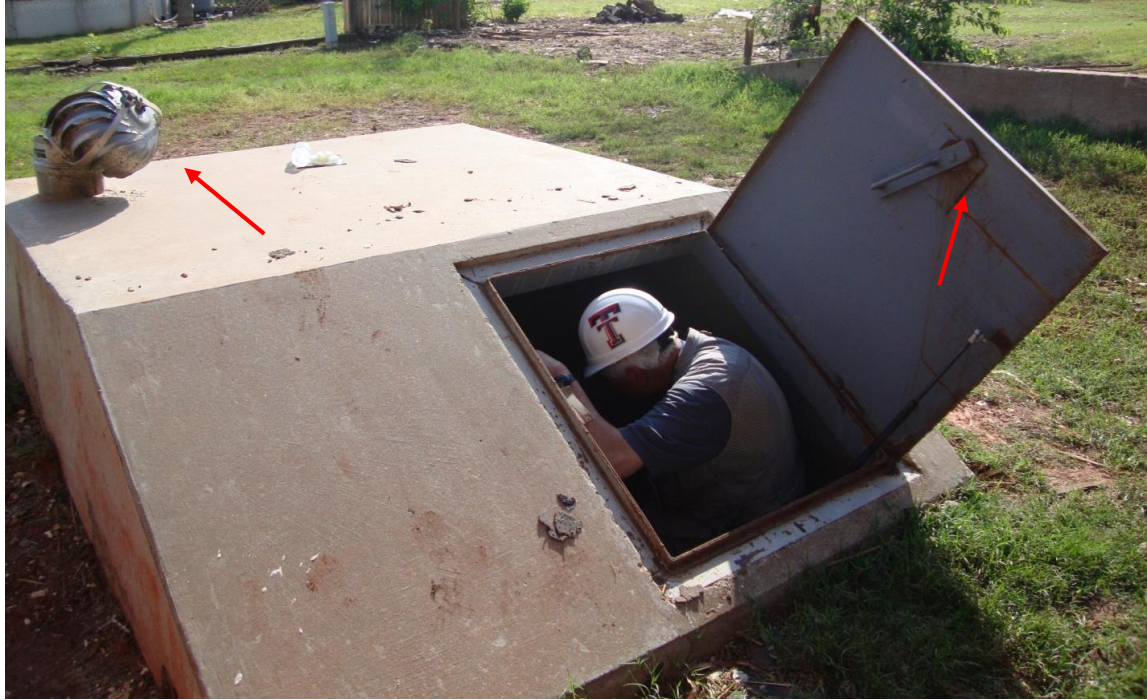
**Figure 1.8.** Clam shell shelter with an insufficient locking system and damaged vent at an EF-2 rated location (No. 3).

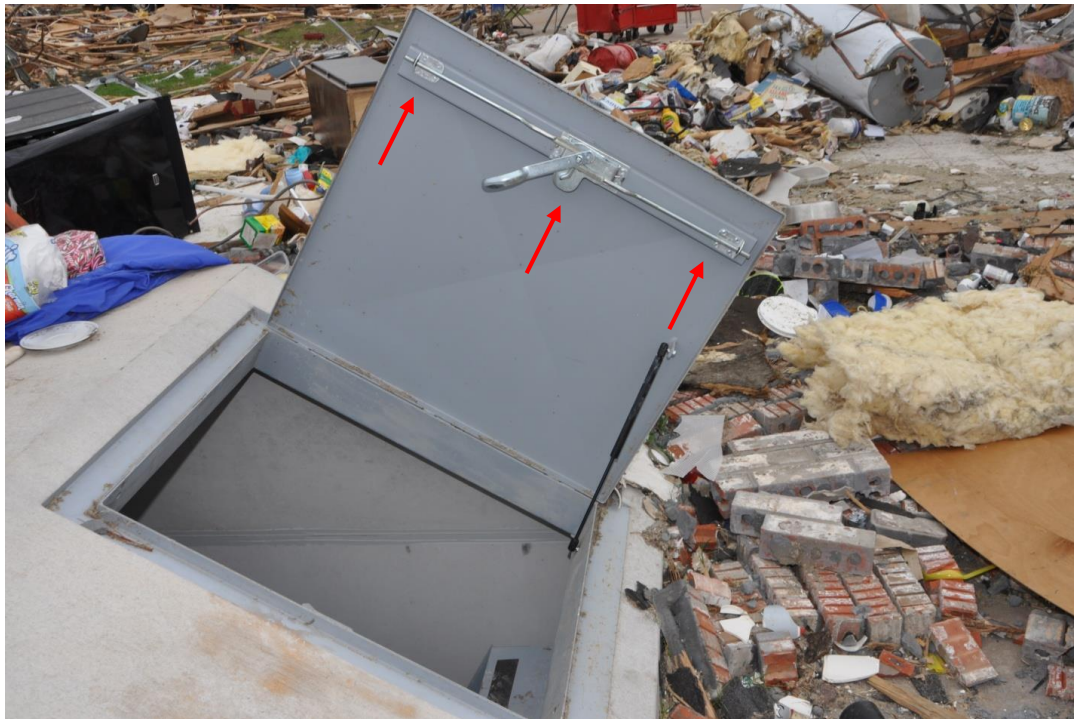
**Figure 1.9.** Clam shell shelter with a tested door that has three locks and three hinges at an EF-4 rated location (No. 28).

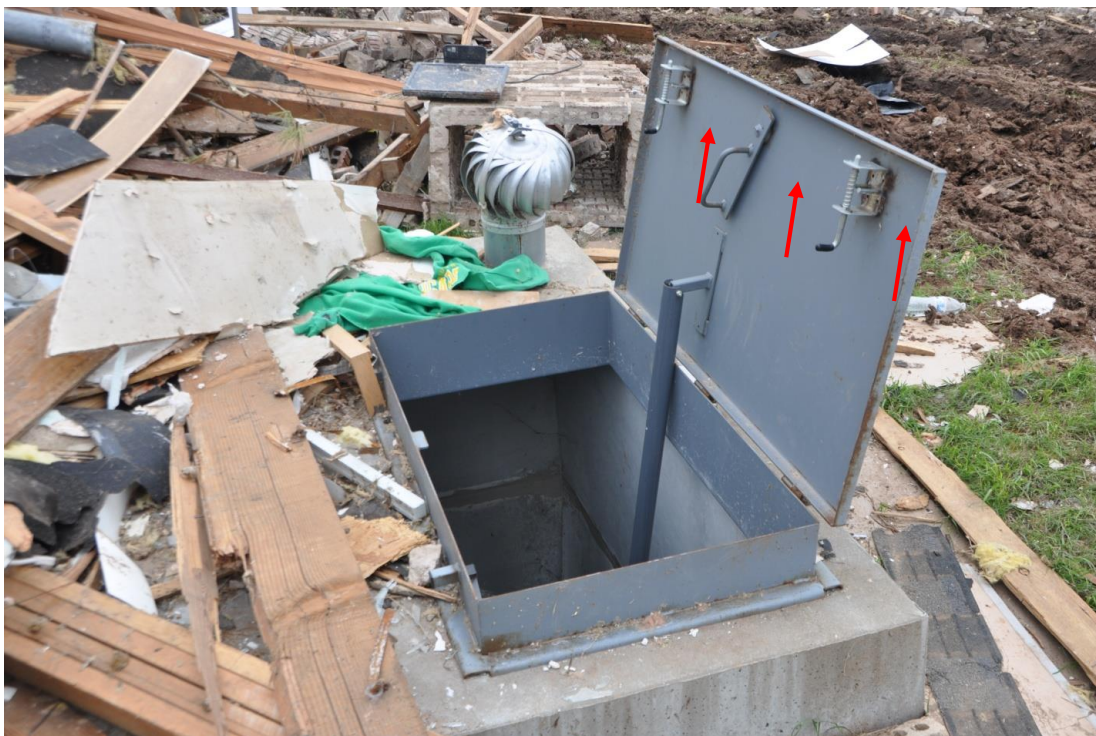
documented in an EF-2 rated location, as seen in *Figure 10*. Performance of these types of shelters was generally acceptable. Accessibility to the shelters can be an issue because these types of shelters are located outdoors and the distance people must travel to take shelter must be considered when deciding placement. One shelter was located about 100 feet from the house, which could pose a greater threat to potential occupants if they need shelter quickly. Standing water of several inches was also commonly observed.

**Figure 1.10.** Flat top clam shell shelter with three locks at an EF-2 rated location (No. 17).

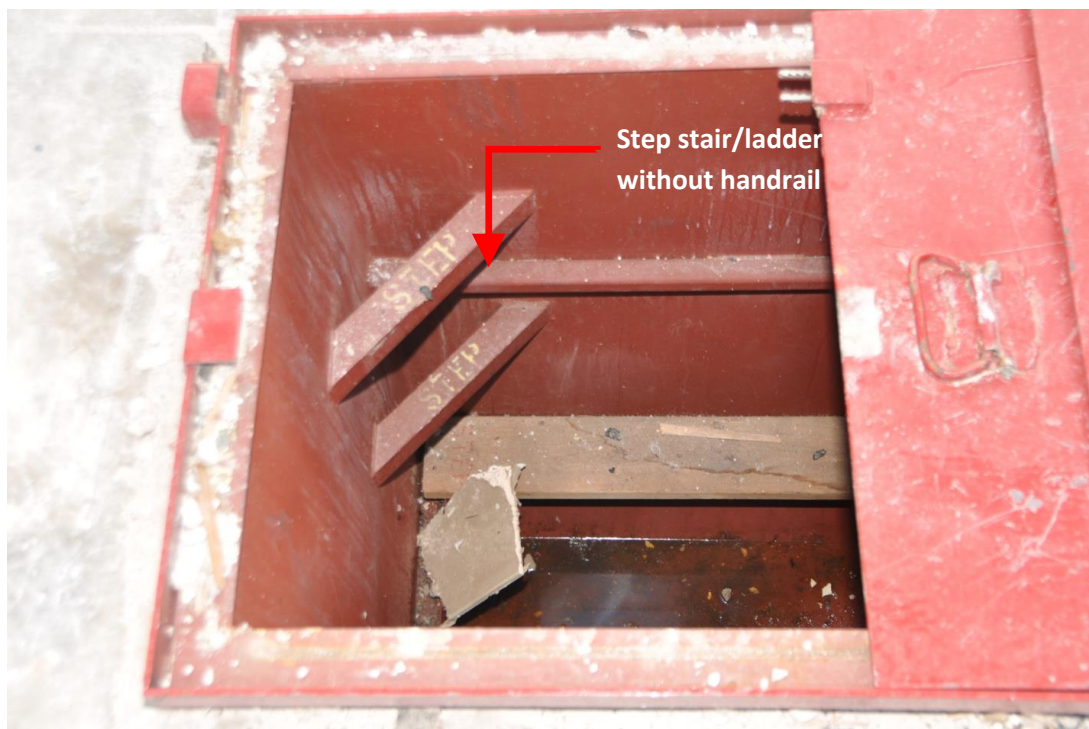
Twenty in-garage floor shelters with heavy sliding doors were documented. All appeared to have performed reasonably, with no major failures. *Figure 11* shows a shelter (No. 12) in an EF-3 rated location with a stair/ladder entry that would not allow for easy access, an inadequate locking system, and some flooding in the bottom. Other issues were similar to exterior below-ground shelters such as: door thickness, locking systems, roller bearings, stairs, and drainage. *Figures 12 and 13* are tested shelters (Nos. 9 and 61) that performed very well in an EF-4 and EF-0 rated locations respectively. Homeowners indicated they preferred the in-garage style shelter because it was cheaper, installation was quick, it did not take up any space, and it gave them confidence by being underground.

**Figure 1.11.** In-garage storm shelter with inadequate stairs, locking system, and flooding in the bottom at an EF-3 rated location (No. 12).

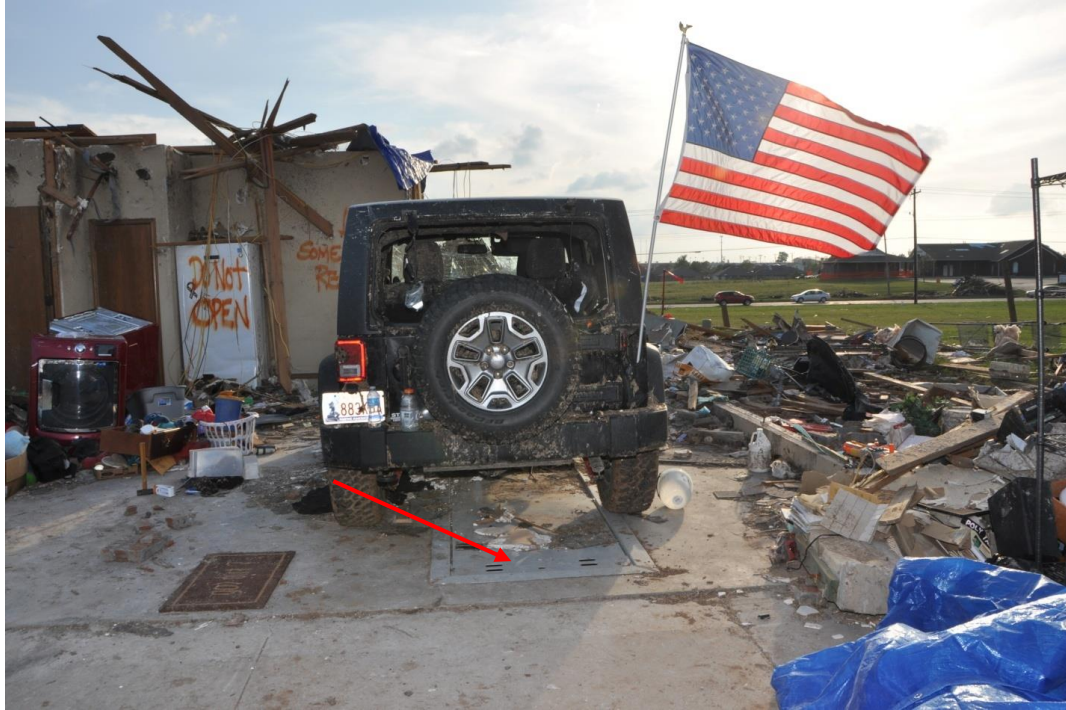
**Figure 1.12.** Tested shelter at a location assigned an EF-4 rating (No. 9). Car was present during the tornado.

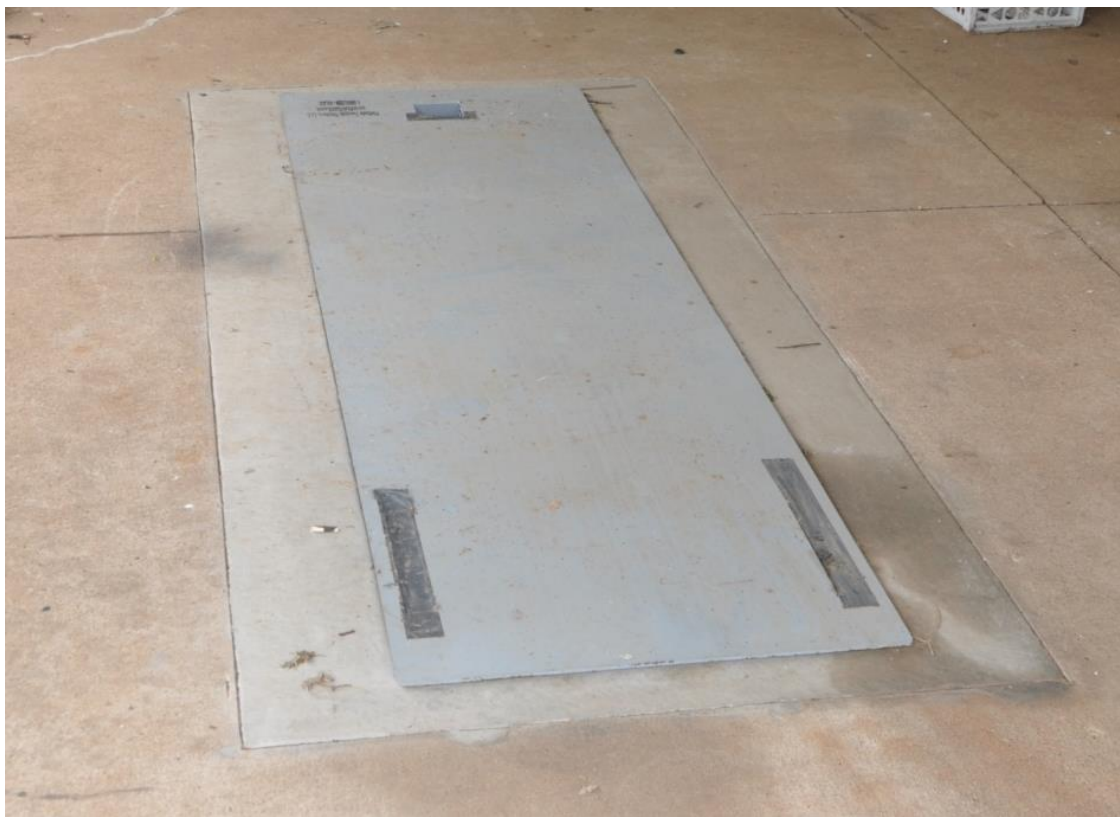
**Figure 1.13.** Tested NSSA shelter at a location assigned with an EF-0 rating (No. 61).

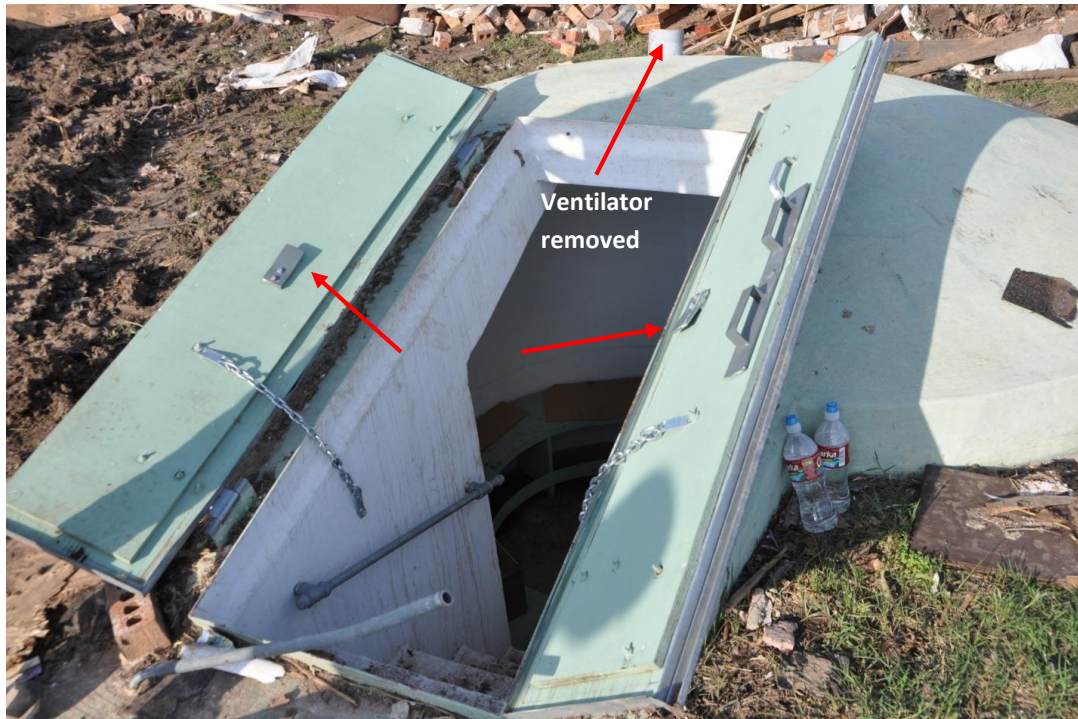
Two dome style shelters were inspected. The shelter pictured in *Figure 14* (No. 43) was cast in place concrete with double plywood doors with lite gauge steel skin cladding, one lock, and two hinges per door. The shelter was observed at an EF-3 rated location. This shelter also had a few inches of standing water in the bottom. The other dome shelter the team documented had three heavy gauge locks with an 1/8 inch steel door. It was partially above-ground, located in an EF-4 rated location, and is shown in *Figure 15* (No. 40). Both appeared to have survived the storm with no major failures, although the construction of the door of the first dome shelter was inadequate.

**Figure 1.14.** Dome shelter with an inadequate door system that included a plywood and lite gauge sheet metal clad door, single locking point, and ventilator removed at an EF-3 rated location (No. 43).

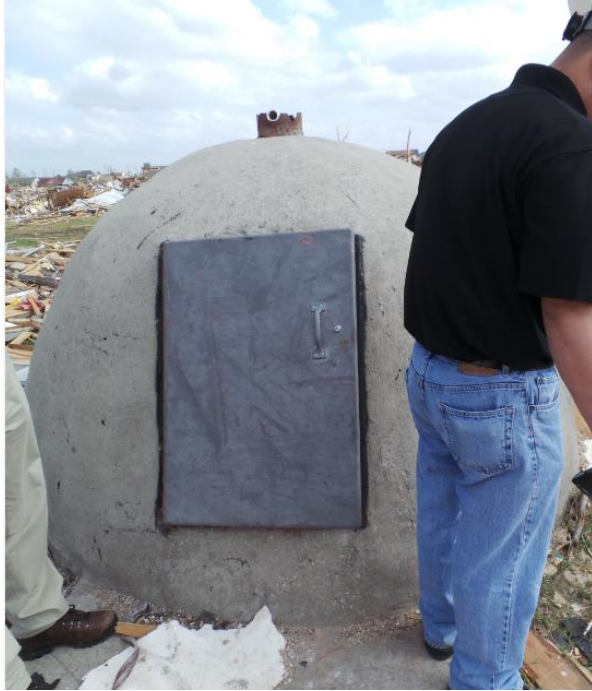
**Figure 1.15.** *Dome shelter partially above-ground located in an EF-4 rated location (No. 40).*

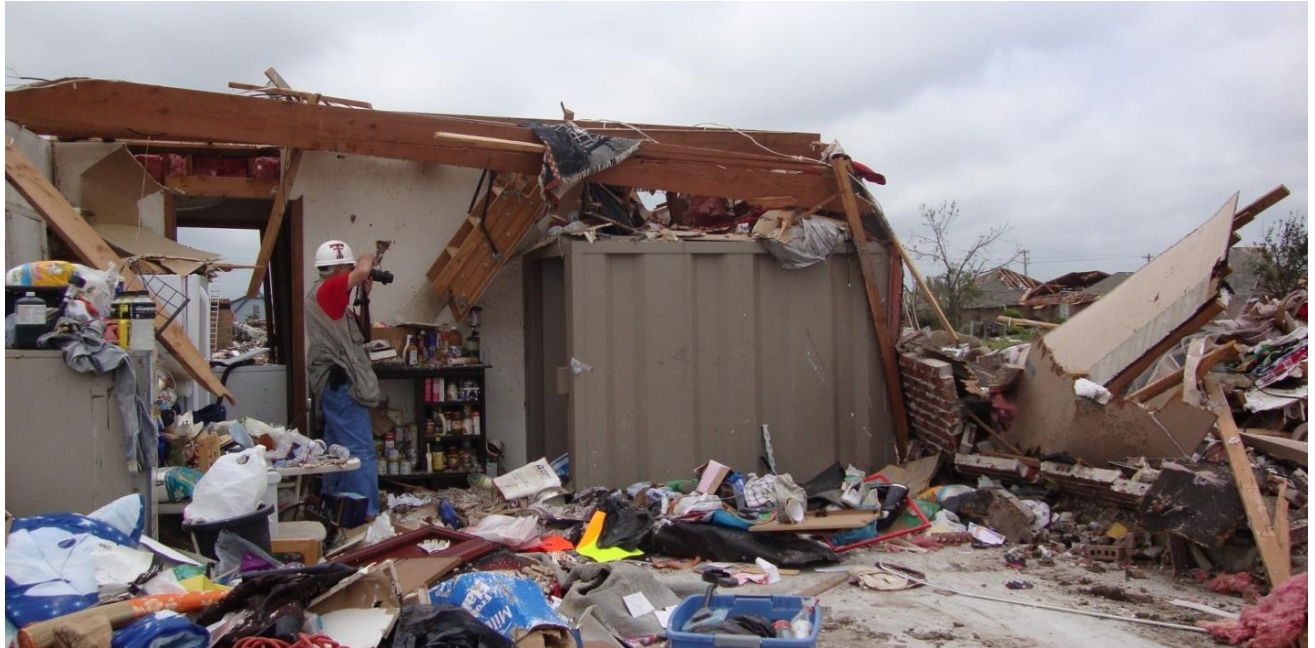
**Figure 1.16.** An above-ground tested shelter that survived EF-4 wind speeds (No. 25).

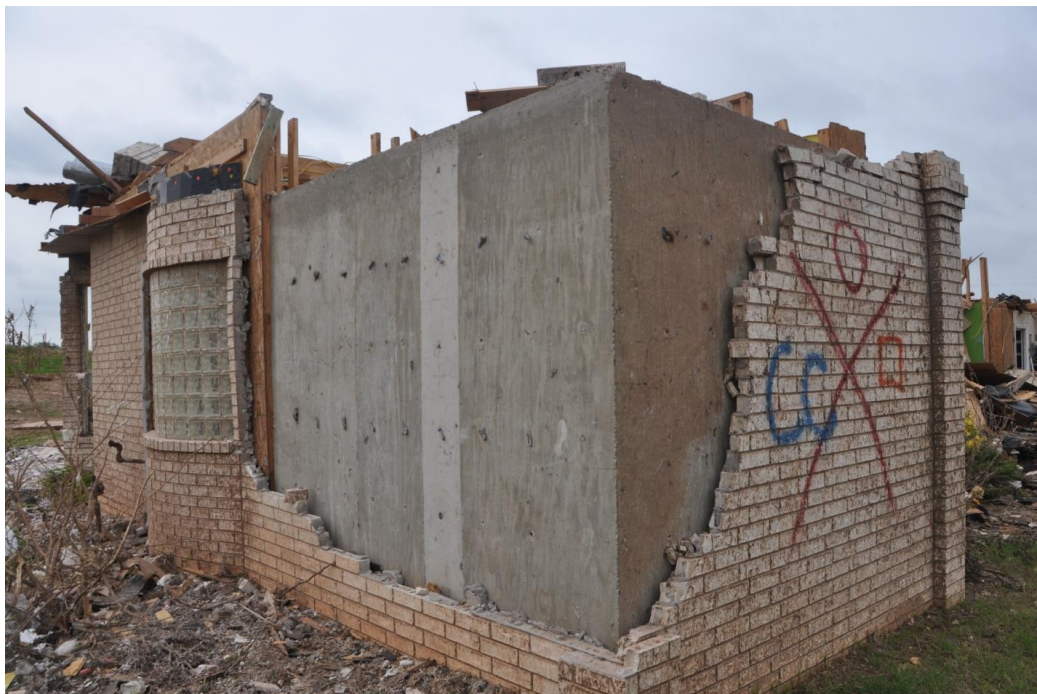
**Figure 1.17.** An above-ground, concrete shelter that also served as a walk-in closet at an EF-2 rated location (No. 49). The concrete was tested, but the door was not.

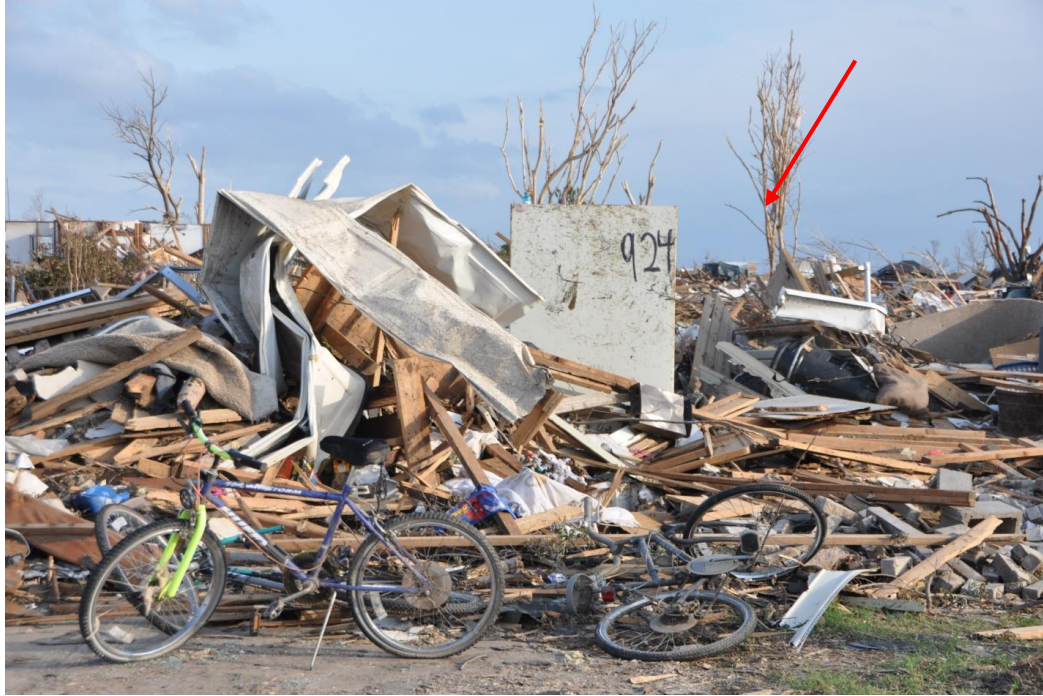
**Figure 1.18.** Above-ground tested steel shelter that performed very well in an EF-3 rated location (No 46).

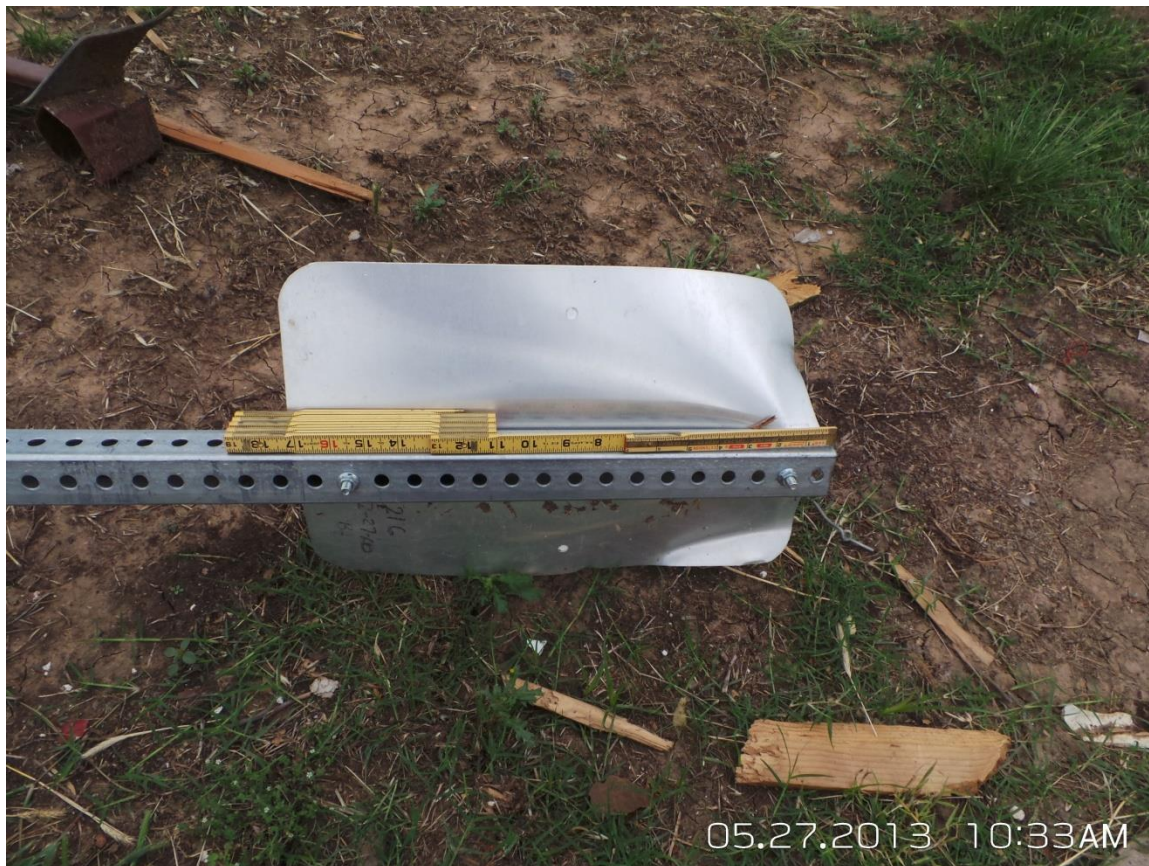
**Figure 2.3 Structure 1, small sign.**

The dimensions of the sign, shown in *Figure 2.3*, are approximately 12 in wide by 17 in tall. This sign is supported with a perforated square steel tube post. Based on the small size of the sign, inspection of the pictures, and the Oklahoma Department of Transportation (ODOT) Specifications (ODOT, 2009), the post was assumed to be 1.5 in by 1.5 in square constructed from 12 gauge ASTM 1011 Grade 50 steel.

The failure velocity for Structure 1 was the highest of all the signs due to the fact that it had the smallest area of all the signs. The calculated wind speed of 136 mph corresponds with low EF-3 damage. Structure 1 was located in what was likely an EF-2 area. There is some uncertainty due to the fact that there were few other structures surrounding Structure 1. However, Briarwood Elementary School, located approximately 100 yards away, experienced EF-5 damage.

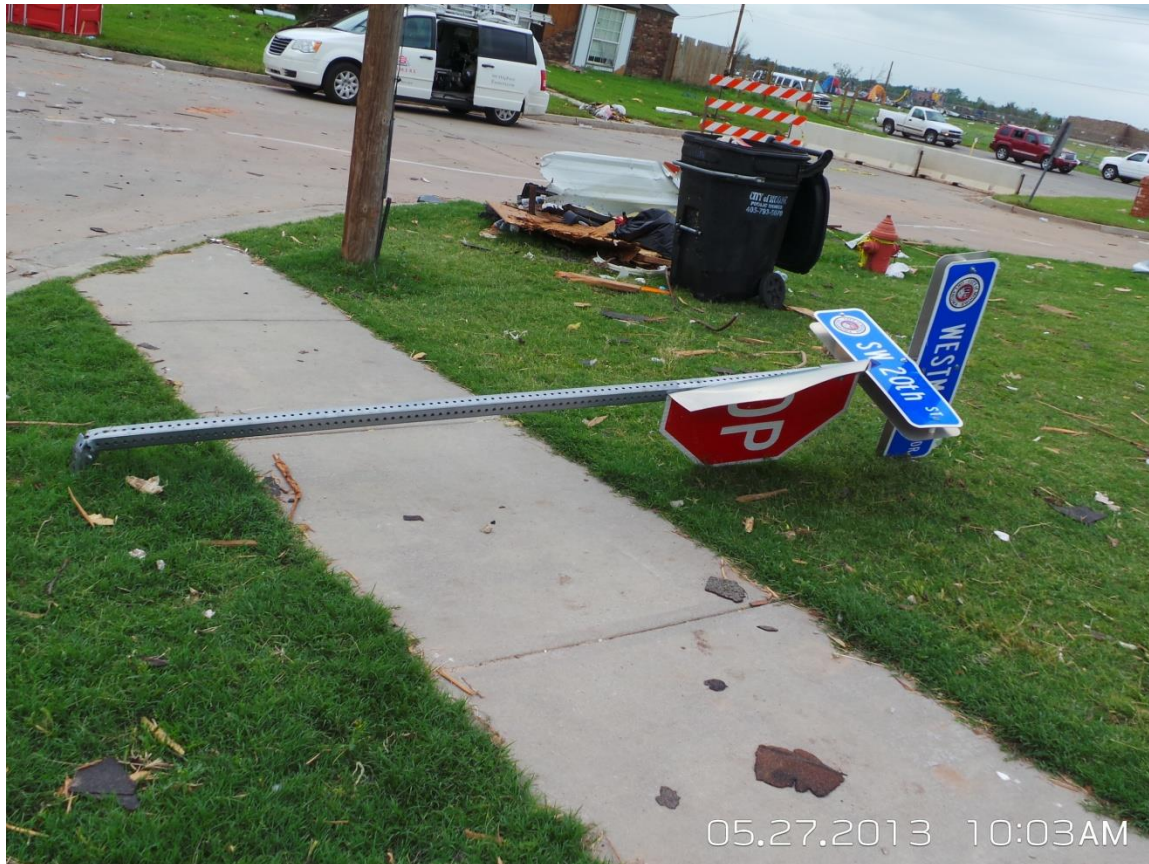
**Figure 2.4** Structure 2, stop sign.

The stop sign structure is shown in *Figure 2.4*. The dimensions of the stop sign dimensions are established from ODOT specifications. There are three different possible sizes, and this stop sign was assumed to be the smallest size, 30 in by 30 in. The stop sign also included street name signs on the post, which were assumed to be 30 in by 6 in. Based on the larger area of this sign, the post was assumed to be 2 in by 2 in square made from 14 gauge ASTM 1011 Grade 50 steel.

Structure 2 was located near the outer edge of an EF-2 zone. The calculations suggest that the wind speed that caused this failure was at least 115 mph, and this structure experienced the lowest wind speeds at failure, mainly due to the large area of the sign and to the fact that the wind angle of attack that caused failure was perpendicular to the face of the sign.

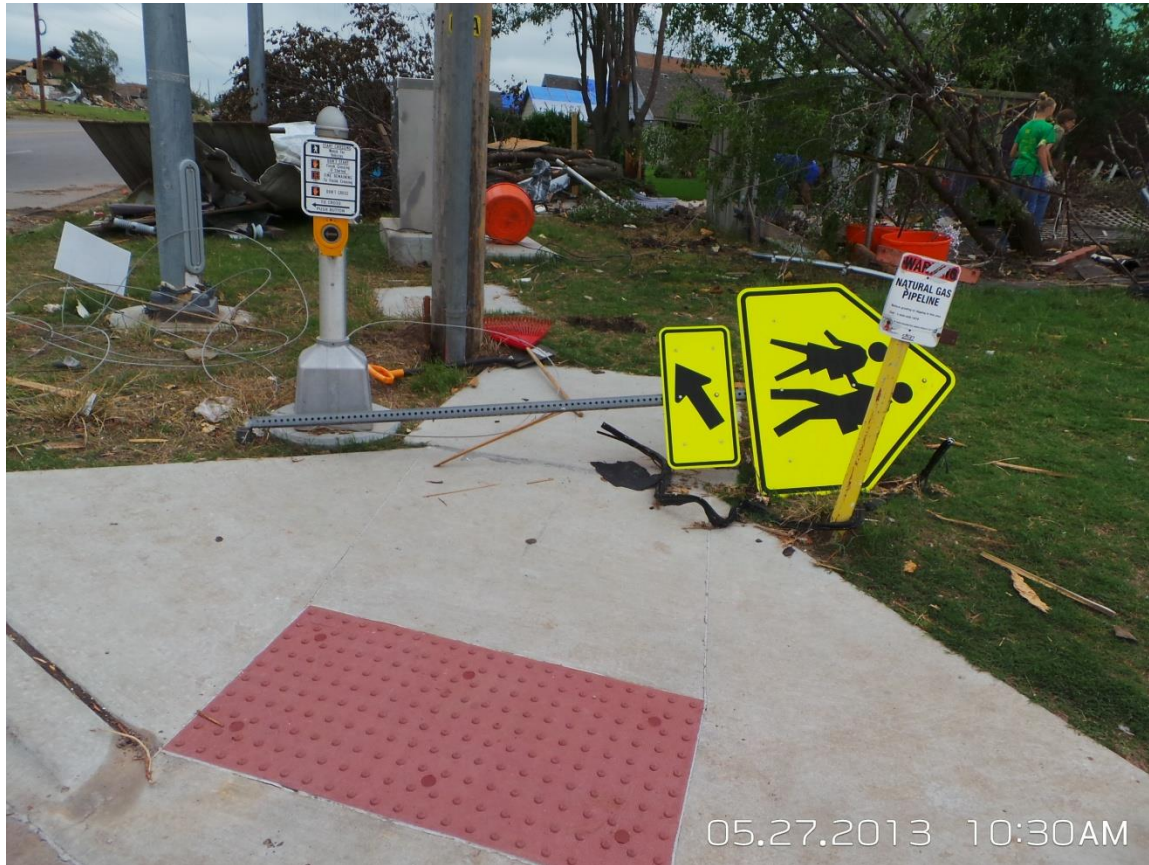
**Figure 2.5 Structure 3, school crossing sign.**

The school crossing sign is shown in *Figure 2.3*. Its dimensions are established using the ODOT Specifications. Again, there are multiple sizes listed and the smallest size, 36 in by 36 in, is used. Additionally, there is a smaller sign below it containing a downward pointing arrow. The size of this sign is listed as 24 in by 12 in. This post is 2 in square tube of 14 gauge ASTM 1011 Grade 50 steel.

Structure 3 was located approximately in the middle of the delineated EF-2 zone, and the surrounding damage suggests EF-2/EF-3 wind speeds. Although this sign had a larger area than Structure 2, the wind acted on the sign at a very sharp angle which means that a much higher wind speed was required to cause failure than when the wind acts perpendicular to the sign face. The wind speed at this location - slightly north of Structure 2 - was at least 120 mph.

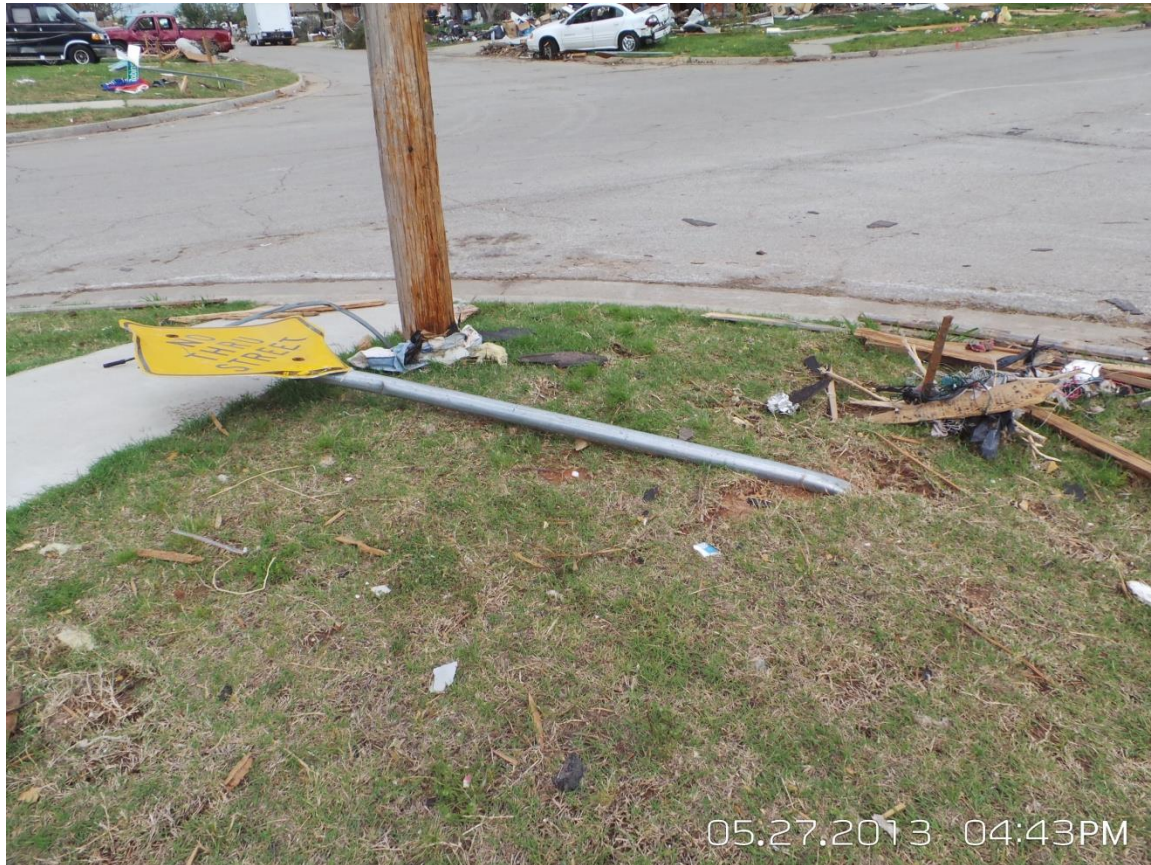
**Figure 2.6. Structure 4, No through street sign.**

This sign, shown in *Figure 2.6*, could not be found in the ODOT Specifications. The dimensions of a “School Bus Stop Ahead” sign, which has the same shape and likely the same size, were used instead. The standard size smallest sign of this type is 30 in by 30 in. This sign was the only one that did not use perforated square steel post, and instead used a circular steel pipe. According to the Specifications, the steel pipe used for signs is a Schedule 40, 2 in ASTM Grade 50 steel pipe, with an outside diameter of 2.375 in and a thickness of 0.15 in.

Structure 4 was located west of the first three structures, and approximately in the middle of the delineated EF-2 zone. Again, surrounding damage suggests EF-2/EF-3 wind speeds. This sign, like Structures 2 and 3, has a large area. However, the larger circular post requires a higher velocity to cause failure. The wind speed at this location was at least 124 mph.

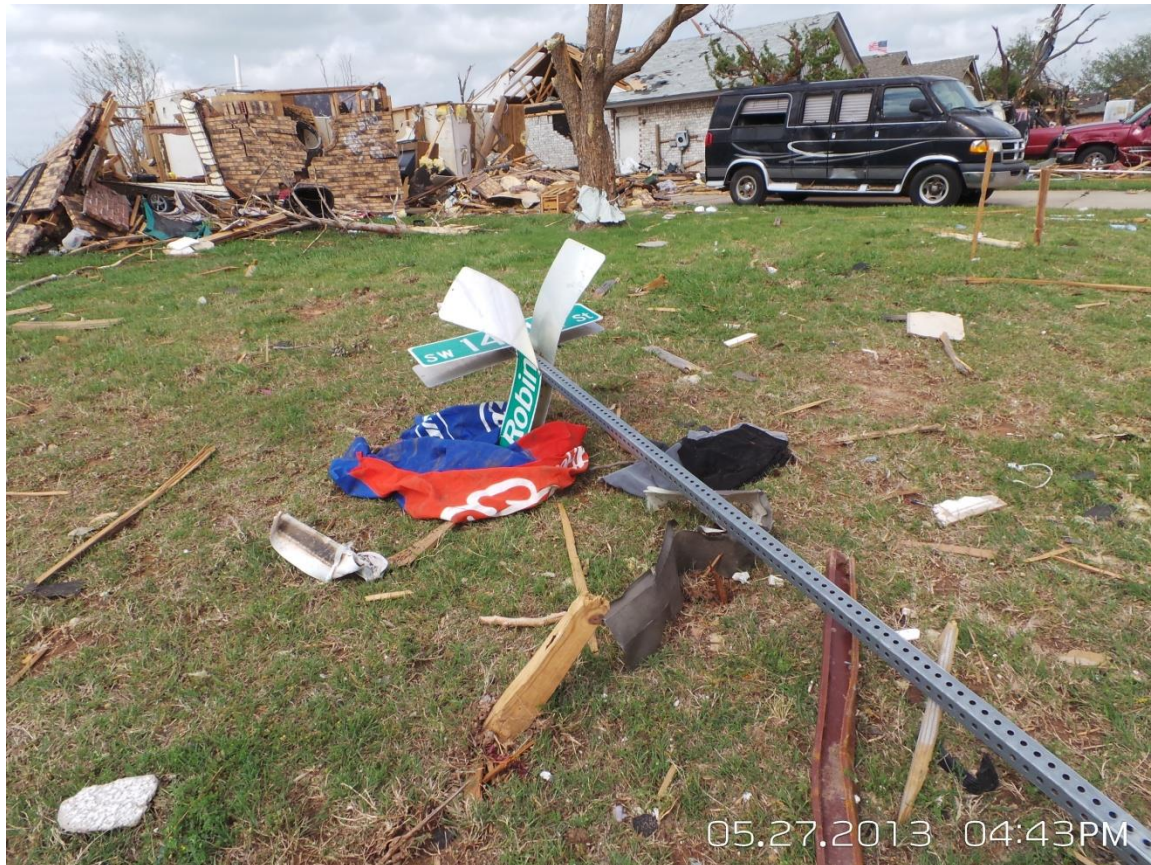
**Figure 2.7 Structure 5, street name sign.**

This sign (shown in *Figure 2.7*) like others, was not listed in the ODOT Specifications. However, it was assumed to be identical to the street name sign on the stop sign, 30 in by 6 in. Based on the small size of this sign, the 1.5 in, 12 gauge ASTM 1011 Grade 50 steel post size was assumed.

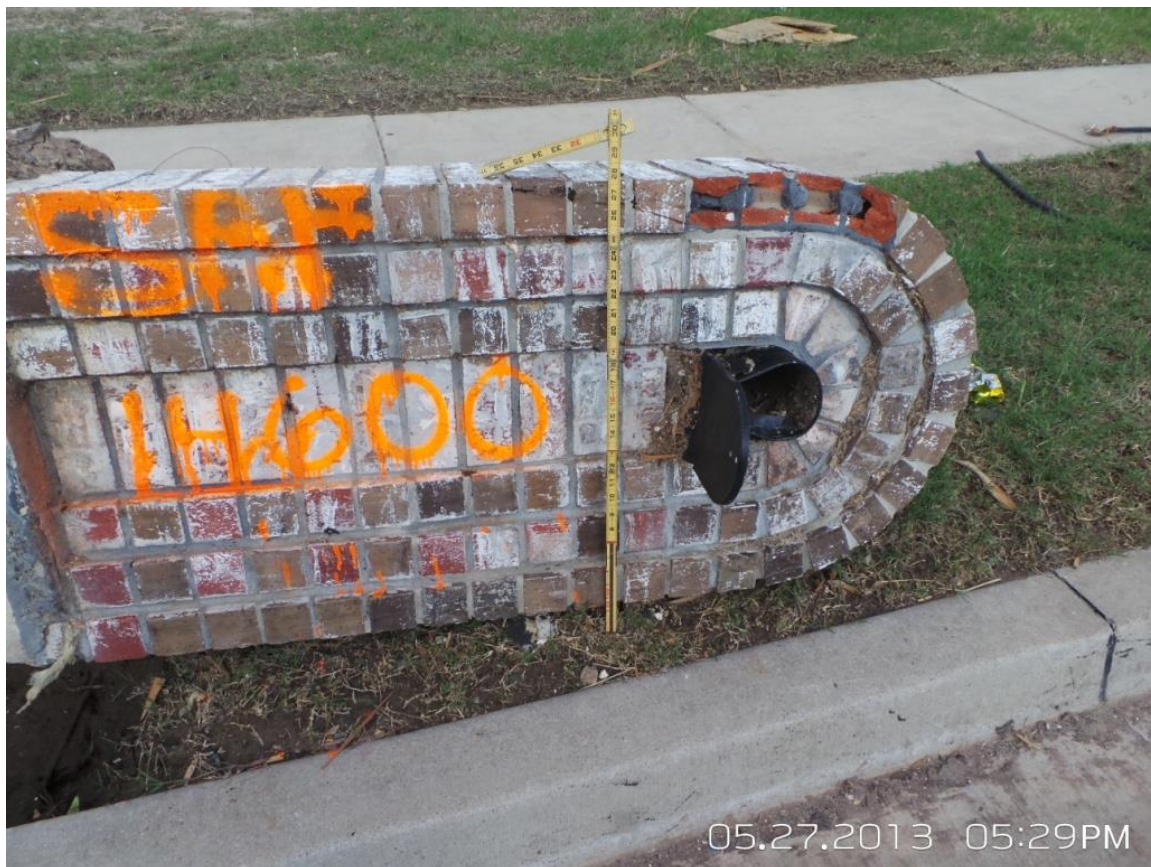
**Figure 2.8 Structure 6, brick mailbox.**

The brick mailbox was the structure with the least amount of readily available information in the selected databases, and almost every property of the mailbox was estimated from three pictures. First, the mailbox was assumed to have a CMU core with a one-brick-deep outer layer. There are many different types of bricks, and each type has a slightly different size and weight. From a measuring tape in one of the pictures, each brick was determined to have a cross section of approximately 2.75 in by 2.75 in. This corresponds with queen-sized bricks, which, according to multiple brick manufacturers, weigh approximately four lbs. By counting the two sides of the mailbox available in pictures, it was estimated that the mailbox consisted of 181 bricks, weighing 724 lbs. The core was determined to have approximately five CMU blocks weighing 230 lbs. The measuring tape, along with brick dimensions, allowed for reasonable estimate of the mailbox's height (46 in), width (25.5 in), and depth (23.5 in).

The mailbox, located on the border of EF-3/EF-4 damage, failed at the highest velocity of all the structures investigated. Wind speeds at this location were at least 149 mph. It should be noted that

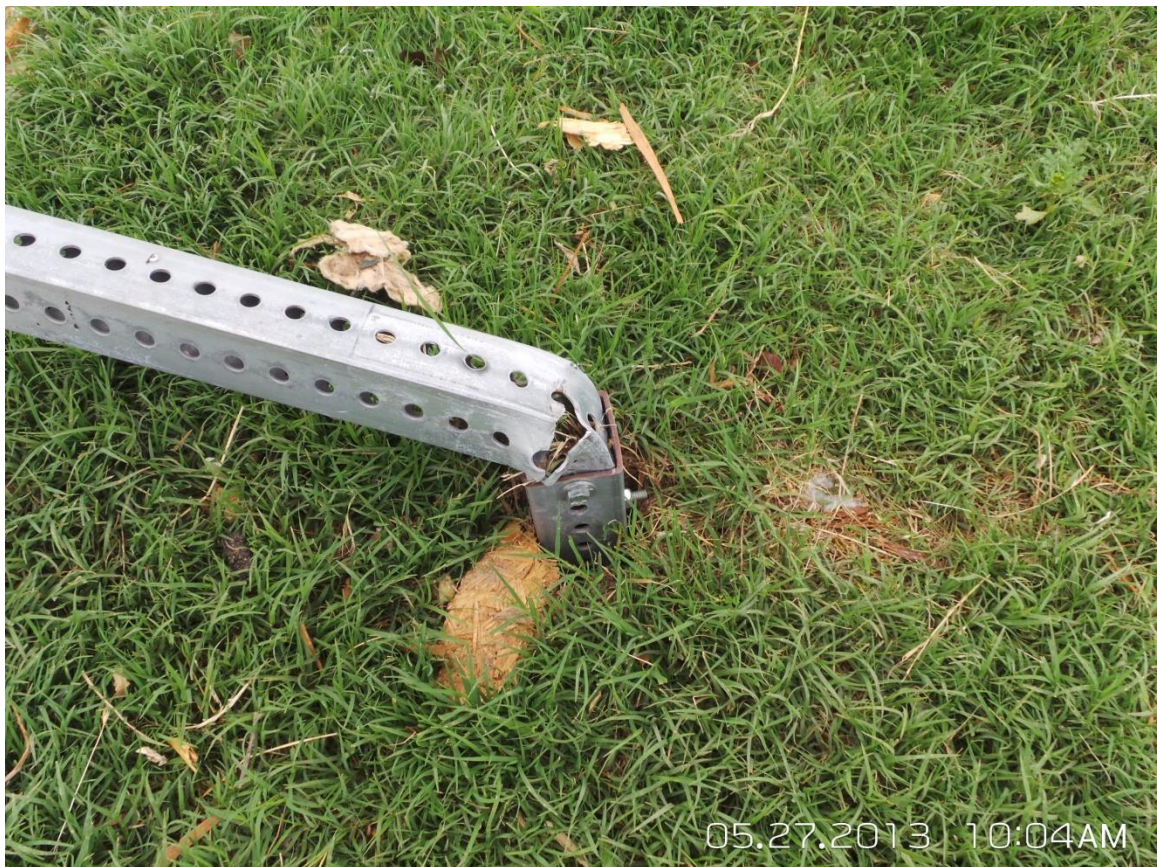
For the signs with the perforated square tube posts, this failure (yielding from pure bending or combined bending and torsion) occurred at the joint between the post and the anchor tube. The bending failure of Structure 2 (stop sign post), is shown in the sign with the pipe post failed at the point where it entered the ground. The limit states used for each of the sign structures is given in *Table 2.1*.

**Figure 2.9 Bending failure of post for structure 2, stop sign.**

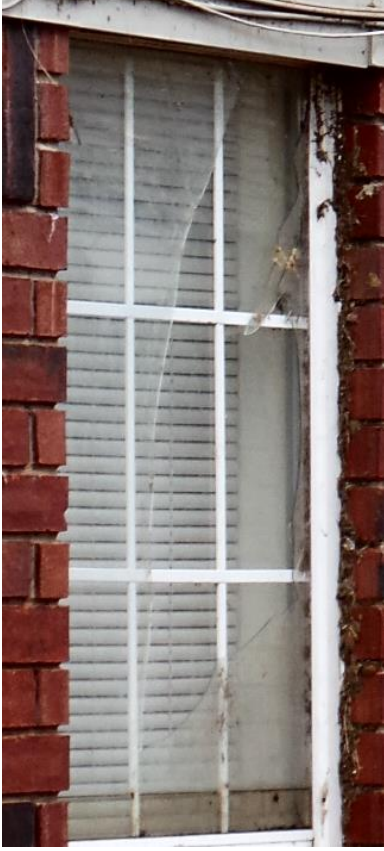
**Figure 3.3.** Specimen L1 fracture pattern.

In contrast, *Figure 3* shows a magnified view of Specimen L1 where the shards are significantly larger with large areas of unfractured glass indicating the fracture was not due to large stresses resulting from a high uniform lateral pressure, but rather due to impact damage caused by wind borne debris impacting the window. Using the assessment criteria, it was determined that all 15 fractured specimens fractured due to debris impact. *Table A.3* lists the criteria for each fractured specimen with a justification for determining the specimens fractured due to debris impact damage.
