Damage Documentation of Tornado
of 9 October 2001
at Cordell, OK

Wind Science and Engineering Research Center
Texas Tech University
Lubbock, TX
March 2002

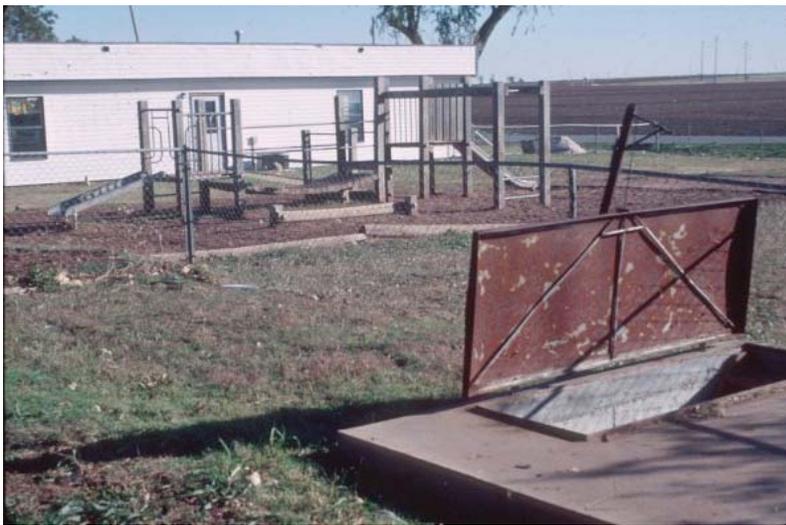
This day care center was outside of the path of the tornado and did not suffer any significant damage. Upon hearing the warning, the teachers led the students around the fence to the underground cellar in the back. A fence separated the day care center from the cellar necessitating a fairly long walk to the cellar. The manager indicated she was planning on having a gate cut into the back fence so the children could walk directly from the center to the cellar when future warnings are posted. See Fig. 4 which shows the cellar in the foreground and day care center behind the fence in the background.

Fig. 4. Lil Learners Day Care Center in background; storm cellar used by students and teachers in foreground. Note fence between the two.

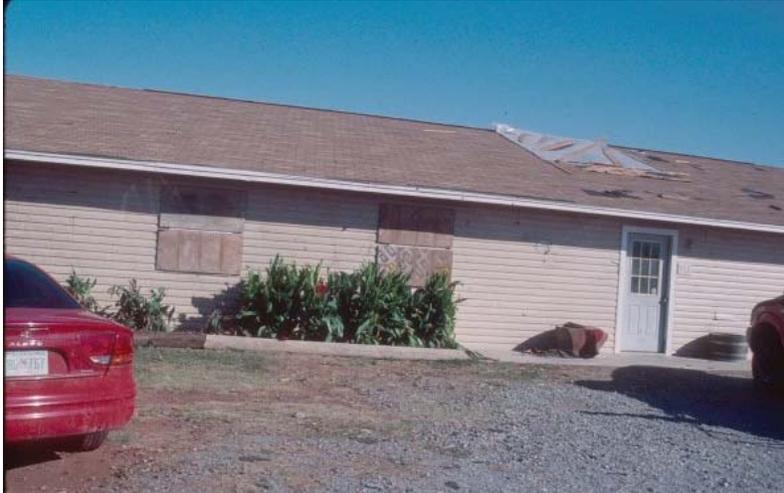
Several windows of the building were broken during the storm. The windows had been boarded up and glass cleaned up by the time WISE personnel arrived. A 2x4 missile penetrated the roof of the center but did not extend down through the ceiling. The roof appeared otherwise undamaged. The builder mentioned that hurricane clips were installed at the time the structure was constructed. Additional damage included scattered removal of some vinyl siding and a hole in the west wall (where an air conditioner was probably installed). The most significant damage noted by the owner was the loss of an extensive set of playground equipment from the backyard (to the west).

Fig. 5: Day Care Depot. Note broken windows and plastic on roof where a missile penetrated. Entrance to safe room just inside the front door.

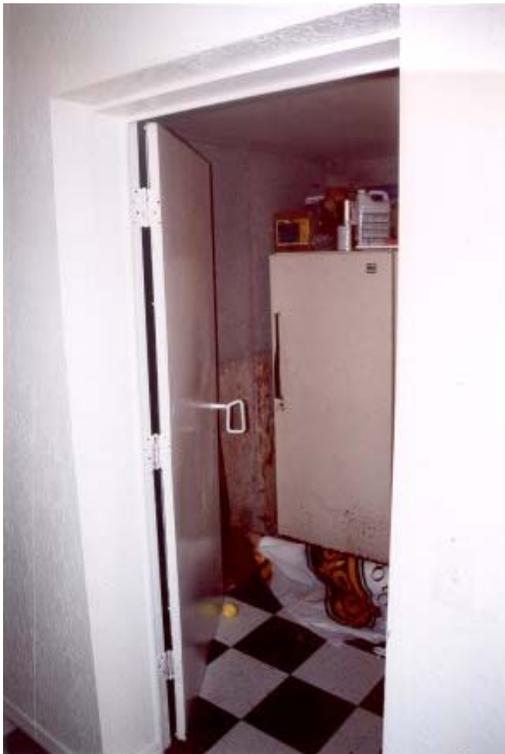
Fig. 6. Day Care Depot: Saferoom
(Items from the building were stored in this room during renovation.)

The safe room walls and ceiling consisted of 6" thick concrete placed in one pour, reinforced with rebar 12" o.c., with footings 12" deep. The total dimensions were about 8' x 10'. The door had steel plates on both sides, 3/16" on the outside and 1/8" on the inside. There was only one lock. The builder said that the door jam was steel, anchored into the wall with horizontal rebar. The safe room was located just off the entrance hallway of the building.

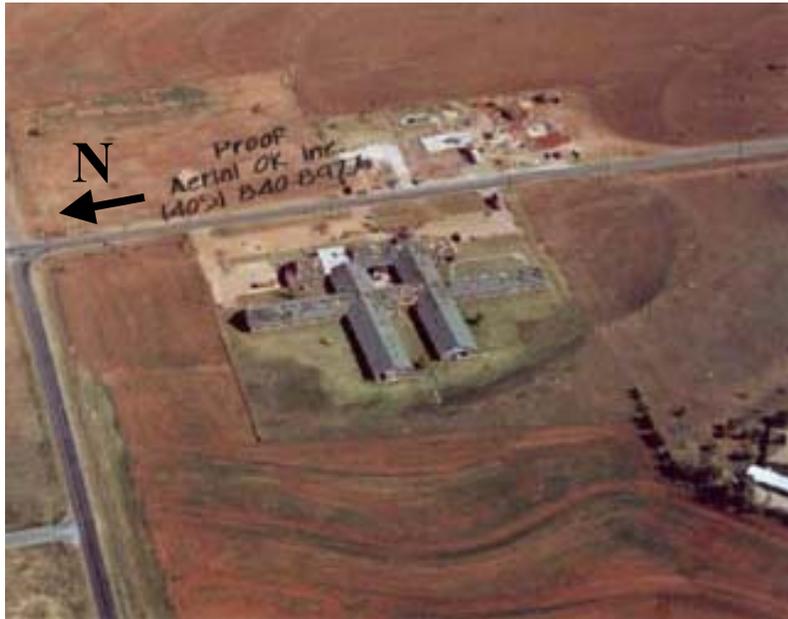
According to personnel at the City Hall, this facility was originally constructed about 15 to 20 years ago, closed about a year and a half ago, and was being renovated. It had not yet opened for business but was scheduled to open in about a month's time. The building was designed with a central area of offices and nurses stations with the residents' rooms along several long wings (Fig. 7). Each wing consisted of a hallway with rooms on each side. The building was oriented facing about 80° east of north.

Figure 7: Aerial view of Cordell Care Center following the tornado. (the tornado moved from the right side to the left side of the photo; courtesy Aerial OK, Inc.)

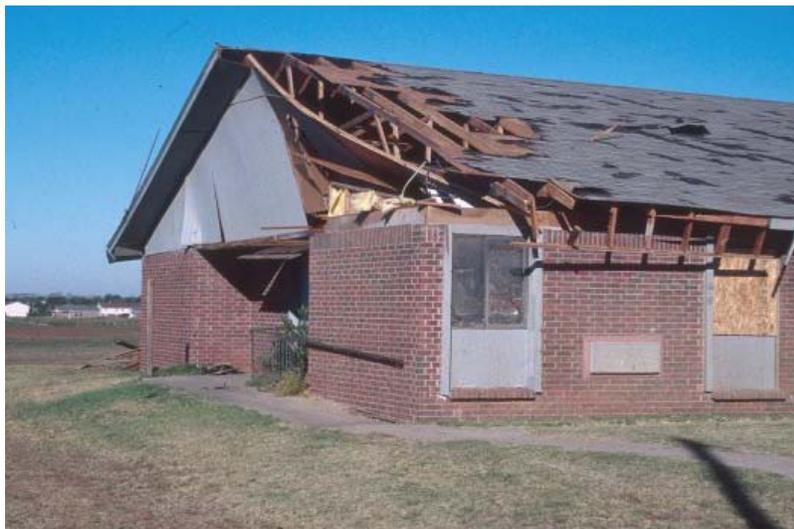
Roof: Significant damage occurred to the gable ends of the long wings (see Fig. 8). In at least three cases, the roof at the end of the wings had apparently lifted up and set back down. Cracks could be seen along the roof-wall connection (Fig. 9). Shingles were lost. No bolts, clips, or screws were observed. Some missiles (2x4) were noticed penetrating through the roof into the rooms (see Fig. 10)

Fig. 8: Cordell Care Center: Failure of gable end wall. (left)

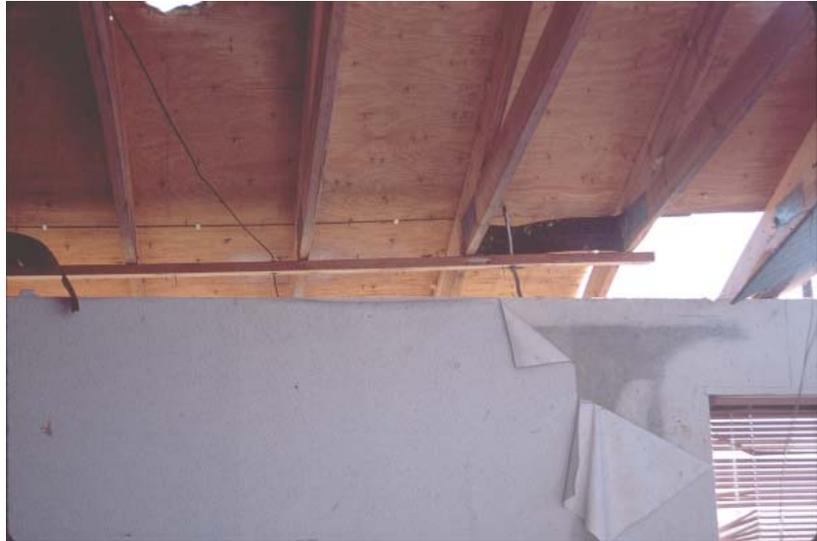
Fig. 9. Cordell Care Center:
Gable end roof damage from
the interior. (right)

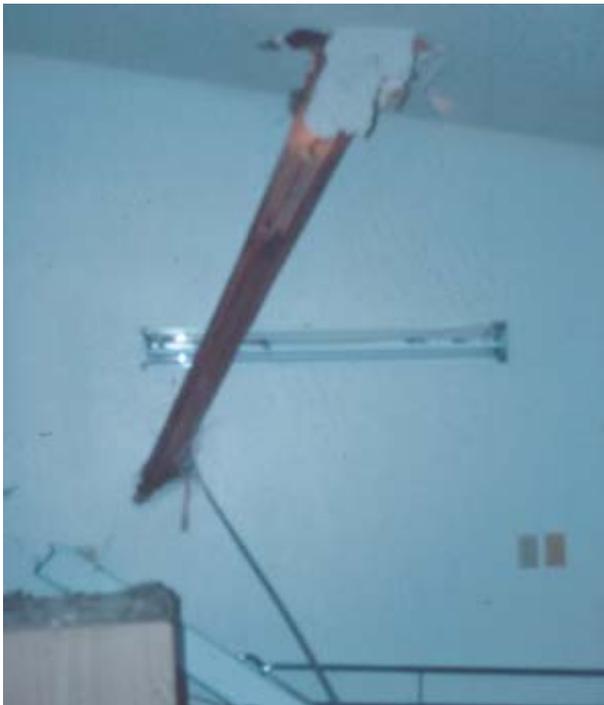
Fig. 10. Cordell Care Center:
Missile penetrating ceiling of
resident room. Headboard of
bed is visible underneath
missile. (below)

Of more concern, however, was the situation at the elderly care center. It was fortunate that no residents were in the building since it is likely that significant injuries would have resulted from flying glass. FEMA 361, *Design and Construction Guidance for Community Shelters* (FEMA 2000), provides guidance for design of community shelters appropriate for elderly care centers.

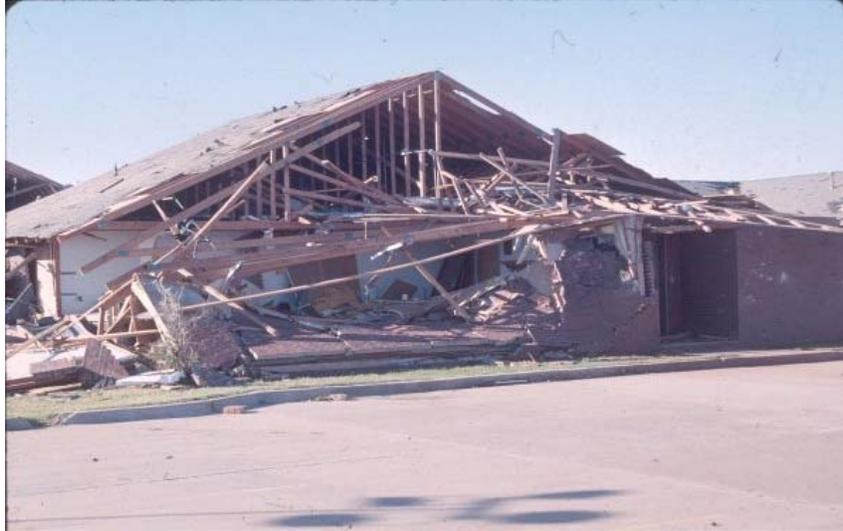
Maintenance Room: This room was on the outer northeast corner of the building. This room collapsed entirely (see Fig. 11). The gable end room was removed. The brick cladding collapsed, as did the frame wall. All connections that could be seen were attached with nails only.

Fig. 11. Cordell Care Center: North end of building showing collapsed maintenance room and dining room just behind it.

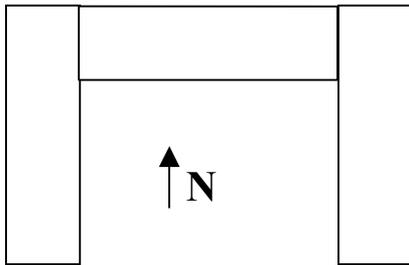
The motel formed an open rectangle with all rooms facing inwards (Fig. 12a). The east wing sustained the majority of the damage. The exterior wall, consisting of 8” unreinforced masonry block, and roof collapsed (Figs. 12a & b). The interior walls were tied, not bonded to the exterior wall thereby providing no lateral support.

Fig. 12a. Motel 41: Plan view to left showing location of demolished wall.

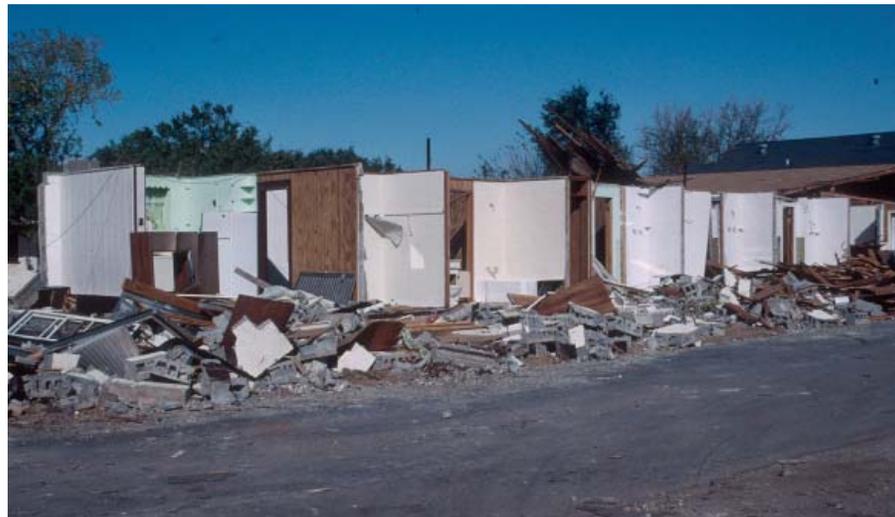
Fig. 12b. Motel 41: Demolished exterior wall (view from southeast)
