DAMAGE SURVEY OF THE BINGER, OKLAHOMA TORNADO OF MAY 22, 1981

James R. McDonald, H. Scott Norville, and Timothy P. Marshall
Institute for Disaster Research
Texas Tech University
Lubbock, Texas
June 1981

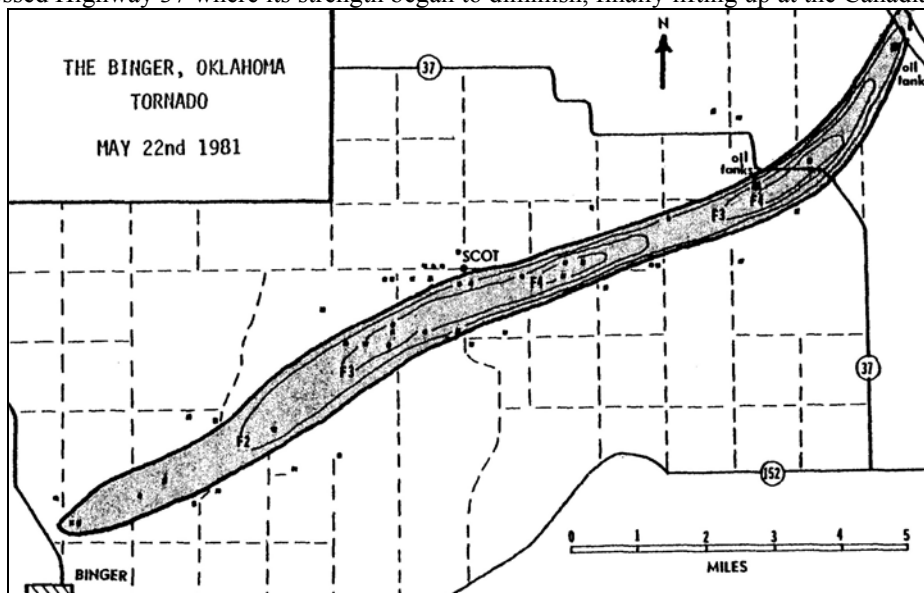
Binger, Oklahoma is located 50 miles west of Oklahoma City and 16 miles south of Interstate 40 on U.S. Highway 281. The city of Binger was not damaged by the tornado. Figure 1 shows the path of the tornado. It was weak F1 until it reached a point approximately 3.5 miles west-southwest of the Scott Community. At this point it began to strengthen and reached an intensity judged to be a strong F4 one mile east of Scott. The tornado continued until it crossed Highway 37 where its strength began to diminish, finally lifting up at the Canadian River.

Figure 1. Damage path of Binger, Oklahoma tornado (shaded). Small, dark boxes are residences. Gradations in damage depicted by F-scale.

The F-scale rating is based on the worst damage observed along the tornado path. Figure 1 shows contours of the severity of the tornado as determined from a ground survey of the damage path. There were two segments of F4 damage. The first segment is based on damage to two houses and the destruction of large trees, which were uprooted, snapped off or stripped of their leaves and branches. The damage at this location appeared to be in the upper part of the F4 range. The second F4 segment crossed the Amoco oil lease and destroyed a farm house and barn near Highway 37. The farm house was leveled. Numerous large missiles were rolled and tumbled up to 500 ft. The reasons for rating F4 instead of F5, as was suggested in initial reports of the damage, are as follows:

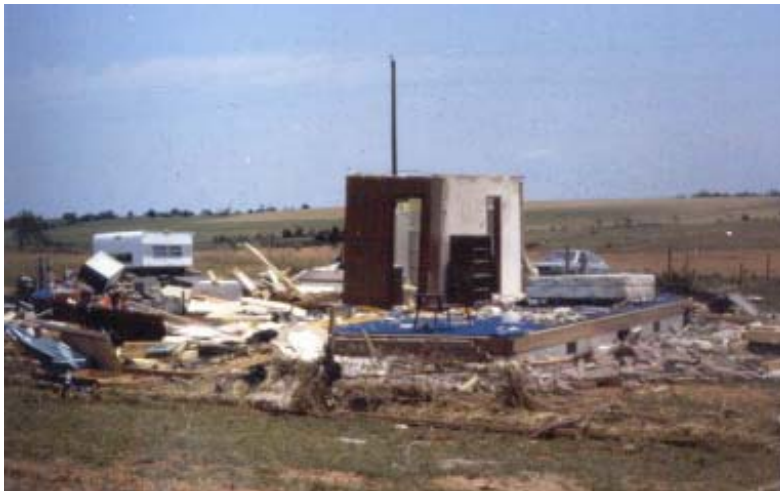
weak. Two houses across the road to the east were destroyed, but both still had strong walls standing (F3). One was a classic example of a small bathroom remaining intact while the exterior walls were destroyed (Fig. 2). A mile farther east a house lost its roof, carport and some exterior walls, but most of the other walls remained intact. Another mile east two houses were totally destroyed, along with a number of large oak, walnut and cottonwood trees. Automobiles and heavy farm equipment (grain truck, combine and tractor) were rolled and tumbled up to 50 yards. Large trees were uprooted. One 24-inch diameter tree was snapped off two feet above ground. Where trees did not uproot or snap off, all leaves and limbs were stripped off leaving only the very largest branches.

Figure 2. Farm house destroyed by the tornado. Interior walls remain standing around bathroom. Damage to this house was rated F-3 on the Fujita scale.

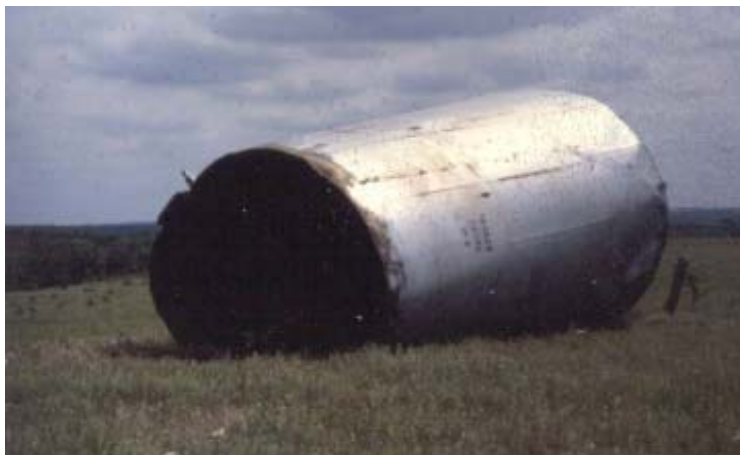
Additional evidence of the power of the storm was observed 4.5 miles west of the Scott community, as the tornado approached Highway 37. Several large oil storage tanks reportedly were blown away from the Amoco Petroleum Corporation lease. One of the tanks (Fig. 3), which had been taken out of service a week earlier because it was struck by lightning, was found 1500 ft south of its original location. The survey team could not find the other two tanks that reportedly were at the lease site. The oil company has been contacted in an effort to locate them. One half mile east of the oil lease, a farm house and barn were destroyed (Figs. 4 and 5). Debris from the house was had been cleaned up by the time the survey team arrived. However, damage to the barn and farm implements, along with the types of missiles generated, indicated F4 tornado intensity at this location. A pickup truck rolled more than 500 ft into a ravine. It was totally disintegrated (Fig. 6).

Figure 3. Empty oil storage tank at Amoco lease. This storage tank rolled and tumbled 1500 feet.

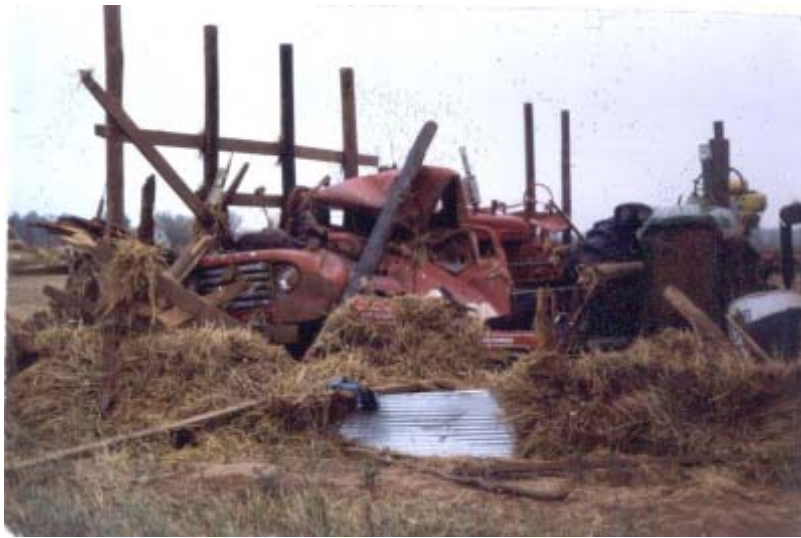
Figure 4. Remains of pole barn found on farm near Rt. 37.

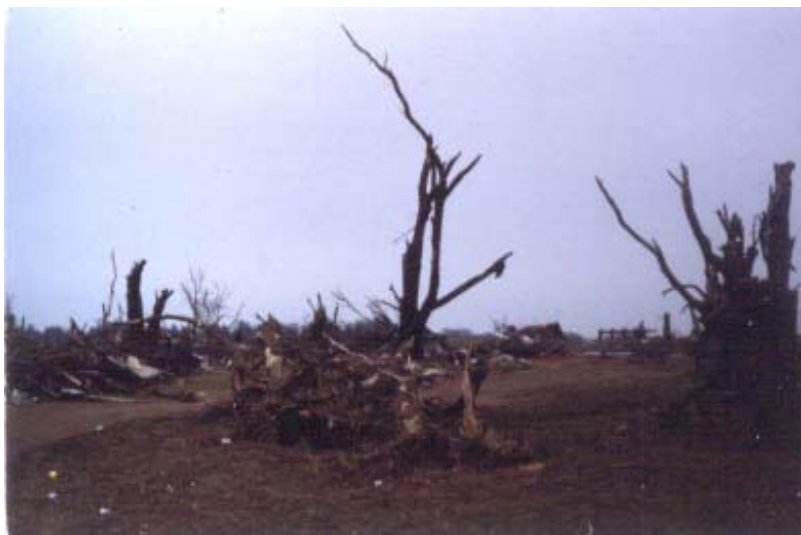
Figure 5. Damage to trees and farm equipment. Large branches were broken off, however, trees were not debarked.

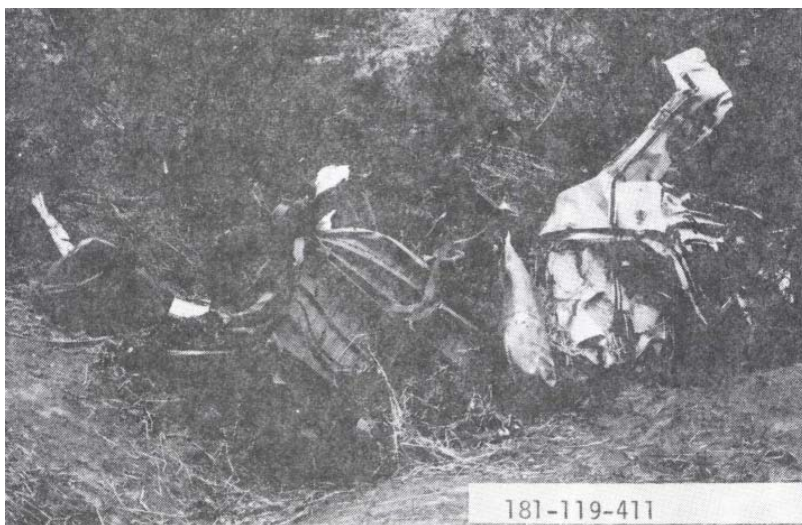
Figure 6. Remains of pickup truck. Ground marks indicated that the vehicle rolled and tumbled 500 feet.

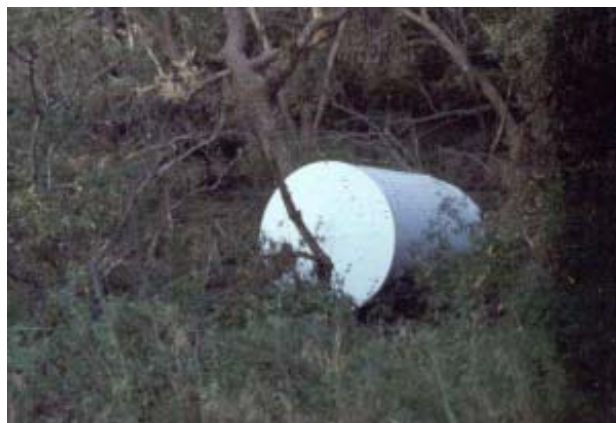
One and possibly two oil storage tanks were blown from a lease located near the bank of the Canadian River. The lease was 2.5 miles north and 0.5 mile east of the point where Highway 37 turns northwest. The well belongs to Woods Petroleum Corporation. One of the oil tanks was found in a deep ravine that leads to the Canadian River, approximately 200 yards from its original location (Fig. 7). A second tank possibly had been pulled from the ravine and hauled away before the investigation team arrived. We were not able to verify this with oil company personnel, but tracks in the area seemed to indicate this. The tank was similar to the one located at the Amoco lease.

Figure 7. Oil storage tank deposited in a ravine. The tank was 20 feet tall and 12 feet in diameter. It rolled through a wheat field and down this ravine about 200 yards.

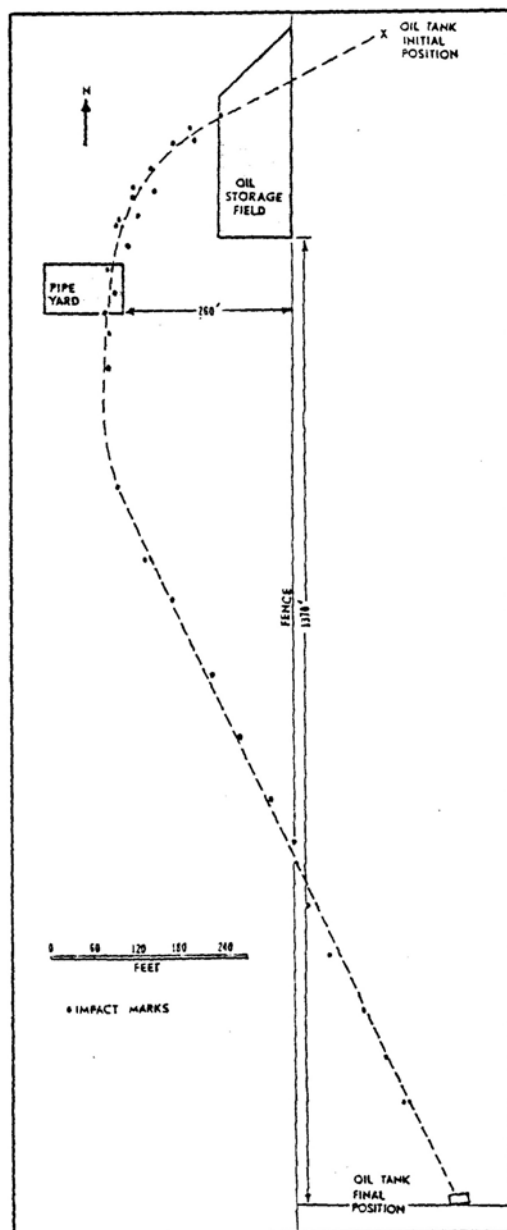
Figure 8 shows the path taken by the oil storage tank on the Amoco lease. The tank was 12 feet in diameter and 20 feet tall. Walls of the tank were 0.25 steel plate. Ground marks were used to identify the path taken by the tank. Movement of the tank was caused by the counterclockwise winds of the tornado as the storm passed south of the tank battery. Future study includes tornado missile trajectory simulation of this oil tank as it was affected by the storm.

Figure 8. Track of ground marks of empty oil storage tank. The tank rolled and tumbled but did not fly. It traveled in an arc-shaped path about 1500 feet.
