EFFECTS OF HURRICANE ALLEN ON BUILDINGS AND COASTAL CONSTRUCTION

by Joseph E. Minor, P.E., William L. Beason, and Timothy P. Marshall

(Reprinted from the Fourth National Conference on Wind Engineering Research, Seattle, WA 1981.)

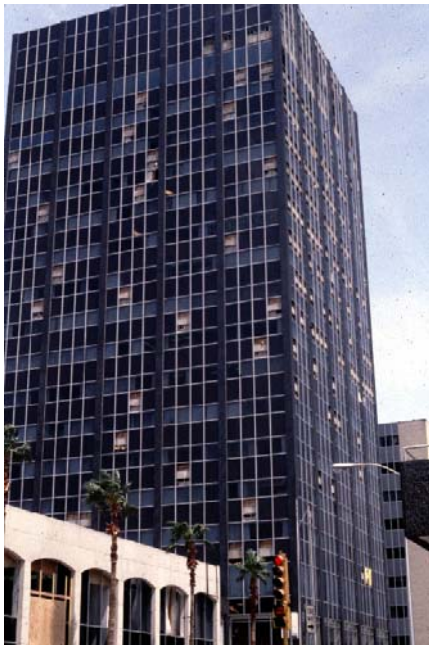
Substantial glass failure occurred at the Guaranty Bank Building in Corpus Christi (Figure 2). Witnesses who remained in the building stated that the majority of the glass failures occurred near 5 a.m. on August 10. Upon investigation, it was discovered that almost all the glass failures occurred on the windward (east and south) elevations and that the failures were caused by both missile impact and wind pressure (Figure 3). Extensive glass damage also occurred on this building during Hurricane Celia on August 3, 1970. Peak gusts recorded at the CRP weather service were 140 knots in Hurricane Celia and 80 knots in Hurricane Allen.

The 1/4 inch annealed (window) and heat strengthened (spandrel) lites were inserted into an "H" shaped molding which also received an aluminum "lip" from the window frame. Apparently, glass plate deflections were large enough to permit the lites to roll out of the molding or to fracture within the molding at the edge of the glass plate. Other fractures were caused by small missile impacts.

In regions where the glass lites were completely gone, roof gravel was found inside the building. This

evidence and missile impact marks on glass remaining in place suggest that missile impact also caused failures. Structures surrounding the Guaranty Bank Building include buildings about 20 stories high about a block to the east and south. It appears that roof gravel from the adjacent buildings were a contributing factor to window failures in the Guaranty Bank Building. Also, two buildings that are upwind are separated by approximately a 100 ft. corridor. During the hurricane, a police officer reported what could have been a standing vortex at the end of the corridor in front of the Guaranty Bank Building. It is possible that the acceleration of the wind through the corridor produced vortex shedding effects which contributed to the window failures.

Figure 2. Many windows were lost at the Guaranty Bank Building during Hurricane Allen.

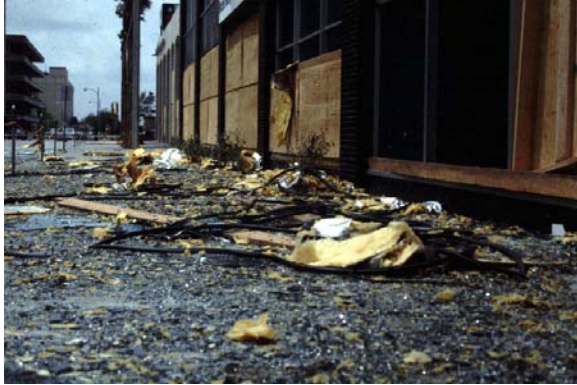
Figure 3. Window glass debris at base of Guaranty Bank Building.

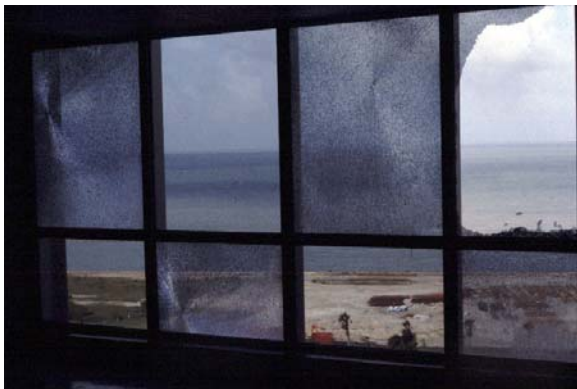
Spohn Hospital is located on the bayfront in Corpus Christi, with an open wind fetch to the east. Window glass failures occurred in this building from missile impacts. The failures were confined to a new, 12-story north wing (Figure 4). These windows consisted of tempered insulating glass units which were secured in an aluminum frame. In all but one case, only the outer of the two 1/4 inch lites had failed. Each failure originated from a single impact point and spread radially outward causing the patterns seen in the photograph. Evidence of roof gravel was found atop the 3-story roof below the window wall. Failures occurred on every floor. The roof gravel originated from an adjacent east-west oriented wing of the hospital. It is theorized that as the wind accelerated over the east-west wing from the east-southeast, roof gravel was lifted over a two-foot parapet and injected into the air-stream. The gravel then fell into the east facing windows at the north wing. There were no other sources of roof gravel in the vicinity of the north wing.

Figure 4. Tempered insulating glass failures from roof gravel impact at Spohn Hospital.

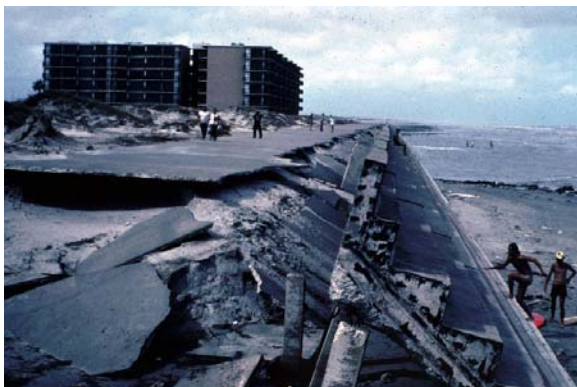
Beach erosion was significant along the barrier islands which protect the Texas shoreline. From South Padre to North Padre and Mustang Islands, severe beach scouring was evident. Storm tides caused considerable damage to a seawall on North Padre Island (Figure 5).

Figure 5. Seawall on North Padre Island was severely damaged by wave action during Hurricane Allen.
