Tornado Damage Documentation – Using the EF-Scale

Super Tuesday Tornadoes
Alabama, Arkansas, Kentucky & Tennessee
February 5 & 6, 2008

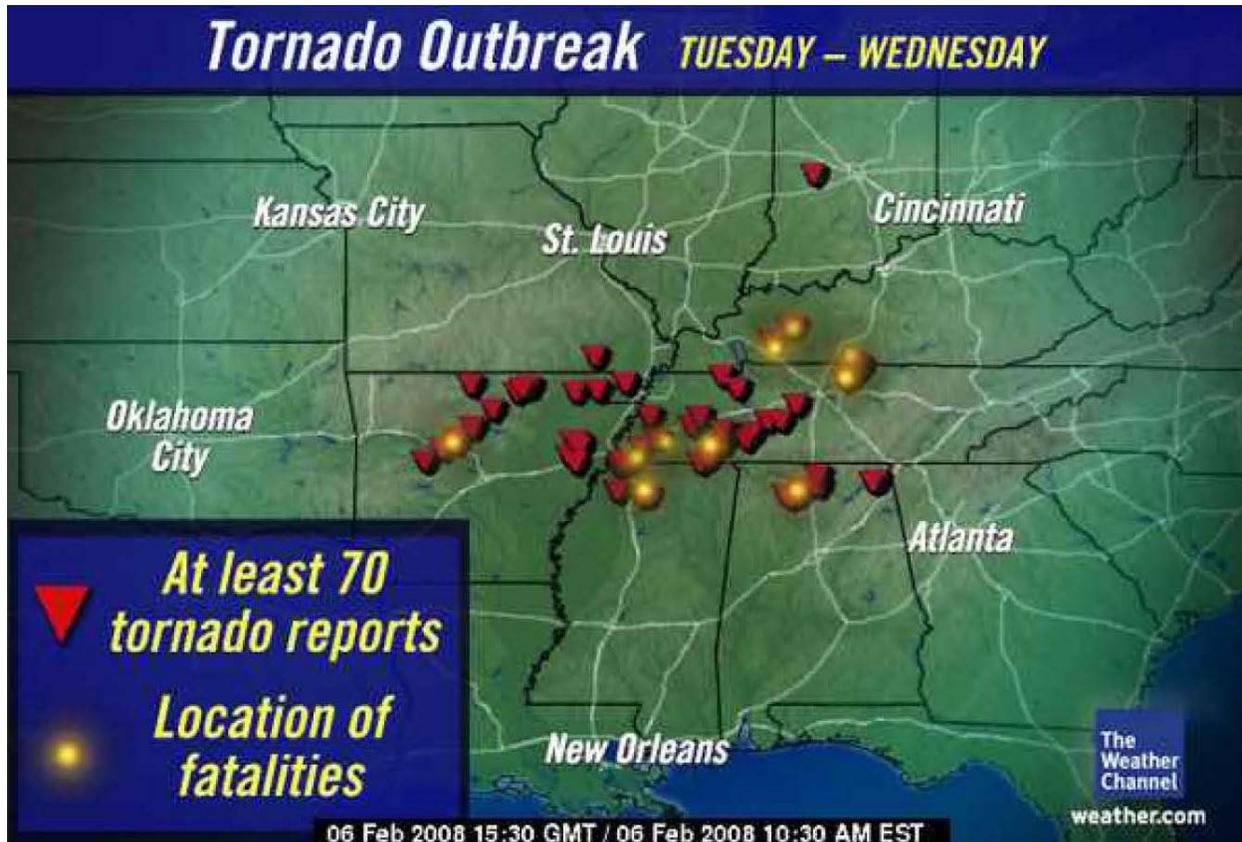
PhotoCredit: The Weather Channel

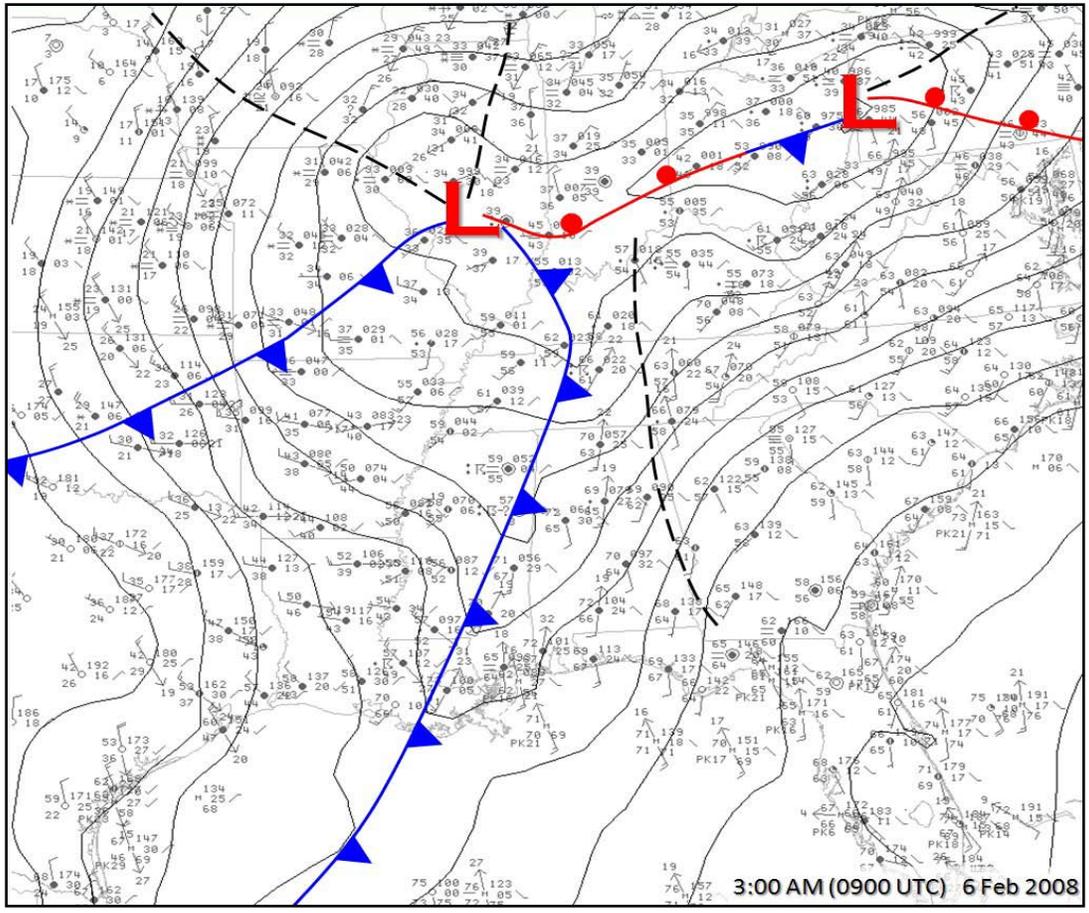
Figure 2.1. A surface map at 0900 UTC, 6 February 2008 (3 AM CST), shows a cold front moving into northwest Alabama, along with 60+ degree dew points ahead of the front .[6]

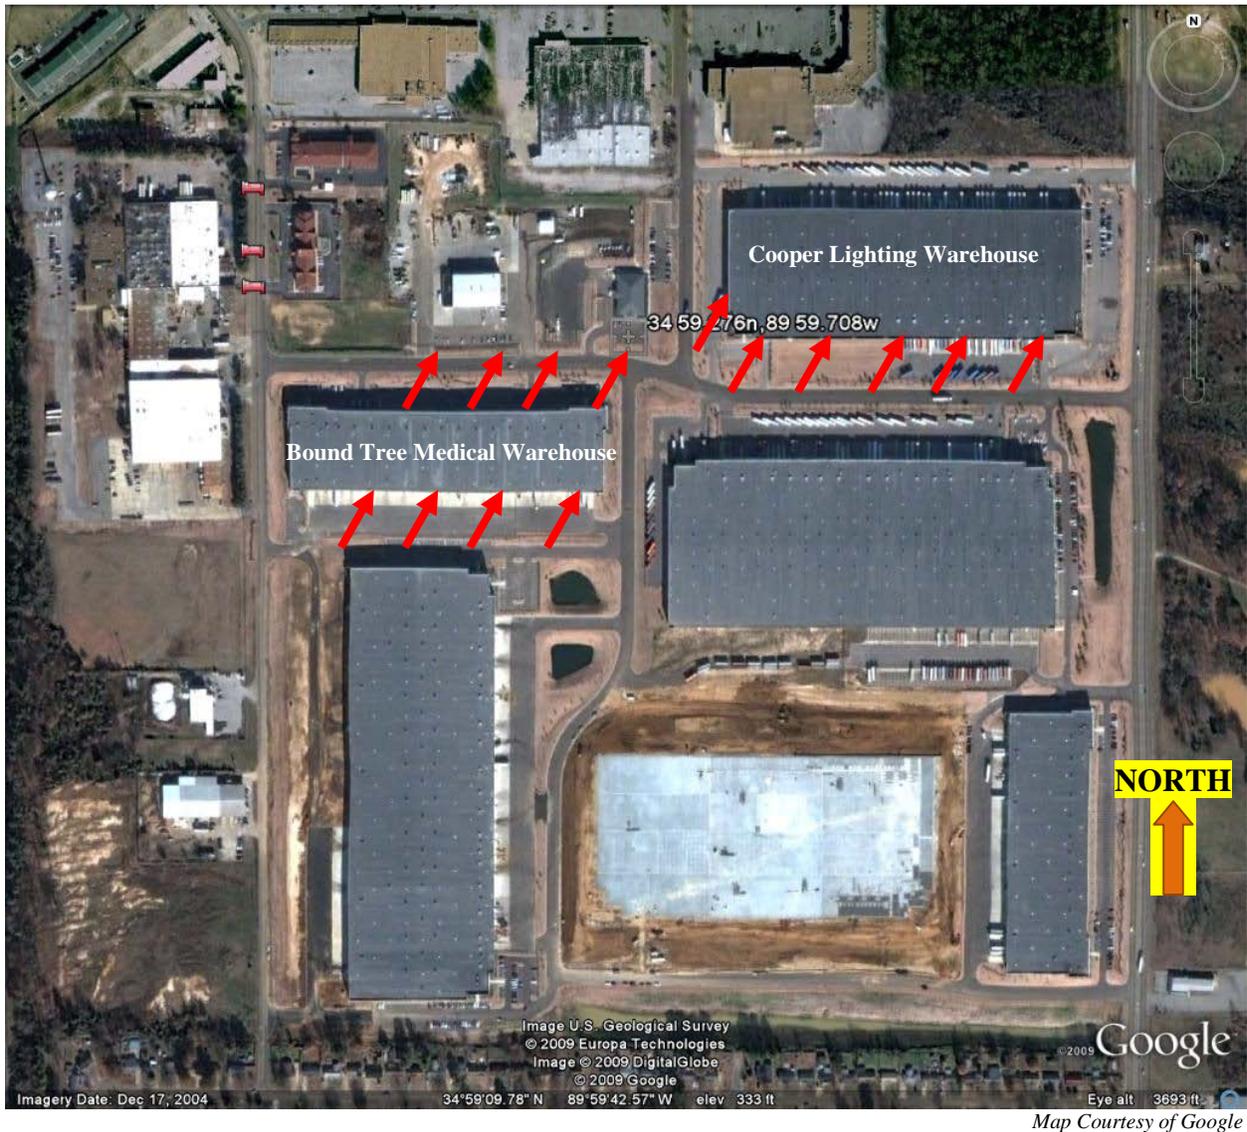
Figure 3.3. Airport Industrial Drive Warehouses (red arrows indicate direction of wind pressures)

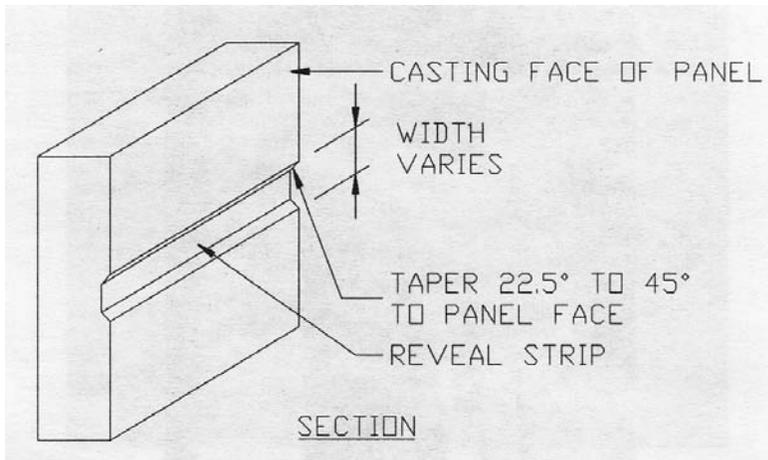
Figure 3.11. ACI recommended reveal strip [11]

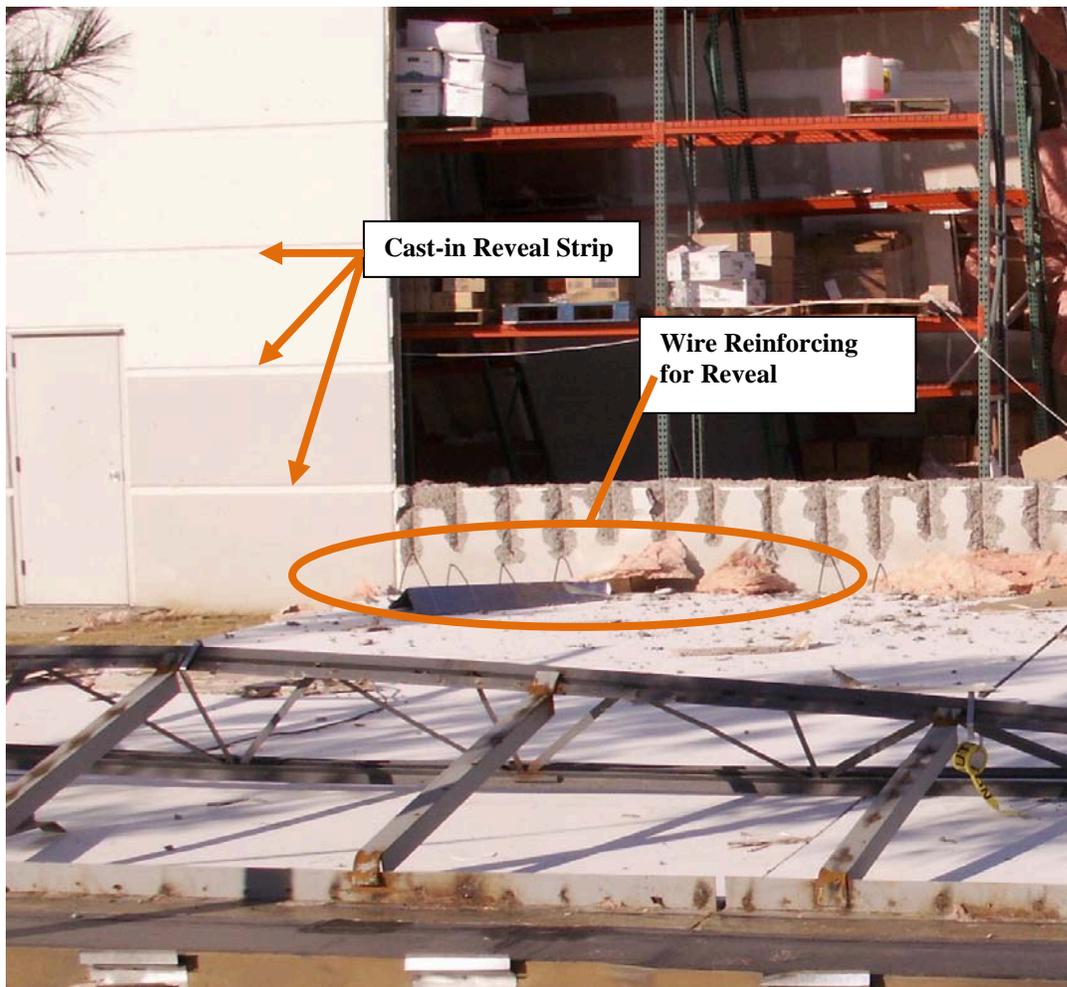
Figure 3.12. Tilt-up panel failure along reveal line, DOD 7

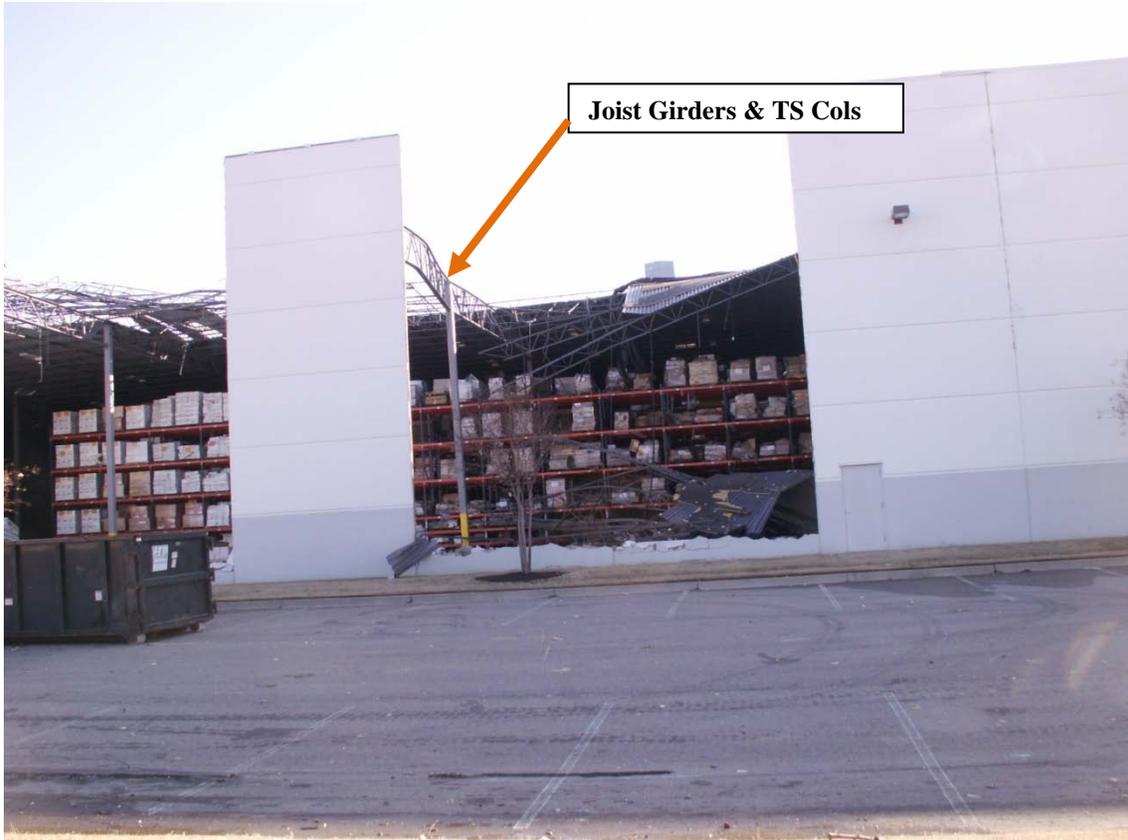
Figure 3.13. Cooper Lighting Warehouse west wall, DOD 7

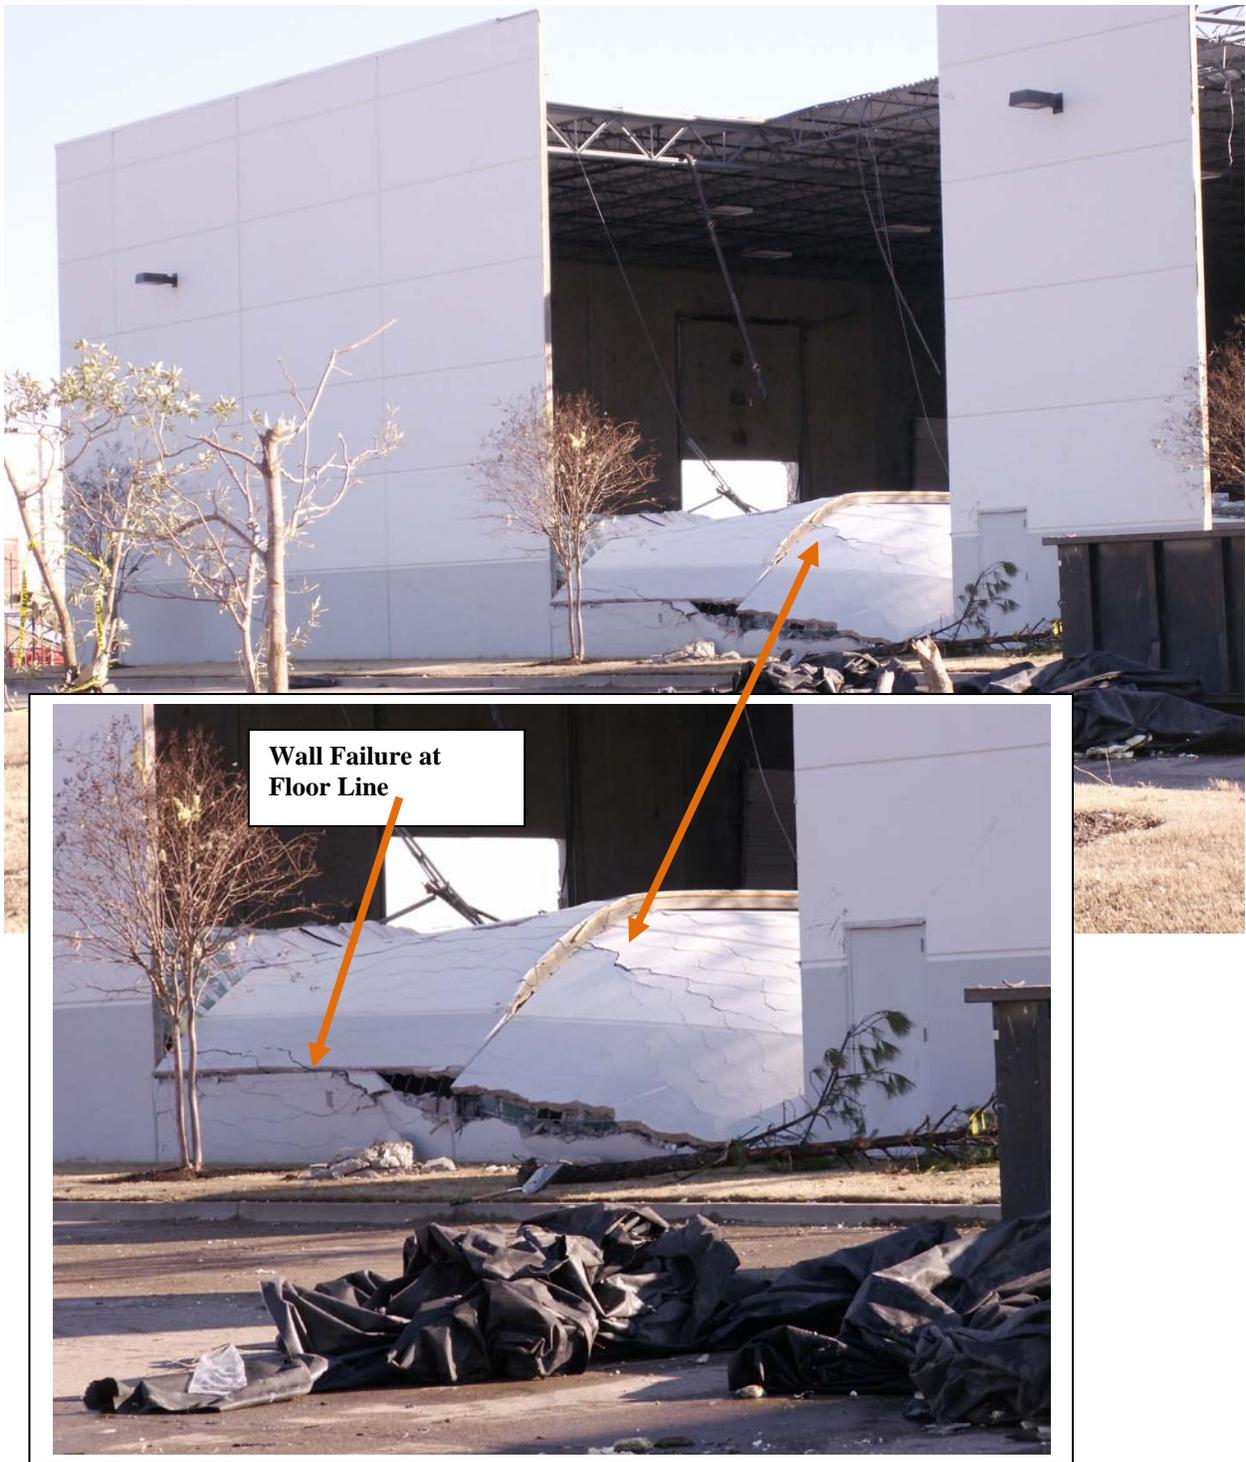
Figure 3.14. West wall failure, Cooper Lighting, DOD 7

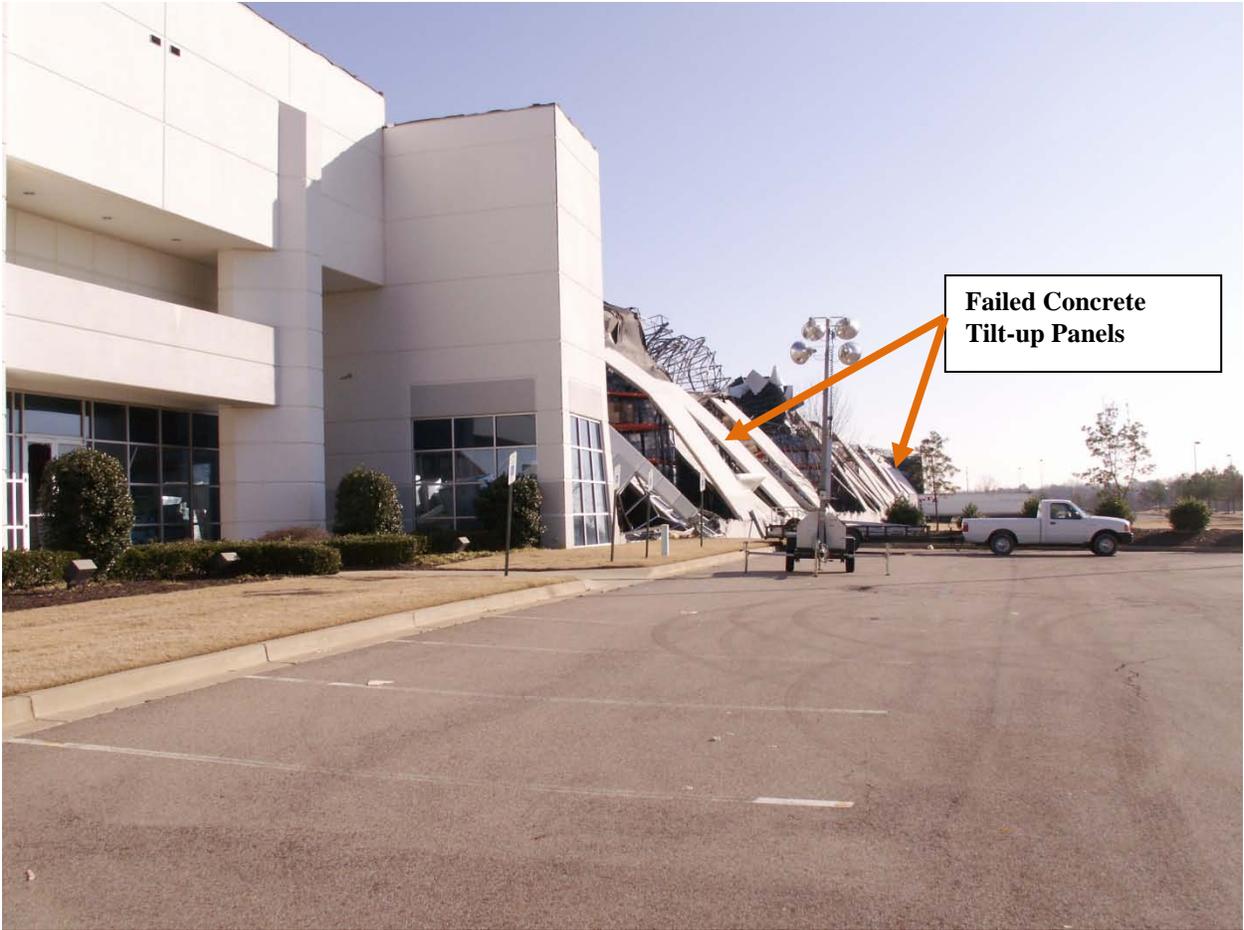
Figure 3.15. Cooper Lighting south wall, DOD 7

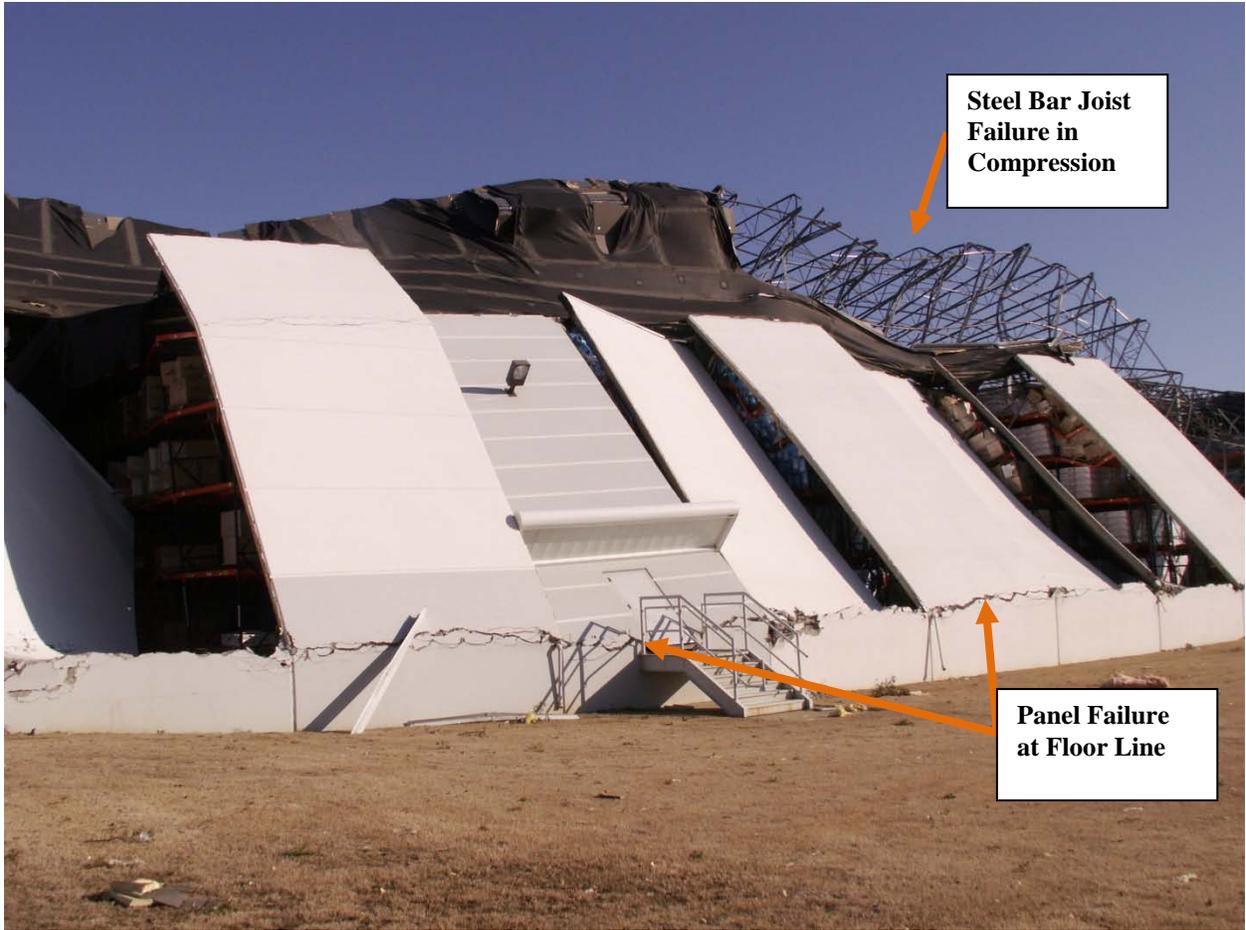
Figure 3.16. Roof structure failure produced by wall collapse, DOD 7

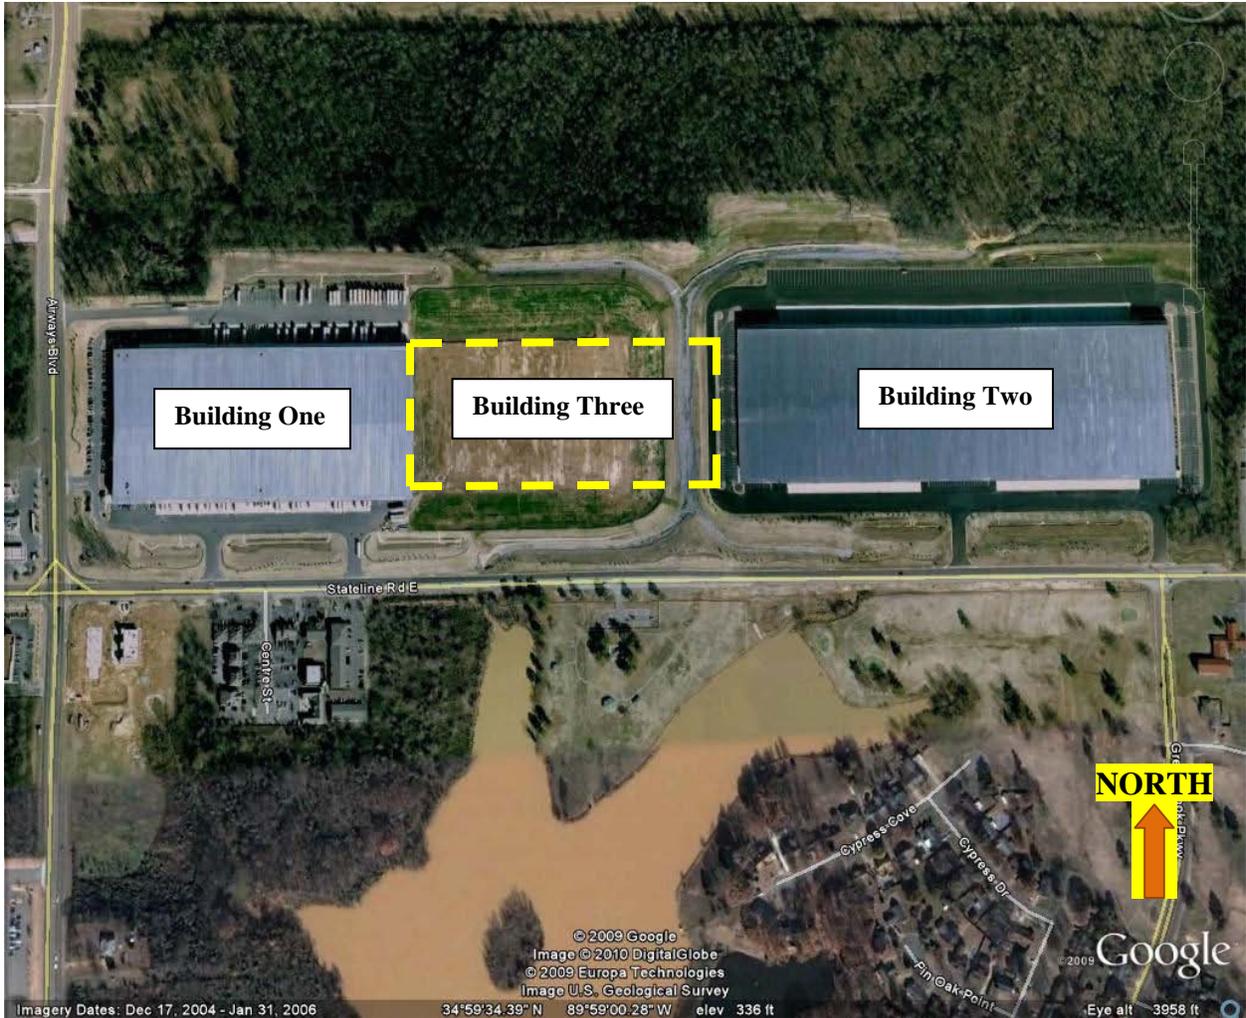
Map Courtesy of Google

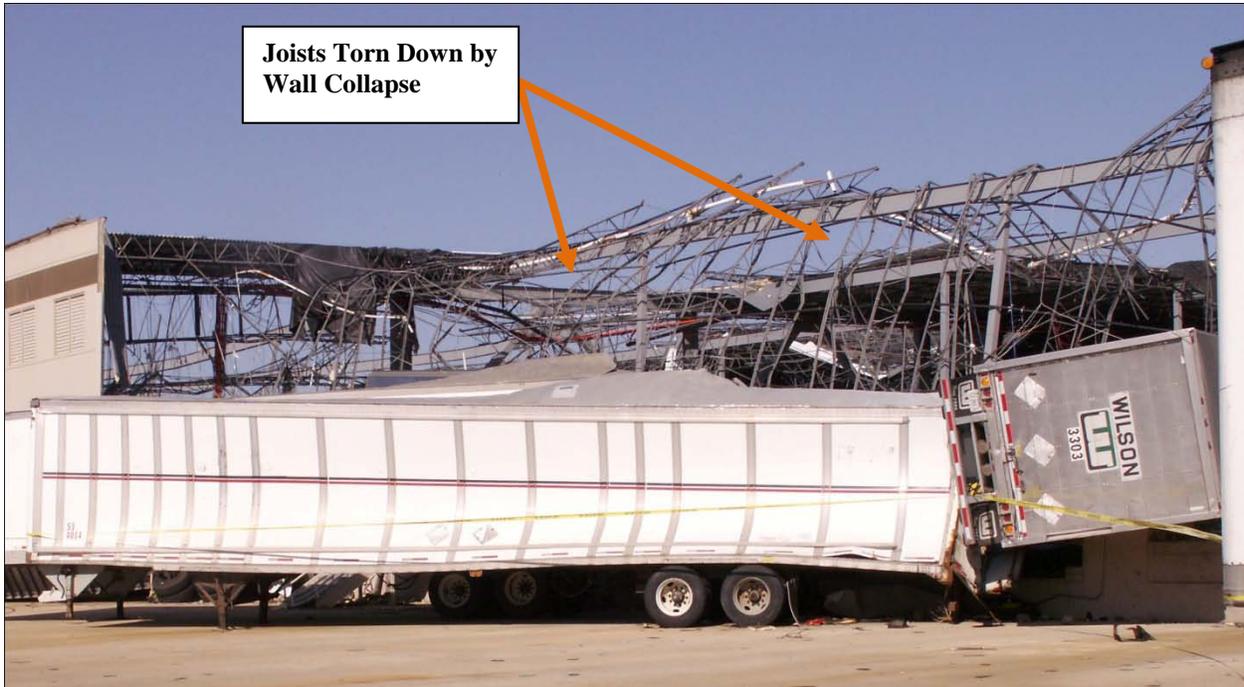
Figure 3.22. Roof decking removed by wind pressures and joists destroyed by falling panels, no wind bracing observed, DOD 7

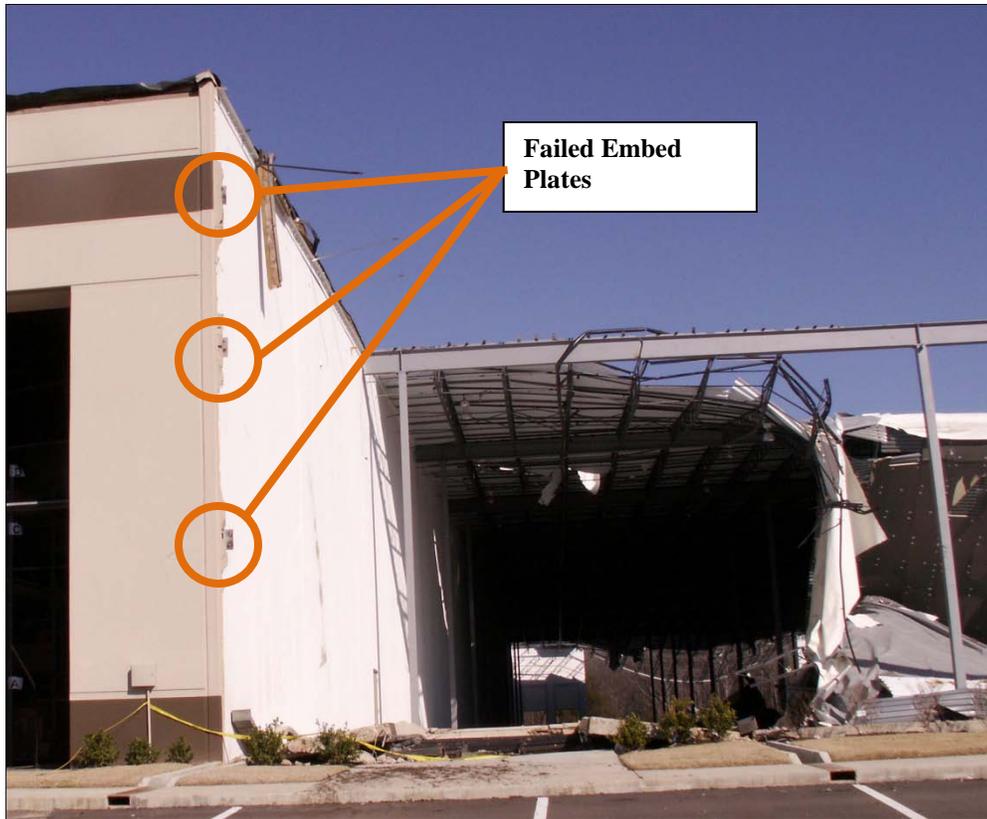
Figure 3.23. Failed embed connector plates between Buildings One & Three

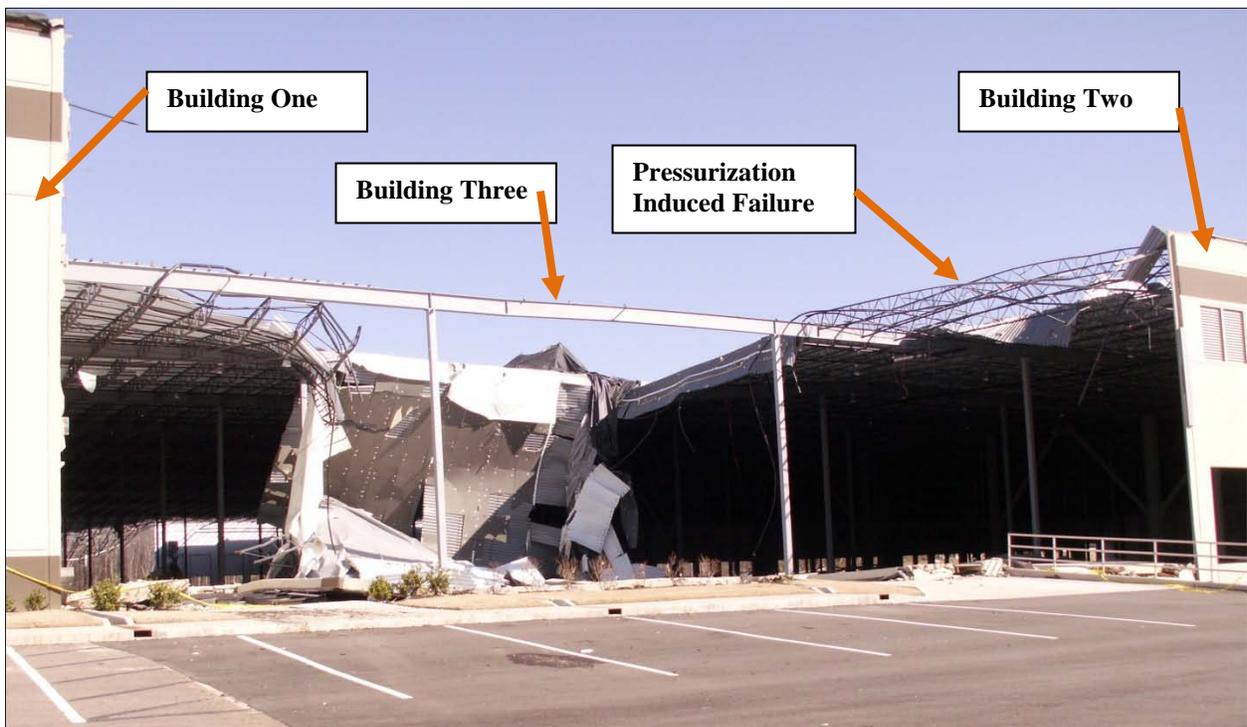
Figure 3.24. Damage to Building Two by Building Three failure, DOD 7

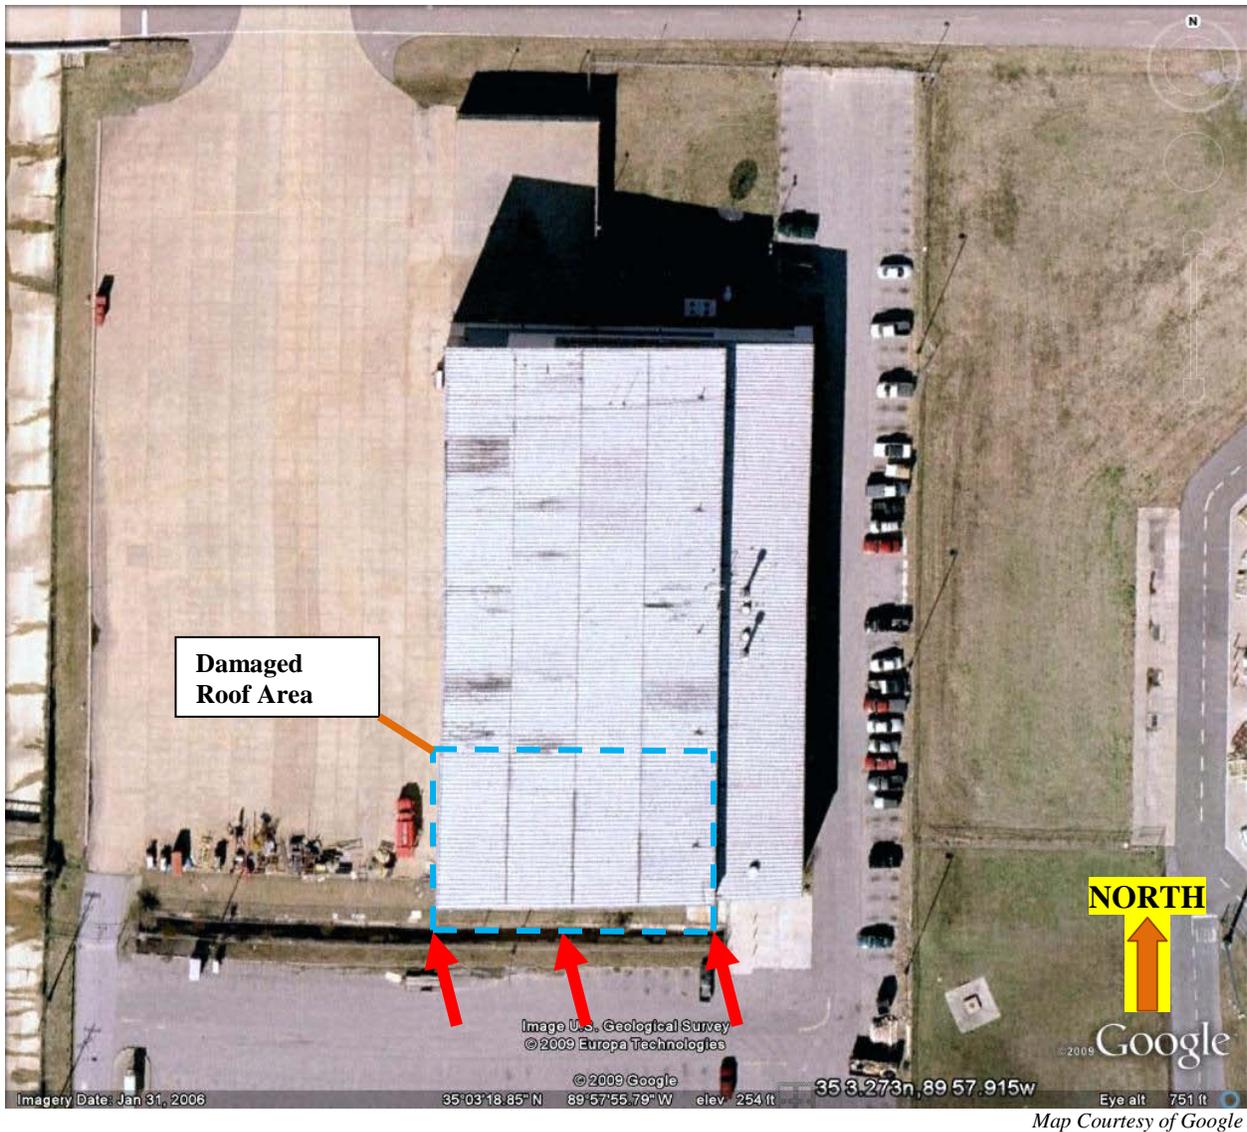
Figure 3.25. Satellite view of Pinnacle Airlines

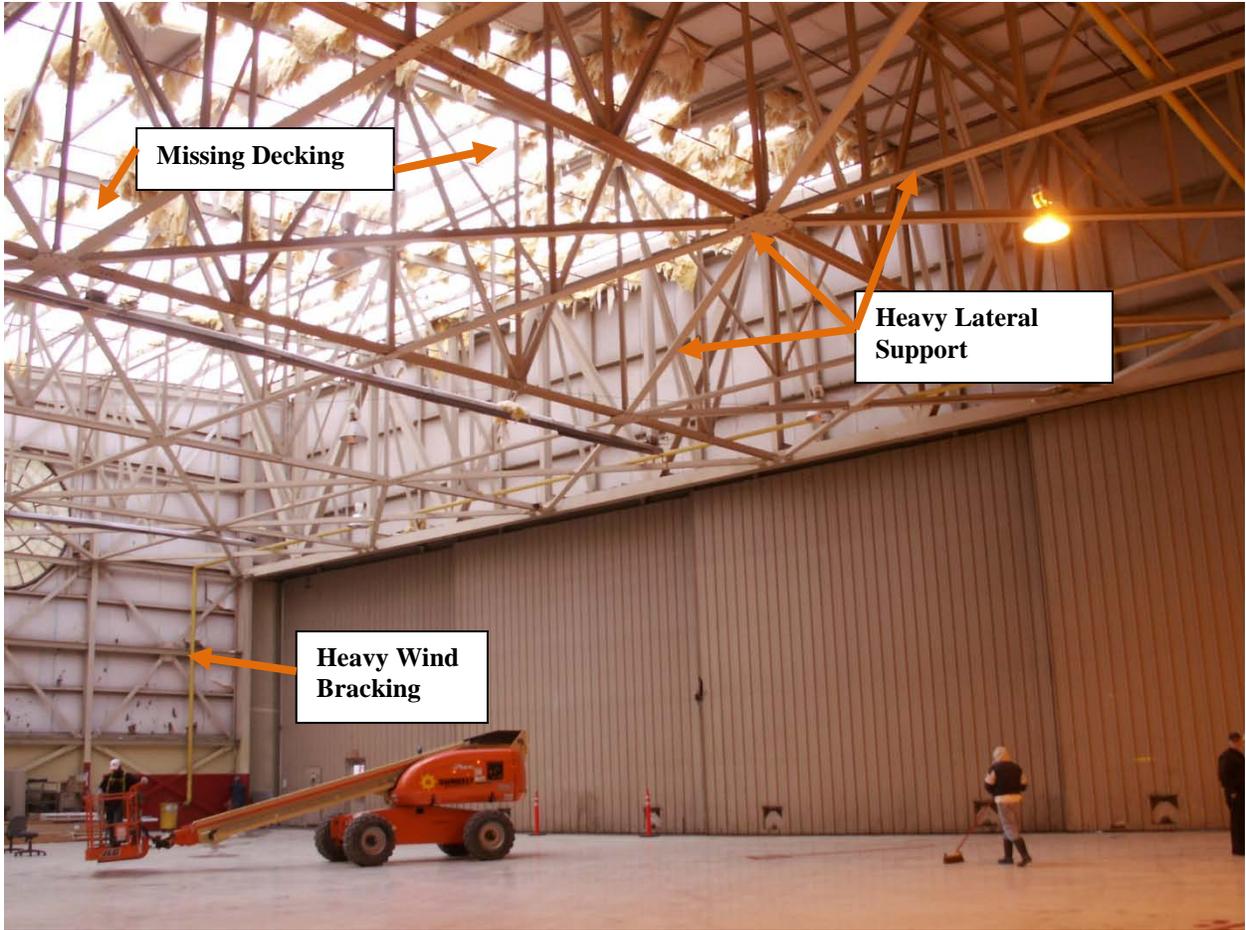
Figure 3.27. Roof Damage to Pinnacle Airlines Hangar, DOD 5

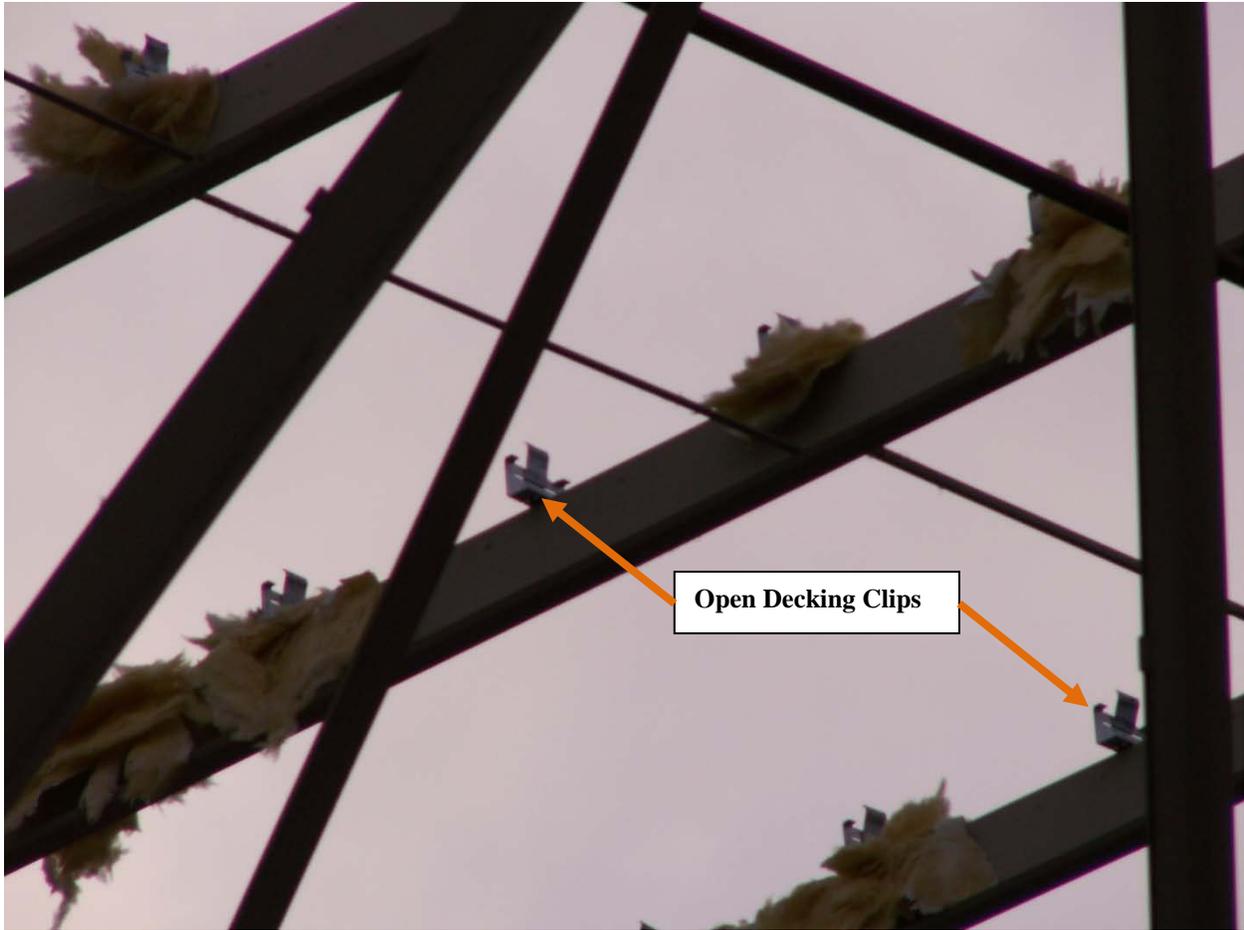
Figure 3.28. Roofing panels released at roofing clips

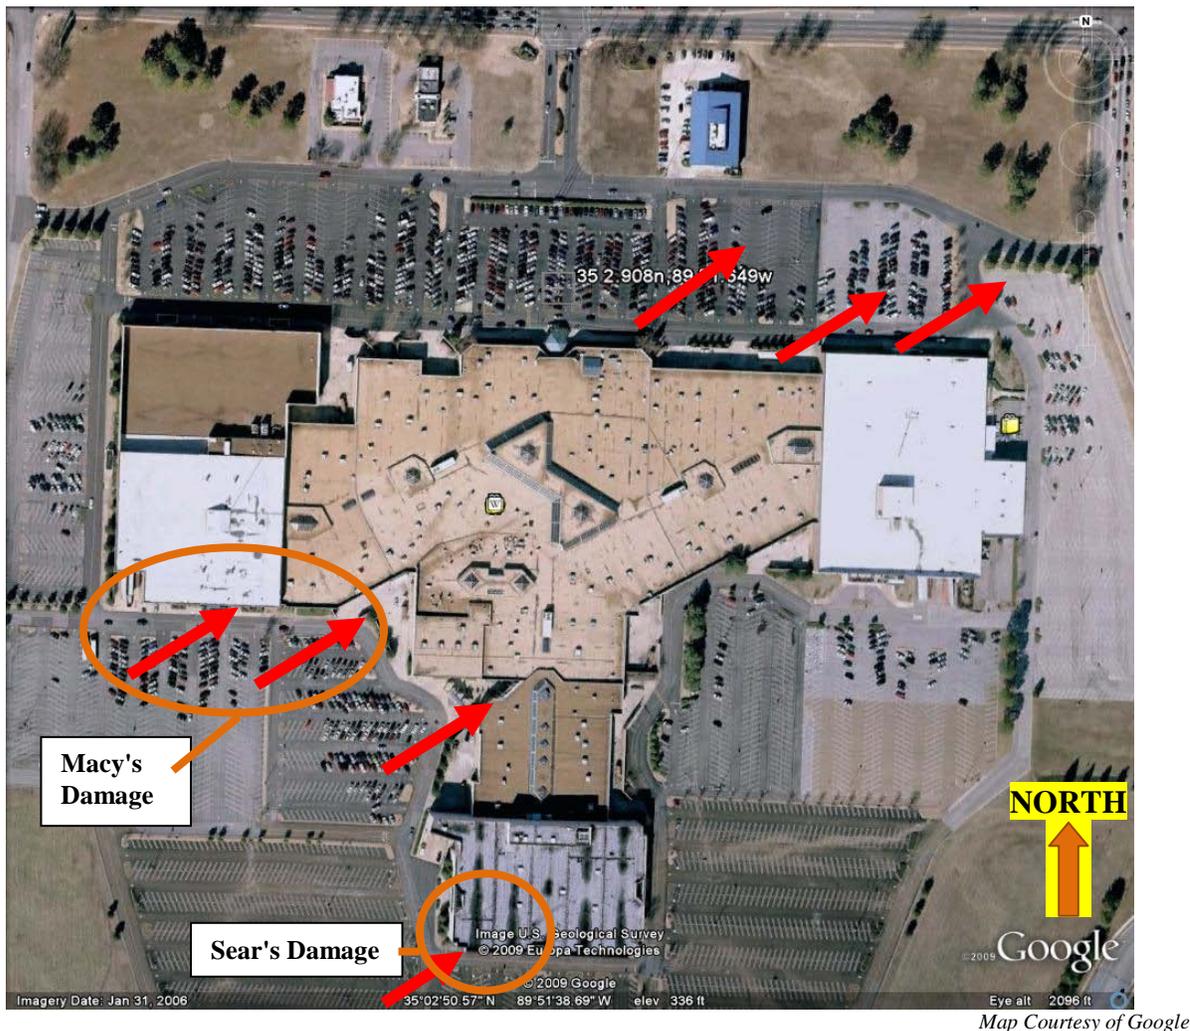
Figure 3.29. Hickory Ridge Mall (red arrows indicate direction of wind pressure)

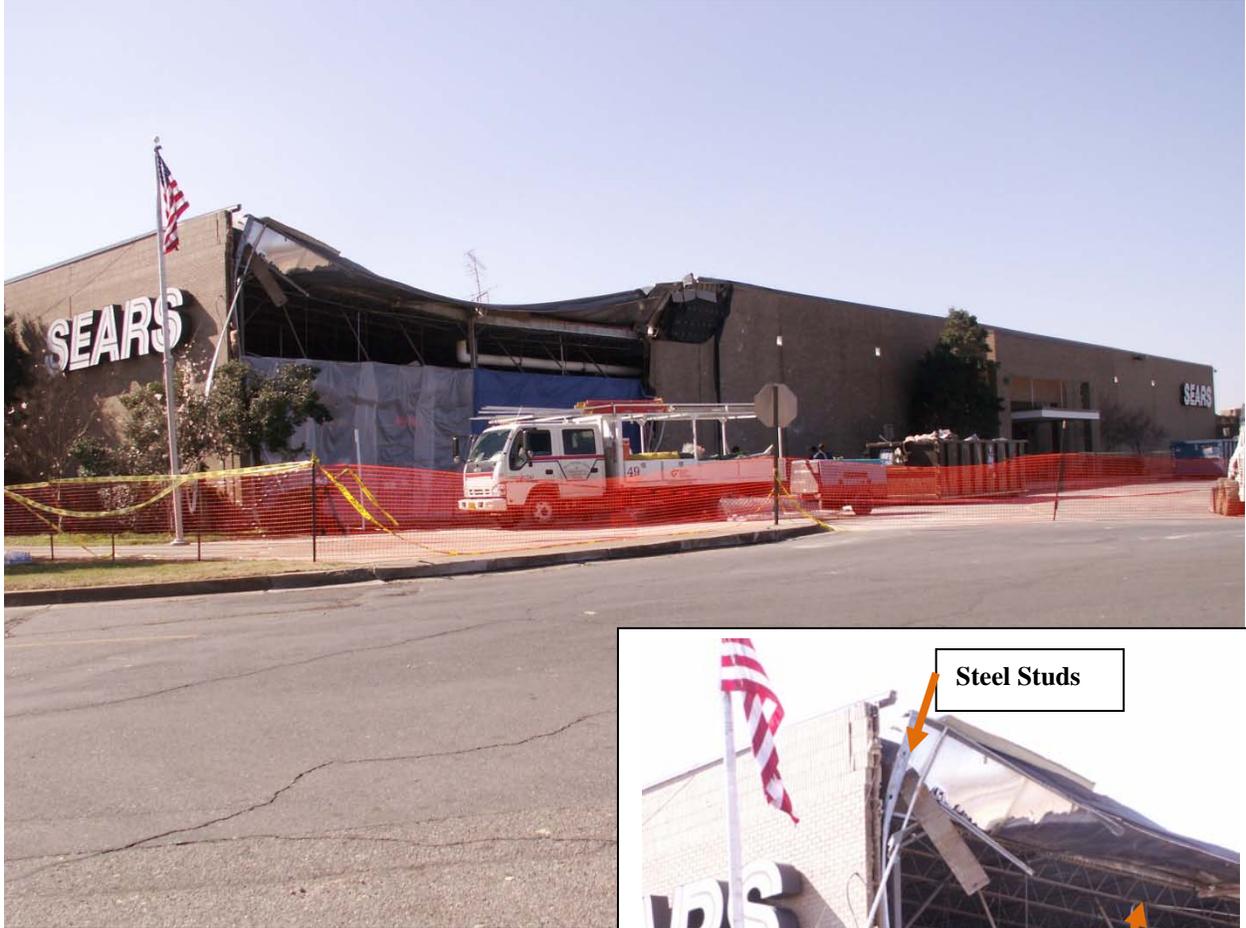
**Figure 3.30. Sears windward corner damage
DOD 6**

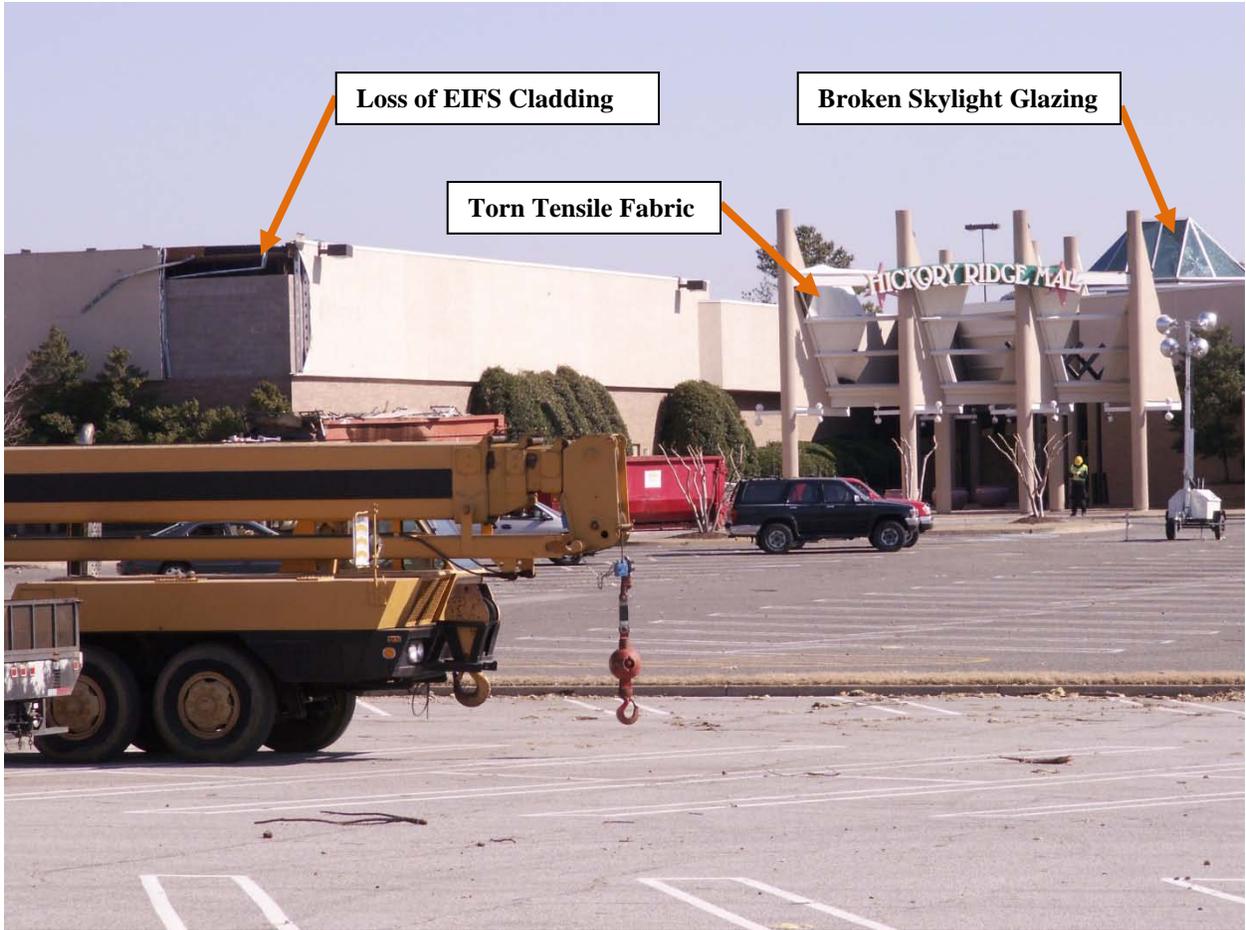
Figure 3.31. EIFS Damage on windward corner near entrance to mall, DOD 5

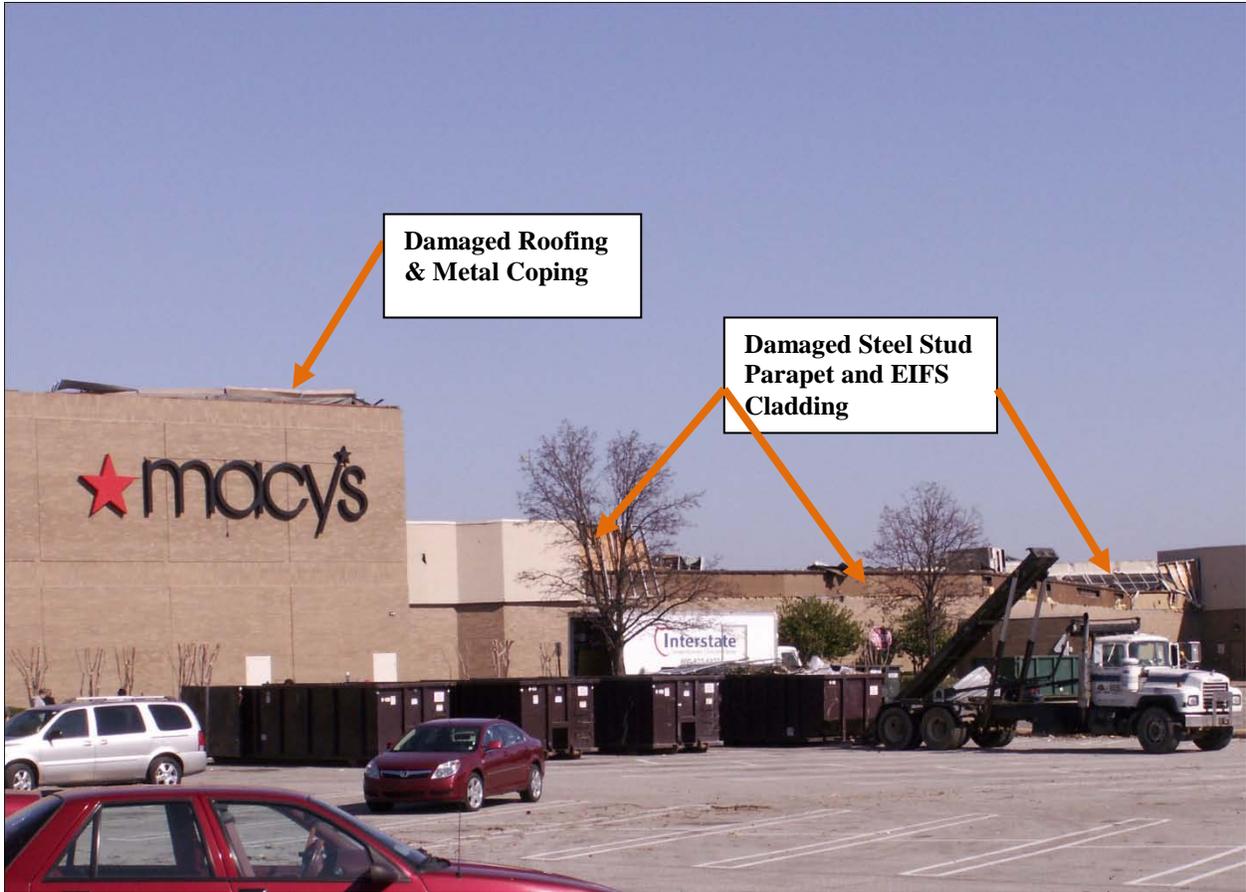
Figure 3.32. Steel stud parapet collapse, DOD 5
