Tornado Damage Documentation – Using the EF-Scale

Super Tuesday Tornadoes
Alabama, Arkansas, Kentucky & Tennessee
February 5 & 6, 2008

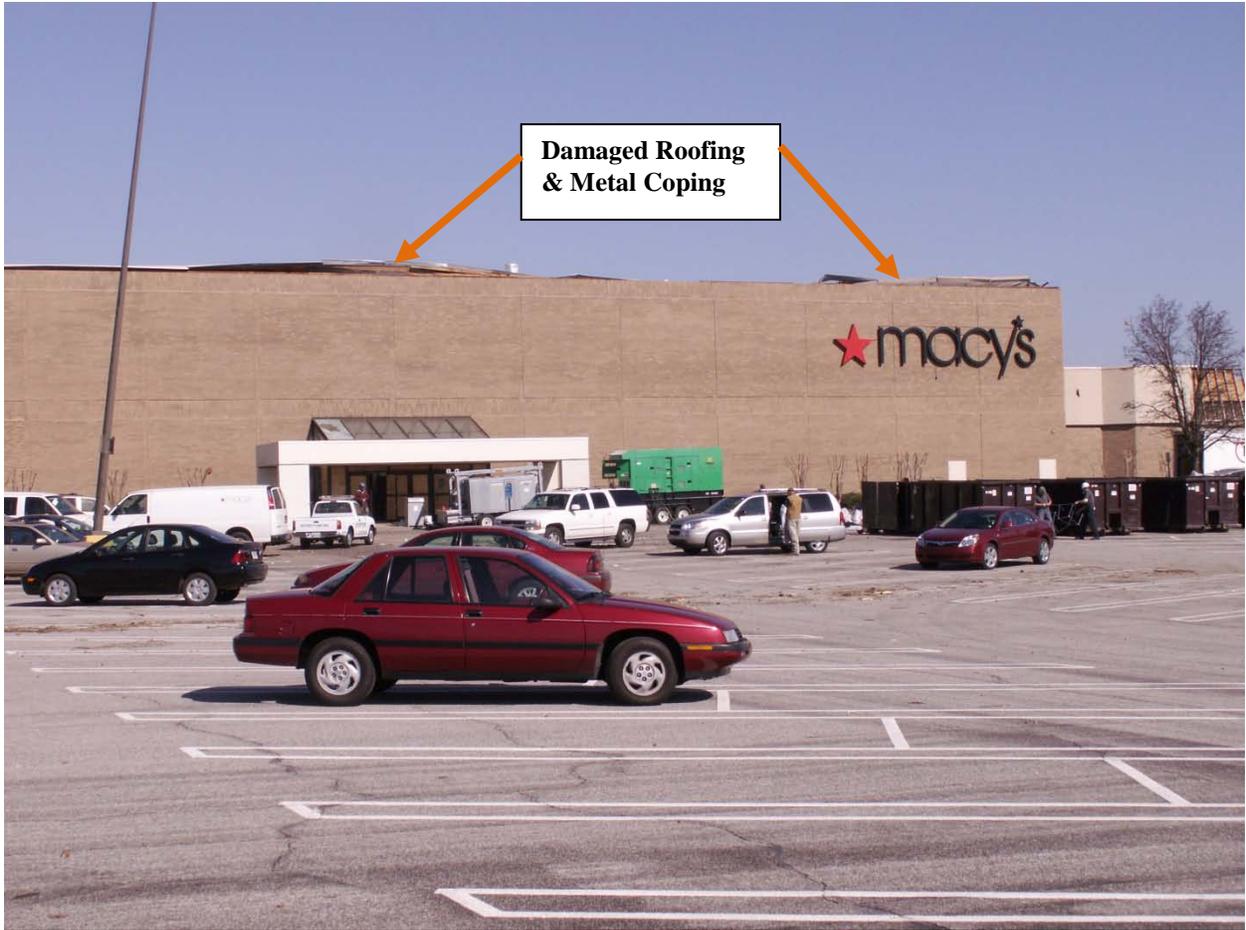
Figure 3.33. Parapet coping damage at Macy's windward face, DOD 2 only visible

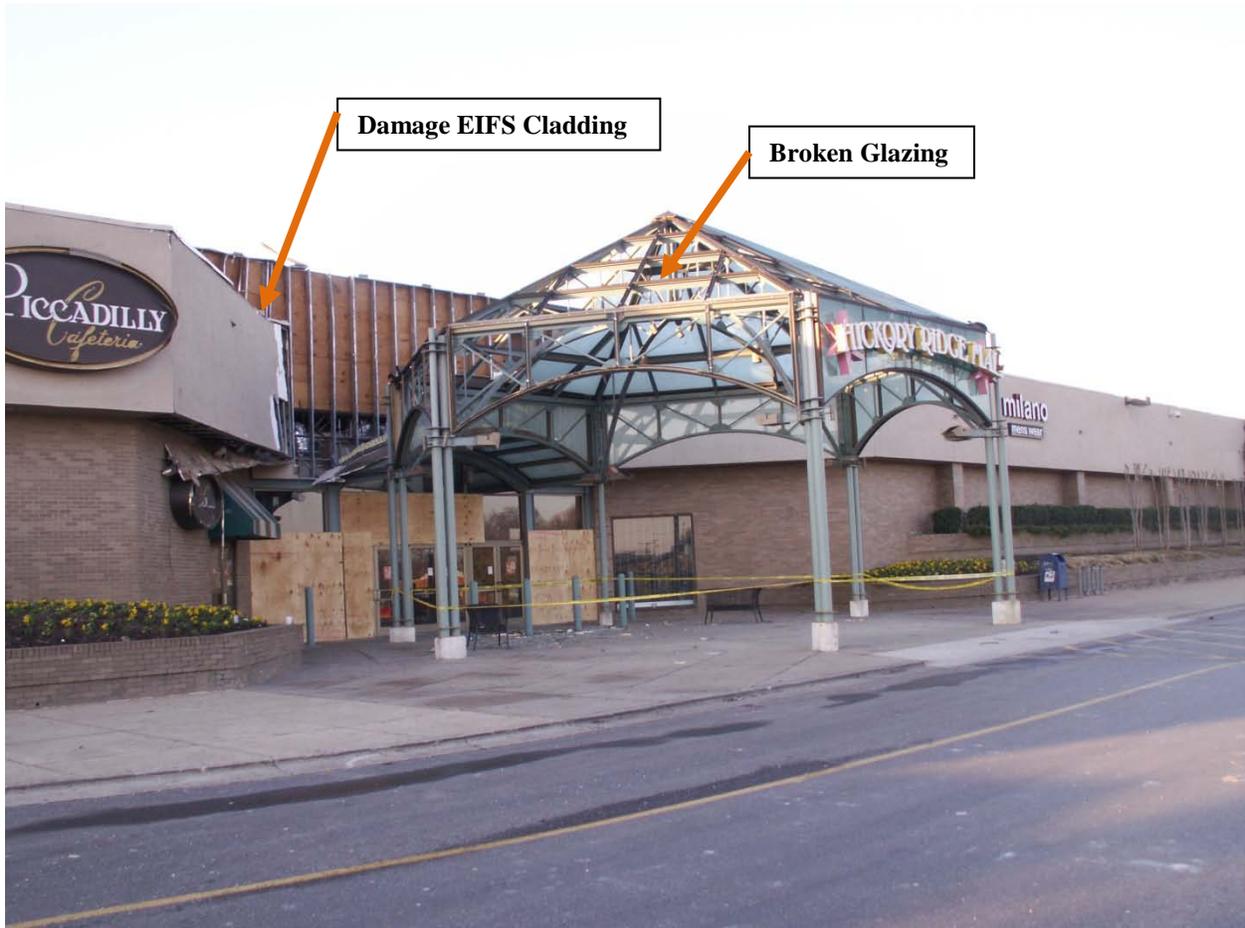
Figure 3.34. Mall parapet, cladding, and canopy damage, DOD 2

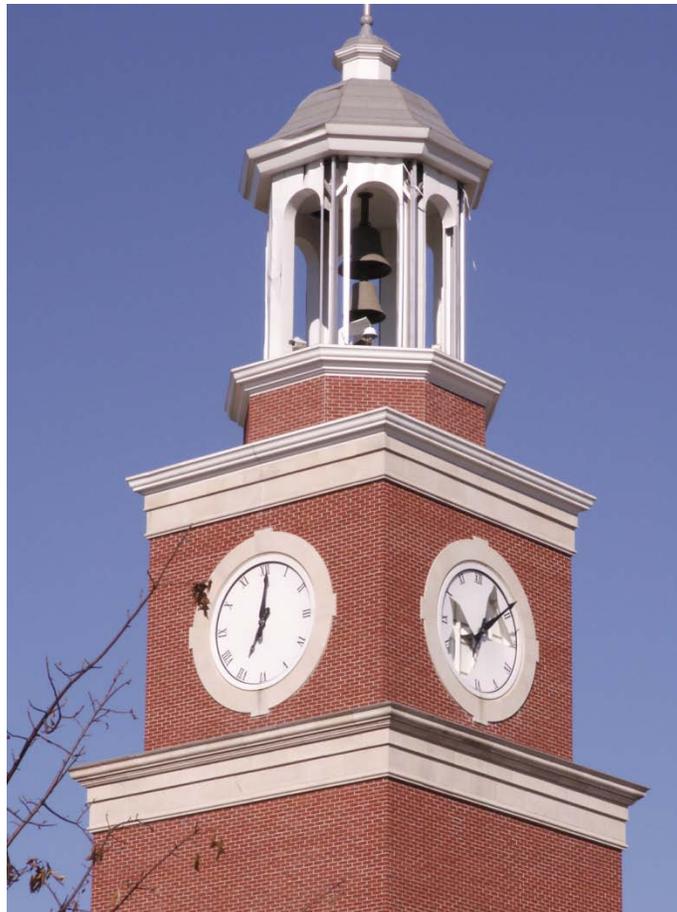
Figure 4.1. Tornado Damaged Miller Tower on Union University Campus

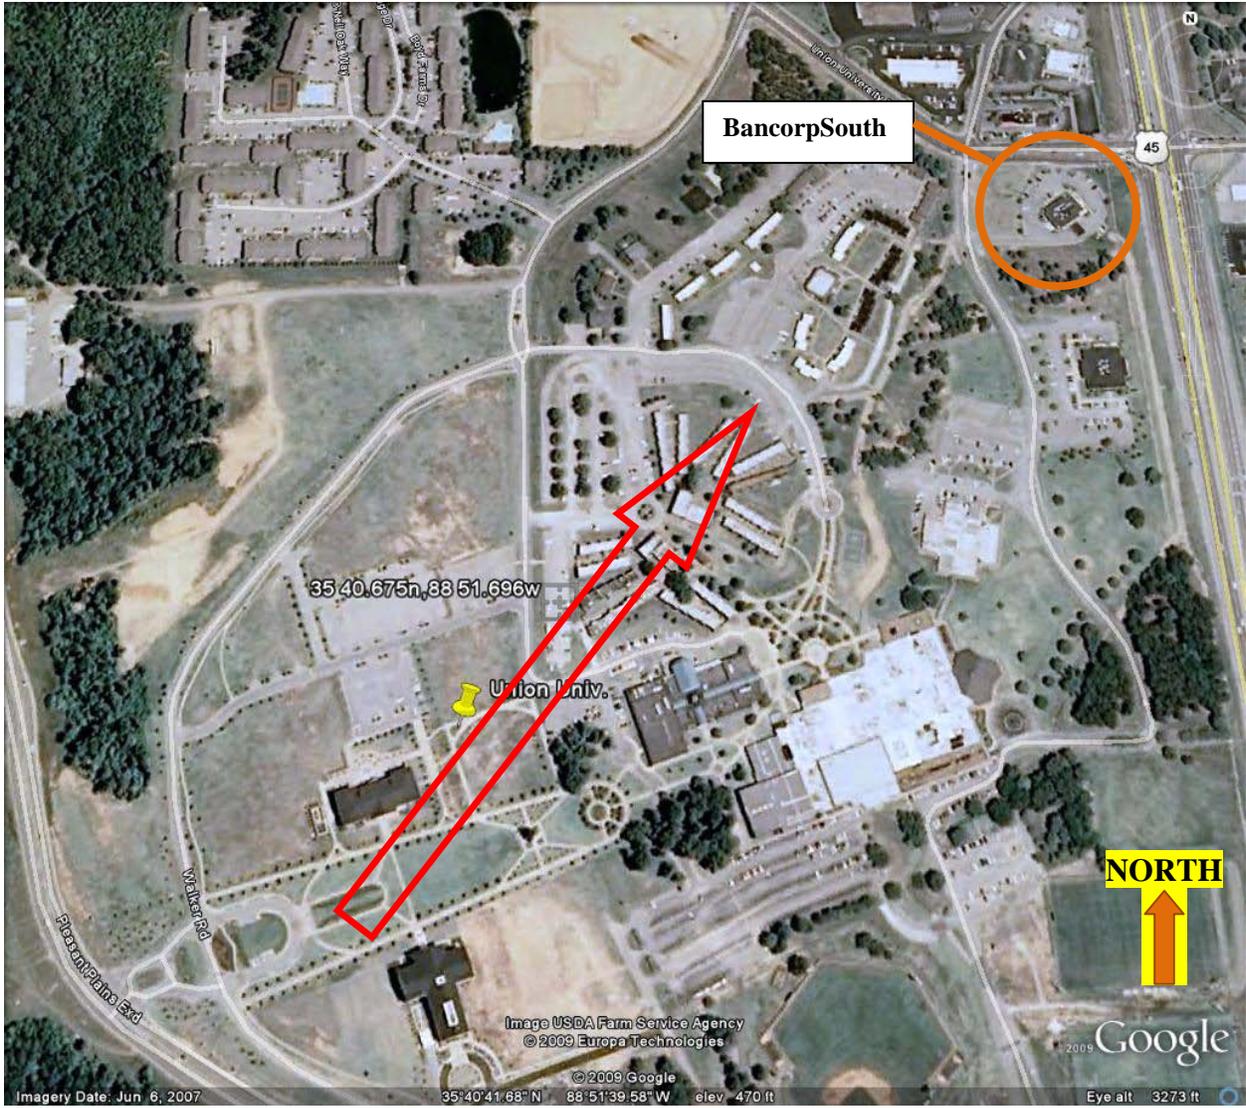
Figure 4.3. Union University Aerial Photograph

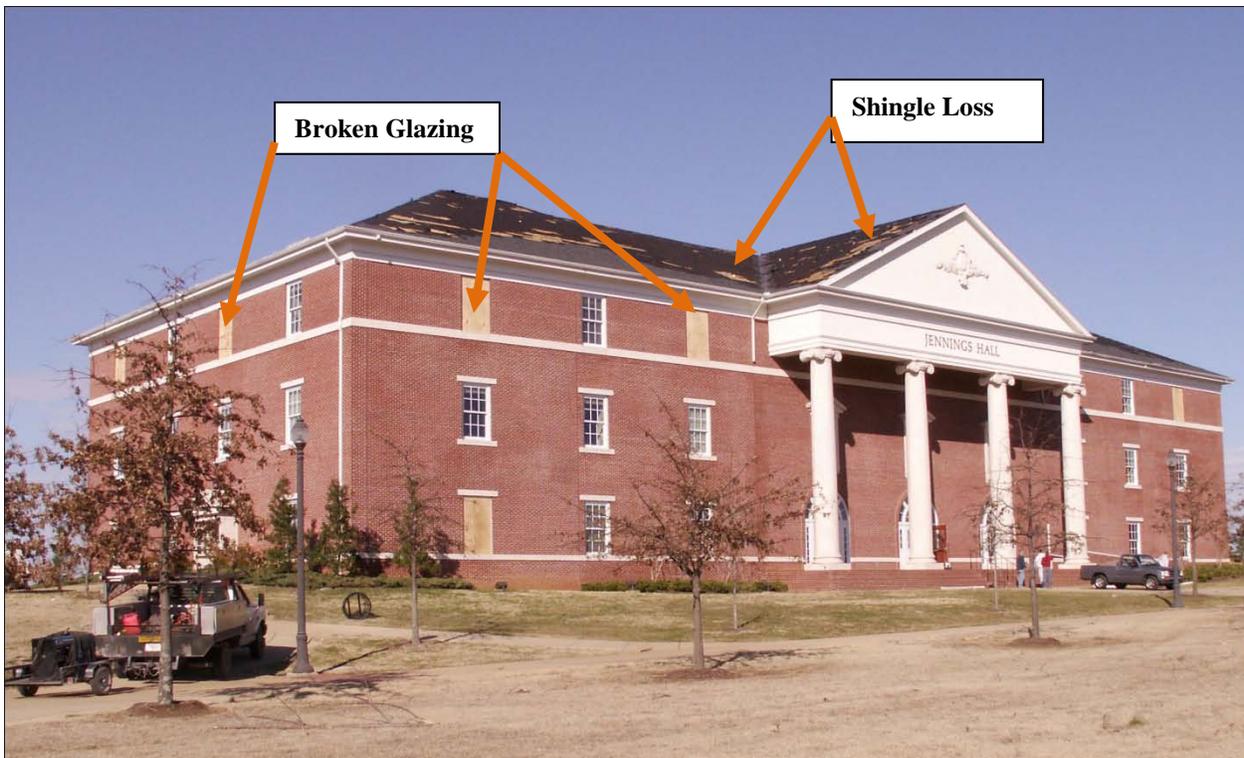
Figure 4.5. Jennings Hall, Union University, DOD 4

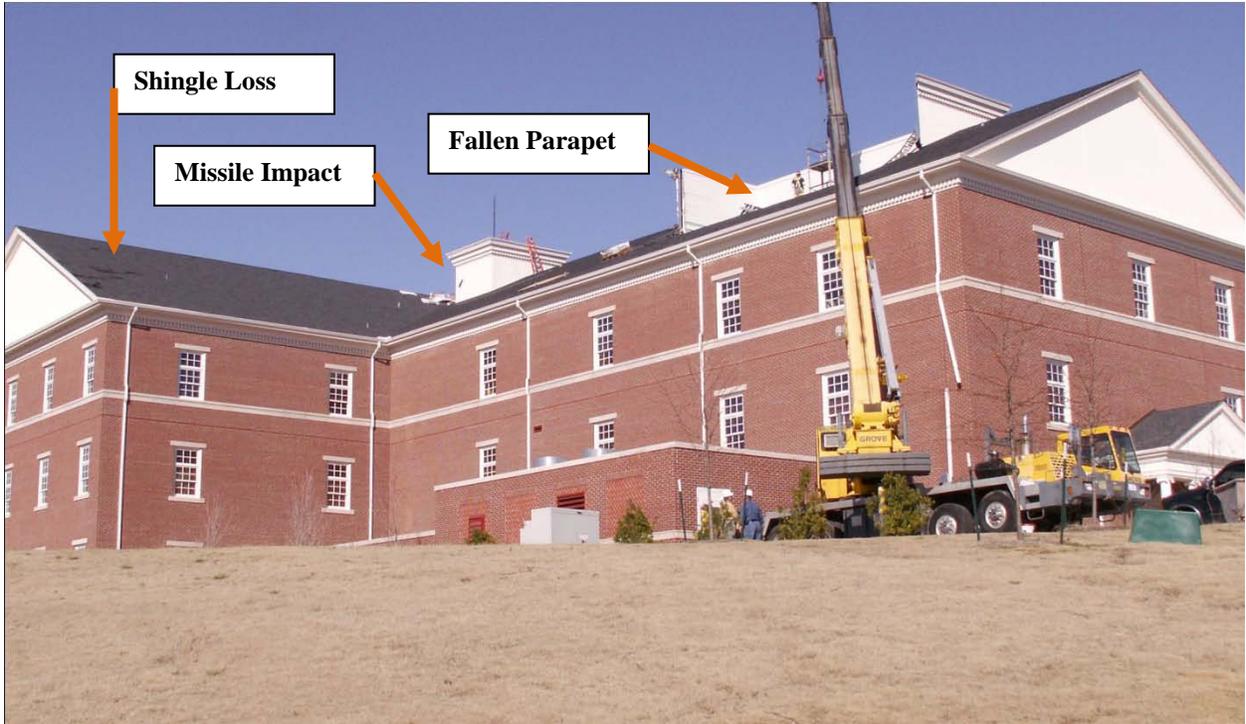
Figure 4.6. Roof damage at White Hall, Union University, DOD 4

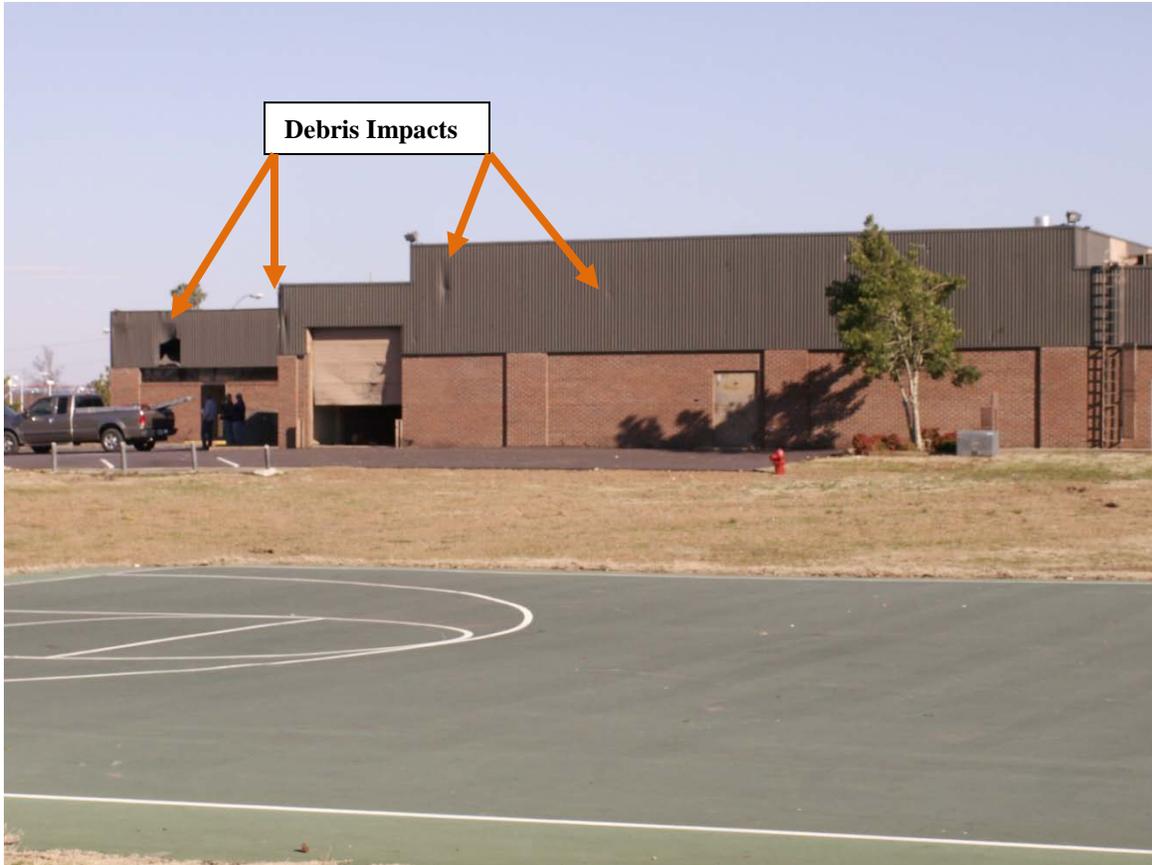
Figure 4.7. Debris Impacts on Blasingame Academic Complex, Union University

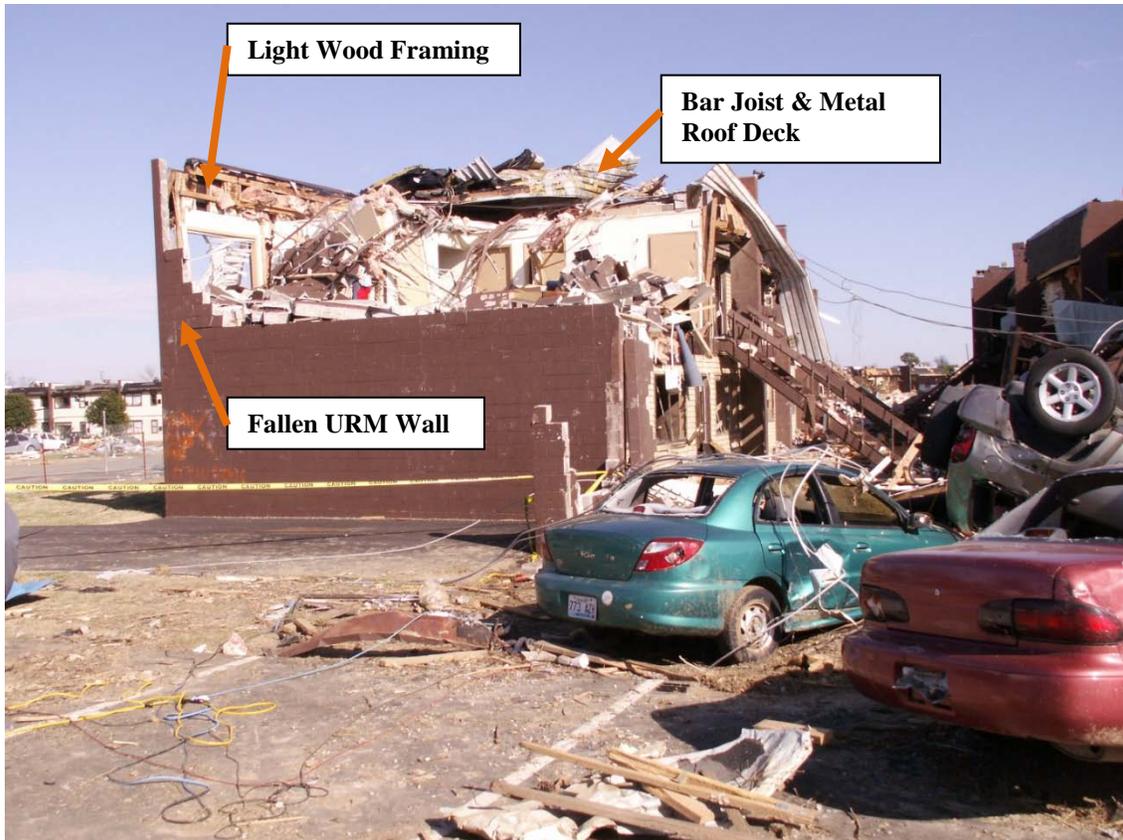
Figure 4.8. Windward CMU wall collapsed and tumbled cars and trucks in Waters Residence Hall parking lot, DOD 6

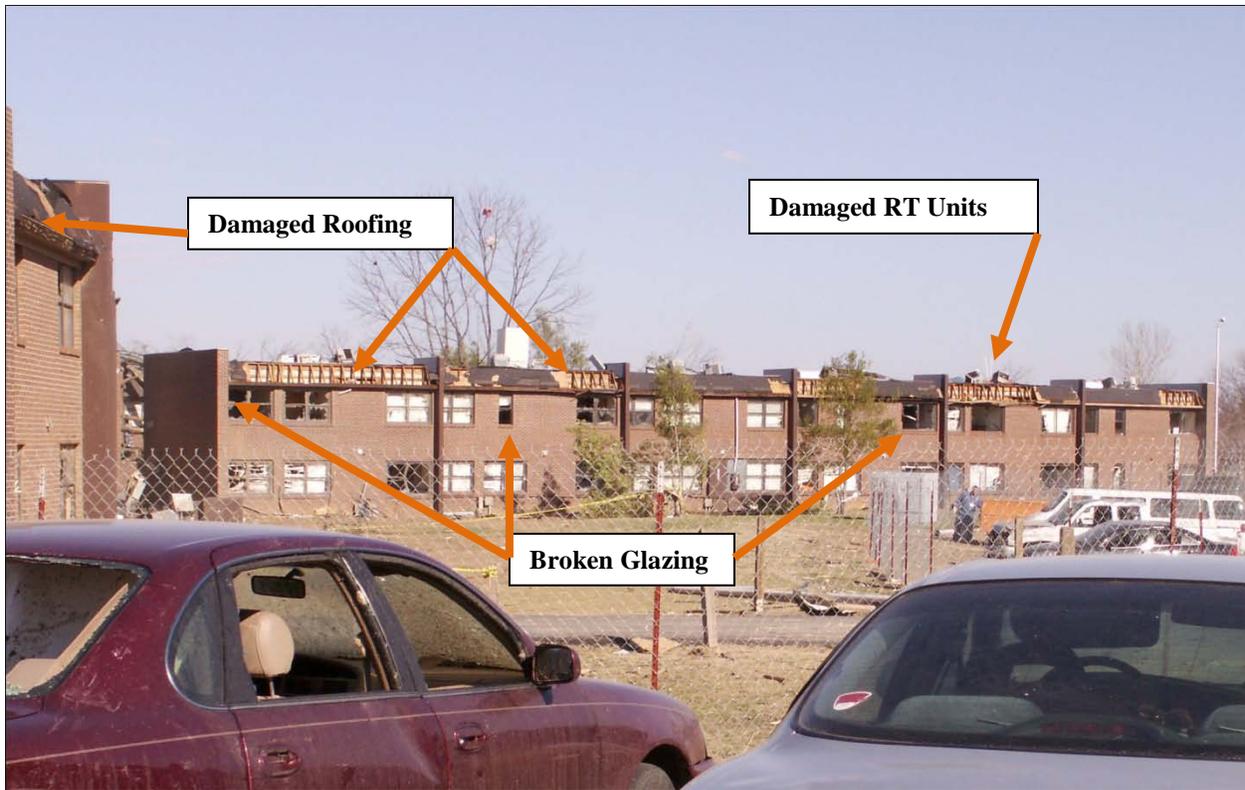
Figure 4.13. Glazing, roofing, and rooftop equipment damage to remote housing units, DOD 3

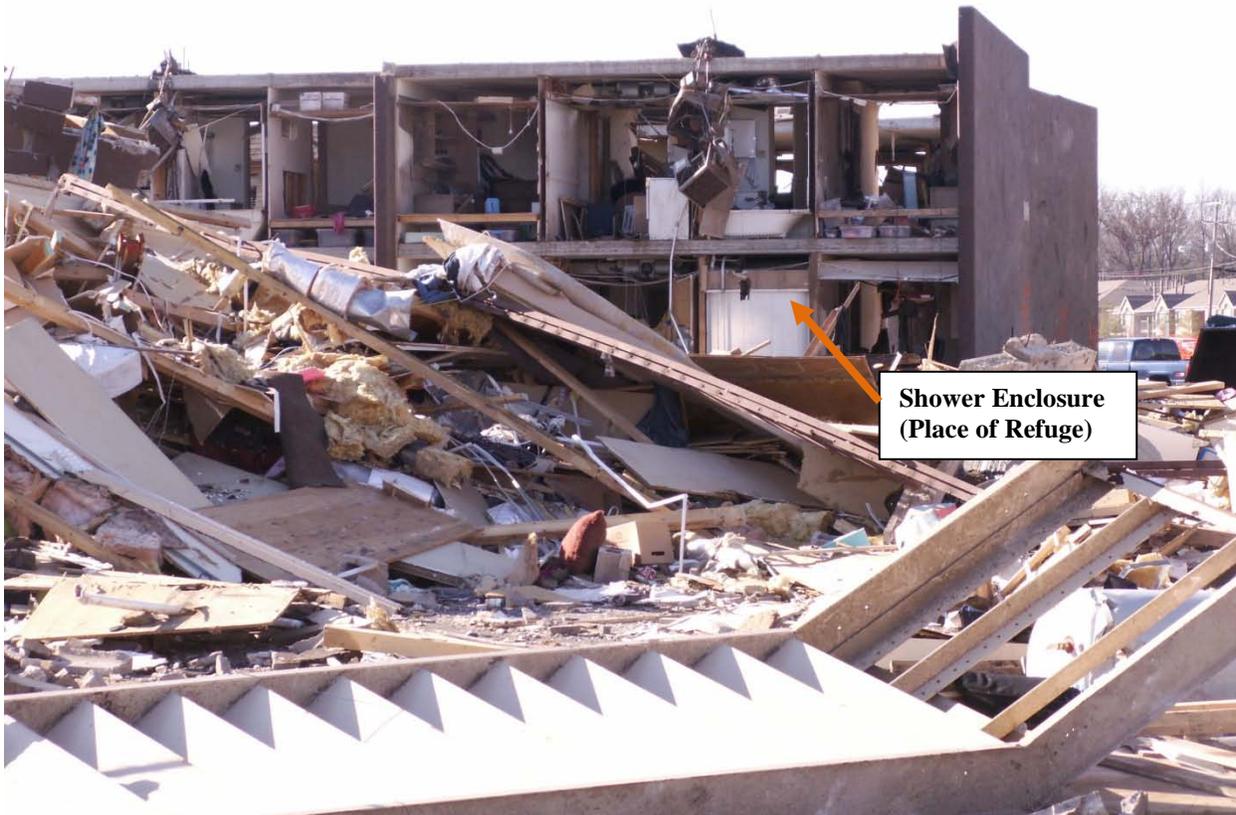
Figure 4.14. Place of Refuge

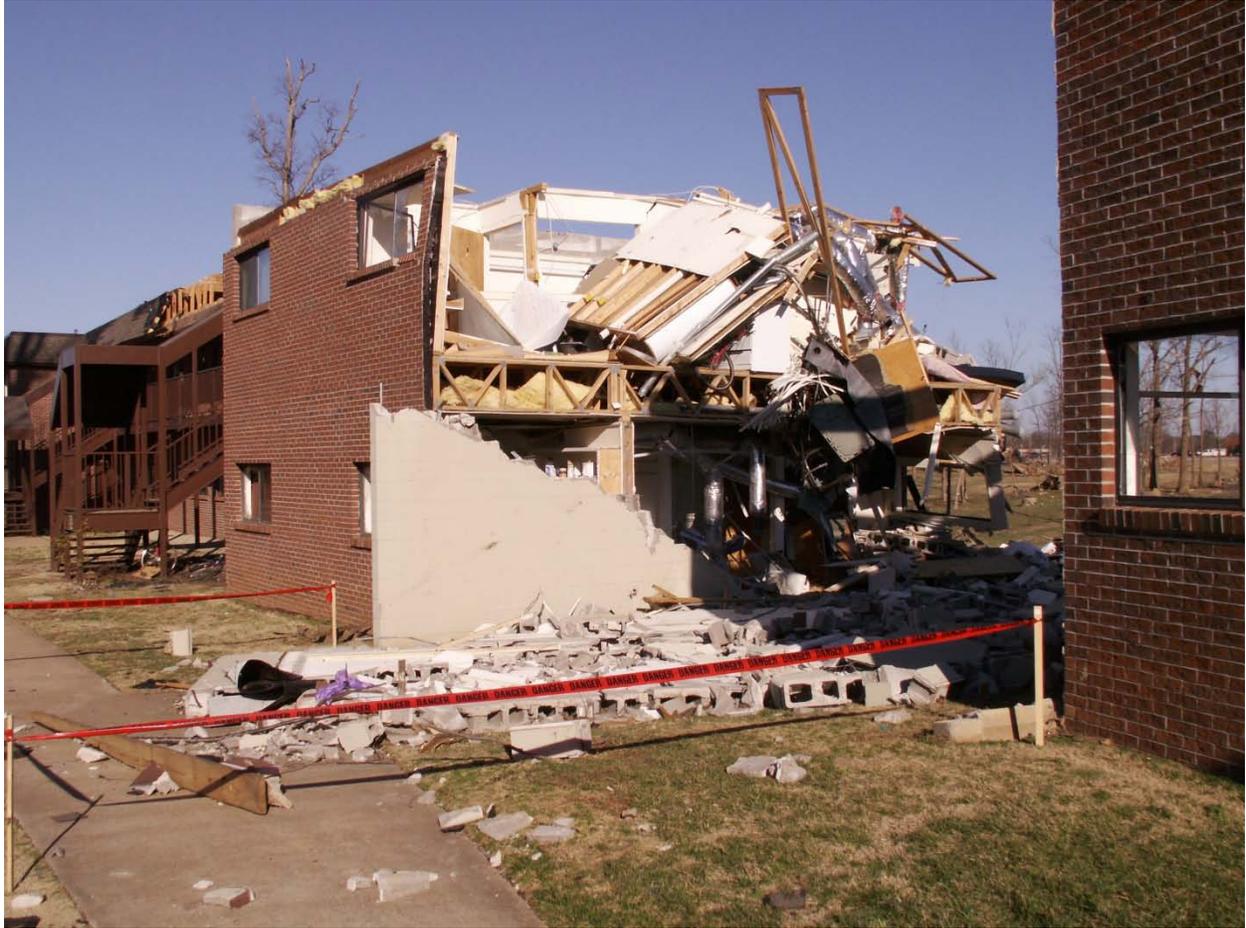
Figure 4-16 Failed End Unit URM Wall

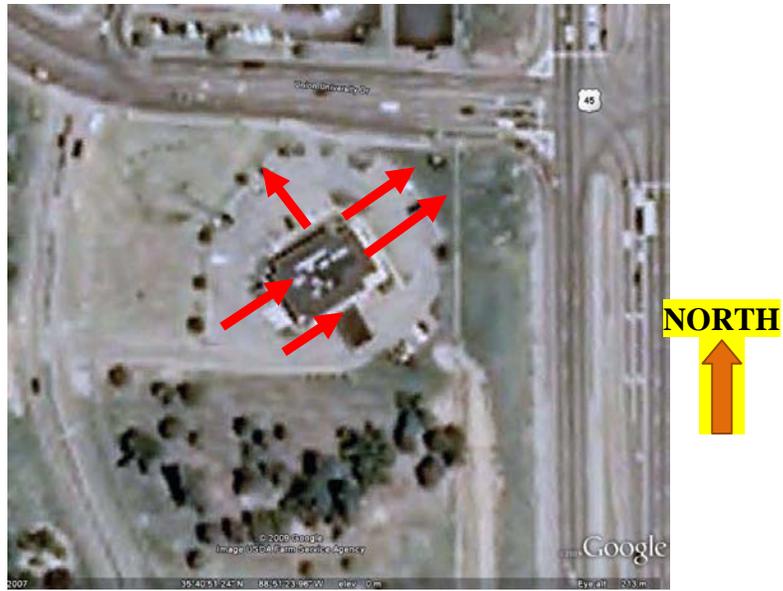
Map Courtesy of Google

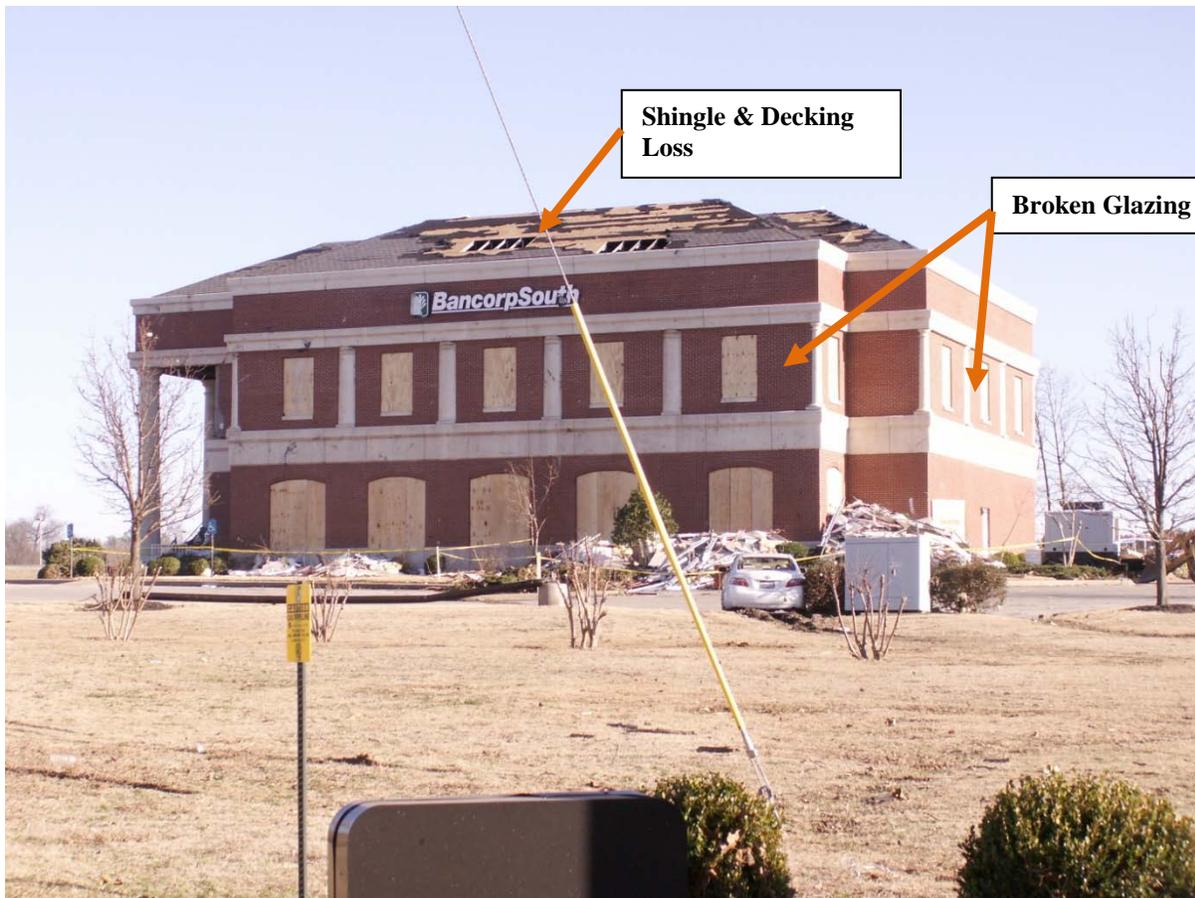
Figure 4.18. Damage to BancorpSouth roofing and glazing, DOD 3

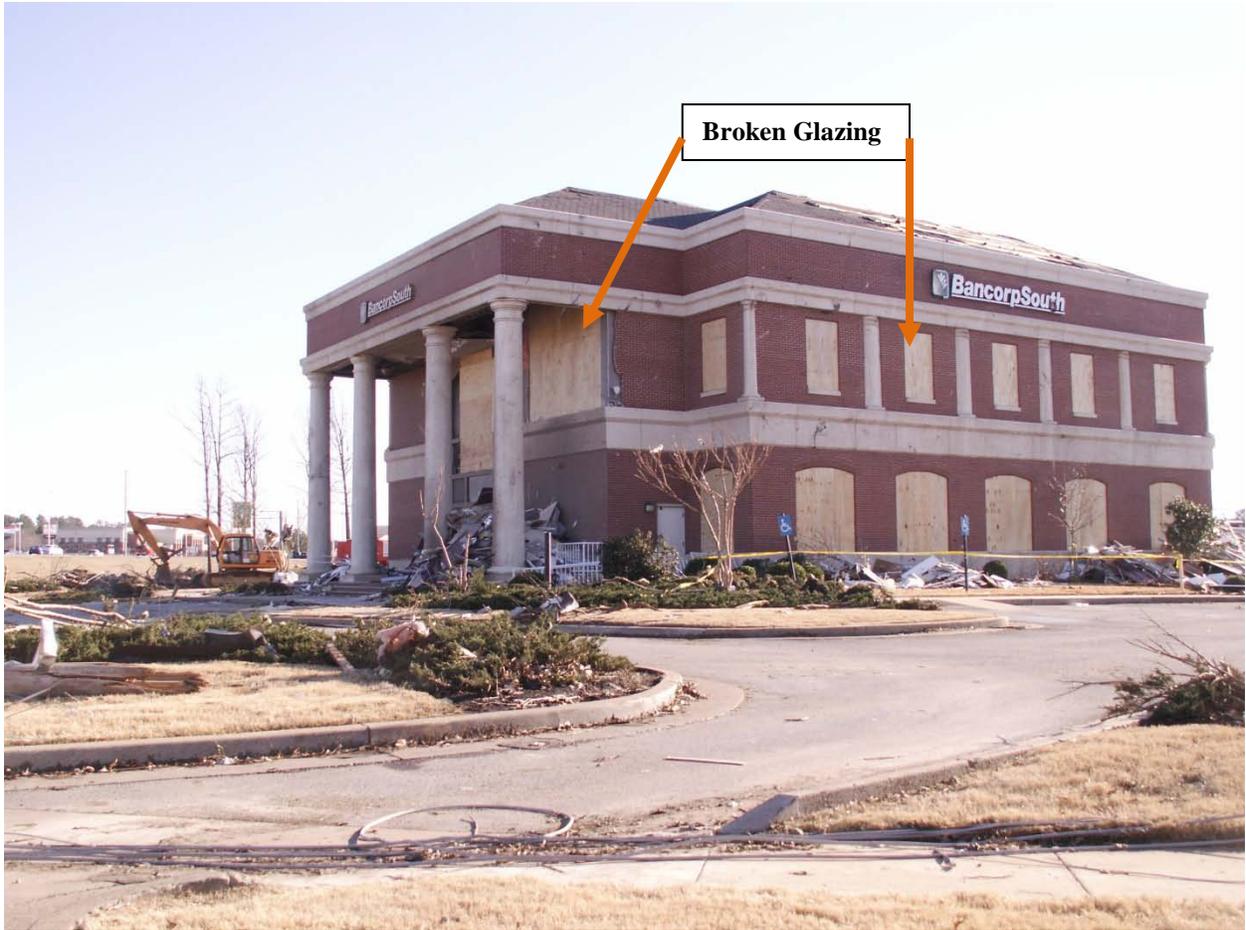
Figure 4.19. Glazing failures led to destruction of interior finishes, DOD 3-4

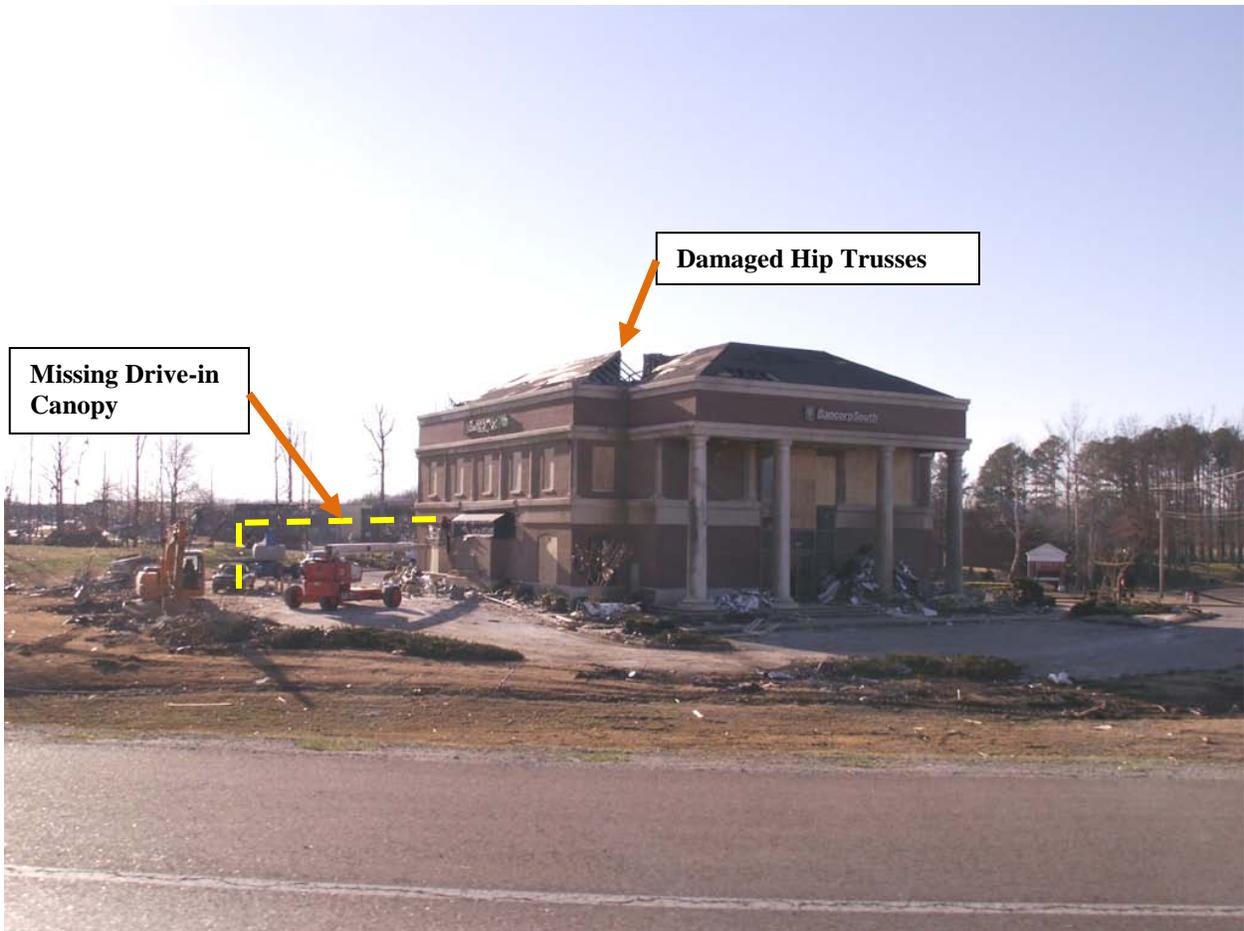
Figure 4.20. Destruction of Drive-In Canopy and Roof Trusses, DOD 5

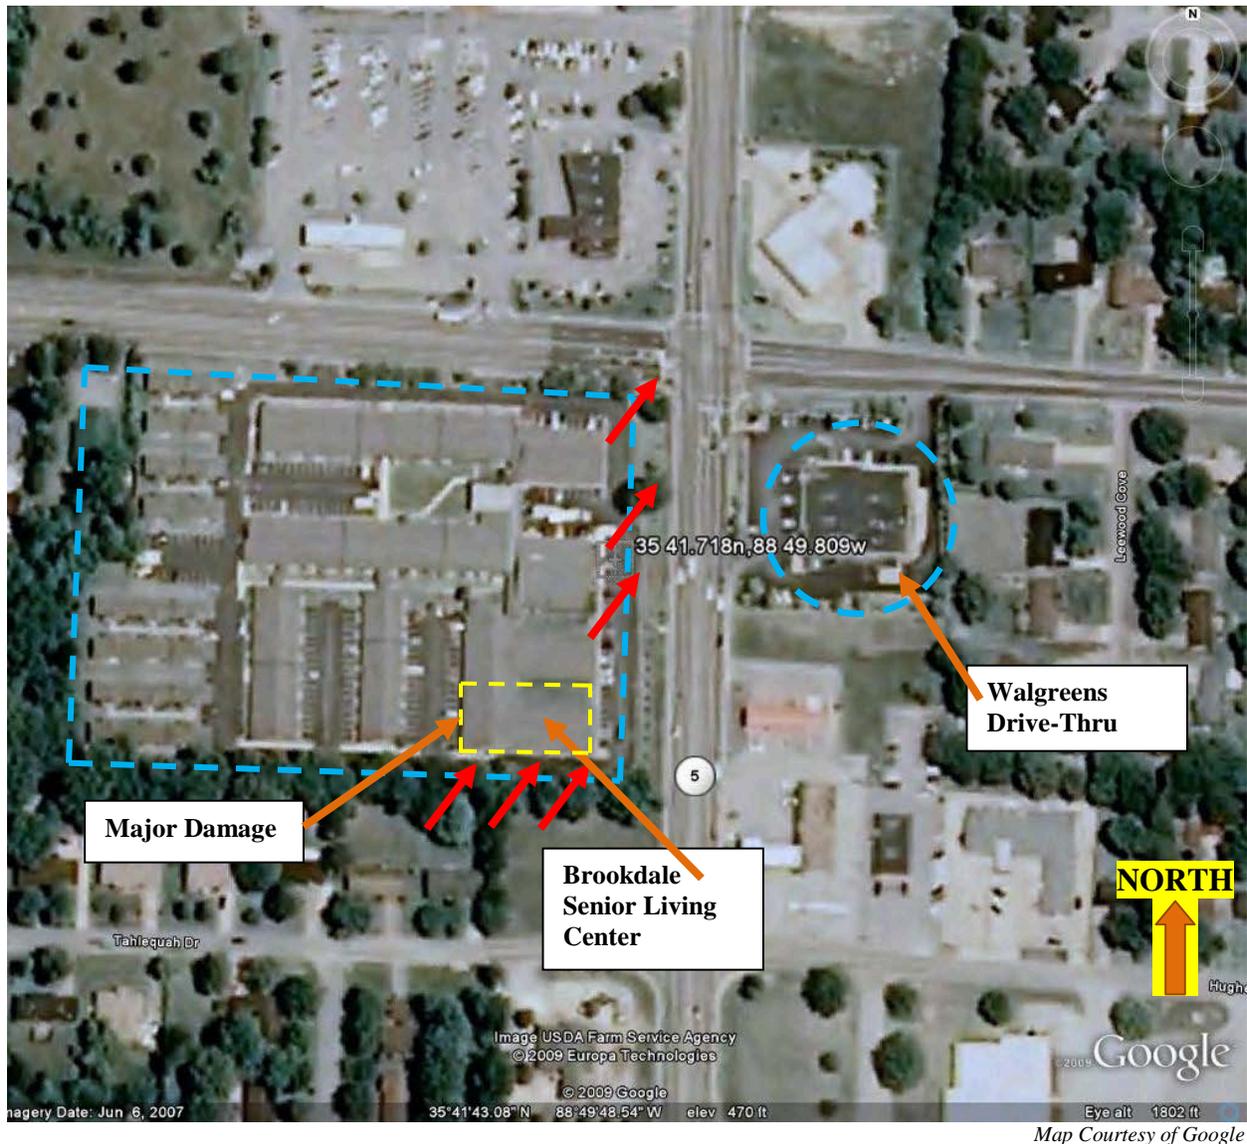
Figure 4.21. Satellite Image of Brookdale Senior Living Center (red arrows indicate positive and negative wind pressures)

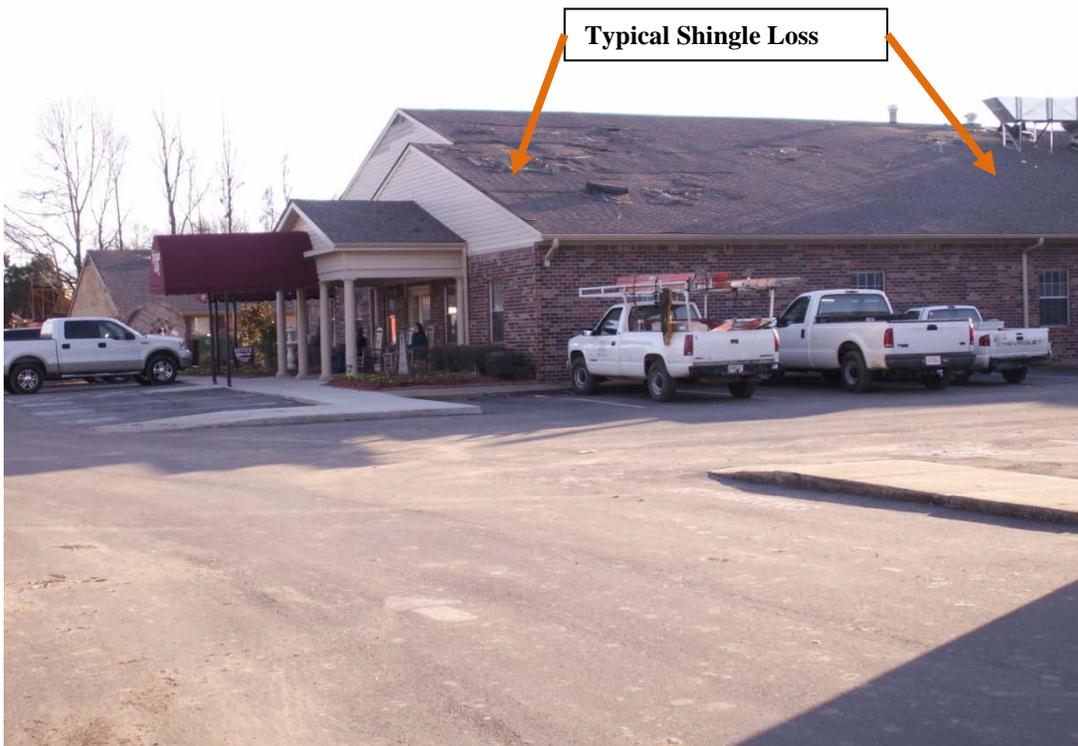
Figure 4.22. Significant loss of roof covering on leeward side, DOD 3

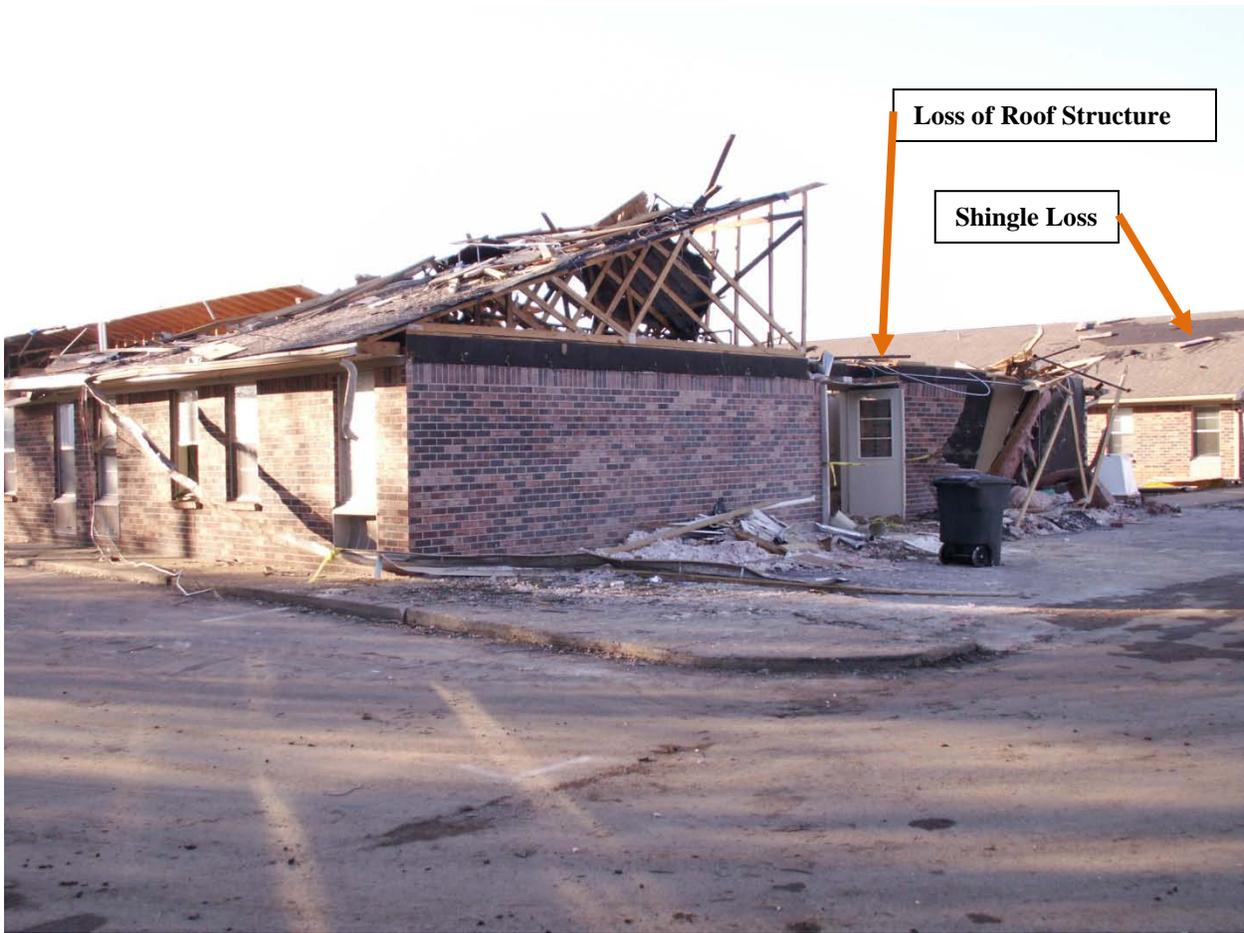
Figure 4.24. Damage of windward roof structure and loss of leeward roof structure, DOD 4

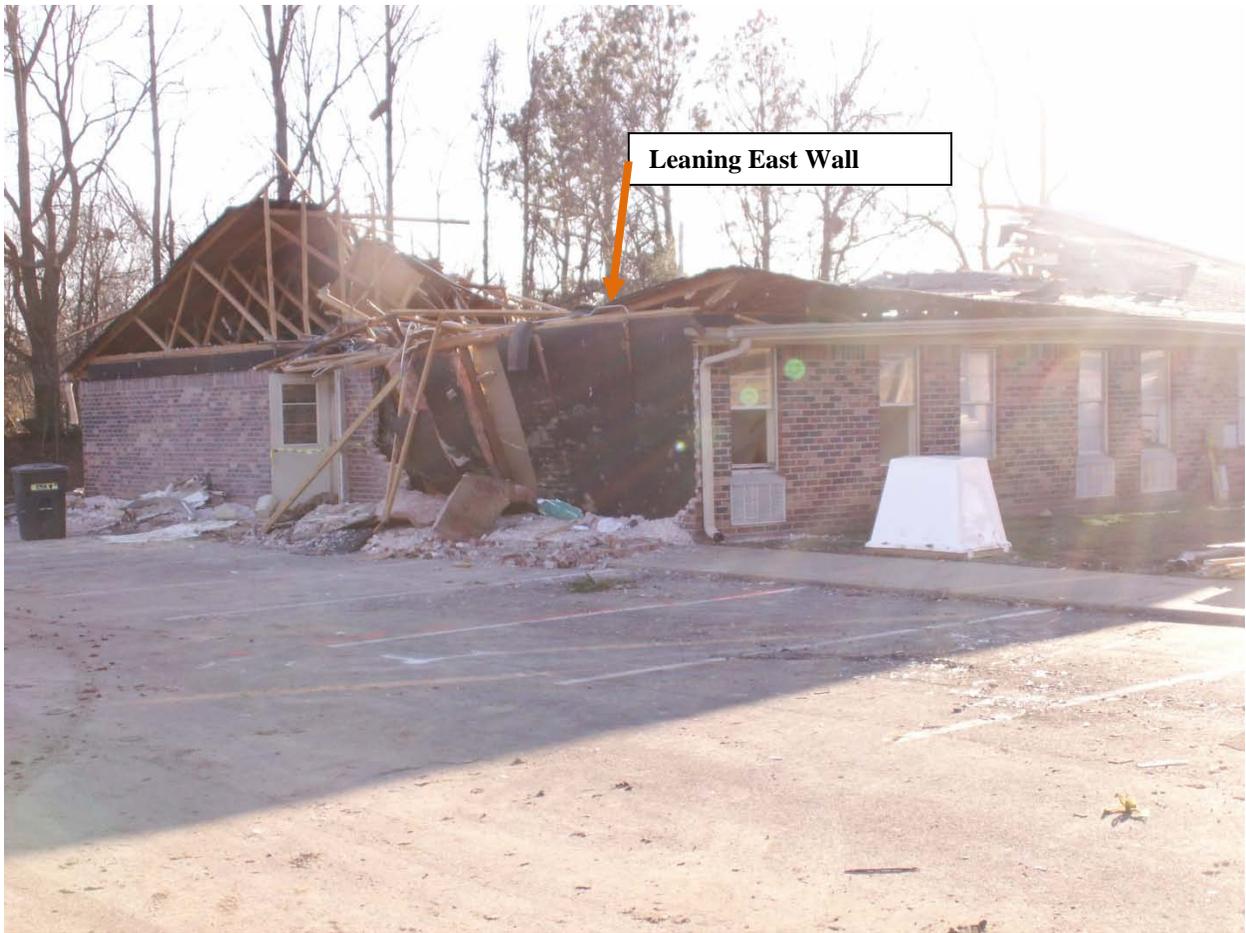
Figure 4.25. Damage to side wall (leeward face) due to loss of lateral support and internal pressures, DOD 4

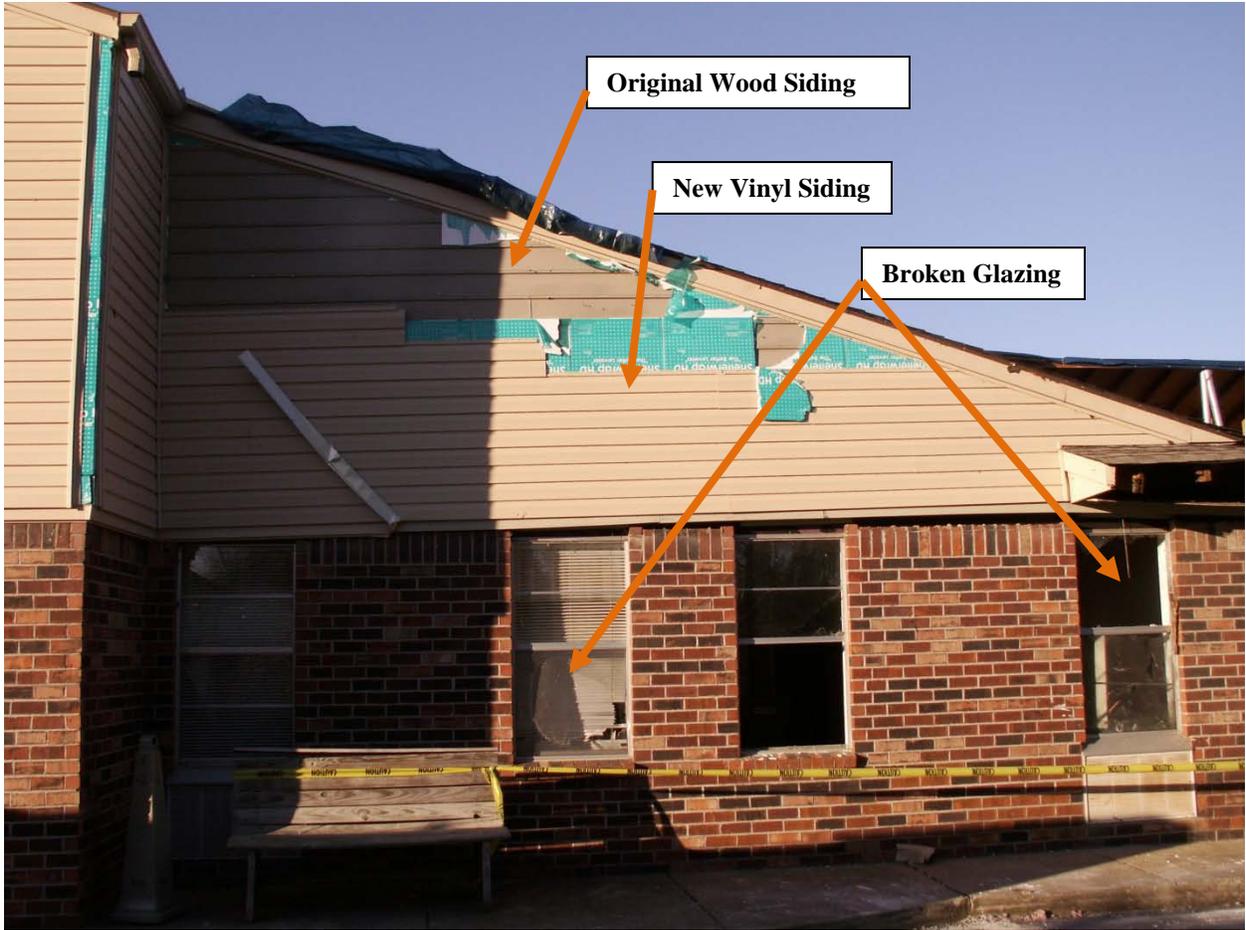
Figure 4.26. Classic loss of siding and glazing materials, DOD 2
