TEXAS TECH UNIVERSITY CENTER FOR MULTIDISCIPLINARY RESEARCH IN TRANSPORTATION

Project Summary Report 4144-S
Research Project 0-4144

March 2002

Study of Re-Refined Oil Use in Diesel Engines: Summary Report

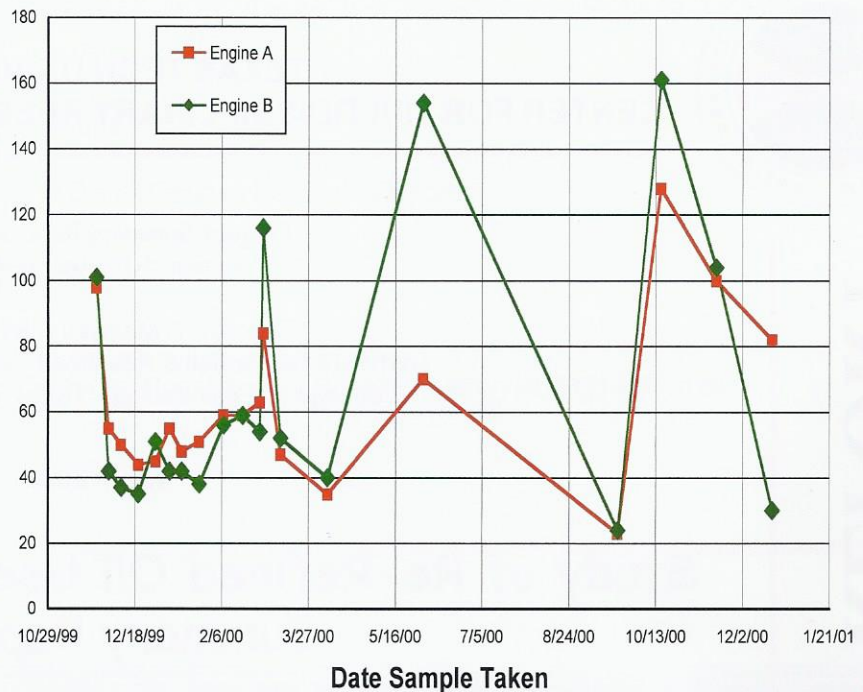
Figure 1: Iron Concentration in Oil Samples

The study investigators were not informed which engine was run on virgin oil and which was run on re-refined oil; the engines were specified as Engine A and Engine B. A plot of iron concentration versus time is shown in Figure 1. This plot is typical of the other wear metals as found in the oil samples. Examination of the figure indicates that the frequency of sampling decreased significantly at about the time the engines were torn down and inspected in July 2000. One of the problems initially identified with Ferry Boat Operations procedures was not changing engine oil frequently enough. The oil change frequency is not known specifically, but can be estimated from the sample dates. Trends shown in the oil sample data tend to track fairly well for the samples taken early in the program. However, for the later samples trends are more erratic. Because there was no re-refined oil used in the engines for a significant part of the test, and possibly for the entire test period, it is not possible to interpret what effect re-refined oil had on engine wear versus virgin oil.

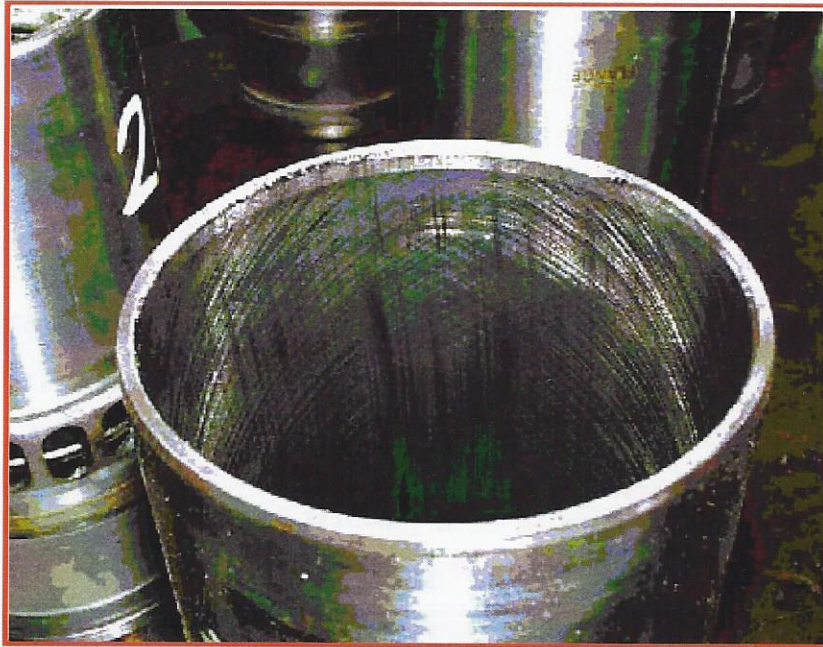
Figure 2: Cylinder Liner from One of the Engines

a Detroit Diesel authorized representative. Major wear components were measured, data was recorded, and pictures were taken of the major engine components. The measurement of engine wear surfaces indicated only insignificant differences in the condition of the two engines. Figure 2 shows a view of one of the cylinder liners. Figure 3 shows a view of the top of the cylinder head.

The engine teardown and inspection indicated essentially equal wear for both engines and in no way indicated any oil related problems.

- ☐ The engines should be run on SAE 40 CF-2/SH oil, virgin or re-refined oil.
- ☐ Engine oil change intervals should be much shorter than is typical for the ferryboat engines.
