# STABILIZATION OF SOIL USING IN-SITU VITRIFICATION

Research Report Number 5-1860-01-1

Project Title: Stabilization of Soils Using In-Situ Vitrification

# CENTER FOR MULTIDISCIPLINARY RESEARCH IN TRANSPORTATION TEXAS TECH UNIVERSITY

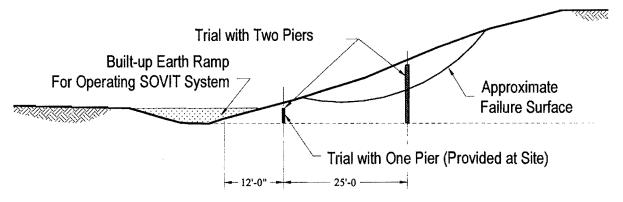
Figure 2 Slope Profile; Motley Drive Site

The slope profiles established based on surveying conducted at the Motley Drive and Hamilton sites are shown in Figures 2 and 3 respectively. The average slope angle at the Motley Drive site was found to be 17 degrees while the average slope angle at the Hamilton site was 19 degrees.

The second pier configuration represents the actual pier layout used at the Motley Drive site. During implementation it became clear that, with the current limitations of the SOVIT system, it was not practical to place the second row of piers at a distance of 37.0ft from the toe. This would require building an earth ram that is more than 10.0ft in height. Therefore, only the first row of piers was placed. Single row of piers near the toe would prevent the slope from failing in the same manner that it had failed previously. However, the factor of safety calculated for these conditions suggest that a failure could occur further up the slope almost as easily. The results of the factors of safety calculated for these two piers configurations are shown in Table 2.

Using a shear load of 28.0 kips/pier, slope analysis was performed for different pier configurations. Out of these only two are shown here. The first, called the *design pier configuration*, identifies the optimum locations and depths of vitrified soil piers to achieve a target factor of safety of 1.30. This involved two rows of piers with a spacing of 6.0ft between piers in each row. The first row of piers is placed at a distance of 12.0ft from the toe of the slope, as shown in Figure 2. These piers are 3.0ft deep. The second row of piers is placed at a distance of 37.0ft from the toe of the slope. They are 13.0ft deep.

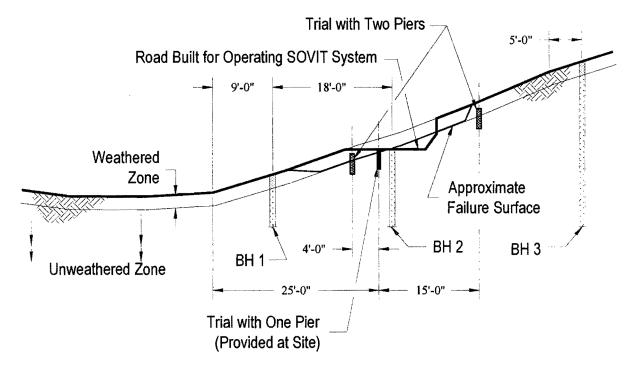
Figure 3 Slope Profile; Hamilton Site

At the Hamilton site, the top 2.0 ft of the soil profile consisted of weathered material while competent, unweathered material was found at depths greater than 2.0ft. It was obvious that the failure that had occurred on this slope was confined to the upper soil horizon. Unfortunately, no intact samples of the weathered material found in the upper soil horizon were recovered during soil investigation. Therefore, the shear strength parameters for the soil were determined through inverse analysis. As a first step, the effective friction angle of the soil,  $\phi'$  was determined based on available technical literature on residual soils. Review of data published by Burns (1999) on residual soils of similar origin showed that 15 degrees was a reasonable estimate for the effective friction angle,  $\phi'$  of this soil [5]. Secondly, slope stability analysis of the unstabilized slope was conducted using  $\phi' = 15^{\circ}$ and trial values for effective cohesion, c'. The c' was then adjusted until a factor of safety of 1.0 was obtained. The c' value that was estimated in this manner was 40 psf. The method used in the analysis of Hamilton slope is known as the *Spencer Method*. A non-circular failure surface that closely matched the actual failure surface was used in this analysis. This failure surface is shown in Figure 3.

The first pier configuration, called the *design pier design*, provides the maximum improvement in factor of safety for a specified length of installed pier. This requires two rows of piers, each 3ft deep running along the length of the slope. The spacing between piers in each row will be 6ft. The first row will be placed at a distance of 21.0ft from the toe of the slope and the second will be placed at a distance of 40.0ft from the toe. Piers that are installed according to this particular configuration will arrest any failure that is similar to the slides that have occurred on this slope previously. They will also prevent any other failure involving the upper or lower reaches of the slope. The factor of safety that is achieved with the above optimum pier configuration is 1.24.

The second pier configuration that is shown in Table 3 is the one that was actually used in this implementation project. Due to the limited mobility of the current SOVIT system, it was not possible to install two separate rows of piers as determined through analysis. Therefore, a single row of vitrified columns was installed at a distance of 25.0 ft from the toe of the slope. The pier depth and the spacing were the same as in the design pier configuration. The pier configuration used in

implementation will be effective in preventing the type of failure that had occurred in the past. However, a single row of piers will not be capable of preventing failure within the upper or lower reaches of the slope. For this reason, the overall factor of safety calculated for the slope remains 1.0.

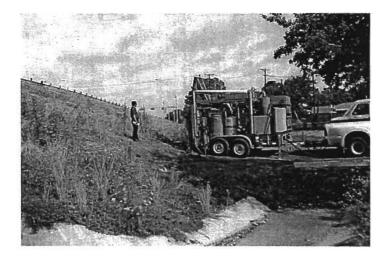
Figure 4 Operation of SOVIT System at the Motley Drive Site

Eleven holes, each 3.0-3.5ft deep and 6.0 center to center spacing, were vitrified at the Motley Drive site. At the Motley Drive site, a current of 1300 Amps was used. Nevertheless, the melt process was very slow due to difficulties in feeding soil into the hole. The soil available at the site had large lumps that did not fit easily within the space between the CGAM and the side of the hole. In addition, the holes at this site had a tendency to cave in more than the holes vitrified at other sites. Because of these problems, only two holes were completed during each of the first two days. The melt process on each hole took two to three hours. A modification of the melt process allowed seven holes to be vitrified on the third day. After each addition of soil, the CGAM was moved up and down for a couple of minutes. This action worked the soil down to the top of the existing melt. This approach reduced the time to complete a hole to less than an hour. Also, the current was increased to 1400 Amps on the third day. Figure 4 below shows the operation of SOVIT system at the Motley Drive site.
