Water Intrusion in Base/Subgrade Materials at Bridge Ends: Final Report

Texas Department of Transportation

Report No. 0-5096-1

October 2005

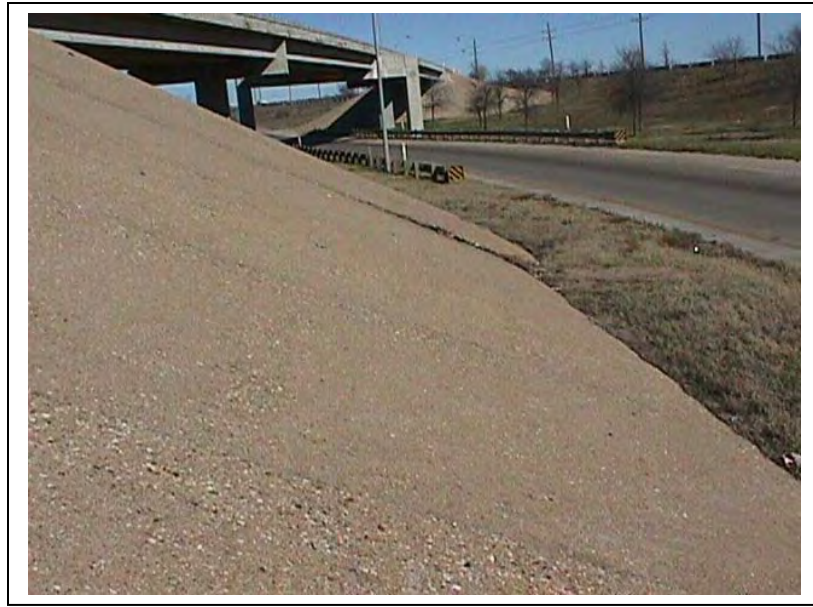
The survey response from the Lubbock district indicated that although they do not experience many problems with water intrusion associated with approach slabs, they have noted problems with water intrusion in riprap and washing out of material at the toe of the riprap. Loss of material beneath the riprap causes large voids to develop beneath concrete slabs and can create differential settlement of the slabs along with concerns for collapse of the slab. The IH 27 overpass over 4th Street in Lubbock is an example of the problem. Figures 4.1 and 4.2 show washed-out fine material at the toe of the embankment. Water is able to enter through damaged or poorly sealed joints between the concrete slabs (Figure 4.3) and wash out fines in the embankment fill. Differential settlement of the slabs is evidenced in Figure 4.4.

Figure 4.4 Differential Settlement of Riprap Slab (Side View)

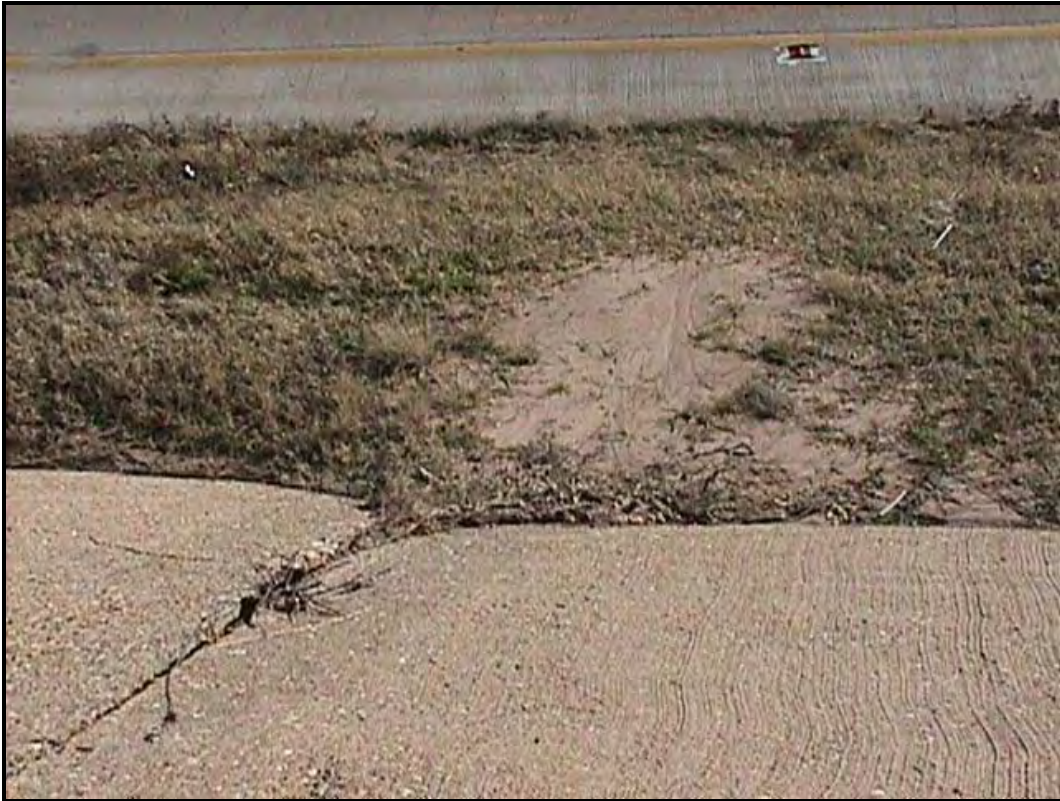
Figure 5.2 Signs of Embankment Fill Erosion at IH-27 Overpass over 4th Street in Lubbock District

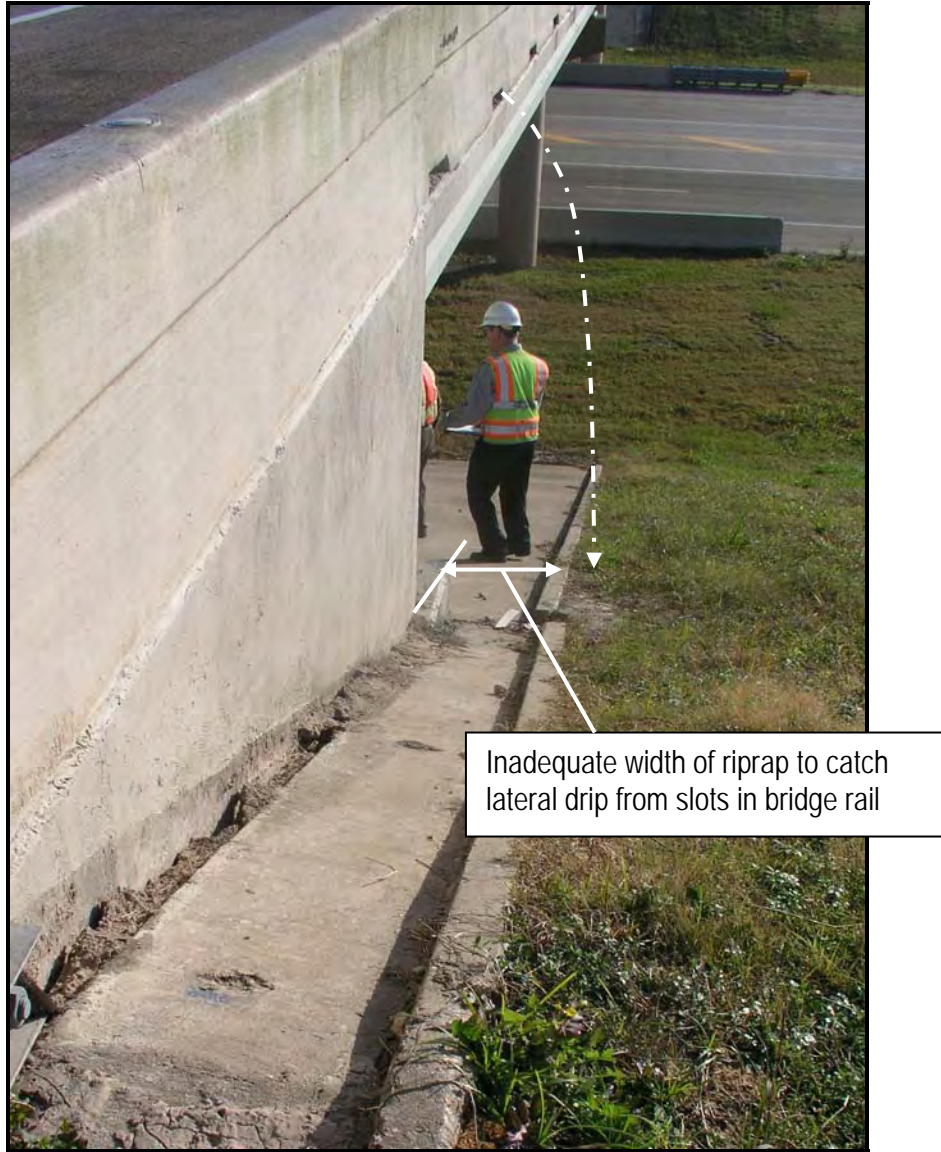
Figure 5.5 Inadequate Riprap Width (Houston District)
