TEXAS DEPARTMENT OF TRANSPORTATION

TXDOT RESEARCH PROJECT 0-6687
MINIMIZE PREMATURE DISTRESSES
IN CONTINUOUSLY REINFORCED
CONCRETE PAVEMENT

Product #1: Training Material

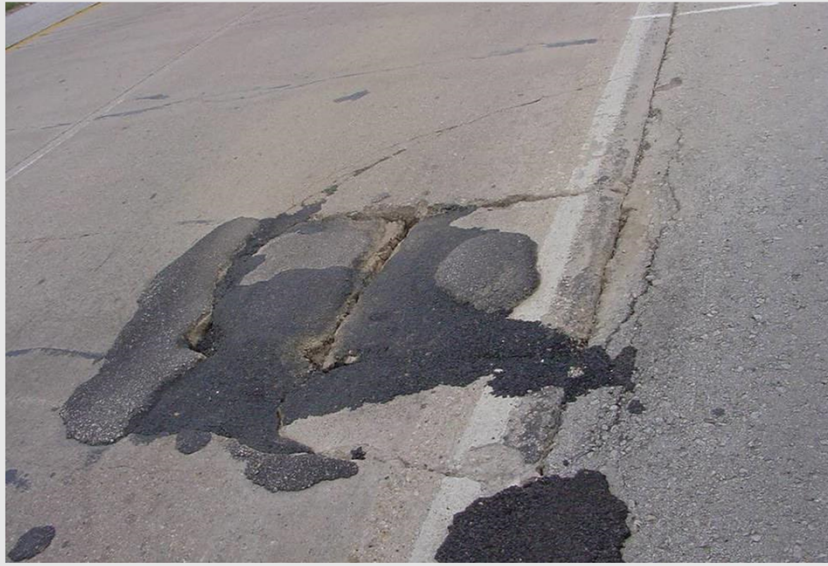
5

This is a typical distress, called punchout, caused by structural deficiencies in CRCP. There is evidence of pumping at a joint between the outside lane and asphalt shoulder, with depression of slab edge and asphalt shoulder at a joint. The “cause” of this distress is insufficient slab support, i.e., deterioration of base/subgrade materials. An argument can be made that deficient slab thickness was the cause of this distress. The fact that this type of distress was not frequent in this section of CRCP indicates that slab thickness might have been adequate. It is noted that asphalt patching materials were placed more than once, and most depression by wheel loading applications was under the wheel path, not at the joint between the outside lane and asphalt shoulder.

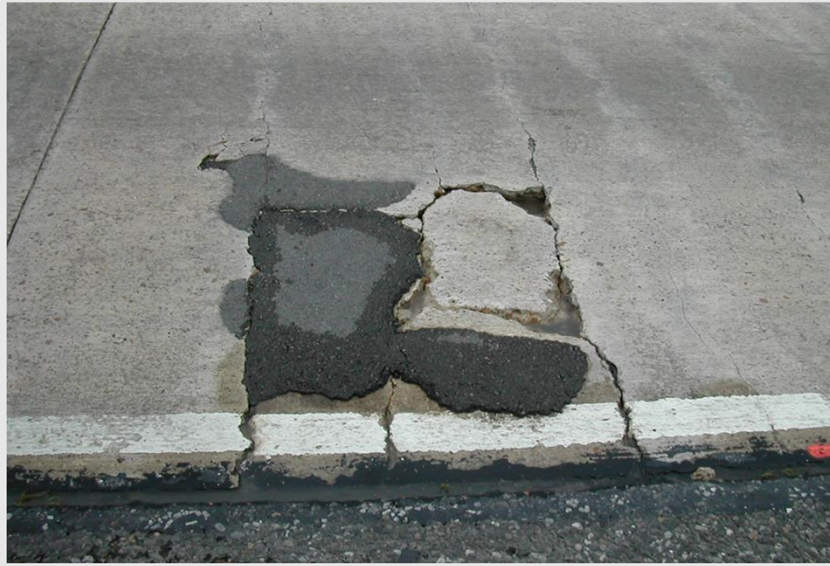
6

The distress shown in this slide is classified as punchout. The difference between the distress shown in this slide and in the previous slide is that, in the previous slide, the depression of the slab was in the form of a half-moon, while in this slide, the distress is near the transverse construction joint and longitudinal cracks were confined within three transverse cracks. It is believed that the distress shown in this slide could be due to the combined effects of construction operations near a transverse construction joint and potentially design detail (the end of additional tie bars coinciding with the boundary of this distress). From the standpoint of potential distress mechanism, it may not be correct to classify this distress as structural distress. However, in the current distress classification system, it is considered as a structural distress.

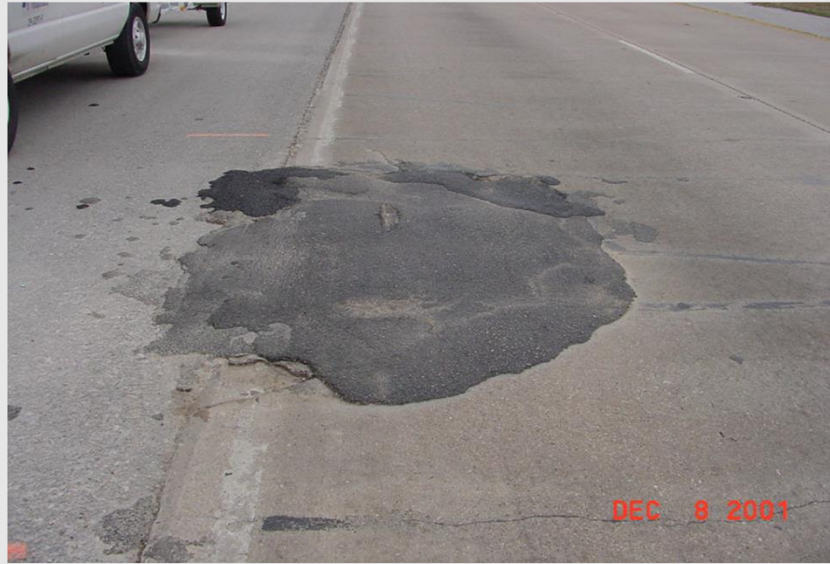
7

The distress shown in this slide is covered with asphalt and the mechanism of this distress is not easy to identify. However, based on the area and location of the distress, it is considered as a structural distress.

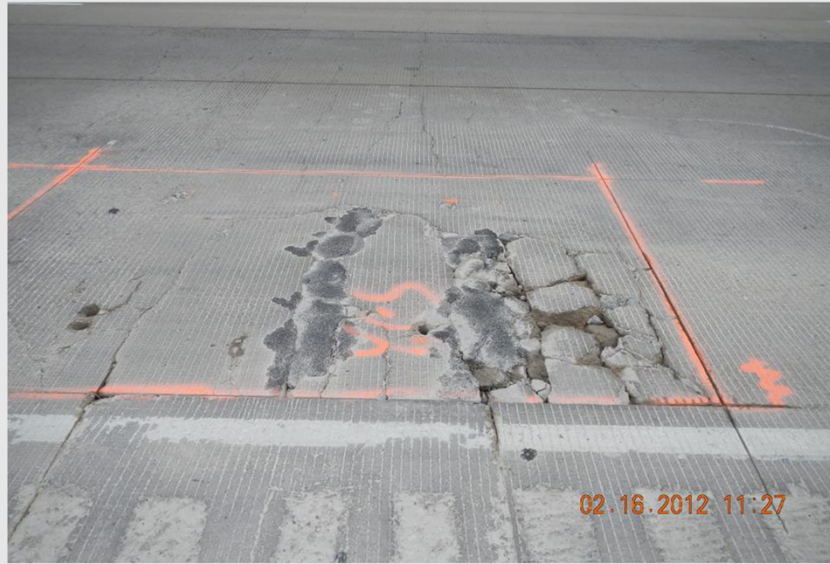
8

The distress shown here is also classified as structural distress, since it is not spalling. On the other hand, the slab is 13-in thick, on 4-in asphalt base. Also, at the time this picture was taken, the pavement was less than four years old. Investigation of this distress indicated severe delaminations at the depth of longitudinal steel. Even though this distress is classified as structural distress, it appears that structural deficiency was not the cause of the distress.

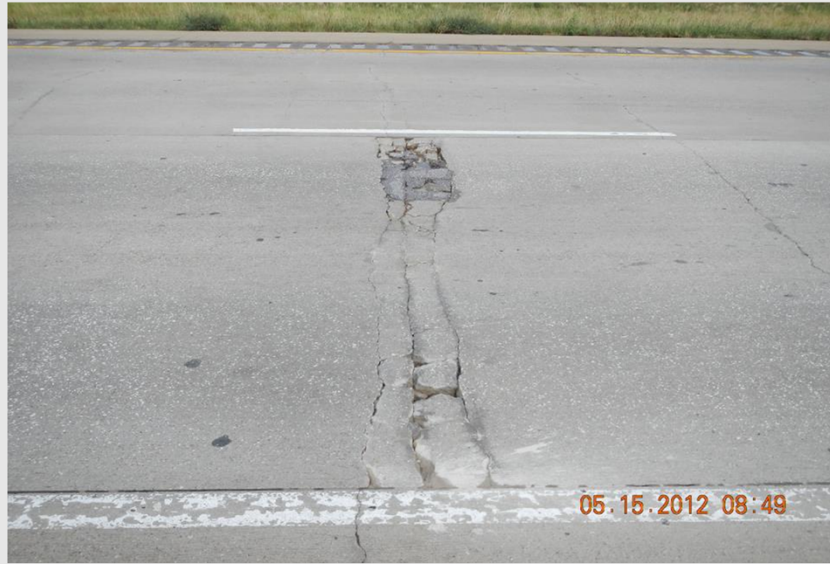
9

This distress does not meet the traditional definition of punchout. No cantilever action by CRCP segment bordered by two short transverse cracks is observed. No evidence of pumping or other deficiencies in slab support are noted either. Evaluation of WIM (weight in motion) data in this section revealed truck traffic with weights far exceeding legal limits. From that standpoint, it can be stated that this distress was due to the structural deficiency of CRCP system. The use of thicker slabs could have prevented this distress from occurring.

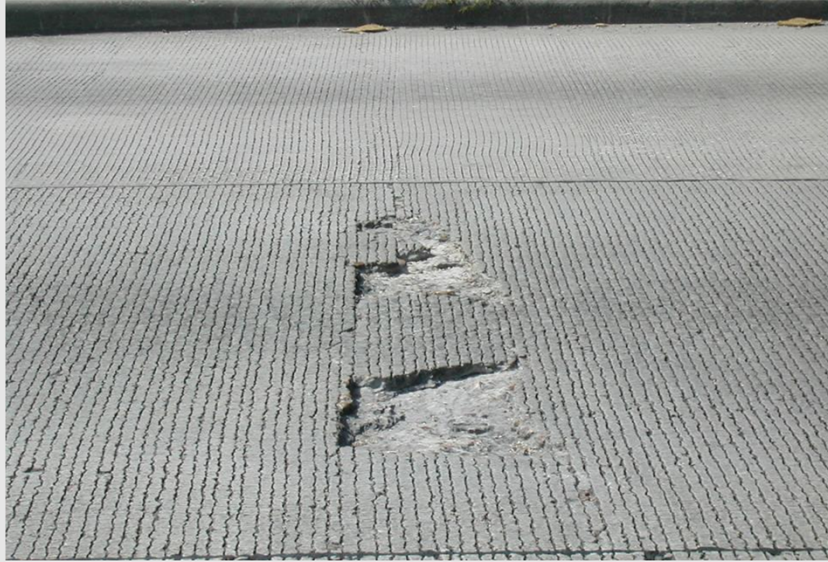
10

This distress shows a typical spalling due to the use of a specific coarse aggregate type, whose coefficient of thermal expansion is larger than other aggregate types.

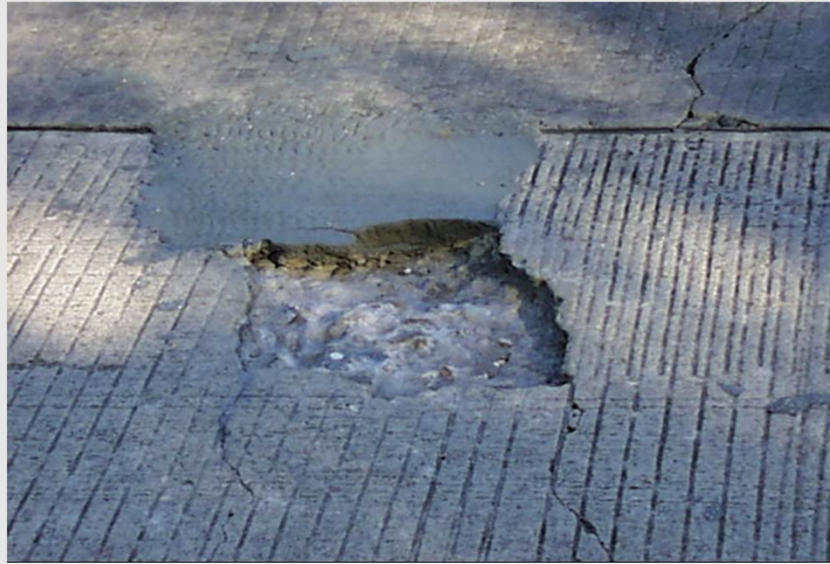
11

Another spalling distress in severe condition. Shallow delamination is observed. This section was placed in the winter in Houston when the concrete placement temperature was ideal. This distress indicates “temperature control” during concrete placement is not effective in reducing the spalling potential of concrete containing coarse aggregates prone to spalling.

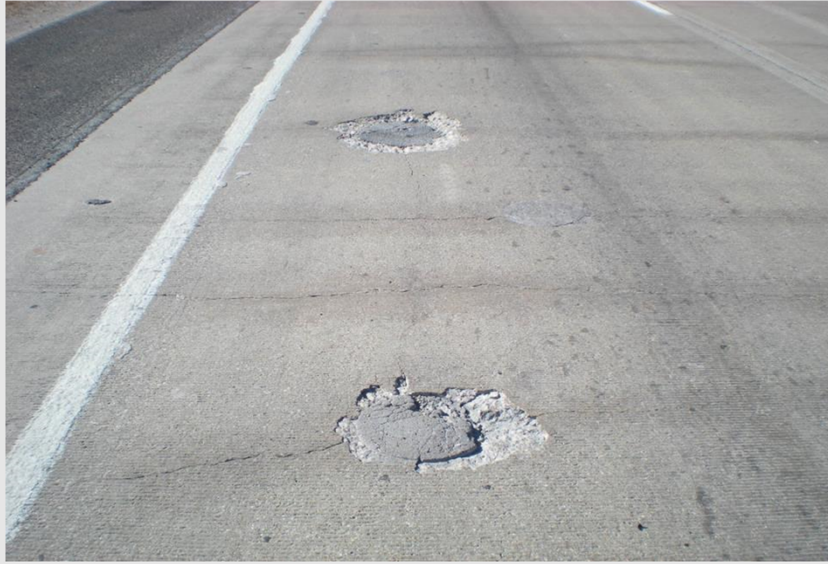
12

Spalling with longitudinal cracking. It appears that wheel loading applications at locations with transverse and longitudinal cracks resulted in spalling. Spalling in this project was quite rare, and it is considered that the quality of construction was a cause for this distress.

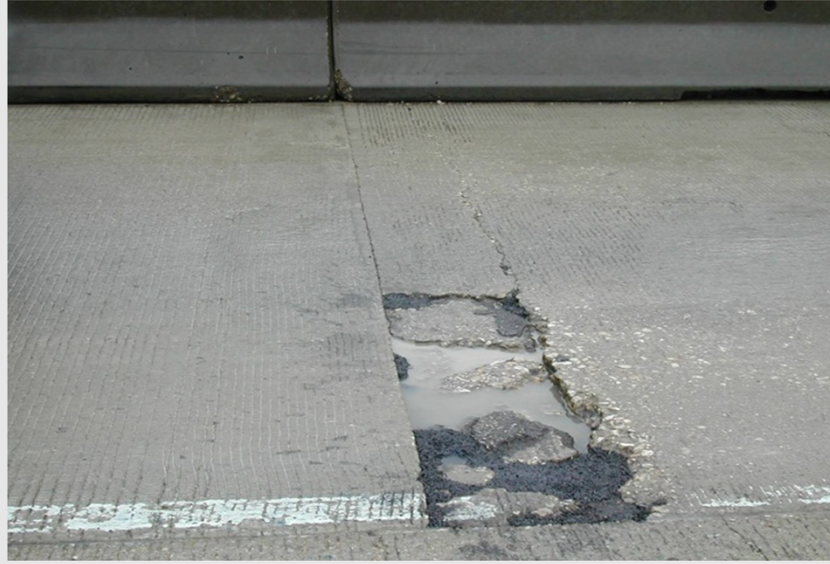
13

Typical shape of a distress at a transverse construction joint (TCJ). A transverse crack next to the TCJ coincides with the end of additional longitudinal tie bars. This distress is not structural capacity related; rather, it appears to have to do with TCJ.

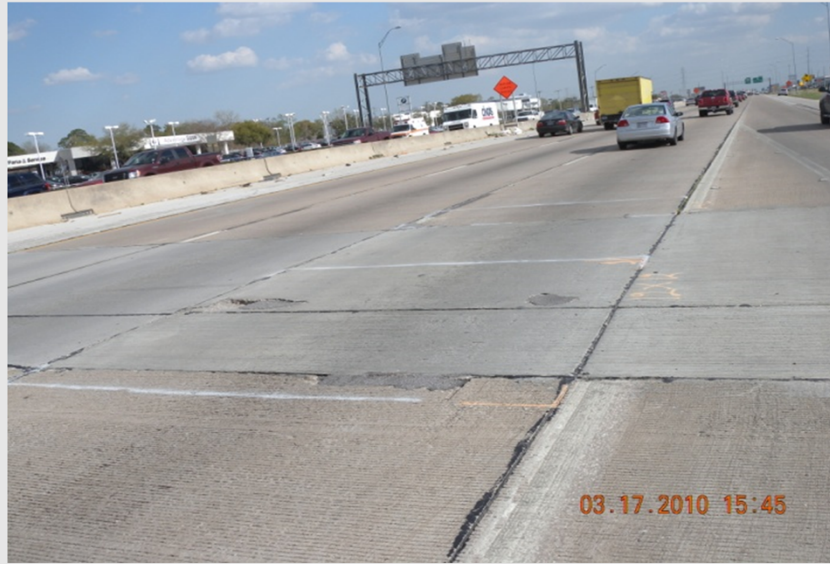
14

Repair of distresses at transverse construction joint between CRCP sections built at different times. TCJs connecting old CRCP with new sections are prone to distresses. This type of distress is not due to structural deficiency of the pavement system. Rather, it has a lot to do with slab movements due to temperature variations, and the inability to provide continuity of slab movements at TCJ. Slab movements in old CRCP at the end of the section due to temperature variations are usually large, primarily due to the free end of the pavement. Depending on the coefficient of thermal expansion of concrete and base friction, the longitudinal movements of the CRCP could be large, and when new CRCP is placed, new CRCP should be capable of restraining the slab movements of old CRCP. The forces, primarily axial forces, in the longitudinal steel at TCJ must be quite large, and if bond stress between steel and surrounding concrete along longitudinal tie bars exceeds bond strength, debonding could occur. In that case, slab movements in both old and new CRCPs could be excessive, potentially resulting in distresses at TCJs.

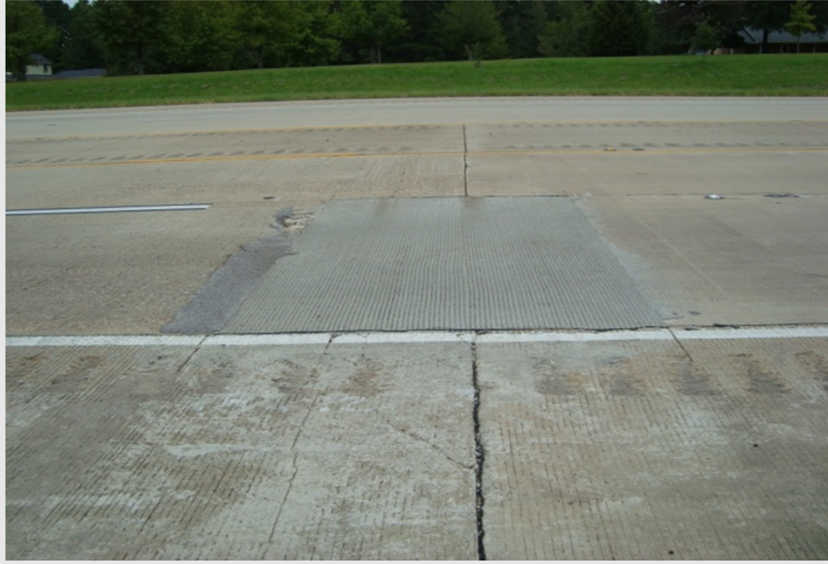
15

This shows a repair of distress at a TCJ. It is reported that additional longitudinal tie bars at TCJs in southbound lanes were placed at every spacing between longitudinal bars, i.e., double the required amount. Additional tie bars for the construction of northbound lanes were in accordance with the requirements in the design standards, and no distresses were observed. This case illustrates that doubling additional tie bars at TCJs is not a good practice.

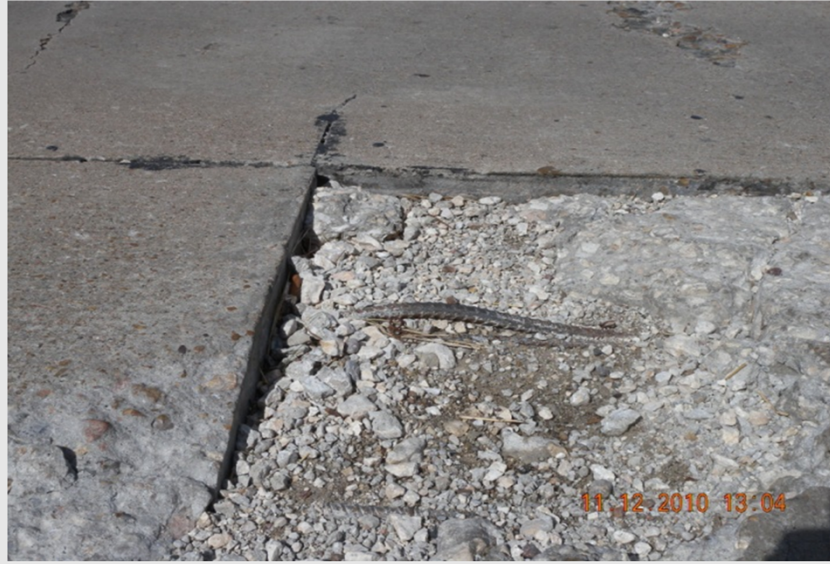
16

This slide shows a distress caused by slab expansion. The distressed area was previously repaired with full depth repair. The bent bar is epoxy grouted tie bar. When the slab was cut for a full depth repair and new concrete was poured for a repair, slab restraint was removed and the existing slab slowly expanded, pushing epoxy grouted tie bars and causing delaminations. In the picture, a comparison of the saw cut mark made in a lane without repair and the repair boundary indicates that the concrete slab cut full-depth expanded. In other words, CRCP has been in compression, and when the restraint was removed, the concrete expanded. Theories accepted in CRCP research state that concrete in CRCP is normally in tension, while in this project, the concrete was in compression. The discrepancy between theories and actual behavior is not fully understood; however, it appears that concrete setting temperature and creep of concrete are responsible for the discrepancy. There are evidences of CRCP expansions, even though the expansion quantity is quite small, which also explains the high level of crack stiffness and load transfer at transverse cracks observed in CRCP sections investigated in the TxDOT rigid pavement research project.

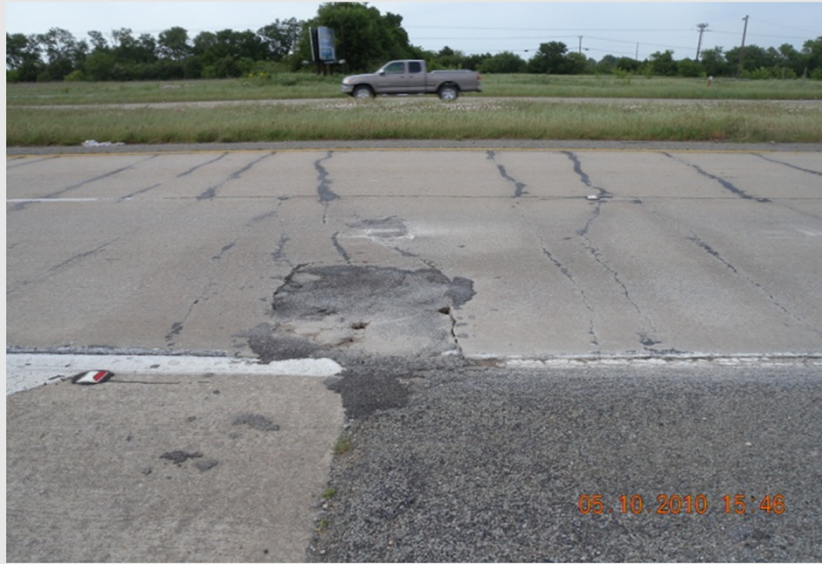
17

The distress shown here is at a gore area. In a gore area where the outside shoulder is asphalt pavement as shown in this picture, there is a discontinuity between gore concrete and asphalt shoulder. As a result, when there are temperature variations, the concrete in the gore near the asphalt shoulder is trying to move more than the concrete in the outside lane. The gore concrete and outside lane are connected with tie bars along the longitudinal joint. The potential for these differential movements resulted in the distress in the outside lane near the end of the gore area. To prevent this type of distress, tie bars should be omitted for some distance from the end of the gore area.

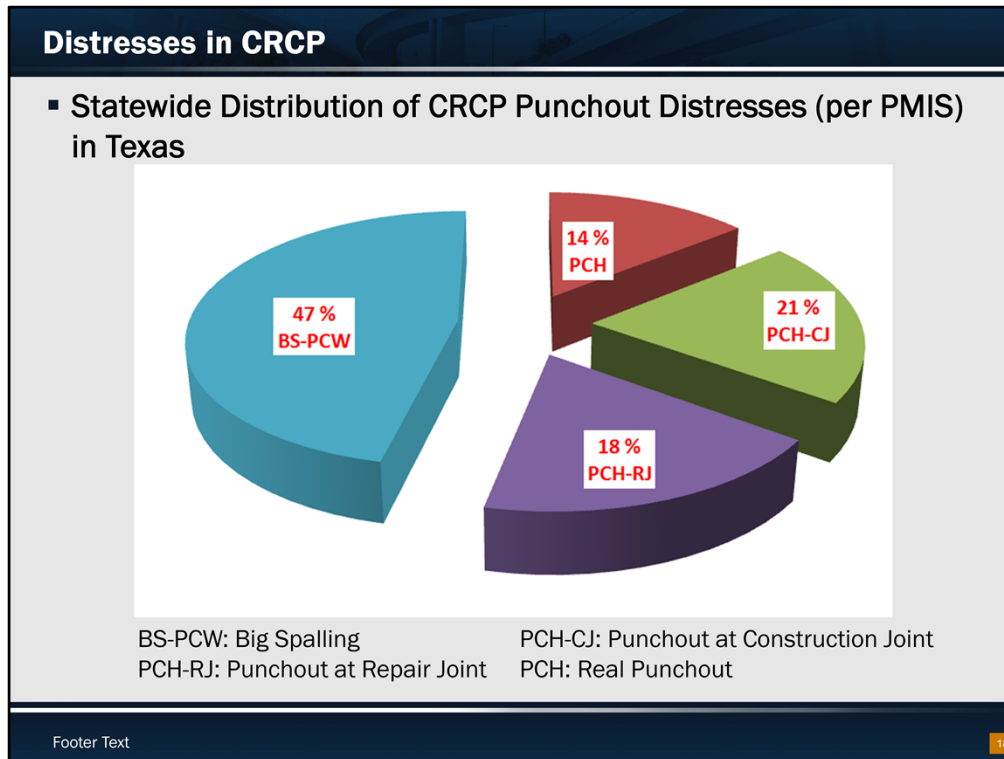
This graph shows classification of CRCP distresses recorded as punchout in TxDOT PMIS. The research team for the TxDOT rigid pavement database project tried to identify the mechanisms of all the punchouts in the Amarillo, Childress, Dallas, Fort Worth, Houston, and Wichita Falls Districts. Based on the field observations, the distresses were classified as shown in this graph. About half of all the distresses classified as punchout were actually large spalling, most of which were in the Houston District. About one-fifth of the distresses were at transverse construction joints. Eighteen percent of punchouts in TxDOT PMIS were actually at repair joints. The remaining 14 percent of the total distresses were real punchouts that could be attributed to structural deficiency of the pavement system. In other words, 86 percent of distresses recorded as punchouts in TxDOT PMIS are not directly related to structural deficiency of the pavement system. Rather, they are more related to materials and construction quality issues. The information in this graph indicates that increasing slab thickness only is not the most cost-effective way of improving CRCP performance in Texas. Rather, identifying the mechanisms of the remaining 86 percent of the distresses and improving materials selection and the quality of construction operations might be a more cost-effective way of improving CRCP performance in Texas.

For the distress types shown in the previous slide, TxDOT developed a new policy or improved existing specifications. To address severe spalling problems, based on the findings from the TxDOT research project 0-6681, a new CoTE requirement was developed and implemented. With the implementation of a new CoTE requirement, it is expected that severe spalling problems will be no longer an issue in new CRCP. Specification Item 361 for full-depth repairs has been improved, and improved specification requirements will be incorporated in the 2014 version of the specification. Proper implementation of Item 361 is expected to minimize distresses at repair joints. Continued use of tied concrete shoulder or widened lanes and non-erodible base will keep the distresses due to structural deficiencies of the pavement system quite rare. Distresses in transverse construction joints (TCJs) need to be minimized, which requires the identification of their mechanisms and the development of specifications or design details, which is the focus of this research project.

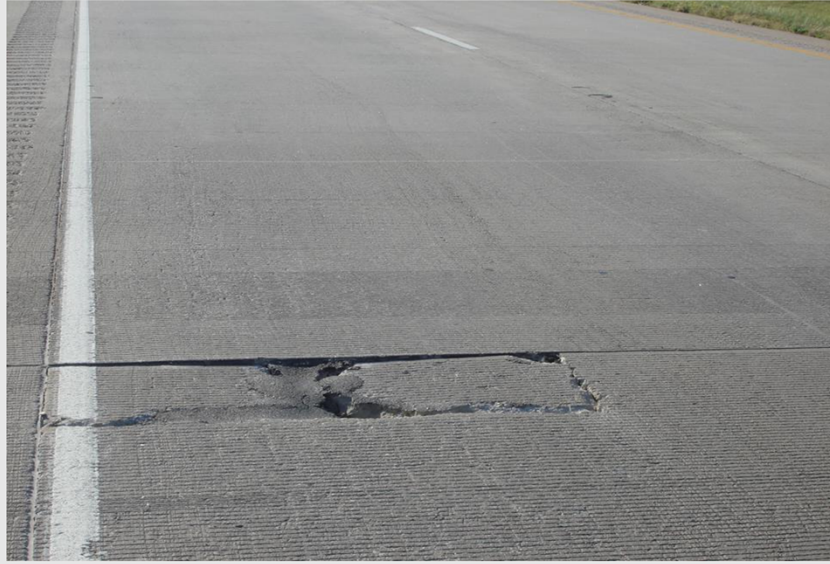
22

This shows a distress at TCJ in a relatively new CRCP. This CRCP has all the right features, including tied concrete shoulder and stabilized base. Still, this distress occurred, which indicates that this distress has nothing to do with structural capacity of the CRCP system.

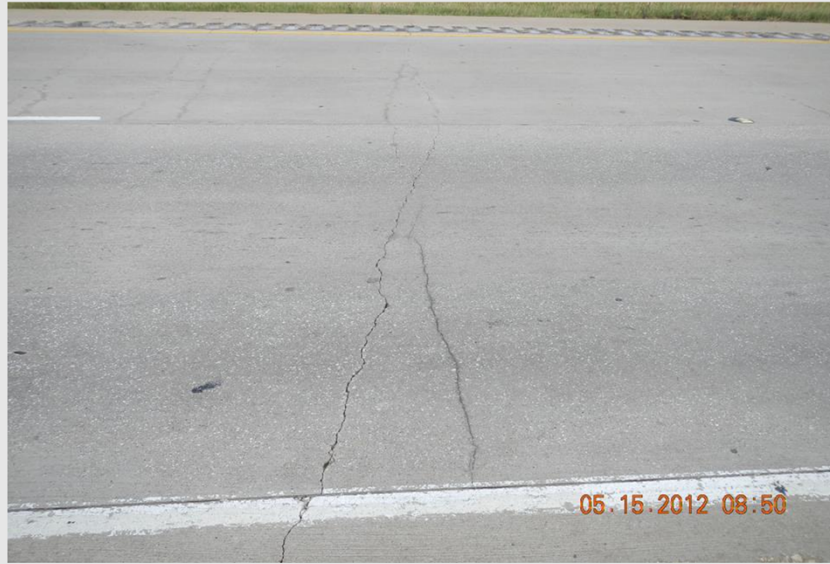
24

The transverse crack on the left is a normal crack in CRCP caused by temperature and moisture variations, while that on the right is a crack caused by wheel loading applications that occurred at a later age. Note that the crack on the right did not propagate into the outside shoulder.

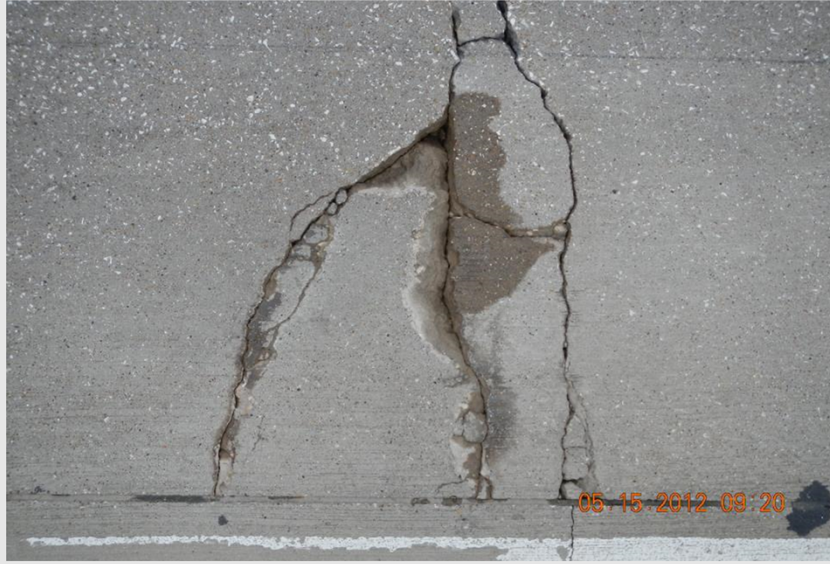
25

This shows a Y-crack-turned to distress. The water on the concrete surface indicates the distress here may not be a full-depth distress; rather, there may be delaminations at the depth of the steel, which prevented the water from draining.

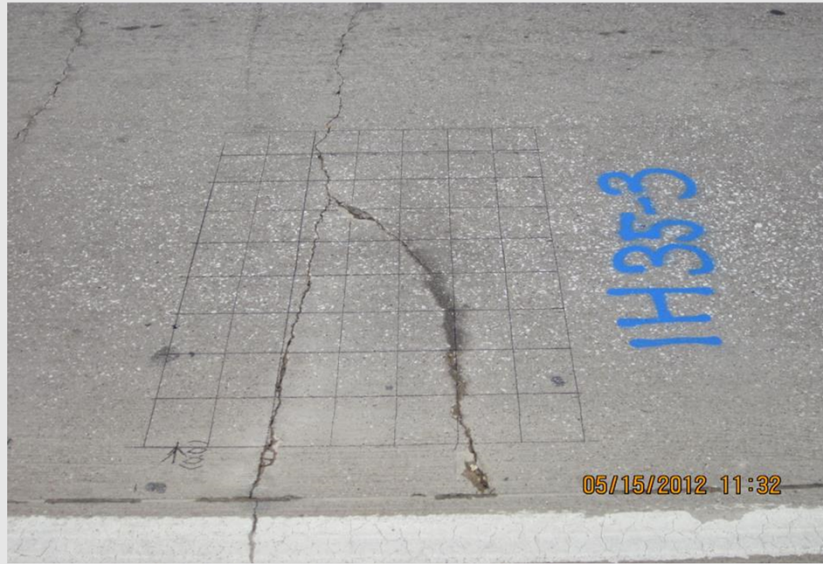
26

The condition of the concrete in this area was evaluated with MIRA, followed by coring. The evaluations showed horizontal cracking at the depth of the longitudinal steel. It should be noted that the crack on the right of the Y-crack stopped at the longitudinal joint between the outside lane and shoulder, which indicates the crack was caused by wheel loading applications.

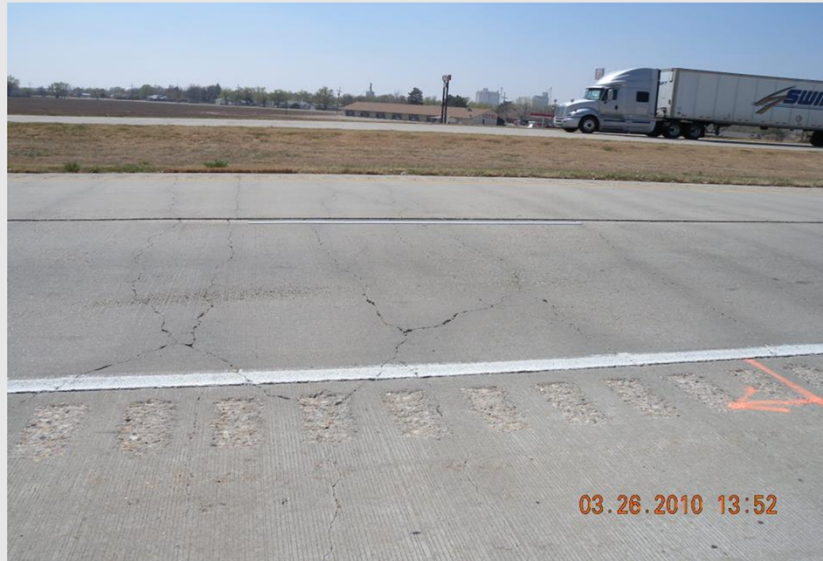
27

This shows Y-cracks caused by materials and potentially unusual temperature conditions during concrete curing. However, they did not develop into distresses.

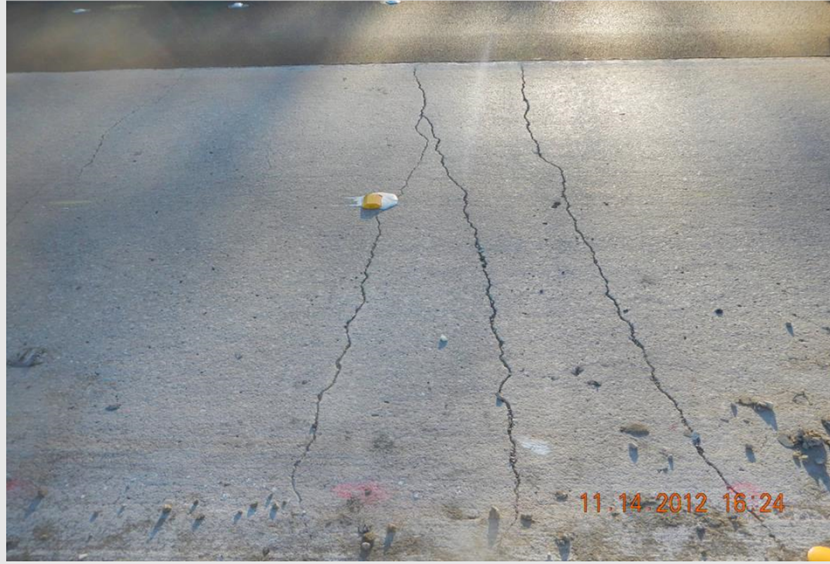
28

The Y-crack in this slide is not related to wheel loading applications. Rather, the crack appears to have occurred at early ages due to environmental loading (temperature and moisture variations). This pavement was constructed in 1972, and the Y-crack survived 40 years of traffic applications.

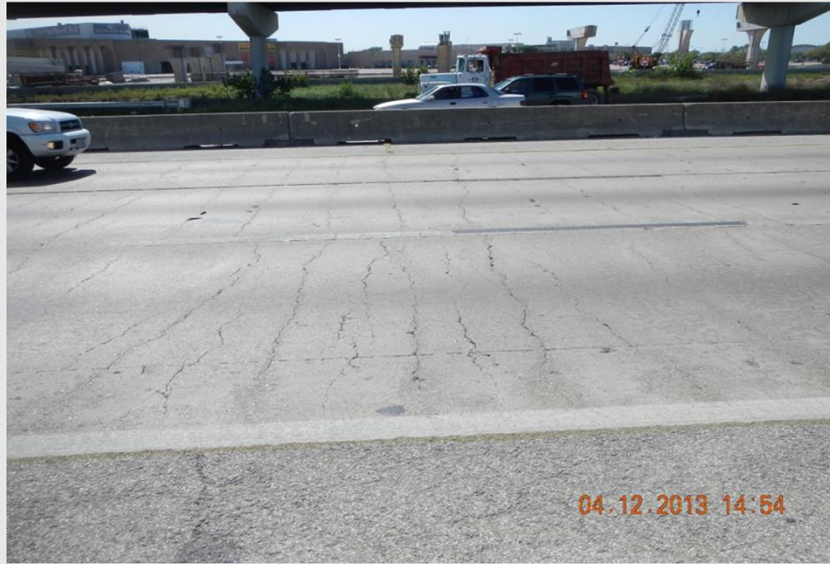
30

This section was built in 1960, so it is more than 50 years old. Transverse crack spacing is quite small; still, the pavement survived more than 50 years of heavy traffic on US 290 in Houston. This section shows that narrow transverse crack spacing does not necessarily represent weak elements in CRCP.

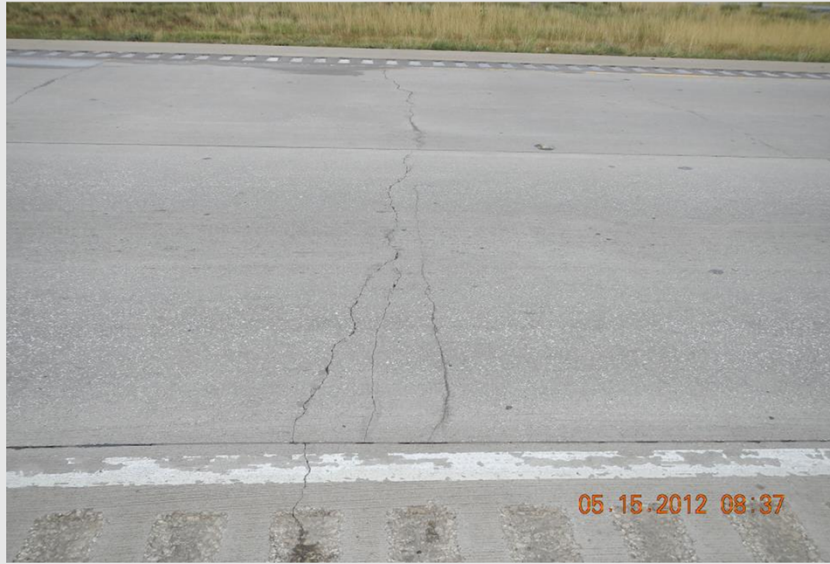
31

This slide shows narrow transverse crack spacing caused by wheel loading applications with weights exceeding legal limits. The slab segments bounded by transverse cracks will develop into distresses.

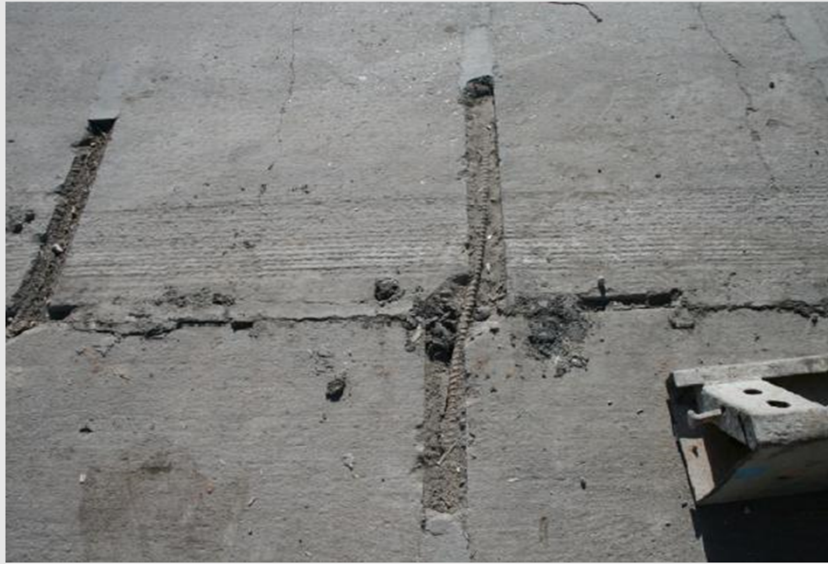
33

This shows slab expansion as large as 3.5 inches when the portion of the concrete in one lane was removed for pavement repair, which caused deformations in the stitching bar. The exact cause of this slab expansion is not known.

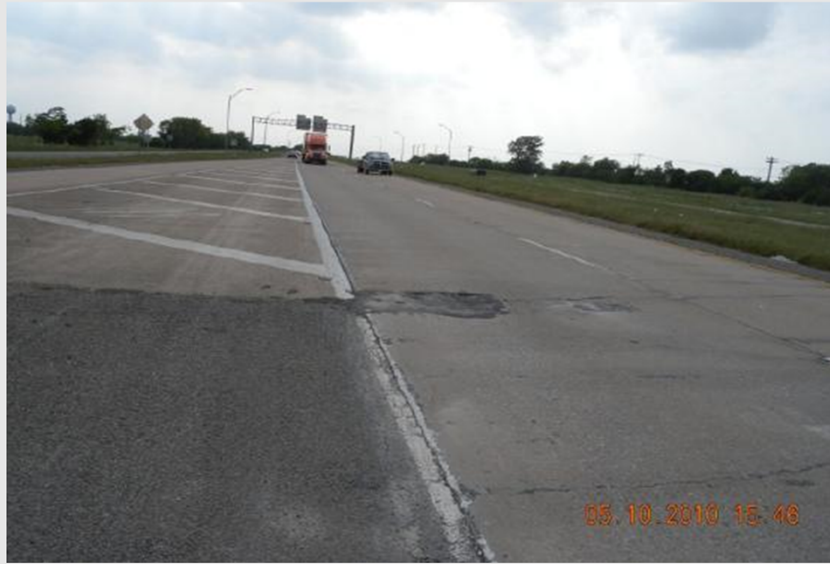
35

Distress at gore area, followed by asphalt patch

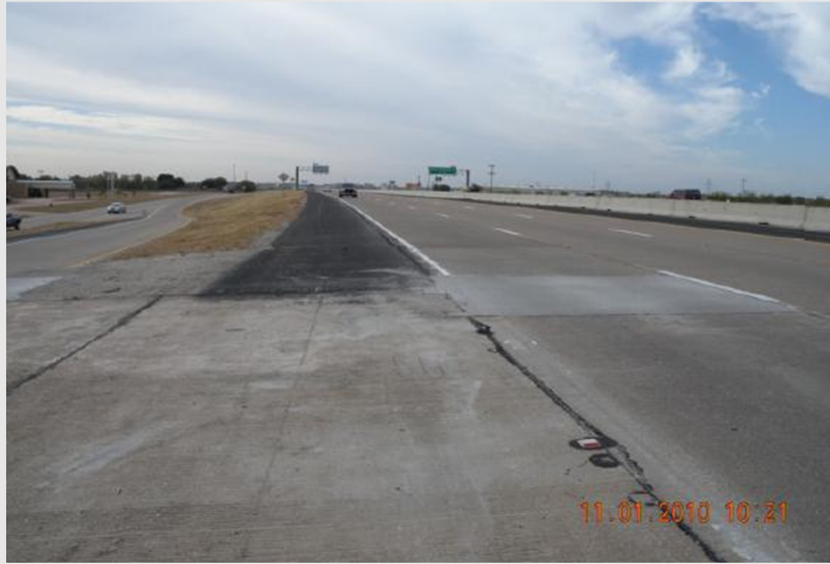
36

Repair of a distress at gore area

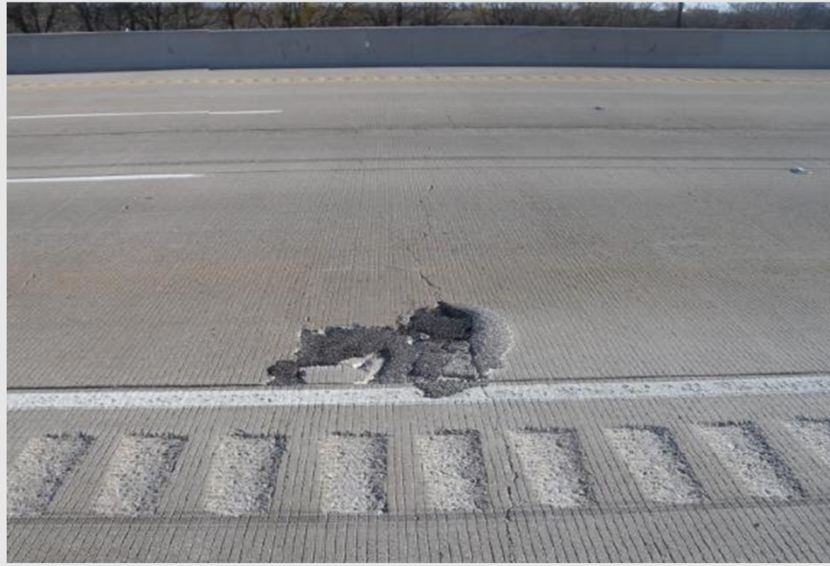
38

This shows a distress at LWJ. It is noted that the distress is not only near the LWJ, but under the wheel path as well. In other words, it could be that slight damage to concrete from differential movements transmitted by transverse steel and tie bars at LWJ occurred first, and subsequent wheel loading applications could have caused the distress.

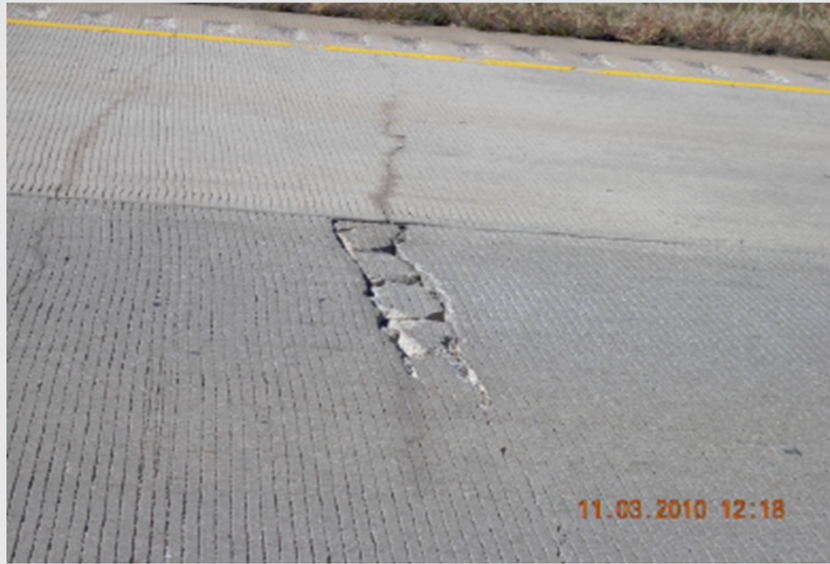
39

This is a distress at LCJ. It is noted that the transverse crack on the right of the distress is a normal crack in CRCP from temperature and moisture variations. On the other hand, the crack on the left has characteristics of a transverse crack due to heavy wheel loading applications. Or, it could be that there were differential displacements between the two lanes, which could have caused minor damage to the concrete in the outside lane.

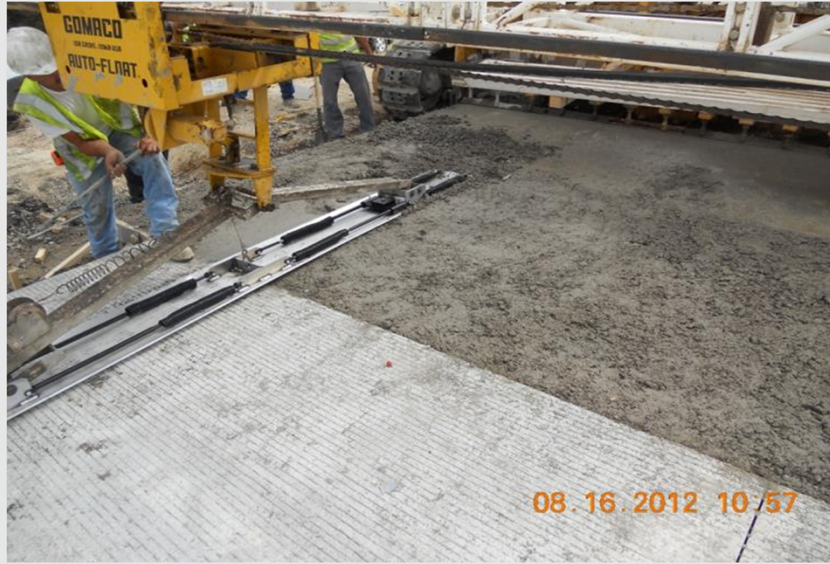
43

This shows the auto-float operation at a TCJ. Note the surface condition of the concrete. The rough surface condition is due to the hand operations of concrete placement near a TCJ. This rough surface will be smoothed by excessive floating, which may not be able to remove all the voids in concrete.

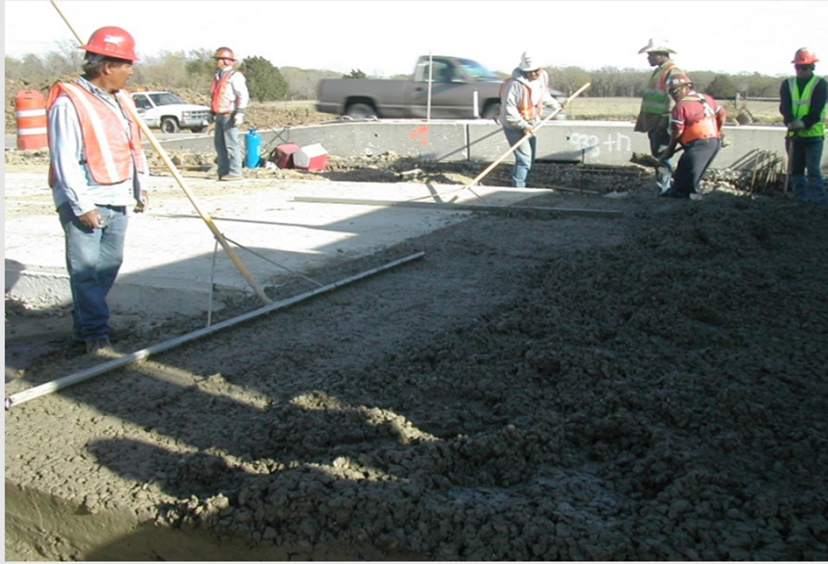
44

This shows finishing operations at a TCJ. Note that a slip form paver placed the concrete, but with no surface finishing operation, which is done by hand operations. Hand operations are not effective in removing all the voids from concrete. Field evaluations of concrete near TCJs indicate voids in concrete near the surface, degrading the durability of the concrete.

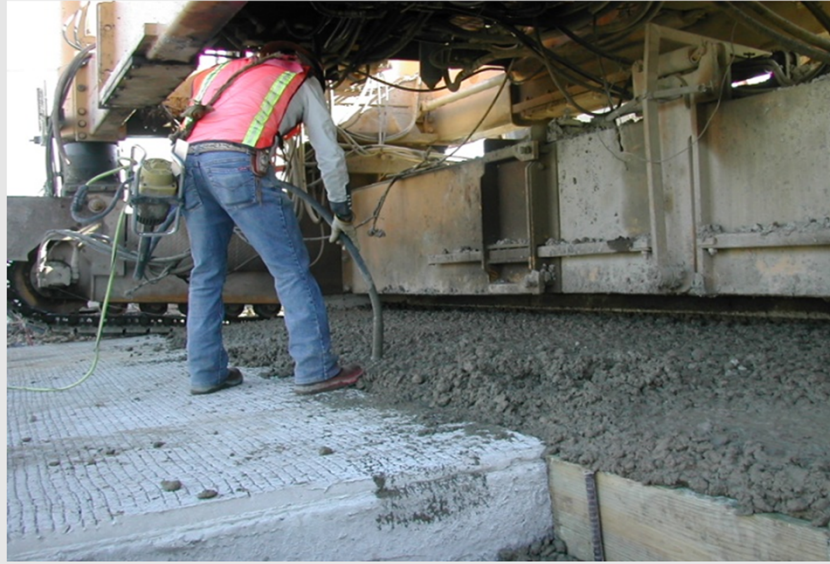
45

This illustrates consolidation of concrete at a TCJ by a hand vibrator, which is again different from consolidation operations in the other areas where a paver with mechanical vibrators consolidates the concrete.

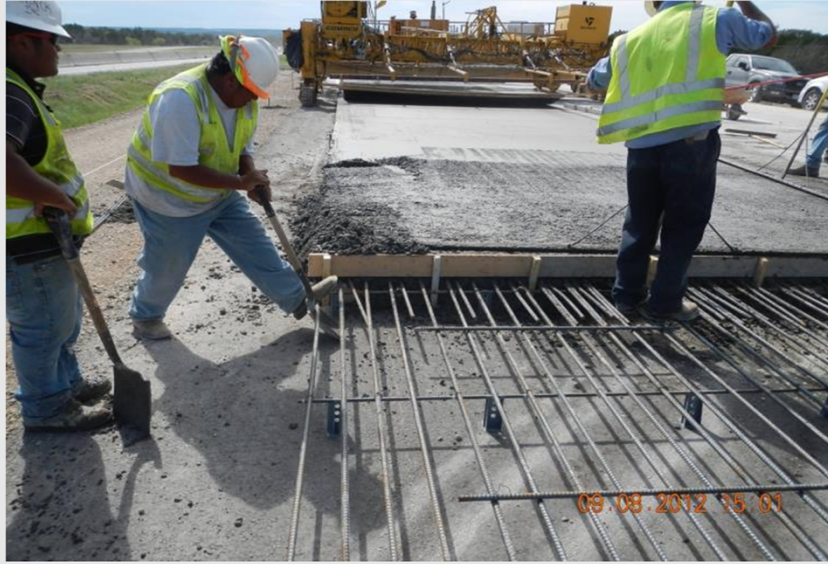
46

This shows the result of different concrete placement operations near a TCJ. A paver is not able to start a concrete placing operation right at a TCJ. The concrete placement operations start near a TCJ, only part of which was done by a paver and the rest must be done by hand operations.

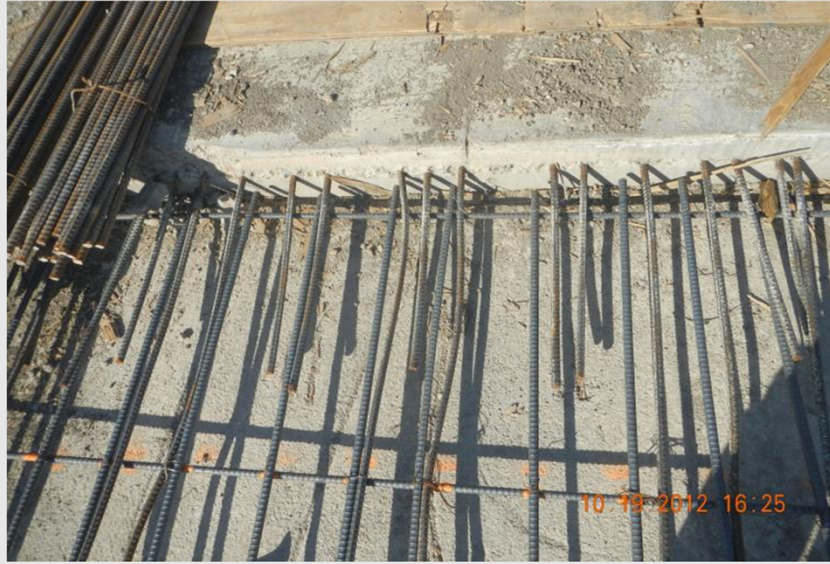
48

This shows the steel placed at a TCJ. It is observed that steel is somewhat crowded and extra effort should be made to ensure good concrete consolidation.

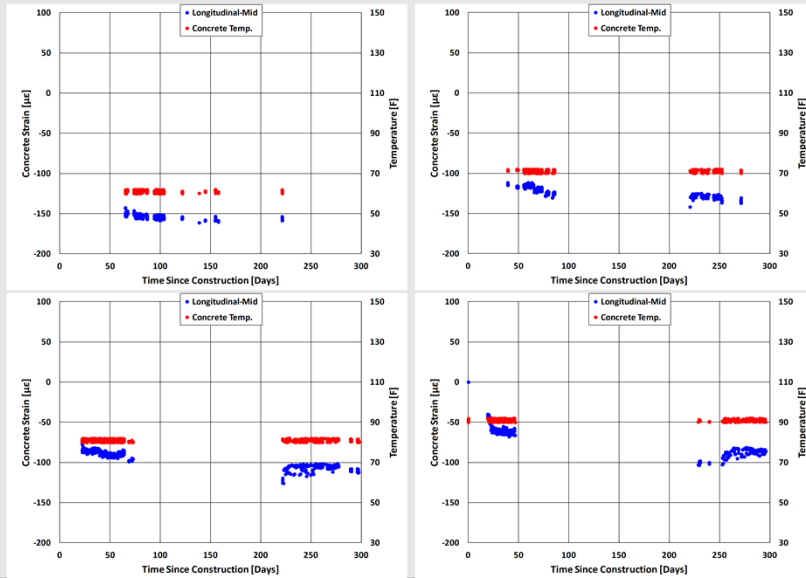
53

Even though distresses due to slab expansions have been observed, as discussed in Slides #16 and #33, the exact mechanism of slab expansions is not fully understood. However, differences in concrete setting temperature and temperature at any time (concrete setting temperature lower than temperature at a point of interest) and potential concrete volume expansions due to chemical reactions such as ASR are considered to have effects on slab expansions.

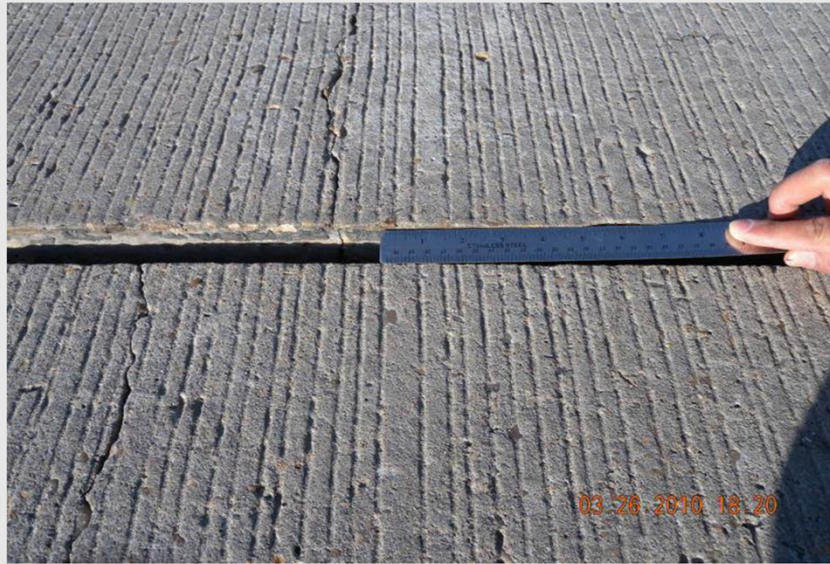
56

This slide shows a differential slab movement in the longitudinal direction as large as 1 in at LWJ between two lanes. Since the same concrete materials were used in this project, the large differential slab movements appear to be due to the instability in the base/subgrade layers. In this slide, lane separation is also noted, which further indicates volume changes in the layers below the concrete slab.
