**Tornado Report**

# Evansville, Indiana November 6, 2005

## **Eastbrook Mobile Home Park**

May 30, 2006

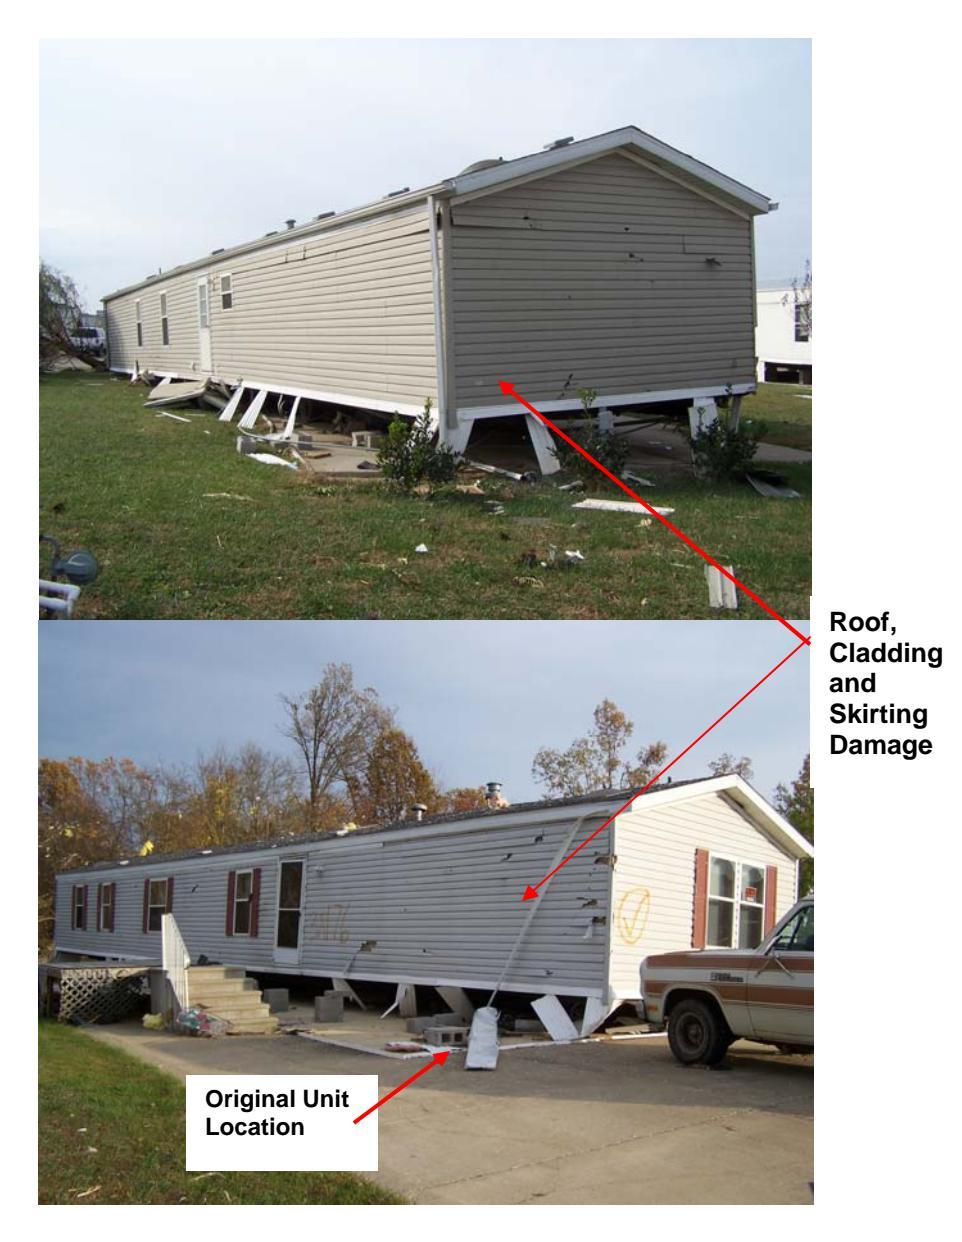
Repairable moderate to severe damage was observed with units located nearer to the storm vortex. This type of damage usually began with failure of anchoring ties, resulting in sliding and isolated structural failures. **Figure 3-5** shows a Zone II/III unit front and back that suffered cladding damage and slid off its stabilizing blocks, collapsing some foundation piers and producing warping of the floor frame. The sliding was initiated with the failure of ties (see **Figure 3-6**). Also shown in this figure is an overhead (Zone II/III) tie that was not attached.

Figure 3-5. Unit tie downs were inadequate to hold the wind pressures and broke, thereby allowing the unit to slide. Unit suffered repairable roof and wall cladding damage.

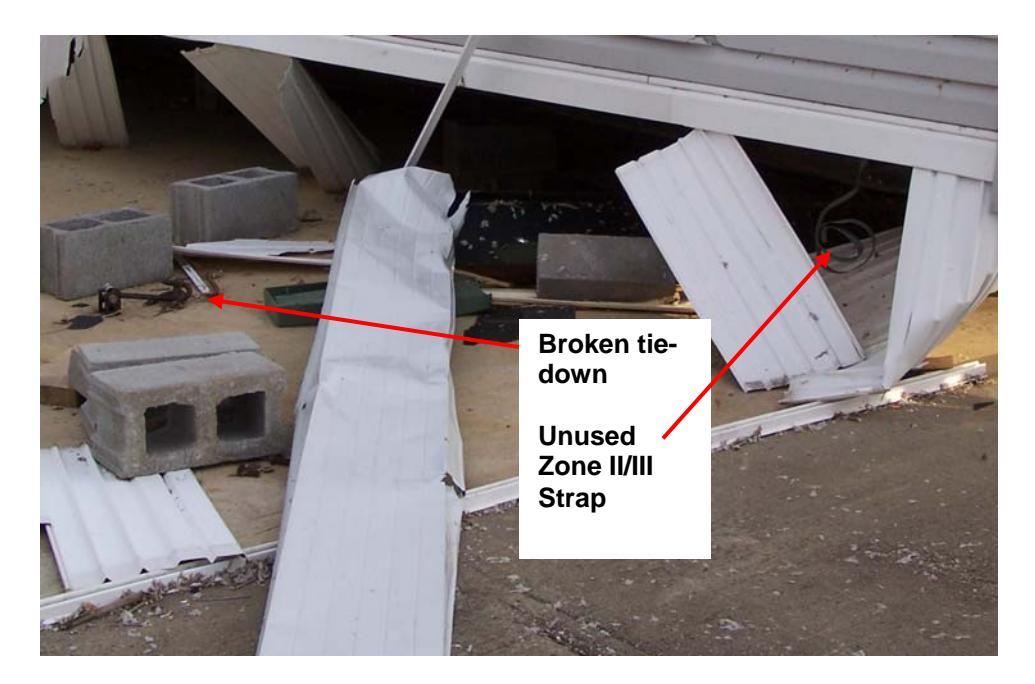
Figure 3-6. Unit sliding initiated by broken tie-downs.

All of the roof cladding and fascia material was blown from the unit shown in **Figure 3-6.** Although the unit is structurally repairable, significant damage to the interior walls, finishes, and contents resulted from storm rainwater. Wind pressure produced forces on tie-downs that broke the tie-downs restraining the unit in **Figure 3-7**, slid the unit off its piers, and peeled off a portion of the roof and siding.

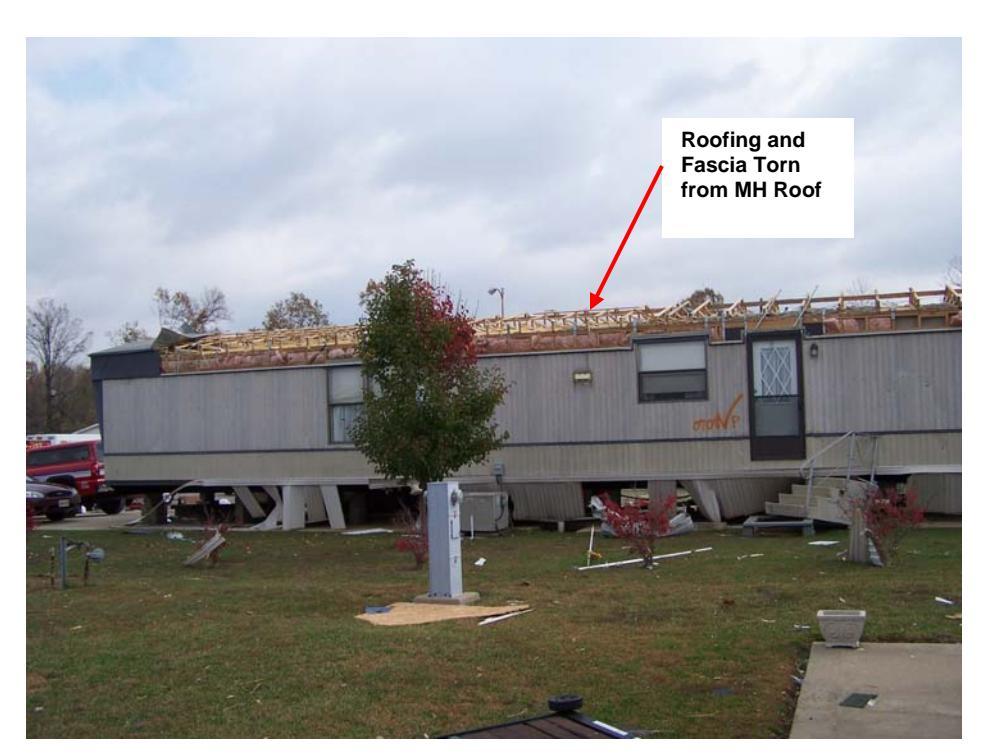
Figure 3-7. Unit severely damaged by the removal of the roof and fascia cladding.

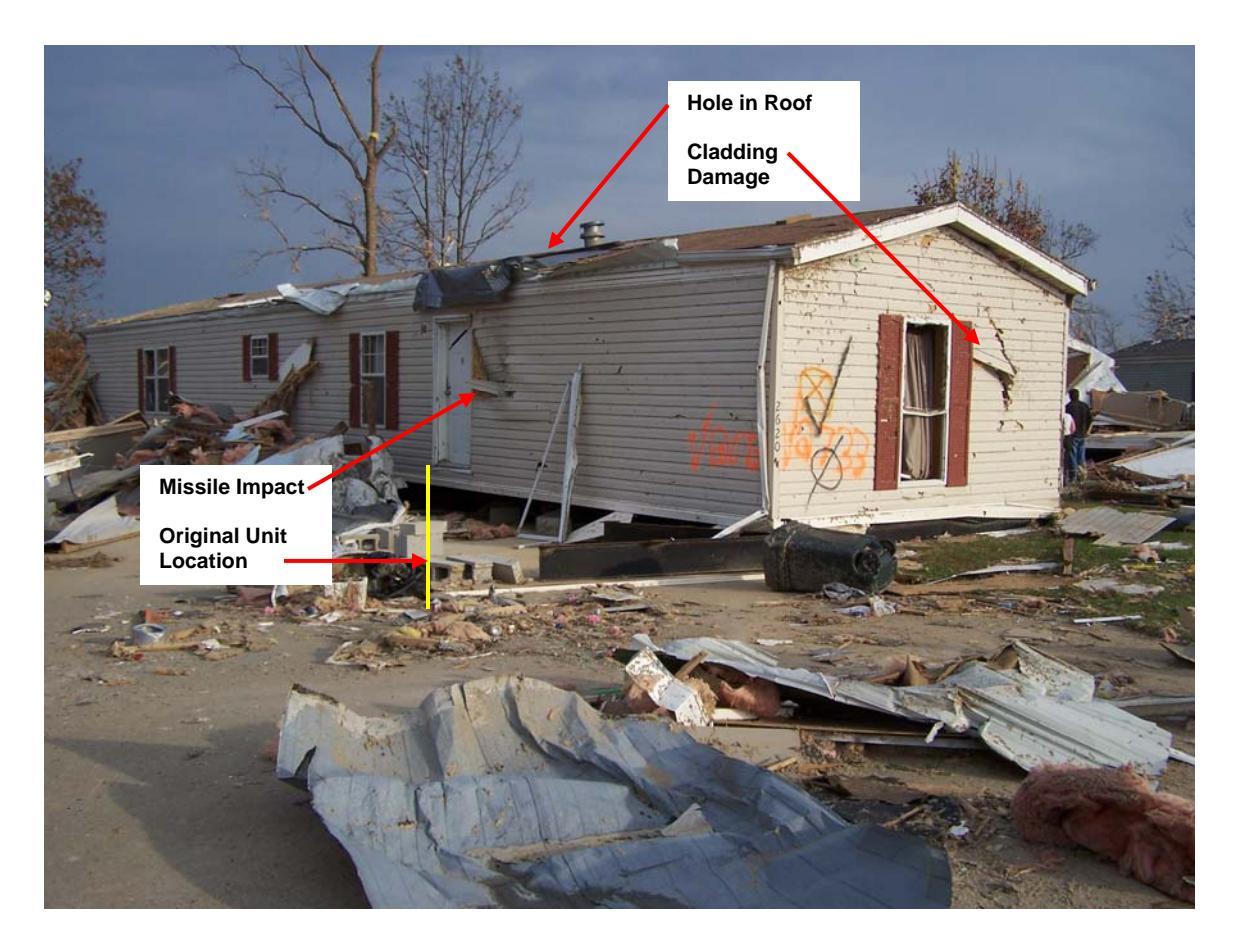
Figure 3-8. Major damage - hole in unit roof, cladding and fascia damage, and missile impacts.

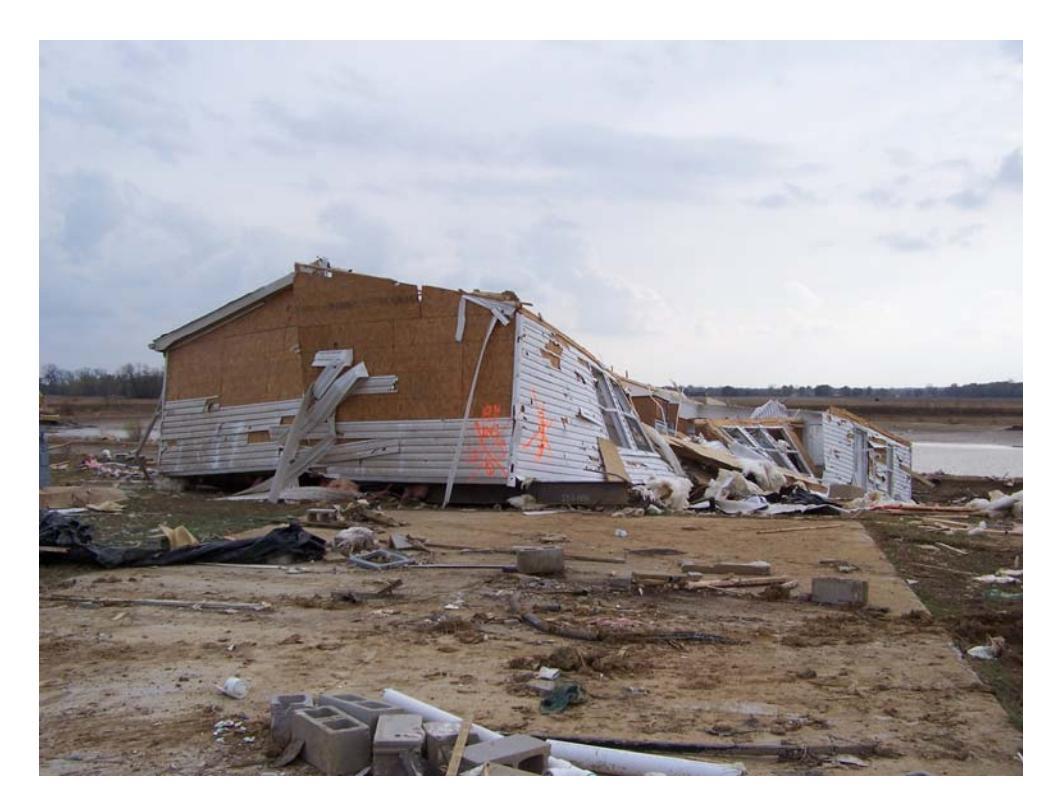
Figure 3-10. Mobile home from Poppy Hills Drive that slid from its anchorage and was structurally racked.

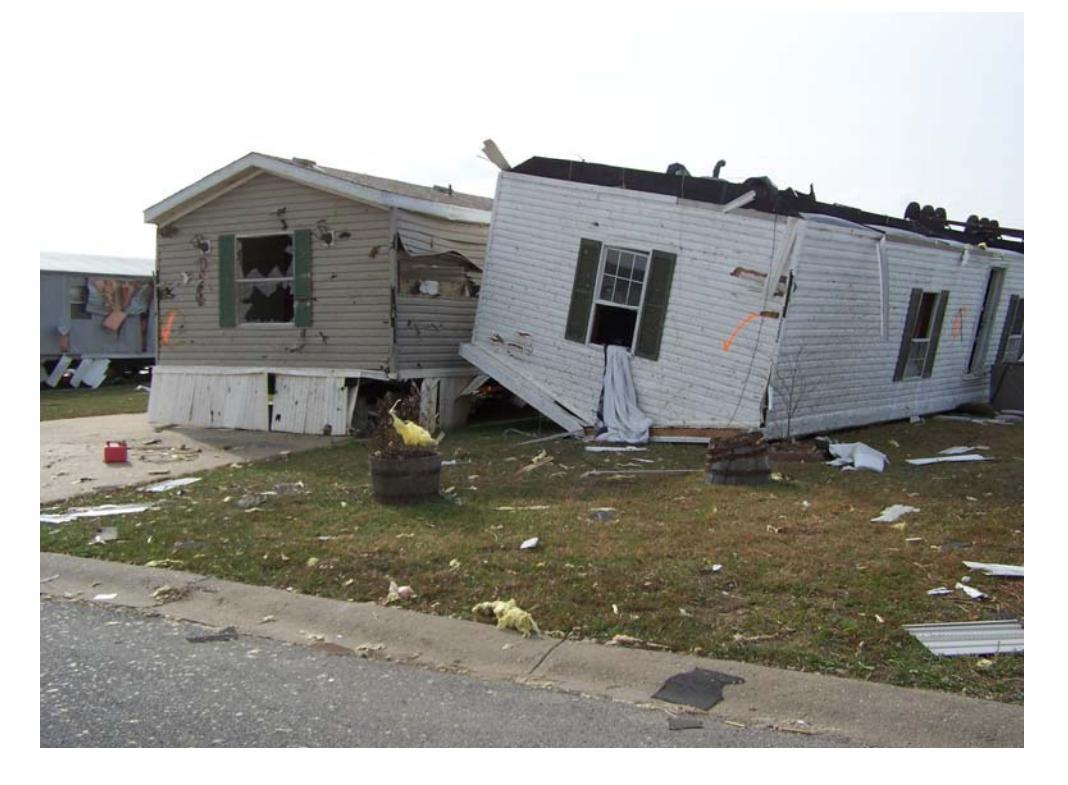
Figure 3-11. Unit lost anchorage and rolled into an adjacent home.

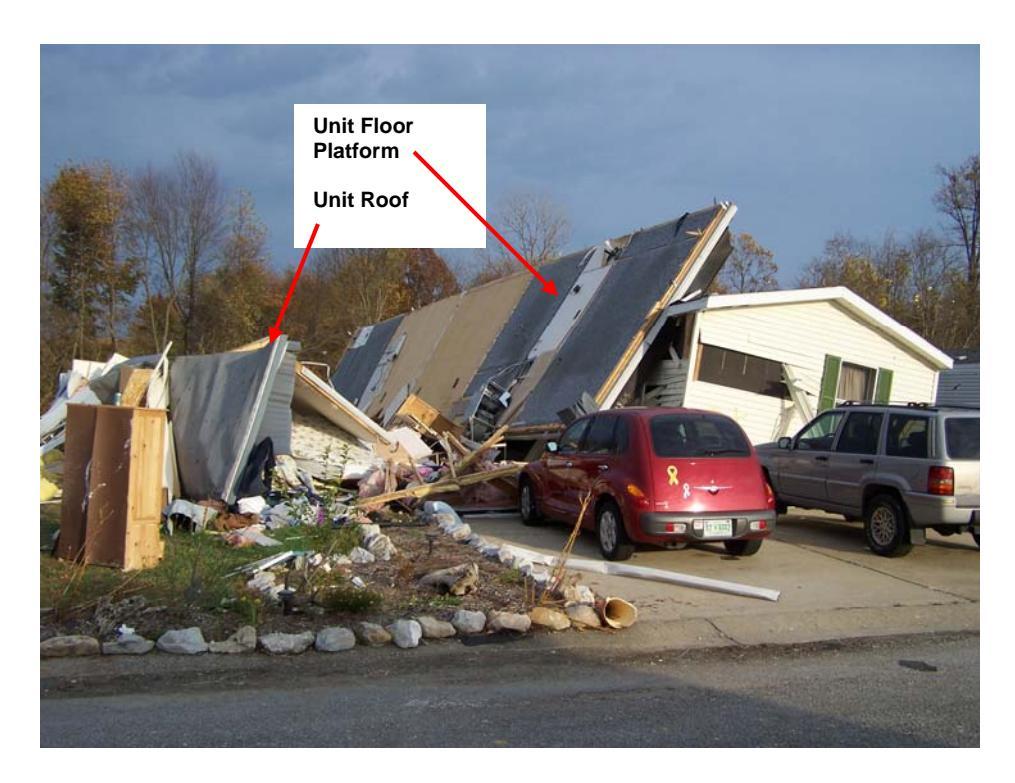
Figure 3-12. Unit rolled onto adjacent mobile home.

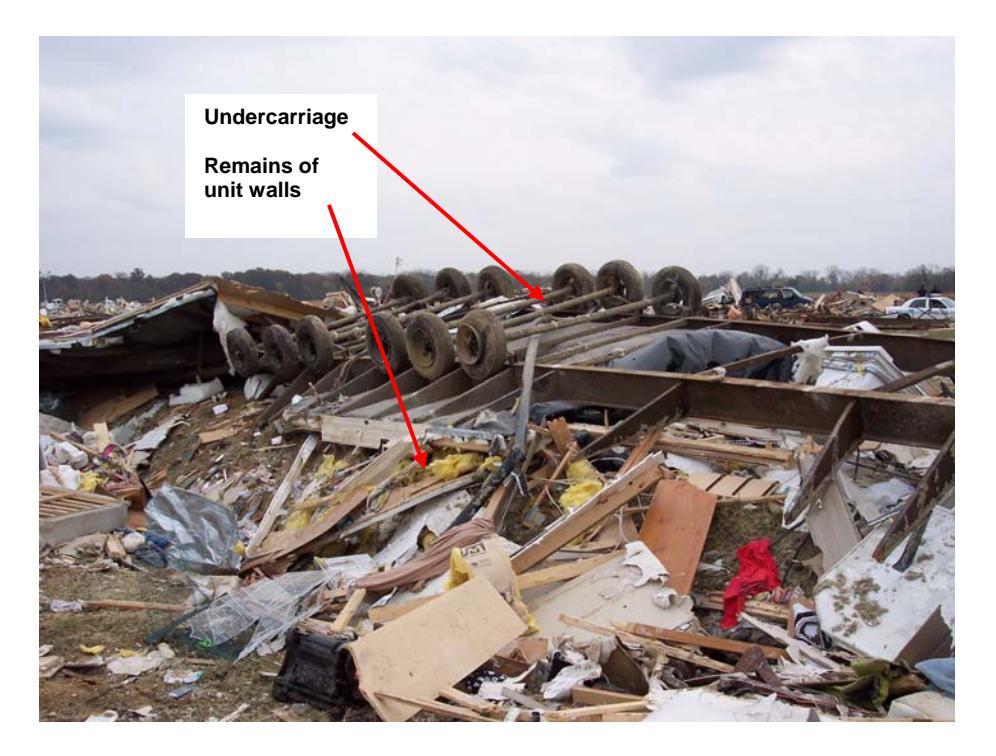
Figure 3-13. Mobile home tossed and rolled – walls, roof, and floor separated from undercarriage.

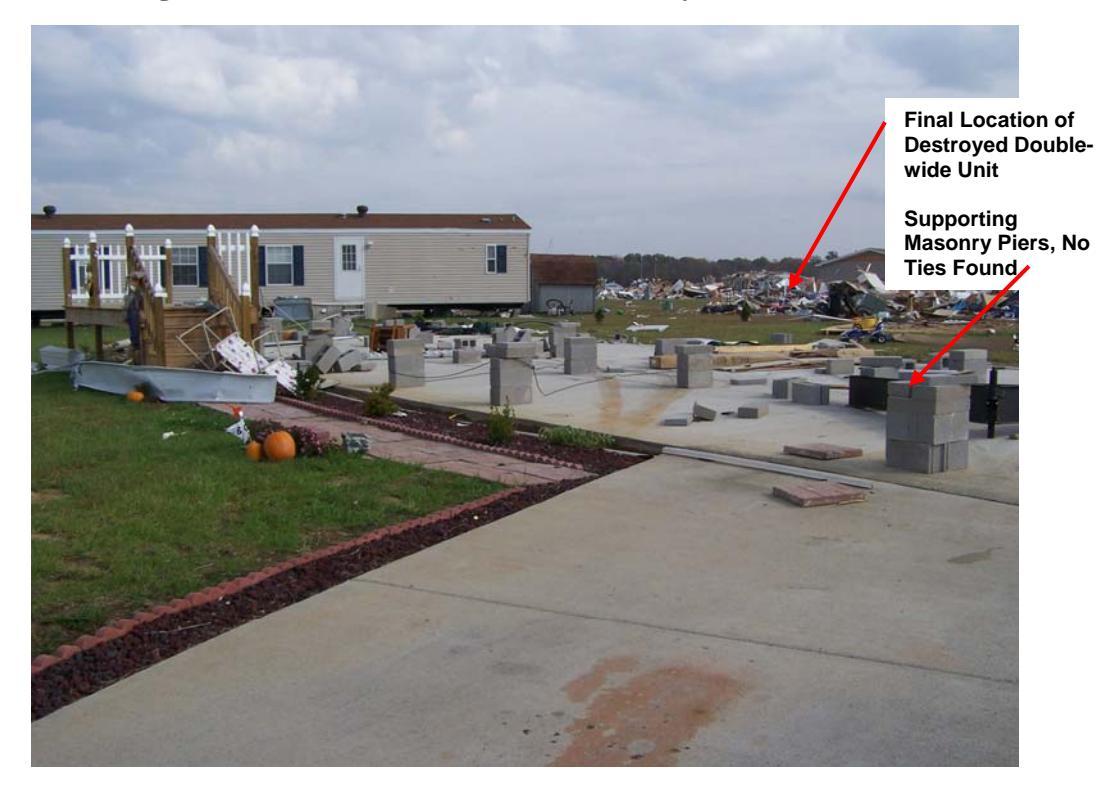
Figure 3-15. Previous location of double-wide unit without any tie-downs; unit was tossed and tumbled to destruction.

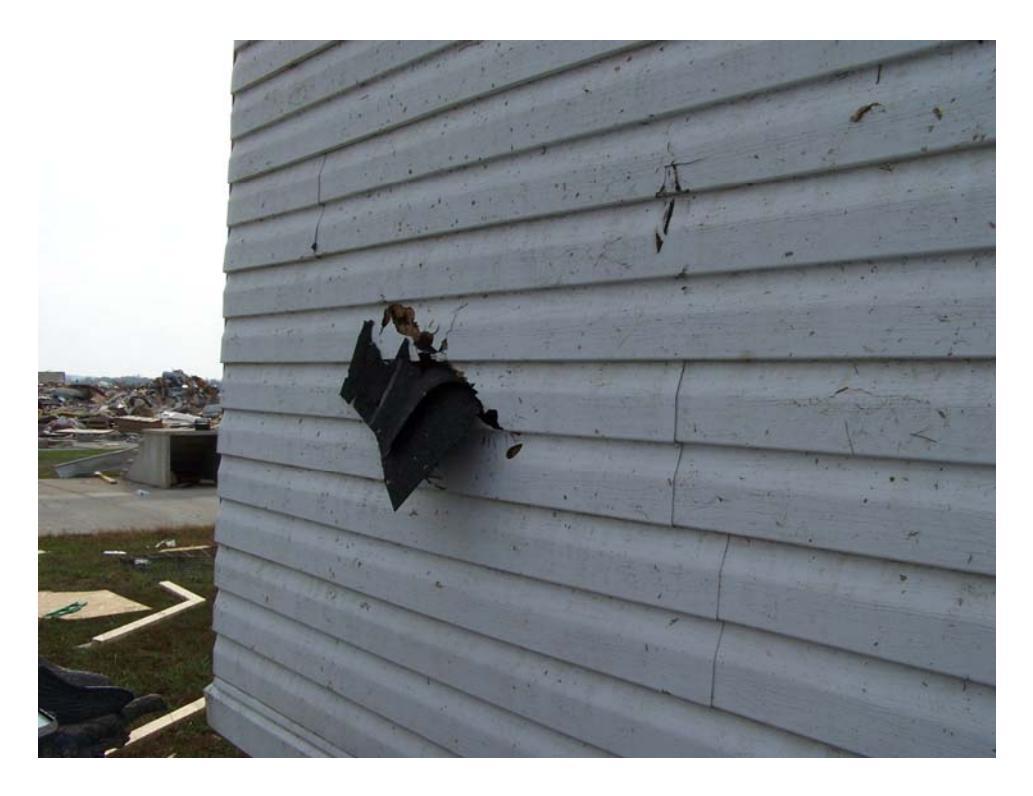
Figure 3-17. Shingle embedded in mobile home wall.

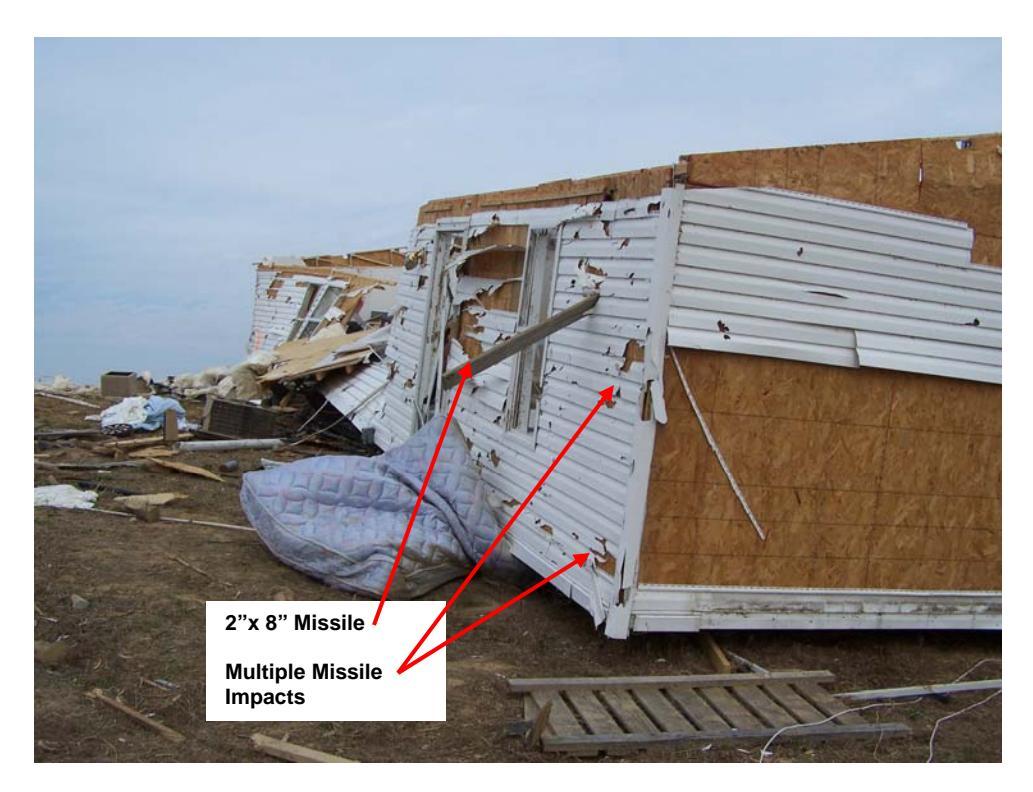
Figure 3-18. Unit perforated with a 2"x 8" wooden missile.

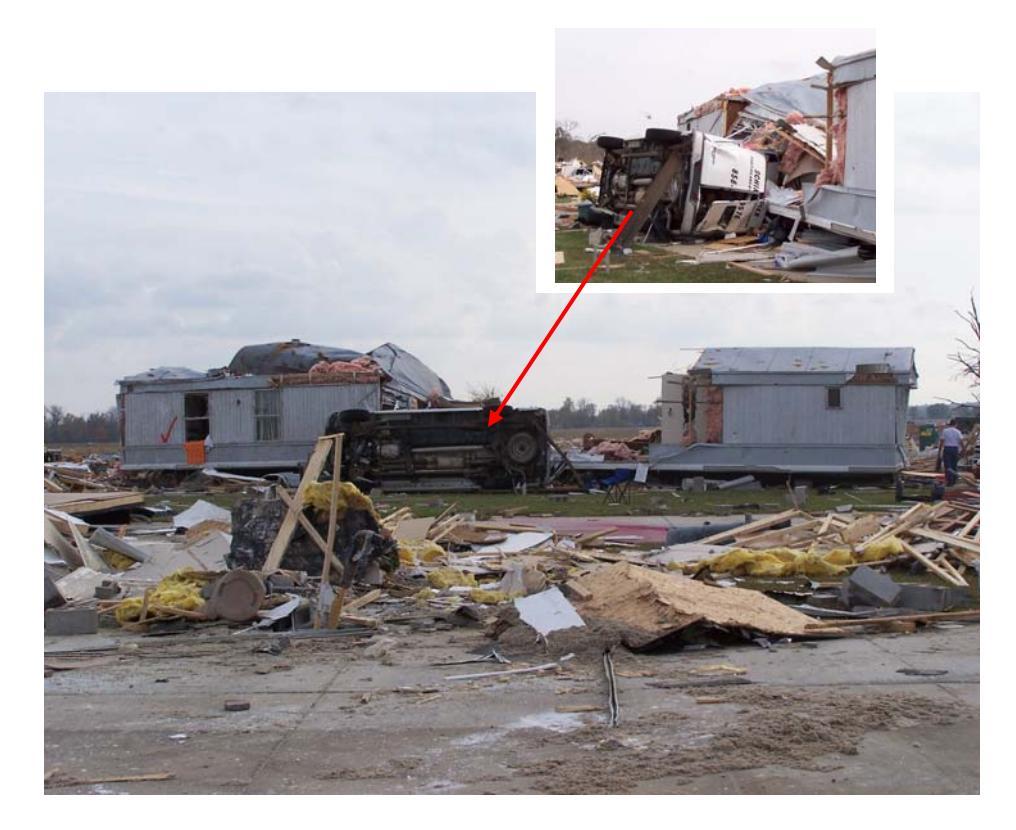
Figure 3-19. Mobile home impacted and cut in half by a large van.

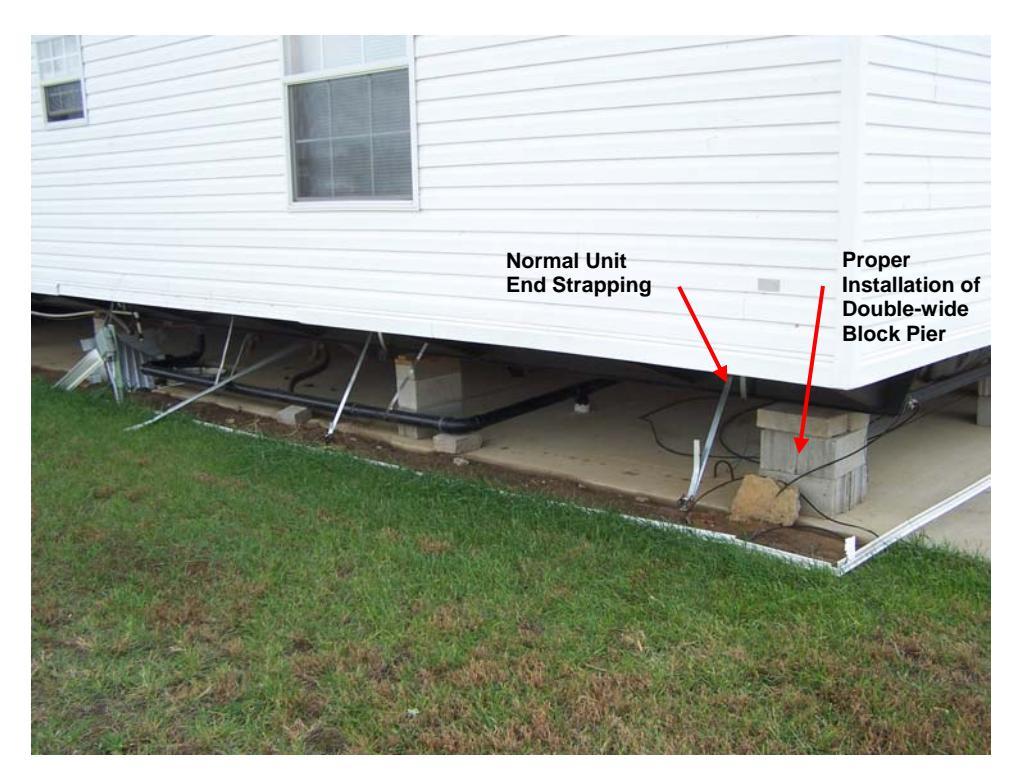
Over 20 of the 180 units were Zone II/III units with over-the-top straps; however, only 4 of these units were observed with these straps connected to ground anchors. NFPA 225 clearly states that, "If sidewall or over-the-top roof straps are installed on the home, they shall be connected to an anchoring device..."<sup>26</sup> It further states that "Manufactured homes shall have anchors to resist longitudinal forces."<sup>27</sup> Longitudinal straps, as seen in **Figure 3-23**, were seldom observed at the Eastbrook Park. The unit end-strapping typically found installed at the Eastbrook Park is shown in **Figure 3-24**.

Figure 3-24. Normally observed unit end strapping.

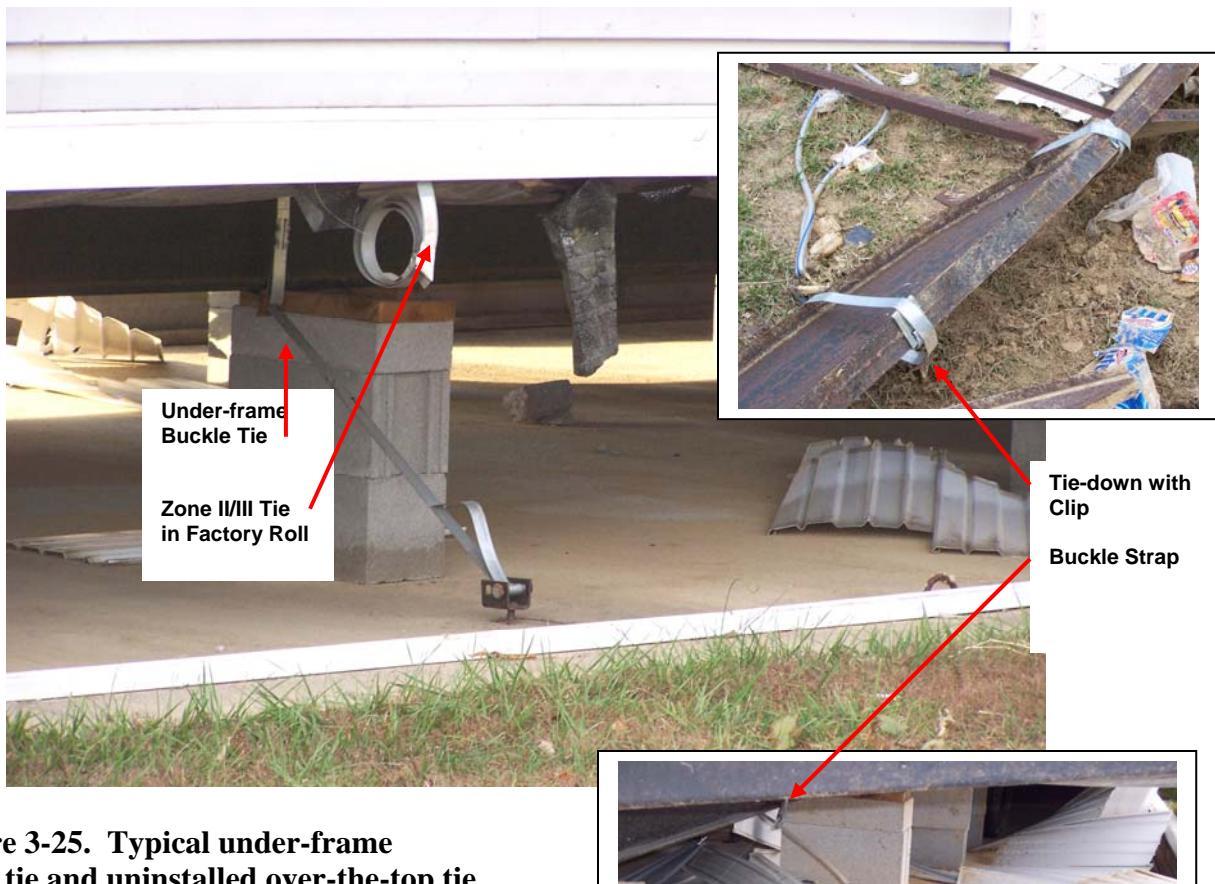
Figure 3-25. Typical under-frame strap tie and uninstalled over-the-top tie.

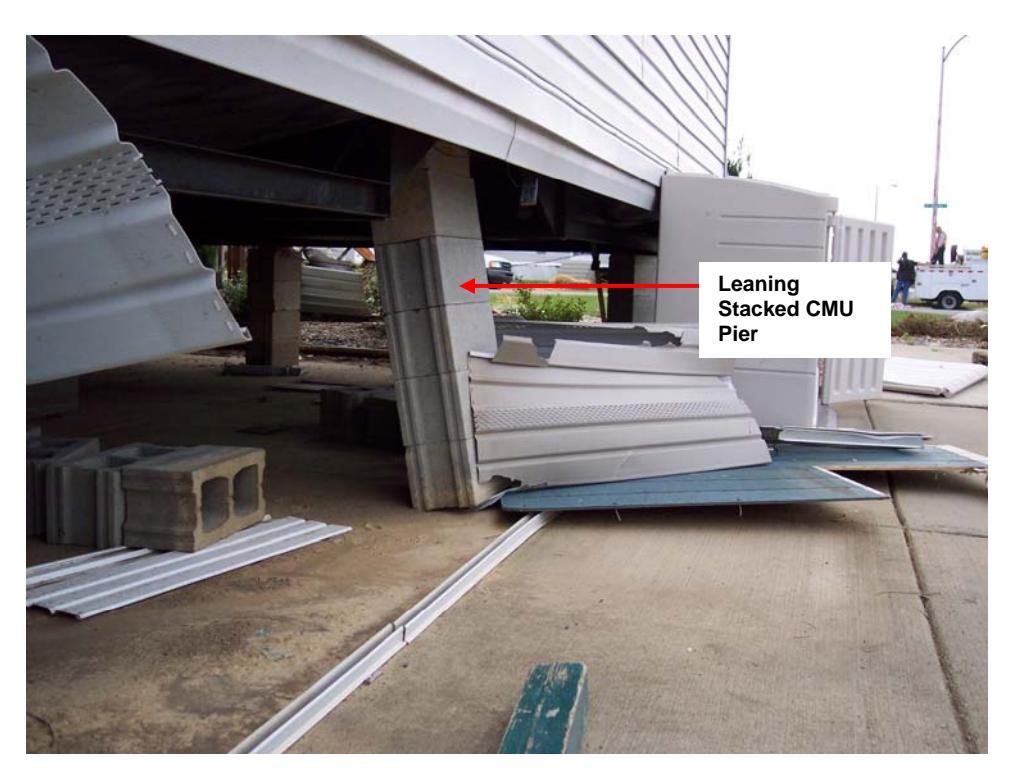
Figure 3-31. Support piers shifted by mobile home sliding.

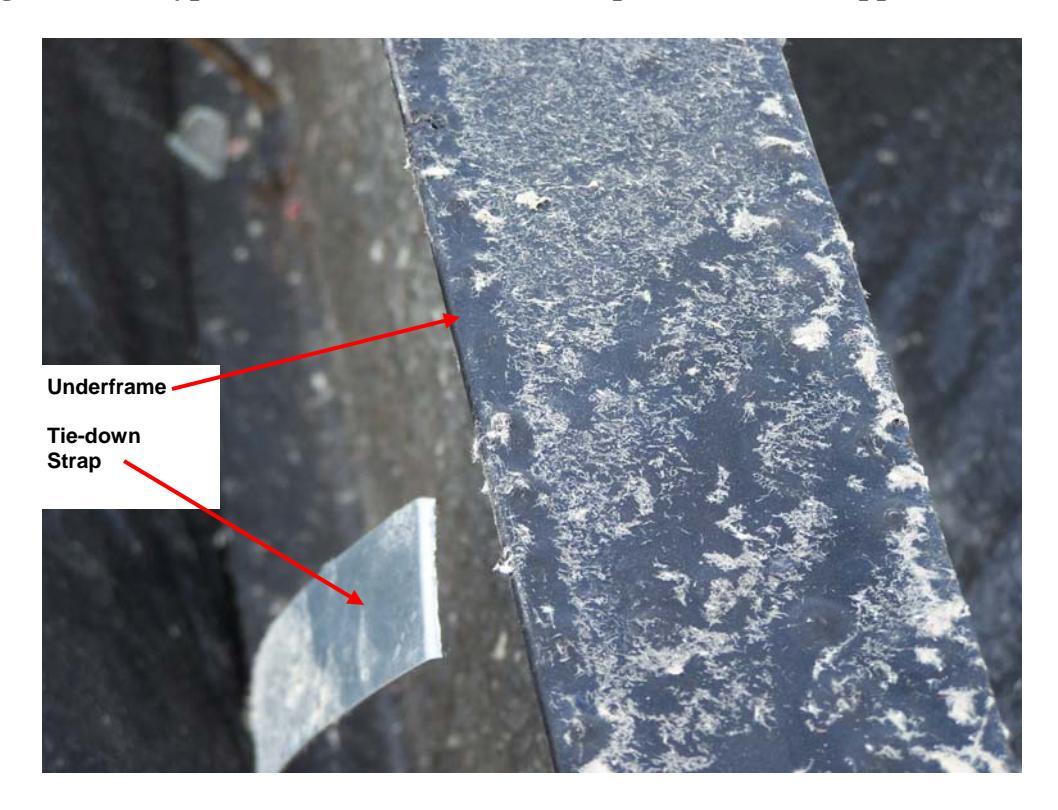
Figure 3-33. Fatigued tie-down strap.

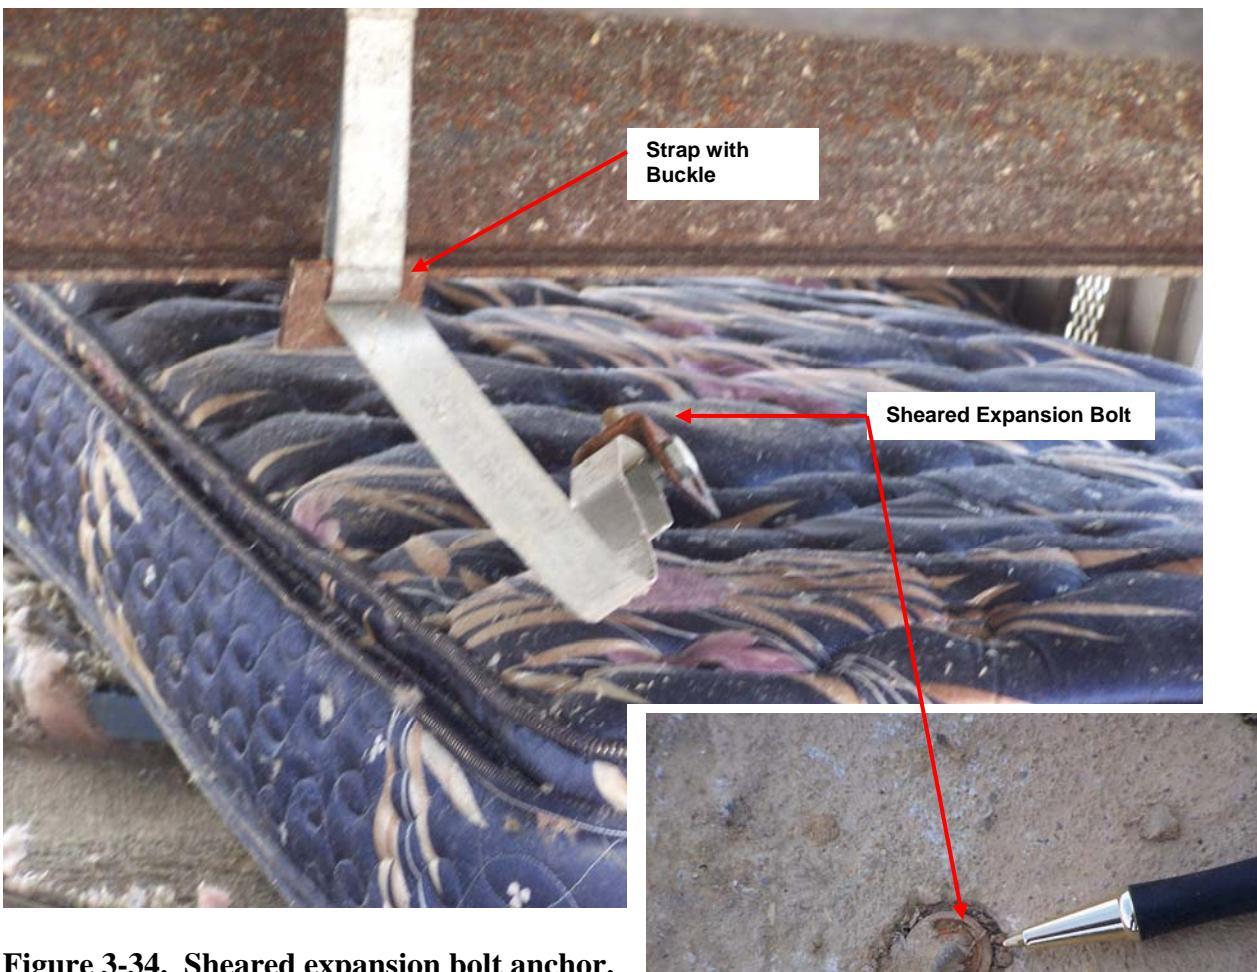
Anchorage failures were not limited to the breaking of tie-down straps. Numerous expansion bolted anchors and several of the rebar loop anchors were sheared at the slab line (see **Figures 3-34 & 3-35**). A large number of anchors were installed improperly, some of which would have led to failures if the units had been closer to the tornado's vortex. In **Figure 3-36** the earth anchor is fully embedded into the ground. The extended stem is easily subject to bending, loosening of the strap, and eventual withdrawal of the anchor from the soil. Similarly, the bolt in the expansion anchor in **Figure 3-37** is not snug to the slab and therefore is subject to bending.

Figure 3-34. Sheared expansion bolt anchor.

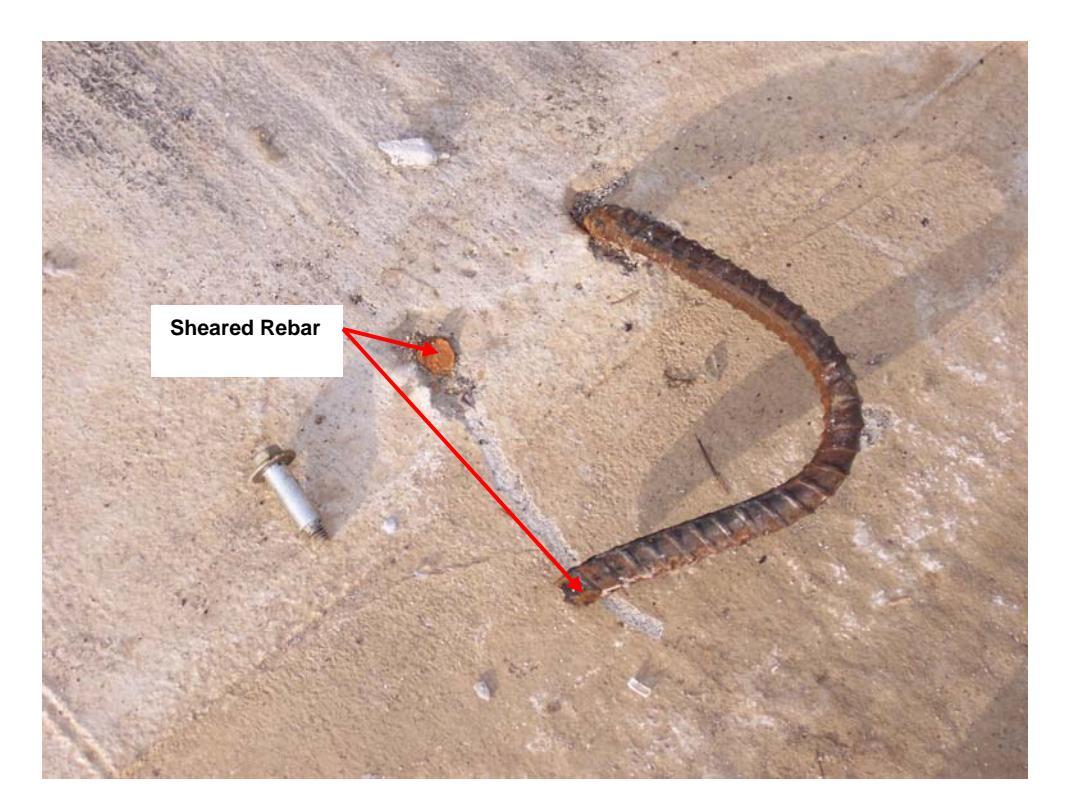
Figure 3-35. Sheared rebar loop anchor.

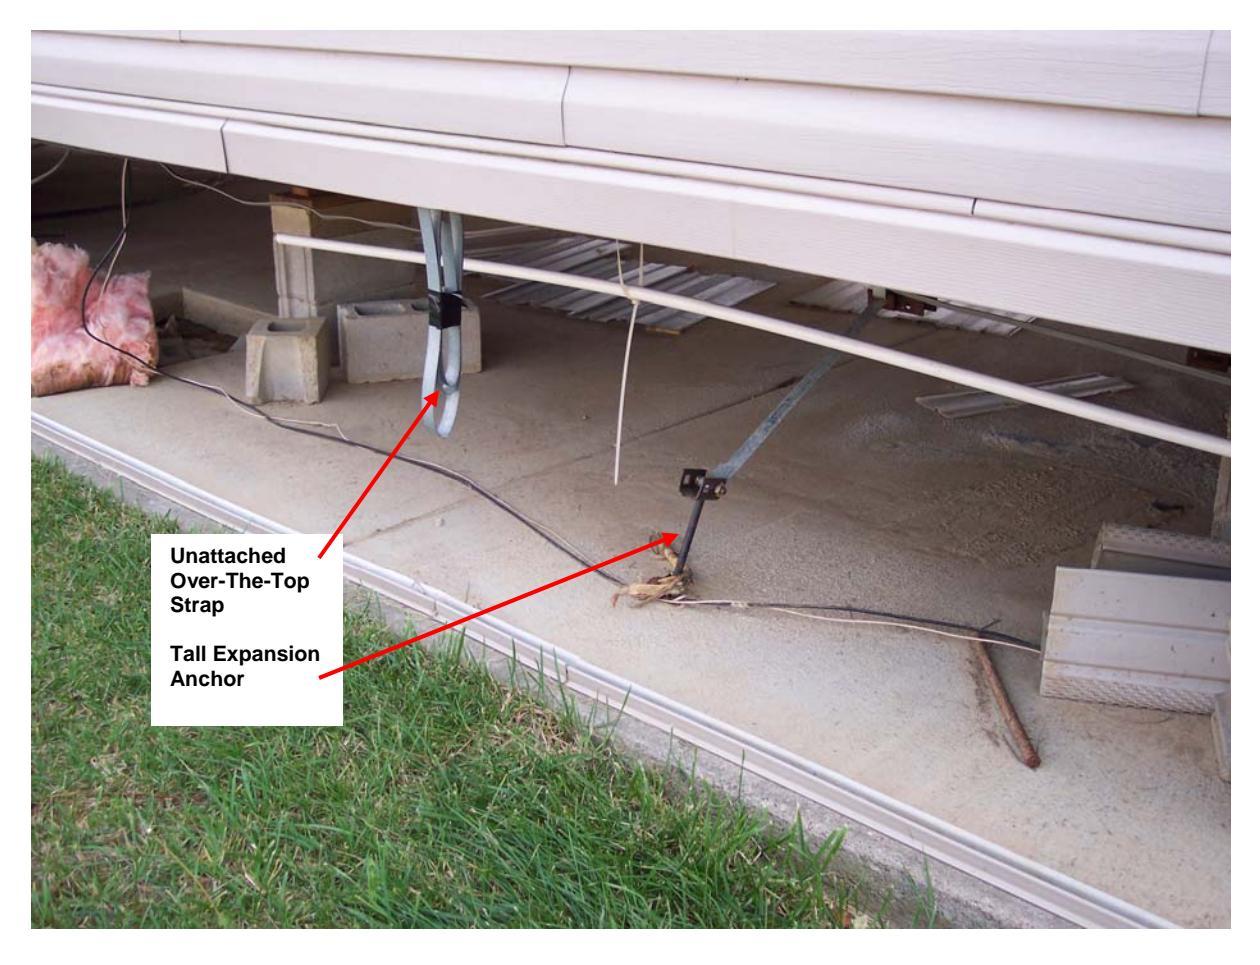
Figure 3-37. Embedded expansion anchor mounted too high above slab and subject to moment and bending.

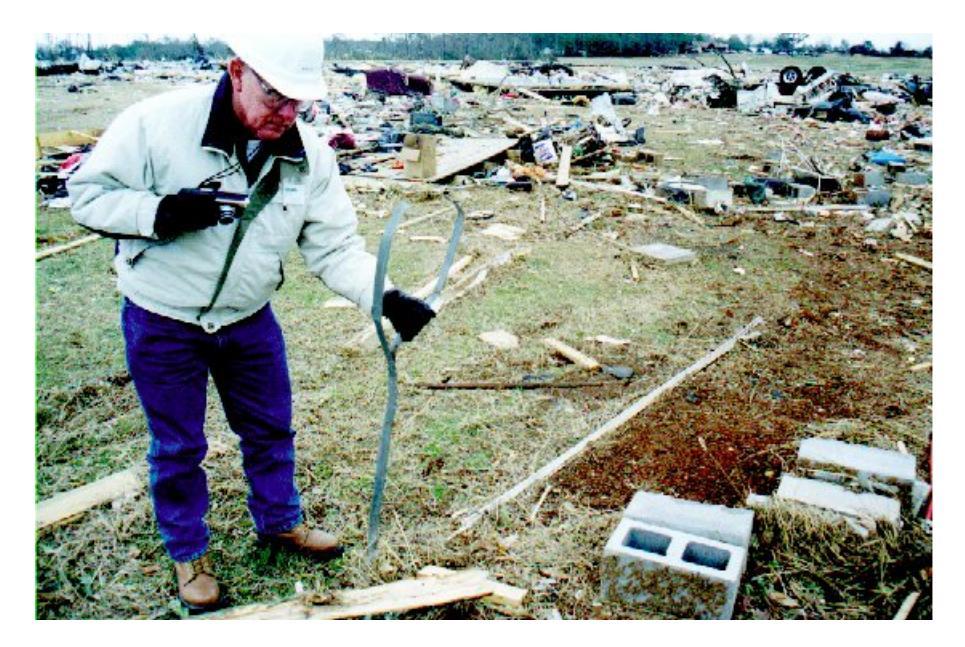
Figure 3-38. Broken mobile home tie-down, Tuscaloosa, AL, December 2000.

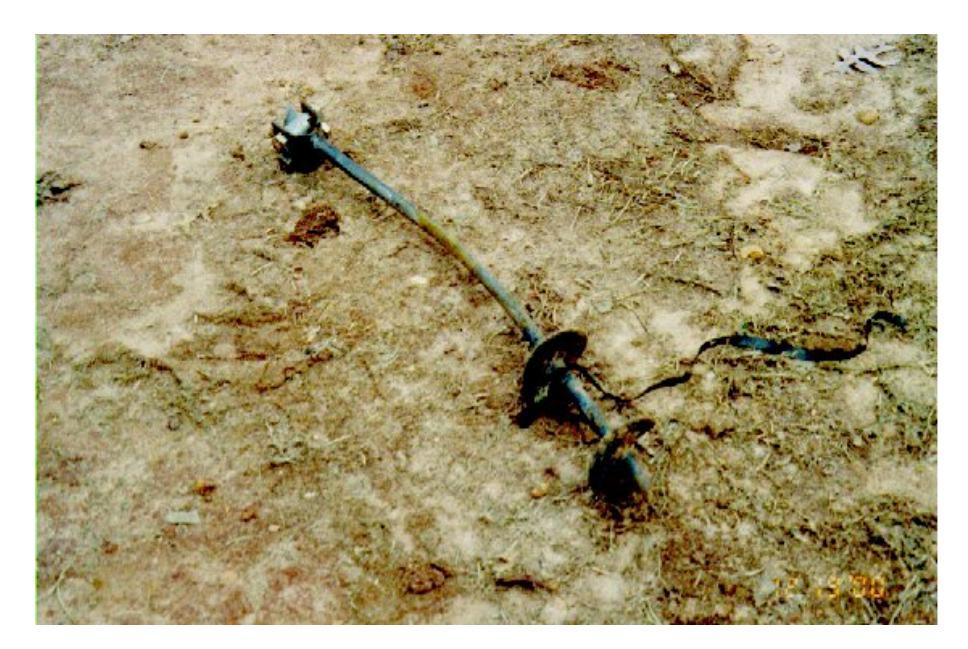
Figure 3-39. Earth anchor pulled out of the ground, Tuscaloosa, AL, December 2000.

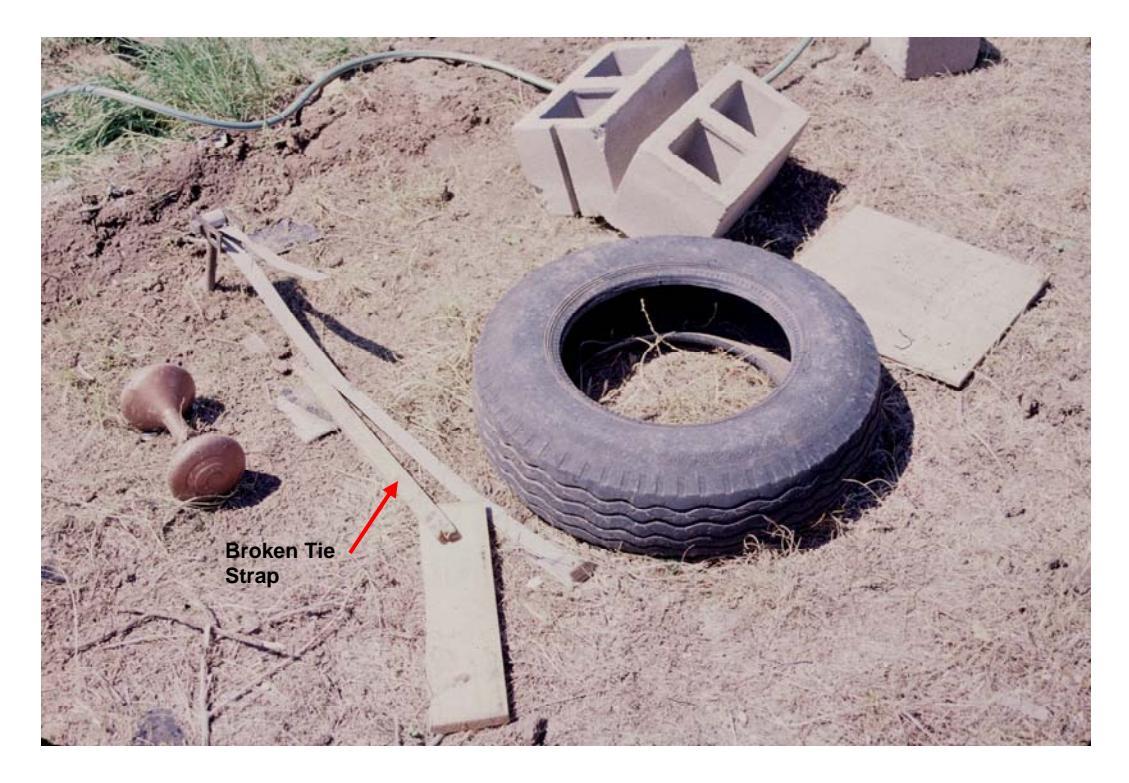
Figure 3-40. Broken mobile home tie-down, Happy, Texas, May 2001.

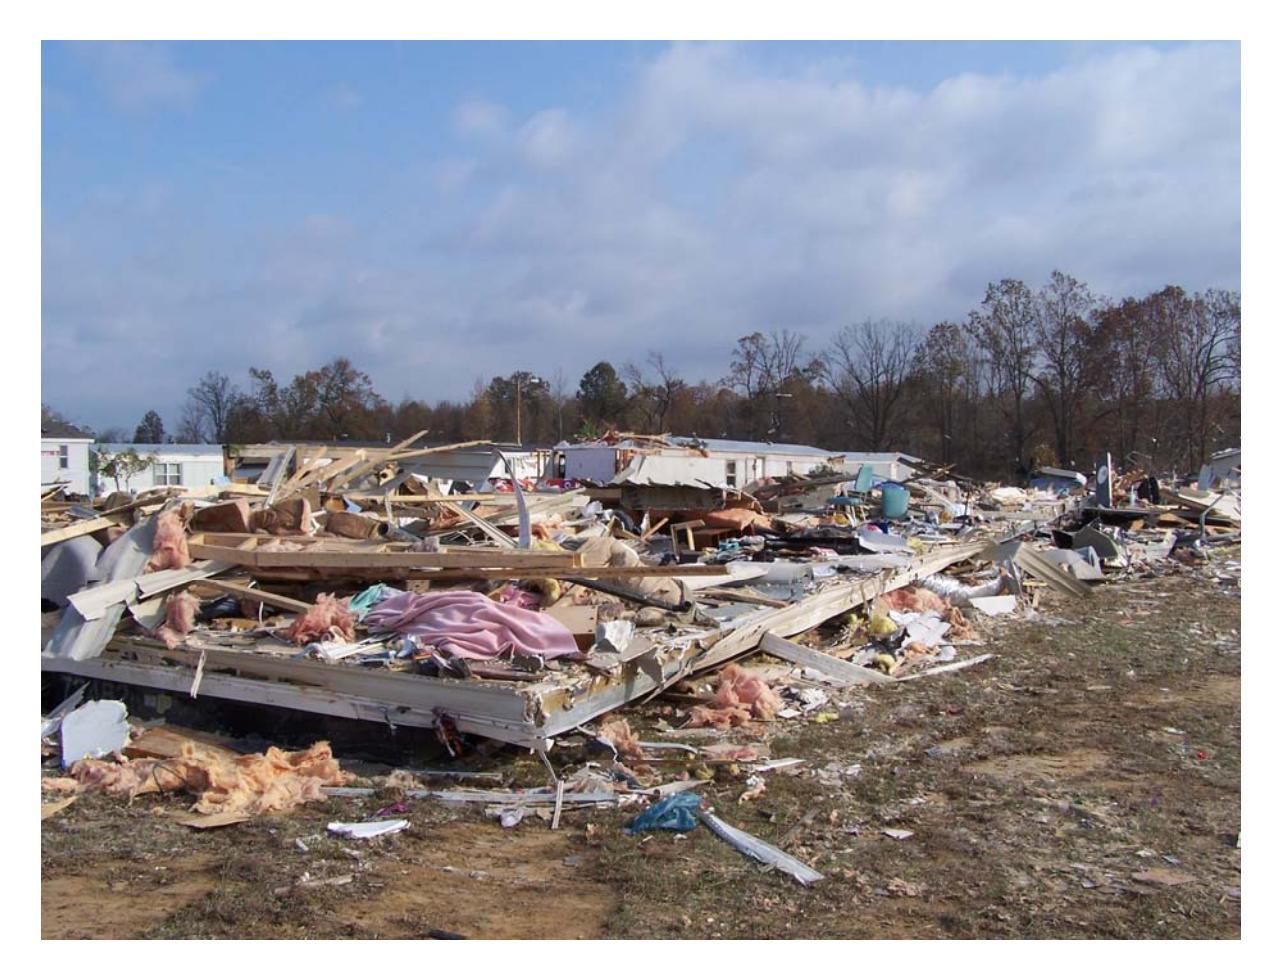
Figure 4-10. Totally demolished unit without wind bracing.

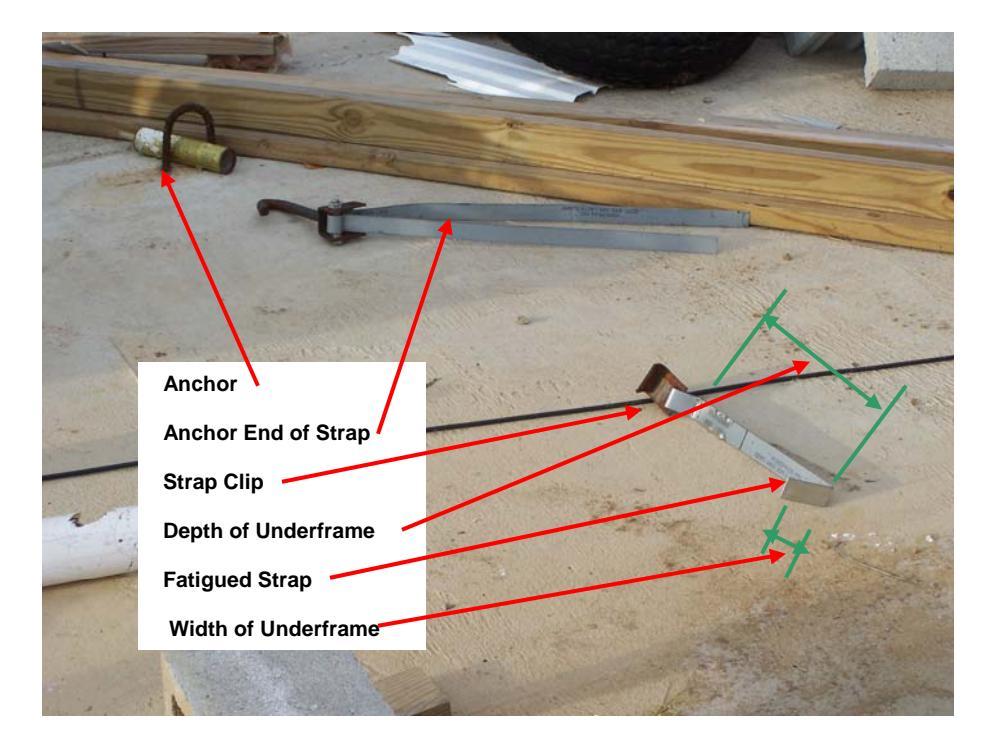
Design and analysis of mobile home tie-down systems presumes a near-perfect installation in which the tie-down strap is tight and remains perpendicular to the steel channel under-frame and that the anchor is installed correctly and is sufficient to carry the ultimate load of the strap. The investigators found no perfect installations. The tie-down strap was typically hooked to the under-frame and wrapped around the frame channel, as shown in **Figures 3-25** & **3-34**, and as illustrated in **Figure 4-14 (a, b, & c)**. This method of wrapping the strap creates a sharp bend in the strap that is easily fatigued by the wind buffeting the unit. Failure of tie-downs was typically found at one of these sharp bends in the tie-down strap (**Figure 4-15**).

Figure 4-15. Tie-down strap broken at bend around mobile home under-frame.
At Eastbrook Mobile Home Park, the investigators rarely observed longitudinal tie-downs installed in the direction of the long axis of the mobile home. Without these ties, the units were allowed to slide longitudinally in the strong multi-directional winds. Longitudinal and lateral displacement of the mobile home unit shown in Figure 4-16 skewed the strap that was previously perpendicular to the under-frame such that the strap became subject to both tension and bending (see Figure 4-17). This condition results in the force applied to the strap by the under-frame being eccentric to the centerline of the strap by a distance, "e," as shown in Figure 4-17. The stress in the strap at the point of contact with the under-frame becomes the sum of the purely tensile stress and the flexural stress resulting from the moment produced by the tensile force, T, multiplied by the eccentricity, e. The AISI, Specification for the Design of Cold-Formed Steel Structural Members, Section 5.1, Combined Axial Load and Bending, require that the sum of the tensile stress and bending stress ratios be less than  $1.0^{30}$  A thin steel strap subjected to tension and bending would. therefore, have a lower tension carrying capacity than a strap subjected to pure tension. The allowable tensile forces for steel strap tie-downs are appropriate for conditions where restraint of the mobile home prevents shifting of the tie-downs from an axis perpendicular to the under-frame steel channel. Where any appreciable shifting of the under-frame occurs, steel straps are apt to fail at significantly lower tensile forces than those for which the tiedown is rated
