**Tornado Report**

# Evansville, Indiana November 6, 2005

## **Eastbrook Mobile Home Park**

May 30, 2006

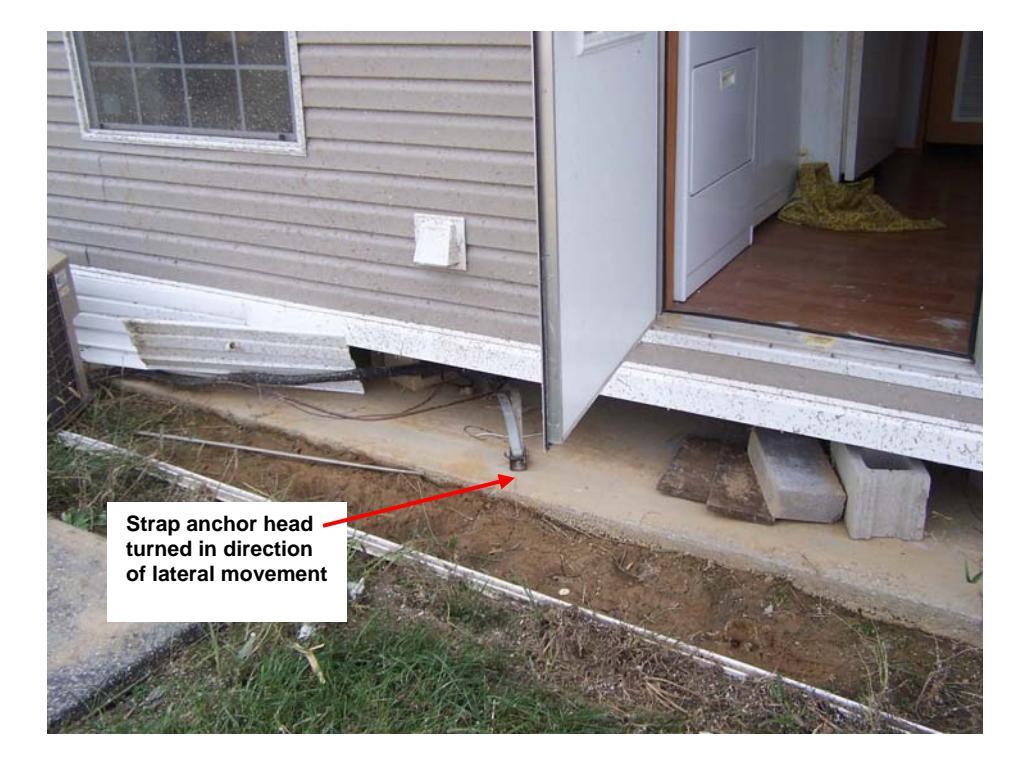
Figure 4-16. Unit laterally displaced, skewing the tie-down strap resulting in strap failure.

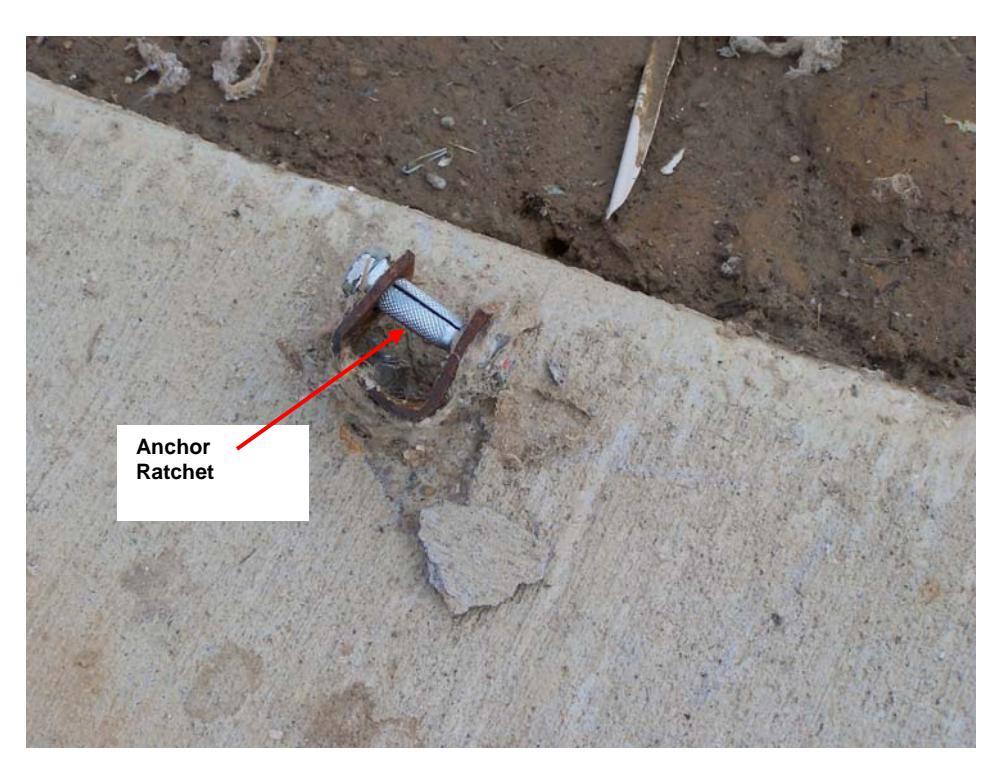
Anchors to which the tie-downs were connected failed frequently. Cam-type ratchets failed, releasing the strap (**Figure 4-18**); anchor heads sheared (**Figure 4-19**); and anchor bolts sheared (**Figure 4-20**).

Figure 4-18. Failed tie-down anchor ratchet.

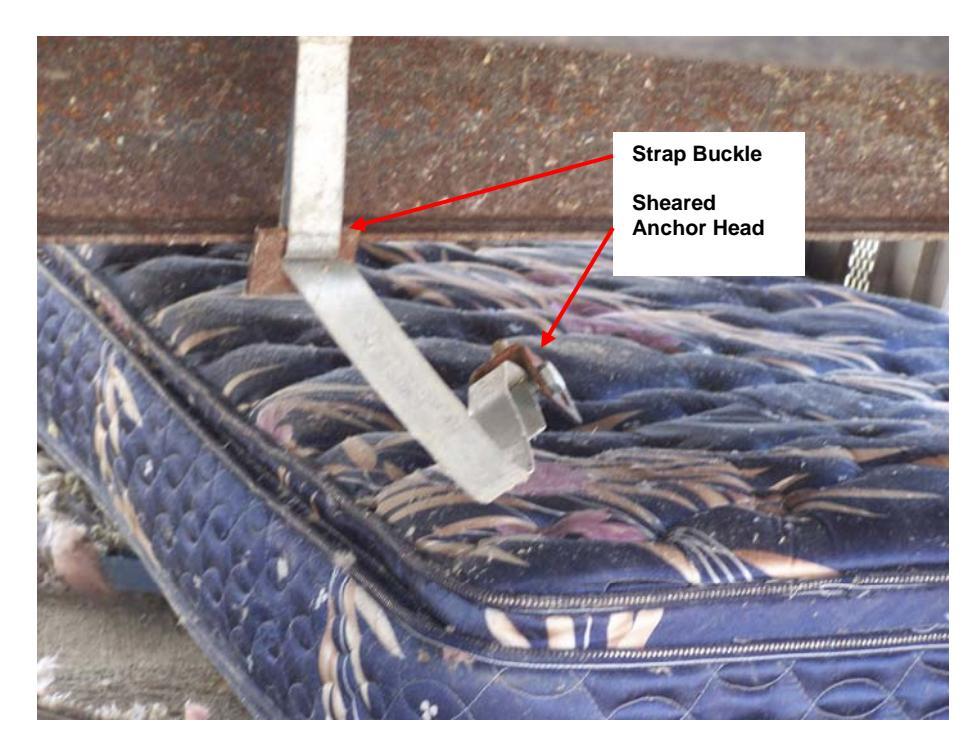
Figure 4-19. Anchor head sheared.

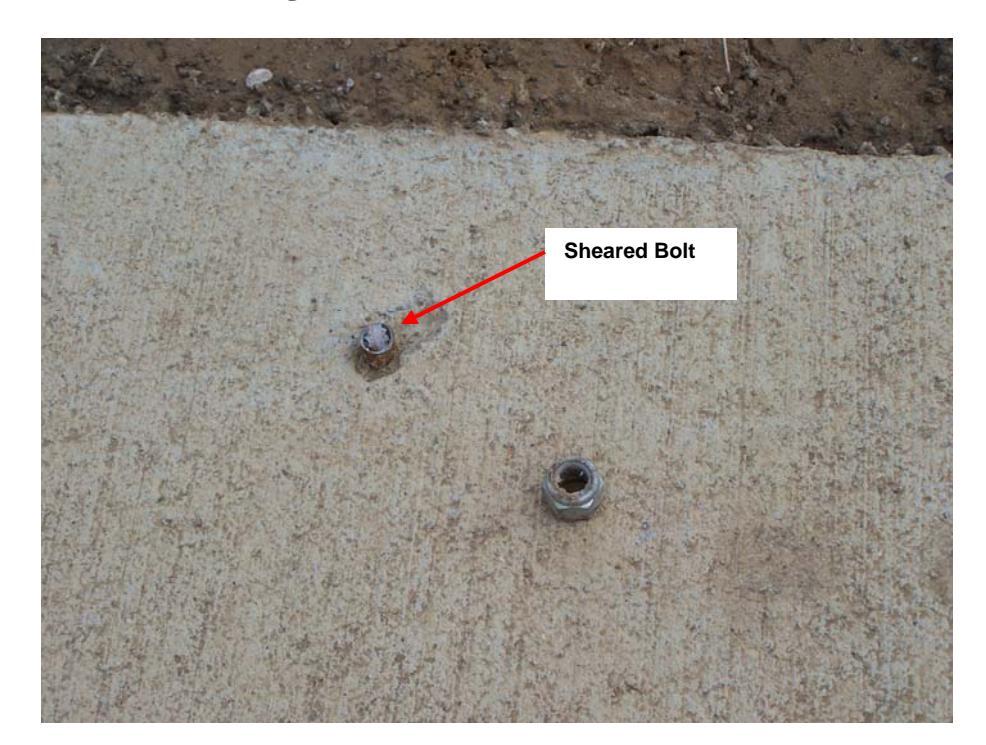
Figure 4-20. Sheared anchor bolt.
