Tornado Damage Documentation – Using the EF-Scale

Central Florida Sumter County, Lake County, Volusia County February 2, 2007

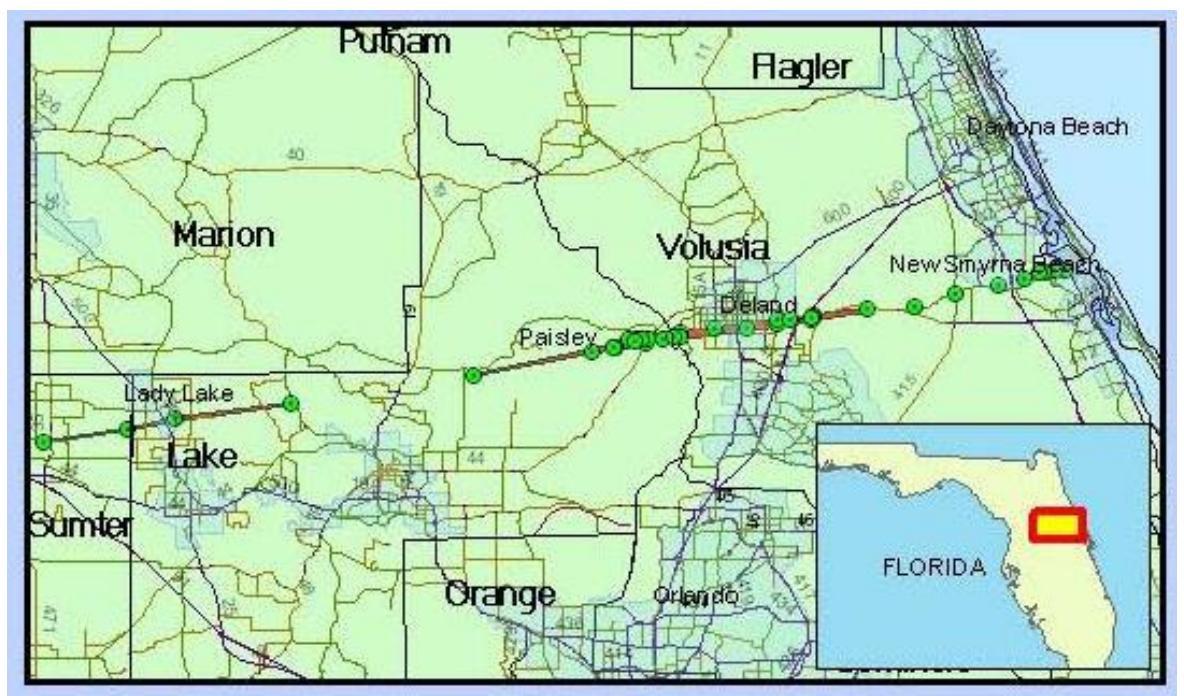
PhotoCredit: National Weather Service

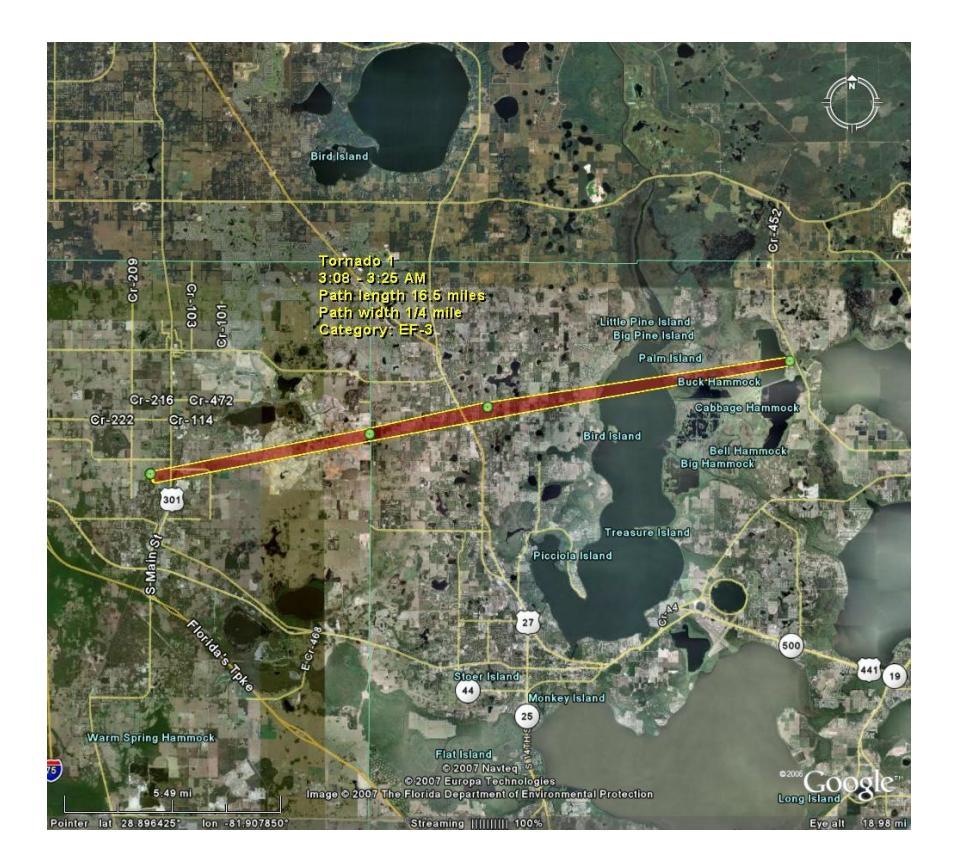
Figure 1-1. Tornado 1 Track - Sumter County to Lake County, Florida[2]

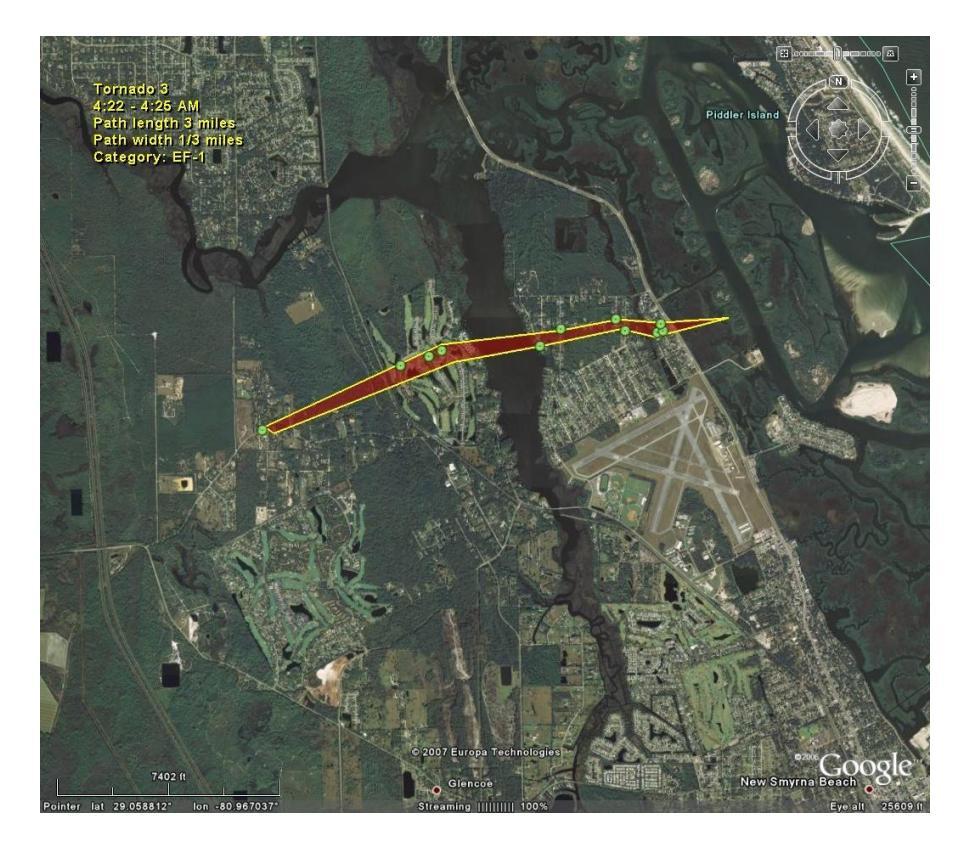
Figure 1-3. Tornado 3 Track - Volusia County, Florida[2]

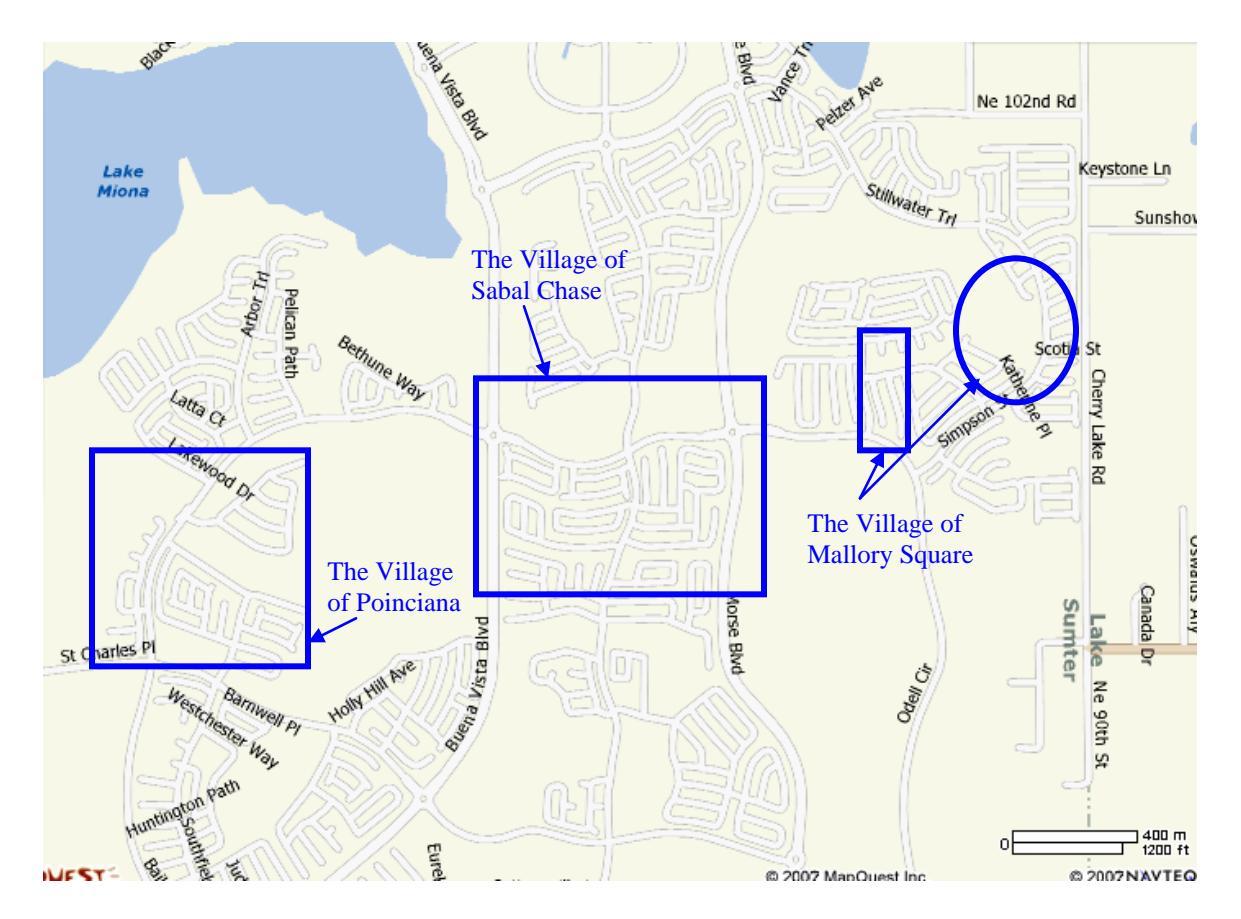
Figure 2-1. Map of the areas investigated in The Villages.

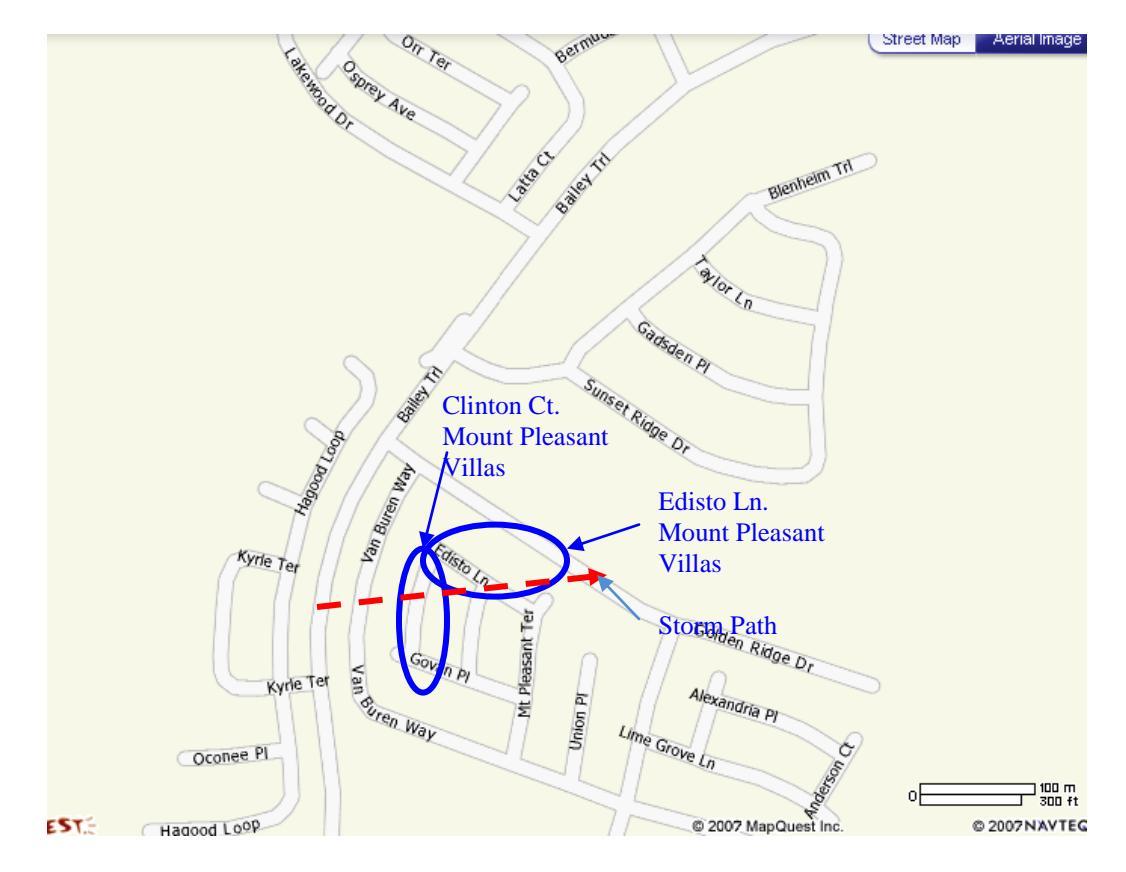
Figure 2-2. Map of area investigated in the Village of Poinciana.

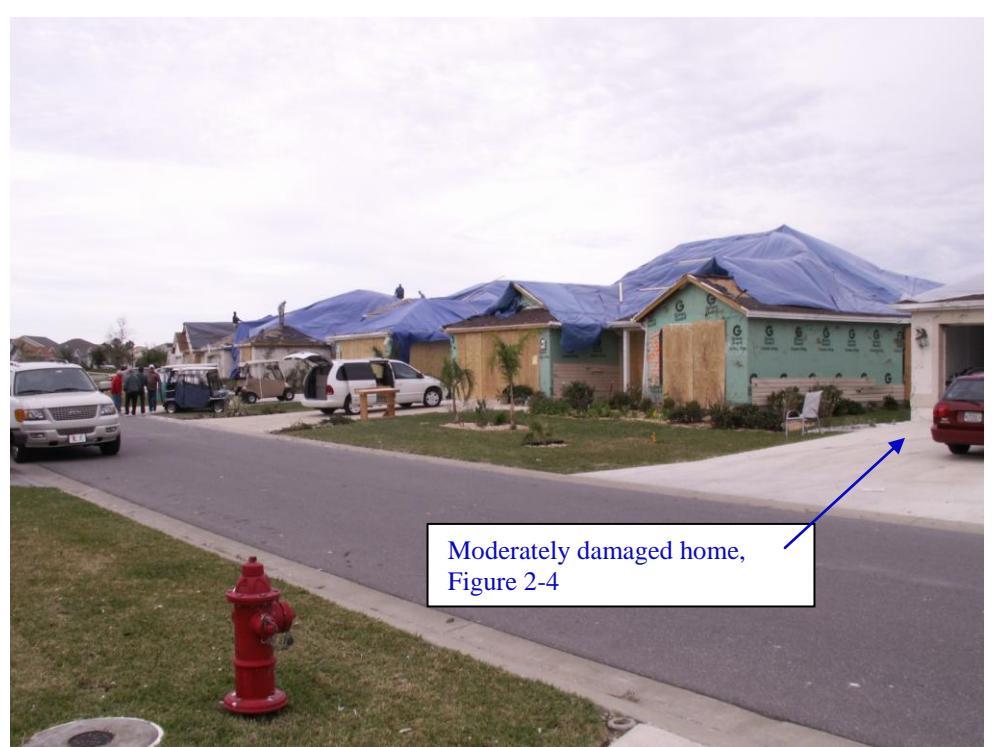
Figure 2-3. DOD 4 Damage along Clinton Ct., in Mount Pleasant Villas in the Village of Poinciana, The Villages, FL.

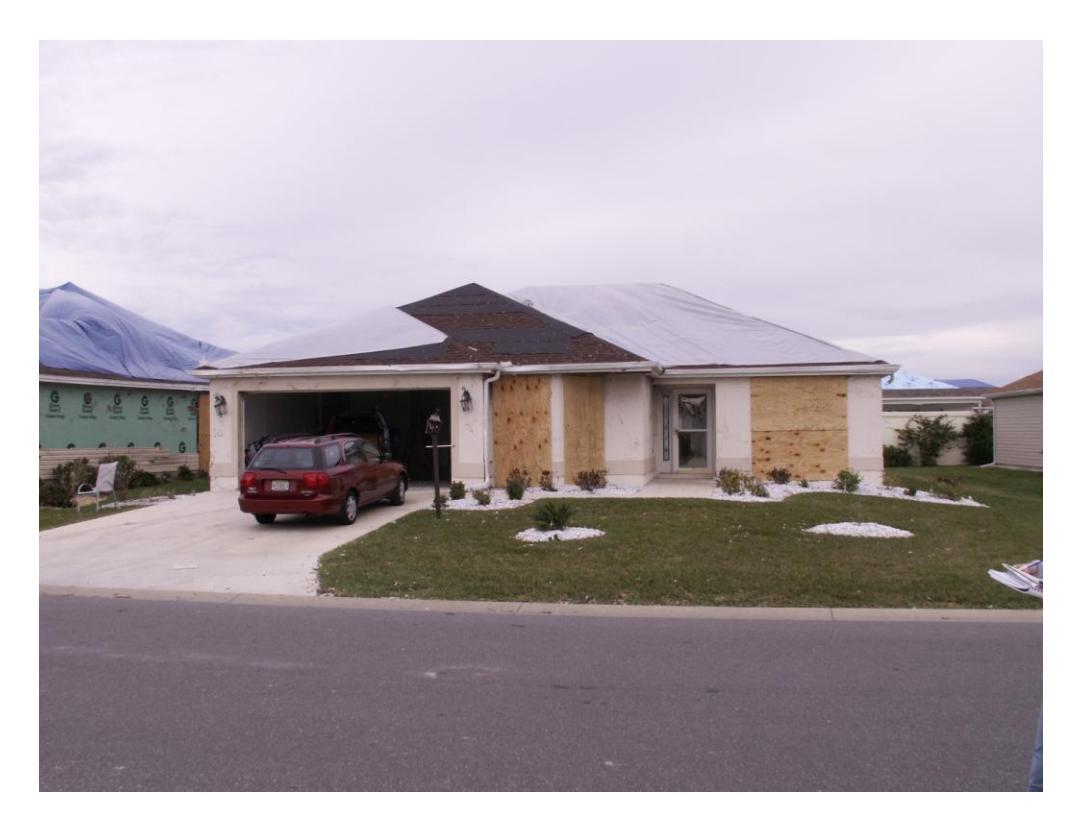
Figure 2-4. Moderately (DOD 2) Damaged Home along Clinton Ct., in Mount Pleasant Villas in the Village of Poinciana, The Villages, FL.

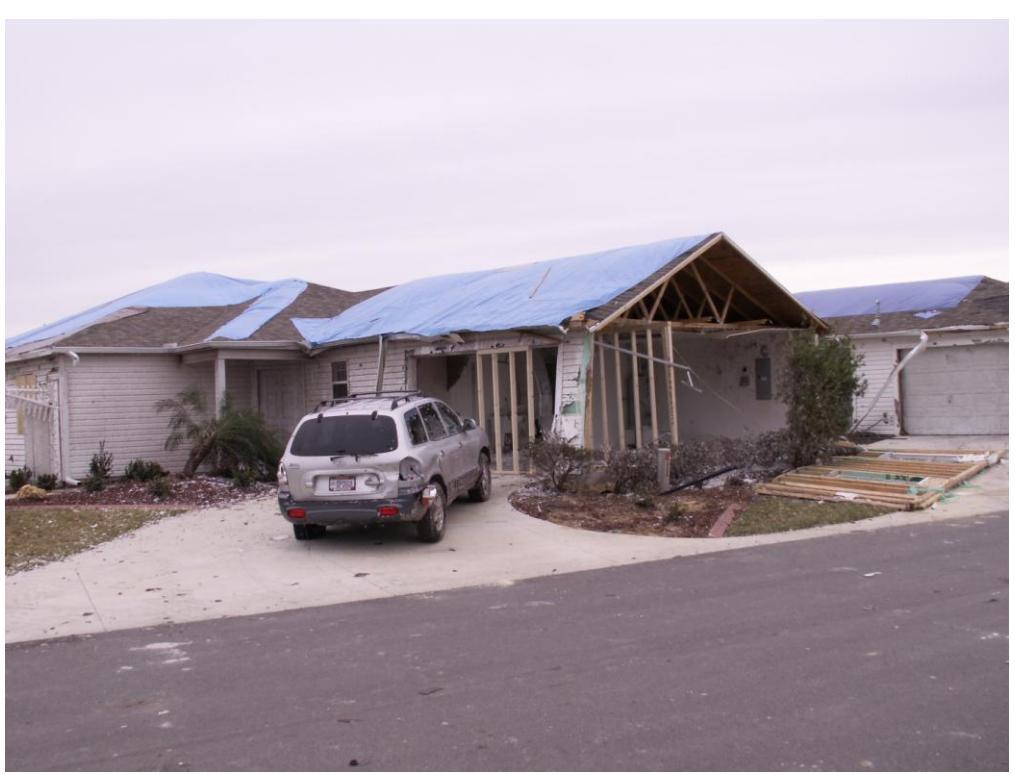
Figure 2-5. Garage Wall blown out on Clinton Ct. Home (DOD 4), in Mount Pleasant Villas in the Village of Poinciana, The Villages, FL.

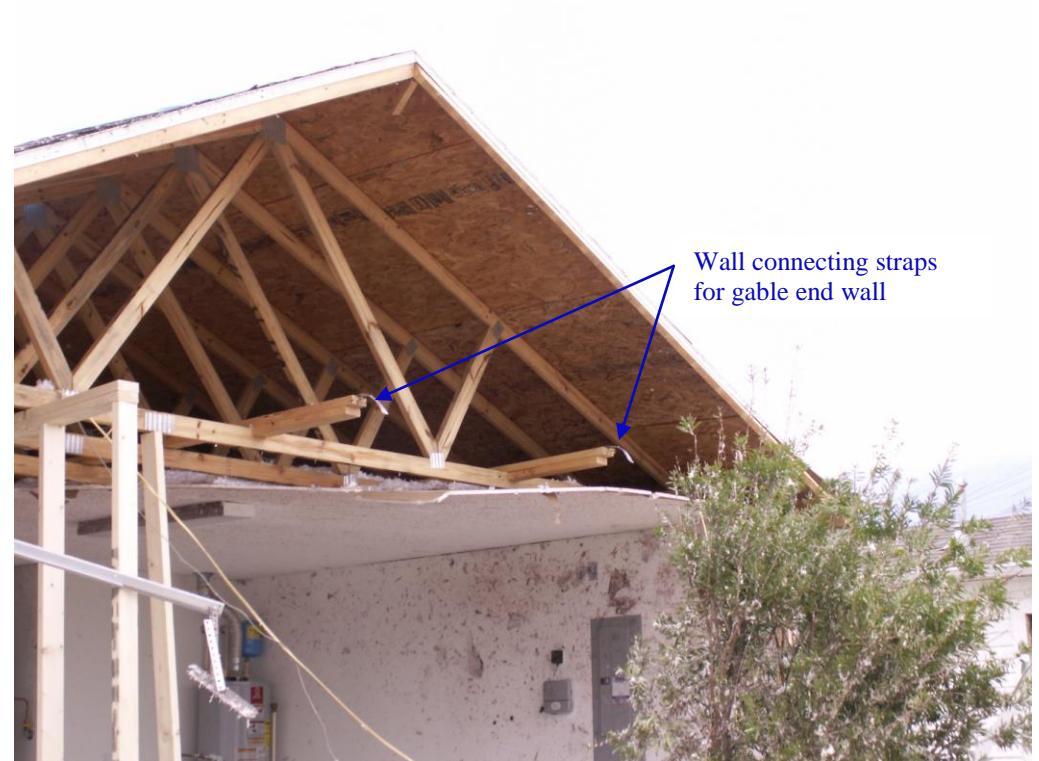
Figure 2-6. Damage along Clinton Ct., in Mount Pleasant Villas in the Village of Poinciana, The Villages, FL.

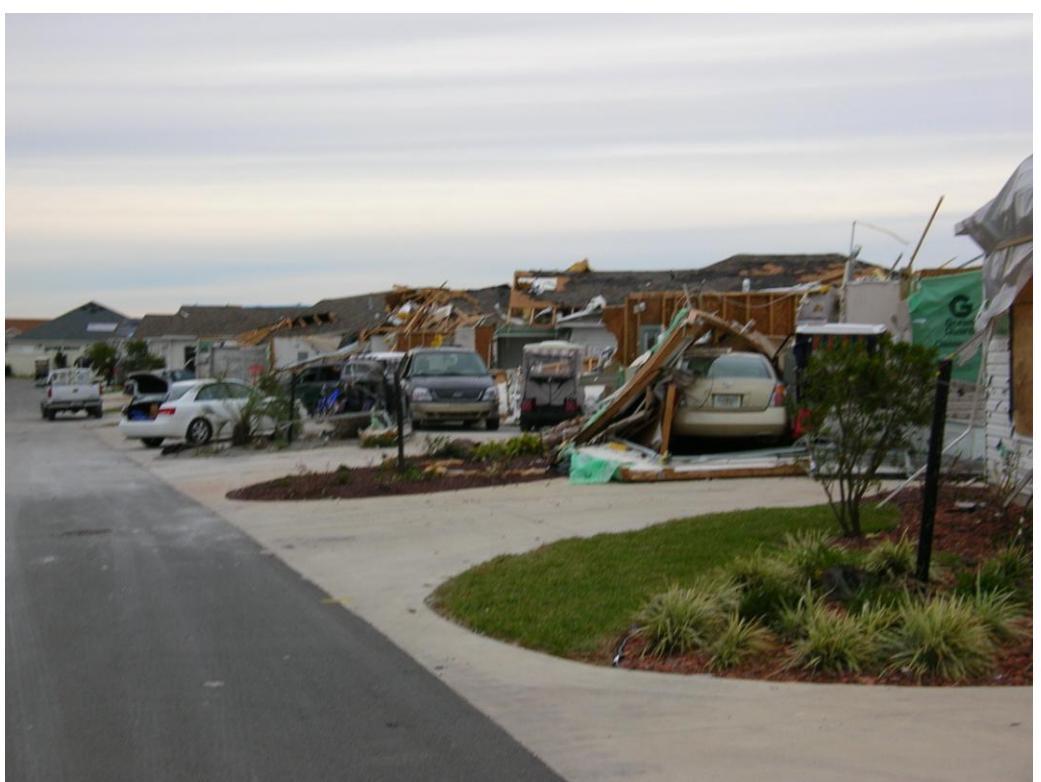
Figure 2-7. DOD 6 Damage along Edisto Ln., in Mount Pleasant Villas in the Village of Poinciana, The Villages, FL.

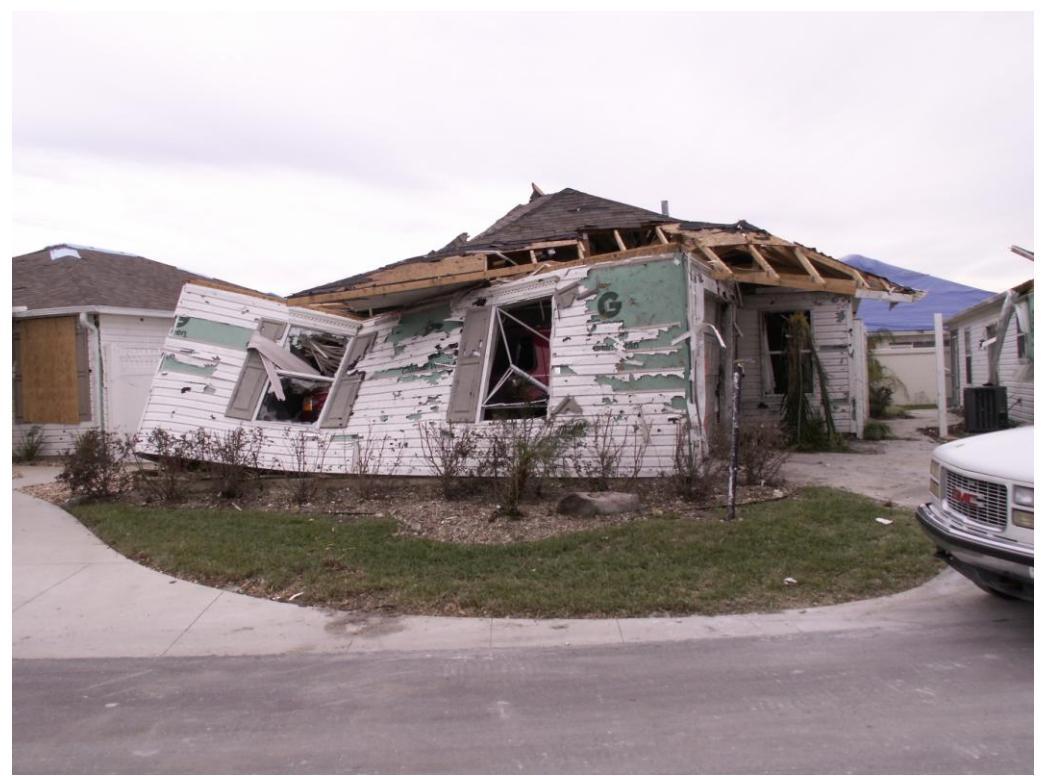
Figure 2-8. DOD 6 Damage along Edisto Ln., in Mount Pleasant Villas in the Village of Poinciana, The Villages, FL.

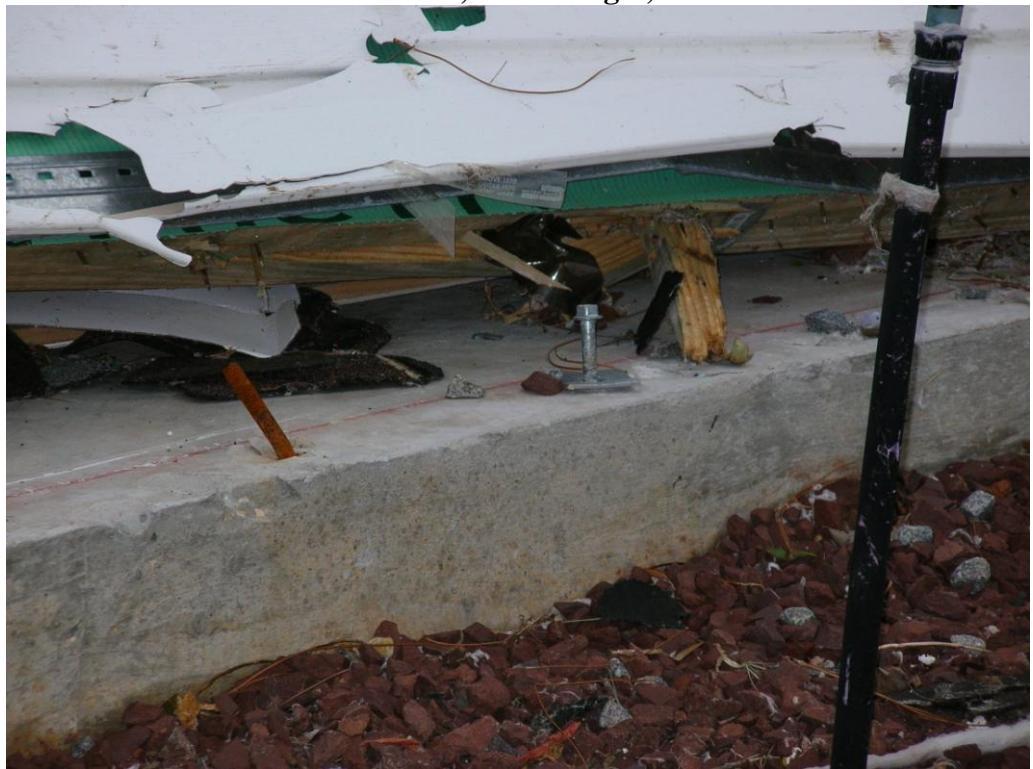
Figure 2-9. Damage along Edisto Ln., in Mount Pleasant Villas in the Village of Poinciana, The Villages, FL.

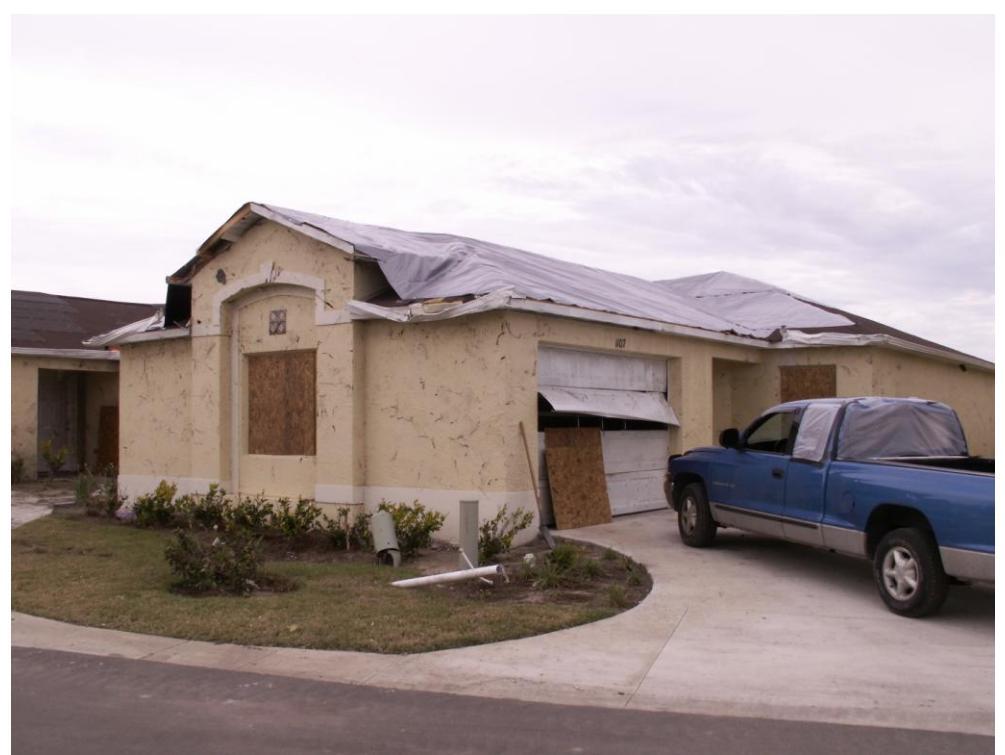
Figure 2-10. DOD 4 Damage along Edisto Ln., in Mount Pleasant Villas in the Village of Poinciana, The Villages, FL.

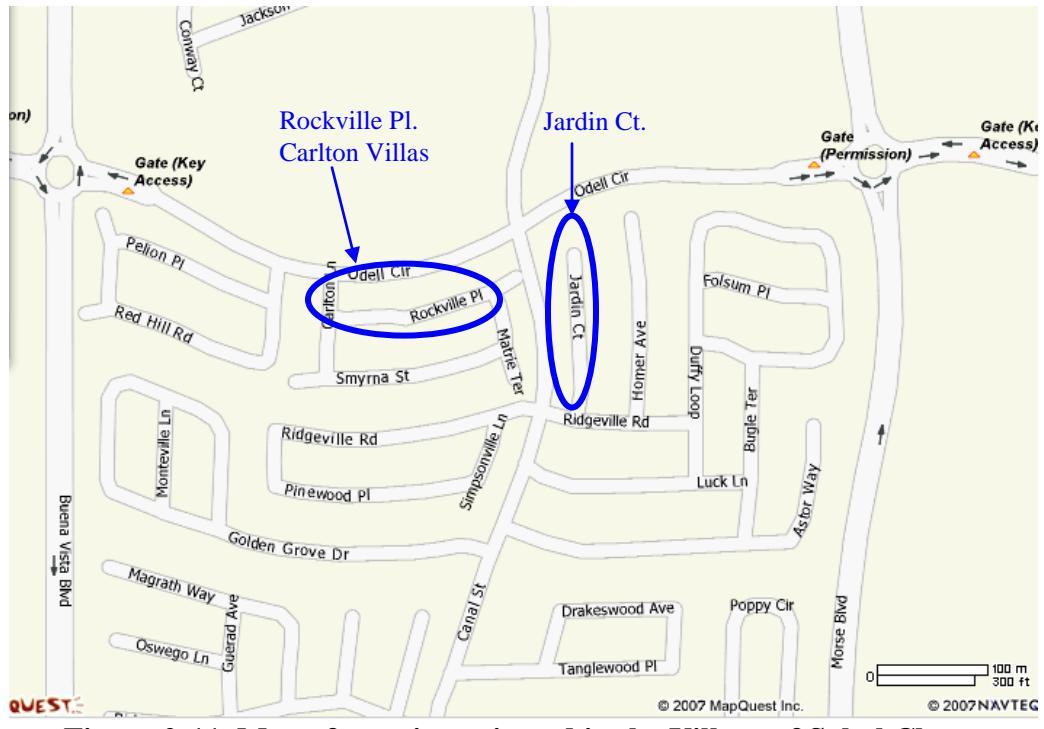
Figure 2-11. Map of area investigated in the Village of Sabal Chase.

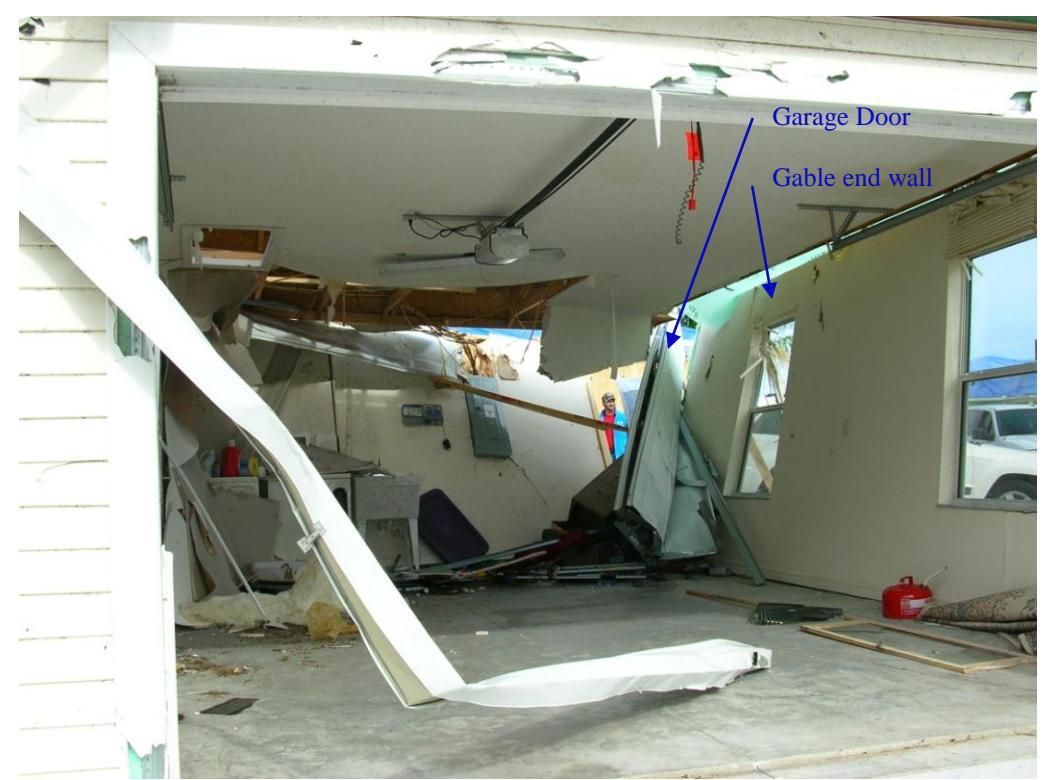
Figure 2-12. DOD 4 Damage to a home on Rockville Pl., in Carlton Villas in the Village of Sabal Chase, The Villages, FL.

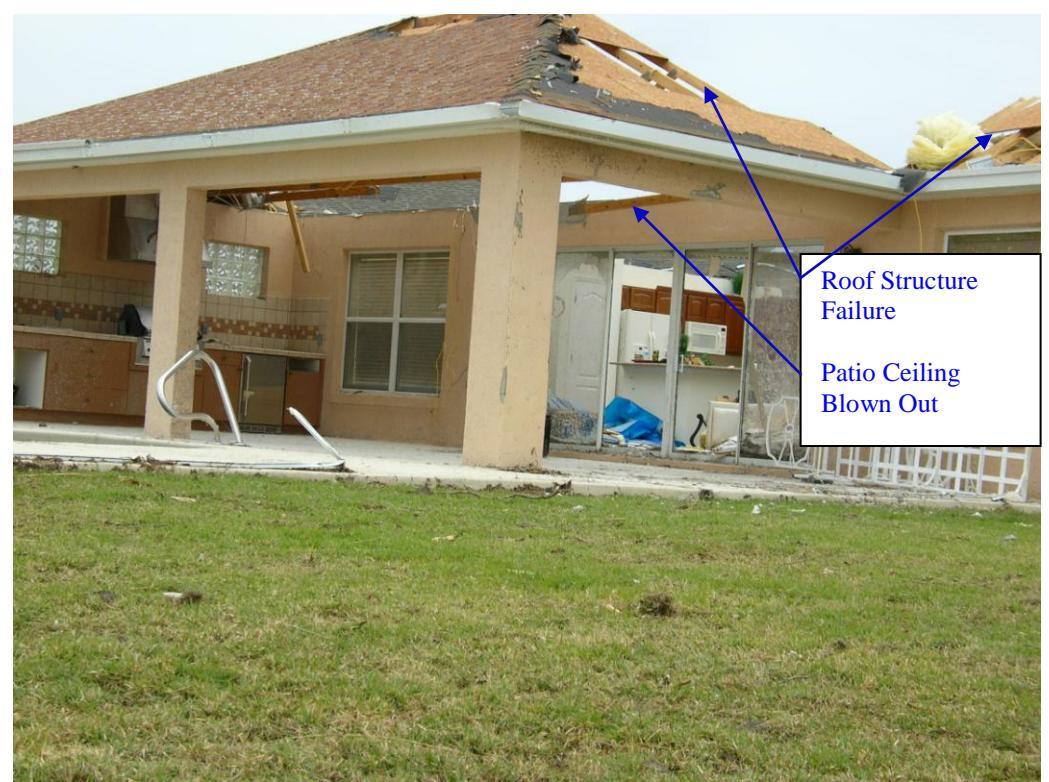
Figure 2-13. DOD 6 Damage to a home on Jardin Ct., in the Village of Sabal Chase, The Villages, FL.

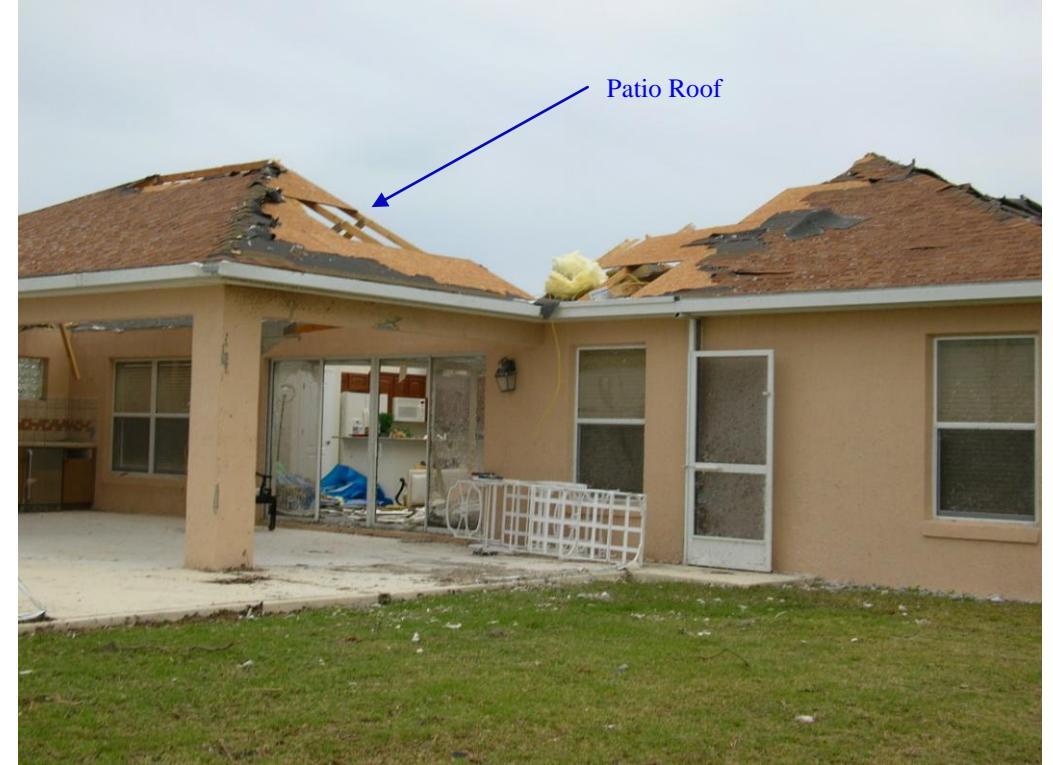
Figure 2-14. DOD 6 Damage to a home on Jardin Ct., in the Village of Sabal Chase, The Villages, FL.

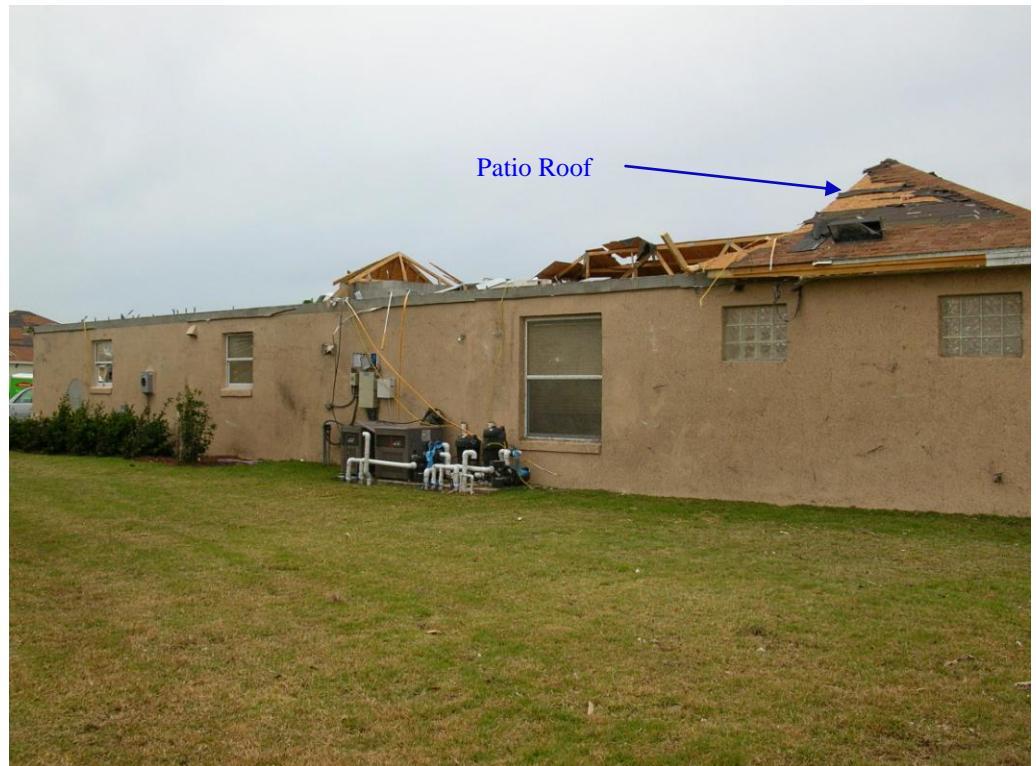
Figure 2-15. DOD 6 Damage to a home on Jardin Ct., in the Village of Sabal Chase, The Villages, FL.

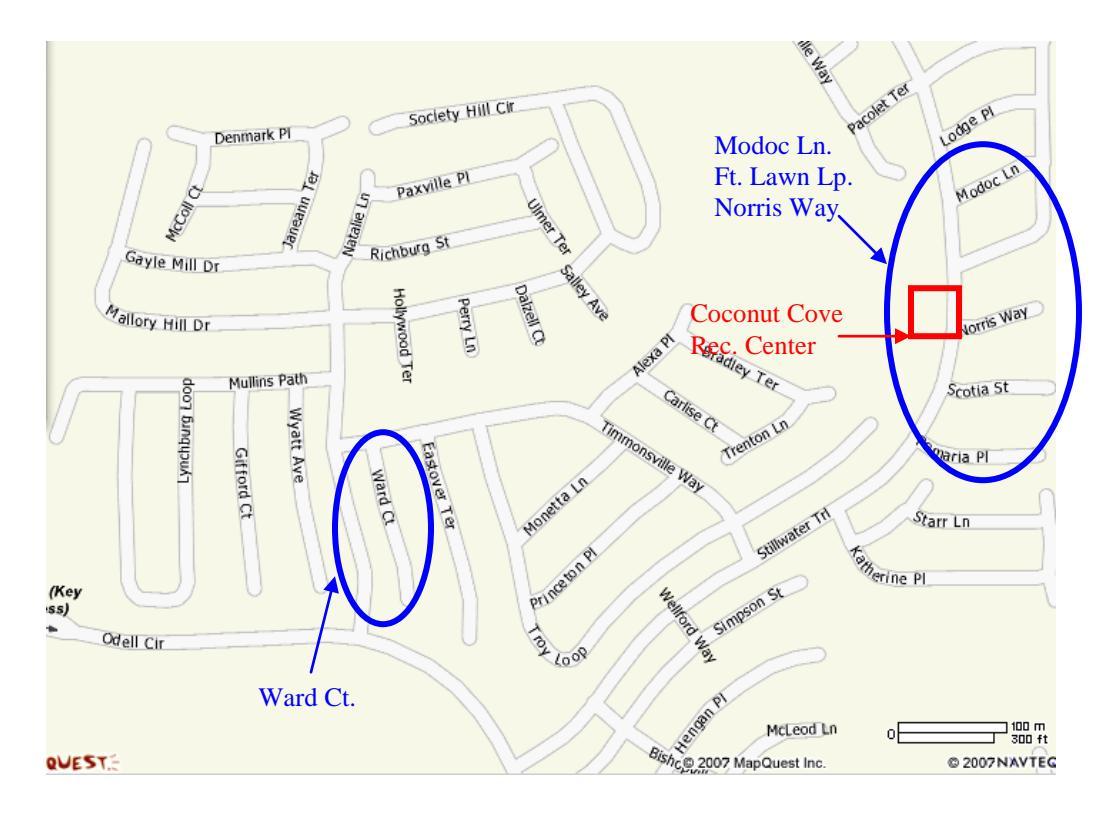
Figure 2-16. Map of area investigated in the Village of Mallory Square.

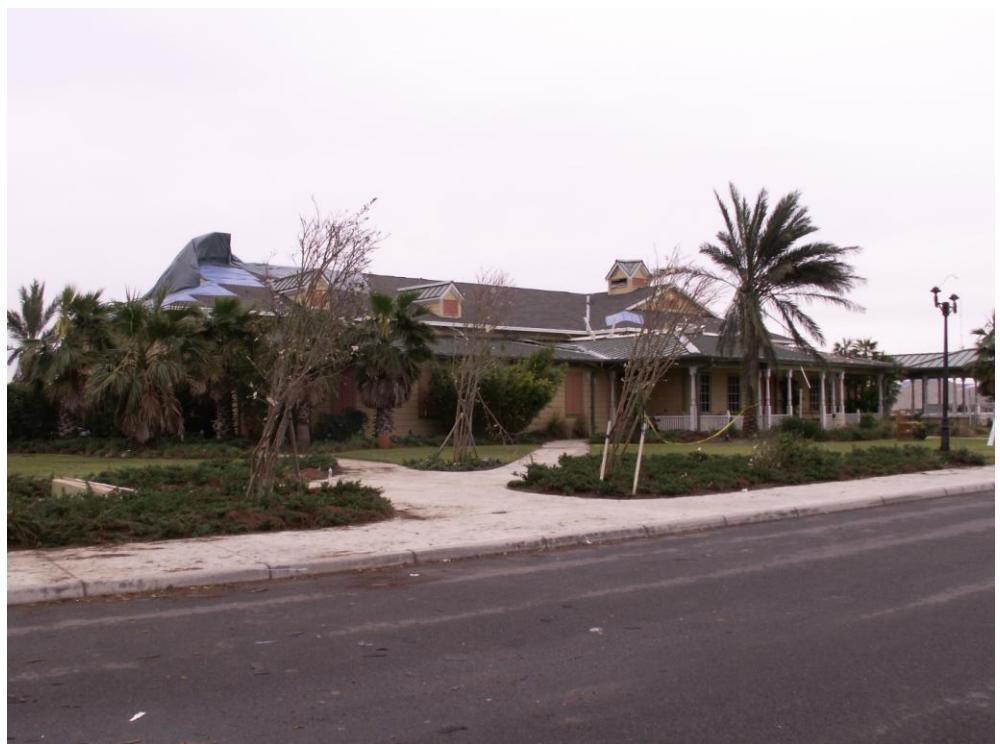
Figure 2-17. DOD 3 Damage to the leeward face of the Coconut Cove Recreation Center(SPB), in the Village of Mallory Square, The Villages, FL.

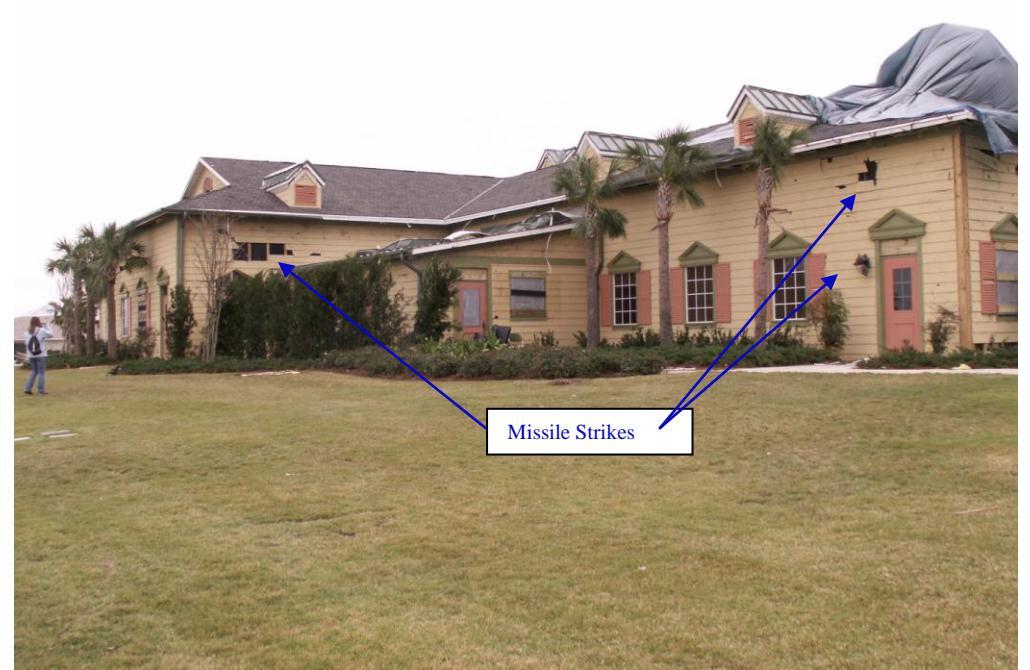
Figure 2-18. DOD 3 Damage to the windward face of the Coconut Cove Recreation Center (SPB) in the Village of Mallory Square, The Villages, FL.

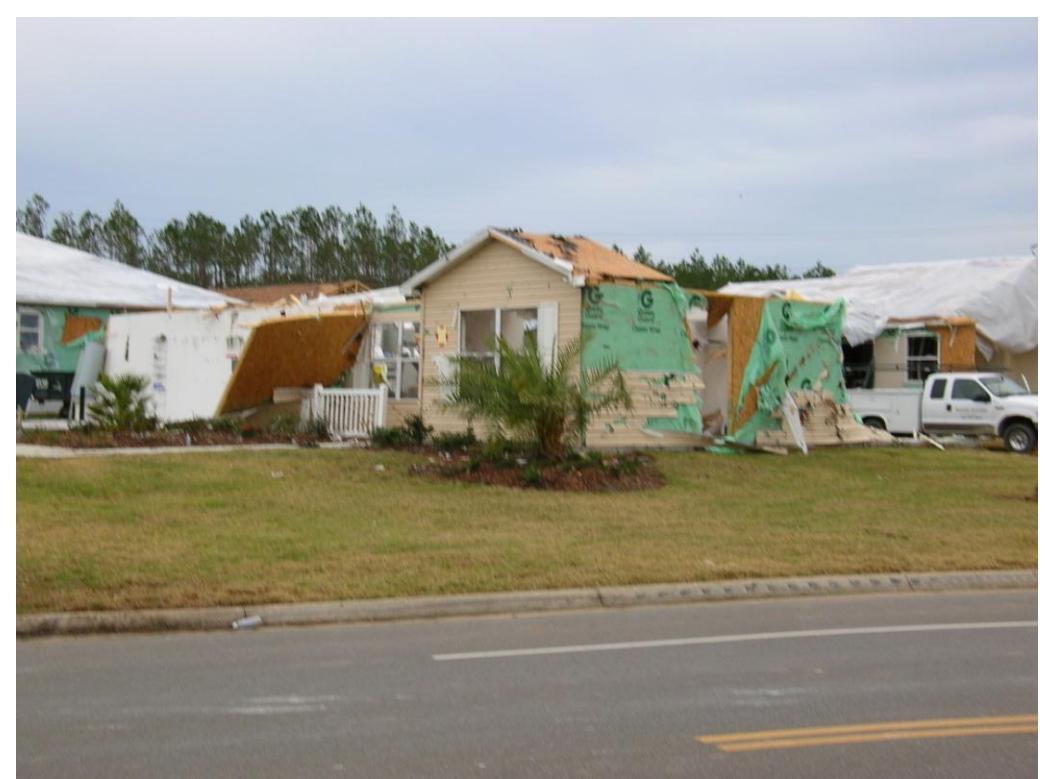
Figure 2-19. DOD 9 Damage to a home on Ft. Lawn Lp., in the Village of Mallory Square, The Villages, FL.

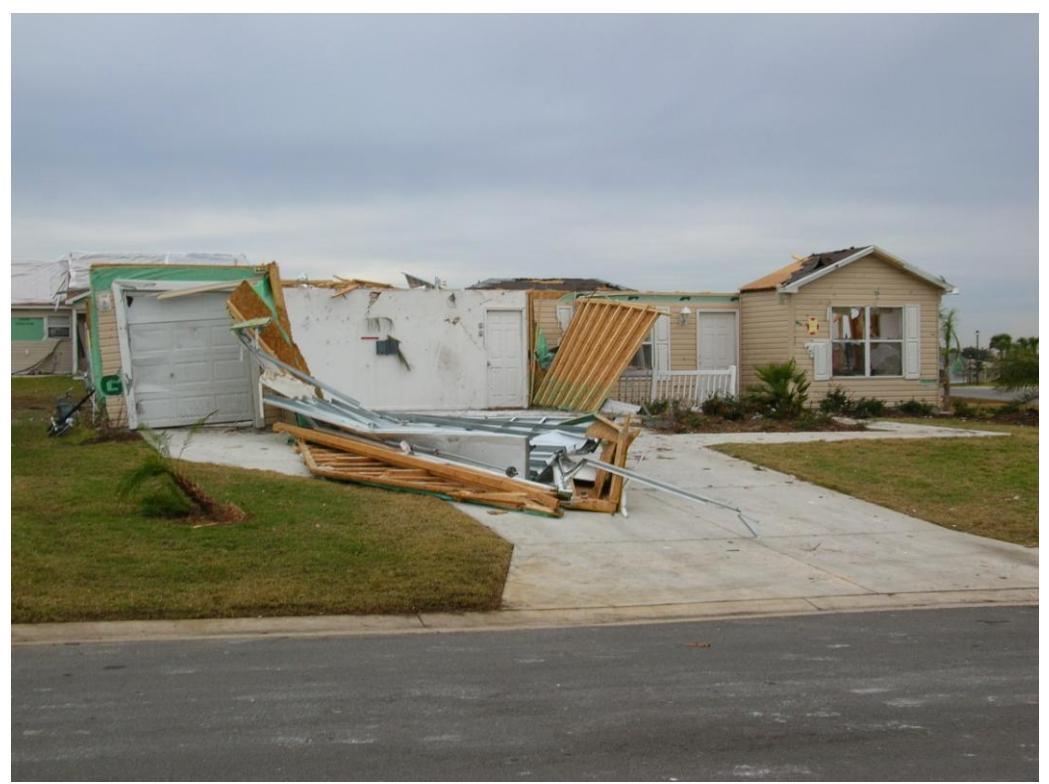
Figure 2-20. DOD 9 Damage to a home on Ft. Lawn Lp., in the Village of Mallory Square, The Villages, FL.

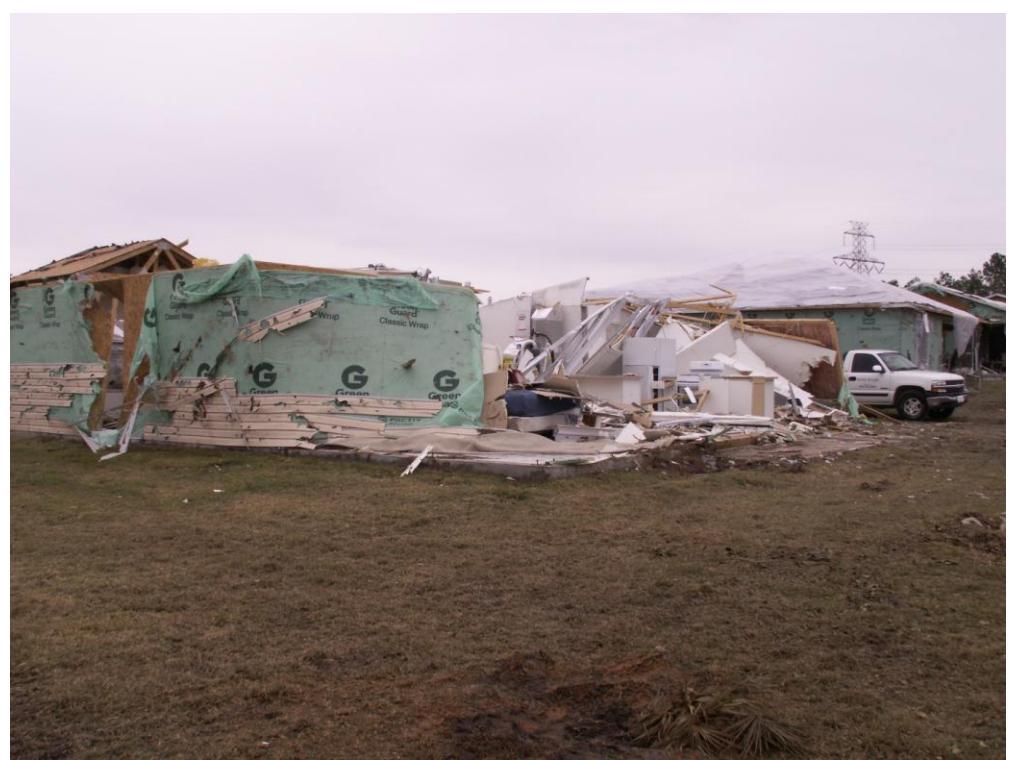
Figure 2-21. DOD 9 Damage to a home on Ft. Lawn Lp., in the Village of Mallory Square, The Villages, FL.

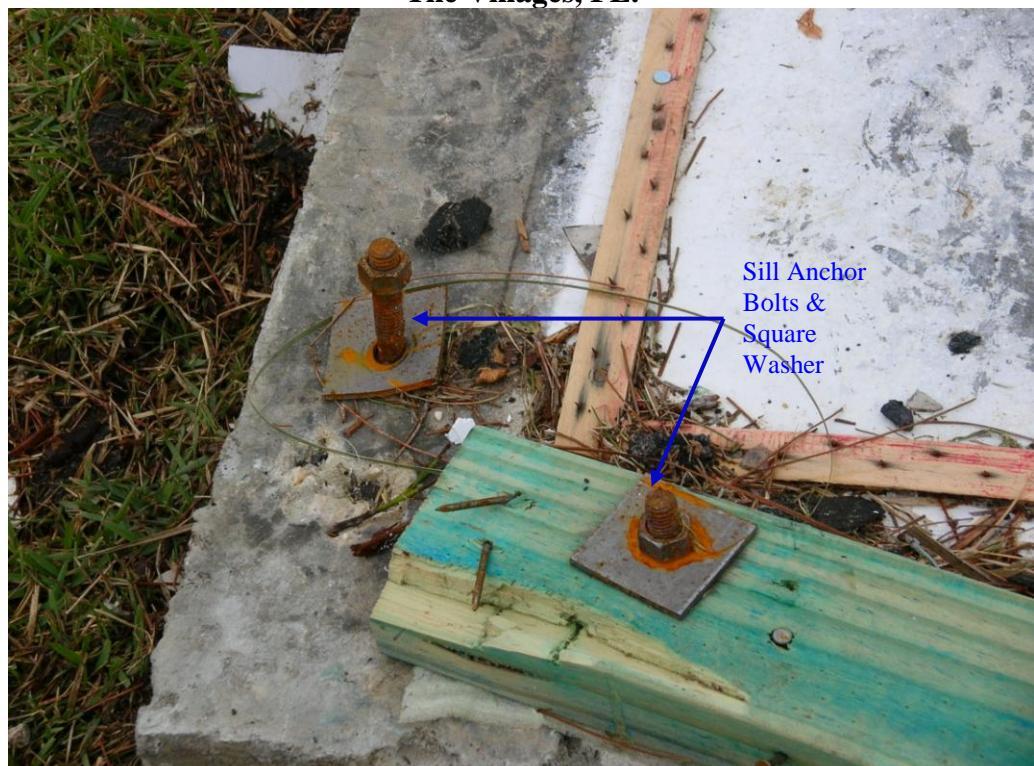
Figure 2-22. Damage to a home on Ft. Lawn Lp., in the Village of Mallory Square, The Villages, FL.

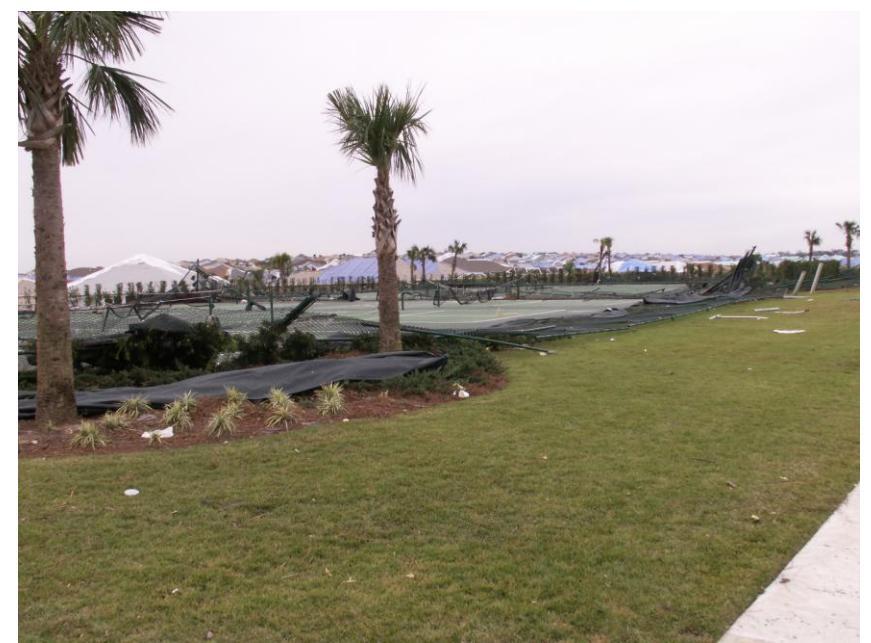
Figure 2-23. Damage to Coconut Cove Tennis Center across from Ft. Lawn Loop., in the Village of Mallory Square, The Villages, FL.

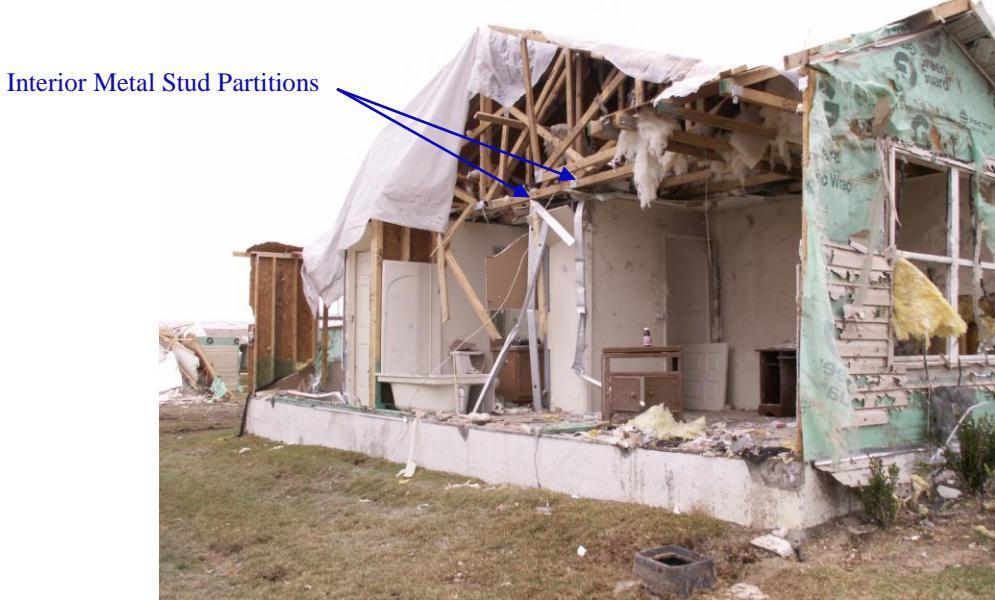
Figure 2-24. DOD 6 Gable End Failure with Steel Stud Interior Partitions, Village of Mallory Square, The Villages, FL.

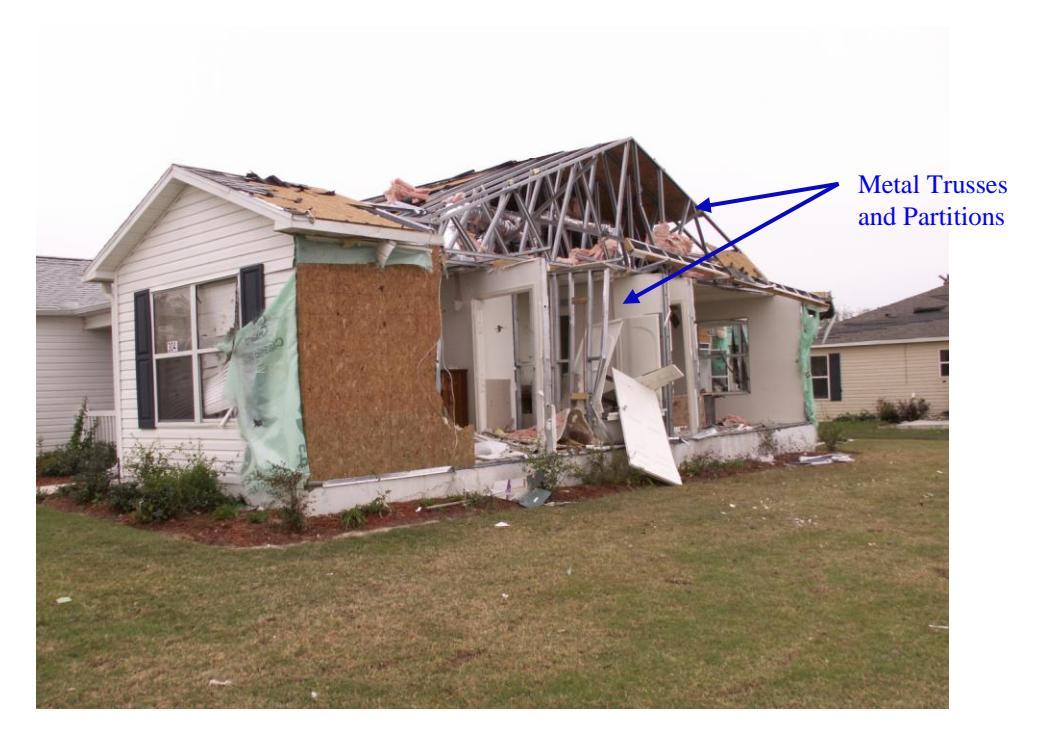
Figure 2-25. DOD 6 Gable End Failure to Metal Stud & Steel Truss Home, in the Village of Mallory Square, The Villages, FL.
