Tornado Damage Documentation – Using the EF-Scale

Central Florida Sumter County, Lake County, Volusia County February 2, 2007

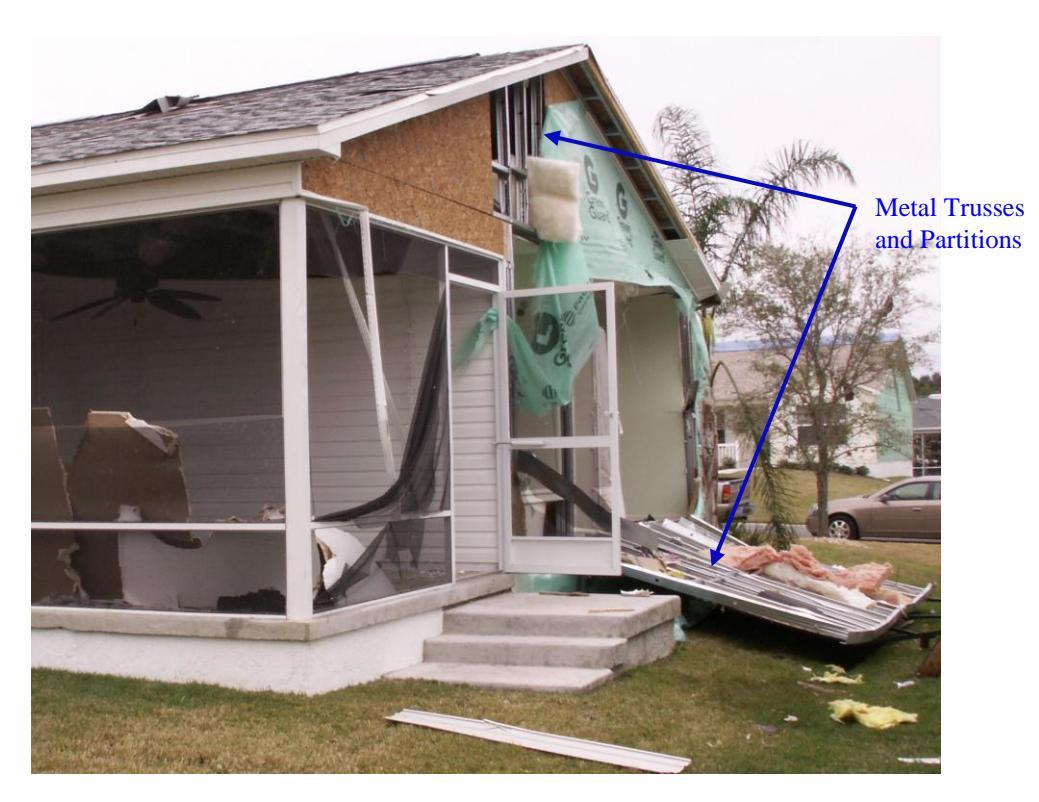
Figure 2-26. DOD 4 Gable End Failure to Metal Stud & Steel Truss Home, in the Village of Mallory Square, The Villages, FL.

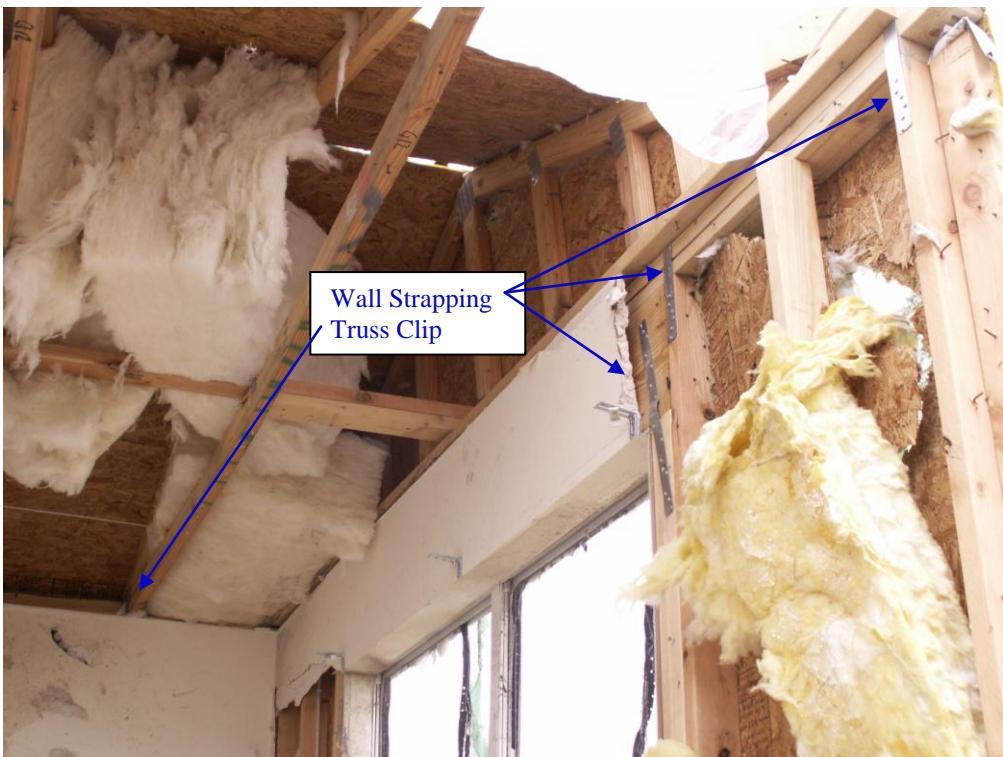
Figure 3-1. Typical Wall Strapping, The Villages, FL.

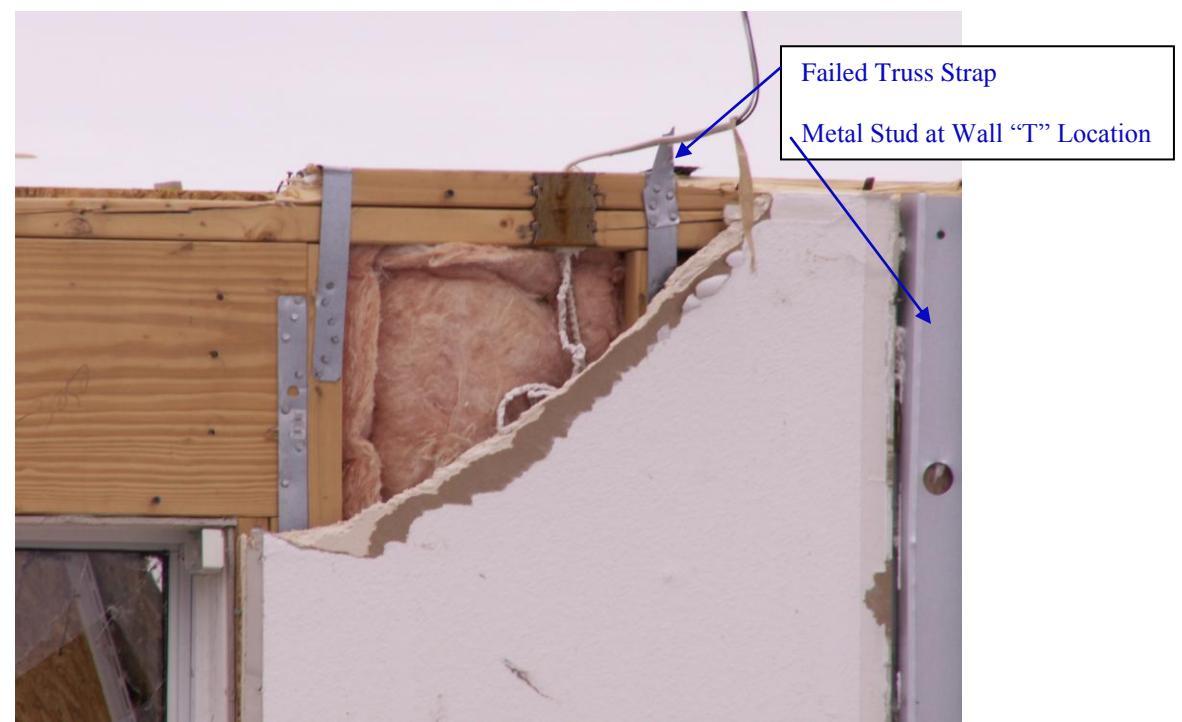
Figure 3-3. Failed Truss Strapping at Wood Frame Wall, The Villages, FL.

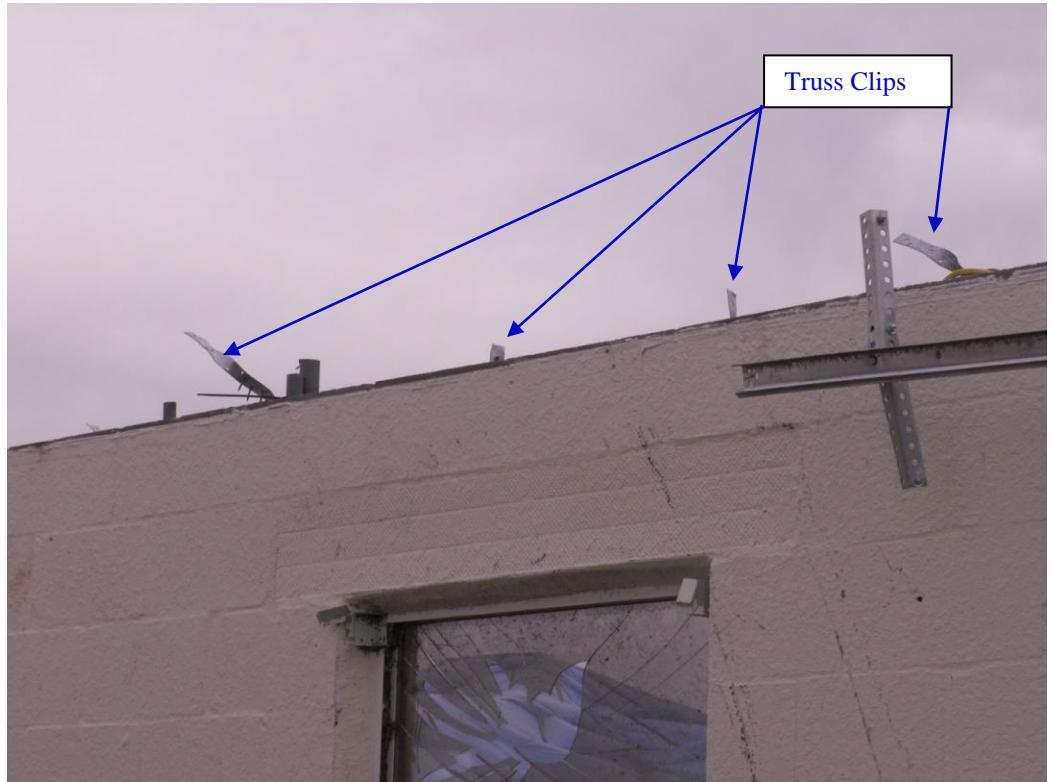
Figure 3-4. Failed Truss Strapping at CMU Wall, The Villages, FL.

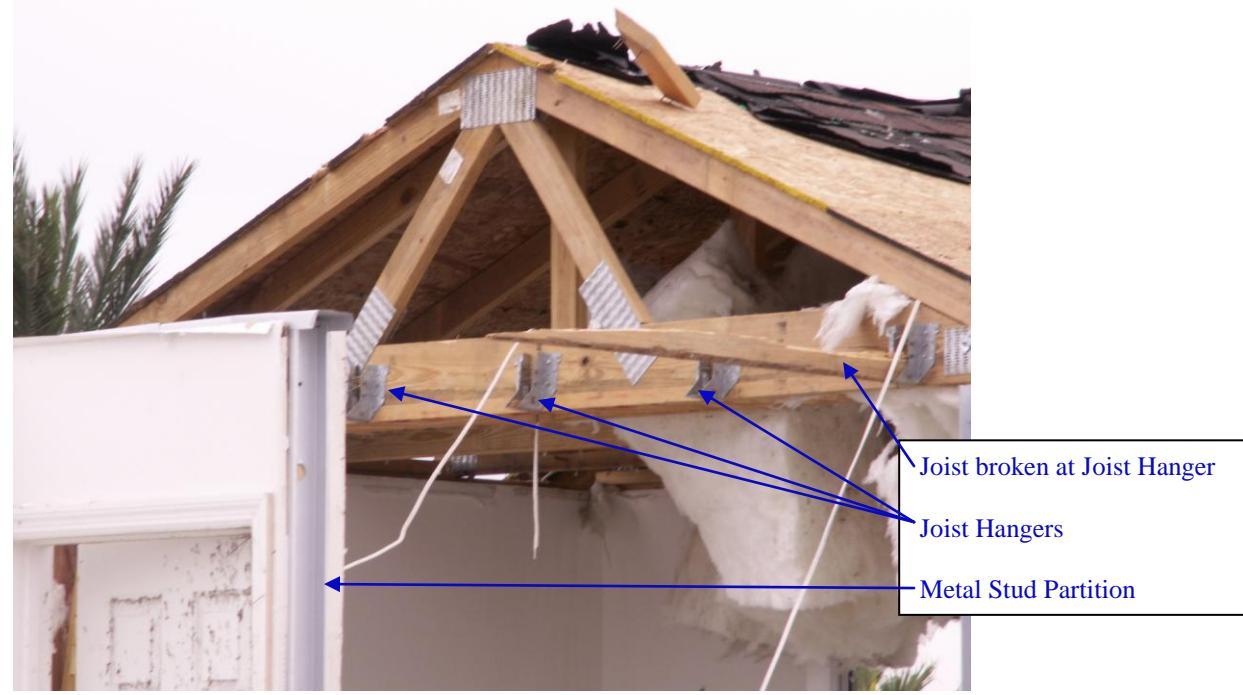
Figure 3-5. Structure Ripped from Joist Hangers, The Villages, FL.

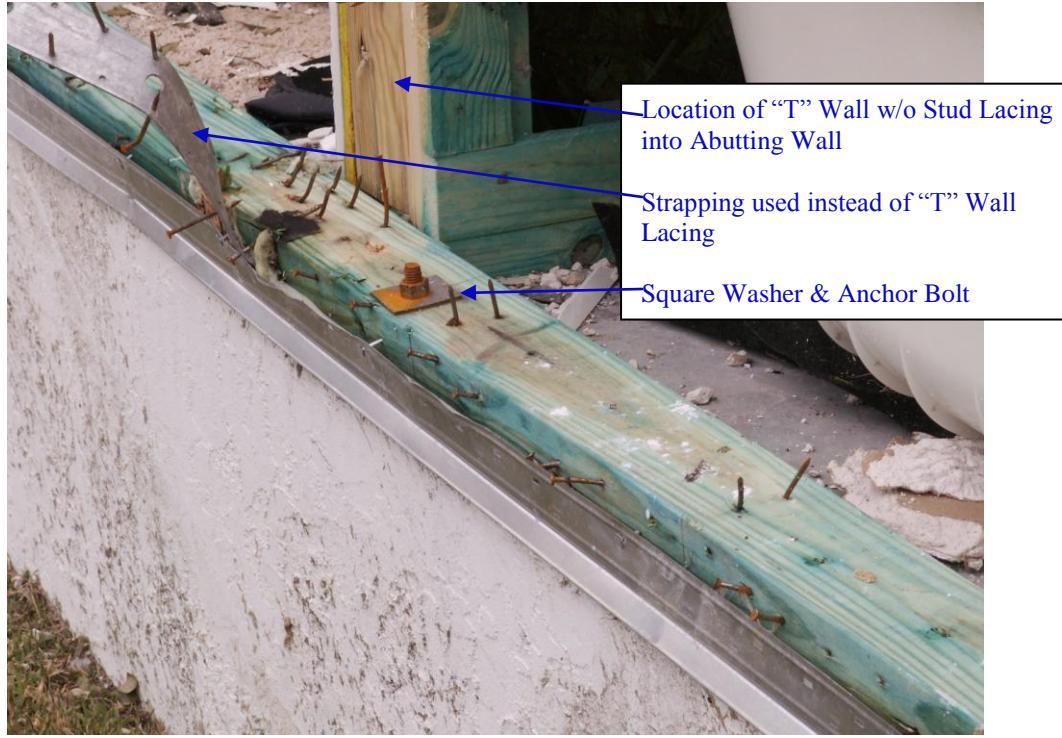
Figure 3-7. Failed "T" Wall Connection, The Villages, FL.

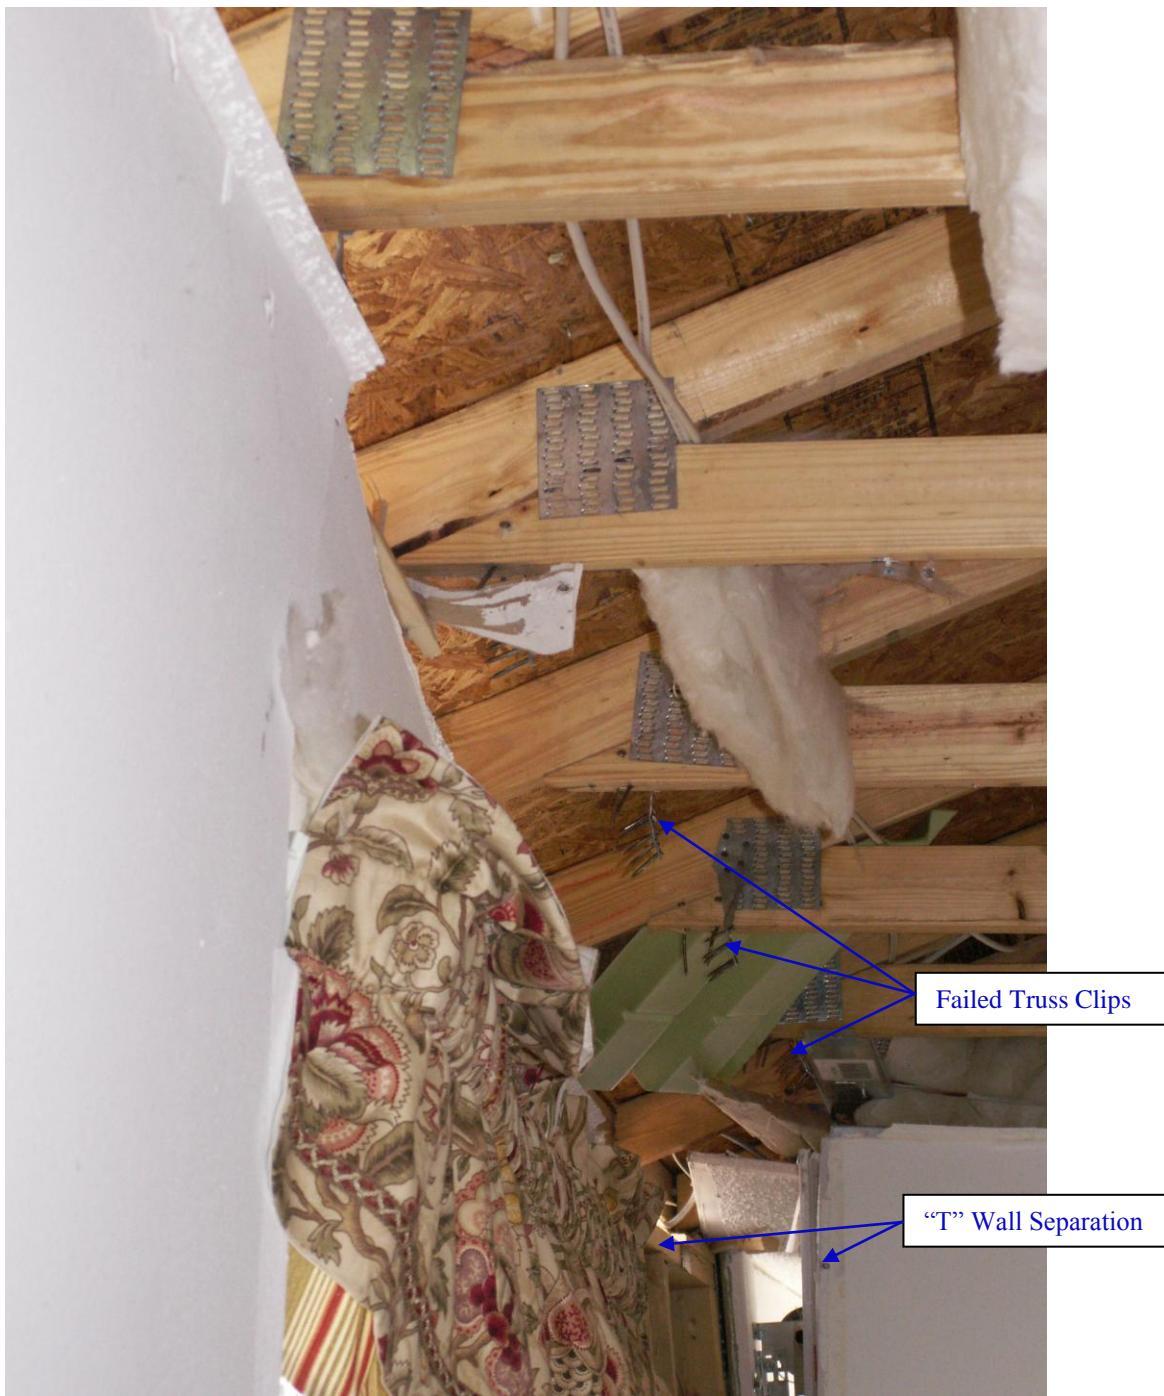
Figure 3-8. Wall Separation at "T" Wall, The Villages, FL.

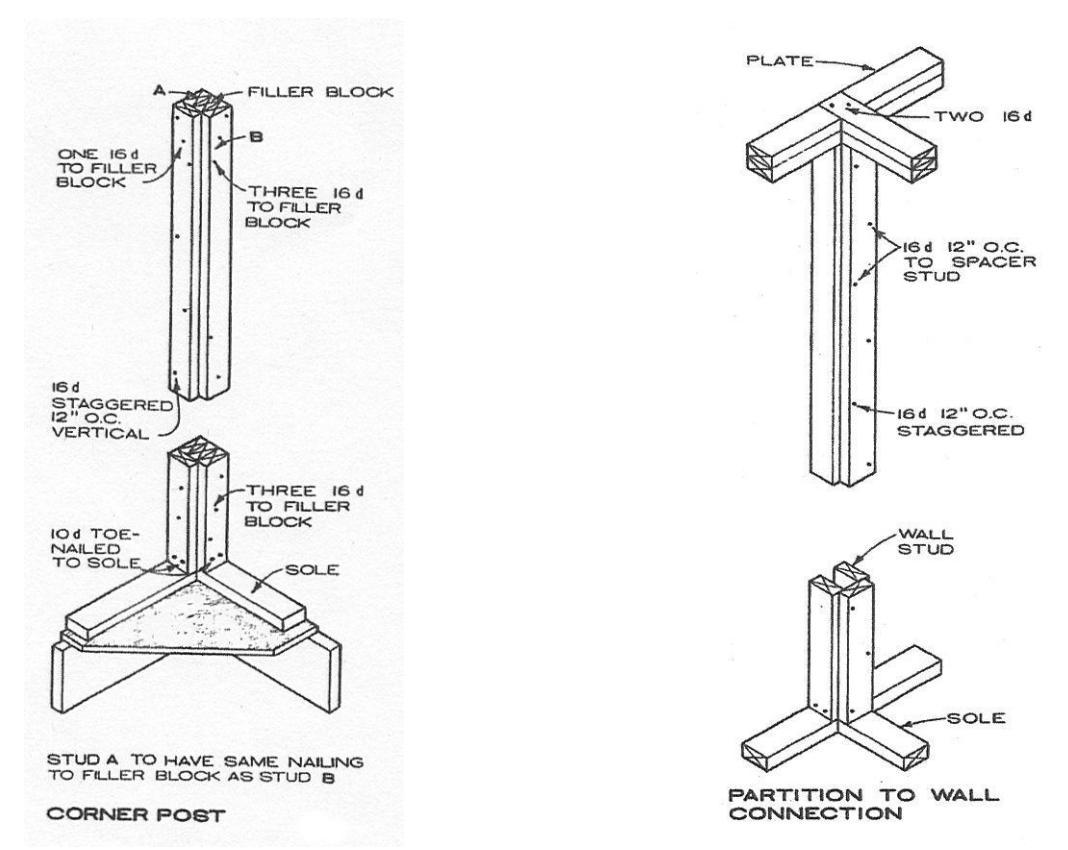
Figure 3-10. Traditional Const - Wall Corner.[7]

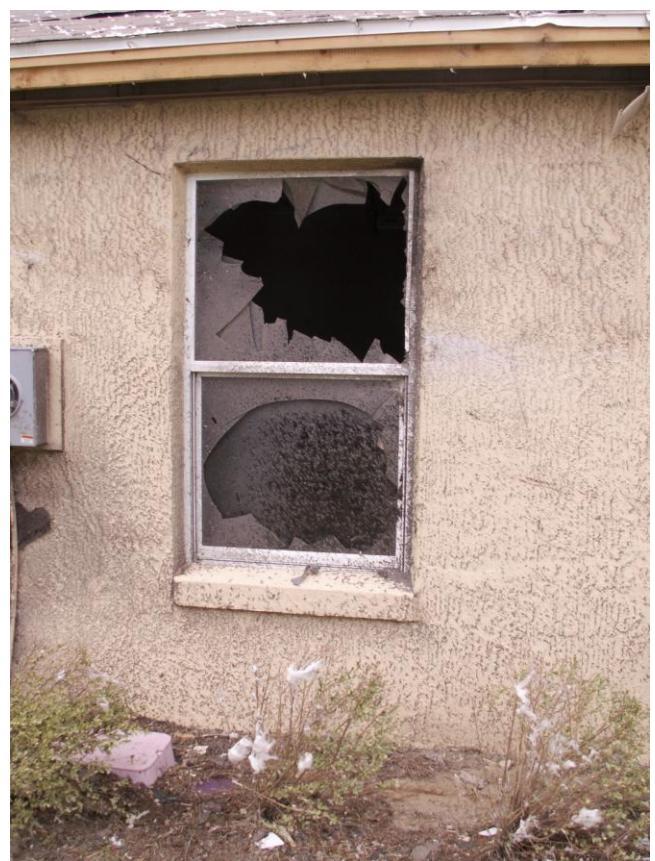
Figure 3-12. Impact Resistant Window Glazing, The Villages, FL.

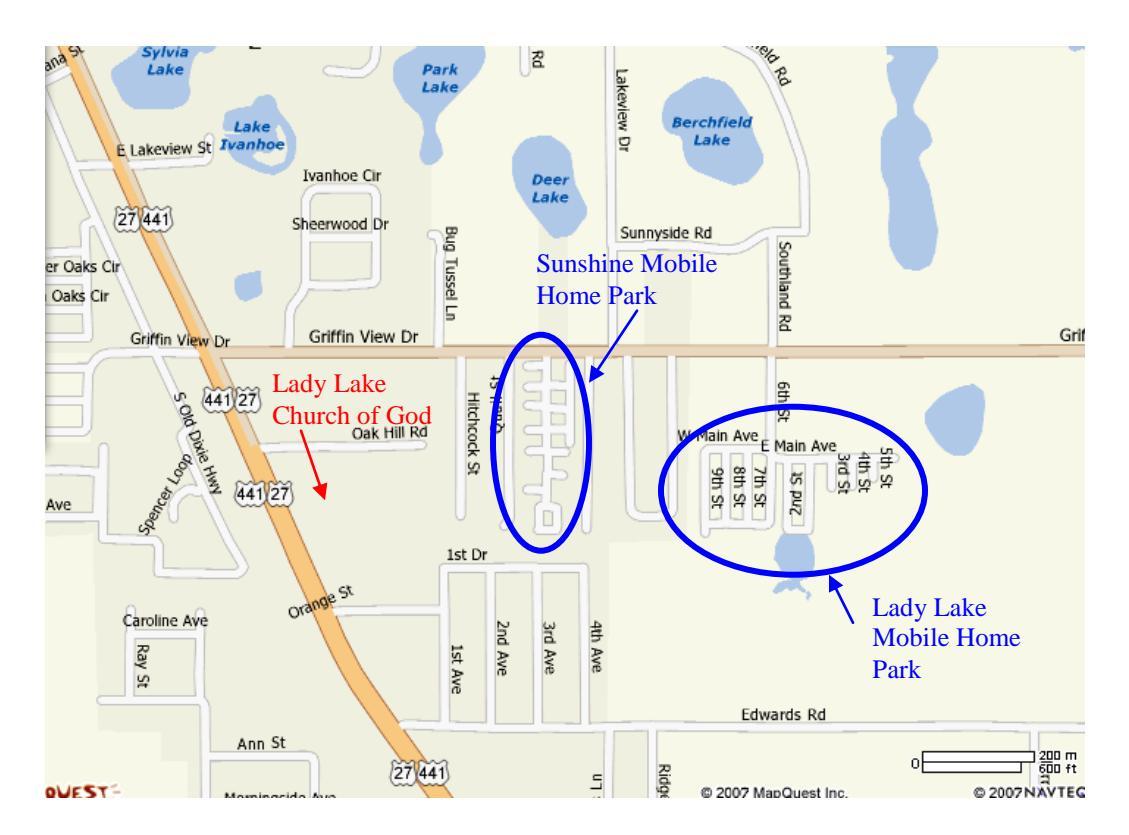
Figure 4-1. Map of area investigated in Lady Lake, FL.

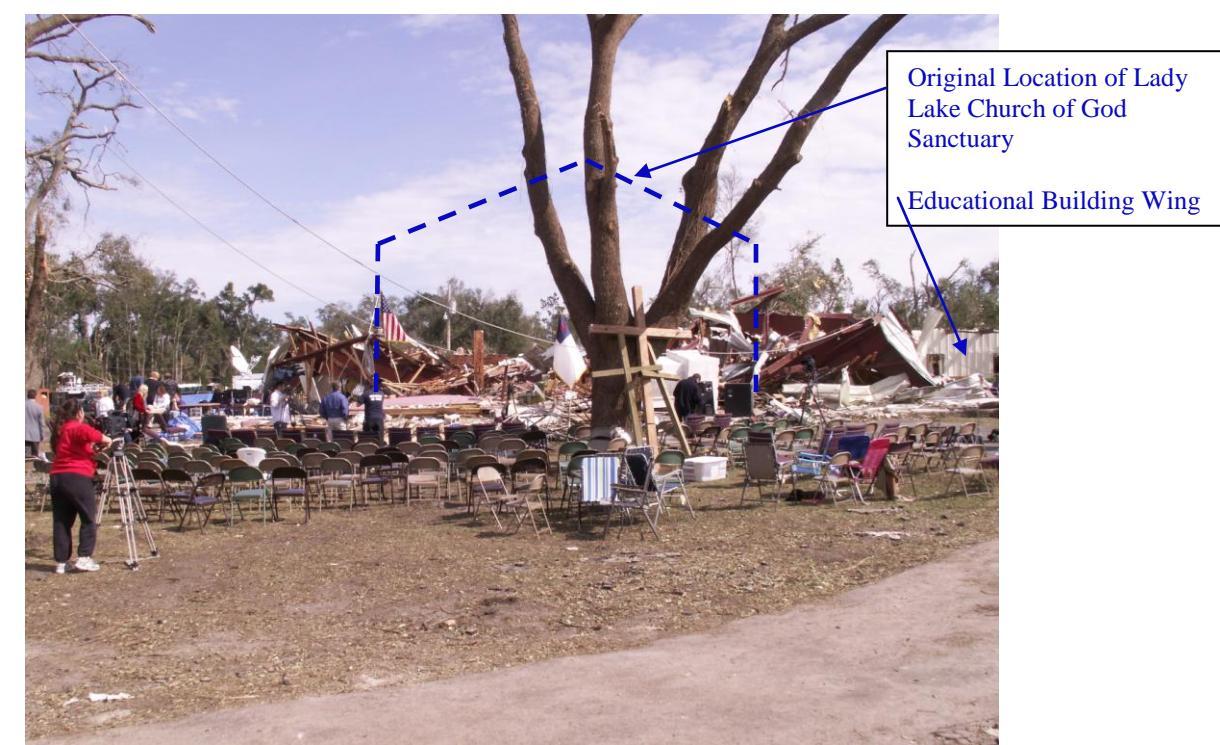
Figure 4-2. (MBS) DOD 8, Lady Lake Church of God view from US HWY 27 (West Elevation), Lady Lake, FL.

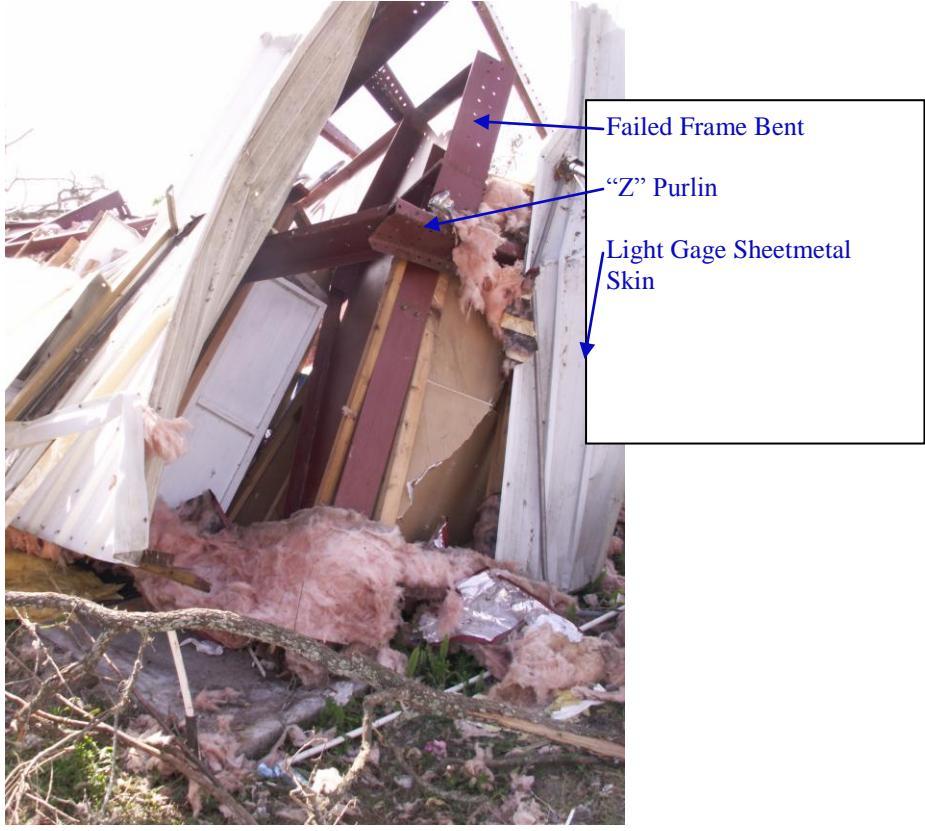
Figure 4-4. (MBS) DOD 8, Lady Lake Church of God, typical failed Frame Bent, Lady Lake, FL.

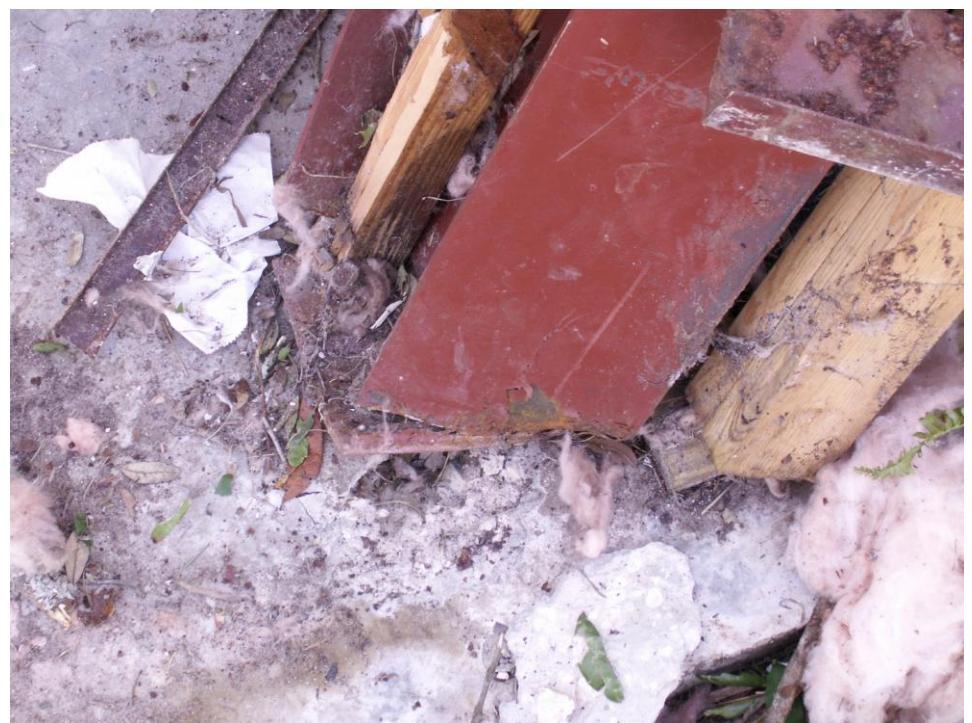
Figure 4-5. (MBS) DOD 8, Lady Lake Church of God view from US HWY 27 (West Elevation), Lady Lake, FL.

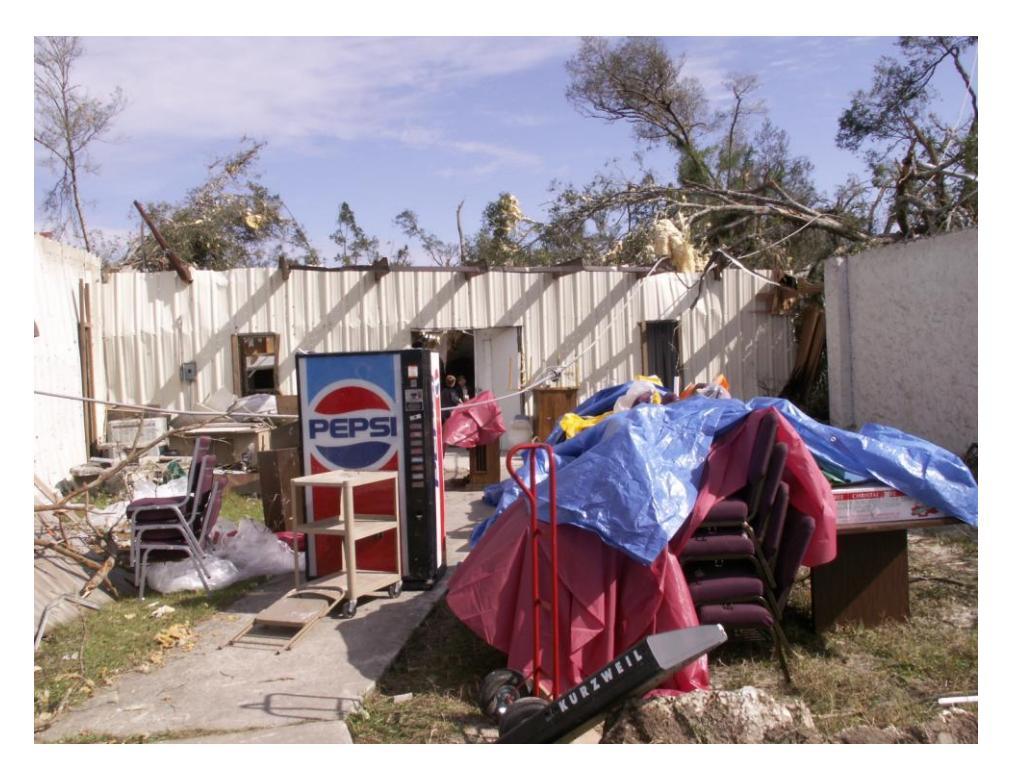
Figure 4-6. (MBS) DOD 8, Educational Building Damage at the Lady Lake Church of God, Lady Lake, FL.

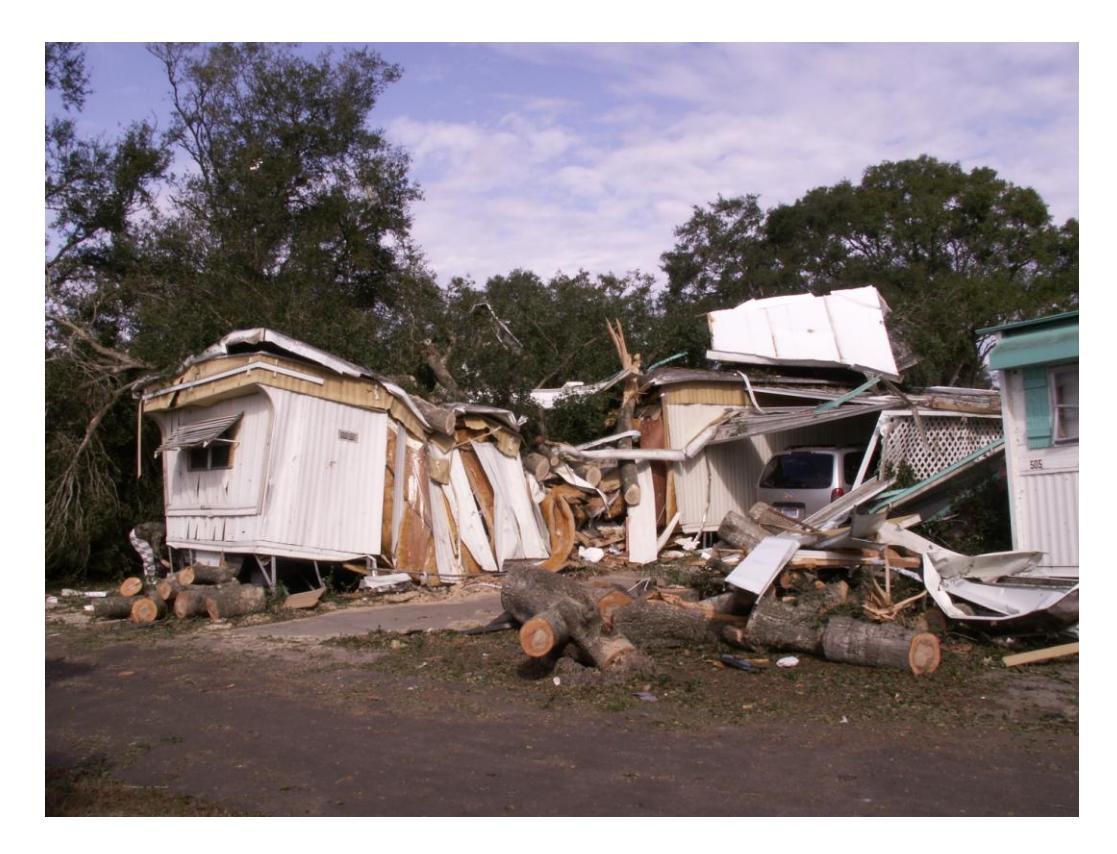
Figure 4-7. Typical tree damage to homes in Sunshine Mobile Home Park, Lady Lake, FL.

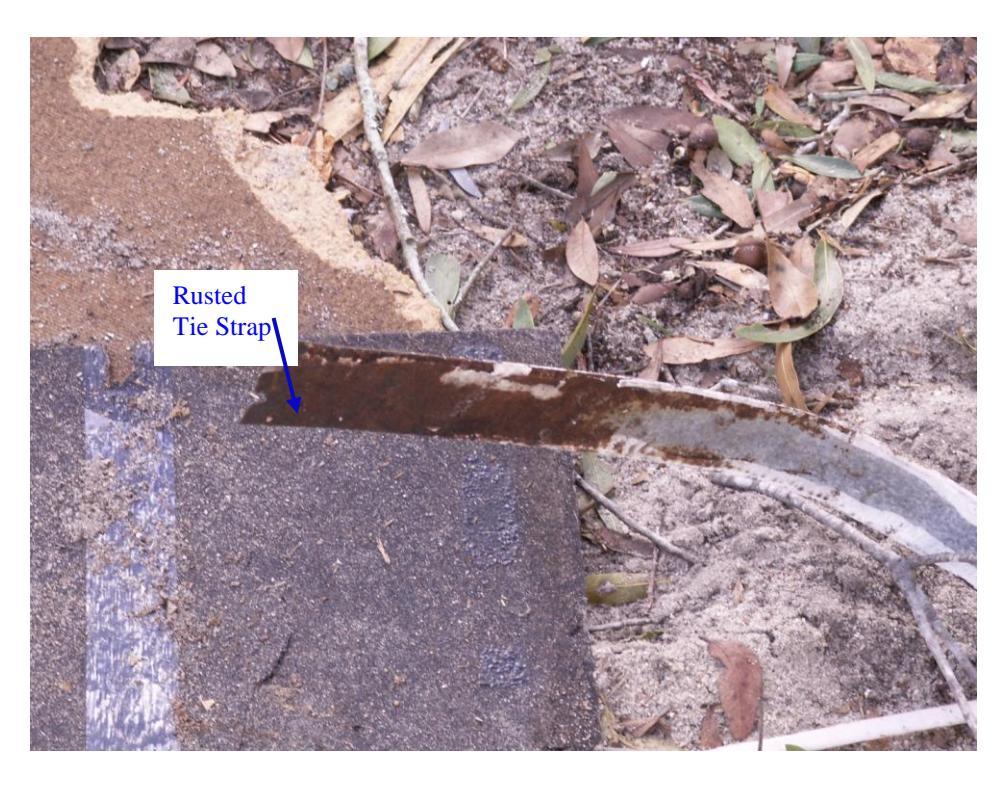
Figure 4-8. A rusted and snapped tiedown in Sunshine Mobile Home Park, Lady Lake, FL.

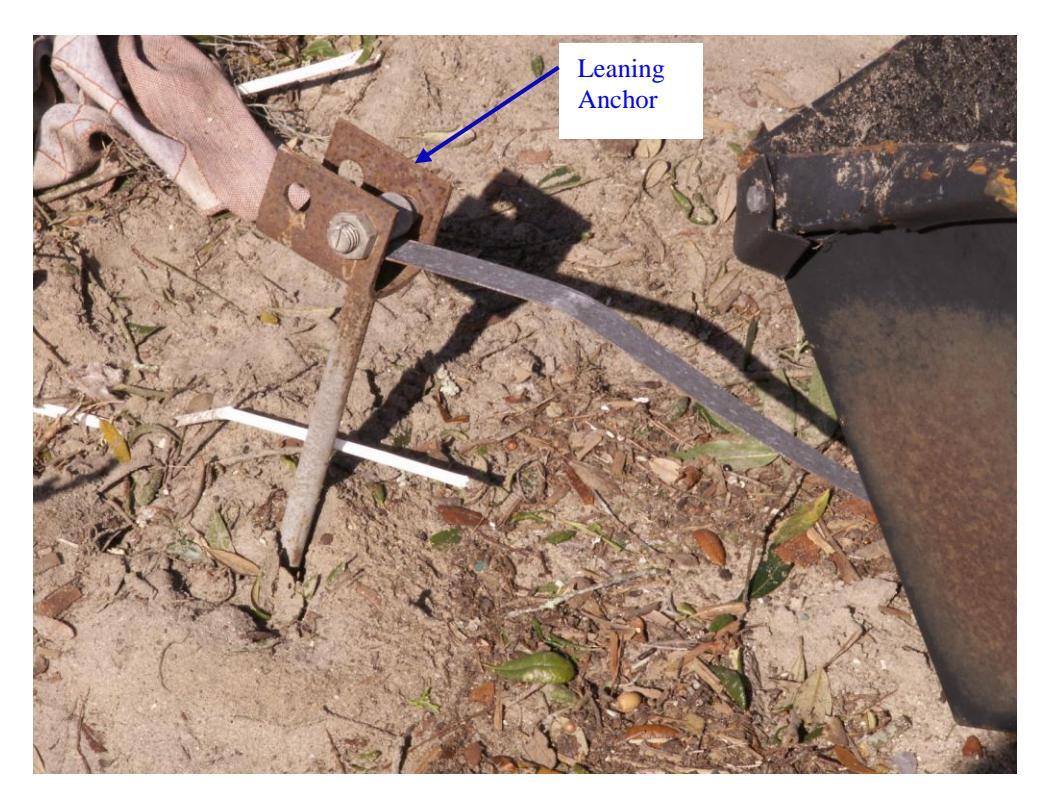
Figure 4-9. Improperly installed anchor that has moved in the sandy soil, Sunshine Mobile Home Park, Lady Lake, FL.

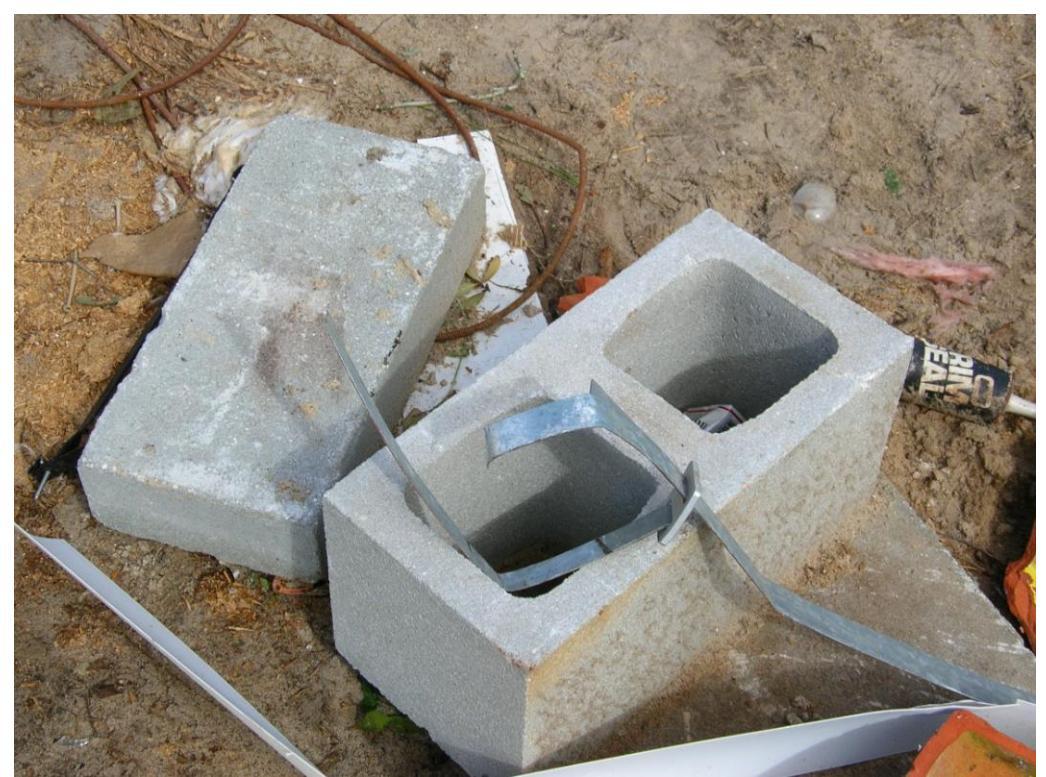
Figure 4-11. An undercarriage strap snapped at a MHSW in Lady Lake Mobile Home Park, Lady Lake, FL.

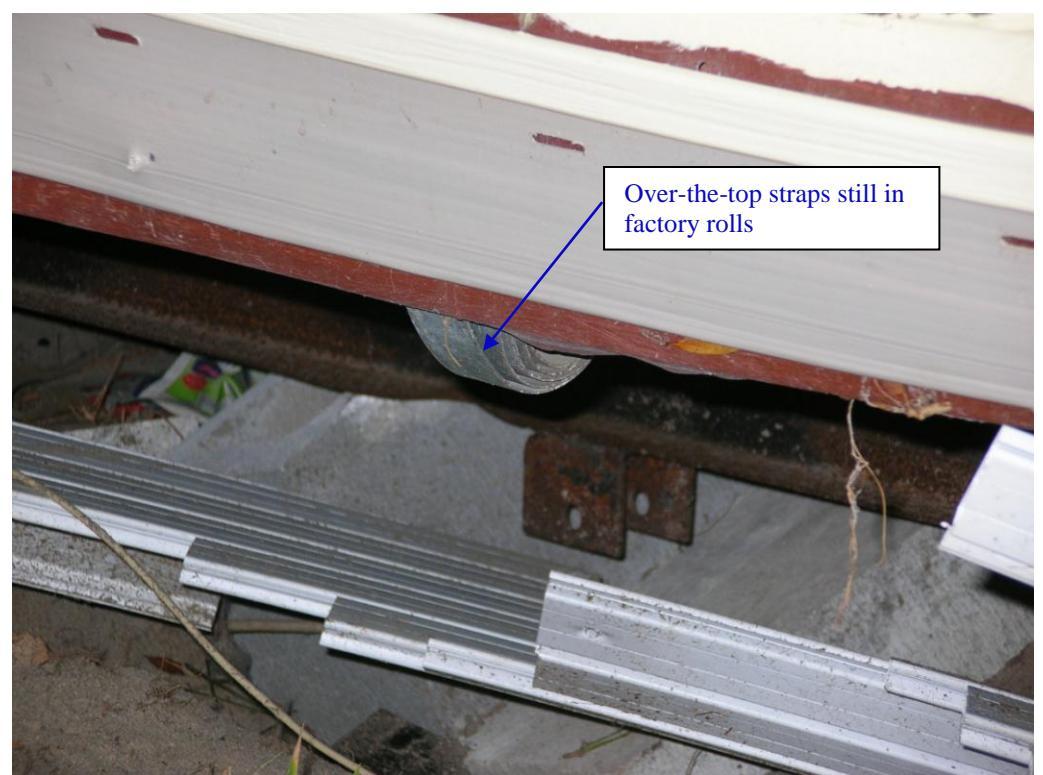
Figure 4-14. A rolled up strap not being used at a MHSW home in Lady Lake Mobile Home Park, Lady Lake, FL.

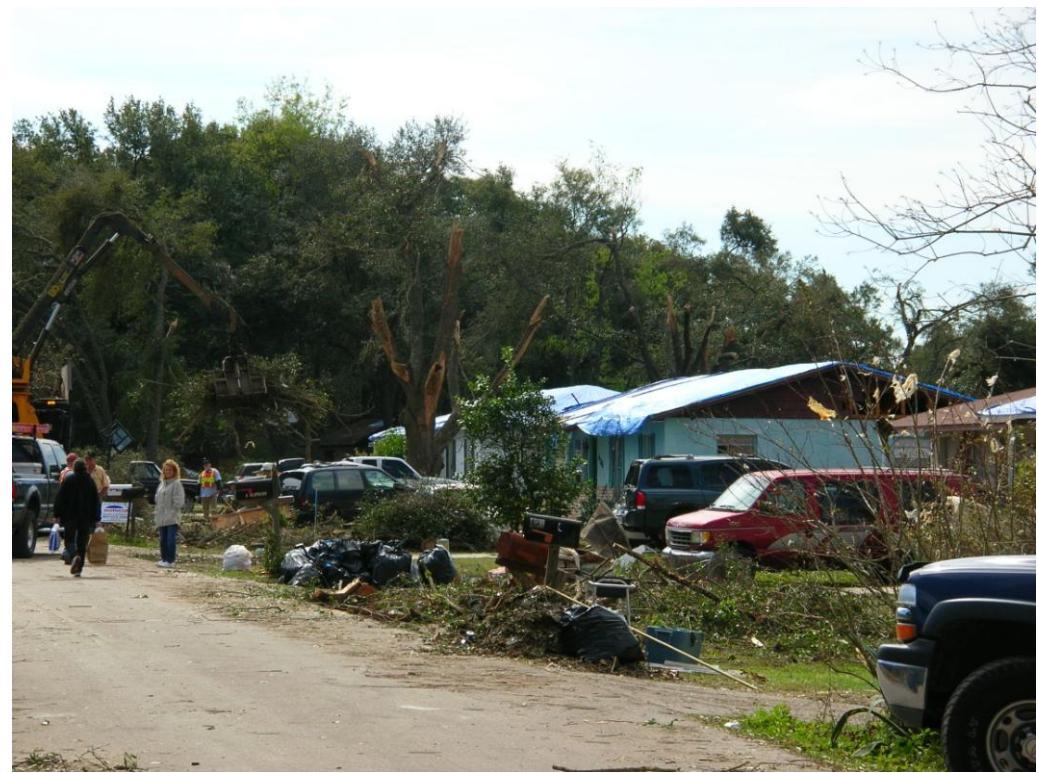
Figure 4-15. DOD 4 Damage to CMU homes between Sunshine Mobile Home Park, and Lady Lake Mobile Home Park is limited to roof damage.

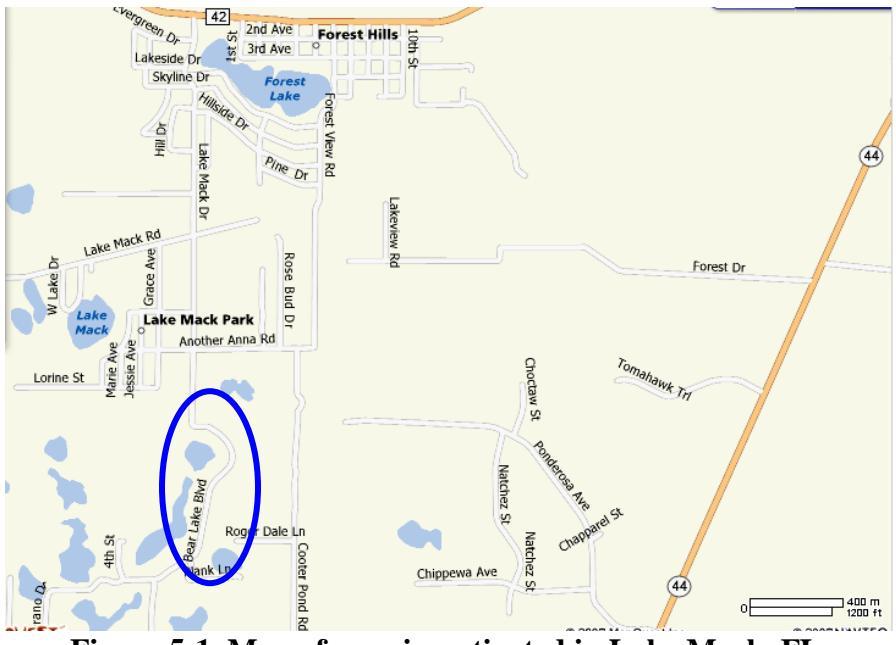
Figure 5-1. Map of area investigated in Lake Mack, FL.

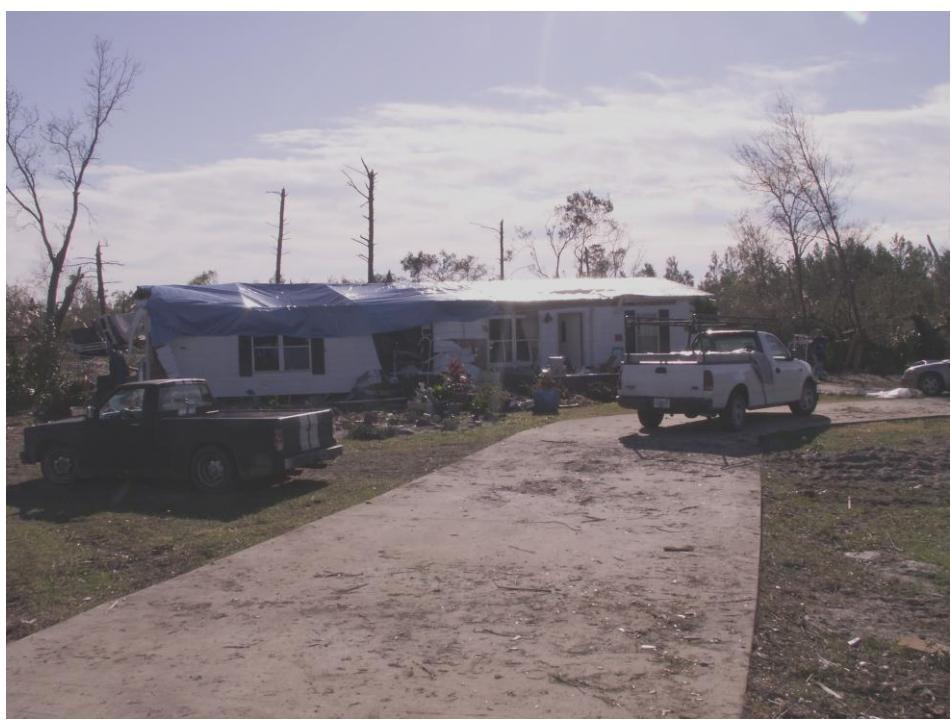
Figure 5-2. DOD 6 MHDW Home, Bear Lake, Lake County, FL.

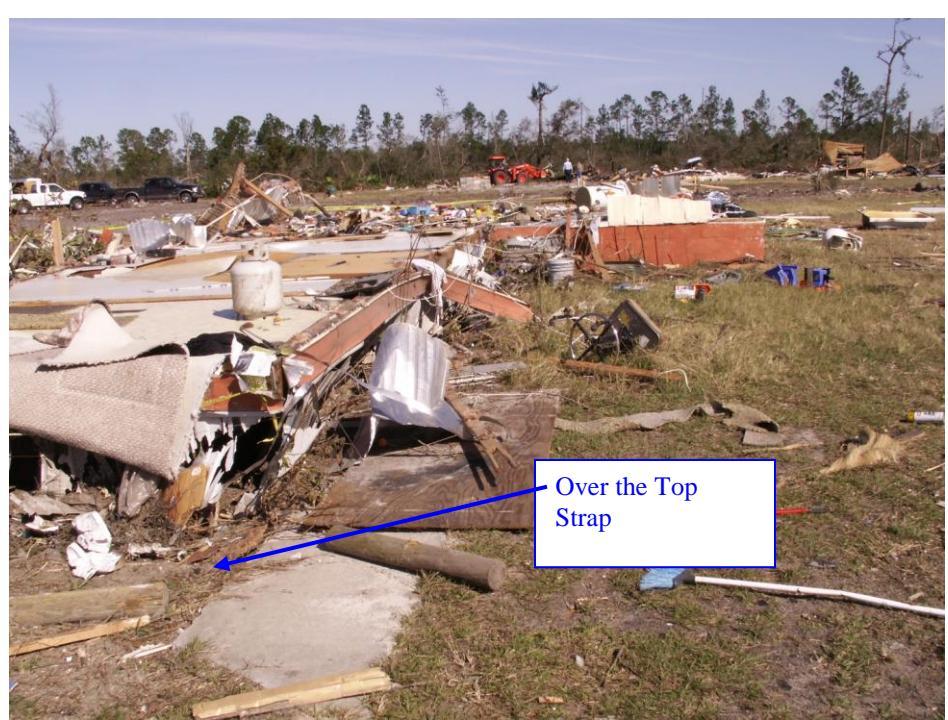
Figure 5-7. DOD 6 MHSW home with over-the-top straps attached at both sides of the home, which blew out from under the straps in Bear Lake, FL.

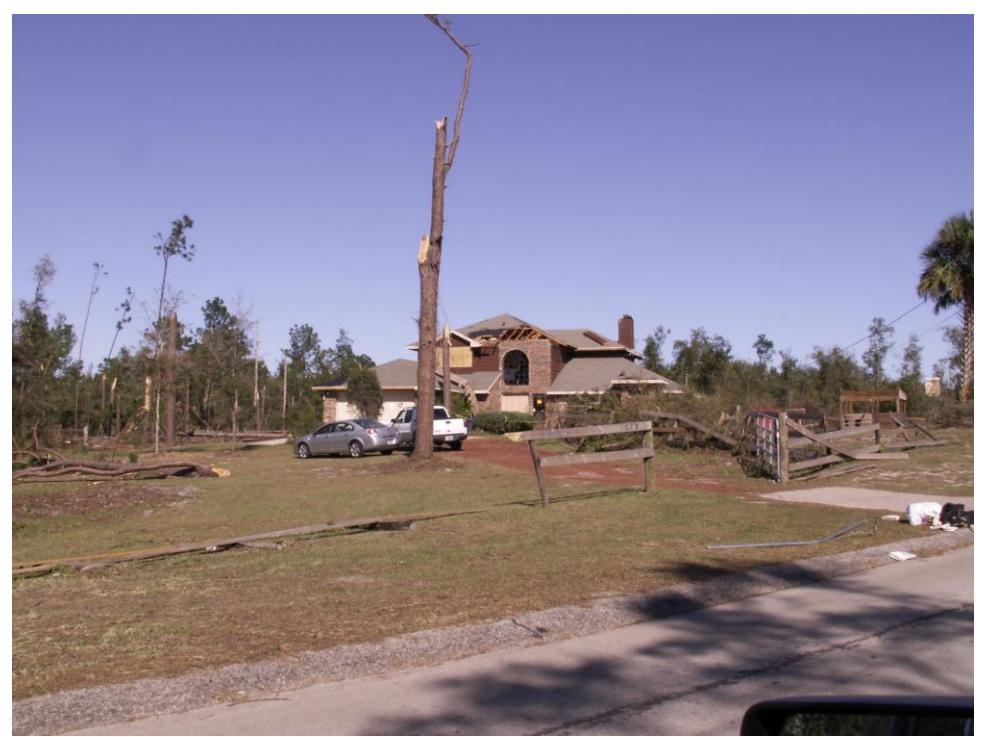
Figure 6-1. DOD 2 Residential Damage, Deland, Volusia County, FL.

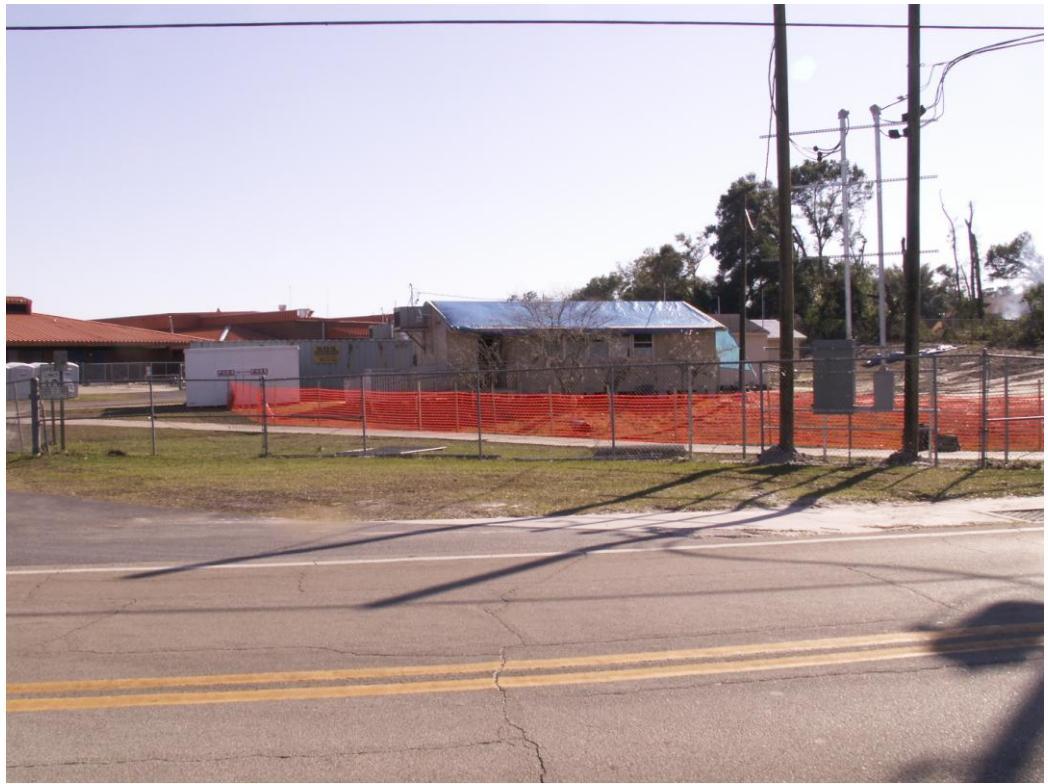
Figure 6-2. DOD 2 Middle School Roof Damage, Deland, Volusia County, FL.

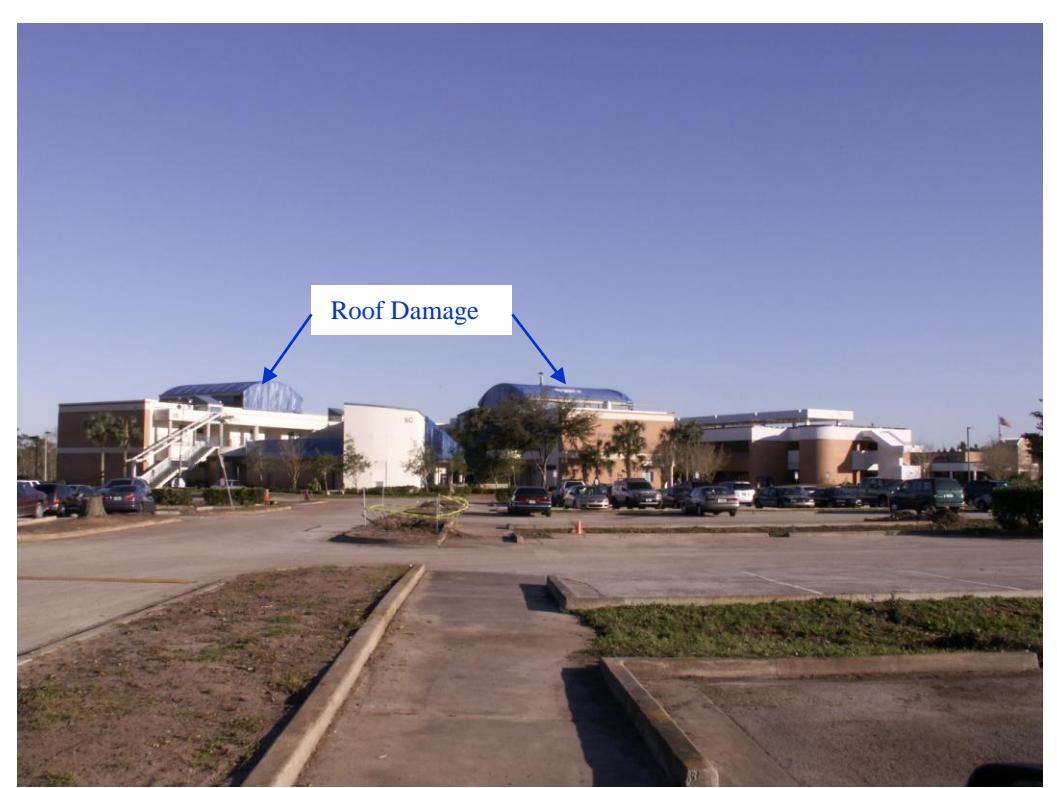
Figure 6-3. DOD 2 Roof Damage, Florida Technical College, Deland, Volusia County, FL.

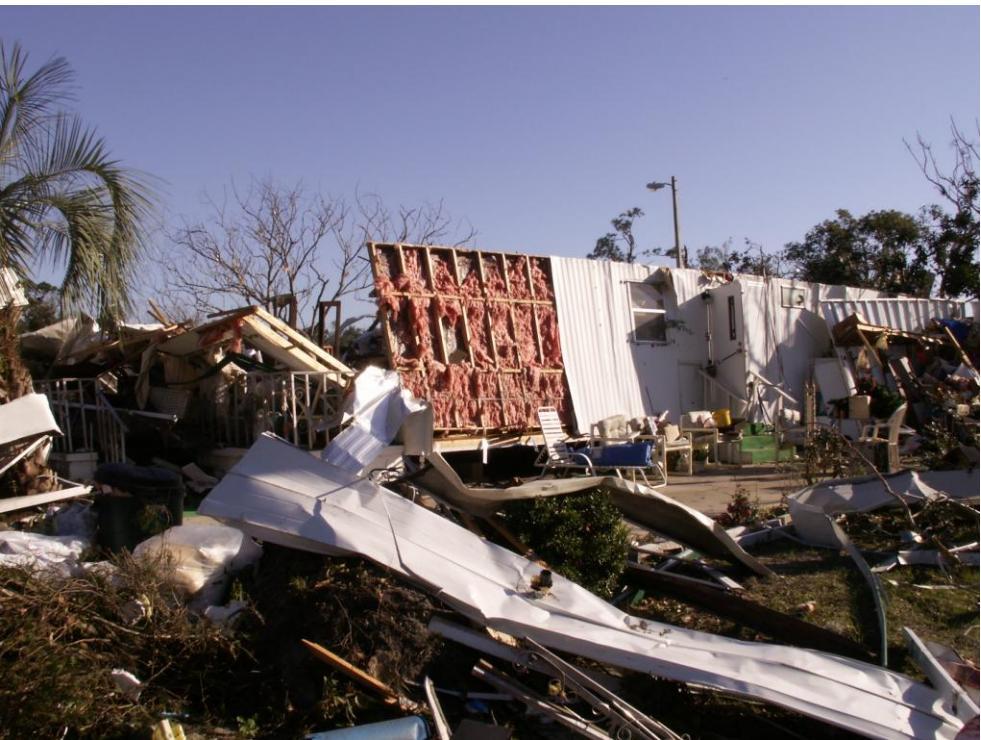
Figure 6-4. DOD 6 MHSW Damage, Hawthorne MH Park, Deland, Volusia County, FL.
