Tornado Damage Documentation – Using the EF-Scale

Central Florida Sumter County, Lake County, Volusia County February 2, 2007

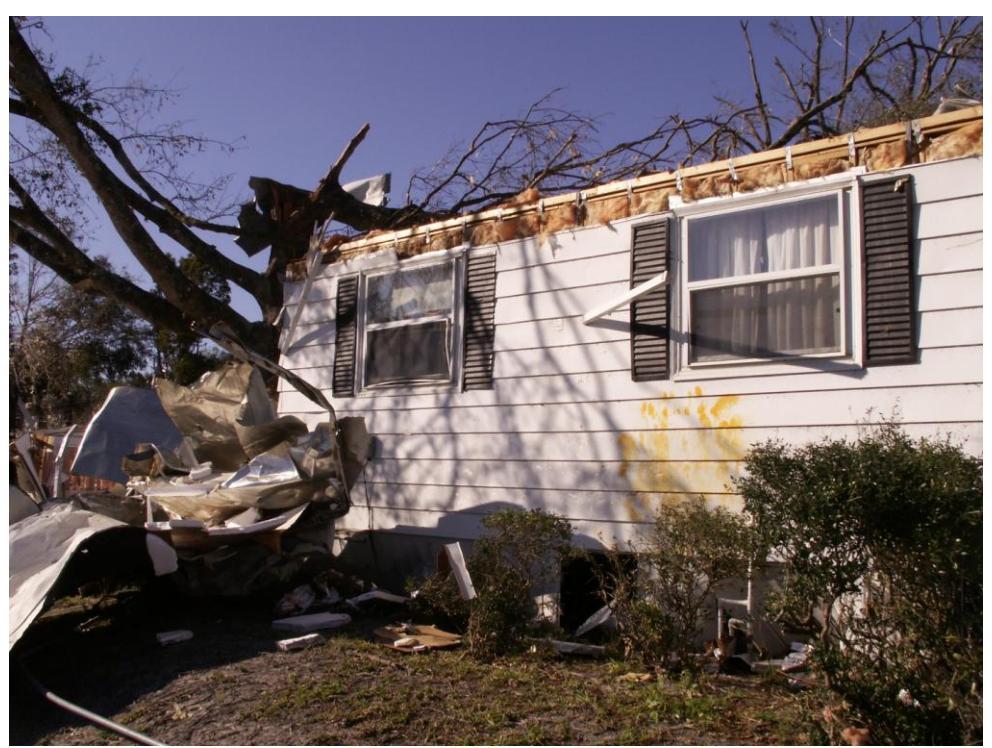
Figure 6-5. DOD 4 MHSW Damage, Hawthorne MH Park, Deland, Volusia County, FL.

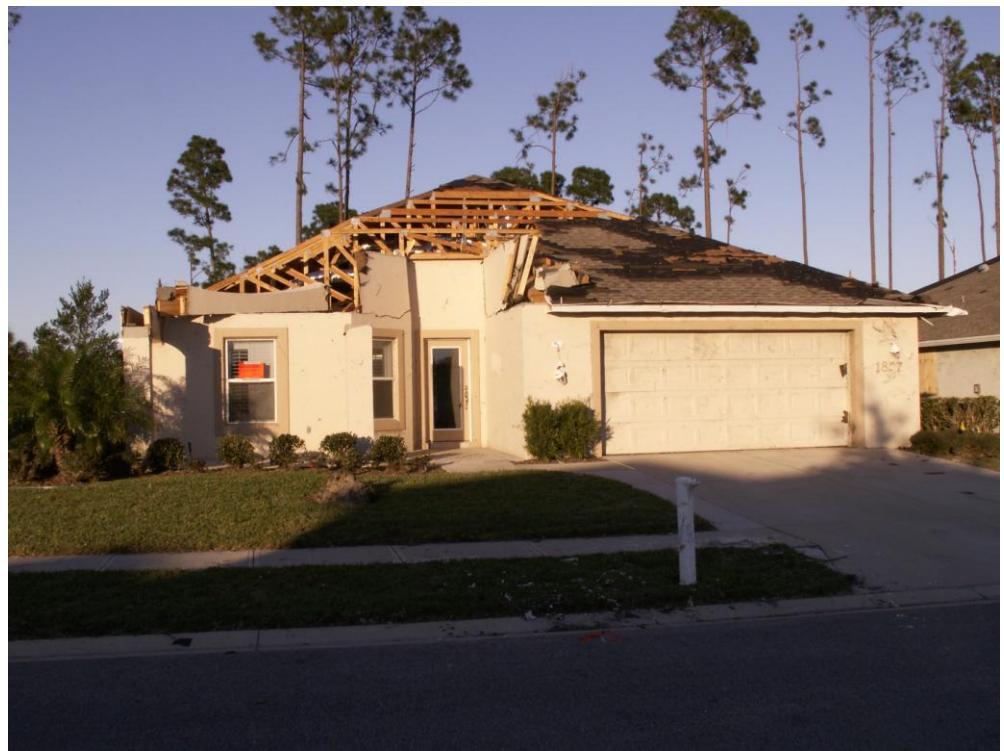
Figure 6-6. DOD 4 Residential Damage, New Smyrna , Volusia County, FL.

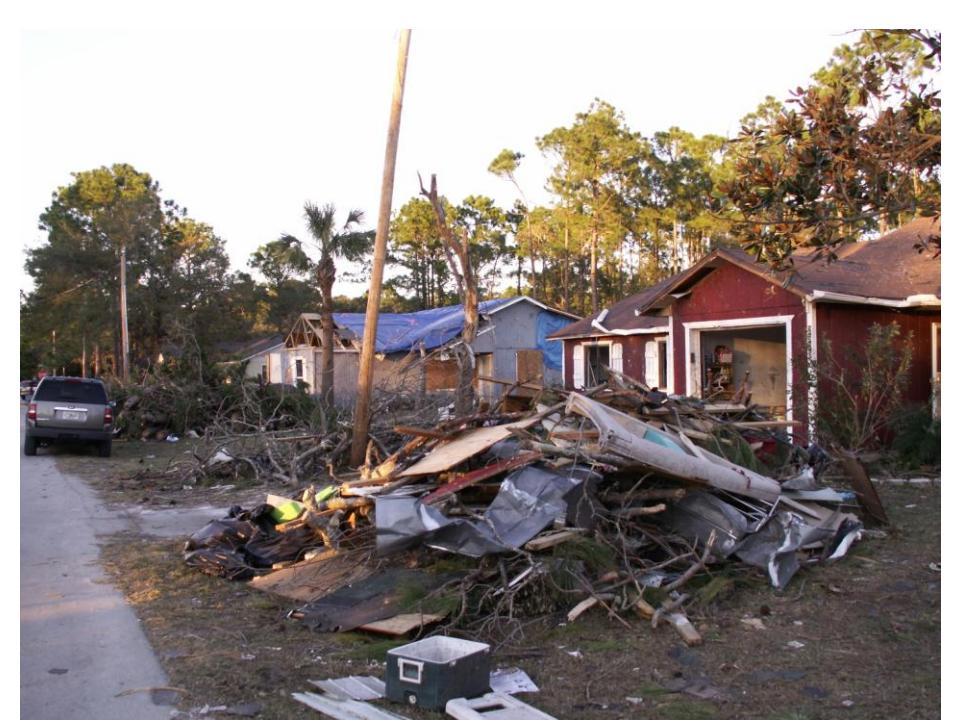
Figure 6-7. DOD 2 Residential Damage, New Smyrna, Volusia County, FL.
