Tornado Damage in Happy, Texas,

May 5, 2002

A report prepared by Larry J. Tanner, P.E.

Submitted to NIST

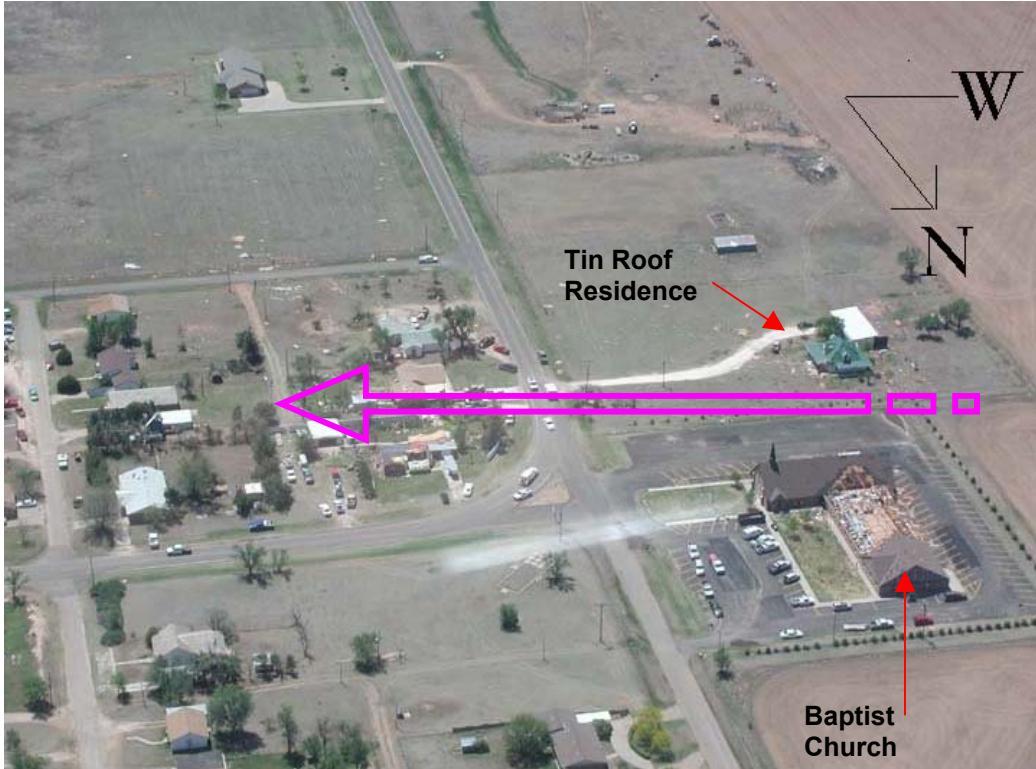
Figure 2. Tornado Path

Figure 2 is an aerial view depicting the entry point of the storm into Happy. The first buildings damaged were the First Baptist Church educational building and a tin roof single-family residence approximately 150 feet south of the church. The church sanctuary experienced minor shingle damage and the northeast corner of the residence roof was damaged. However, the educational wing of the church was extensively damaged.

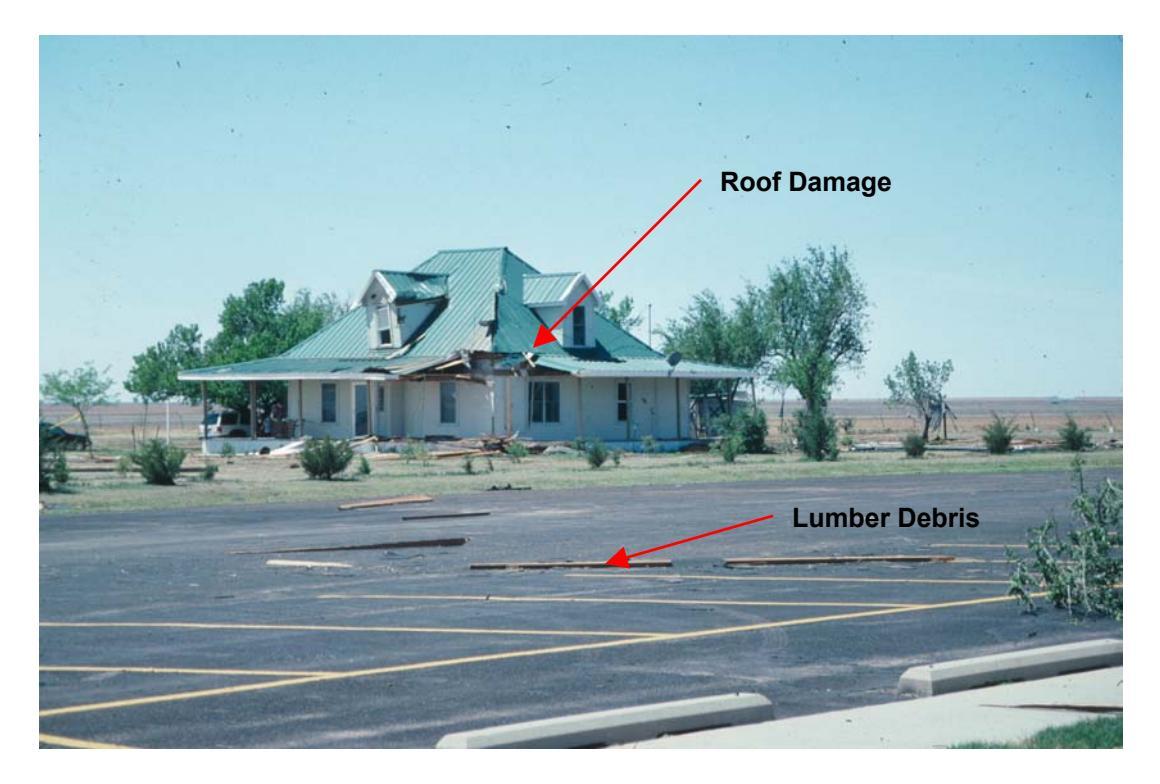
Figure 3. Tin Roof Residence, northeast corner

Of particular interest is the minor damage inflicted on the church sanctuary and the residence, **Figure 3**, and the extensive damage inflicted on the church educational wing, **Figure 4**. The residence suffered minor damage to the roof and porch northeast corner. The lumber debris in the foreground of **Figure 3** indicates the general direction of the storm path. Combining the assigned wind speeds of 113-130 mph (54-61 m/s) with the storm translational speed of 20 mph (9 m/s) renders a storm entry point speed of approximately 122-150 mph (58-71 m/s). The minor nature of the damage to the residence and the sanctuary therefore leads one to believe the vortex width to be quite narrow, less than 150 feet, and perhaps not even on the ground.

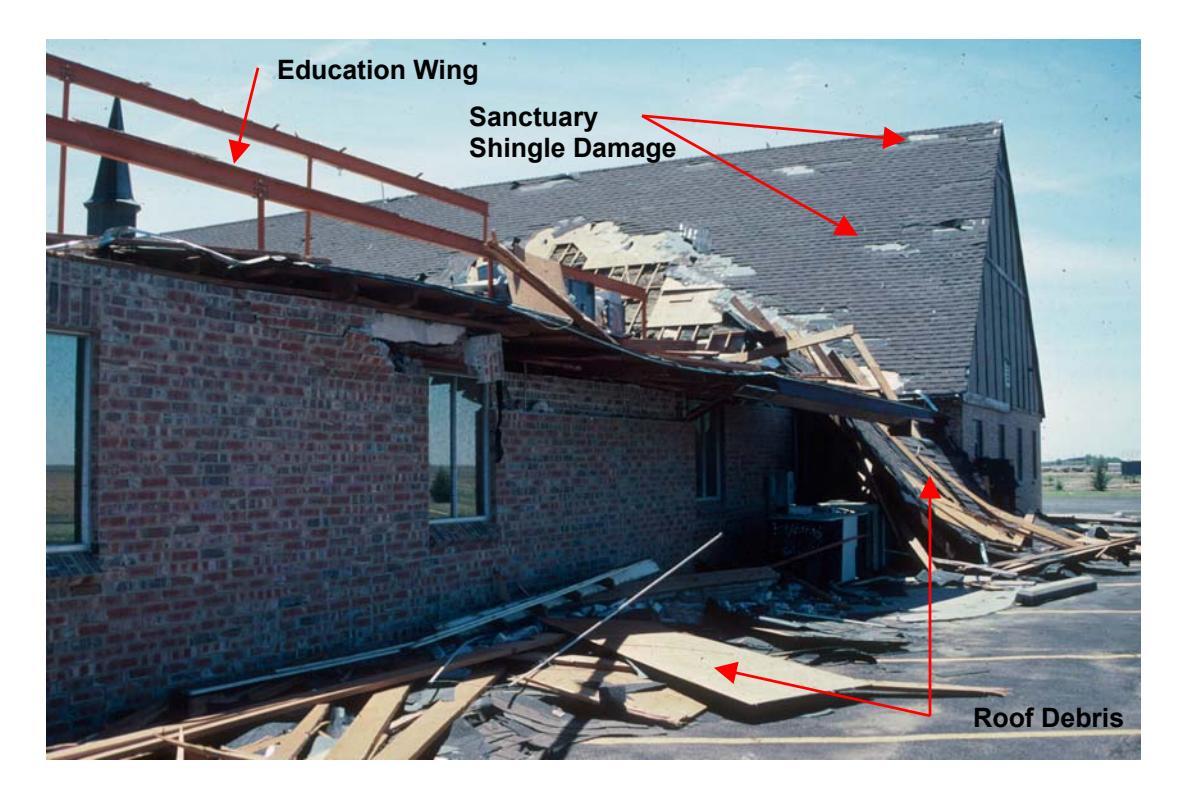
Figure 4. First Baptist Church Storm Damage, northwest corner

Inspection of **Figure 4** reveals the roof debris from the education wing on the west side of the building. One would normally consider the west building face in a west to east moving storm to be considered the windward face. However, the location of the debris suggests otherwise. As previously discussed, the northwest side of this tornado (backside) should have been slower than the other storm quadrants. However, tornado speeds can be modified by numerous conditions that can occur within the storm. The storm contains inflow (convergence) winds, outflow (divergence) winds and localized turbulence (gustiness). These conditions can lead to mesovortices (suction vortices), within and around the tornado edges, which form and dissipate continuously and produce higher wind speeds than the central storm vortex for its duration (Fujita, 1981). **Figure 7** shows a model illustrating Fujita's theory.

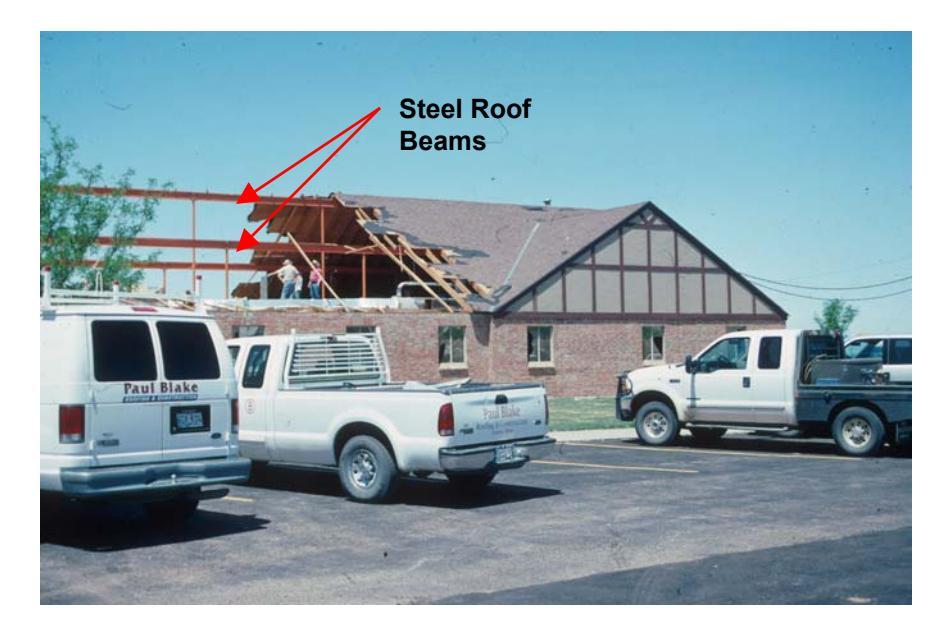
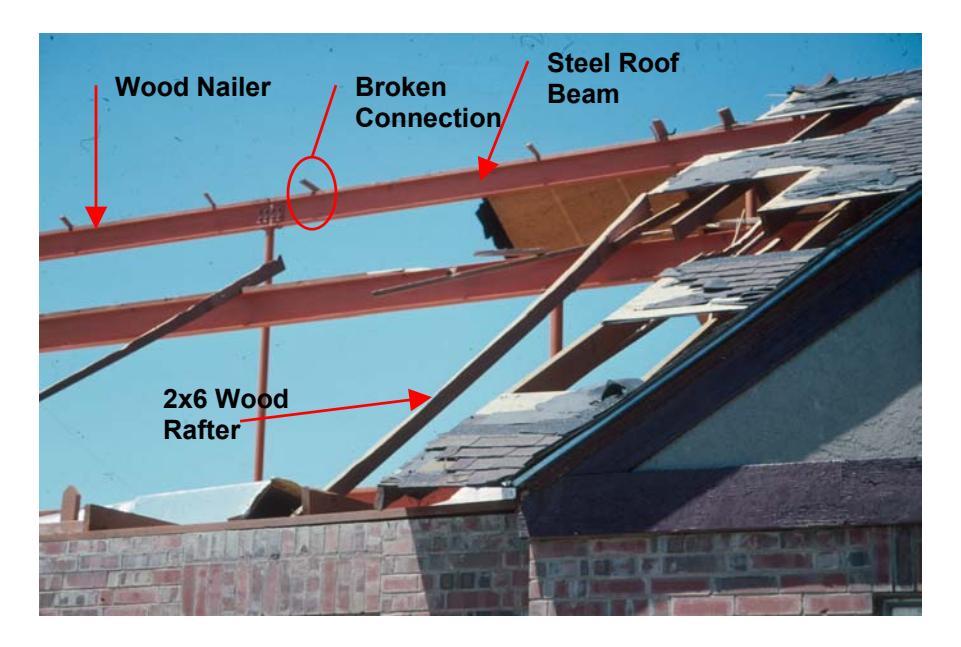
Somewhat anomalous is the extensive damage inflicted on the second story of the church education wing; see **Figure 5** and **Figure 6**. Several explanations can be offered for this anomaly. As previously explained for the tin roofed residence, the fastest wind speeds is assumed to be in the right front quadrant of the storm where you have the tangential velocity added to the translational velocity. In agreement to this theory, the back left quadrant would therefore be the weakest (tangential minus translational), or in this case, 93-110 mph (39-52 m/s). This would indicate that this near catastrophic failure occurred at wind speeds near the code design speeds and reflects little residual building strength.

Figure 5. Church Education Wing, east view

Figure 6. Education Wing Roof Structure

The First Baptist Church, Happy, Texas, was professionally engineered and constructed in 1965. Explanations for the building failures are numerous. It is unknown whether the level of engineering calculations included wind design. The science of wind engineering has progressed considerably since the construction of this church. In that era, it was common practice to rely upon the dead weight of building materials to resist the uplift forces produced by wind. Connections and member sizes would therefore only be designed for gravity loads. The church sanctuary was constructed of glue laminated wood arches and heavy timber decking. The education wing however was constructed of plywood sheathing nailed to long span 2x6 wood rafters, which were toenailed to steel beams by virtue of a wood nailer bolted to the top flange of the beams. **Figure 6** shows the long span of the rafters and various broken connections. Given the wind speeds, previously assumed, the roof structure could have experienced failure resulting from the reverse loading of the structural elements.

- 1. Partial destruction of site-built, wood frame structures indicates wind speeds above, but near the code design speed of 90 mph (38 m/s).
- 2. Damage to the education wing of the First Baptist Church was the result of backside winds from the tornado vortex, possibly a mesovortex or other turbulent winds. The roof failure was the result of uplift forces (negative pressures) acting upon long span rafters, lightweight decking and connections designed for gravity loads.

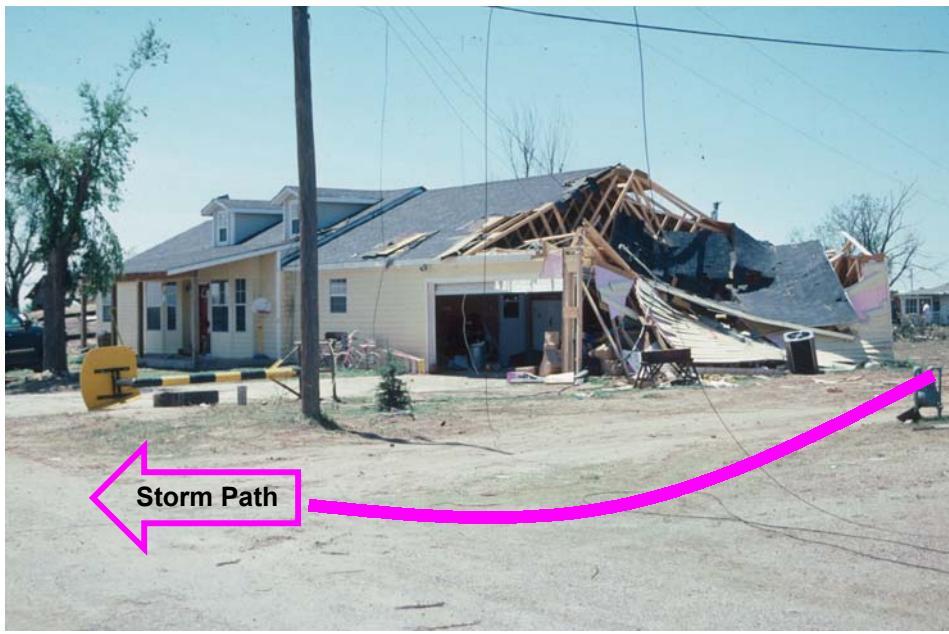
Figure 8. Classic F1-F2 Residential Damage, northeast view

From the church, the storm veered southward producing classic F1-F2 roof damage to several homes, see **Figure 8**. The storm proceeded to destroy the school bus barn and exited the southwest corner of the town. According to Minor, "housing damage data can be used to determine the width of the tornado path" (Minor et al., 1993). **Figure 9** indicates the storm path and width with a line of debris.

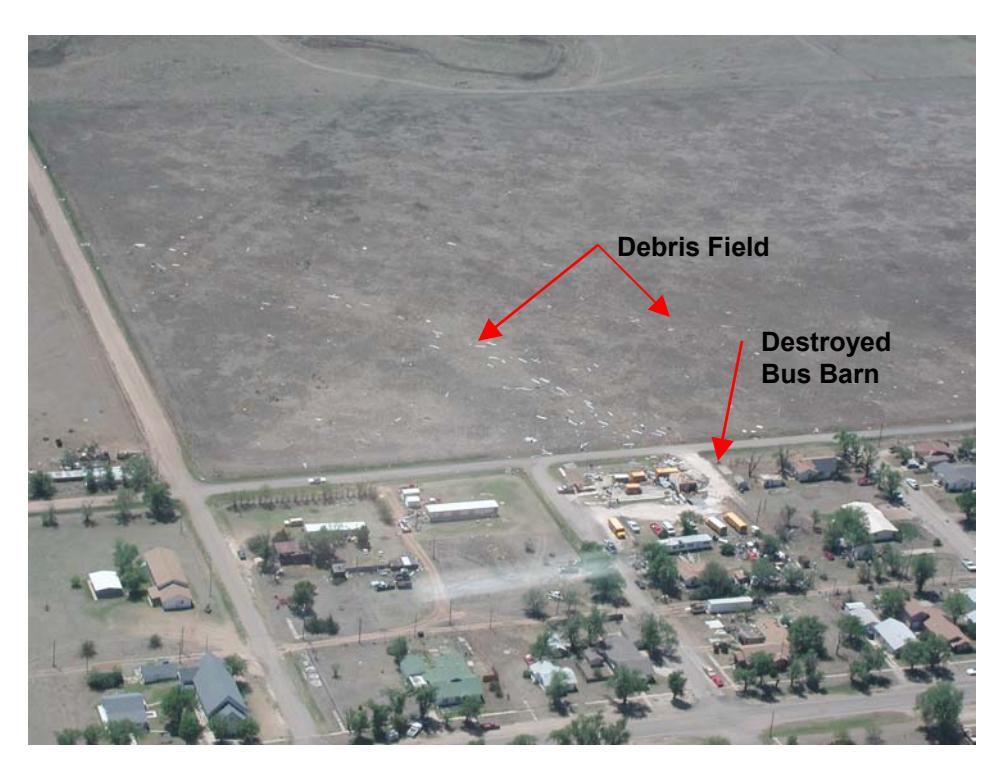
Figure 9. Debris Field, indicates storm path

- 3. The storm path was indicated by a debris field of lightweight wood members and portrays a circular path, possibly the result of storm downbursts and/or microbursts.

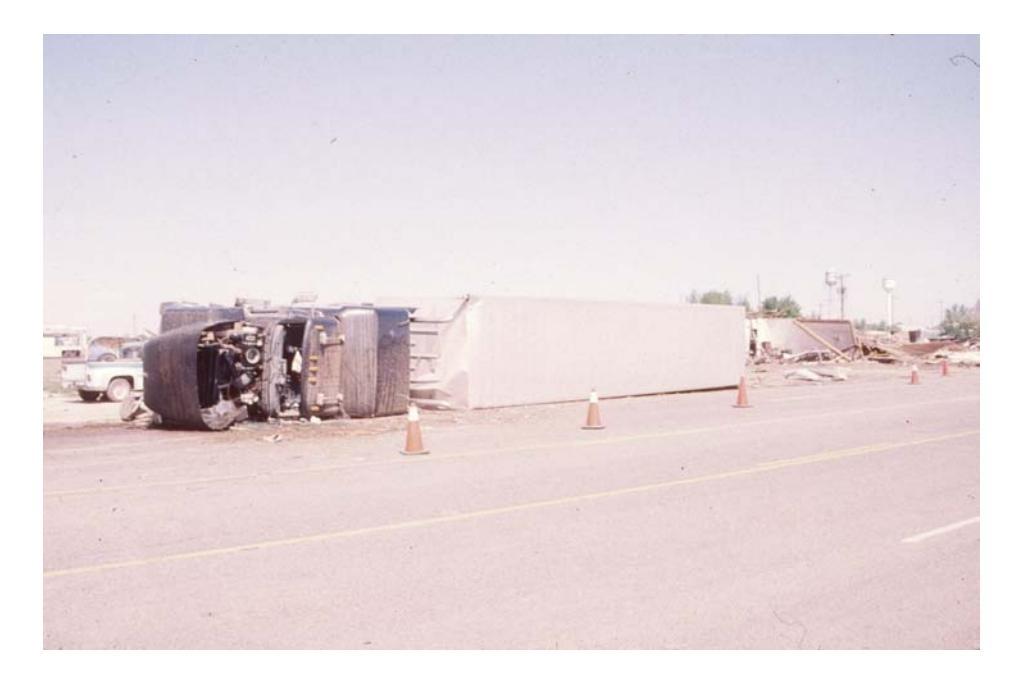
Re-entering the town, the storm toppled a semi-tractor trailer and damaged or destroyed numerous automobiles, **Figure 14.** It then struck a site-built wood frame home removing its roof, **Figure 15**, and transporting the roof section approximately 150 feet (48 m). Evidence of debris generation is shown in **Figure 16**, most of which was short wood 2x members. At this point, the storm path was assessed to be 350 feet (107 m) wide. The storm proceeded to strike two manufactured homes, destroying both and killing two occupants of one. Although the age or general condition of the manufactured homes was unknown, the initial mode of failure included the removal of ground anchors on one side, **Figure 17**, and the subsequent breaking of the anchor strap on the opposite side, **Figure 18**. Both homes were rolled approximately 80 feet (24 m) and totally destroyed, **Figure 19**. Light wood frame structures near the destroyed manufactured homes were minimally damaged, **Figure 20**. Explanations of this anomaly suggest that the storm path was either quite narrow or that the manufactured homes were subject to the weak side (back left

Figure 14. Semi-tractor Trailer Overturned by Tornado

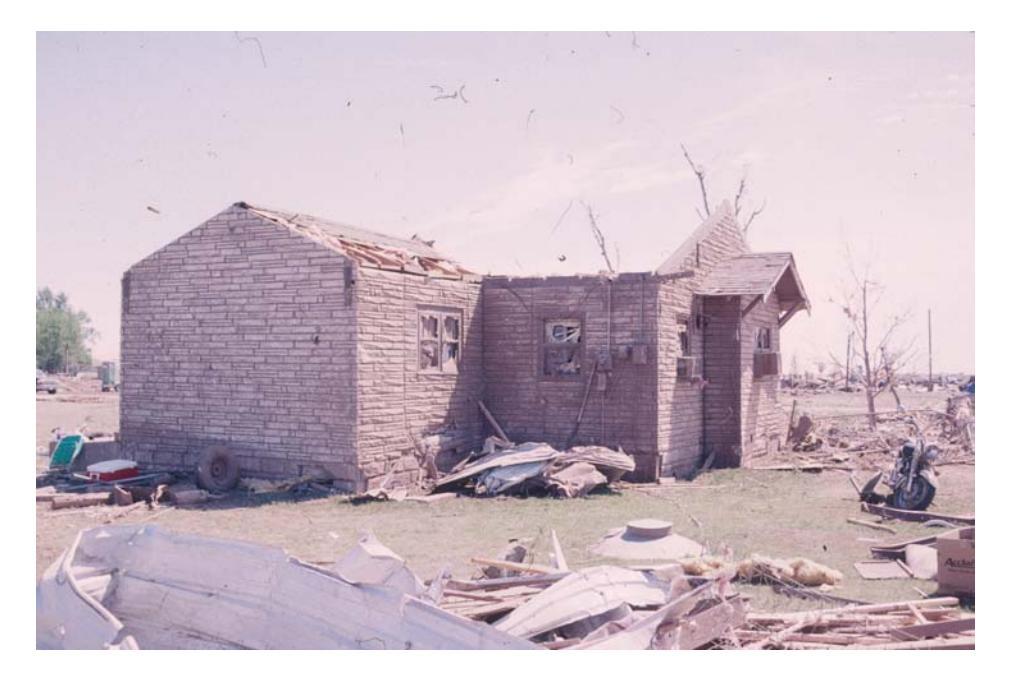
Figure 15. Wood Frame Home, Roof Removed

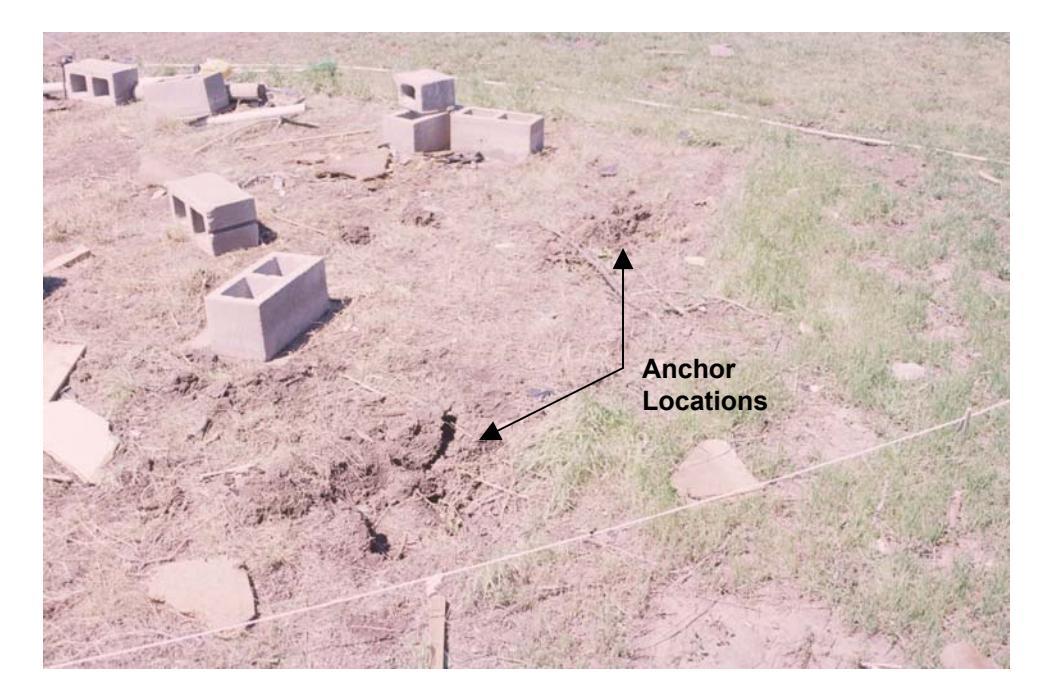
Figure 17. Manufactured Home, anchors pulled out of ground

- 4. The lack of storm damage to lightweight structures near the north side of the manufactured home, where two deaths occurred, would indicate a very narrow and weak storm, or that the manufactured home was located on the weak side (back left quadrant) of the storm. Given these storm conditions and the site investigation, failure of the home was initiated by an improperly installed anchoring system that released the home into the wind field allowing it to tumble and be destroyed.

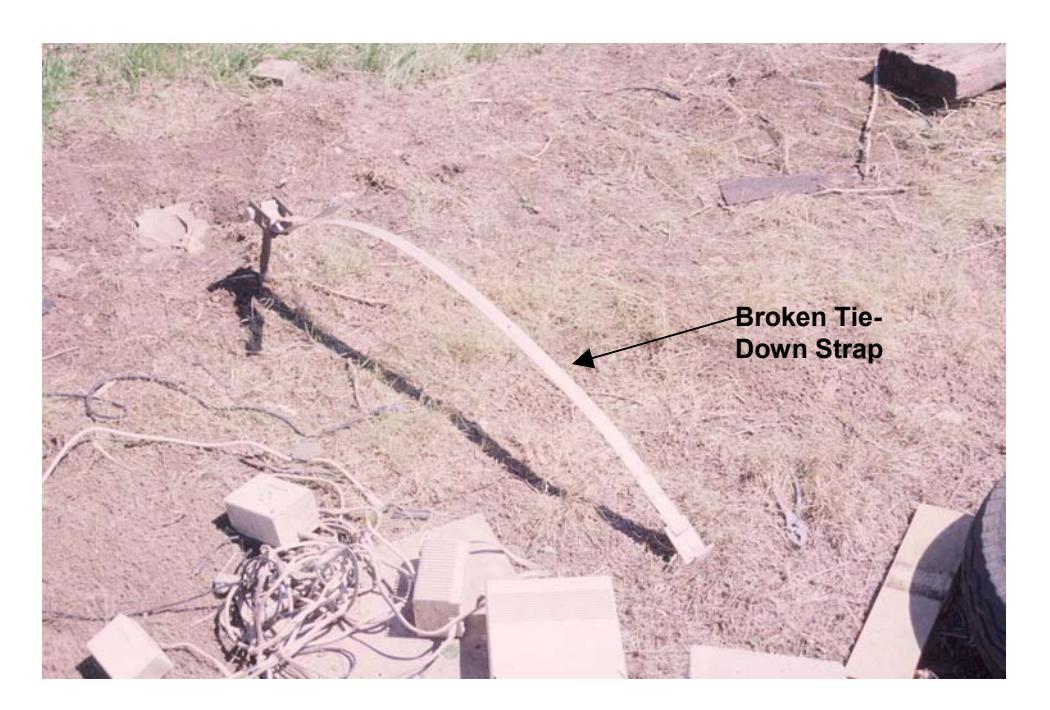
Figure 18. Manufactured Home, broken tie-down

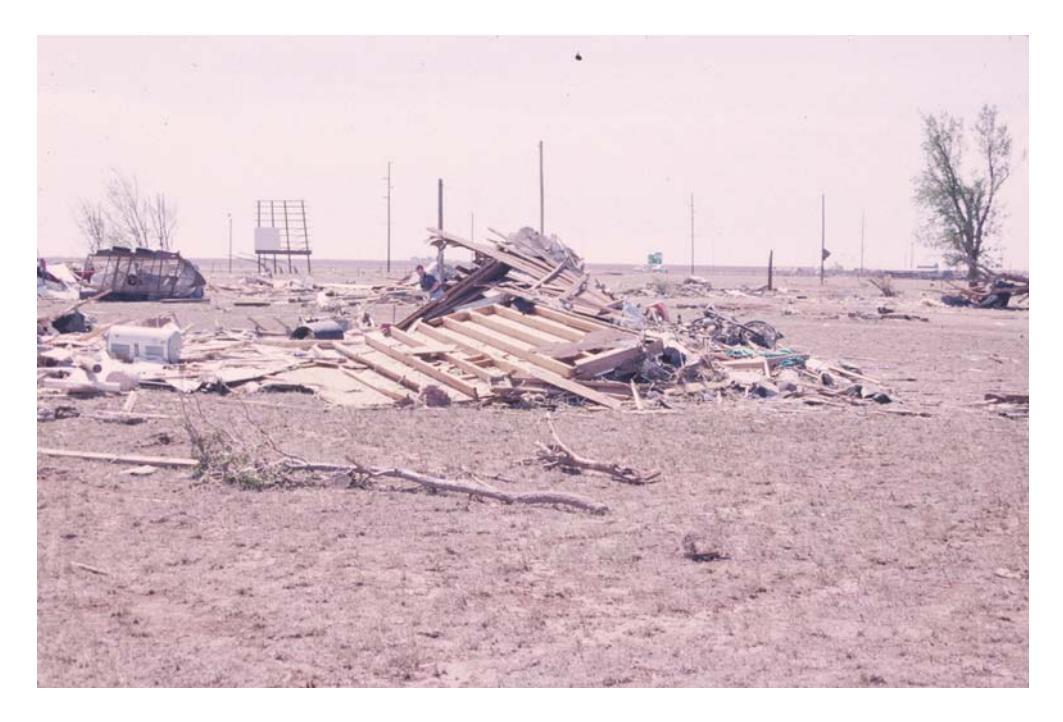
Figure 19. Destroyed Manufactured Home

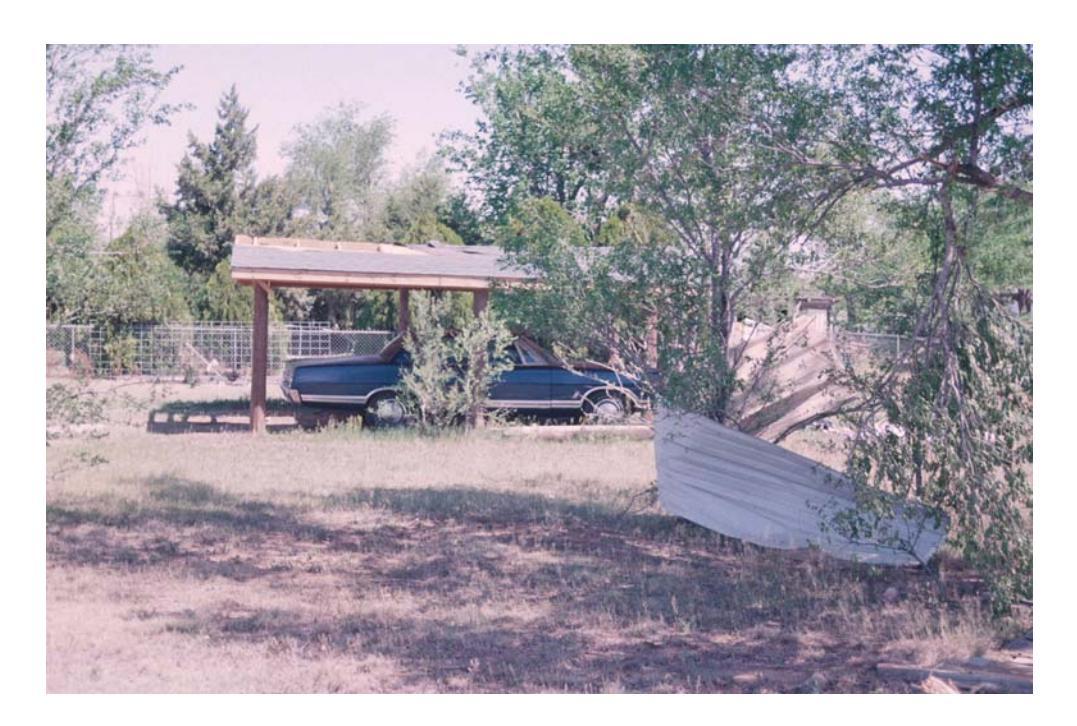
Figure 20. Open Structure, near manufactured home with deaths

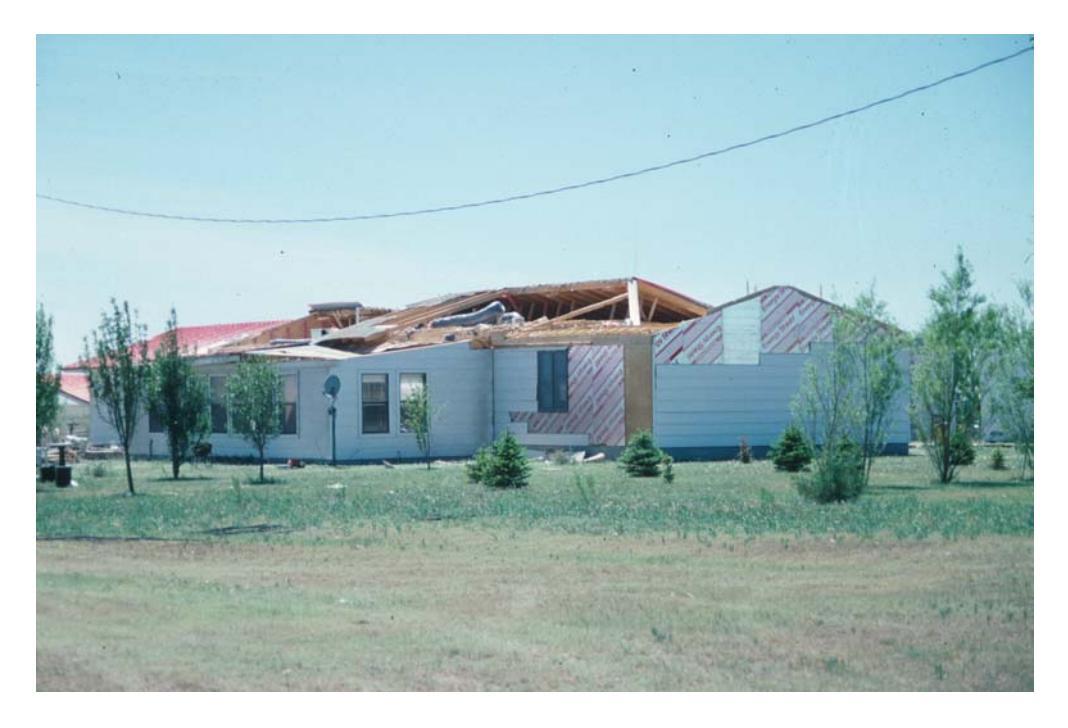
Figure 21. Damaged Farm Home

quadrant) of the storm. The storm then crossed Interstate Hwy. 27 and damaged two farm homes 3 miles (4.8 km) east of the city, **Figure 21**.
