NOAA Technical Memorandum ERL NSSL-82

THE TORNADO: AN ENGINEERING-ORIENTED PRESPECTIVE

Joseph E. Minor
James R. McDonald
Kishor C. Mehta

Institute for Disaster Research
Texas Tech University
Lubbock, Texas

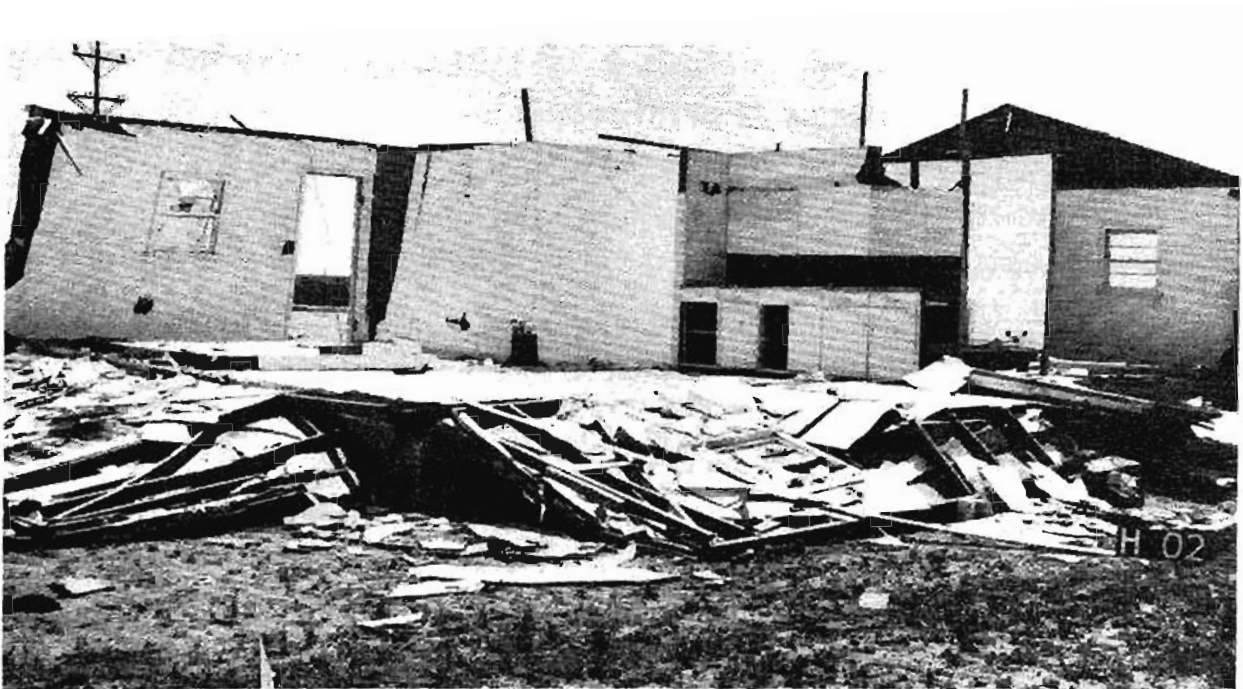
FIGURE 5. WINDS ACTING ON RESIDENTIAL STRUCTURE CAUSED CLASSIC FAILURE MODE. Three walls and roof experienced outward-acting pressures.

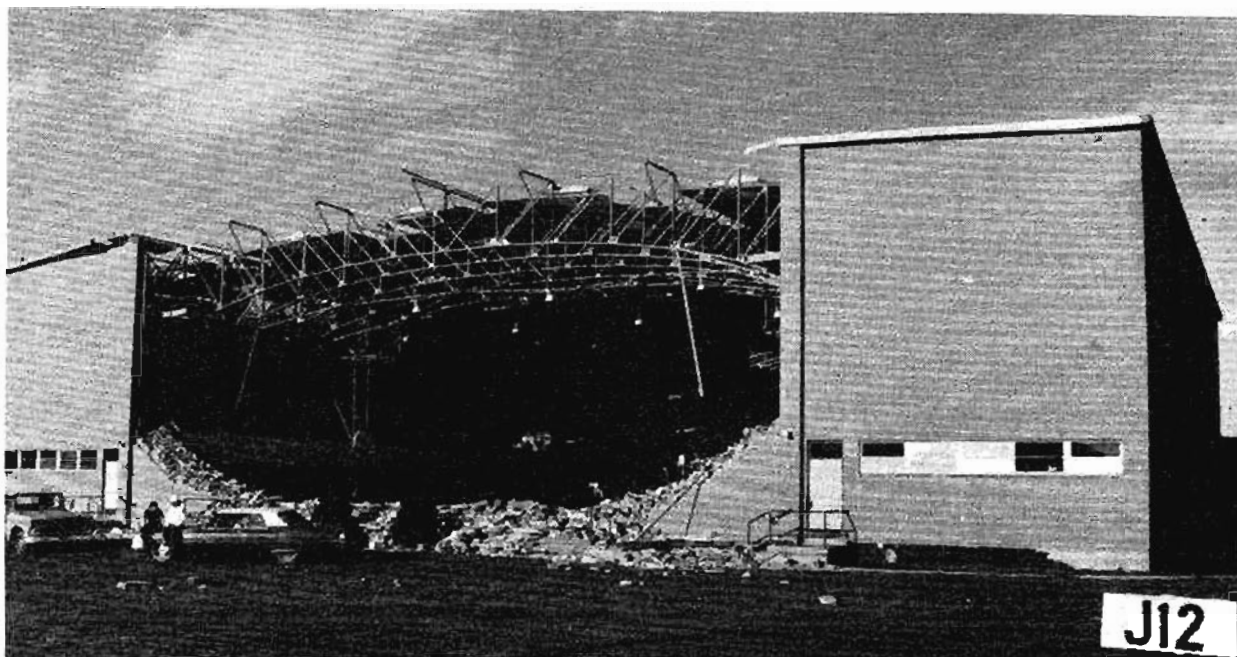
FIGURE 6. WIND-INDUCED PRESSURE ON WINDWARD WALL CAUSED FAILURE OF MASONRY. Concrete block and brick wall fell inward.

The windward wall of the gymnasium that is illustrated in Figure 6 has fallen inward. This failure in Joplin, Missouri was the result of inward-acting (stagnation) pressure on a large vertical surface which was presented to the wind. The structural engineer must exercise care designing this type of wall as very large total forces are encountered. In this specific case a weak roof to wall connection may have been a factor in the failure. If the roof lifted first (because of local, upward-acting pressures along the windward eave), the wall would have been free-standing, in effect, between the two vertical construction joints.

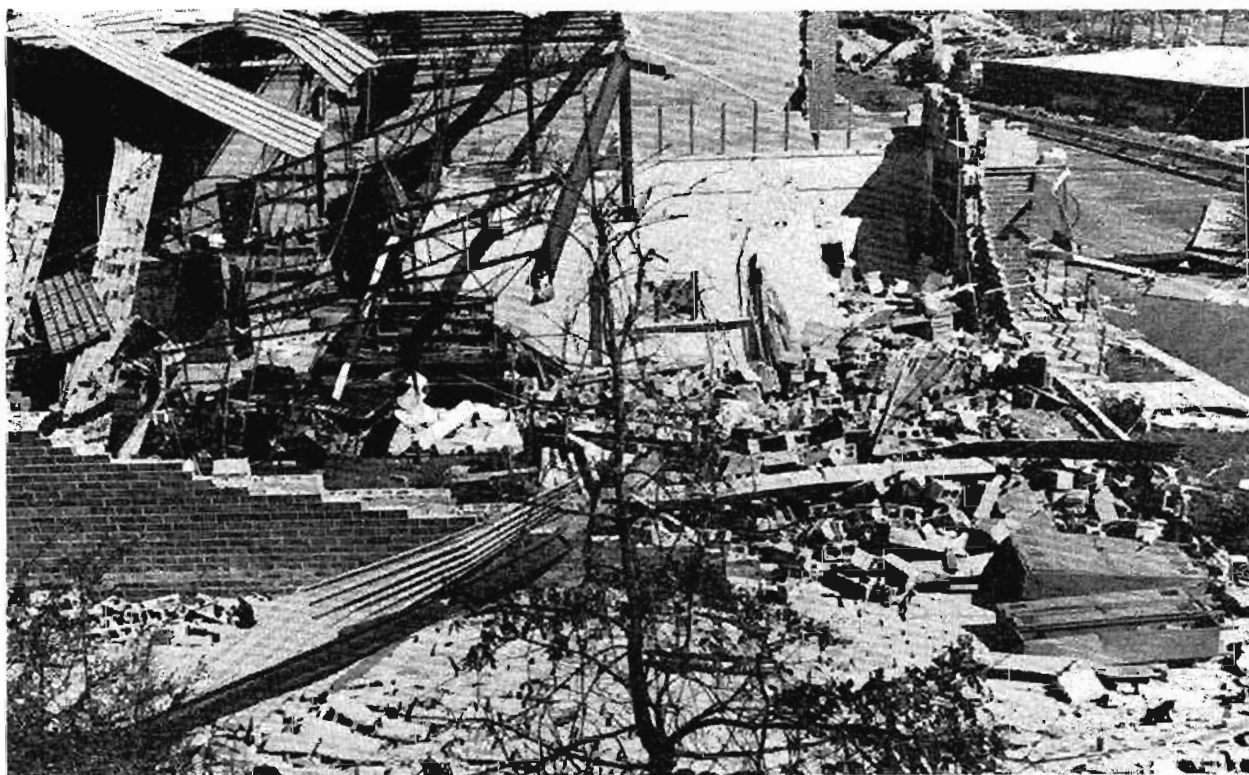
FIGURE 7. EFFECTS OF WIND ENTERING BUILDING AFTER FAILURE OF WINDWARD WALL. Side walls and roof failed outward, assisted by internal pressure.

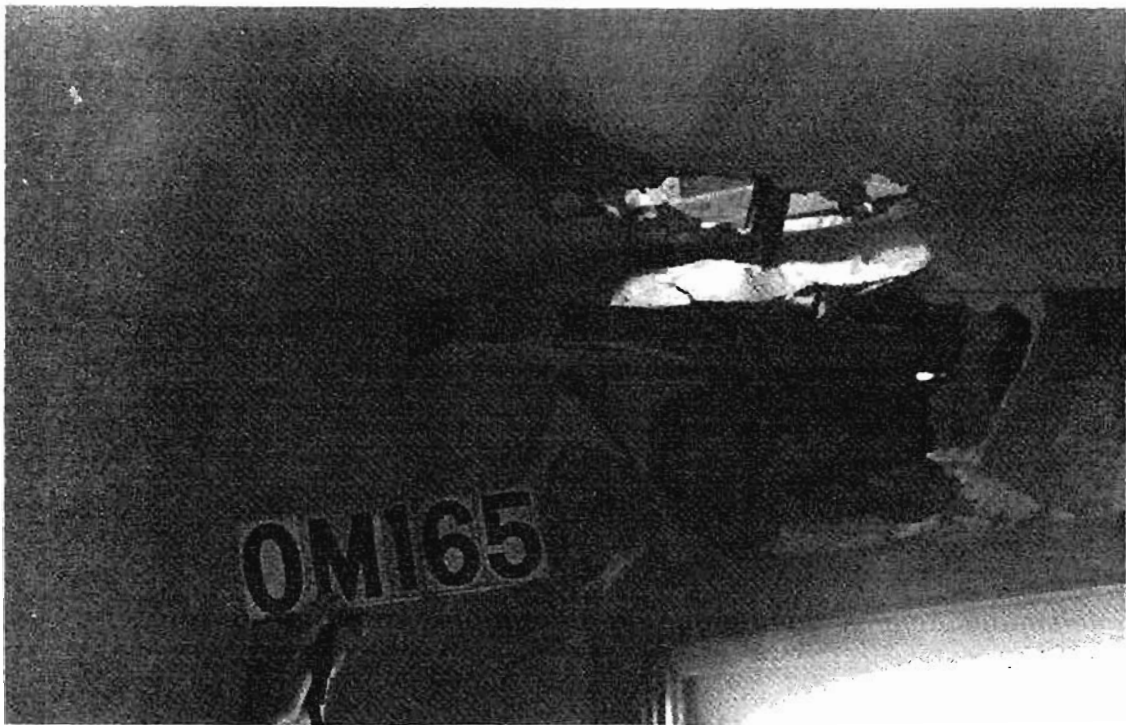
FIGURE 12. MISSILES CAN PENETRATE WINDWARD WALLS.
Damage induced by missiles can lead
to failure of wall components.

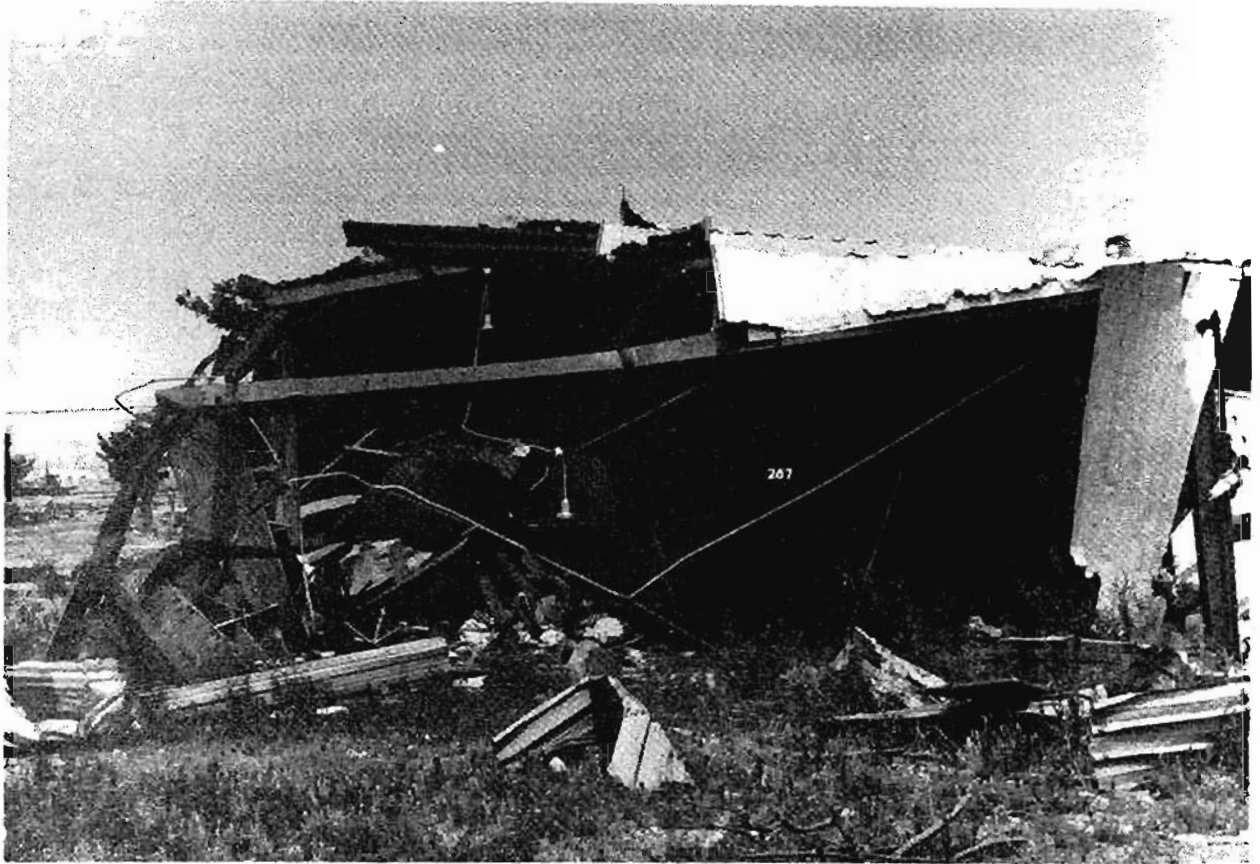
FIGURE 13. MISSILES MAY IMPACT PRINCIPAL STRUCTURAL FRAMES OF BUILDINGS CAUSING COLLAPSE. Oil tank in center left of photograph traveled 600 ft (183 m) to impact metal building.

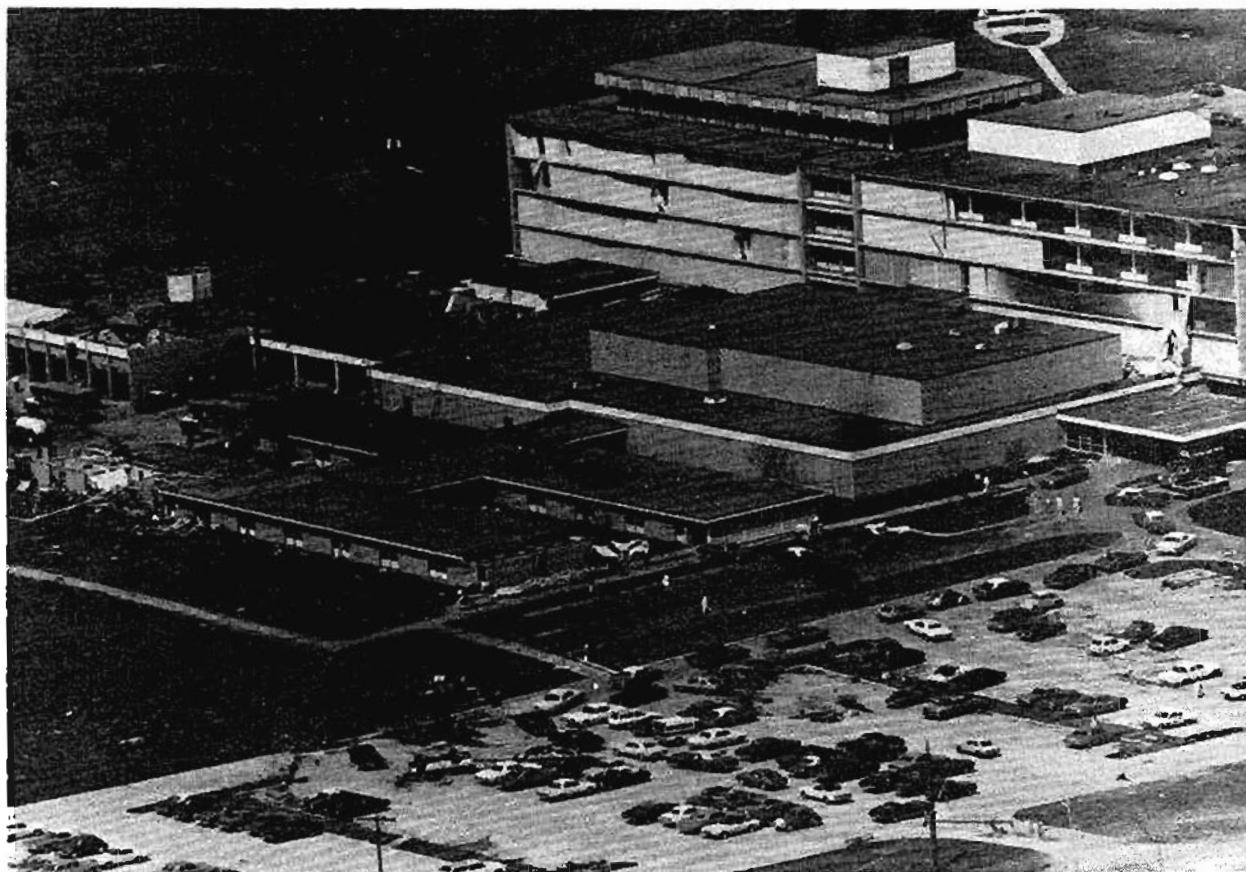
FIGURE 14. BERGAN MERCY HOSPITAL IN OMAHA, NEBRASKA IS A FULLY ENGINEERED BUILDING. The six-story wing sustained the full force of a tornado on May 6, 1975, with minimal damage.

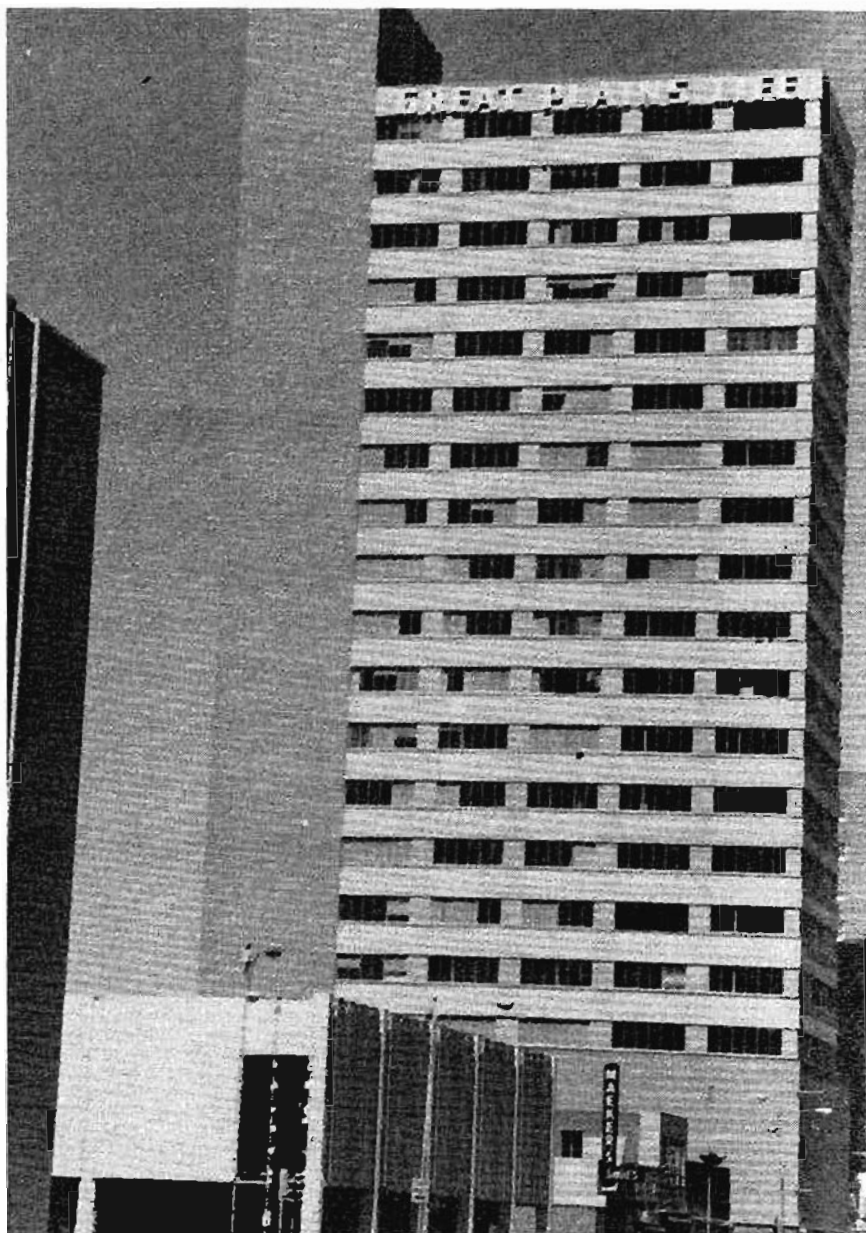
FIGURE 15. THE GREAT PLAINS LIFE BUILDING IN LUBBOCK, TEXAS WAS DAMAGED BY WINDS ON MAY 11, 1970. Although the steel frame was permanently deformed, the fully engineered building has been restored to useful service.

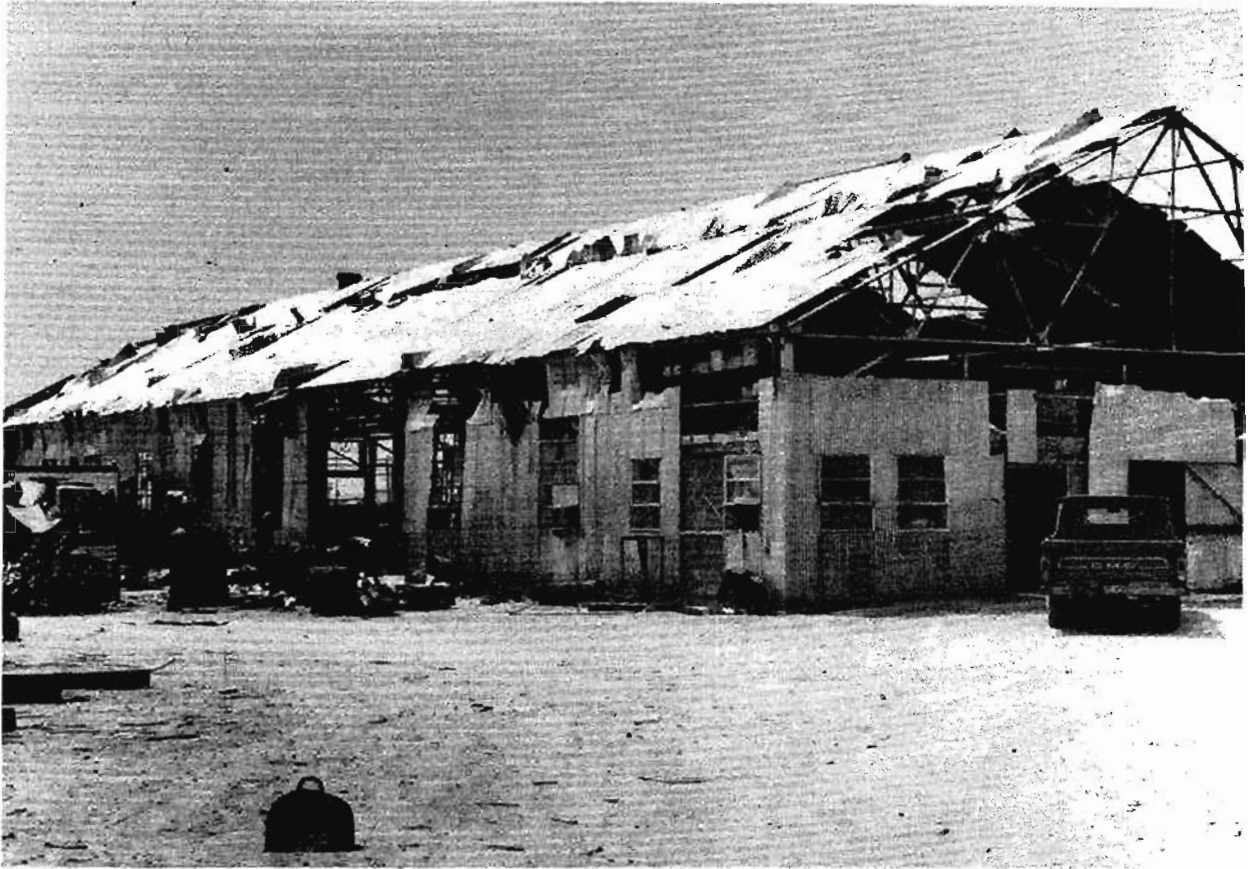
FIGURE 18. METAL BUILDING SYSTEMS EXPERIENCE LOSS OF CLADDING. Local pressures along eaves and corners are reflected in damage pattern.

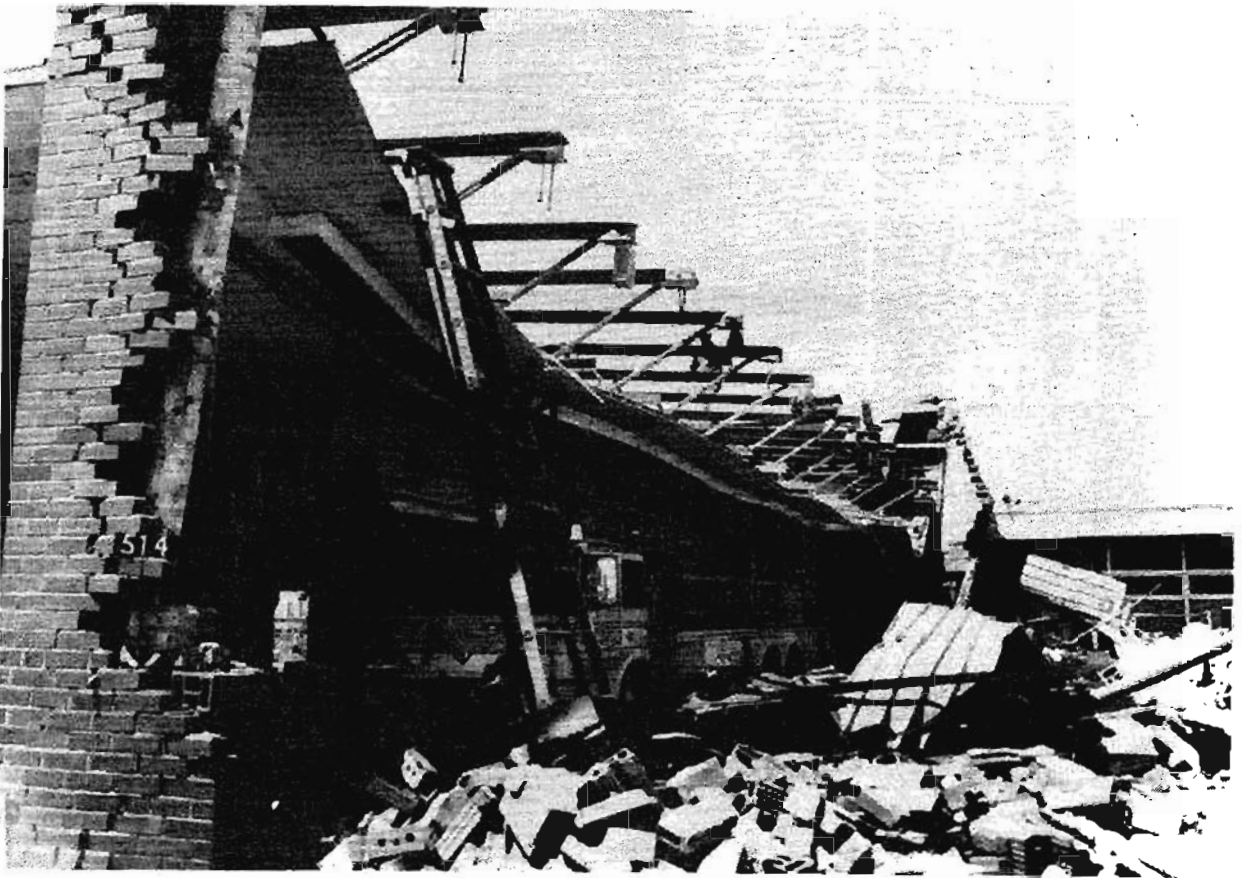
FIGURE 19. LOADBEARING MASONRY WALL FAILED OUTWARD, PERMITTING ROOF TO FALL ONTO FIRE TRUCK. This failure was at the Central Fire Station in Lubbock, Texas.

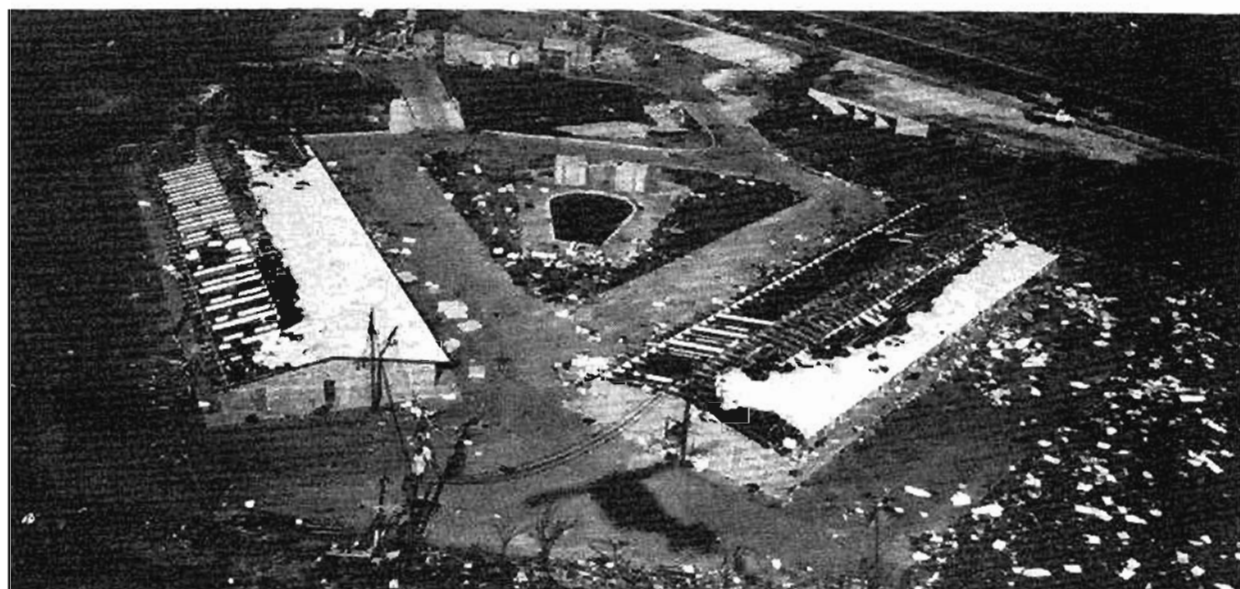
FIGURE 21. ROOFS WHICH EXTEND OVER WALKWAYS CAN BE FAILURE INITIATION POINTS. This motel in Lubbock, Texas lost its roof in this manner in May 1970.

Motel and apartment units which are framed principally with wood usually receive some engineering attention. Again, however, this attention is marginal and tends to leave the buildings vulnerable to wind-induced forces. Common are roofs removed because of inadequate connection to walls, and roof failures brought about by "overhangs" over walkways (e.g. along the pathway in front of rooms) being lifted when wind-induced pressures build underneath. In these failures, damage appears to be severe and is usually described as "total destruction," yet the windspeeds causing the damage are nominal, e.g. 125 mph (55.9 m/s) or less. Figure 21 illustrates common failures in this type of structure.

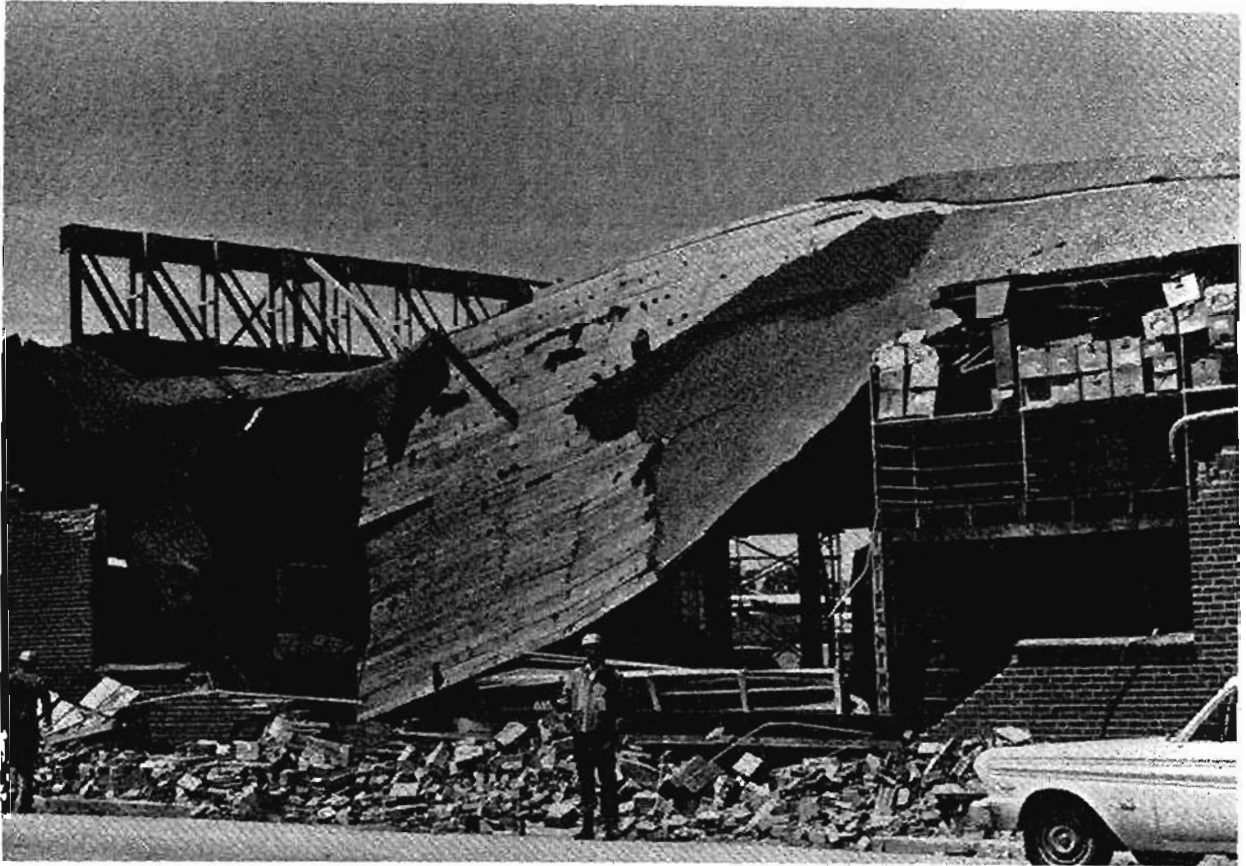
FIGURE 22. BUILDINGS COMPOSED OF STEEL, WOOD, AND MASONRY ARE OFTEN "MARGINALLY ENGINEERED." Hybrids such as this building in Lubbock are vulnerable to wind damage.

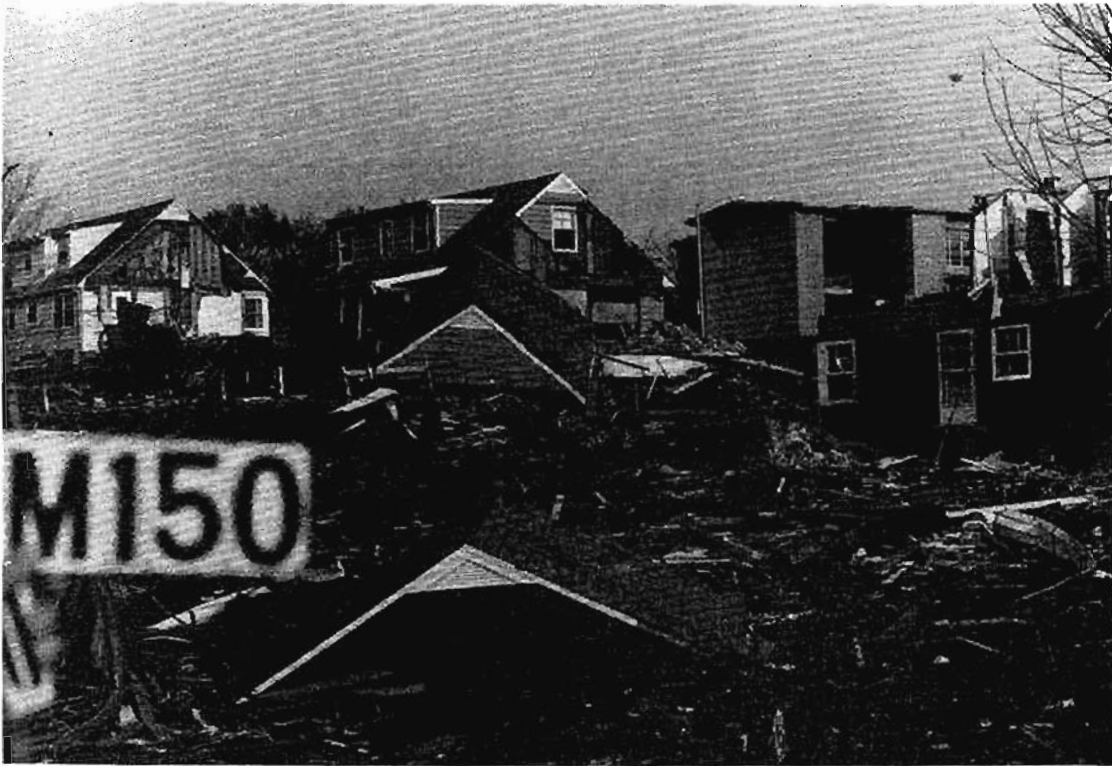
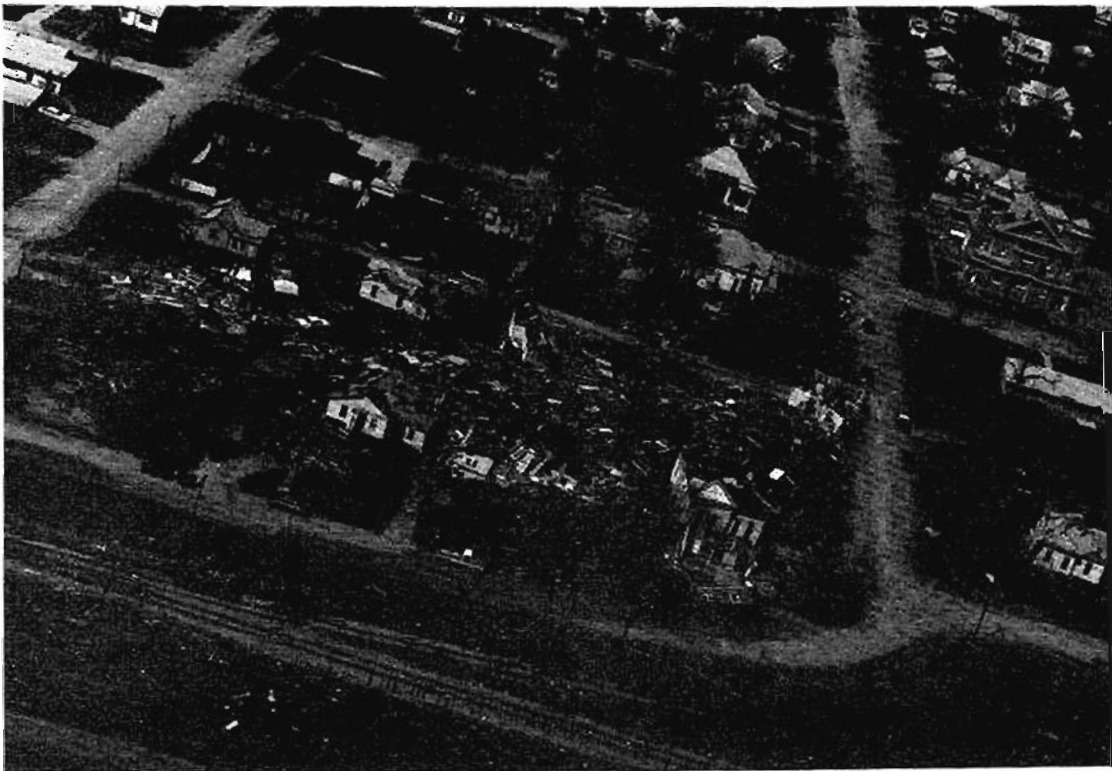
FIGURE 23. HOUSING DAMAGE CAN BE TRACED TO POOR CONSTRUCTION PRACTICE. Inadequate roof anchorages (top) and foundation anchorages (bottom) resulted in damage to houses in Omaha (Nebraska) and Burnet (Texas).

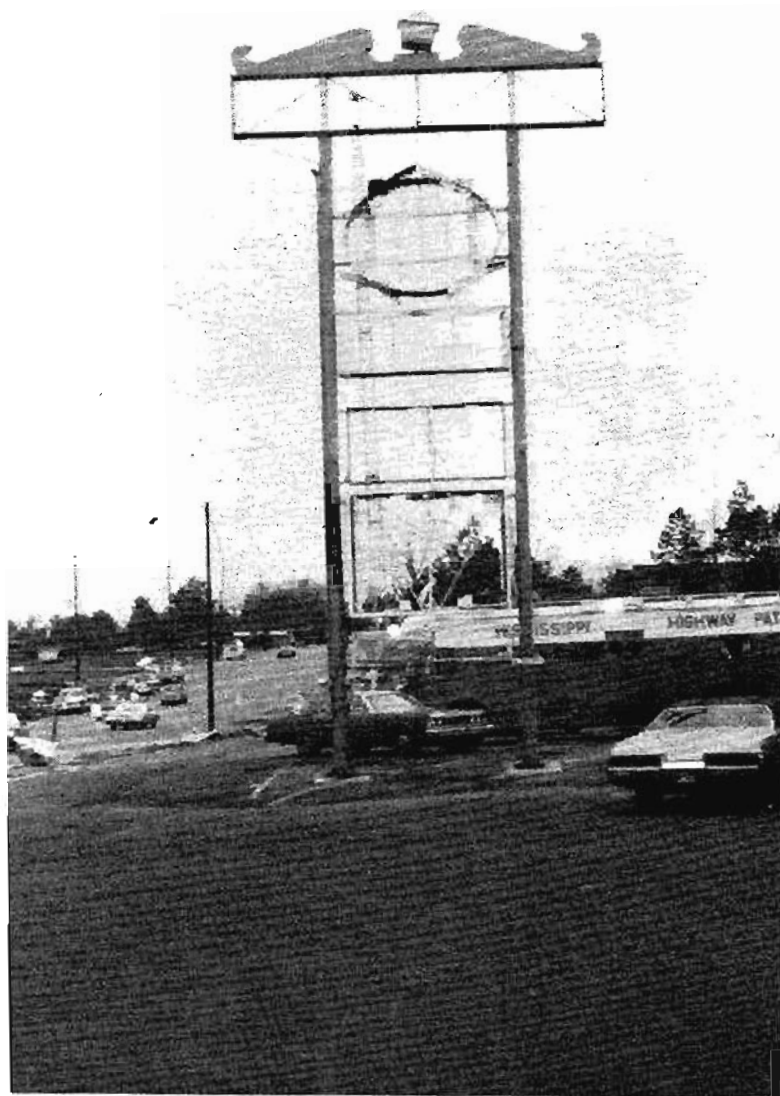
FIGURE 24. FREE-STANDING STRUCTURES PROVIDE THE BEST OPPORTUNITY FOR ANALYSIS OF WINDSPEED. This sign in McComb, Mississippi provided windspeed estimates for a tornado which occurred in January 1975.

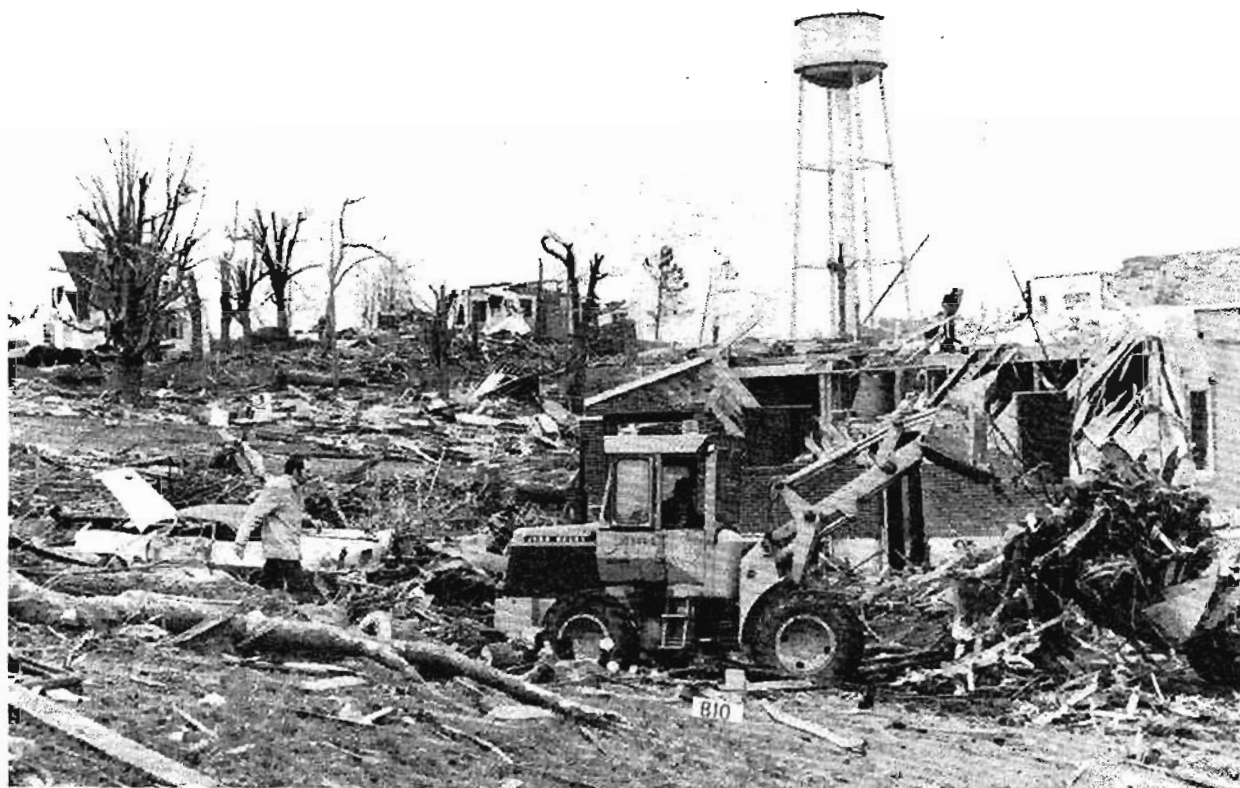
FIGURE 25. A "CLEAN" STRUCTURE SUCH AS A WATER TOWER CAN PROVIDE GOOD WINDSPEED ESTIMATES. This water tower in Brandenburg, Kentucky was very close to the tornado path on April 3, 1974.

Free-standing structures such as signs (Fig. 24) and chimneys, and "clean" structures such as bridge beams, TV antennae, and water towers (Fig. 25) are readily analyzed with respect to damaging windspeeds. These types of structures provide good, reliable windspeed estimates.

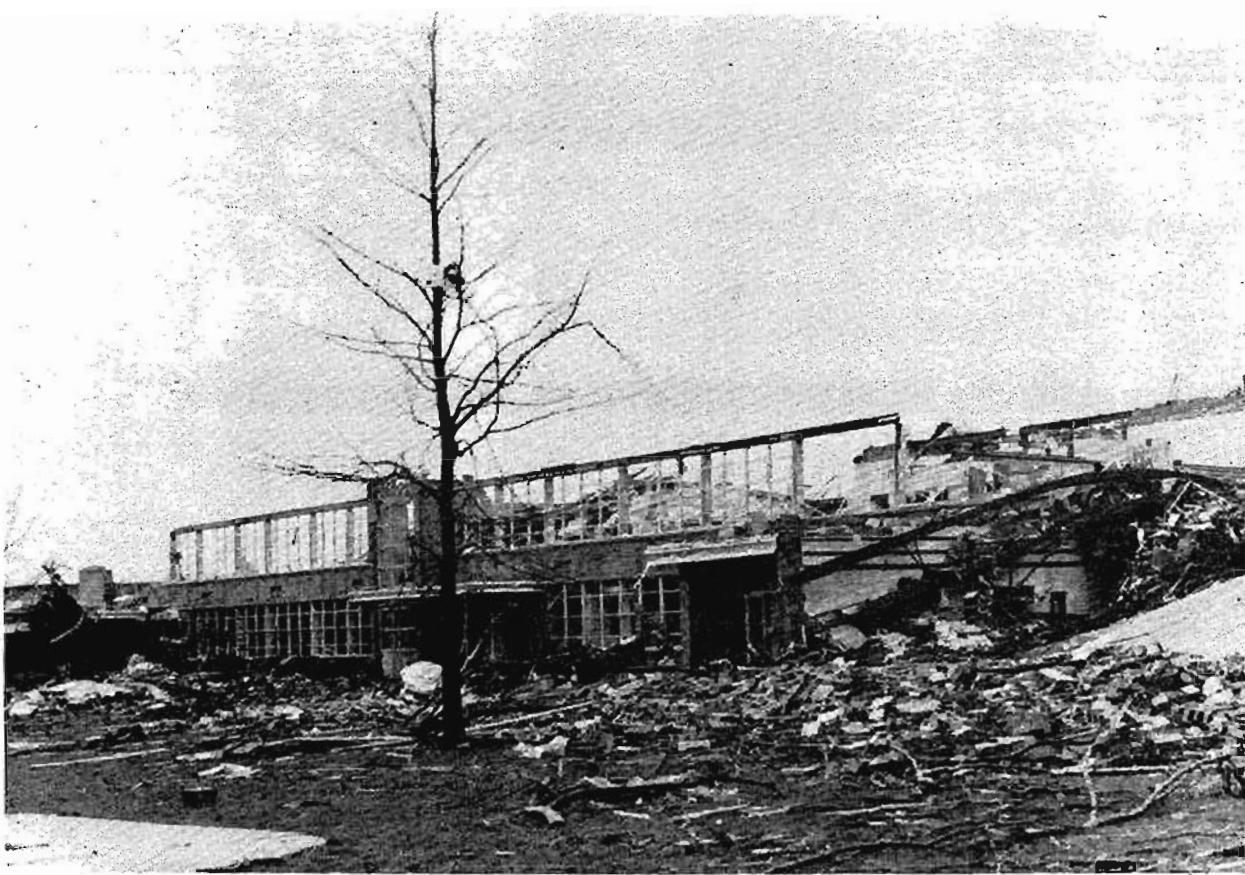
FIGURE 27. COMPONENTS OF CONVENTIONAL BUILDINGS CAN BE USED IN WINDSPEED ANALYSES. The roof of Xenia High School provided windspeed estimates for the Xenia, Ohio Tornado of April 3, 1974

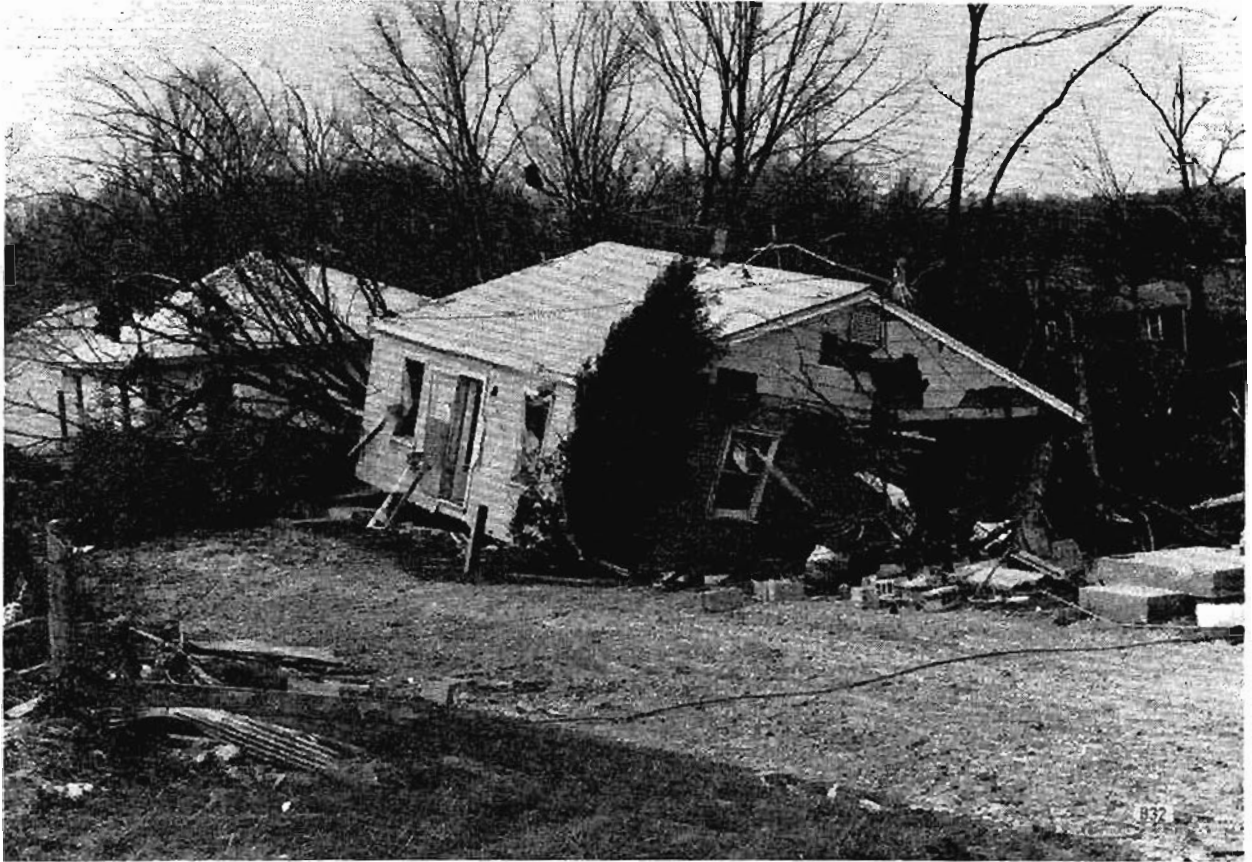
FIGURE 28. HOUSING CAN PROVIDE ROUGH ESTIMATES OF WINDSPEEDS. This house in Brandenburg, Kentucky was moved by tornadic winds in the 80-120 mph (36-67 m/s) range.

Residential structures and rural buildings (Fig. 28) are difficult to analyze. Connection and anchorage details in these buildings are, generally, not standard and there are wide variations

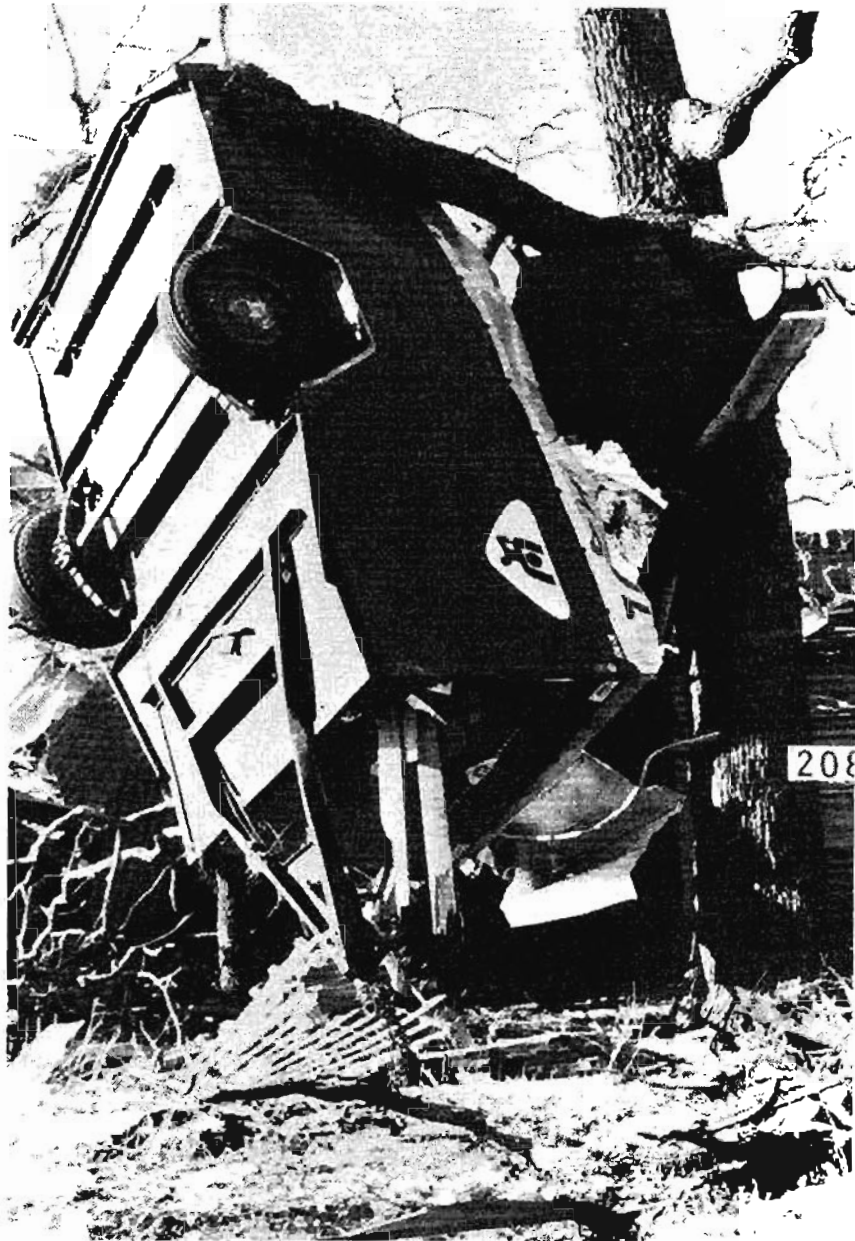
FIGURE 29. ODD-SHAPED MISSILES PROVIDE THE LEAST RELIABLE BASIS FOR DETERMINING TORNADIC WINDSPEEDS. This trailer tumbled 600 ft (183 m) or more in the Hubbard, Texas Tornado of March 10, 1973.

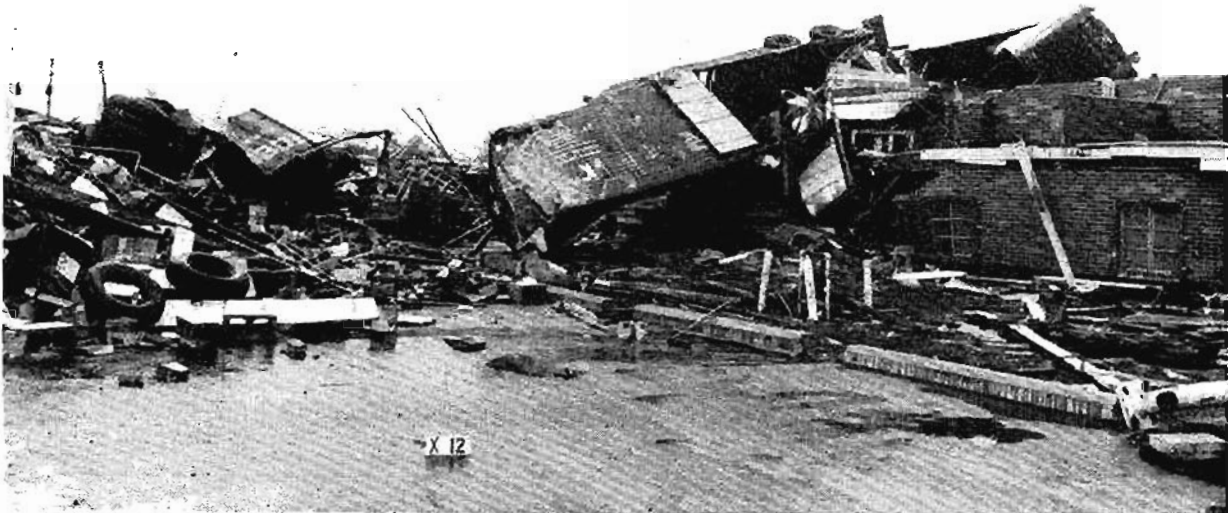
FIGURE 34. THE TWO TRUCKS WERE ODD-SHAPED MISSILES. Calculations of windspeeds required to lift the trucks onto the building are not considered to be as reliable as other calculations.

one-story bowling alley structure located across the street (Fig. 34). The trailers traveled approximately 150 ft (46 m). The trailer superstructures were made of wood. The truck trailers were not connected to the truck cabs, and they were essentially empty at the time of the tornado incident. Windspeeds required to lift the truck trailers (aerodynamically) can be calculated as follows:

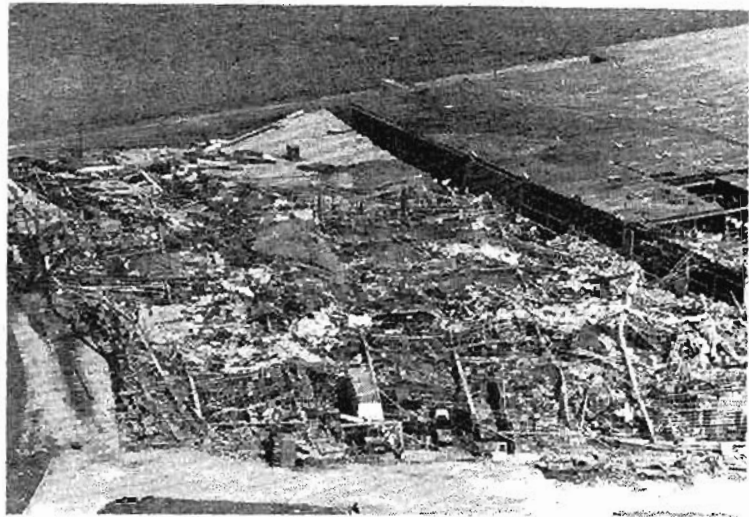
FIGURE 40. WEAK STRUCTURES ADJACENT TO STRONG STRUCTURES MAY MISLEAD DAMAGE INVESTIGATORS WITH REGARD TO WINDFIELD GEOMETRY. The inadequate connection detail (top) made the warehouse susceptible to wind damage at relatively low windspeeds (bottom).

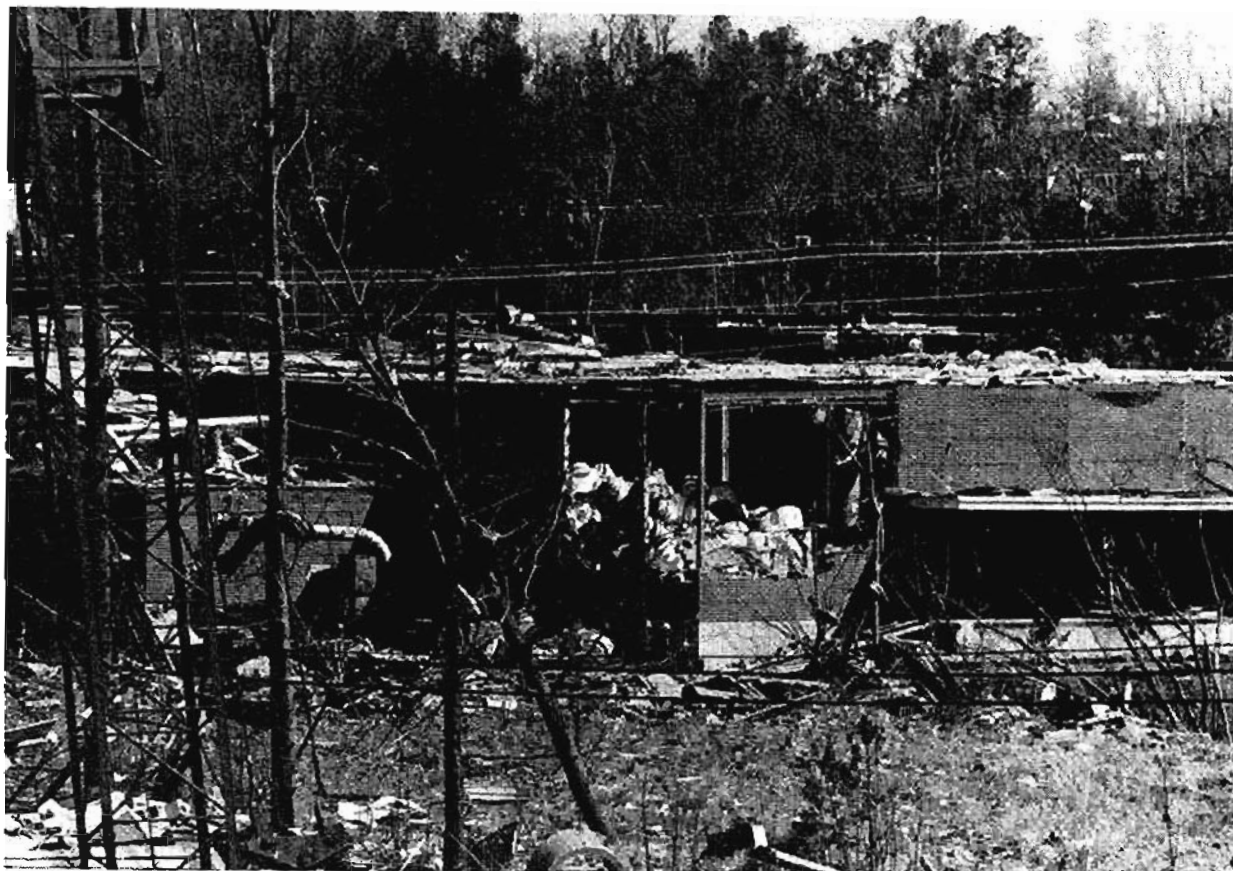
FIGURE 41. OUTWARD ACTING PRESSURE CONCENTRATIONS AT BUILDING CORNERS CAUSE LOCAL DAMAGE. The damage investigator should not conclude that a tornado passed over the corner of this warehouse.

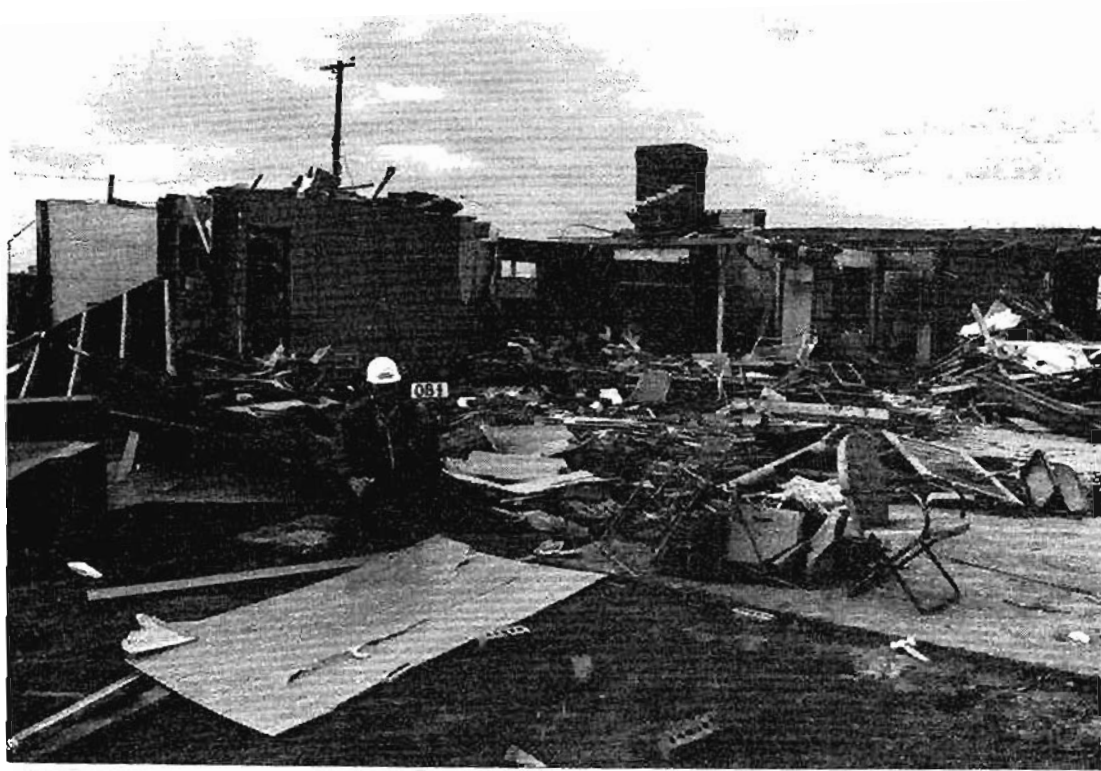
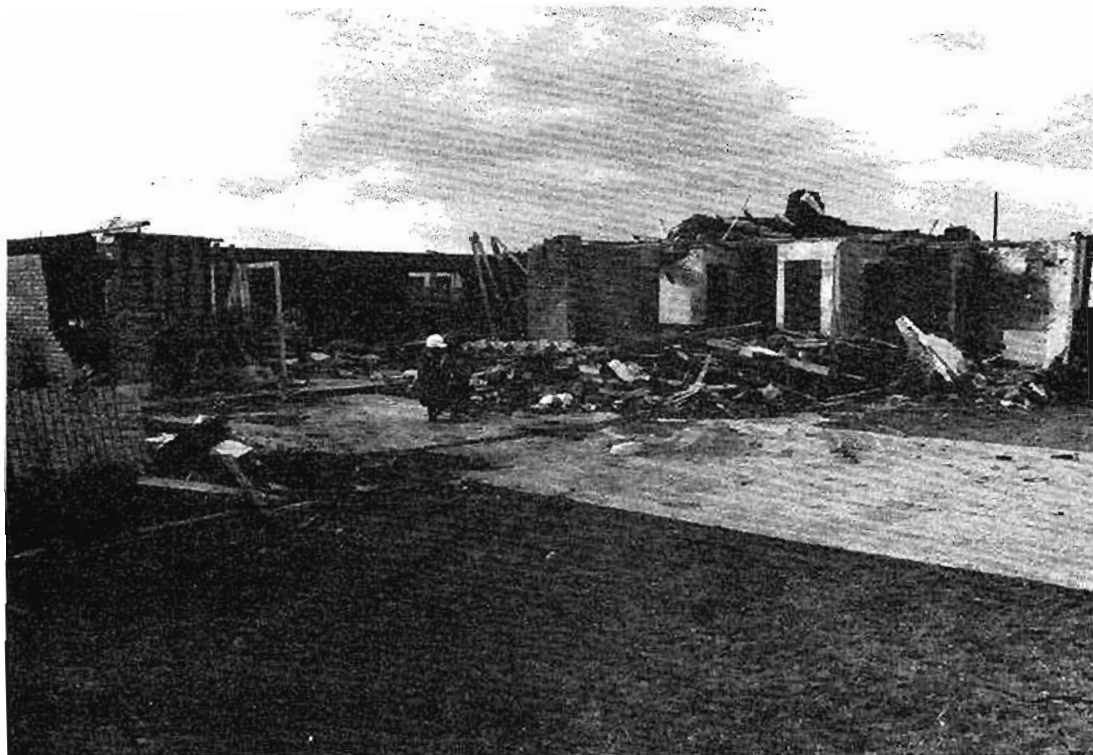
FIGURE 44. THESE HOUSES IN PLAINVIEW, TEXAS FAILED FROM FRONT TO REAR, BEGINNING IN THE GARAGE AREAS. This failure mode is clear evidence of the direction of extreme winds.
