NOAA Technical Memorandum ERL NSSL-82

THE TORNADO: AN ENGINEERING-ORIENTED PRESPECTIVE

Joseph E. Minor
James R. McDonald
Kishor C. Mehta

Institute for Disaster Research
Texas Tech University
Lubbock, Texas

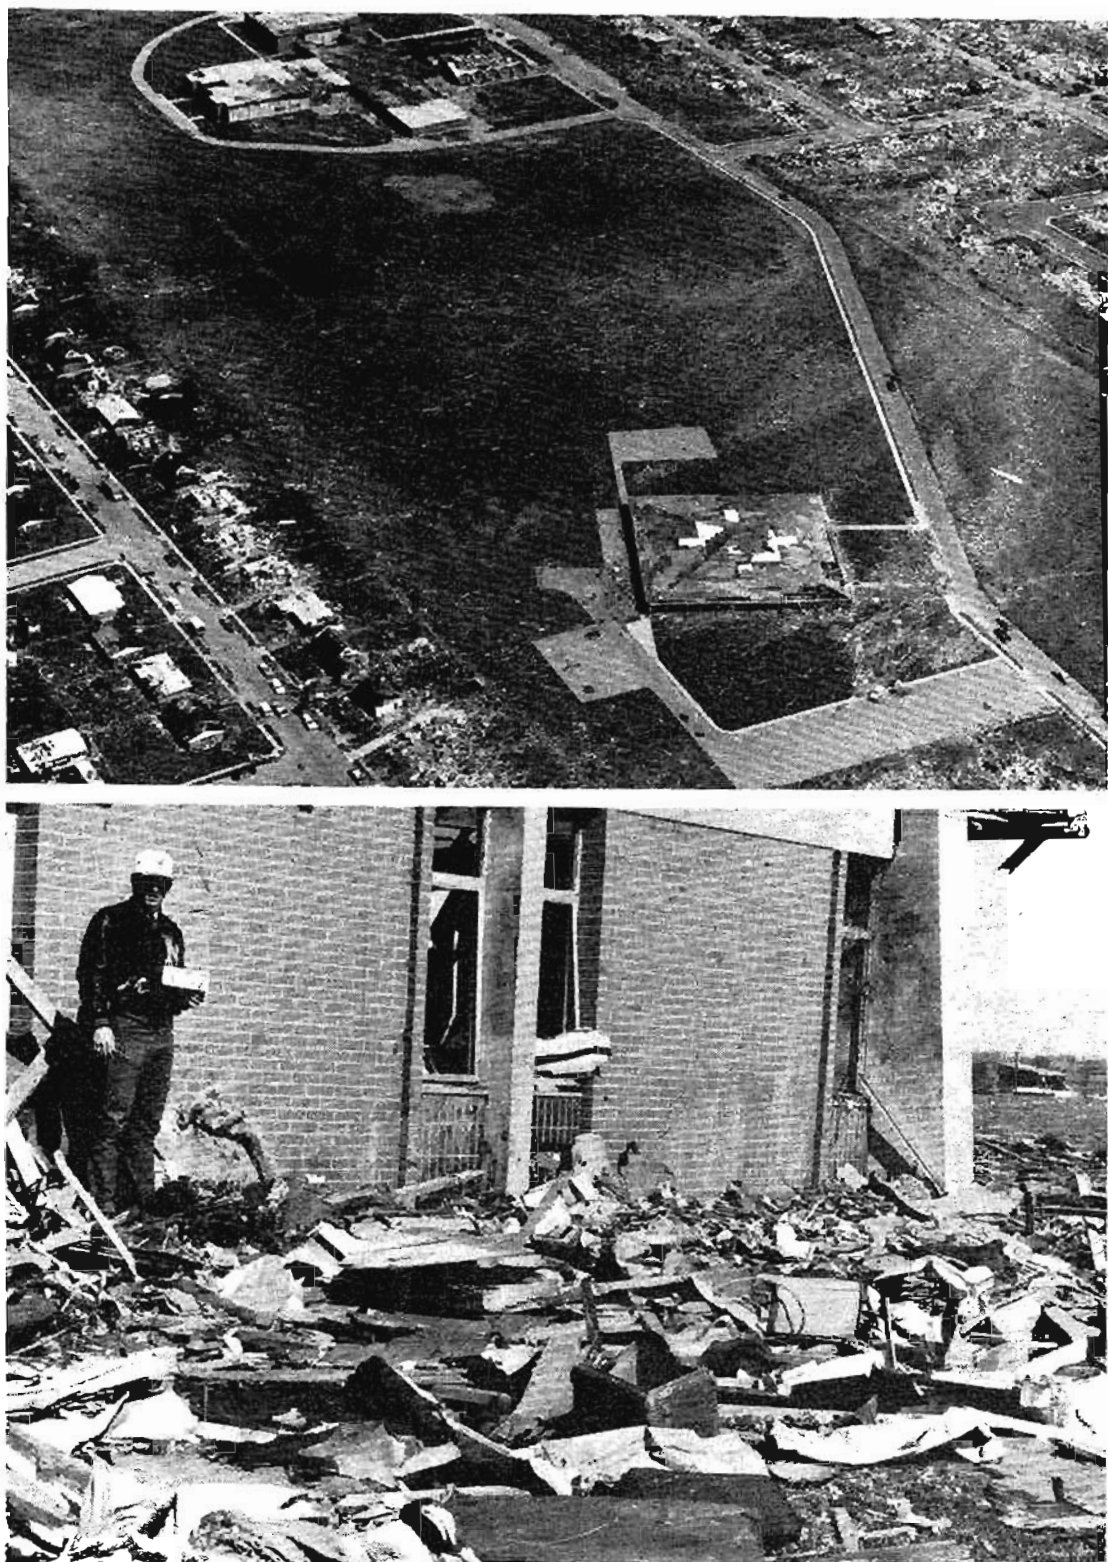
FIGURE 45.

CARE MUST BE EXERCISED IN EVALUATING DEBRIS PATTERNS FROM AERIAL OBSERVATIONS. The streak of debris (top photograph) was caused by modifications of the debris pattern by Arrowood School (bottom photograph) in Xenia, Ohio.

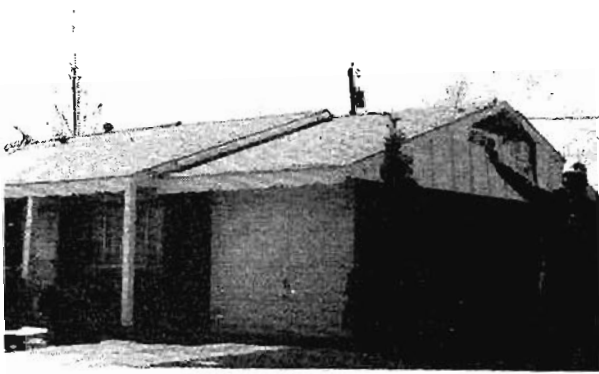
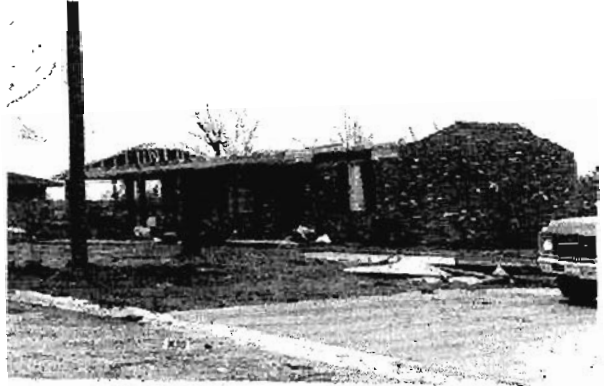
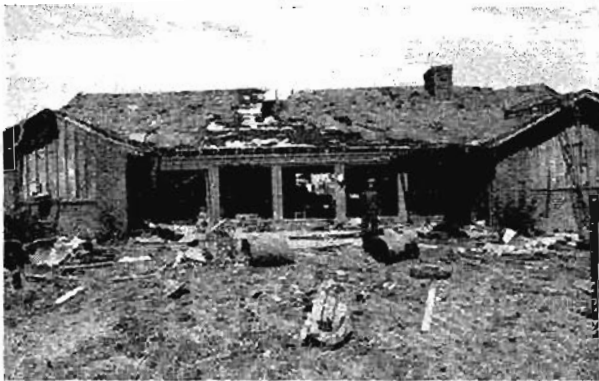
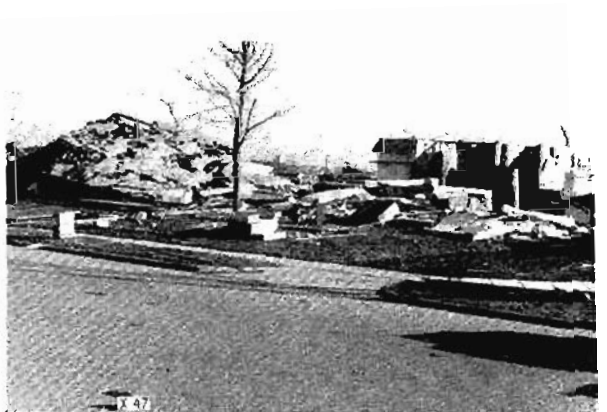
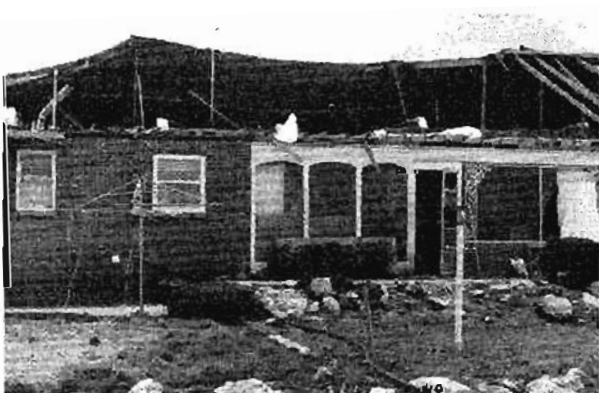
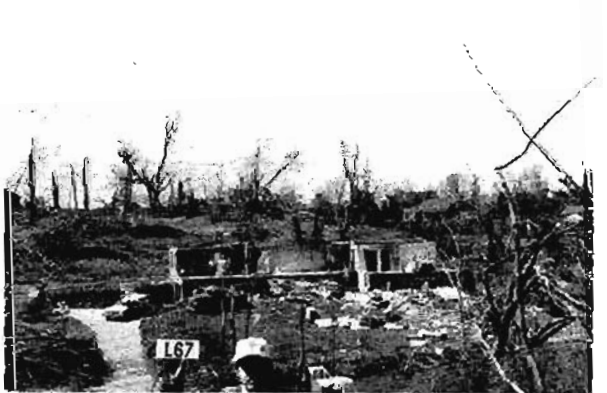
FIGURE 46. ILLUSTRATIONS OF RESIDENTIAL DAMAGE IN EACH OF THE SIX DAMAGE CATEGORIES DESCRIBED IN TABLE IV. The indicated windspeed occurred only if (1) the damage is typical of several units in an area and (2) the housing was constructed under provisions of an enforced building code.

building codes and a strong codes enforcement program. Table IV was developed by four investigators at Texas Tech University who have observed windstorm damage to houses for six years. Photographs which illustrate each of the six categories of damage are shown in Figure 46. Comparisons of the residential damage description advanced here for code-enforced housing with the Fujita-scale descriptions of damage (Fujita, 1971) are shown in Figure 47. There is relatively good agreement between the two damage vs. windspeed relationships at the lower windspeeds, but above about 125 mph (56 m/s) the Fujita scale associates much higher windspeed with damage that is similar in description to the descriptions advanced in Table IV. A principal reason for this difference seems to be methodology. An individual house should not be examined with the objective of making a windspeed estimate, nor should a distinction be made between windspeeds which occurred at adjacent house locations because one of the two houses had a different degree of damage. The many variables which govern the behavior of a house in a windstorm (discussed below) make degrees of individual housing damage unreliable indicators of tornadic windspeeds. Only where some standard of construction quality can be established, e.g. in an incorporated city with a building code and an active code enforcement program, can windspeed estimates from housing damage be attempted. (Rural housing is a very poor indicator of tornadic windspeeds.) It is necessary to examine several houses in a group before making windspeed assessments such as those advanced in the first three windspeed ranges in Table IV. Development of coarse distinctions between moderate windspeeds (125-150 mph) (56-67 m/s) and severe winds (150-200 mph) (67-89 m/s) also involves more than the viewing of individual houses, or assessments of the appearance of damage in aerial photographs. Figure 48 shows aerial views taken in Xenia, Ohio following the Xenia Tornado of April 3, 1974. The tornado path, defined by limits of damage caused by 75 mph (34 m/s) winds or greater, covers the entire photograph. In the section just above West Junior High School in Figure 48, some houses are totally destroyed, leaving nothing but debris. Other houses have their roofs removed but their walls are still standing. Roofs and walls are intact on a few other houses, although there is considerable damage to the structure.

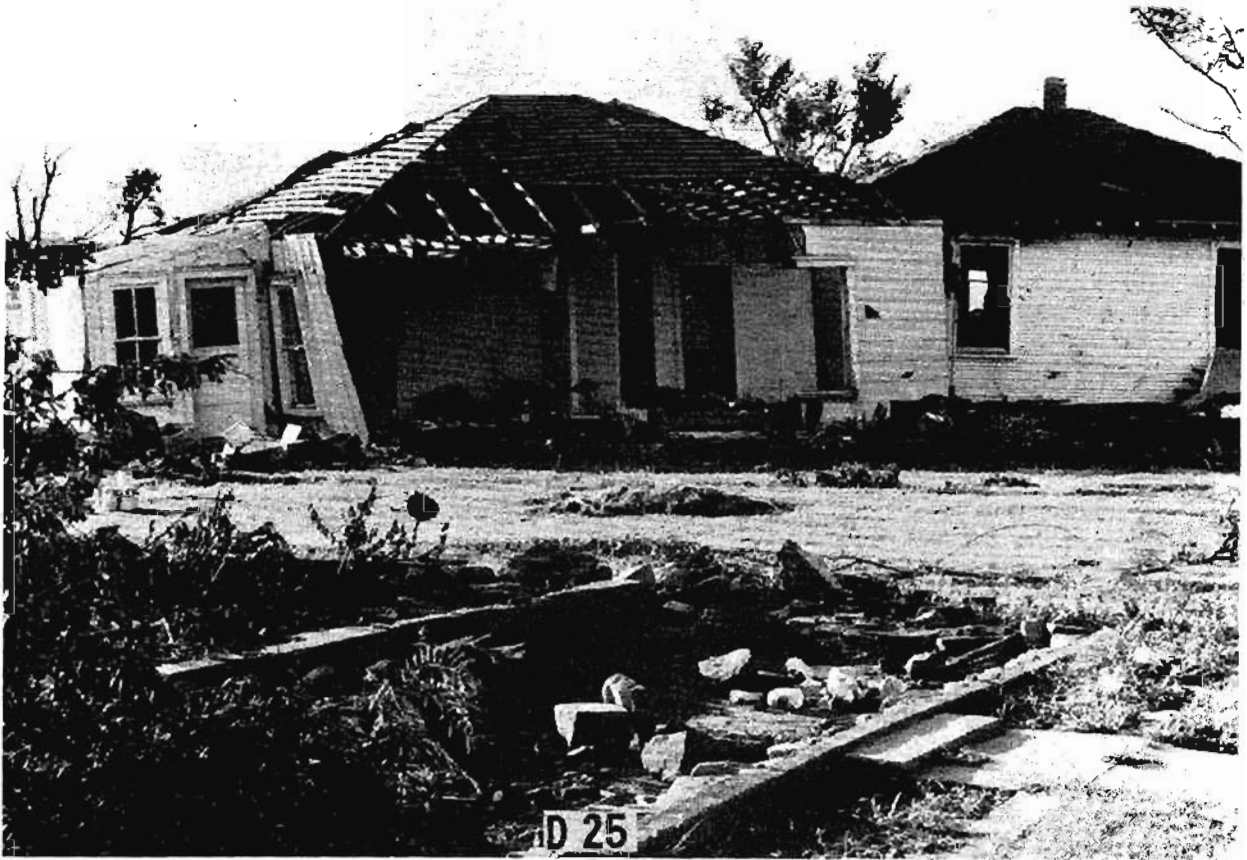
FIGURE 50. RURAL HOUSING IS CHARACTERIZED BY POOR SUPERSTRUCTURE-TO-FOUNDATION CONNECTIONS. This house in Drumright, Oklahoma was moved intact from its foundation (foreground) because there are no anchoring devices.

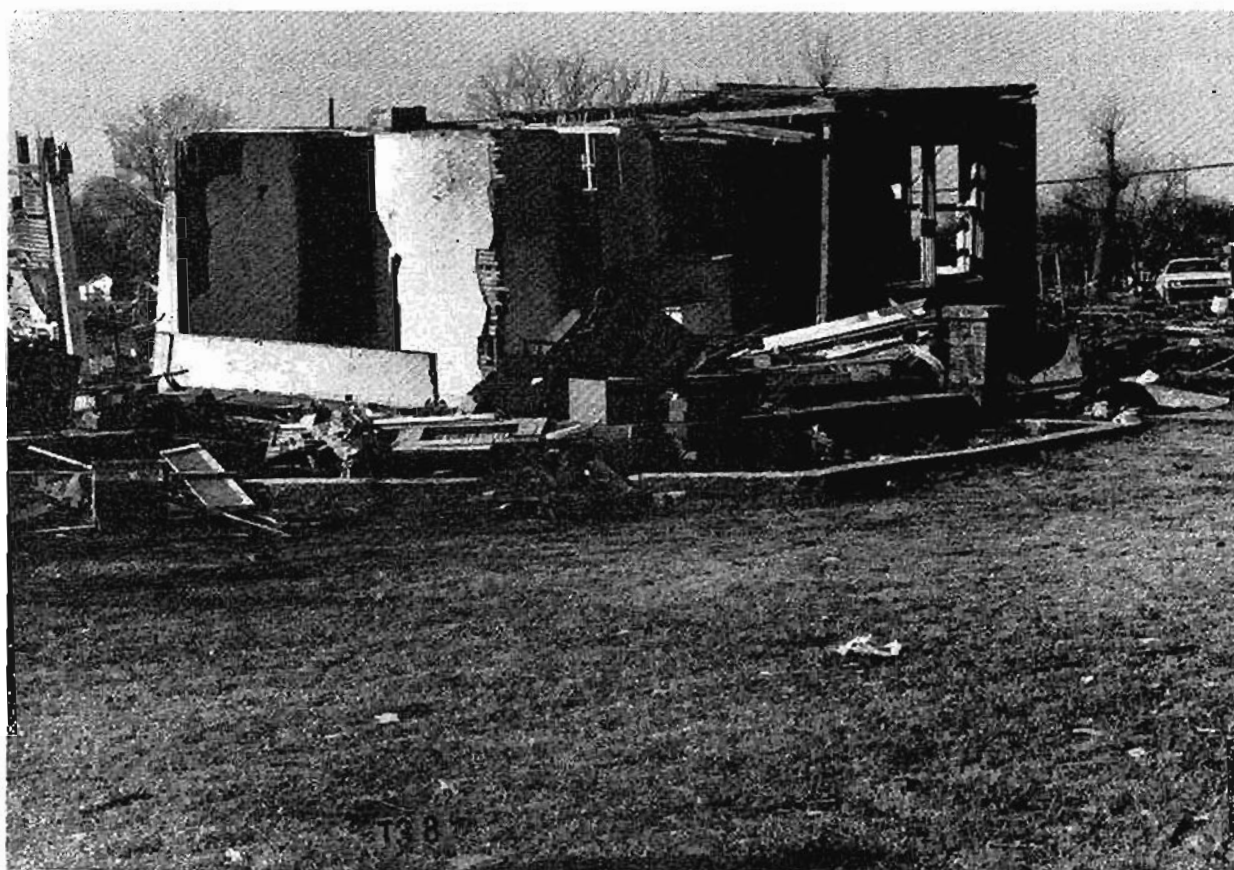
FIGURE 51. HOUSES WITH NO ANCHORAGES HAVE LITTLE RESISTANCE TO LATERAL FORCES. Note the smooth, anchor-free surface on the perimeter foundation of this rural house near Tulsa, Oklahoma.

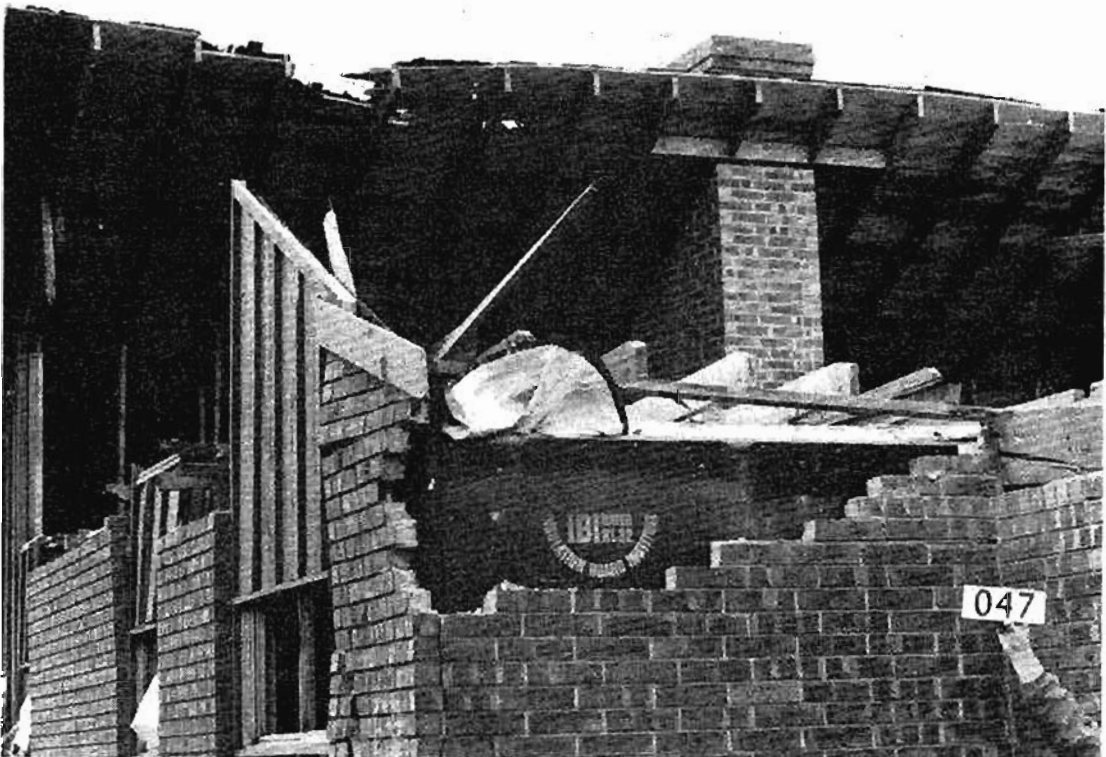
FIGURE 52. TRADITIONAL METHODS OF CONSTRUCTION IN SPECIFIC CITIES ARE REVEALED WHEN A WIND EVENT OCCURS. Roof framing schemes involving only rafters are traditional in Plainview, Texas; this construction procedure invites failure of entire roof segments.

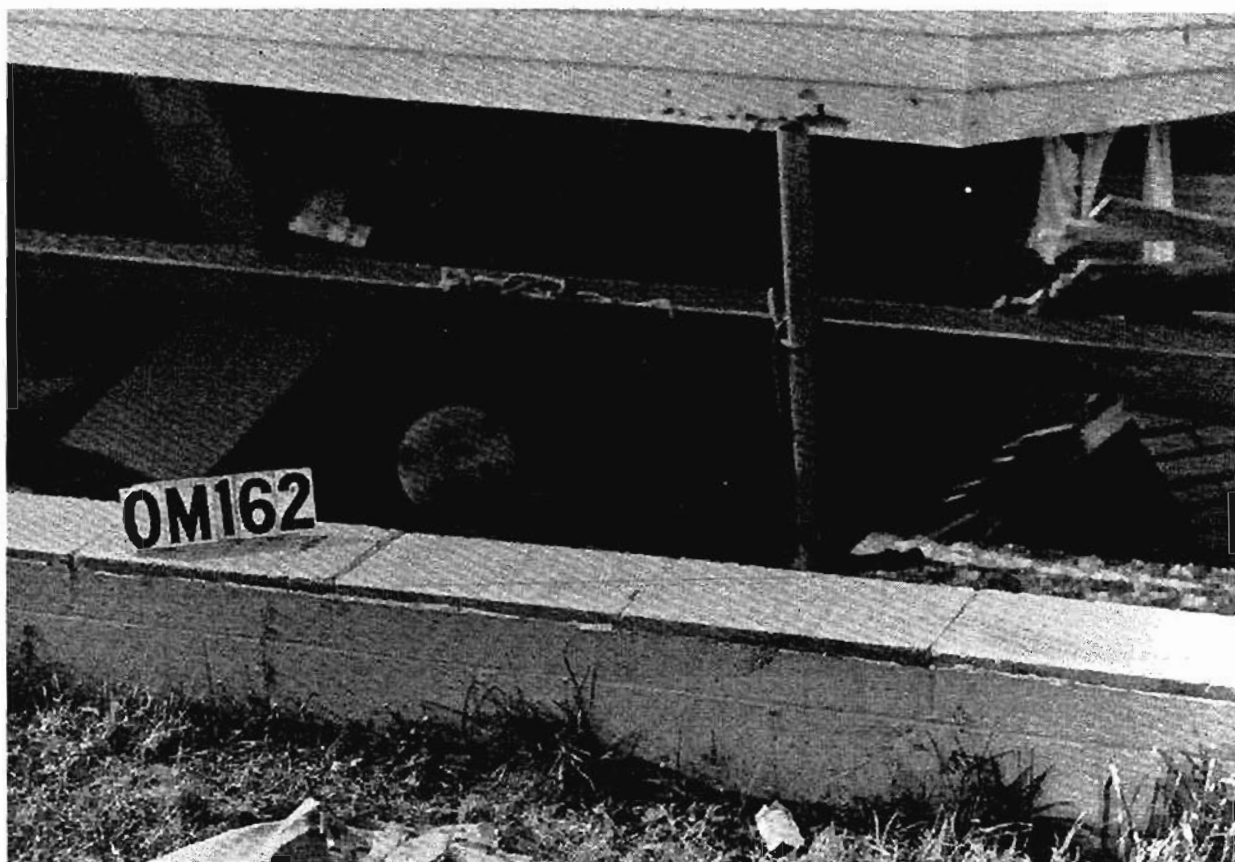
FIGURE 53. PARTIALLY BURIED CONCRETE BLOCK PERIMETER FOUNDATIONS ARE TRADITIONAL IN OMAHA, NEBRASKA. The Omaha Tornado of May 6, 1975 pushed many houses off the perimeter walls.

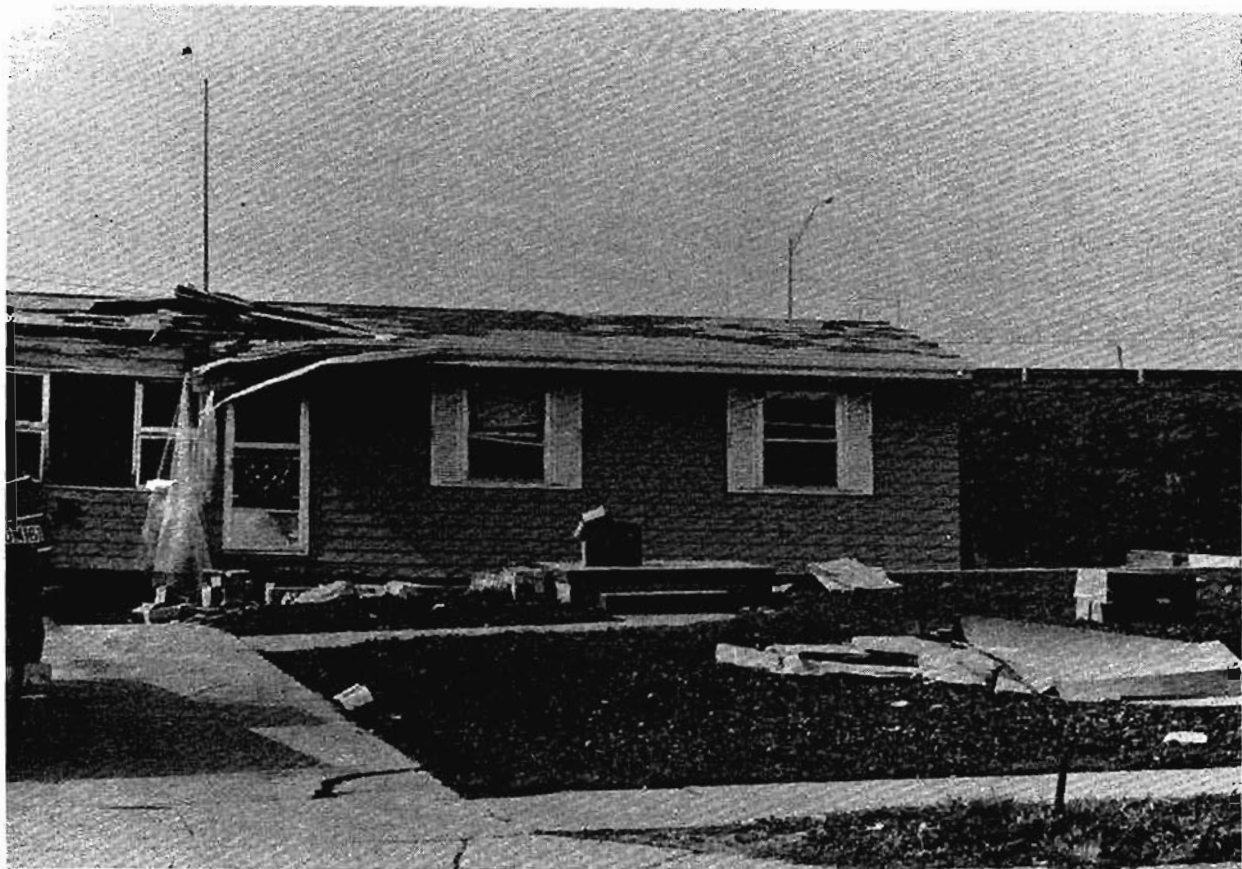
FIGURE 54. THE ENTIRE SUPERSTRUCTURE UNIT OF THIS HOUSE HAS BEEN MOVED Laterally. The traditional method of construction in Omaha contains no foundation anchorages which will resist this motion.

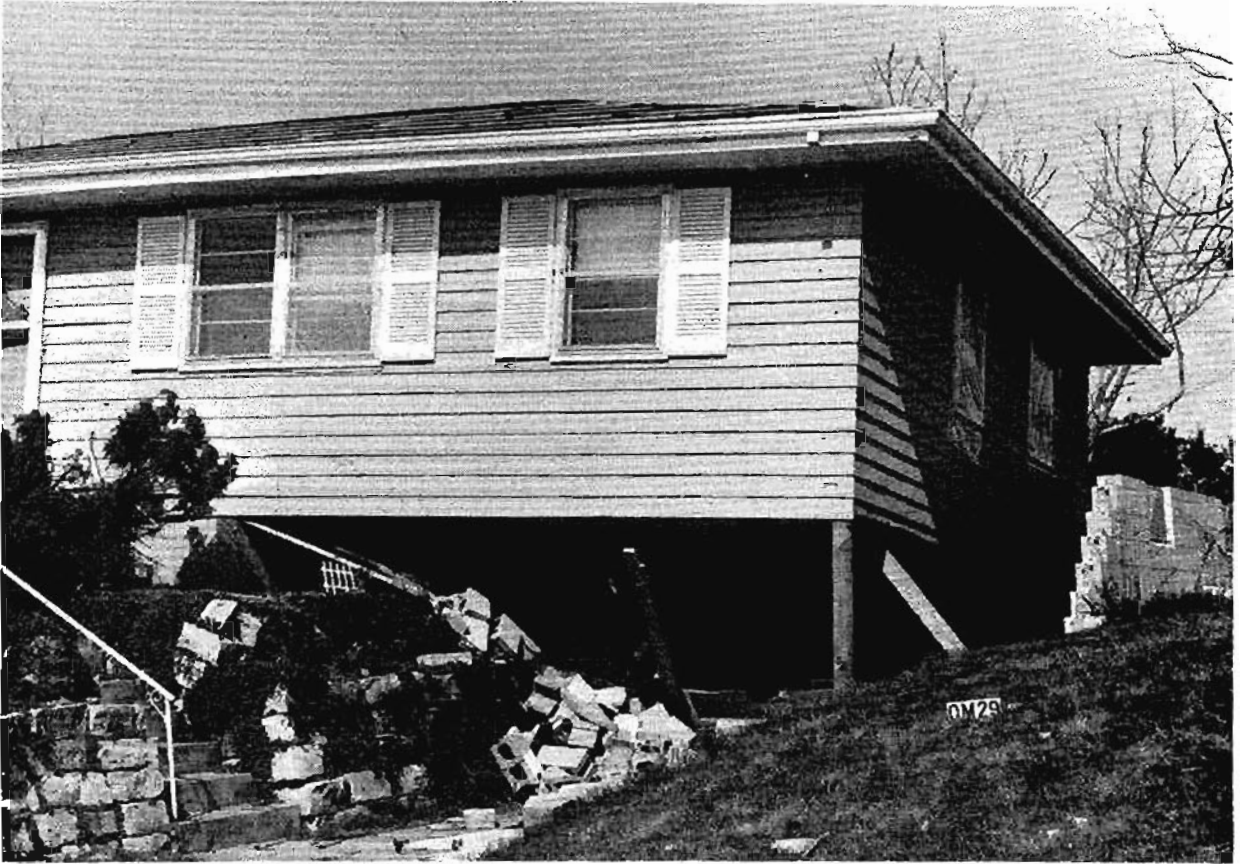
FIGURE 55. RELATIVELY LOW WINDSPEEDS MOVED THIS OMAHA HOUSE FROM ITS FOUNDATION. This superstructure to foundation anchor detail had become traditional in the Omaha area.

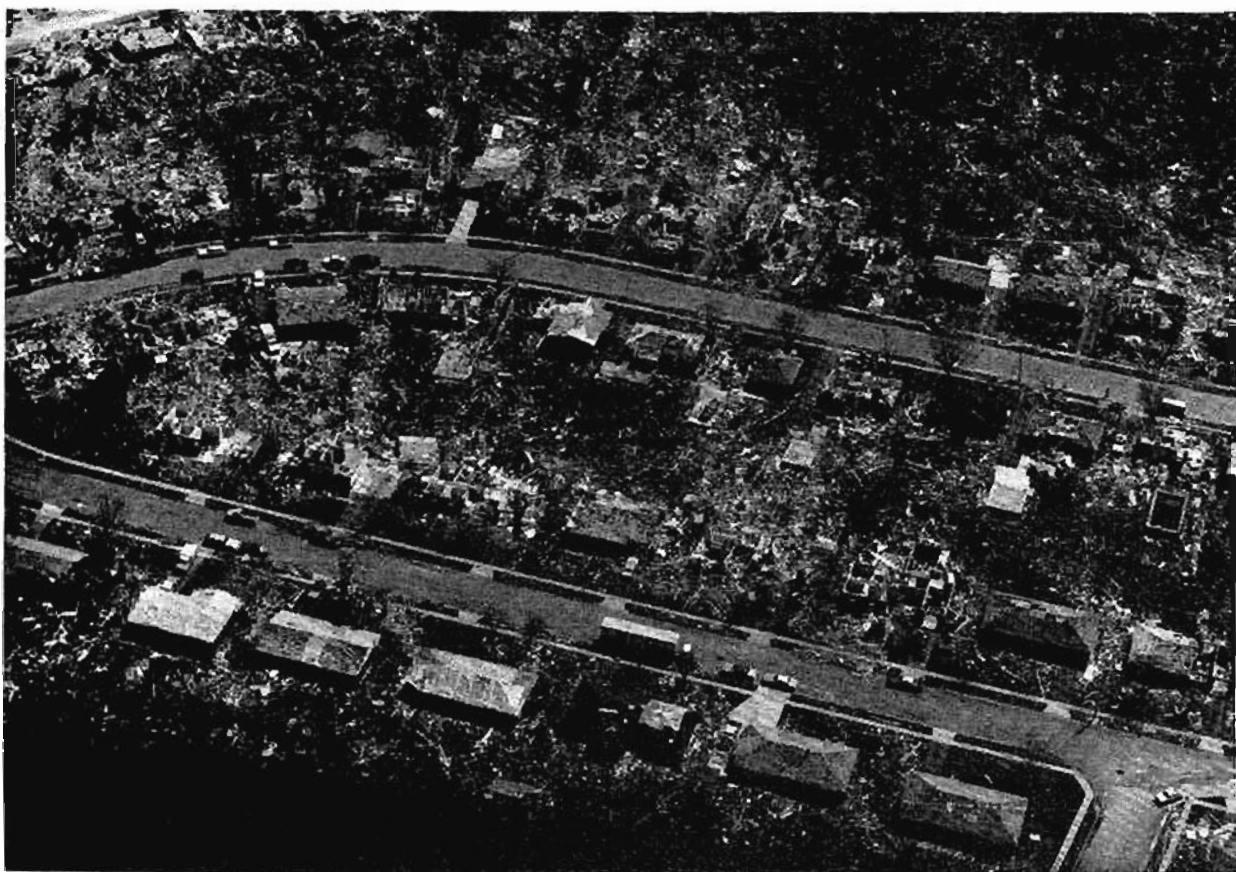
FIGURE 57. ORIENTATIONS OF GARAGE DOORS ARE RELATED TO SEVERITY OF HOUSING DAMAGE. These houses in Xenia, Ohio were damaged more severely if their garages had a westward orientation (north is to the left).

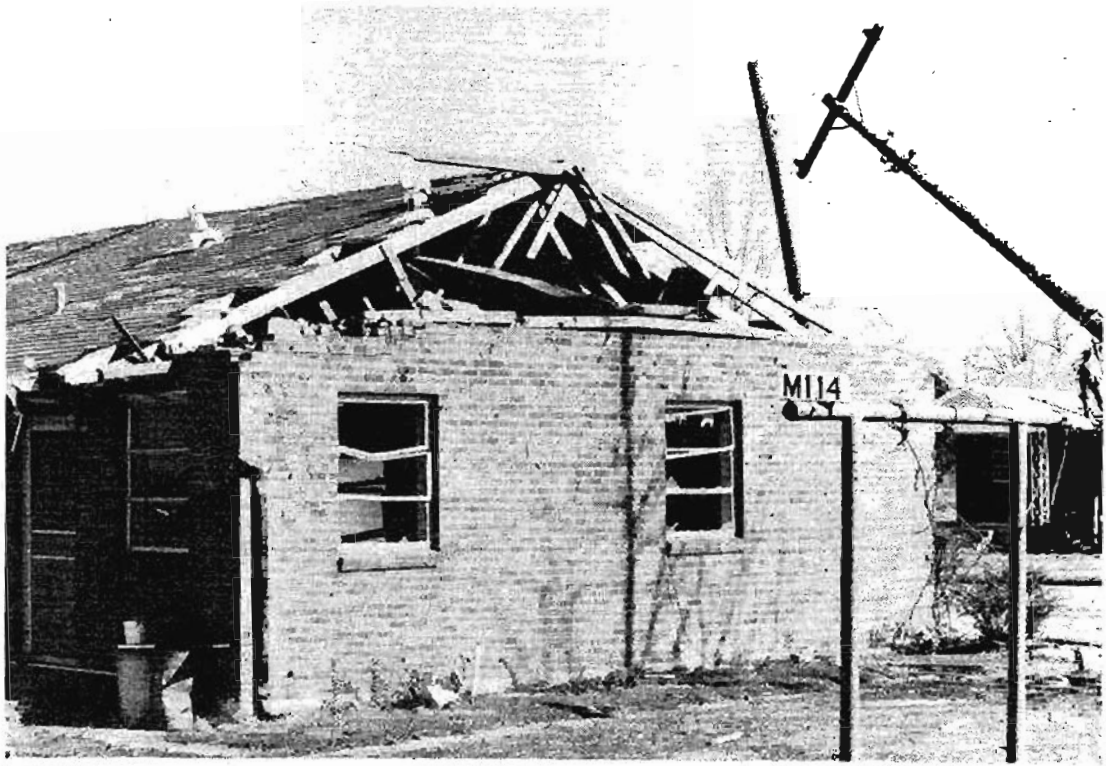
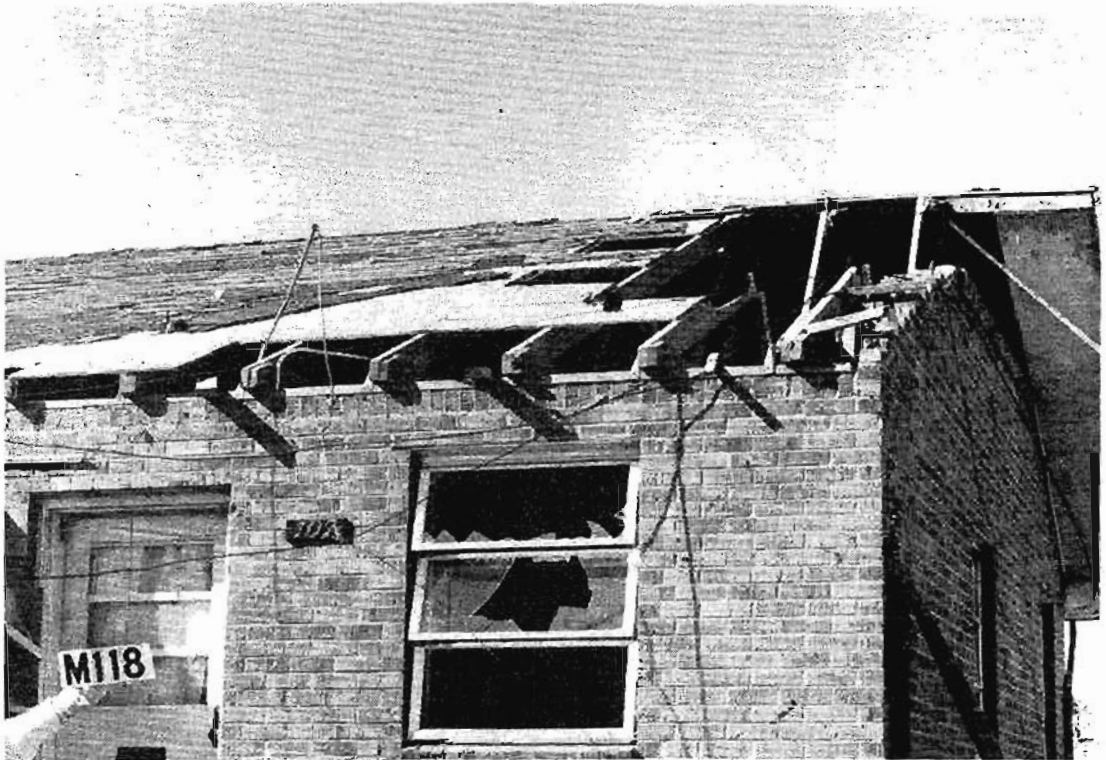
FIGURE 58.

PORCHES, OVERHANGING EAVES, AND GABLES WHICH FACE THE APPROACHING WIND OFTEN ARE FAILURE INITIATION POINTS. These houses in McComb, Mississippi had eaves extending beyond gables.

Failures initiated because of porches, overhanging eaves, or gables which faced into the wind are illustrated in Figure 58, and roof damage associated with a porch can be observed in the lower part of Figure 48. Often, failures initiated at these points lead to complete destruction of the house.

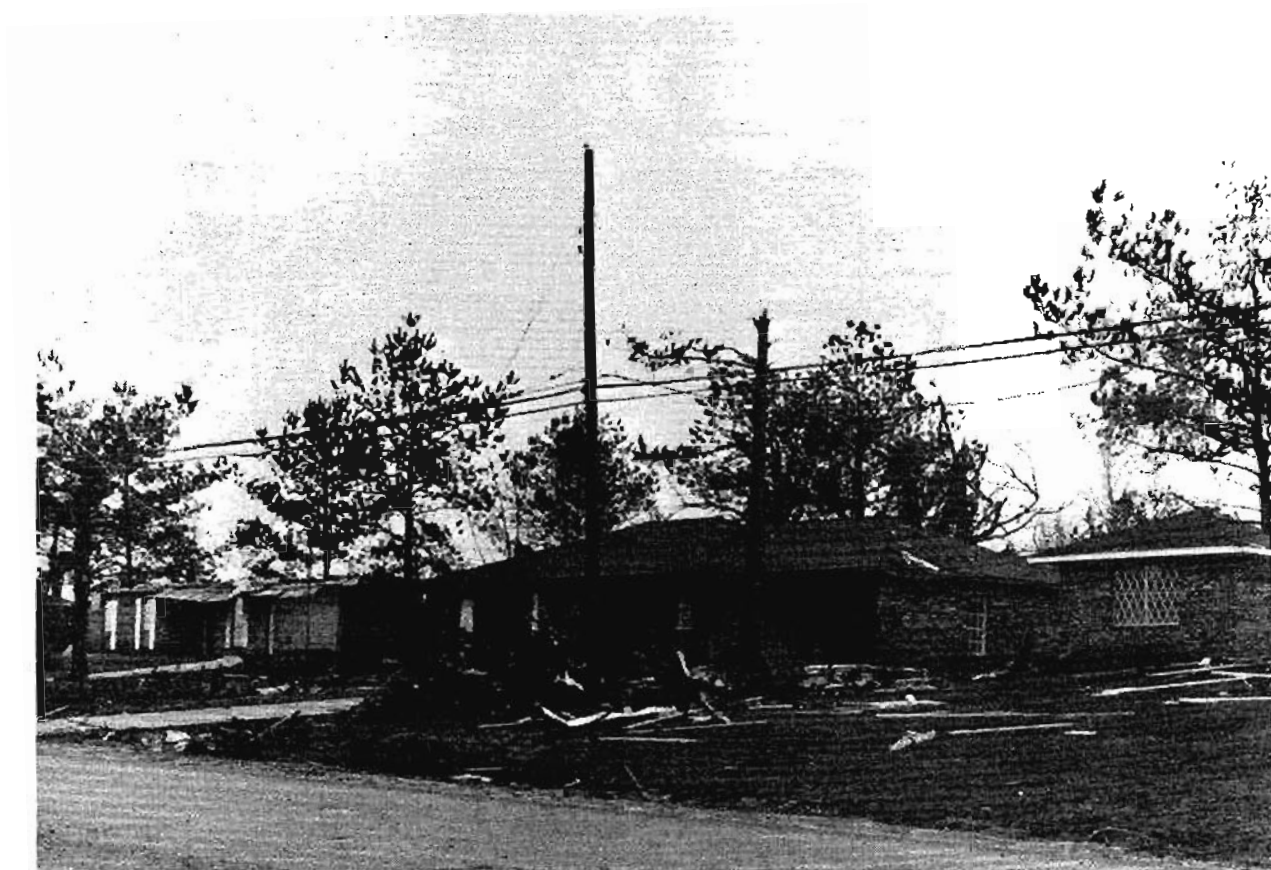
FIGURE 60. ROOF GEOMETRIES SEEM TO INFLUENCE THE SEVERITY OF DAMAGE EXPERIENCED BY HOUSING. The house with a hip roof (right) sustained less damage than the house with the gable roof (left) in McComb, Mississippi.

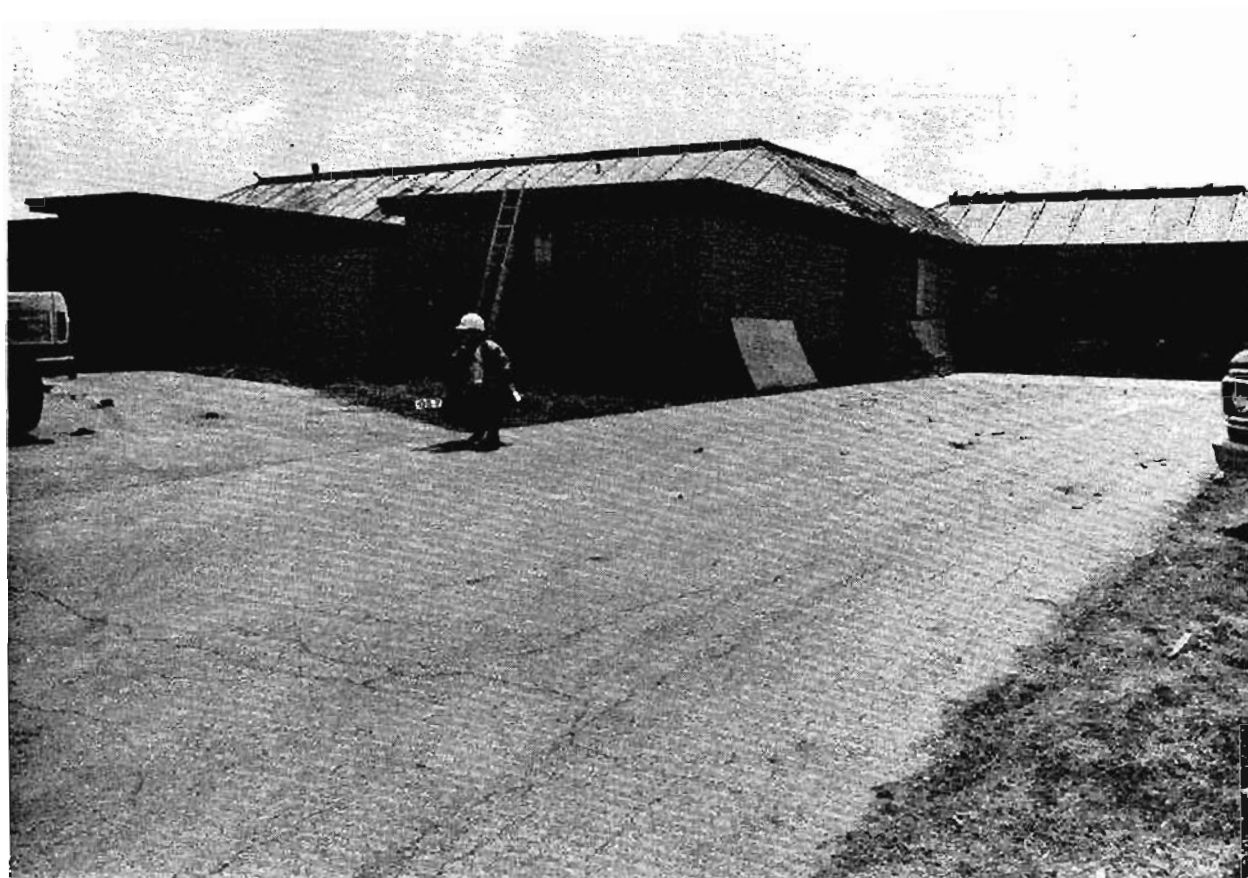
FIGURE 61. THE MANSARD SHAPE OF THE ROOF OF THIS HOUSE MAY HAVE IMPROVED ITS RESISTANCE TO WIND. The family did not move out of this house, while families on either side had to relocate because of severe damage to gable roofs.

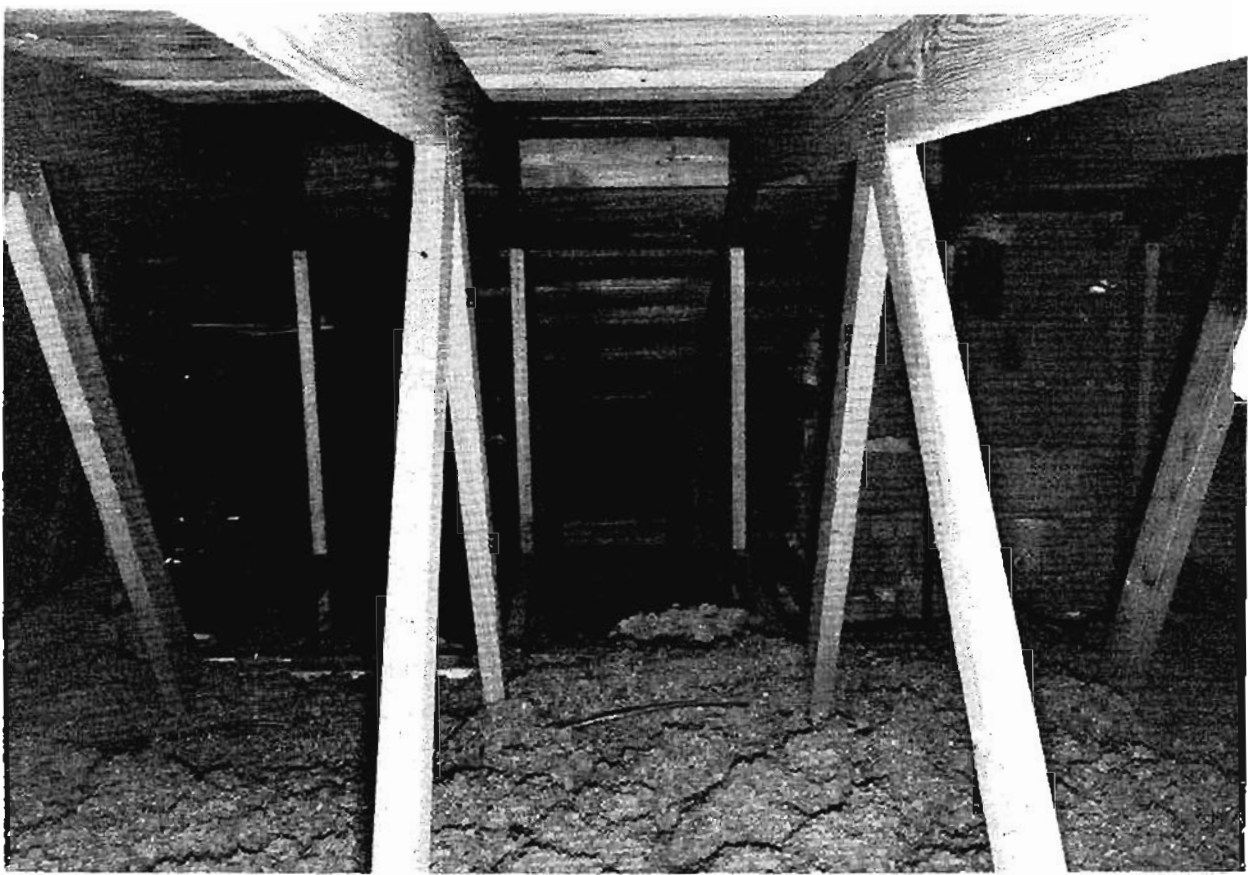
FIGURE 62. THE FRAMING PLAN FOR THE MANSARD ROOF IN FIGURE 61 INCLUDED A UNIQUE DETAIL. Wall studs extended through the top plate to form the end vertical member in the mansard truss.

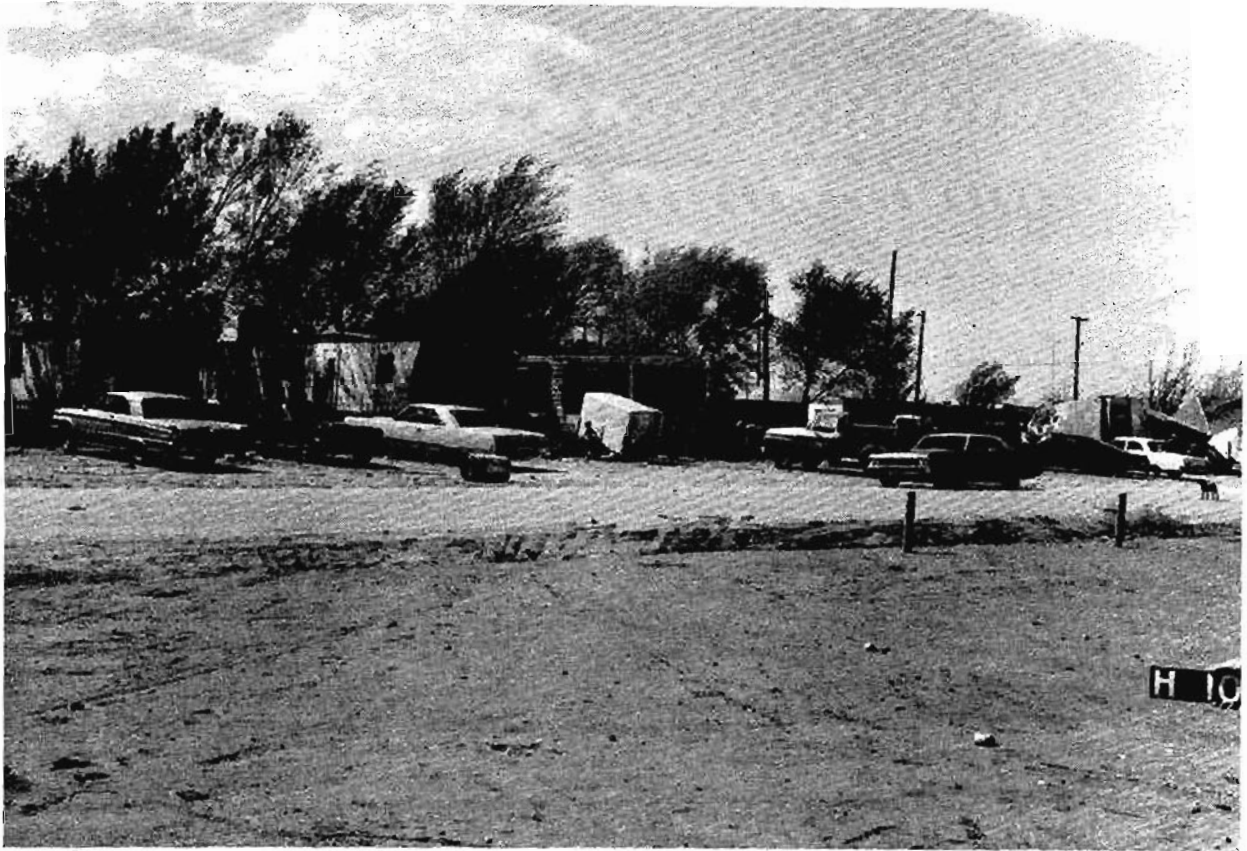
FIGURE 63. TREES AFFORD SOME PROTECTION FROM WIND. The mobile homes in the trees (left) sustained less damage than those in the open (right) during the Hereford, Texas Tornado of April 19, 1971.

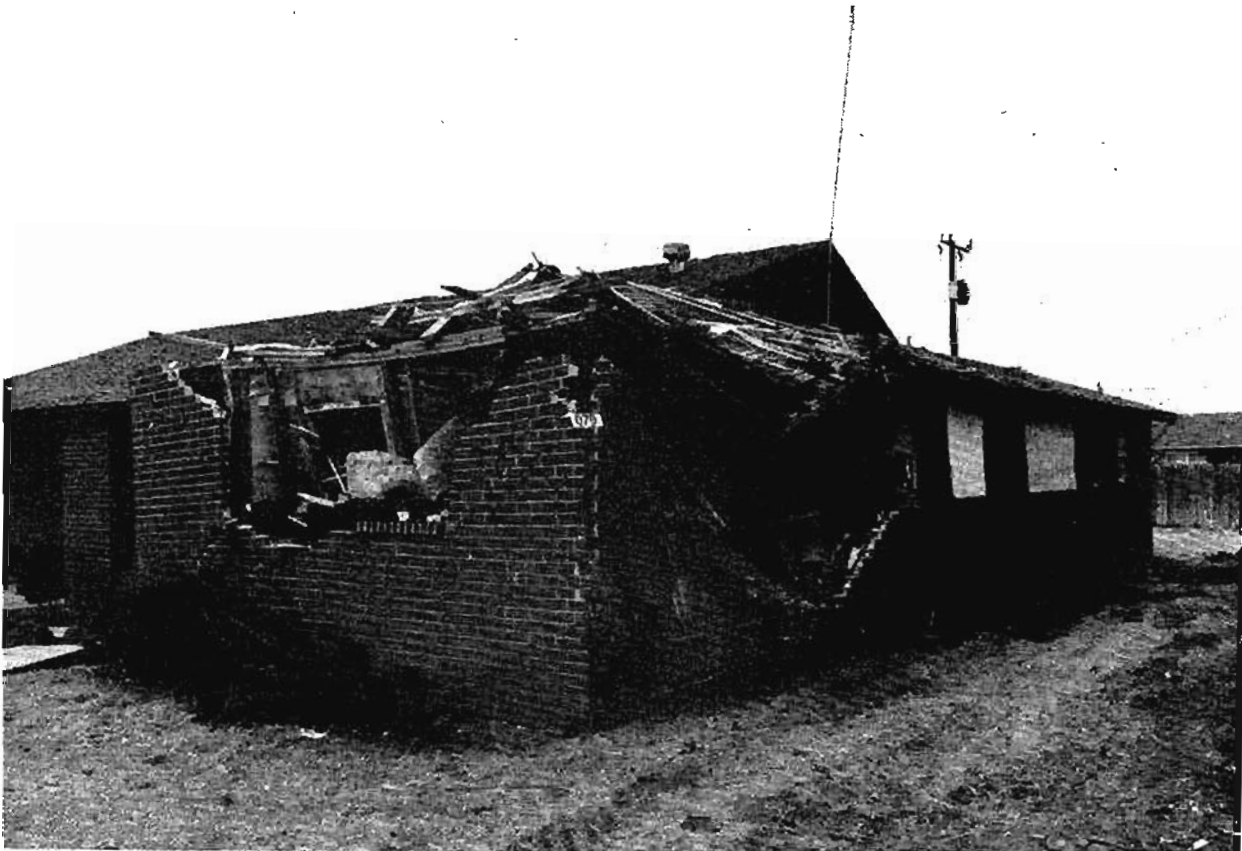
FIGURE 64. THE ISOLATED HOUSING DAMAGE WAS CAUSED BY DEBRIS IMPACTING FROM A FAILING HOUSE ONE-HALF BLOCK AWAY. The Plainview, Texas incident is a classic example of missile-induced failure.

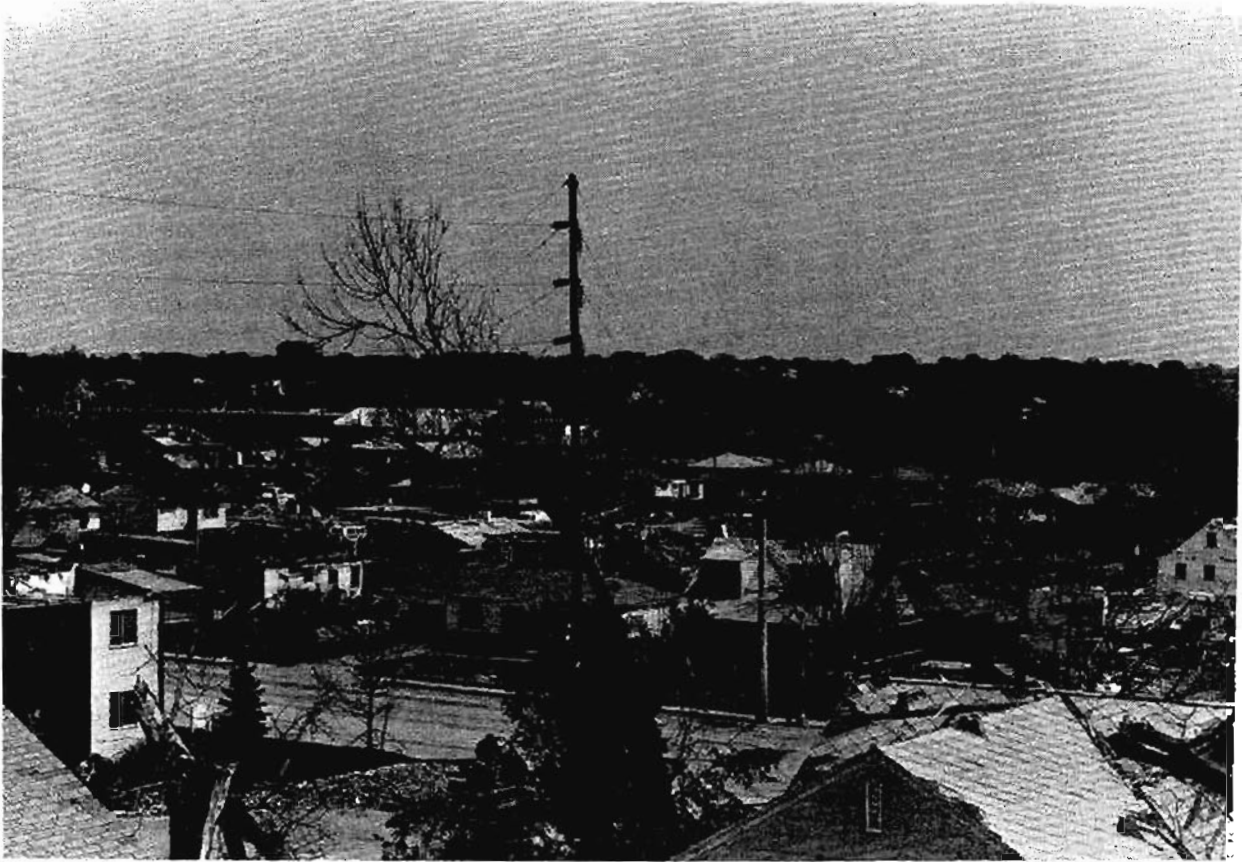
FIGURE 65. TORNADOES CAN FOLLOW THE TERRAIN VERY CLOSELY.
The Omaha Tornado of May 6, 1975 caused severe
damage in valleys between hills.

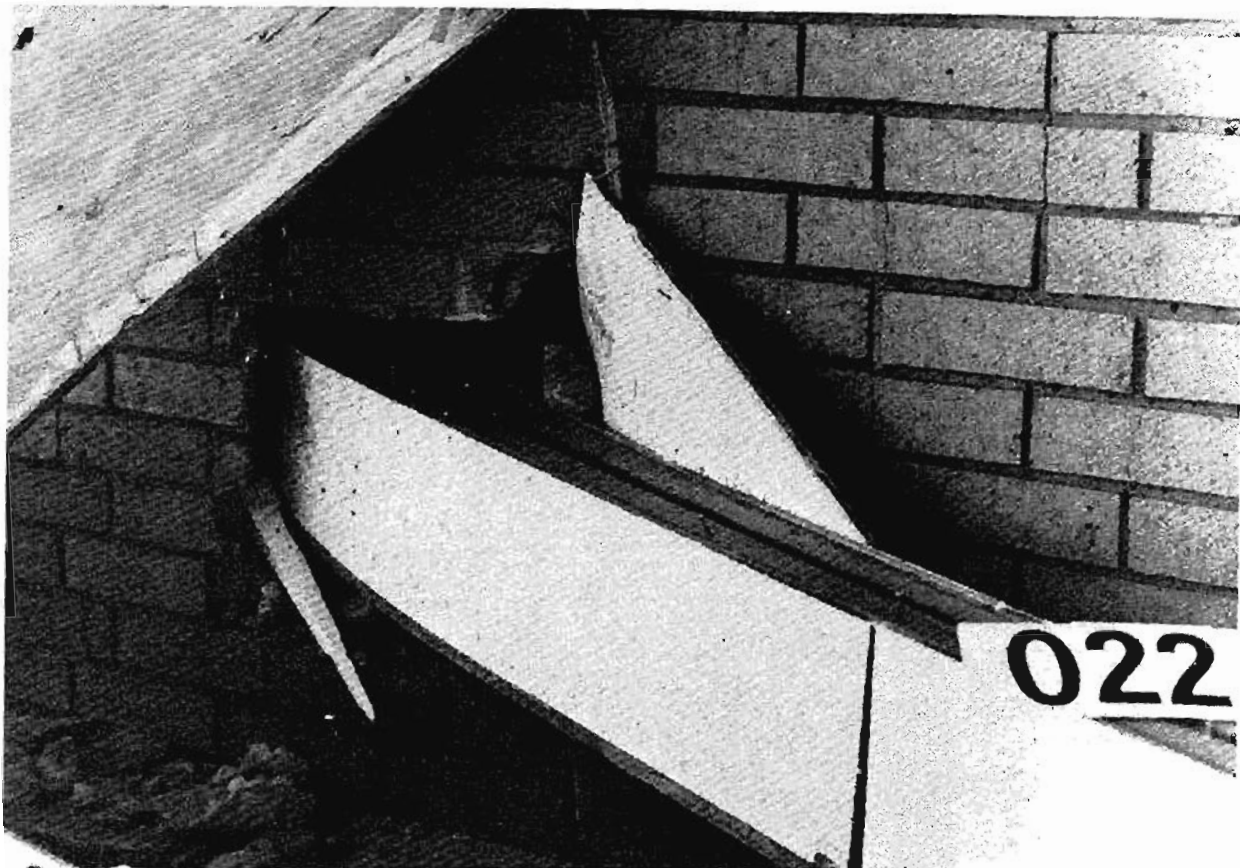
FIGURE 66. MISSILES ARE MAJOR FACTORS IN INDUCING DAMAGE TO HOUSING. The large beam shown here was attached to a carport roof which became airborne.

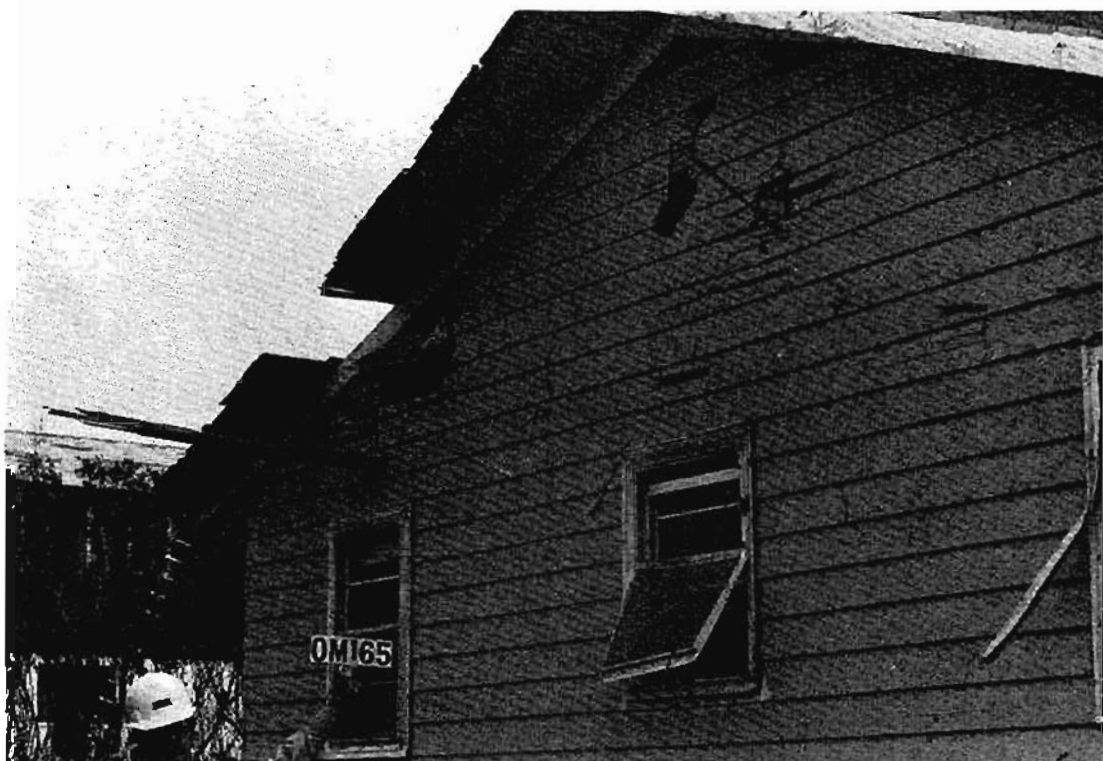
FIGURE 67. EXAMPLES OF TORNADO-GENERATED MISSILES IN RESIDENTIAL AREAS. Many missiles in Omaha, Nebraska penetrated exterior walls (top) while some missiles in Plainview, Texas entered the house (below).
