NOAA Technical Memorandum ERL NSSL-82

THE TORNADO: AN ENGINEERING-ORIENTED PRESPECTIVE

Joseph E. Minor
James R. McDonald
Kishor C. Mehta

Institute for Disaster Research
Texas Tech University
Lubbock, Texas

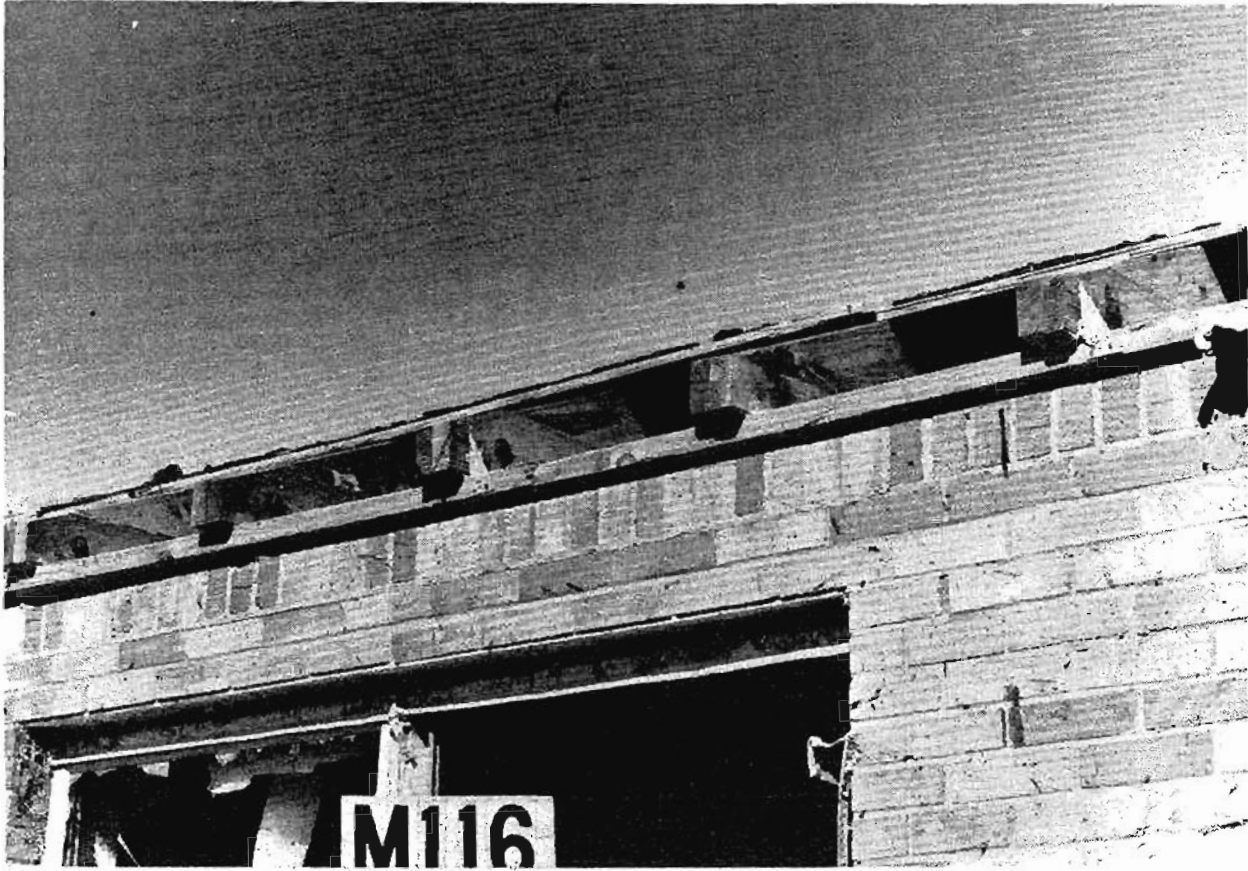
FIGURE 70. HURRICANE CLIPS CAN BE INSTRUMENTAL IN REDUCING THE SEVERITY OF DAMAGE. The clips along the wall plate hold the rafters to the walls.

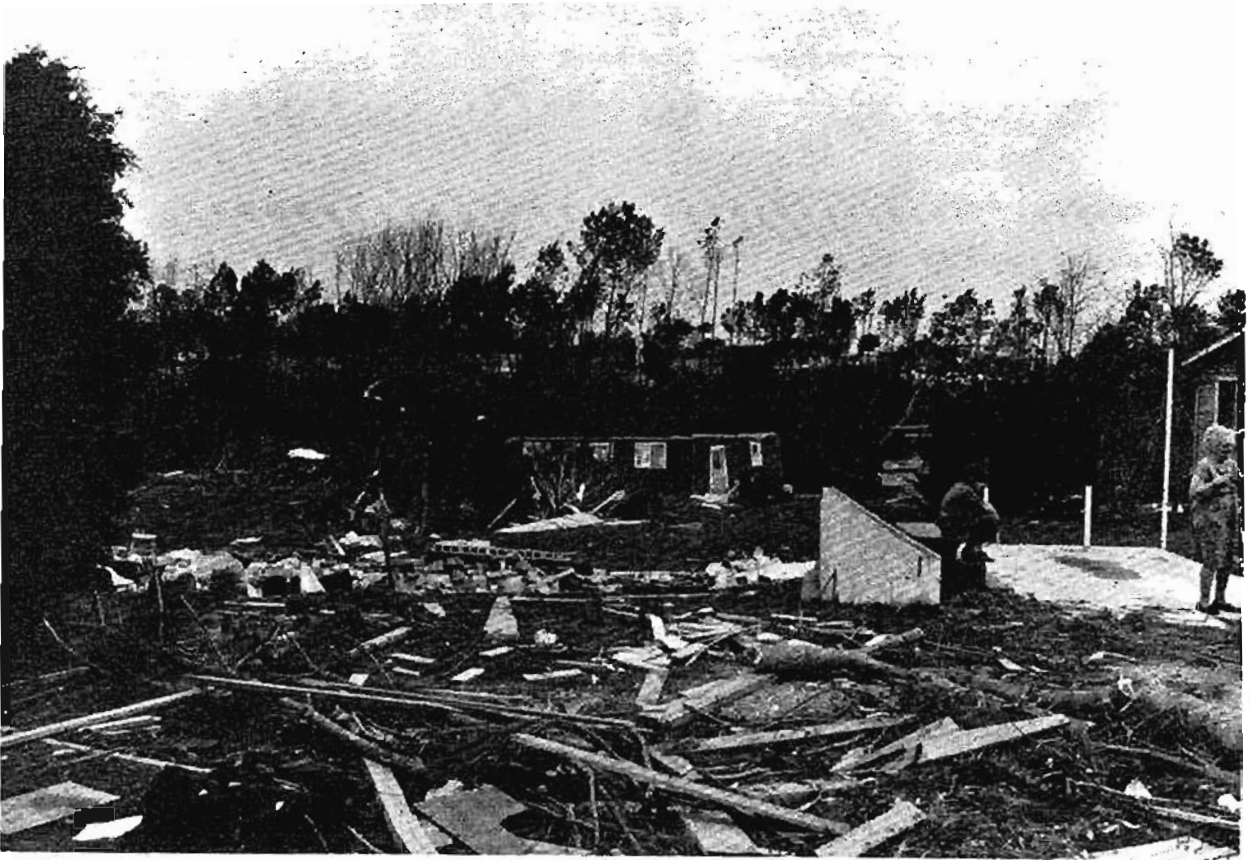
FIGURE 71. THE HOUSE WAS MOVED FROM THE BLOCK FOUNDATION (FOREGROUND) TO ITS FINAL POSITION 100 FT AWAY. The roof was removed but the superstructure retained its integrity.

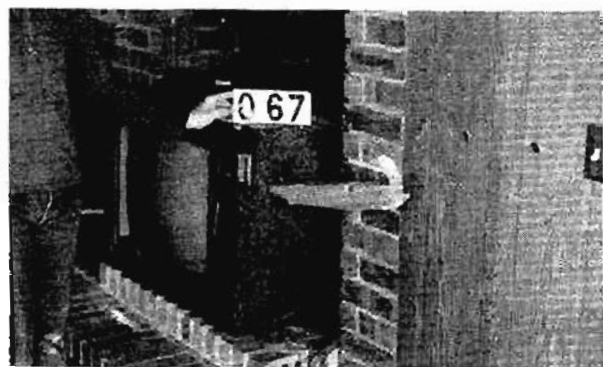
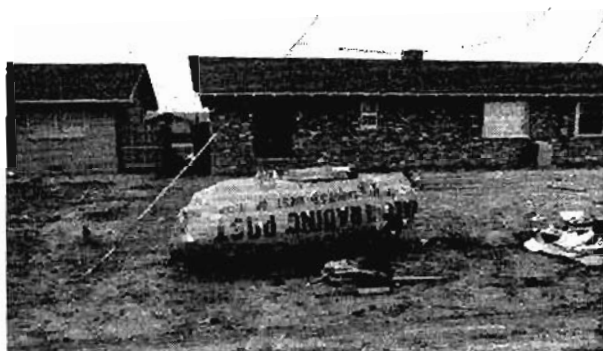
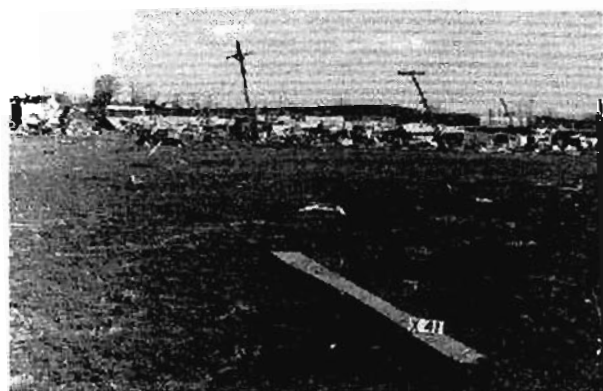
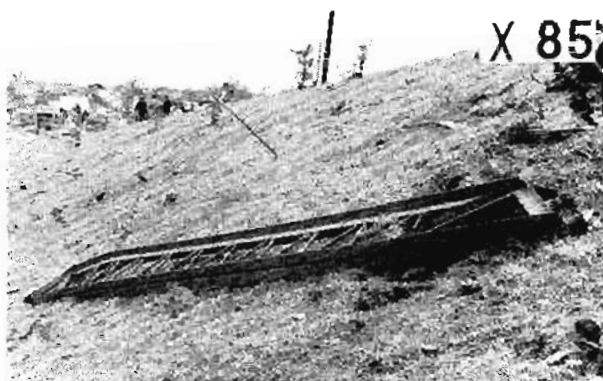
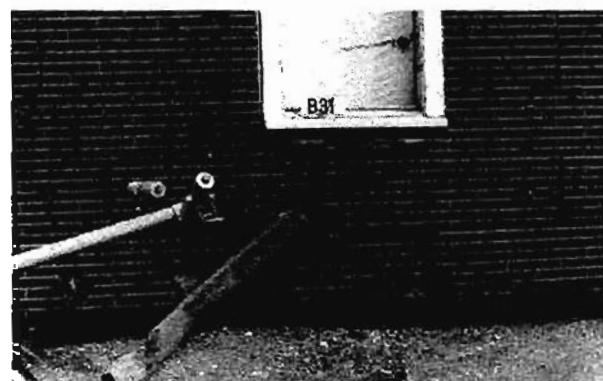
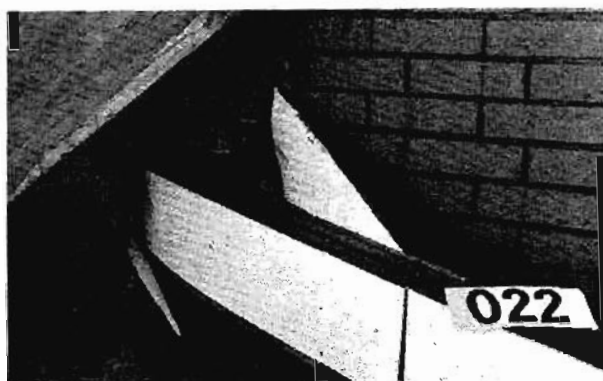
FIGURE 72. TYPICAL TORNADO-GENERATED MISSILES. Missile sizes range from splintered boards to heavy beams and trusses.

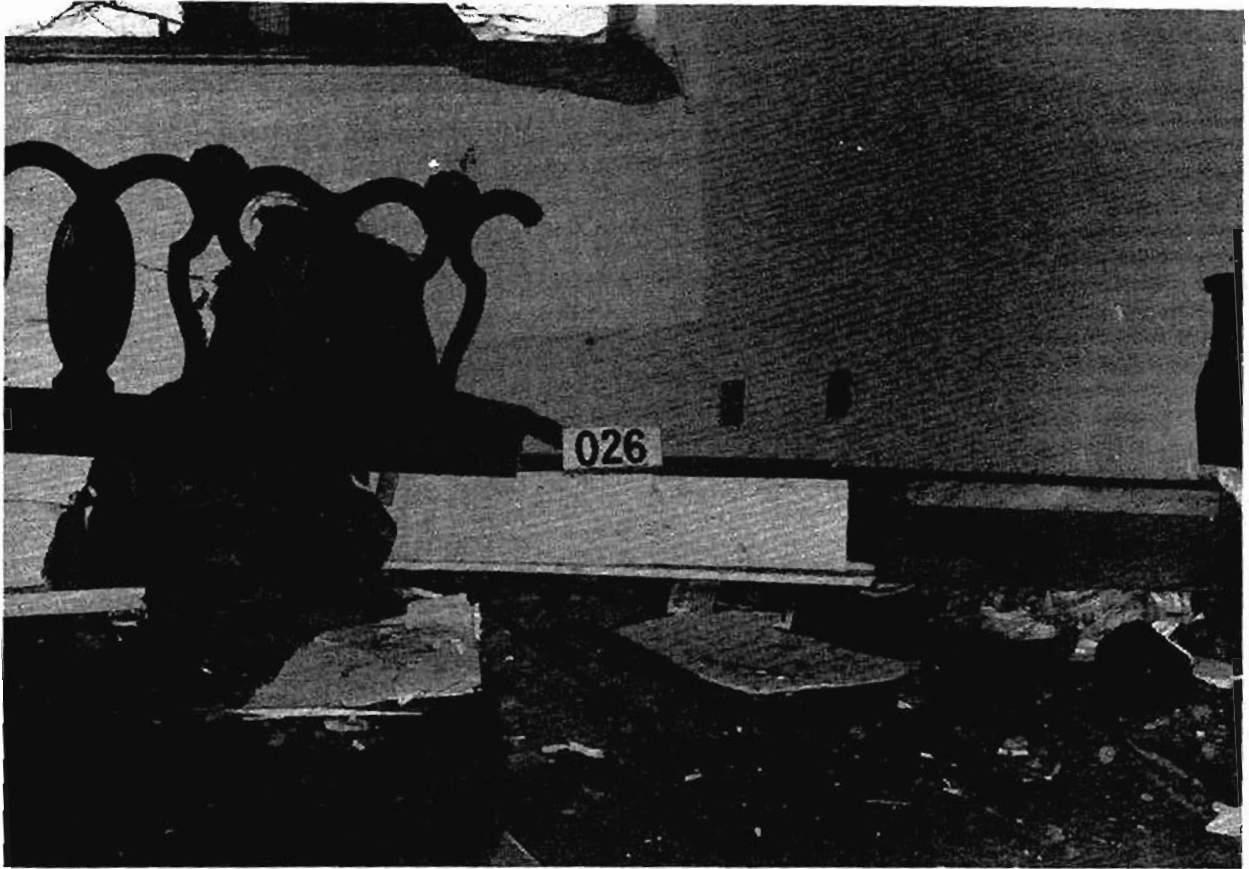
FIGURE 79. LARGE BEAM PERFORATED RESIDENTIAL WALL IN PLAINVIEW, TEXAS.
The beam was attached originally to a carport roof which
came to rest opposite the wall shown.

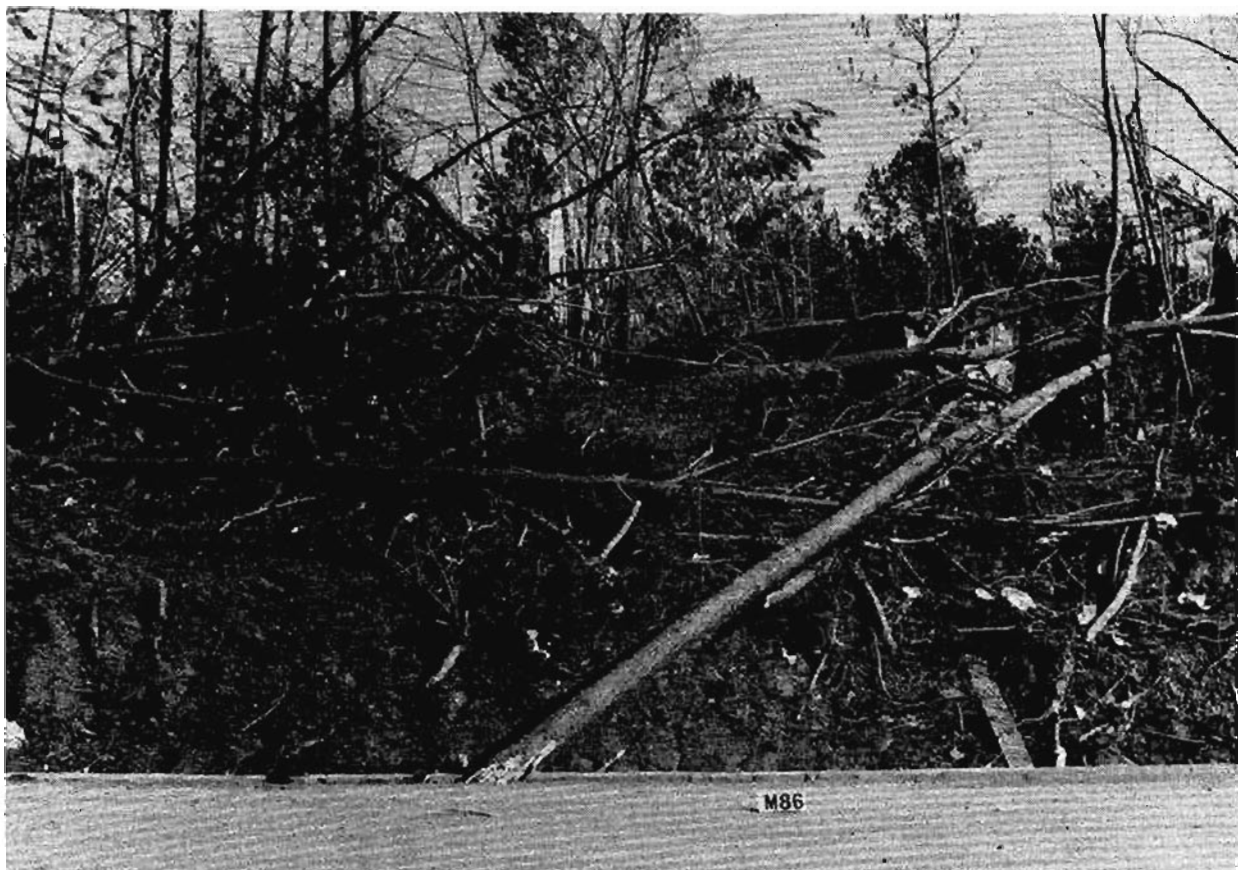
FIGURE 81. THE 8-FT EMBANKMENT OVER WHICH THE McCOMB, MISSISSIPPI SCHOOL BUSES (FIG. 80) PASSED. The buses were probably airborne as they passed the embankment.

Automobiles, vans, buses, and semitrailers can, under the right circumstances, become airborne. In general, these items tend to roll and tumble along the ground. Figure 80 is an aerial view of North Pike Elementary School near McComb, Mississippi which experienced a tornado in January, 1974. Three, 40-passenger school buses can be seen in the woods nearby. At the time the tornado struck, the buses were parked in a circular drive near the entrance to the building. Investigations following the storm confirmed that these buses did indeed become airborne. There is an 8-ft embankment along the drive next to the woods (Fig. 81). There were no ground marks to indicate that the buses had rolled or tumbled up the embankment. The buses were unoccupied at the time of the tornado. The tornado moved from left to right, in the photograph. The buses were located on the right-hand side of the tornado path at the approximate radius of maximum winds.

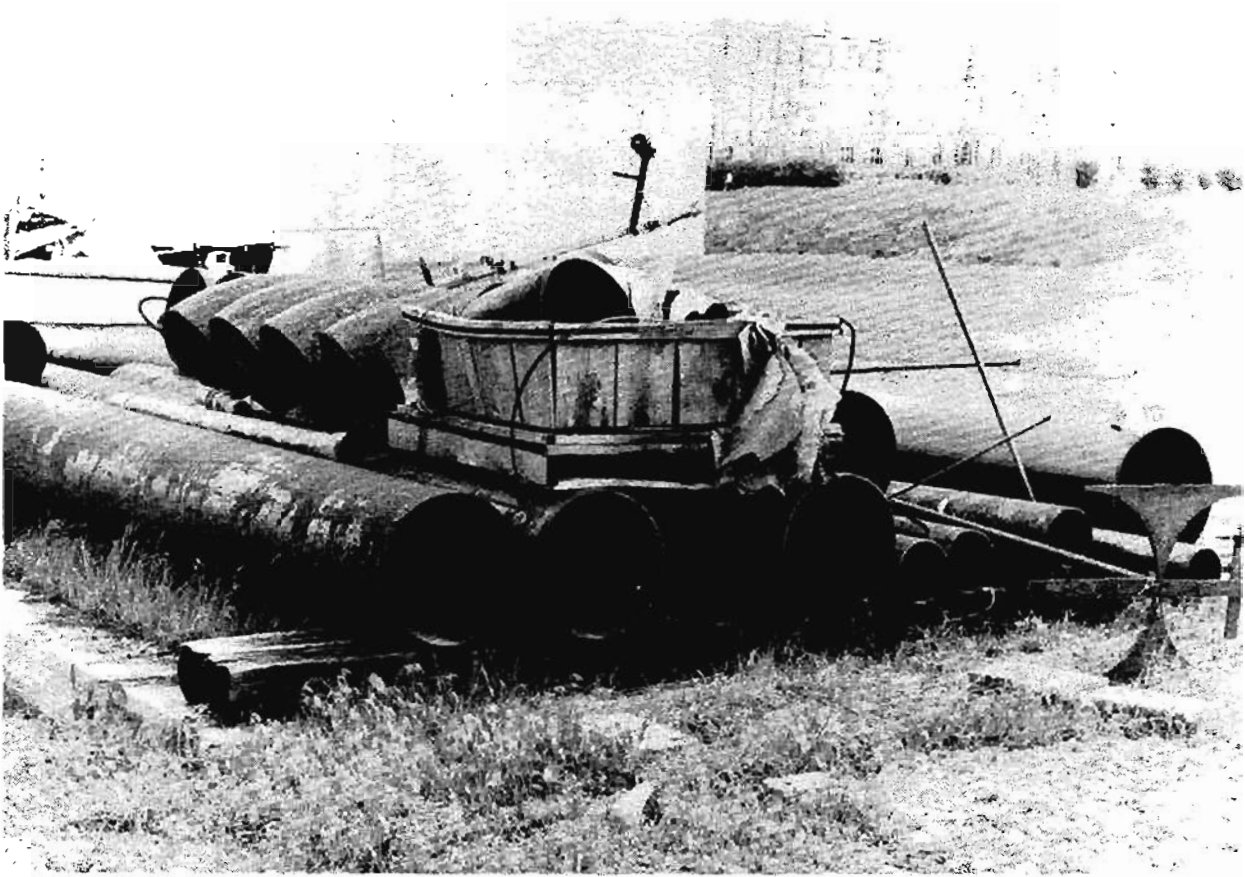
FIGURE 86. LARGE DIAMETER PIPE THAT WAS UNDISTRUBED BY TORNADIC WINDS. The Washita, Oklahoma Tornado of April 17, 1976 had an opportunity to move this pipe.

Figure 86. This tank is immediately down-wind from the warehouse and the racks of stored pipe and equipment. There was no evidence of significant impacts on the tank from flying debris. The observation that seems appropriate from this and similar investigative efforts is that heavy material stored near ground level is not likely to become airborne in severe windstorms.

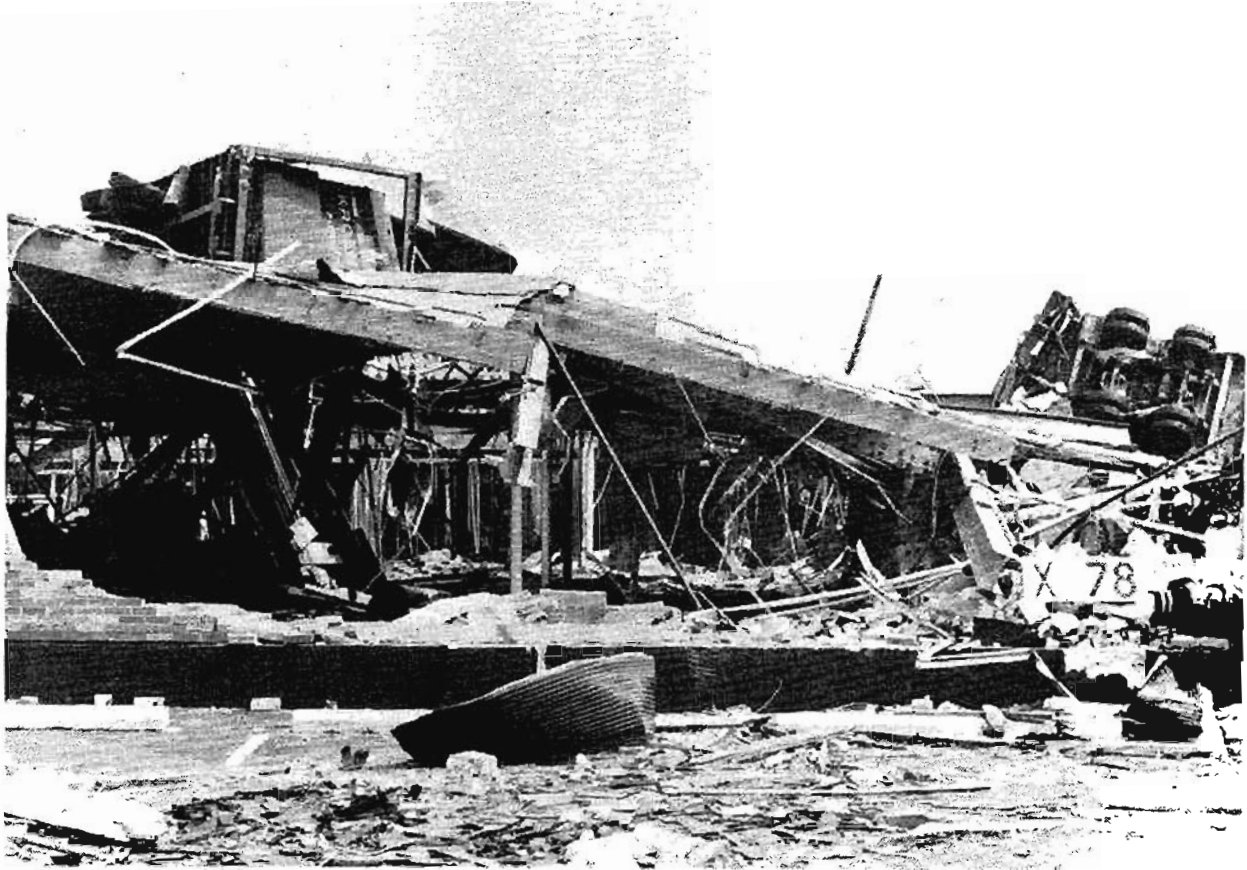
FIGURE 87. FURNITURE VANS ON BOWLING ALLEY ROOF FOLLOWING XENIA, OHIO TORNADO OF APRIL 3, 1974. The empty vans had a large "flight parameter".

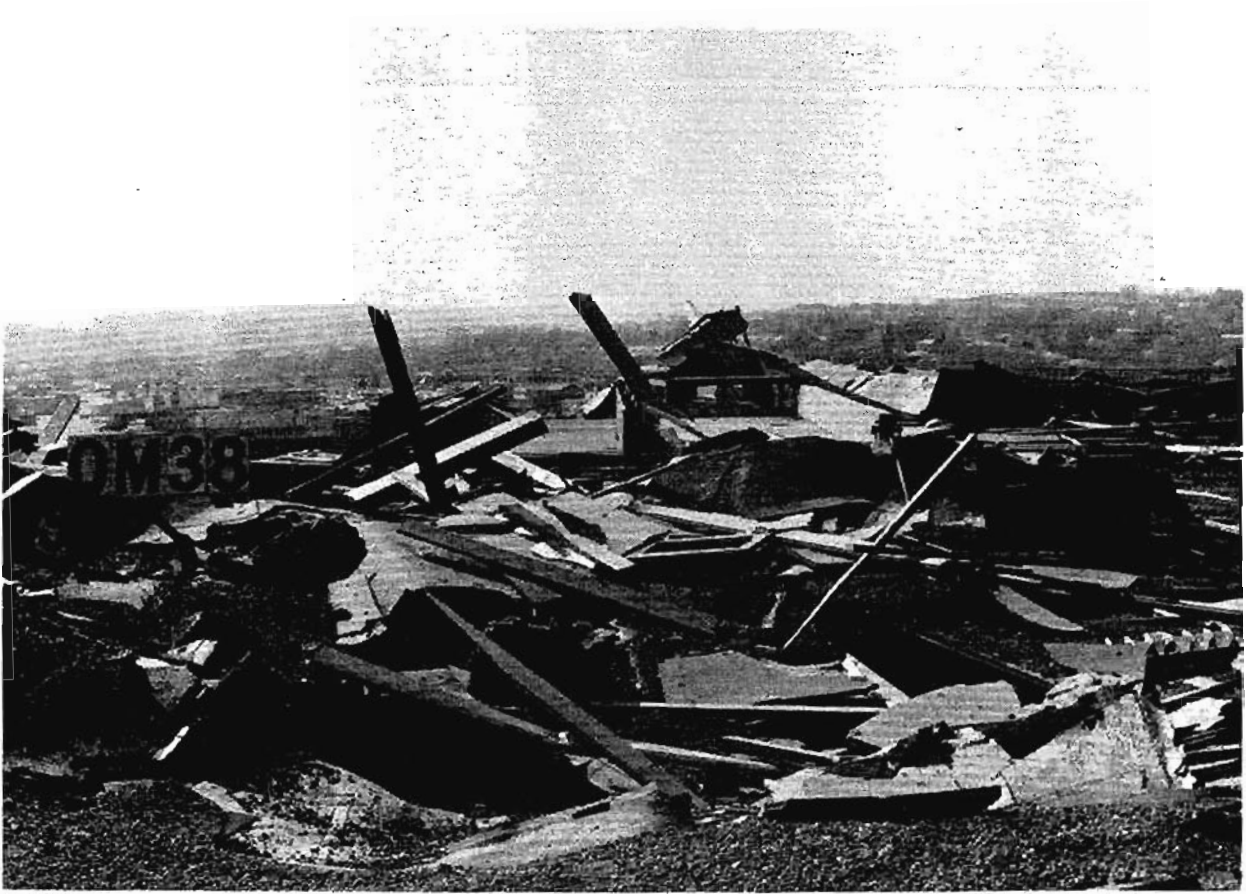
FIGURE 93. THE SOURCE OF THE TIMBER MISSILES (FIG. 92) WAS THE WESTGATE ELEMENTARY SCHOOL. Laminated wood beams formed integral parts of a roofing system, parts of which became airborne.
