Analysis of the Above-ground Shelter Door Failure

April 27, 2014 Tornado, Mayflower, Arkansas

¹Larry J. Tanner and ²Ernst W. Kiesling

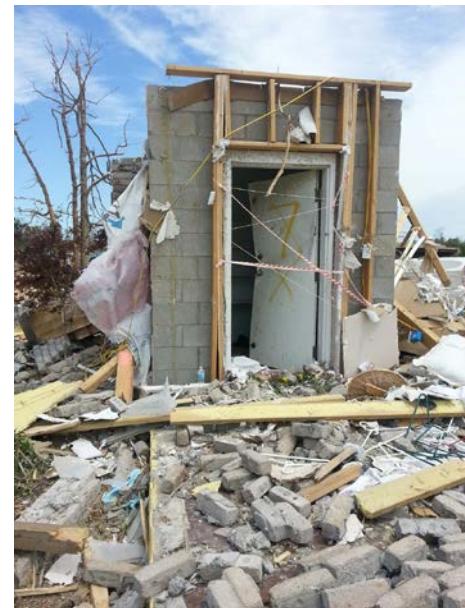
Surviving above-ground shelter with failed door

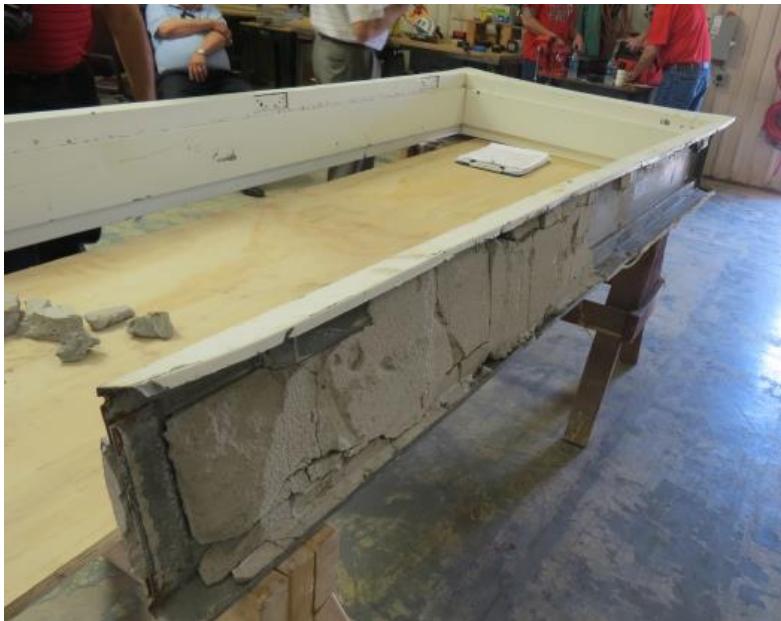
The door frame was installed as a “wrap-around” of the 8-in. concrete masonry, grout filled, without any apparent wall anchorage. The frame measured 8 3/4-in. wide, with a 2-in. return, a 1 7/8-in. door rabbit, a 5 1/4-in. soffit, and was 18 ga. in metal thickness. The frame further contained 10 ga. hinge reinforcements, a 14 ga. lock box, and 22 ga. strike mud boxes.

Grout filled frame without anchorage

Safe Room Door frames are required by FEMA P-320 and ICC-500 to have the equivalent shear strength of (5) 3/8-in. bolts in each jamb and (3) 3/8-in. bolts in the door head.

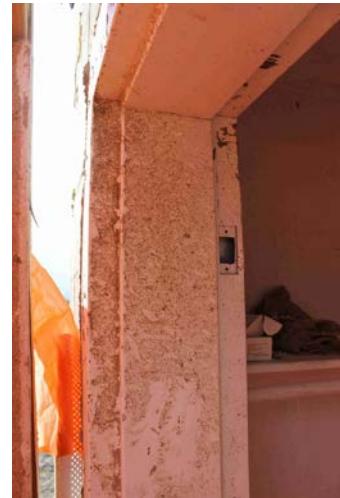
Door frame installed in shelter

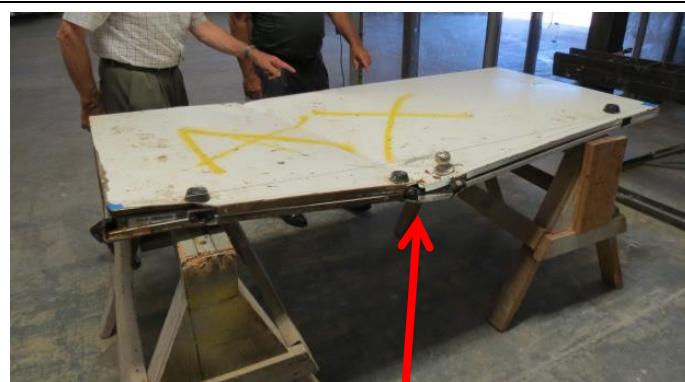
The door measured 3-ft. wide x 6-ft. 8-in. x 1 3/4-in. thick and was clad with 18 ga. metal skins that half-wrapped the jamb edge channels. The door was prepared for three dead bolts and a latch set.

Door received for examination

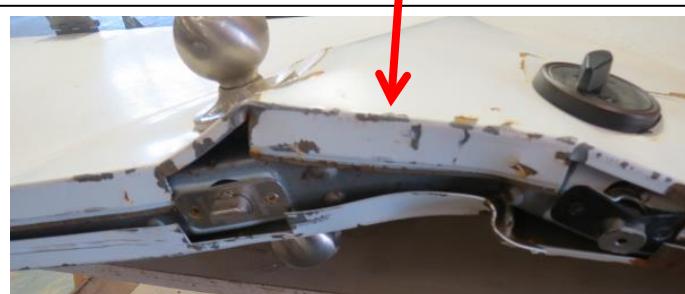
It was sliced in three locations to investigate the internal construction. The edge channels were 1 11/16-in. x 5/8-in. x 16 ga. with door skins projection welded at 2 1/2-in. centers along the top and bottom channels and 5-in. centers along the edge channels. Numerous projection welds were discovered to have failed. Hinge reinforcement was 4 1/2-in. x 1 1/2-in. x 11 ga. The hardware reinforcement consisted of 16 ga. partial boxes, tack welded to the edge channel. The door core was a standard 3/4-in. x 3/4-in. honeycomb. No vertical steel stiffeners were included in the door construction.

Door edge separation at latch and deadbolt location

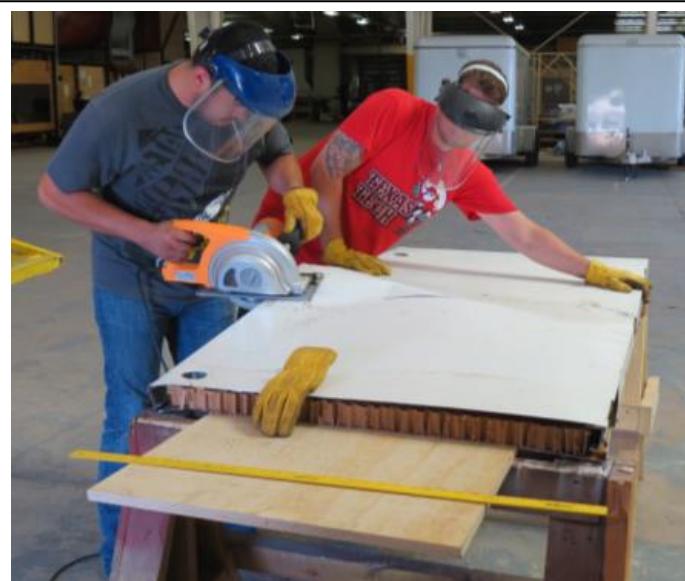
Door sliced for internal investigation

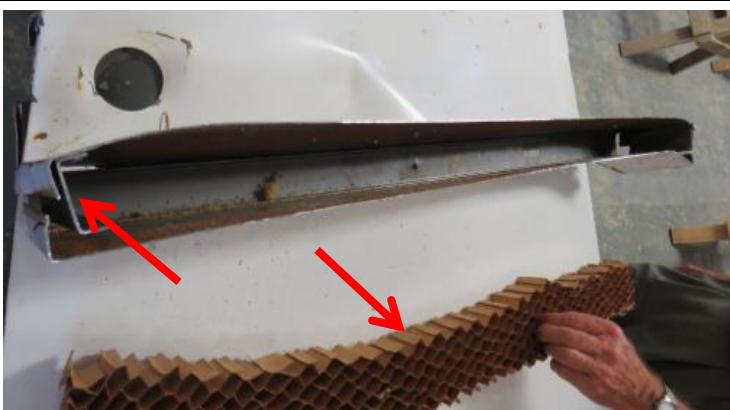
16 ga. Edge Channels and honeycomb core

- 14 ga. door skins
- 14 ga. edge channels
- 14 ga. vertical stiffeners
- 10 ga. hinge reinforcement
- 10 ga. lock box reinforcement

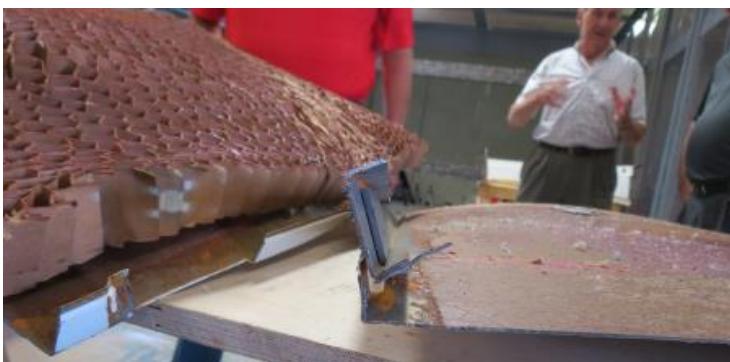
11 ga. Hinge reinforcement

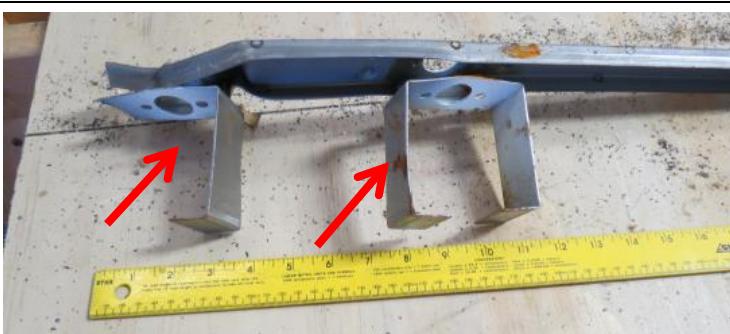
Lock/Latch and Deadbolt 16 ga. stiffeners

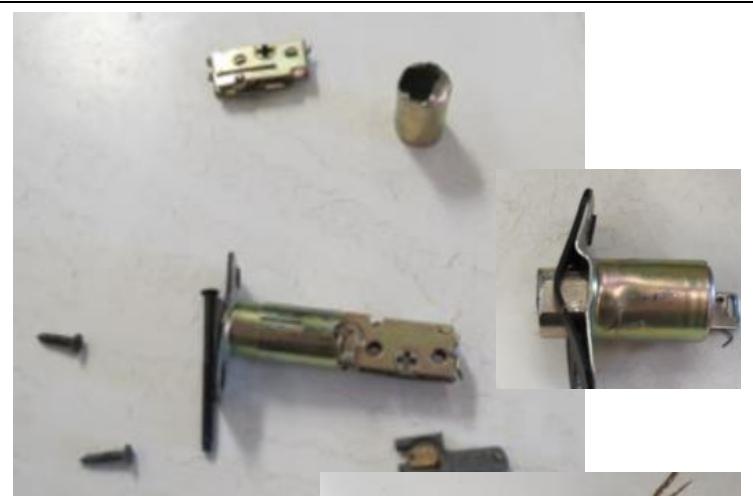
The attached door hardware included branded (3) Residential Grade deadbolts and a latch/lock. Hinges were branded 4-in. x 4-in. x 0.130 (5-knuckle) commercial grade.

Damaged Deadbolts

- *(3) Grade 1 deadbolts*
- *(3) Heavy duty hinges preferably ball-bearing*
- *Full headed American hinge screws*

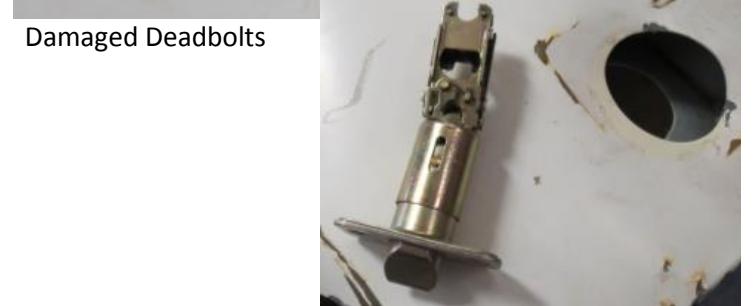
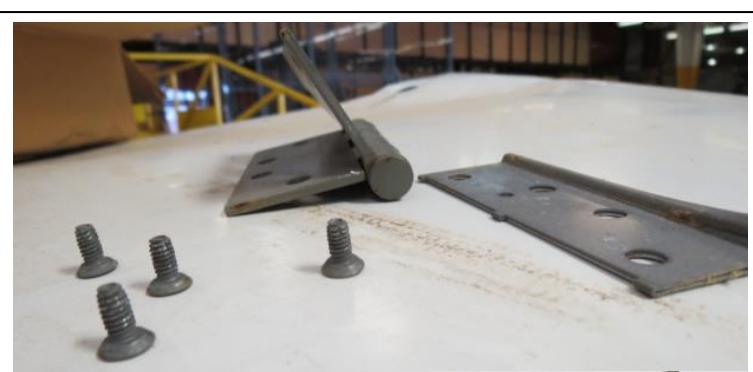
Damaged Hinges and Screws

Note: Foreign hinges are manufactured to minimum tolerances, thereby requiring the bugle head of the screw to be undercut in depth.

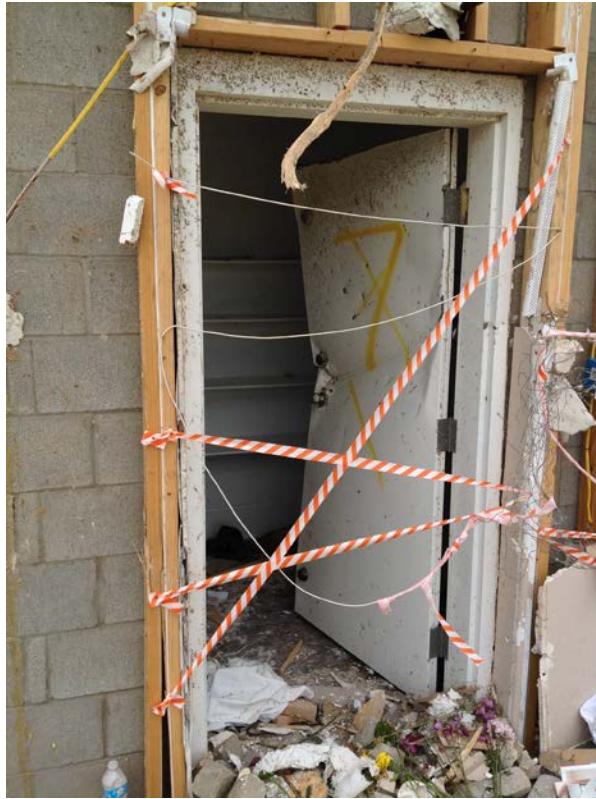
The crease on the door face would appear to be caused by the impact of a sheet material, possibly a piece of roof decking. Given the debris impact standard of a 15 lb. wooden 2-in. x 4-in. propelled at 100 mph by a 250 mph ground speed tornado, a 45 lb. x 4-ft. x 8-ft. x 7/16-in. OSB roof decking would be propelled by that same storm at approximately 35 mph, and the resulting Momentum and Kinetic Energy would have been the same. Therefore, the door was not impacted by some astronomical object traveling at a high rate of speed. Door failure resulted from the improper usage of a door, frame, and hardware not intended for tornado safe rooms.

Mayflower, Arkansas Door Damage

- *Site constructed tornado shelters should be constructed in strict accordance to FEMA P-320*
- *Safe Room doors should be FEMA 320 "Tested Door and Hardware Assemblies"*
- *Refer to the NWI website <http://www.depts.ttu.edu/nwi/research/DebrisImpact/Reports>*
- *Door manufacturers should provide notices to resellers and wholesalers of the dangers of selling non-tested door products for tornado safe rooms.*
