Incident Report

Chemistry 332

Date of Incident October 14, 2011

Re: Subject: **Report of Findings, Incident of October 14, 2011**
RCG File No.: 11004383

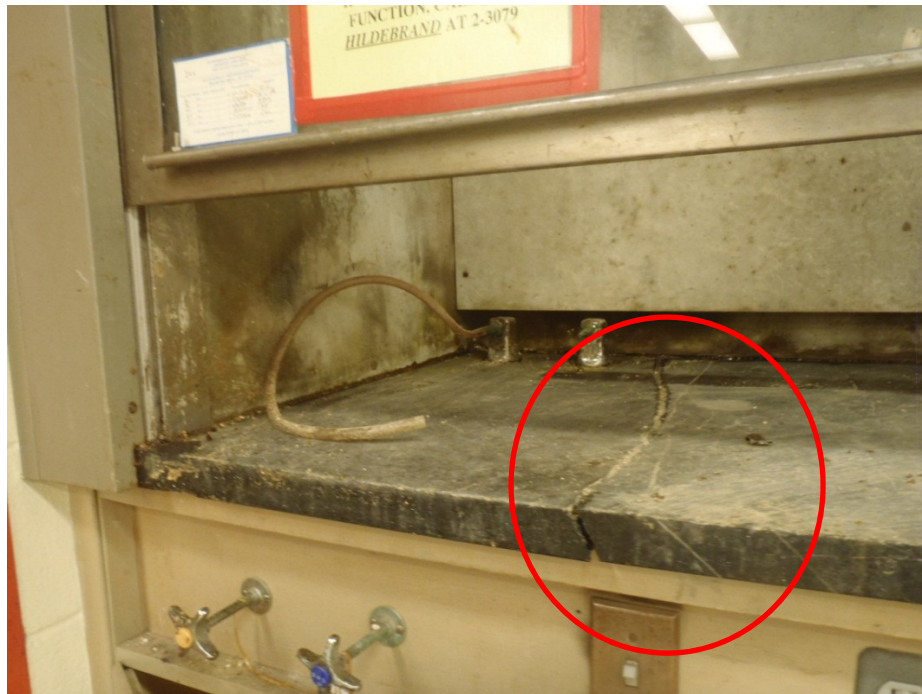
Image 1. Area where incident occurred. Prominent crack in fume hood countertop.

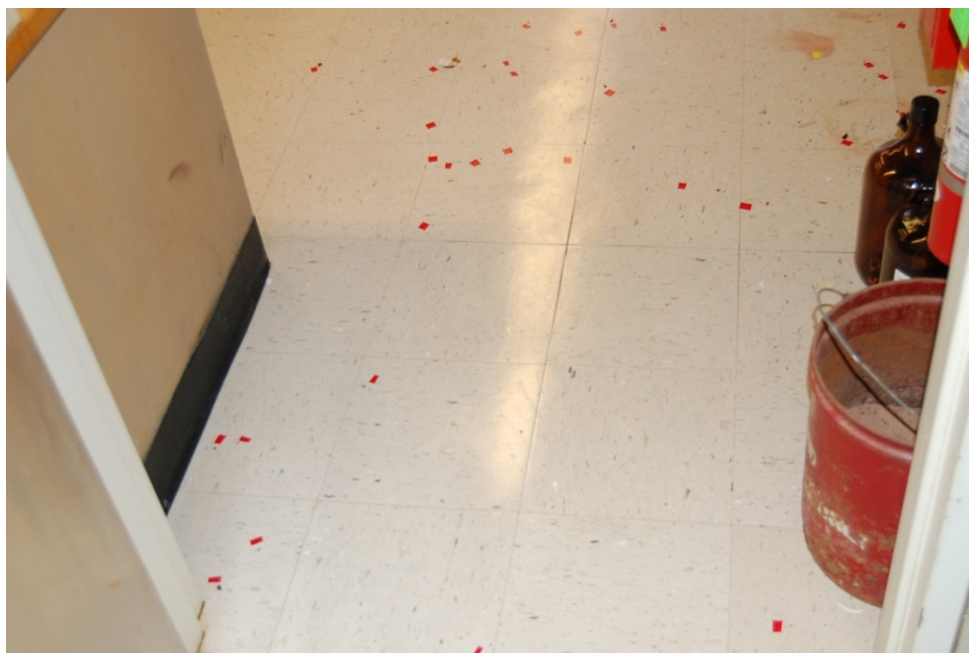
Image 3. Floor of laboratory approximately 56 feet from incident. The red marks are where amber glass shards were located.

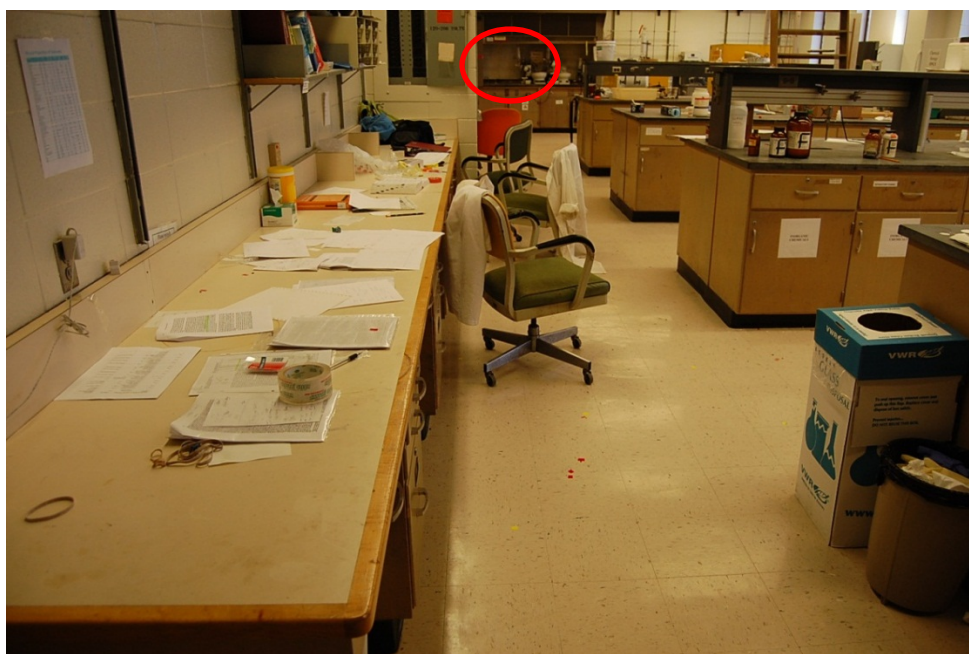
Image 4. Looking east towards the fume hood where incident occurred approximately 56 feet away.

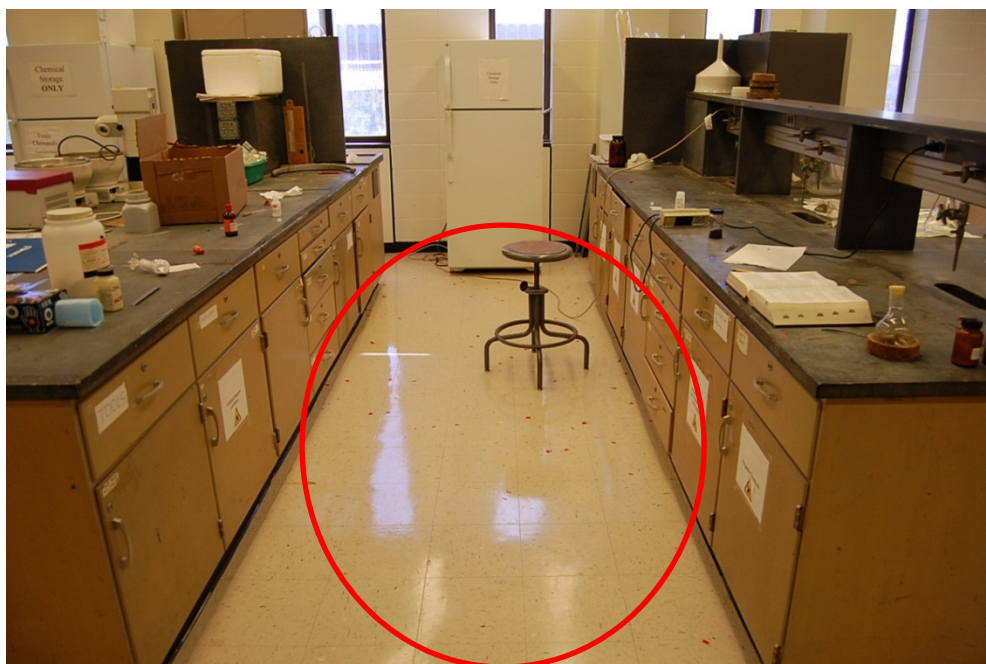
Image 5. Work area looking south. Tape marks indicate where glass shards were located.

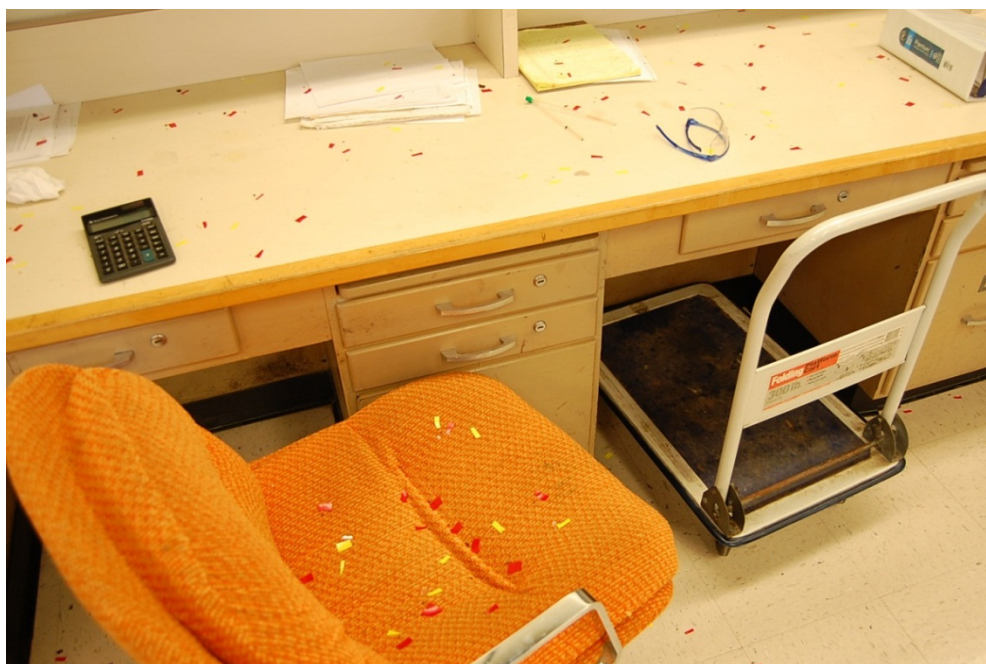
Image 6. Work station on north wall next to fume hood. Tape marks indicate where glass shards were located.

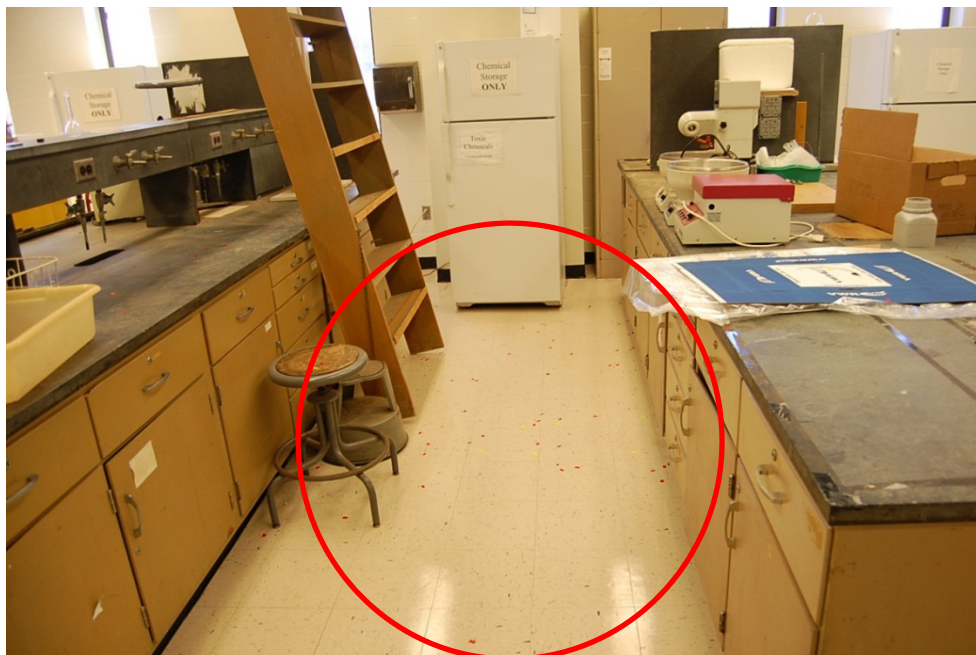
Image 7. Work area looking south. Tape marks indicate where glass shards were located.

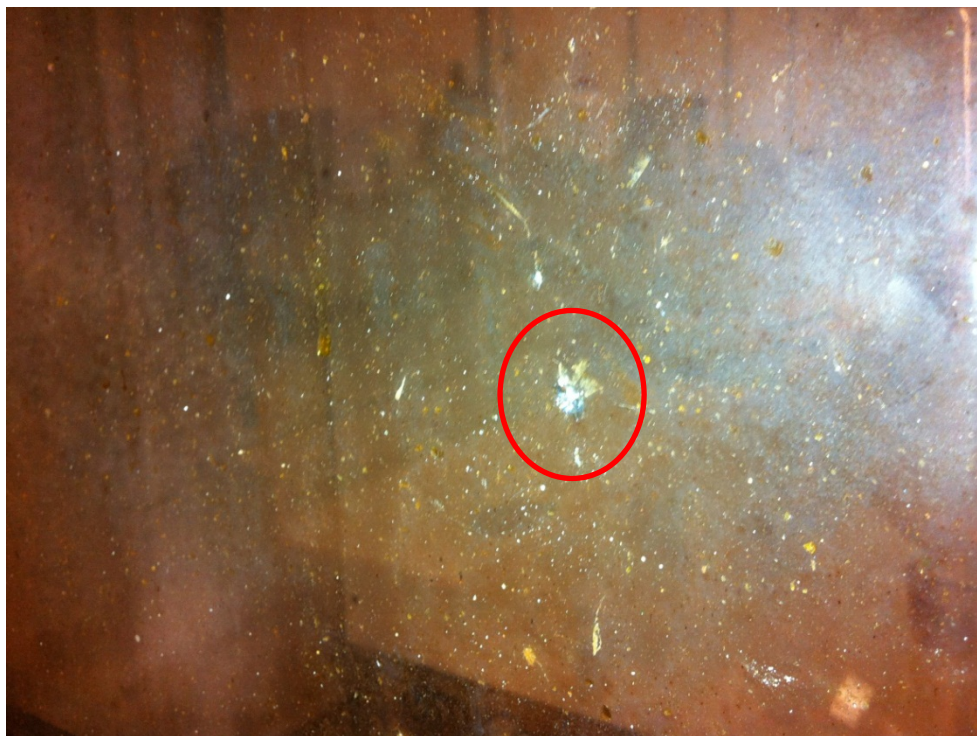
Image 9. Strike mark on fume hood sash where it is cracked.

- If an acid or base chemical bottle is to be used for waste it needs to only have waste of that acid or base added to them.
- Fume hood sashes need to be completely closed when there is no one actively working in the fume hood and the hood must be on.

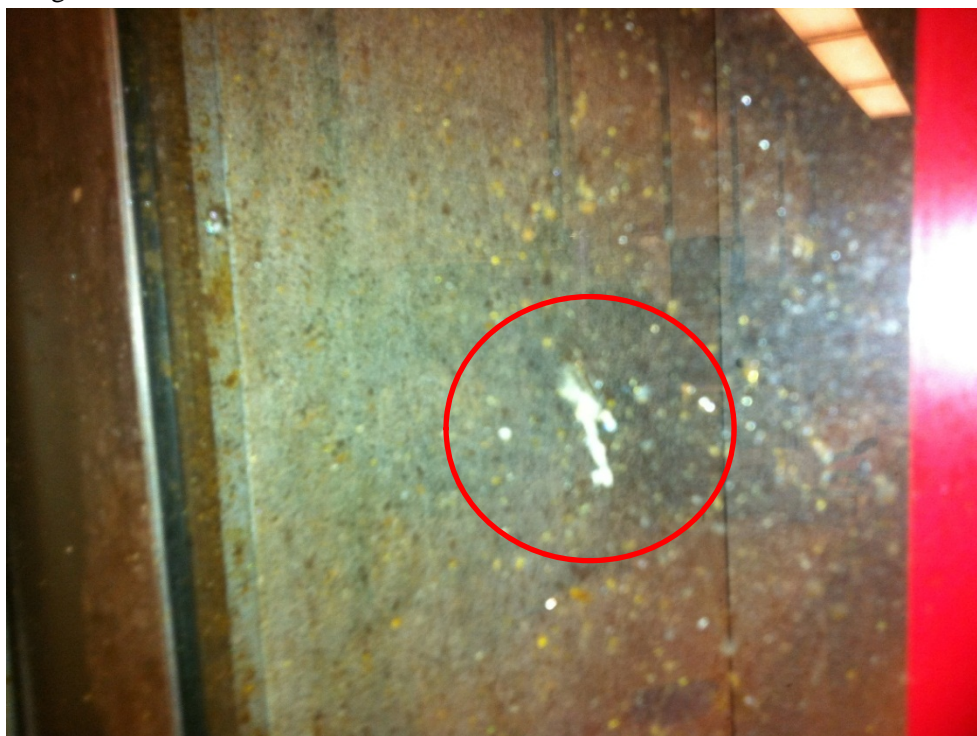
Image 10. Strike mark on fume hood sash where it is cracked.

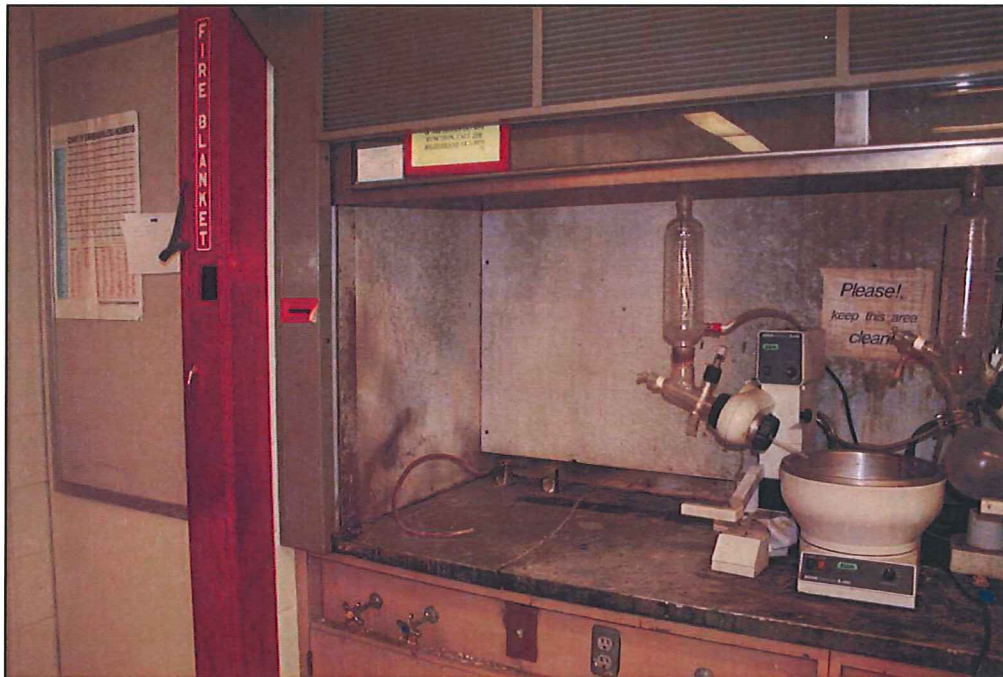
Photograph 1
Corner of Hood where Explosion Originated

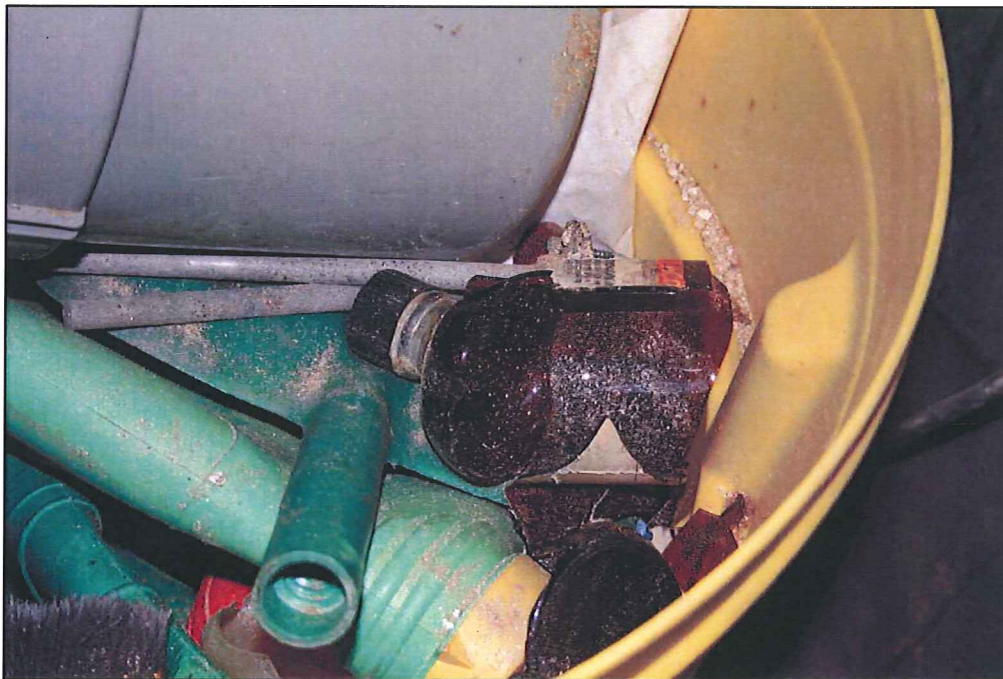
Photograph 3
Partial Remains of Glass Waste Bottle

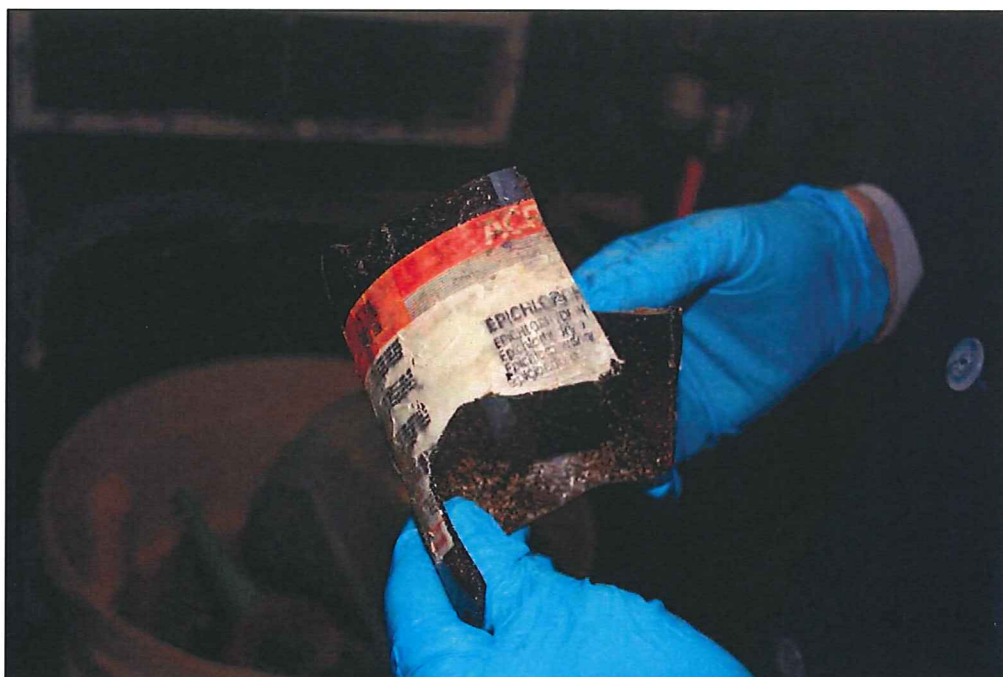
Photograph 4
Partial Remains of Glass Waste Bottle

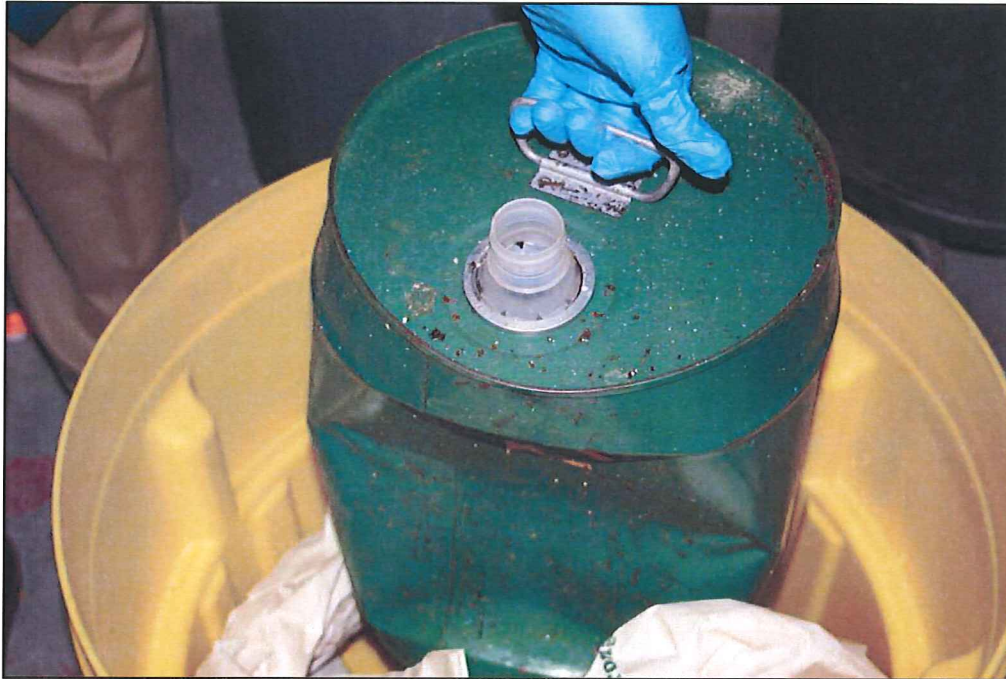
Photograph 5
Remains of Waste Organic Solvent Drum

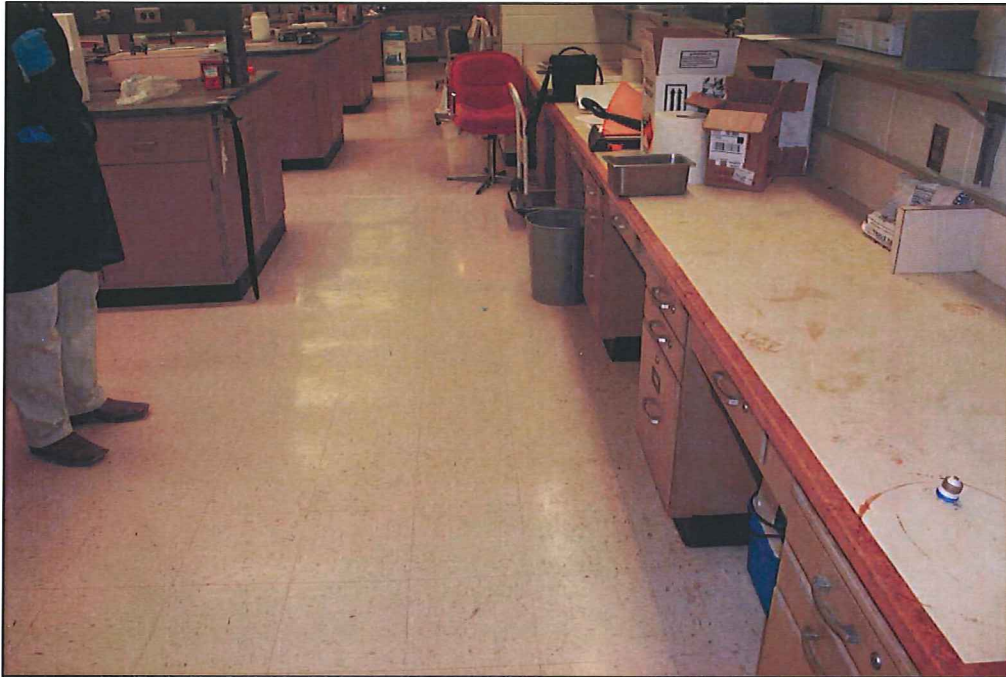
Photograph 7

The sash of the hood was approximately 75 percent open (see **Photographs**). This allowed numerous shards of glass (measuring approximately 1 inch) to be projected about 50 feet to the opposite end of the lab. The force of the explosion was sufficient to fracture the 2-inch thick, stone base of the hood. The three glass bottles in the hood did not survive the explosion. The drum of waste organic compounds was dented but maintained its integrity.

Line of Sight, From Explosion Origin to Far End of Lab
