Multidisciplinary Research in Transportation

Non-Destructive Evaluation of Installed Soil Nails

Research Project 0-4484
Research Report 0-4484-1
<http://www.techmrt.ttu.edu/reports.php>

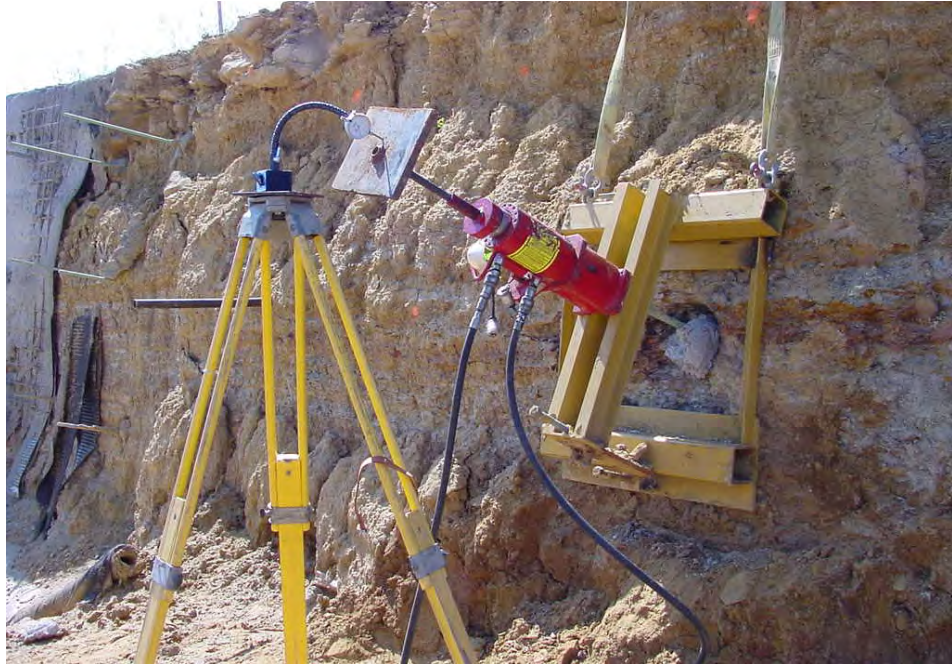
Figure 2.7 Test Setup Used for Soil Nail Load Testing

There are four types of loading tests that can be performed on installed soil nails. They are: (a) ultimate tests, (b) verification tests, (c) proof tests, and (d) creep tests. Ultimate tests and verification tests are typically performed on "sacrificial" test nails. Ultimate tests are performed by loading the soil nail until pullout failure takes place along the grout-soil interface (pullout failure occurs when the soil nail can no longer maintain constant test load without excessive movement). Verification tests are conducted to verify that installation methods will provide a soil nail capable of achieving the specified design adhesion capacity with a specified safety factor. Proof tests are typically performed on a specified number (typically up to 5 percent) of the total number of constructed soil nails. The proof test is a single cycle test in which the load is applied in increments until a maximum test load, typically 125 to 150 percent of the design adhesion capacity, is reached. Creep tests are typically performed as part of the ultimate verification, or as proof tests. Creep testing is conducted at a specified, constant test load, with movement recorded at specified time intervals. Detailed interpretation of each test can be found in FHWA Report SA-93-068: *Soil Nailing Field Inspectors Manual* [2]. A general guideline that is applicable for all four types of tests is that the soil nail tendon should not be stressed to more than 80 percent of its minimum ultimate tensile strength for 150 grade steel, or more than 90 percent of the minimum yield strength for 60 grade steel.

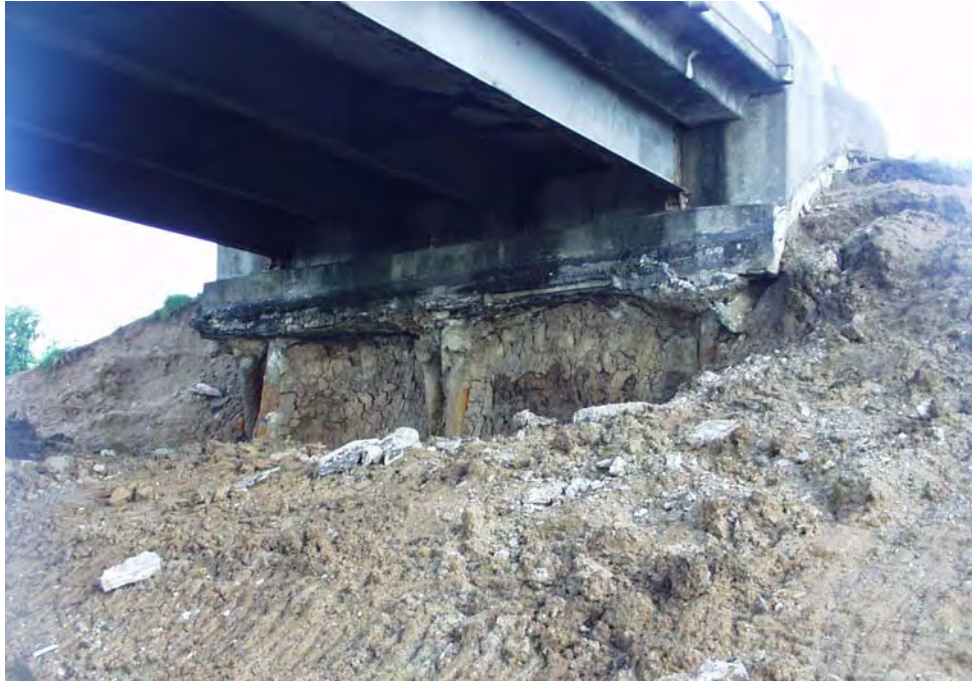
Figure 2.8 Face Sloughing Caused by Unnailed Cut Left Exposed for a Long Period of Time

Figures 2.8 through 2.23 graphically illustrate the common problems found in the construction of soil nailed walls. These examples come from actual construction projects, the majority of which is in Texas, and field studies conducted as part of this research.

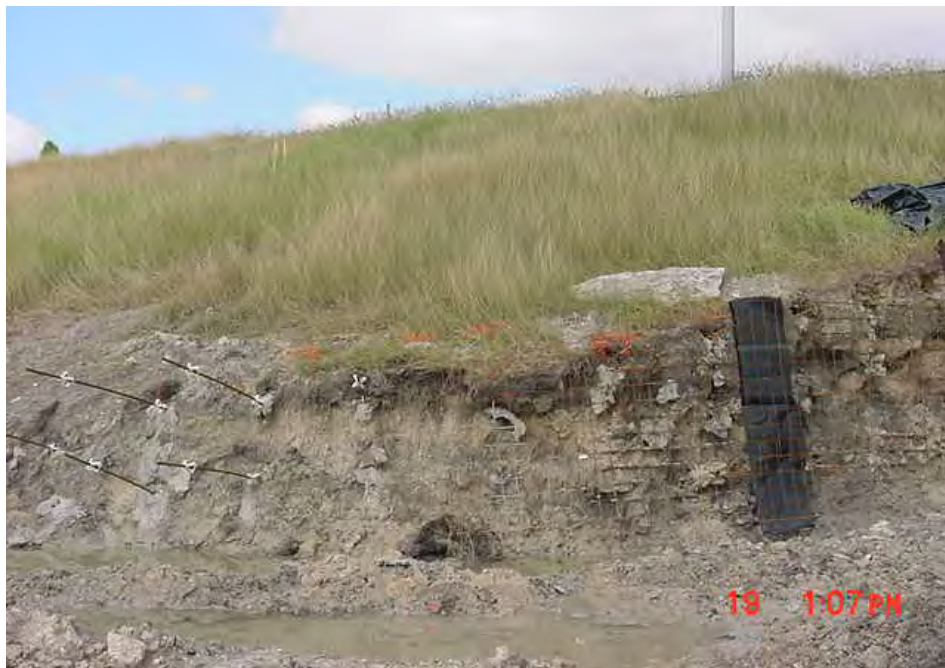
Figure 2.9 Face Instability Caused by Unnailed Cuts Left Exposed for a Long Period of Time

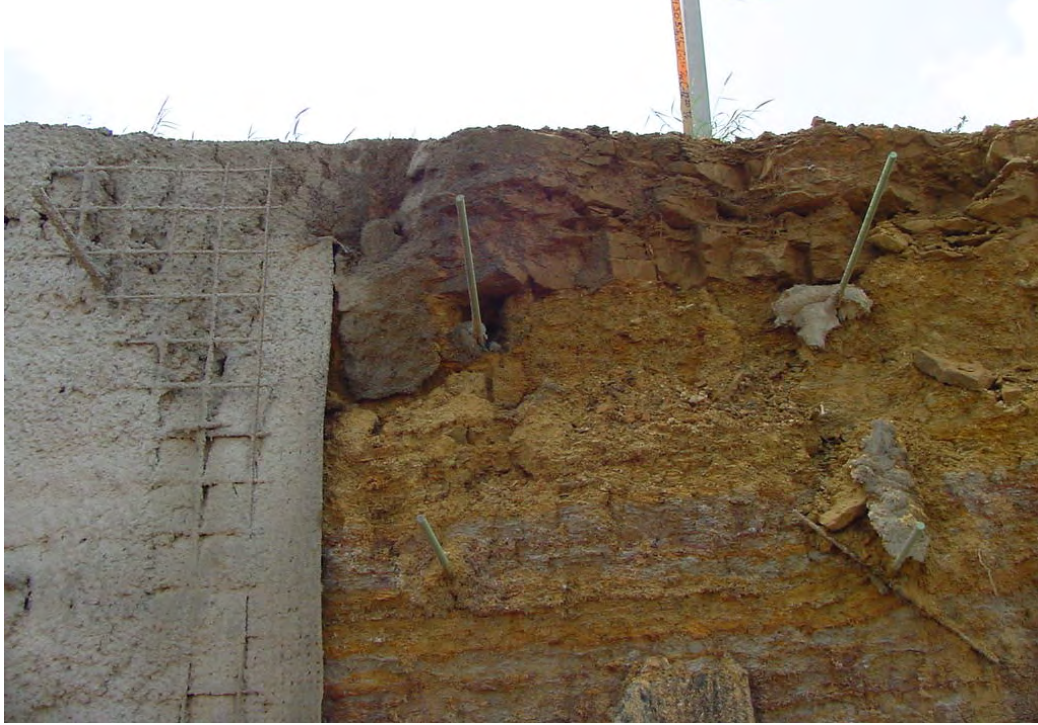
Figure 2.10 Long-Term Face Instability Caused by Drainage

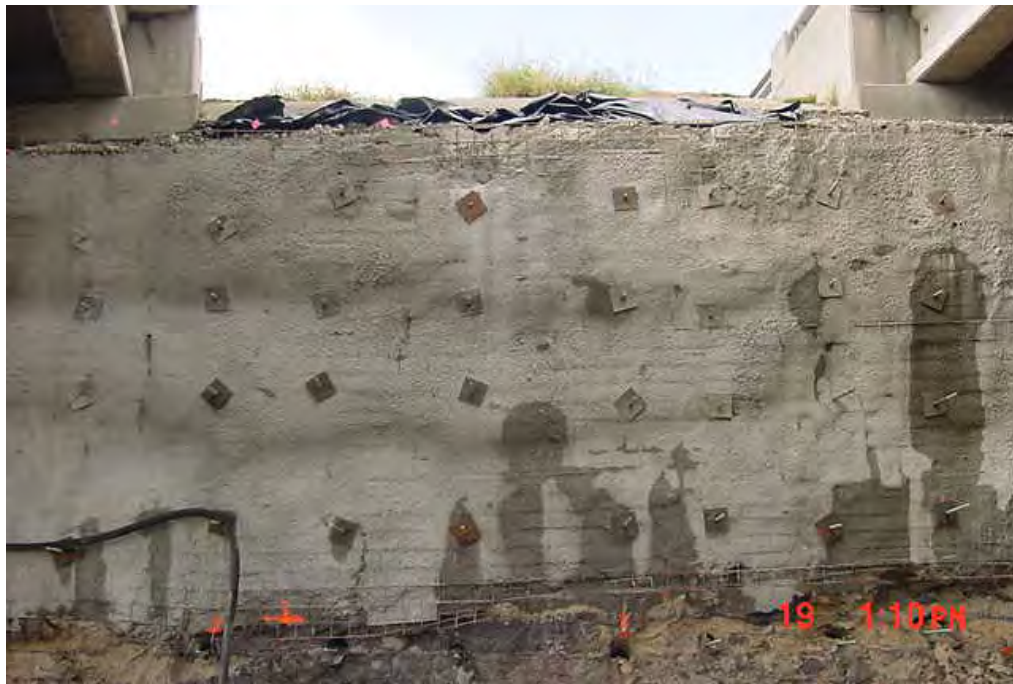
Figure 2.11 Washout Zone Caused by Poor Installation of Drain Elements

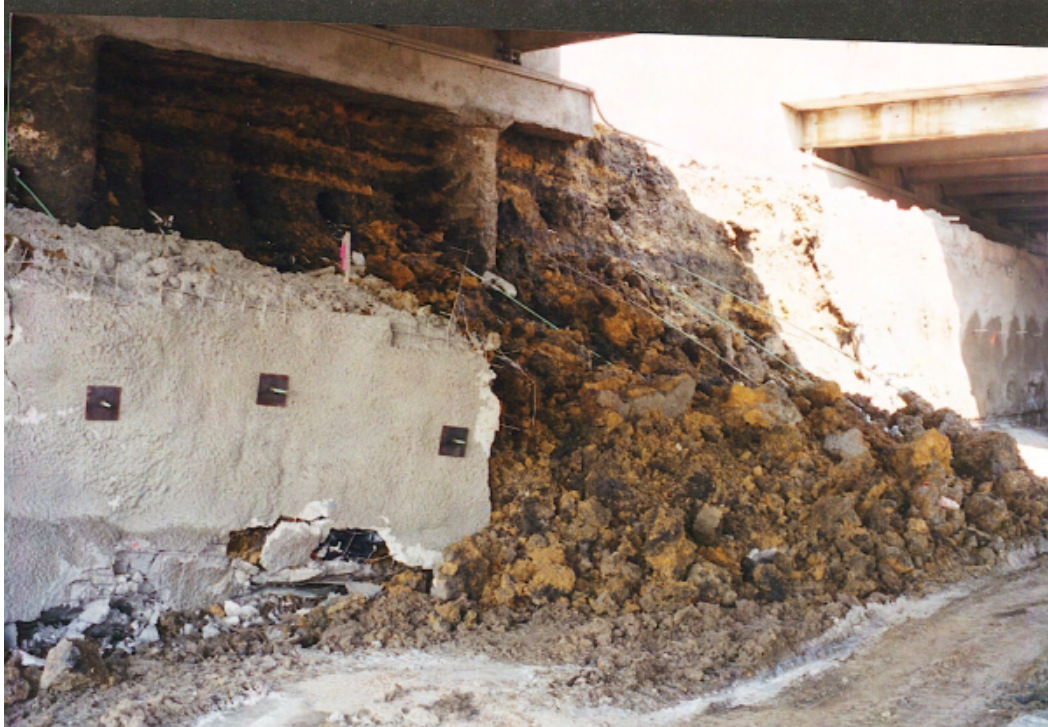
Figure 2.12 Failure of Wall Caused by Incomplete Grouting

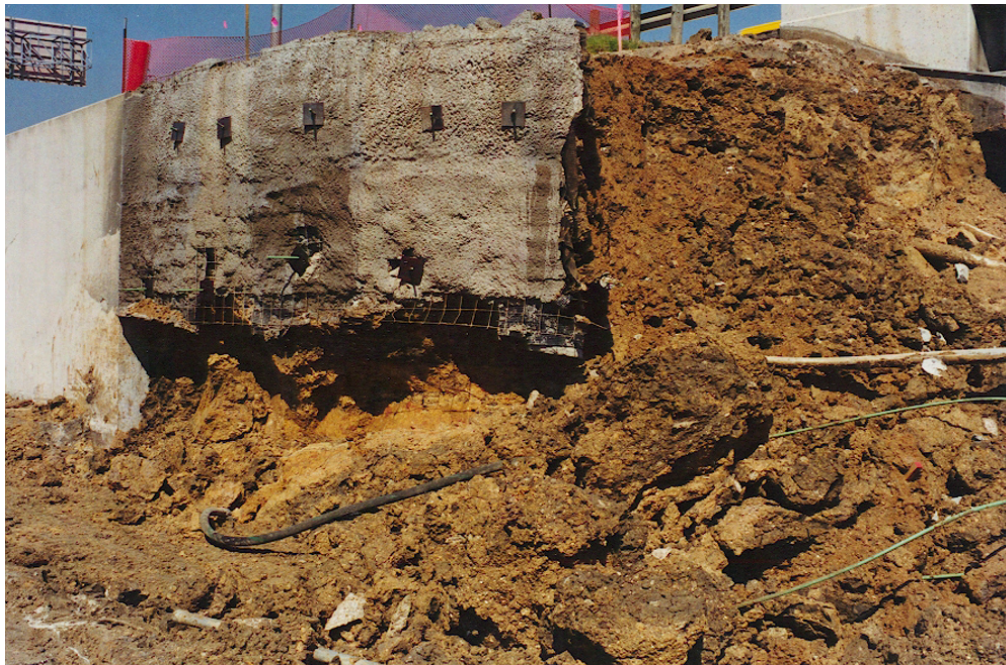
Figure 2.13 Failure of Wall Caused by Incomplete Grouting and Drainage

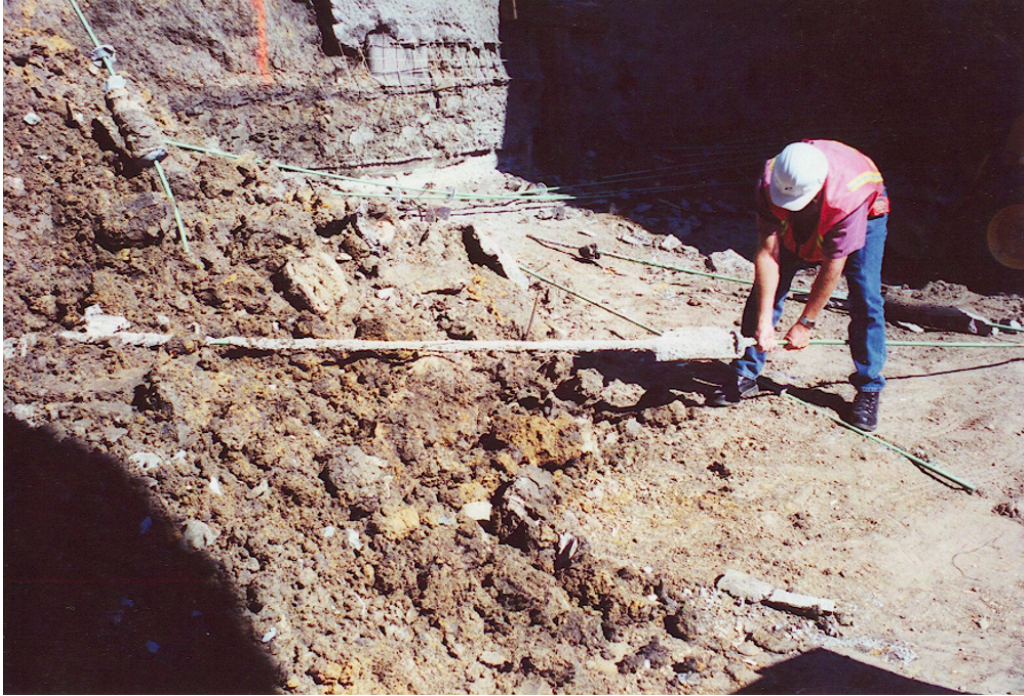
Figure 2.14 Pullout Caused by Incomplete Grouting

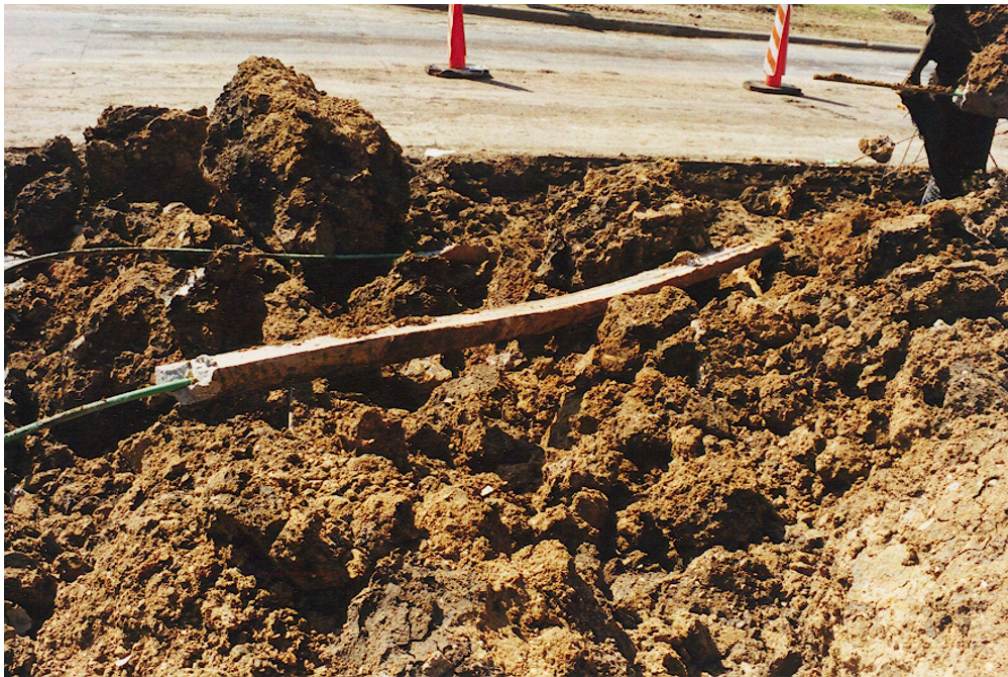
Figure 2.15 Pullout Caused by Drillholes Half Filled with Grout

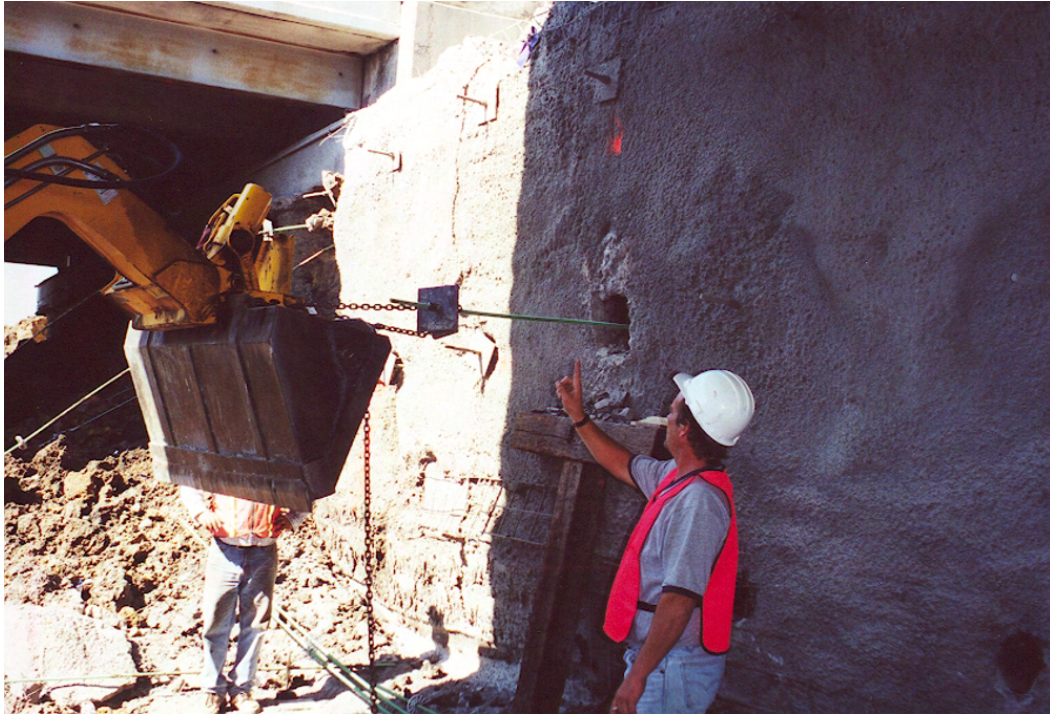
Figure 2.16 Low Pullout Strength Due to Incomplete Grouting

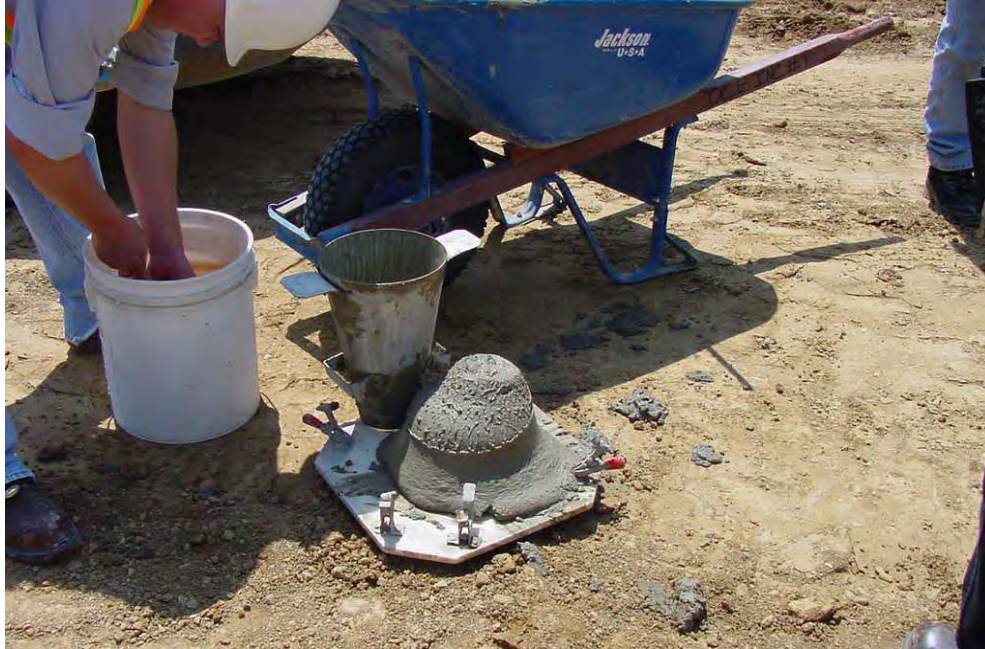
Figure 2.18 Stiff Grout Causes Incomplete Grouting Problem

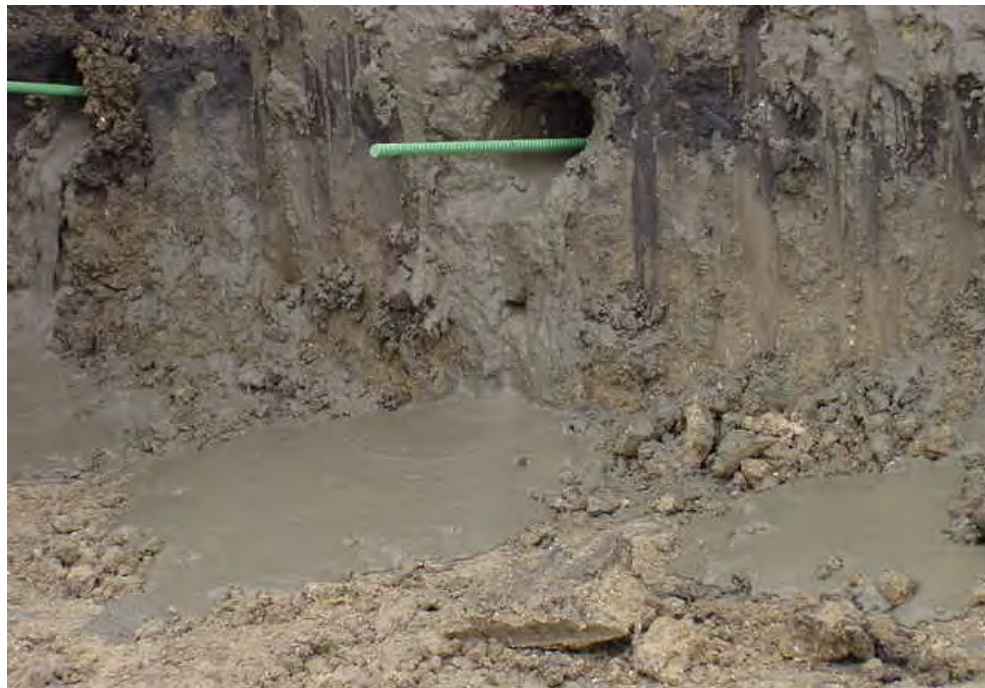
Figure 2.19 Excessively Fluid Mixes Cause Incomplete Grouting of Nail Head (Bird's Mouth Defects)

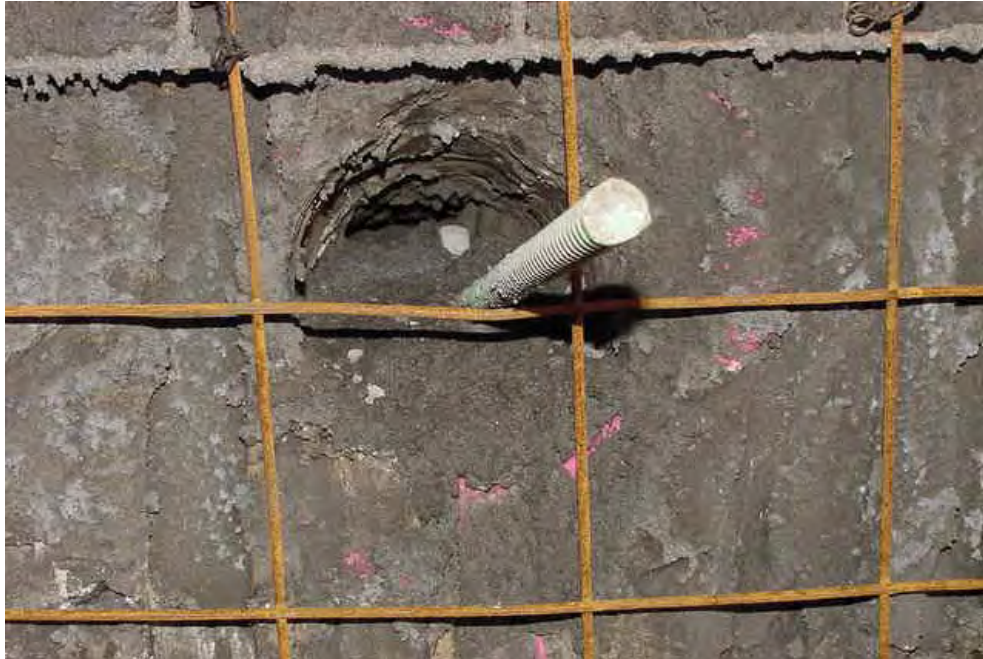
Figure 2.20 Bird Mouth Defect Caused by Poor Grouting

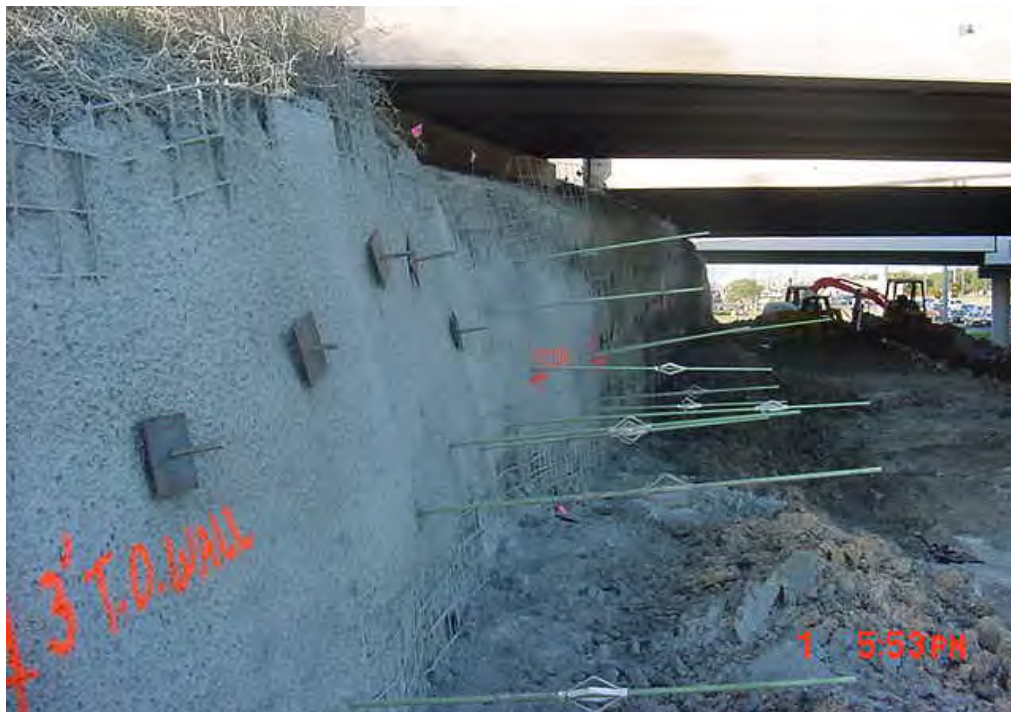
Figure 2.21 Insufficient Tendon Length Caused by Nail Hole Caving

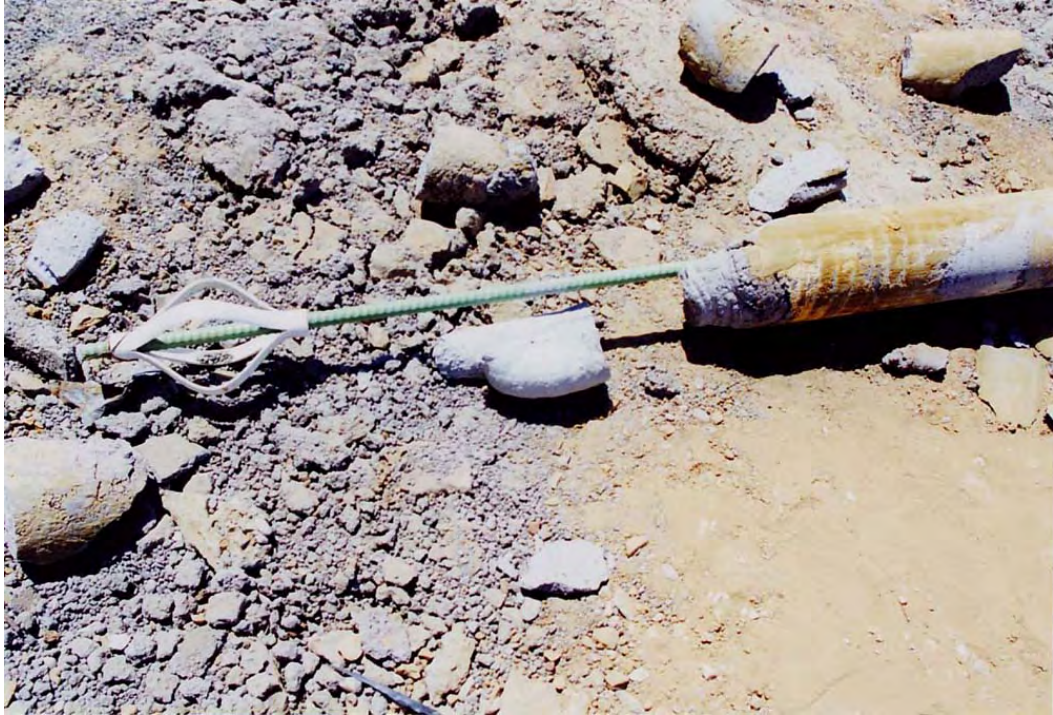
Figure 2.22 Void at the End Caused by Incomplete Grouting

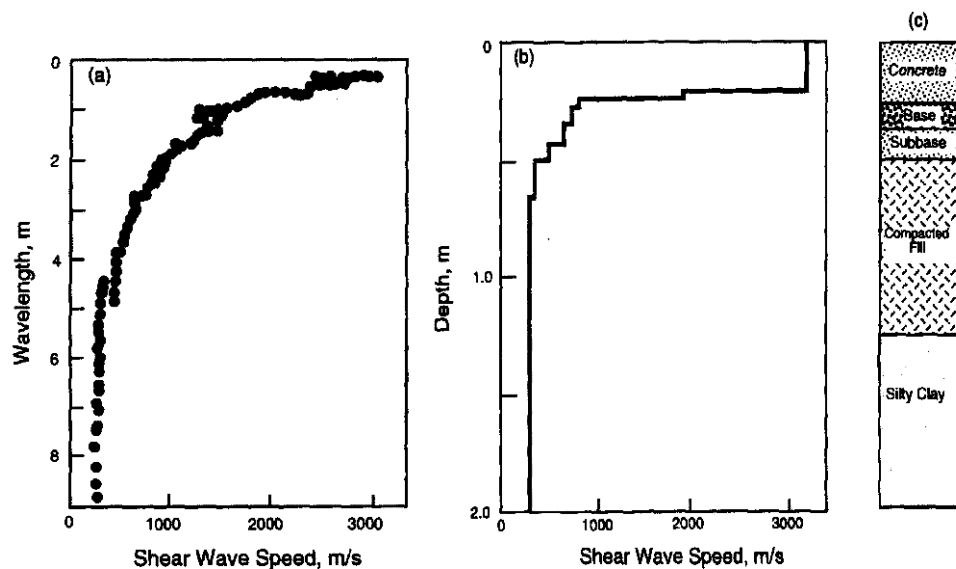
Figure 3.8 (a) Dispersion Curve Obtained from SASW Testing of Concrete Pavement; (b) S-wave Speed Obtained from Inversion of Experimental Dispersion Curve; (c) Soil Profile Based on Boring

The experimental dispersion curve as shown in Figure 3.8 can be used to determine the thickness and stiffness of the top uniform layer such as the asphalt concrete layer in a pavement system. The thickness and stiffness of the underlain layers are determined from the experimental dispersion curve through the forward modeling or inversion process. Even if the forward modeling process is not performed, a comparison between experimental dispersion curves of different sites gives relatively valuable information about the existing conditions, but not absolute values of the stiffness or thickness. Exponential windowing can help in the interpretation of the SASW results as unwanted reflections from nearby boundaries are reduced due to the windowing process. Averaging of SASW data from the forward and reverse profiles can also help in the interpretation of data.

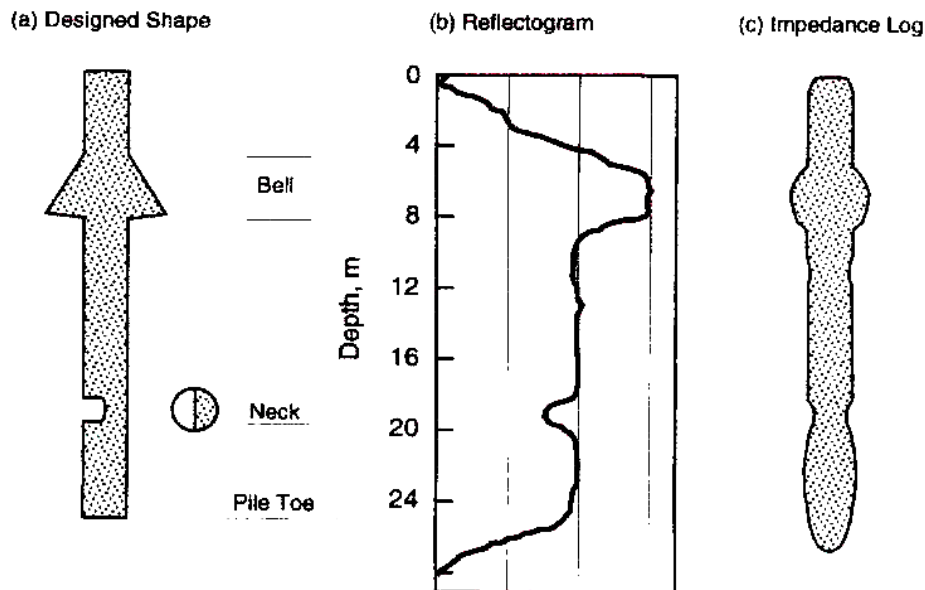
Figure 3.13. (a) Planned Defects in Experimental Pile; (b) Reflectogram Obtained by Signal Processing of Sonic Data; (c) Impedance Log Obtained by Combining Information from Reflectogram and Characteristic Impedance Obtained from Impulse-response Analysis

In addition, simulation of the tested shaft and its surrounding soil can be carried out most efficiently in the frequency domain. The reflectogram and the characteristic impedance can then be combined to give dimensions to the reflectogram to produce a trace referred to as the impedance log (Figure 3.13). The output of this analysis is in the form of a vertical section through the shaft, giving a calculated visual representation of the pile shape. The final result can be adjusted to eliminate varying soil reflections by use of the simulation technique.

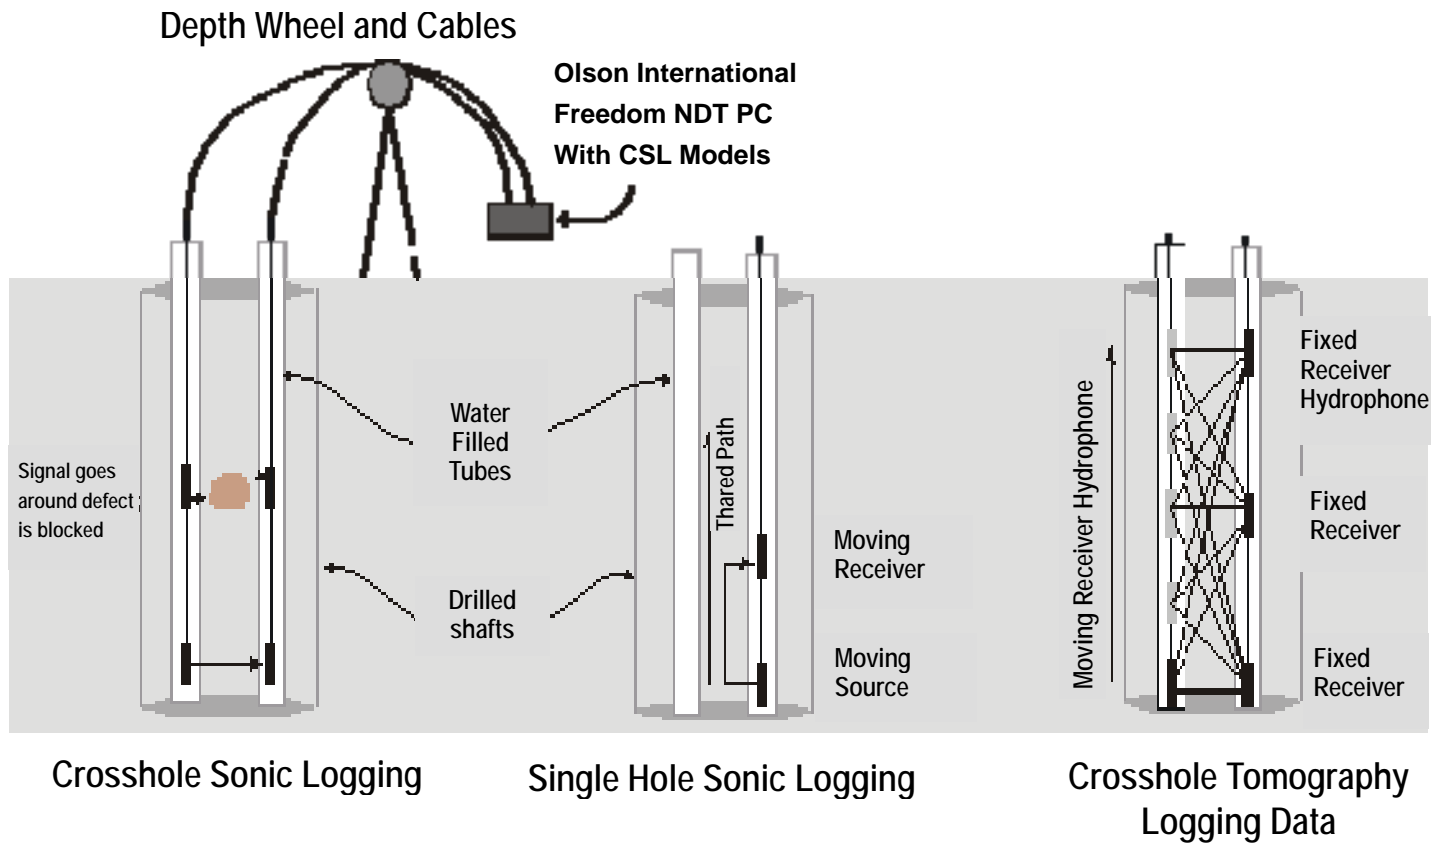
Figure 3.14 Field Setups for Cross-Hole Sonic Logging and Single-Hole Sonic Logging

Figure 3.14 shows field setups for Cross-Hole Sonic Logging and Single-Hole Sonic Logging tests. Also shown in Figure 3.14 is a sketch of how to obtain data for Cross-Hole Tomography analysis which can be used to better define the location, shape and size of a defect located by CSL. Figure 3.15 shows the test equipment for Cross-Hole Sonic Logging.

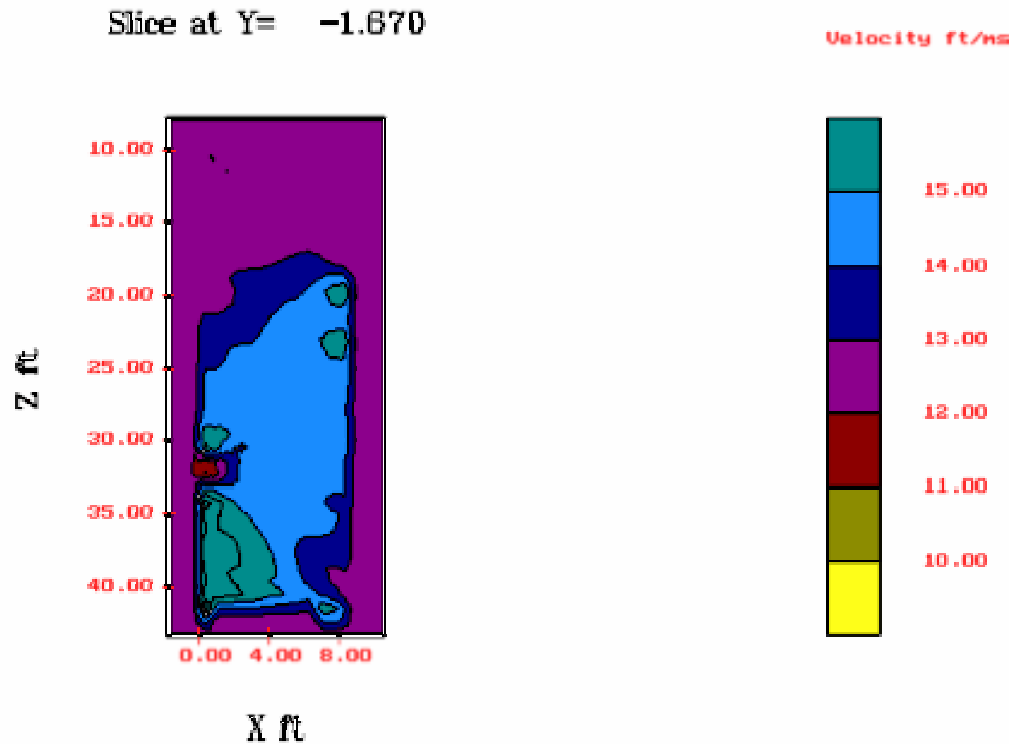
Figure 3.16 Velocity Tomogram on a Drilled Shaft of a Highway Bridge

Moreover, Ultrasonic Tomography analyses can now be done to better characterize the shape of an anomaly lying between a tube pair. As a result of a National Science Foundation Phase I and II Small Business Innovation Research grant for imaging of flaws in concrete, this research was adapted to image flaws identified by Cross-hole Sonic Logging (CSL). Extensive data is acquired by testing all the angles between a tube pair. The tomographic analysis is then performed on picked travel times to delineate areas of slower velocity, poorer quality concrete. The tomogram, shown in Figure 3.16, is from a drilled shaft foundation of a highway bridge. The results of CSL tests showed an anomaly between 15 to 17 feet deep in this shaft. In order to better image the defect between the tubes, a tomographic dataset was obtained between tubes 1 and 4 (semi-diagonal tube pair) which showed the slowest CSL velocity. In these tests, the source was pulled starting from a point located at 43 feet below the shaft head to the top of the concrete with the receiver suspended at a given location. The receiver was fixed at 49 locations separated by 2.25 inch intervals with the first receiver location also at 43 feet deep.

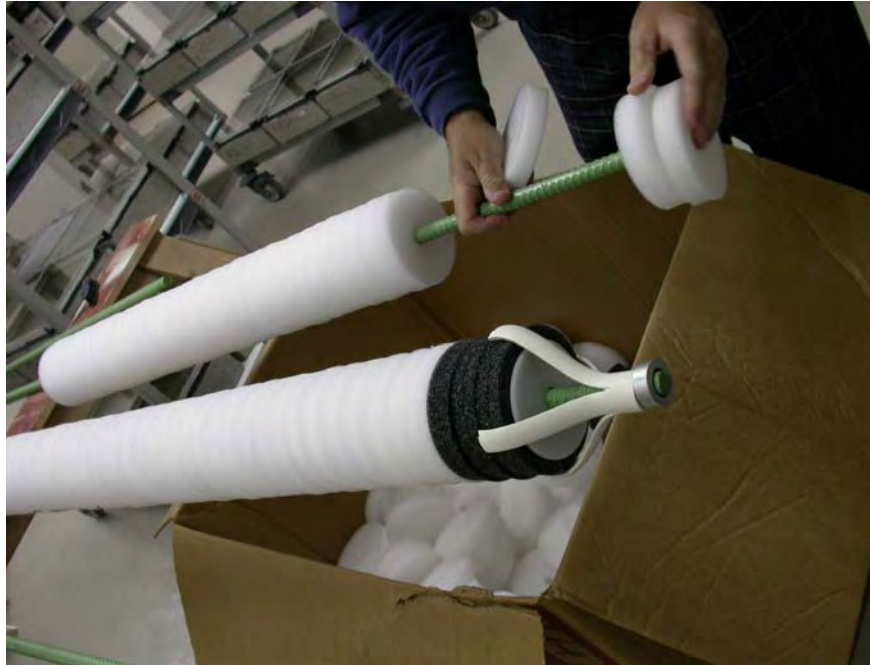
Figure 4.8 Mounting Foam Disks on Steel Tendons

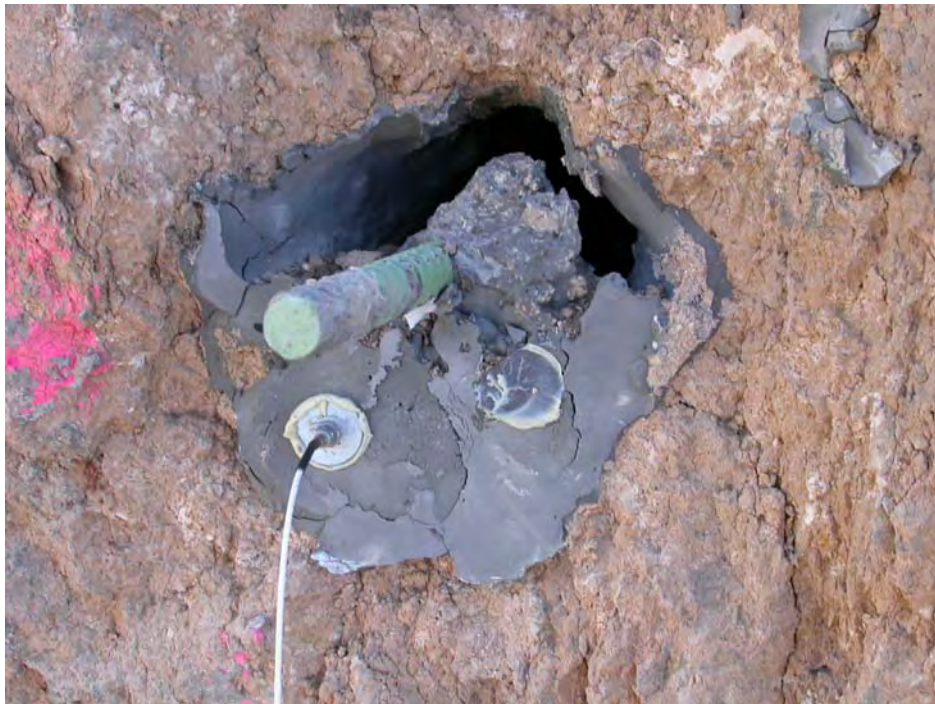
Figure 4.28 Nail Head in Poor Condition

Since shotcrete facing had not been placed prior to testing, the nail head conditions could be easily observed prior to NDT testing. In many cases, the condition of the nail heads was found to be less than optimum for NDT testing. Figure 4.28 shows an example of such a nail head. The transducers or geophones used in NDT testing are mounted on the exposed surface of the nail head. When the nail head is incompletely grouted or when the nail head surface too rough or irregular, good contact between the grout column and the sensors is not achieved. The poor condition of the nail head can also affect the quality of the impact generated. The first series of NDT testing was conducted with the nail heads in the same condition they were found after Phase I construction. Before the second series of testing, nail heads were re-grouted, considerably improving the nail head conditions.

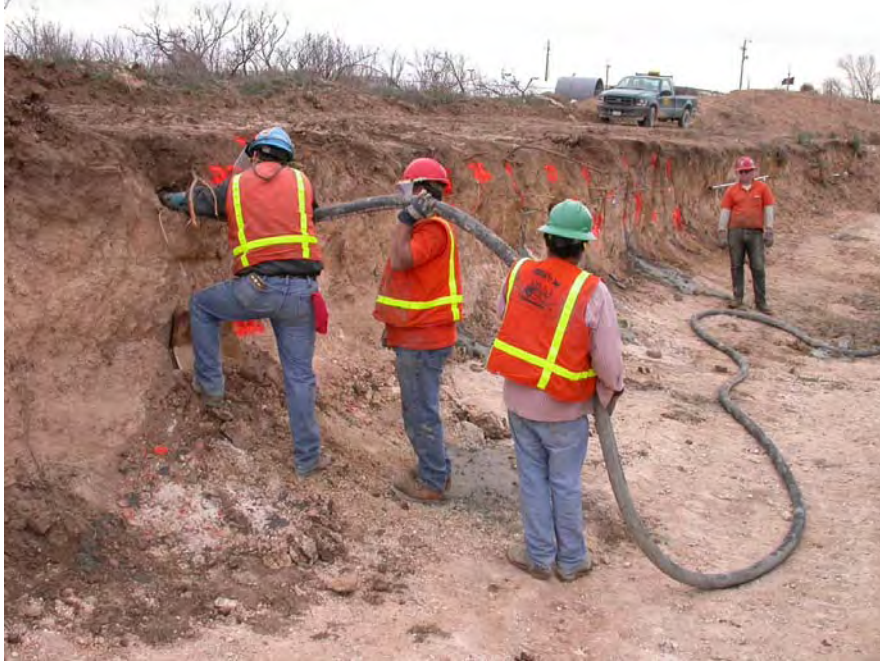
Figure 4.34 Grouting Drillholes before Inserting Steel Tendons

Figures 4.34 through 4.37 document the new grouting procedures used in Phase 2 construction.

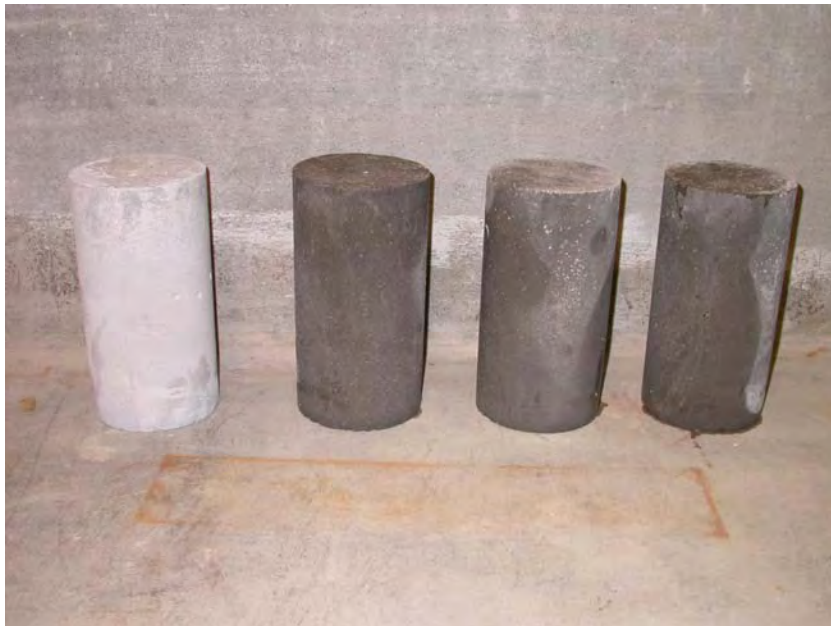
Figure 5.13 Grout Cylinder Used for Wave Velocity Calculation

The Ultrasonic Pulse Velocity method was not used in the field testing for defect detection of installed soiled nails. Instead, this test was conducted in the lab for calculating the stress wave velocity in the grout and steel tendon. The test was performed on the grout cylinders that were sampled from the grout batches used for grouting field experimental nails (Figure 5.11).

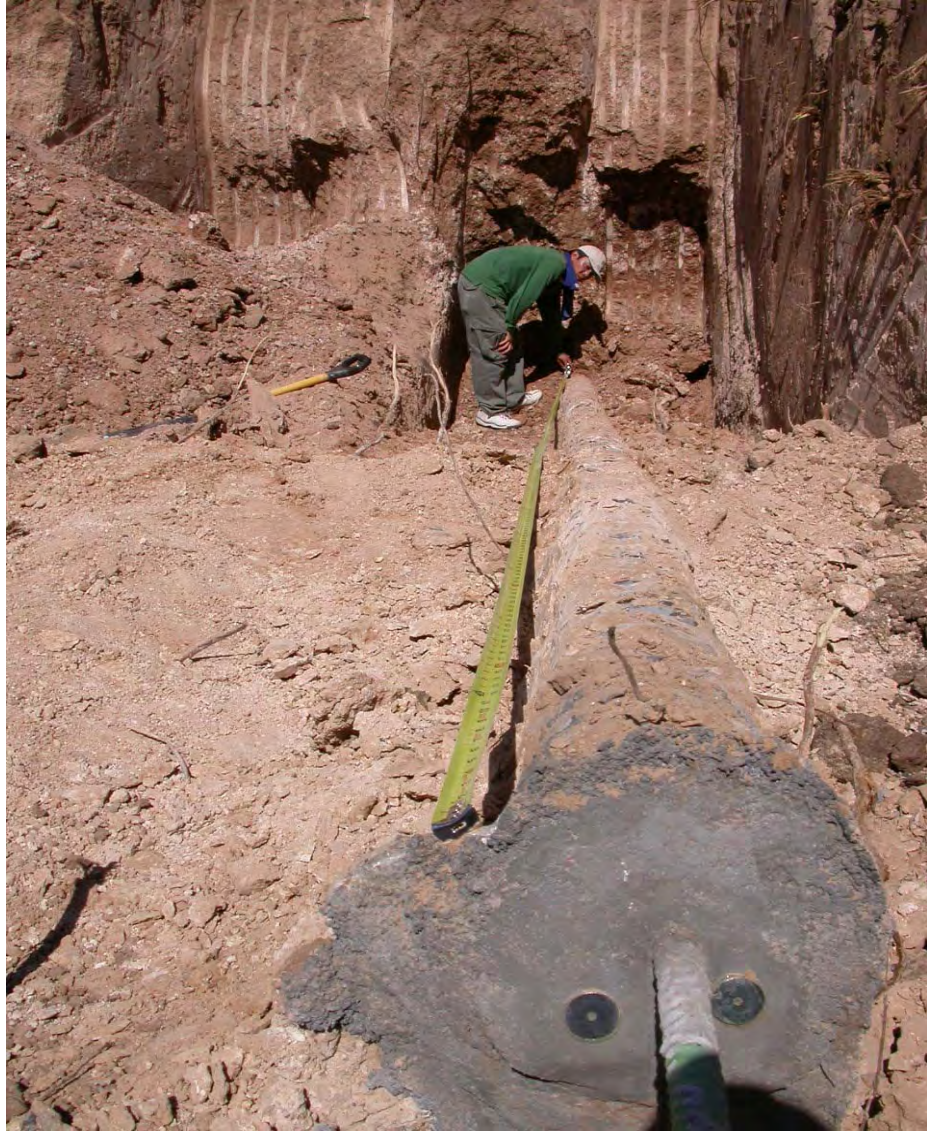
Figure 5.28 Measuring and Recording Actual Nail Grout Condition

Upon completion of all 3 cycles of field NDT evaluation, the test nails were exhumed to observe actual grout condition. Initial excavation was done using a backhoe. The steps used in the exhumation are as follows: use the backhoe to remove the soil from the top of nails (Figure 5.22); remove the soil in between nails (Figures 5.23 and 5.24); use hand shoveling to remove the remaining soil (Figure 5.25); document the actual condition of exposed nails (Figure 5.26).

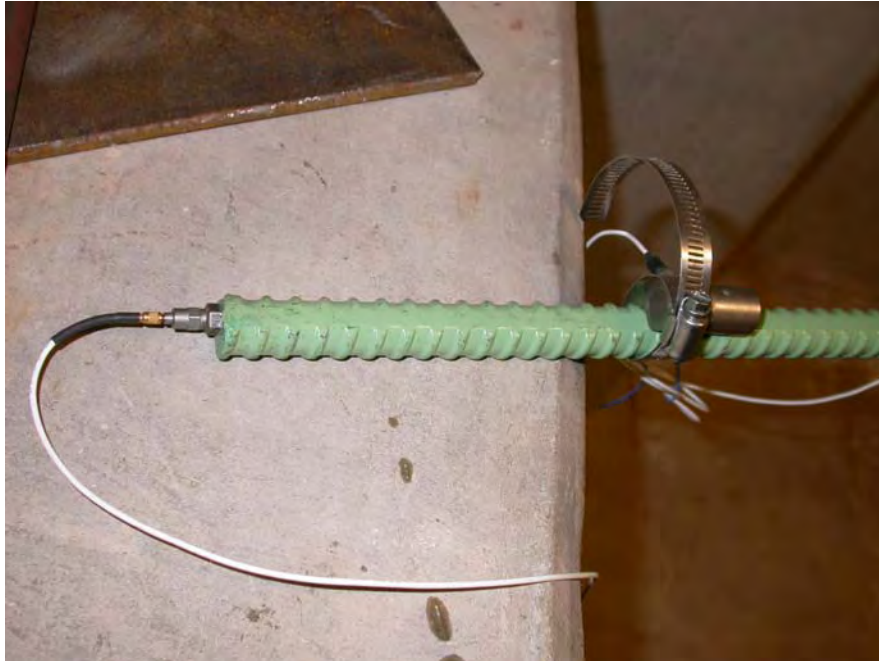
Figure 5.29 Laboratory Sonic Echo Tests on Standalone Steel Tendon

The average wave velocity in grout was calculated by averaging the above eight wave velocities. This yielded a wave velocity of 13,364 feet/sec for the grout. In addition, a number of Sonic Echo tests were performed on a standalone steel tendon with known length to calculate the wave velocity in steel tendon (Figure 5.28). The result of tests indicated the wave propagation velocity in the steel tendon is approximately 20,100 feet/sec. However, in an actual soil nail, the steel tendon is embedded in grout. Therefore, when an impact is applied at the head of a soil nail, either on the steel tendon or on the grout, stress waves propagate along the grout and steel tendon at the same time. Although stress waves travel faster in steel tendons than in the grout, when the grout and the tendon are bonded together well, the stress waves travel through the soil nail as a composite. A theoretical composite wave can be calculated based on an average steel and grout velocity using correct volume of grout and tendons. However, the theoretical calculation was not performed in this case. Instead, the composite velocity was obtained from a direct calibration on an actual soil nail (Nail 1) with an assumption that Nail 1 was in sound condition. The calibration yielded a composite wave velocity of 16,000 – 16,500 ft/sec.

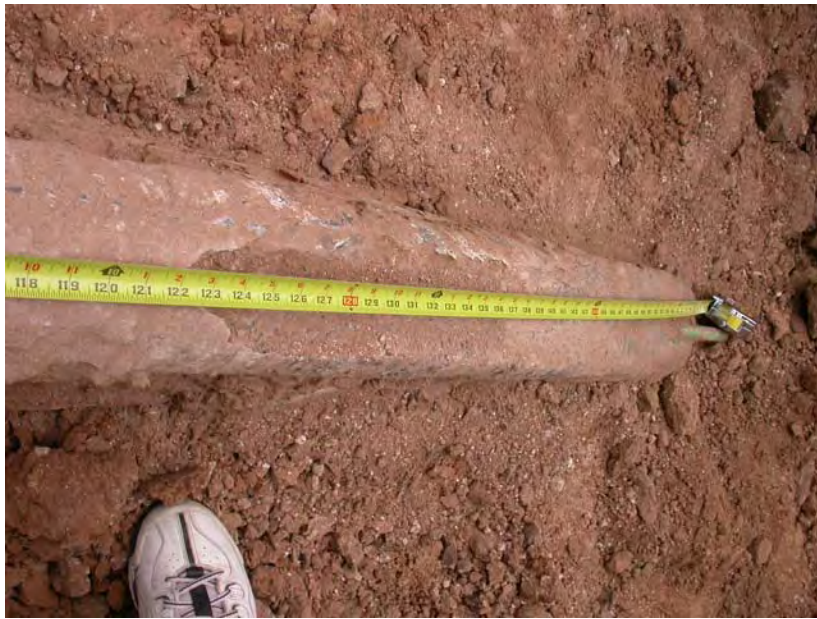
Figure 5.40 Nail No. 7 – Grout Tapers off at a Length of 10ft

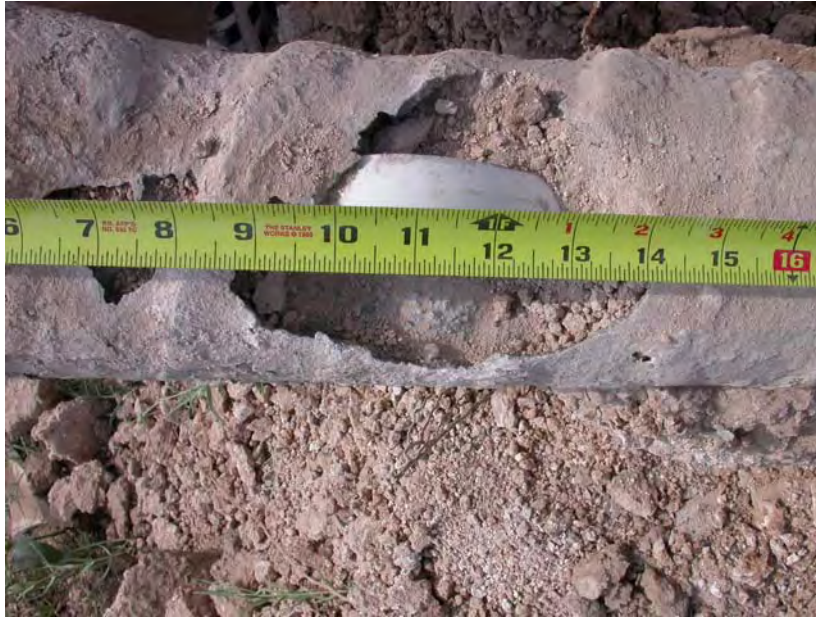
Figure 5.45 Shallow Defects Found in Nail No.16

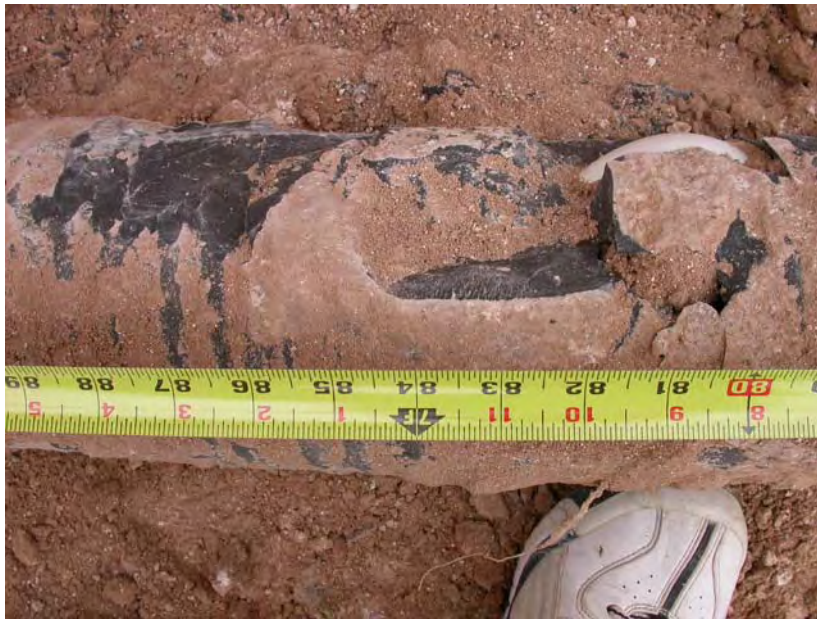
Figure 5.49 A minor defect on Nail 5 at 7 ft

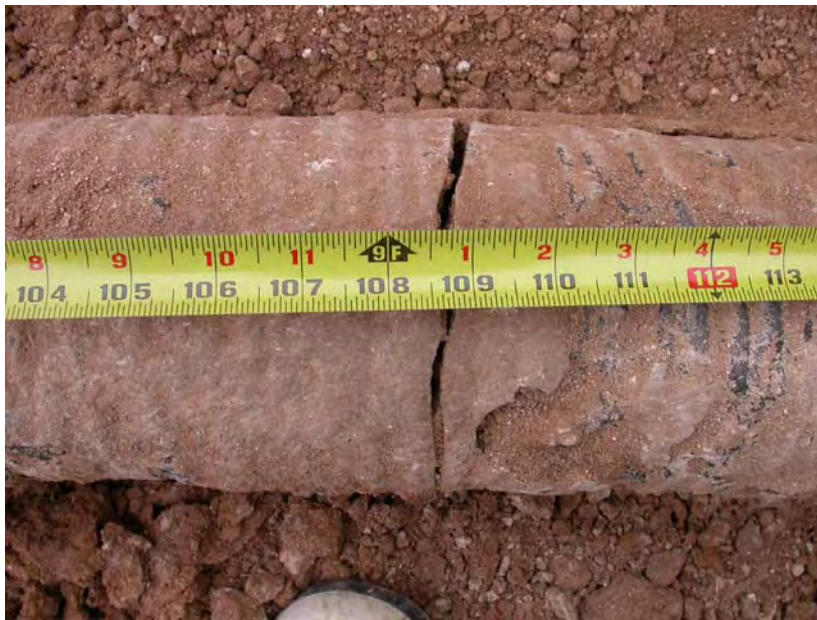
Figure 5.50 A Crack on Nail No. 5 at 9ft

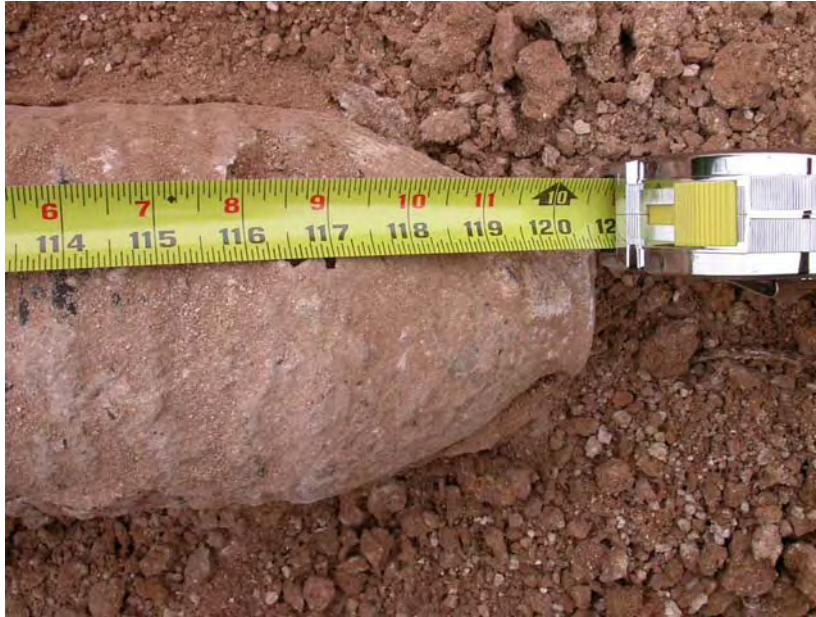
Figure 5.51 Nail No.5 Grout Column Ends at 10ft
