Multidisciplinary Research in Transportation

Non-Destructive Evaluation of Installed Soil Nails

Research Project 0-4484
Research Report 0-4484-1
<http://www.techmrt.ttu.edu/reports.php>

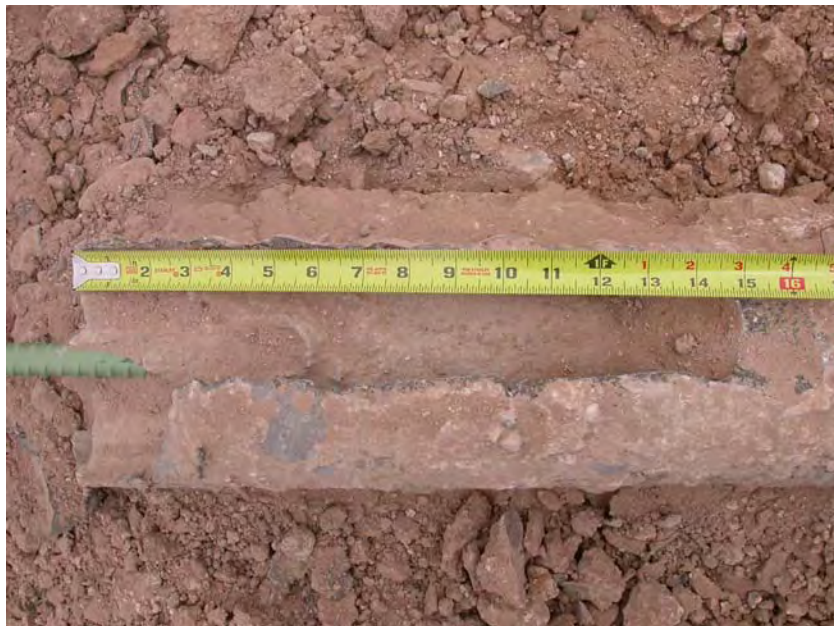
Figure 5.52 Bird’s Mouth Defect Observed in Test Nail No.11

Figure 5.51 shows Test Nail No.11 which was designed as a 15 feet long with a bird’s mouth defect. The Impact Echo test results for this test nail are given in Figure 5.52. Accordingly, the Impact Echo tests predicted a shallow defect at 0.54-4.57ft. This observation matched with the actual observations.

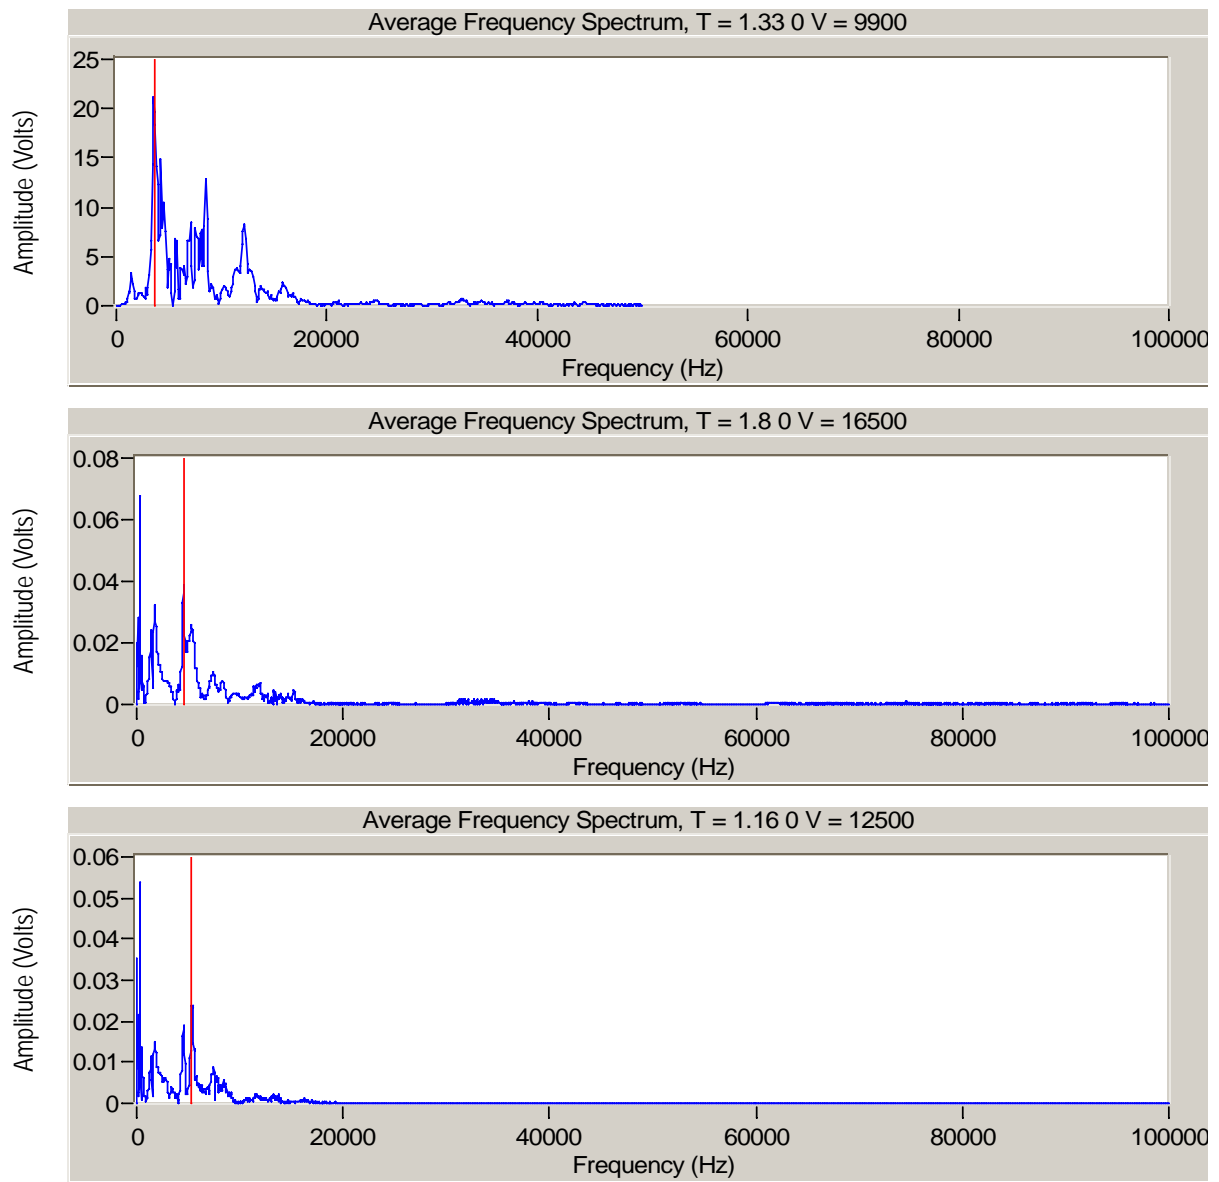
Figure 5.53 Impact Echo Test Results for Test Nail No.11

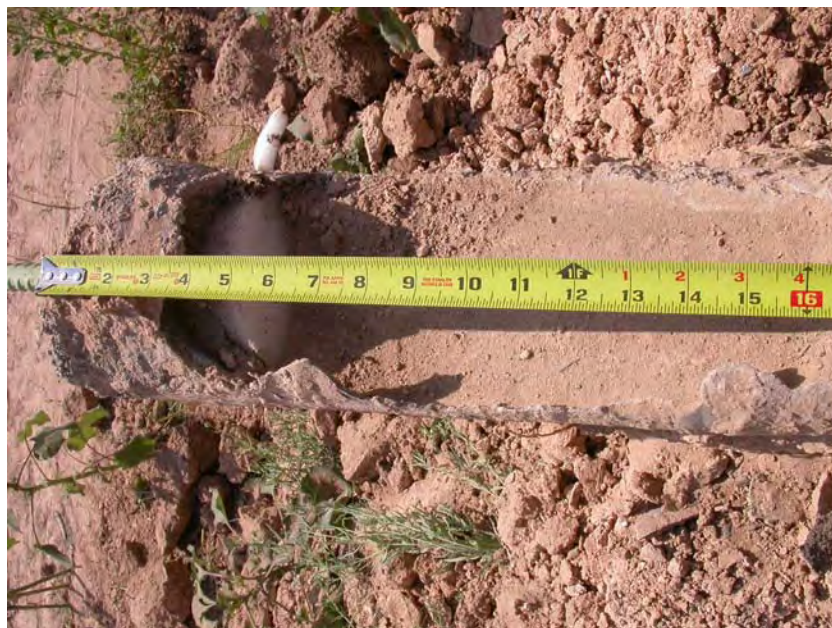
Figure 5.55 Bird's mouth Observed in Nail No.17

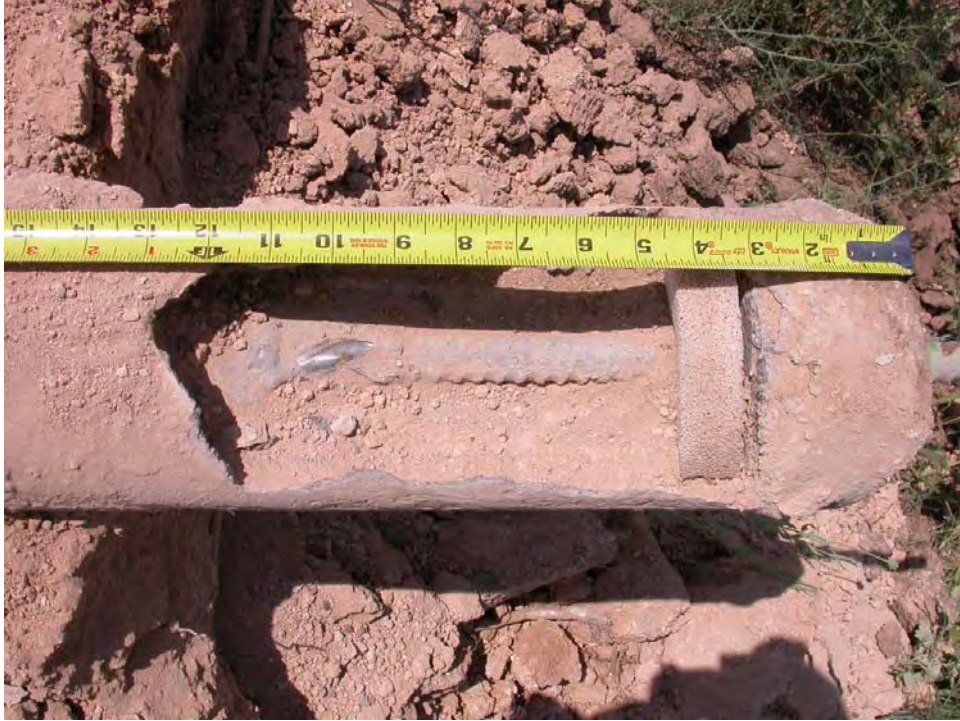
Figure 5.57 Bird's Mouth Observed in Nail No.23

Figure 5.55 represents the Impact Echo test results for Nail No.23. This nail was designed as a 25 feet long with bird's mouth defect. The Impact Echo tests detected shallow defects at 0.982-2.54. This prediction matched the bird's mouth defect observed in nail exhumation (Figures 5.56). Table 5.5 is a summary of results from Impact Echo tests performed on 32 experimental nails at TTU campus site.

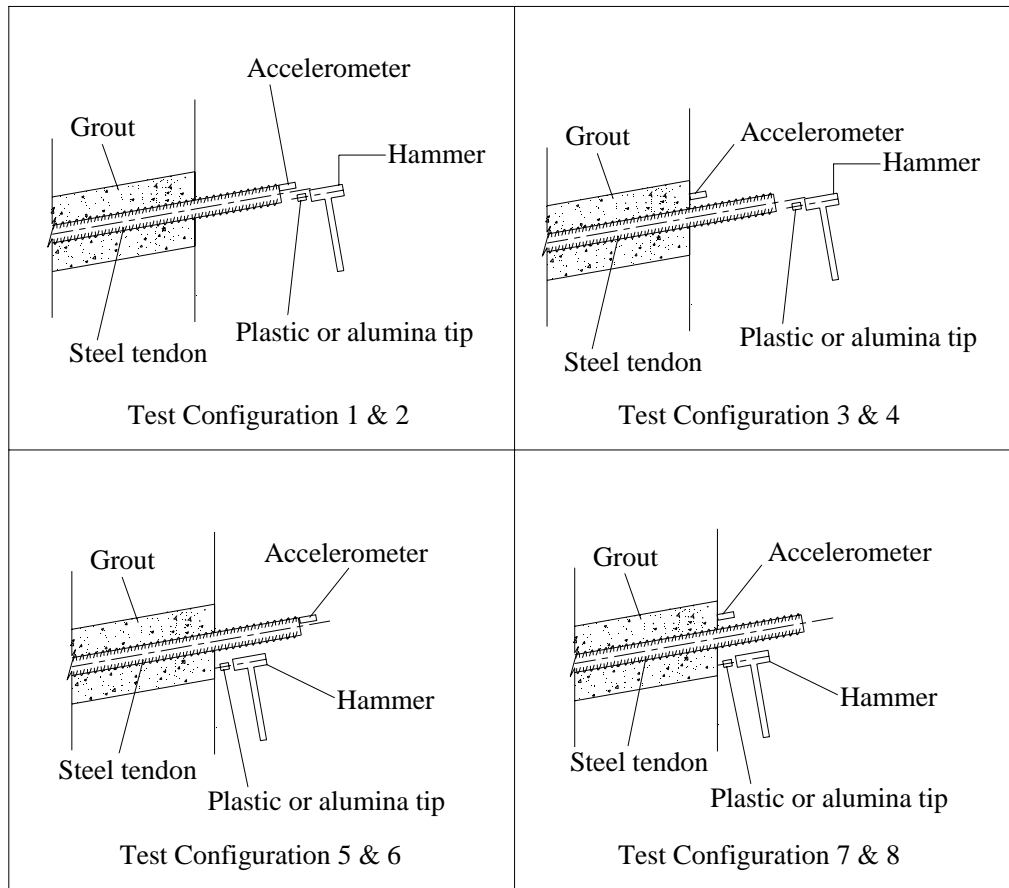
Figure 5.58 Different Test Configurations for Sonic Echo

Sonic Echo and Impact Echo tests can be performed under different configurations based on where the impact is made (grout versus steel tendon), where the sensor is mounted (on the grout versus steel tendon) and what type of tip is used in the impact (aluminum versus plastic). Based on the analysis of test records, it appears that different test configurations have different advantages in detecting different types of defects. Eight major Sonic Echo test configurations are discussed in this section.

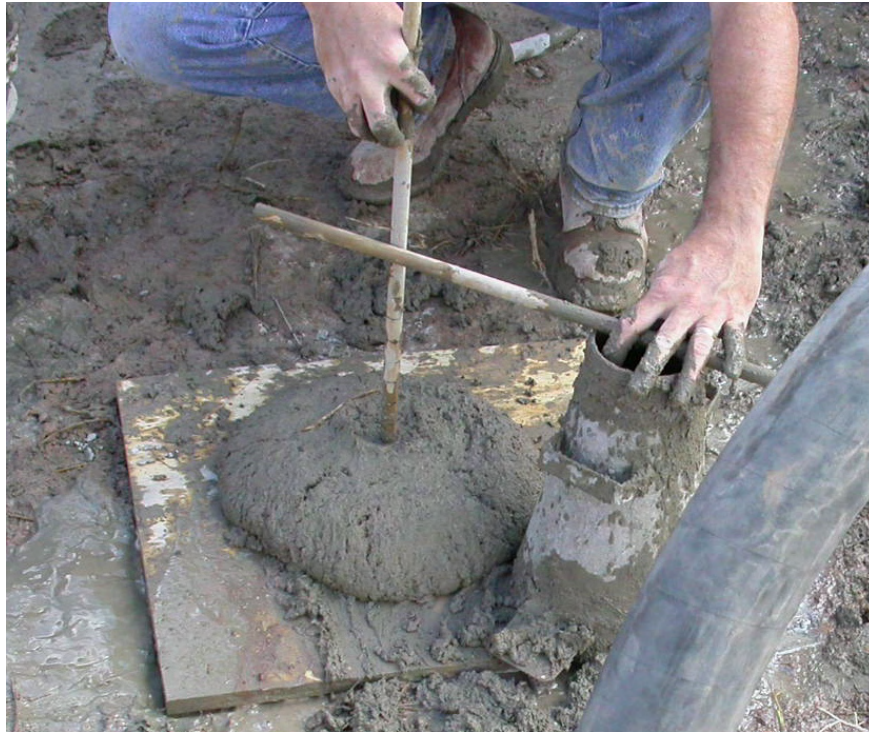
Figure 6.6 ASTM Slump Test of Sand-Cement Grout in Progress

The sand cement grout was initially provided by the transit mix supplier at an ASTM C143 slump of 8 inches. This material was installed into three tubes, one at each tremie position. The same mixture was re-tempered with the addition of water to the mix truck; ASTM slump was measured to be 11 inches. The next set of four tubes was filled with this grout using the three tremie positions. In each case, the grout was pumped as the tremie was withdrawn. This was continued until the end of the tremie was at the end of the tube and the grout flowed from the open end. This was the process used in all cases. Figure 6.6 shows the slump test of the first sand cement mix; Figure 6.7 shows the puddle of the 11 inch slump sand cement grout.

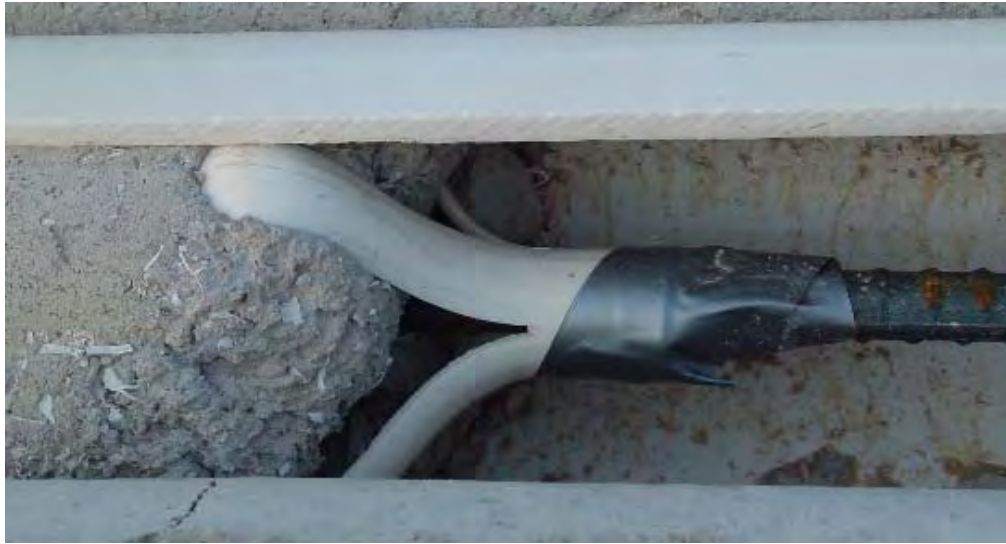
Figure 6.11 Sand 1 Grout in Tube 8, Showing Middle Centralizer and Distant End of Grout Column

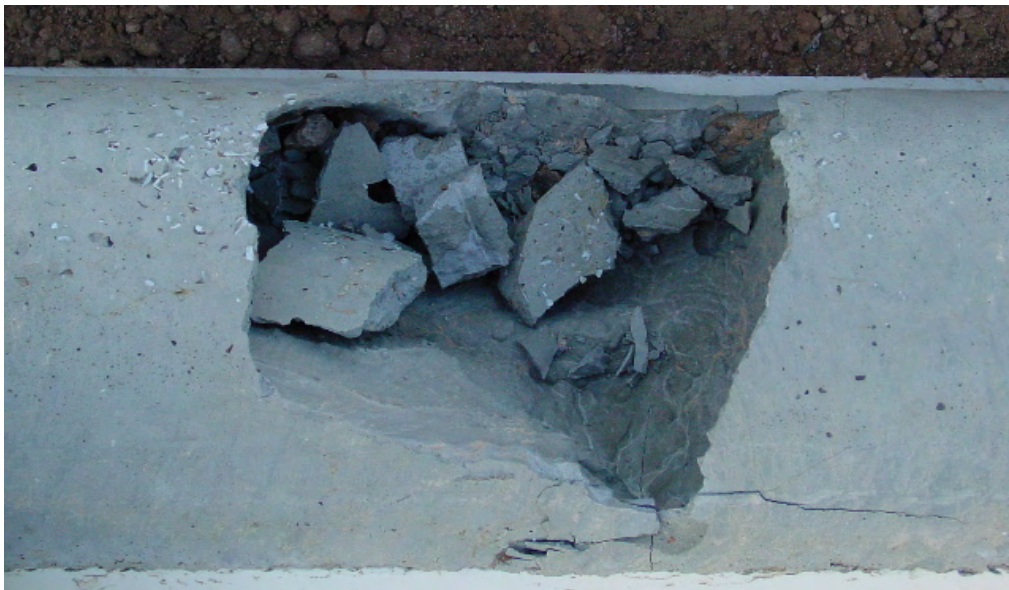
Figure 6.12 Neat Cement Grout In Tube 1, Showing A Void Across About $\frac{1}{2}$ Of The Grout Column Diameter

Several types of defects were noted as the tubes were exhumed. Figure 6.12 shows an air pocket defect in a neat cement column and Figures 6.13 and 6.14 show cylindrical voids. Each of these was apparently caused when the tremie was withdrawn quicker than the tube filled with grout, thereby trapping air and leaving a defect.

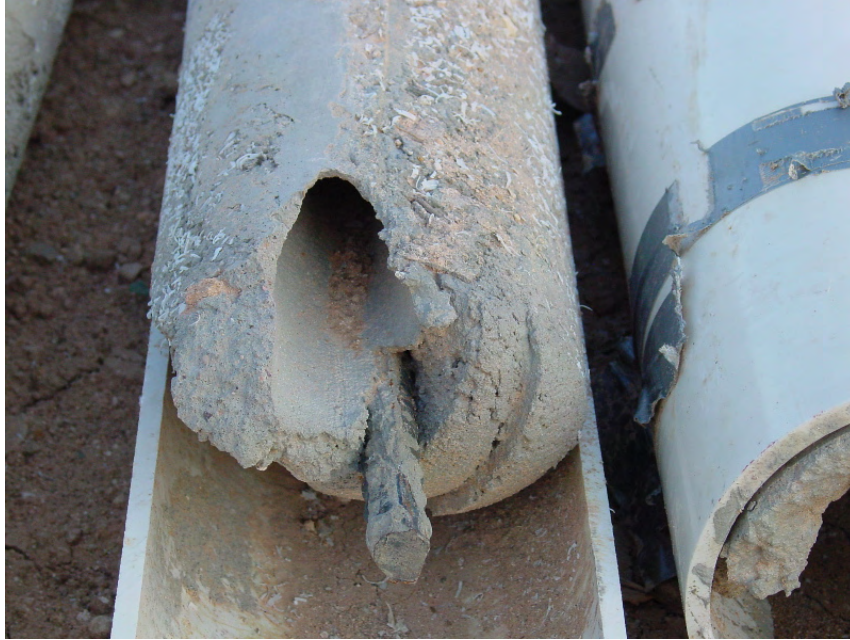
Figure 6.13 Sand Grout Column With A Defect Caused By Withdrawal Of The Tremie From The Surface Of The Grout As It Was Being Pumped

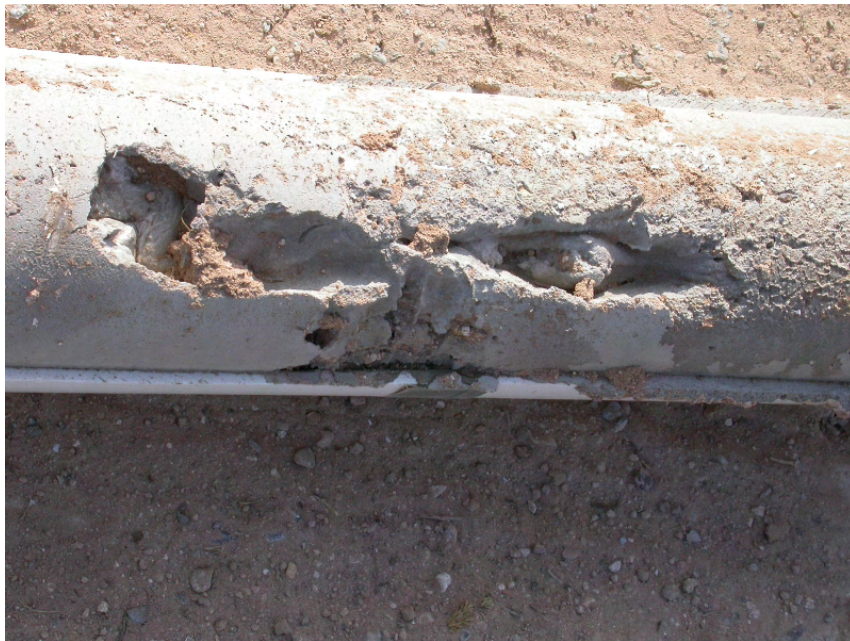
Figure 6.14 Sand Grout Column with a Defect Caused as an air Pocket was Formed during Grouting
