AESTHETIC, ENVIRONMENTAL, AND GEOMORPHOLOGICAL IMPLICATIONS OF CHANNEL MODIFICATIONS

October 1998

Research Study No: 7-2983-S

Research Report Number 7-2983

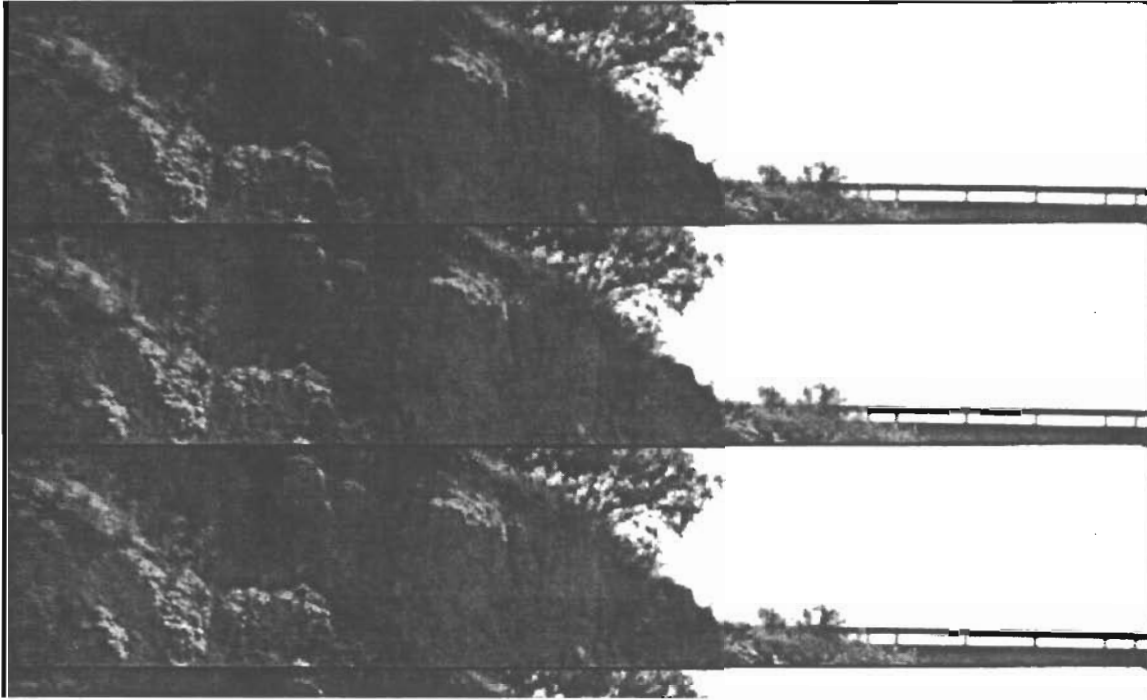
PROBLEM 1 - EXAMPLE A

Figure 2. Photograph viewing east from west of U.S. Highway 83 bridge crossing the Pease River in Childress County showing impingement of channel margin on north abutment. Northward migration of the erosional cutbank on this meander loop is endangering the abutment on the north side of the bridge. Local rock rubble was dumped on the upstream (west) side of the abutment in an attempt to slow erosional retreat of the bank. Location of this crossing at the apex of a meander loop resulted in predictable endangerment of the abutment placed on the erosional cutbank. A new bridge structure under construction (at time of visit) to the east of existing bridge will probably experience similar problems as channel migration proceeds. One approach to prevent this problem would be to examine aerial photographs of the channel meander system and locate the abutments such that they are outside the meander bandwidth.

Many or most structural, aesthetic, and environmental problems associated with channel crossings can be avoided by selection of an optimum location and roadway approach for the crossing. The existing TxDOT design guidelines point out the potential problems associated with choosing a poor location for the crossing. Nevertheless, in several sites examined for this report, the underlying cause for problems experienced at the crossing was the initial poor location on the outer bend (“cut bank”) of a meander loop where the rate of lateral channel migration is most rapid (Figure 2 and Figure 3). Siting the bridge at this location promotes rapid impingement of the channel margin on the bridge abutment or approaching roadway, and necessitates eventual bank protection measures or channel “training” efforts that would otherwise have been unnecessary. These in turn result in aesthetic and environmental concerns.

Selecting an optimum location for a channel crossing requires anticipation of likely future channel behavior. Study of aerial photography or county soil survey maps of the area can accomplish this. Inspection of these usually will reveal 1) the part of the flood-plain subject to recent channel migration, and 2) remnant “scroll topography” in the active part of the river floodplain that records the direction of past channel migration. The likely extent and direction of future channel migration can be approximated in this manner.

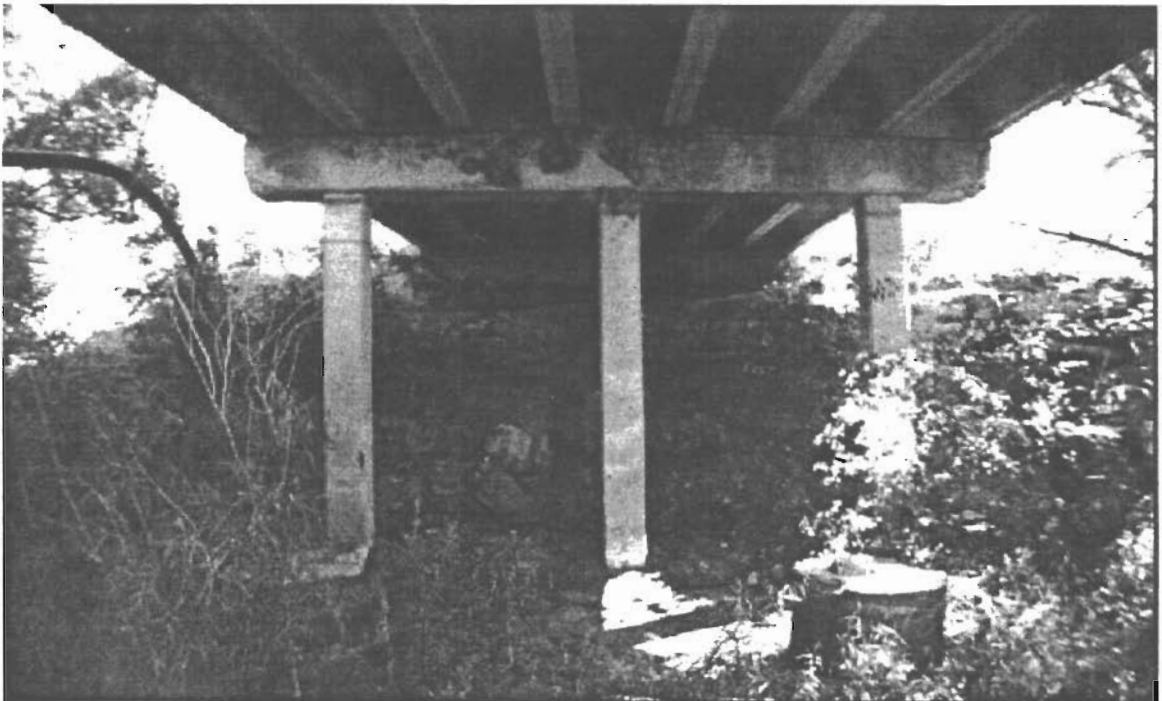
PROBLEM 1 - EXAMPLE B

Figure 3. Bridge crossing the North Pease River on State Highway 94 in Childress County showing impingement of channel margin on north abutment. Northward migration of the erosional cutback on this meander loop is endangering the abutment on the north side of the bridge. No bank protection measures have been attempted. Location of this crossing at the apex of a meander loop resulted in predictable endangerment of the abutment placed on the erosional cutbank. The bridge is providing habitat for swallows (note nests underneath structure).

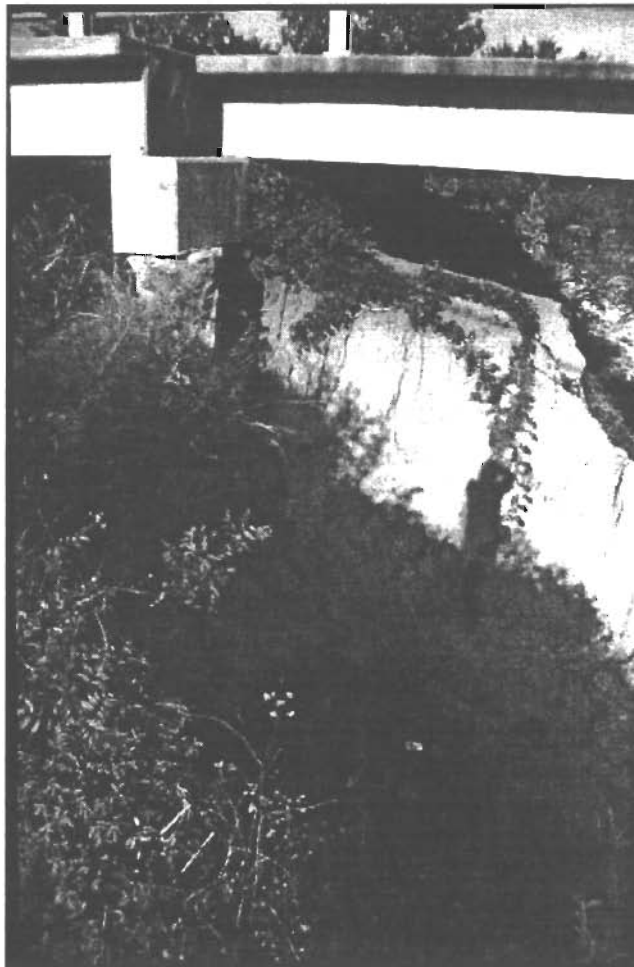
PROBLEM 3 - EXAMPLE B

Figure 6. Erosion of north abutment beneath FM 68 bridge crossing the North Sulfur River in Fannin County. Uncontrolled runoff from road and bridge surface is eroding the abutment.

Most crossings examined for this study, including new construction, illustrate poor designs (from an environmental perspective) for drainage from bridge abutments and roadside channels. Natural vegetation or flexible permanent lining for roadside drainage channels is preferable for aesthetic and environmental purposes since they are able to trap and absorb particulate and some dissolved contaminants in runoff water. Use of rigid concrete surface in roadside channels may be more effective hydraulically, but less aesthetic than a natural vegetation lining. Rigid channel linings probably do not constitute an environmental problem.

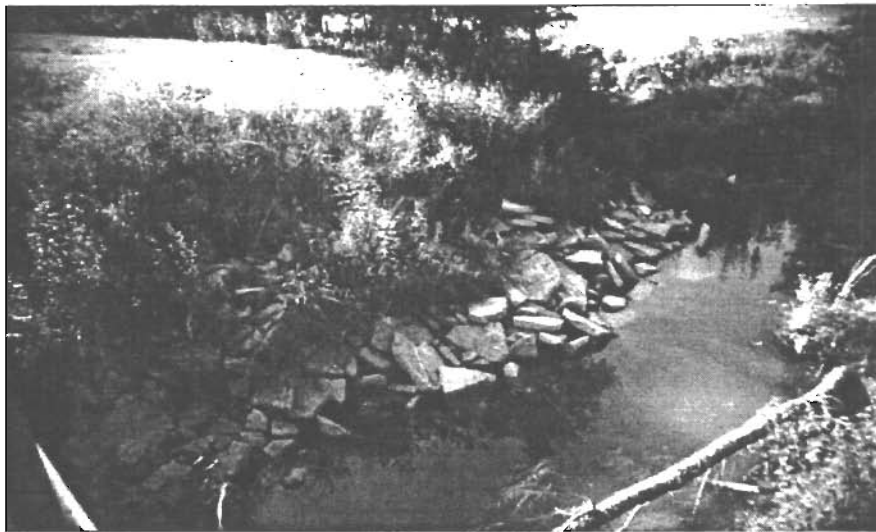
PROBLEM 4 - EXAMPLE A

Figure 7. FM 1550 bridge crossing Brushy Creek in Fannin County (above) with concrete rubble dumped to mitigate impingement of flows on west channel bank and abutment of bridge.

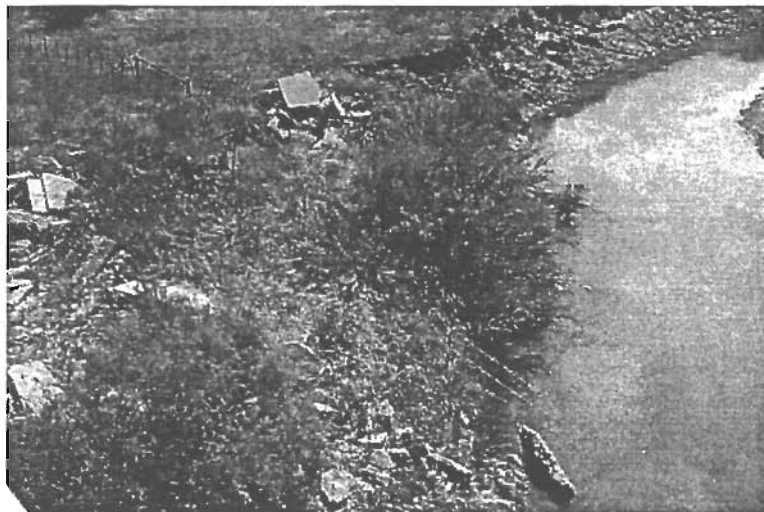
Figure 8. FM 267 bridge crossing the North Wichita River in Childress County showing impingement of margin on south abutment. Southward migration of the erosional cutback on this meander loop is endangering the abutment and approach roadway on the south side of the bridge. Concrete, brick, and asphalt rubble has been dumped on the upstream (west) side of the abutment in an attempt to slow erosional retreat of the bank. This haphazard bank erosion control has fostered illegal dumping and littering in the same area, and resulted in aesthetic and environmental concerns.

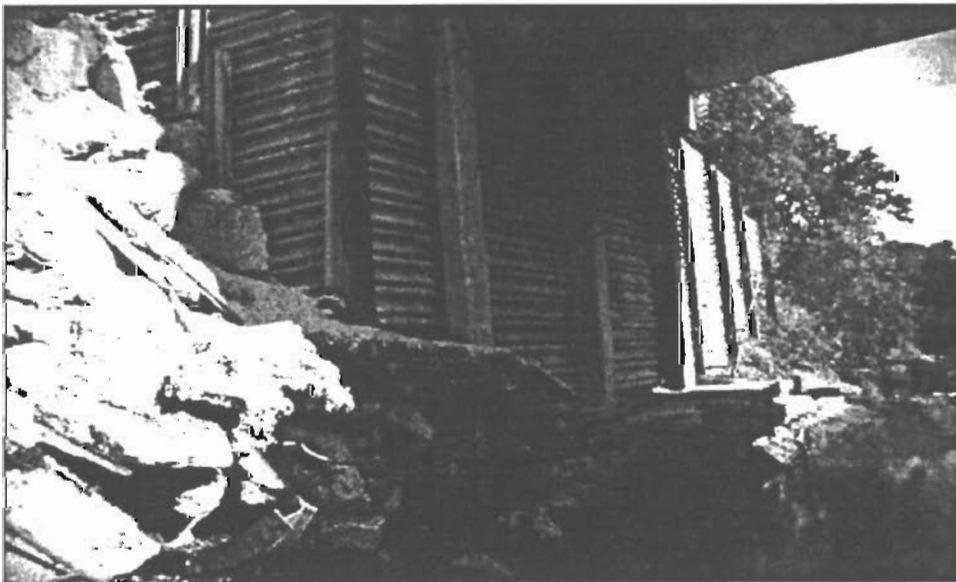
Figure 10. Concrete rubble dumped on the upstream upside of the abutment was covered in-place with poured concrete in an attempt to slow erosional retreat of the bank. Such “unconventional” measures pose an aesthetic and perhaps an environmental concern.

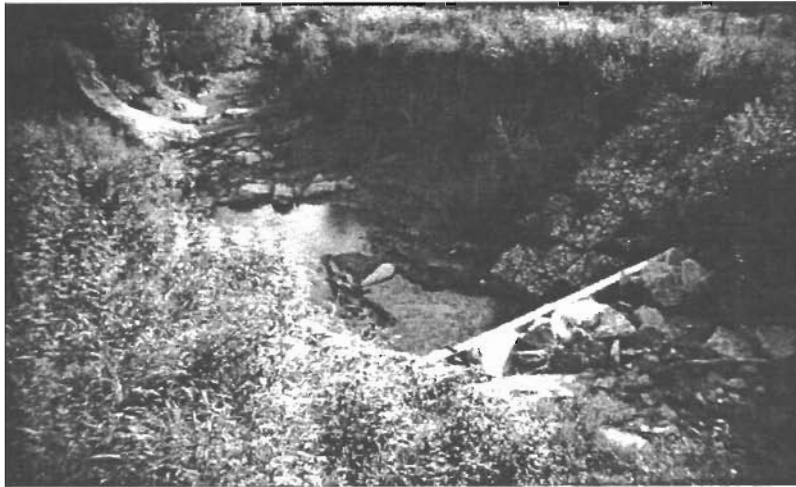
PROBLEM 5

Figure 11. FM 1550 bridge crossing Brushy Creek in Fannin County showing effects on tributary drainages of lowering in channel bed by regional down cutting of the Sulfur River.

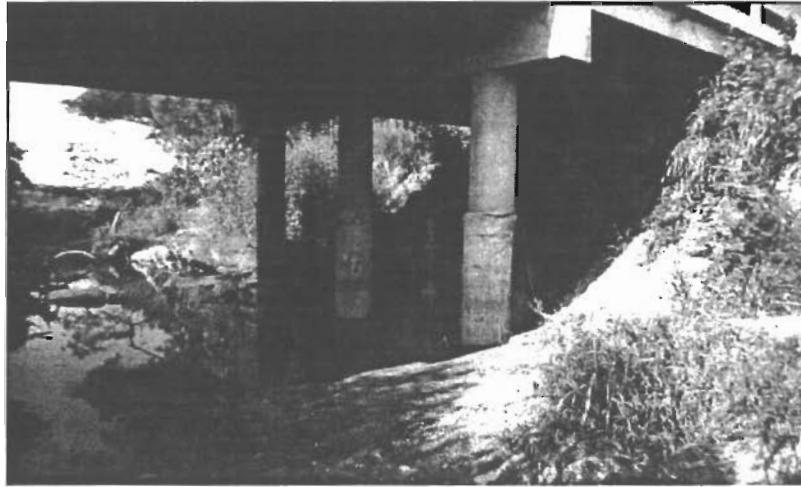
PROBLEM 5 (CONTINUED)

Figure 13. Erosion of the channel bed is endangering bridge support structures and abutments, also resulting in environmental and aesthetic problems. Artificial straightening in the trunk stream channel downstream (Sulfur River) caused at least a 2-meter drop in channel bed elevation in this tributary drainage.

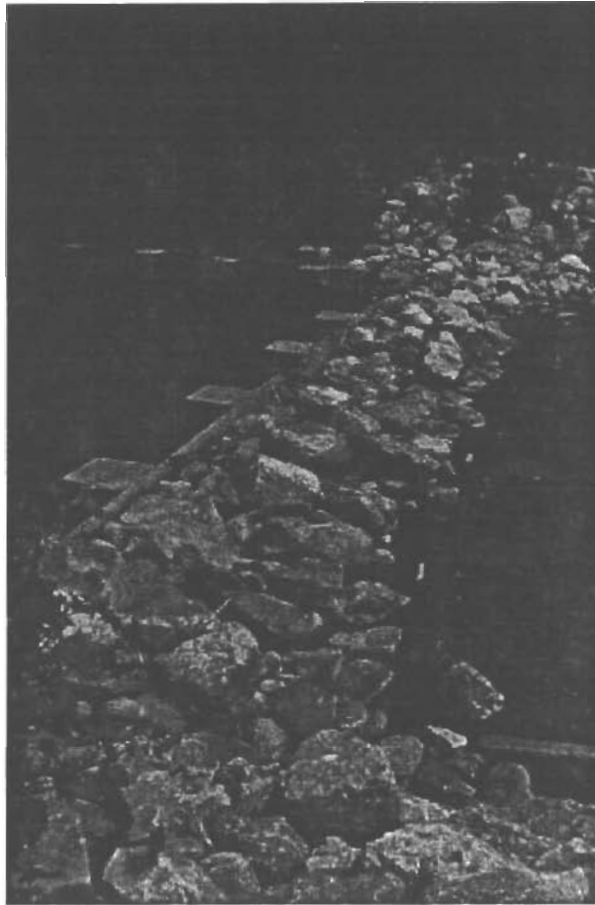
PROBLEM 6 (CONTINUED)

Figure 16. Downstream side of the grade control structure.

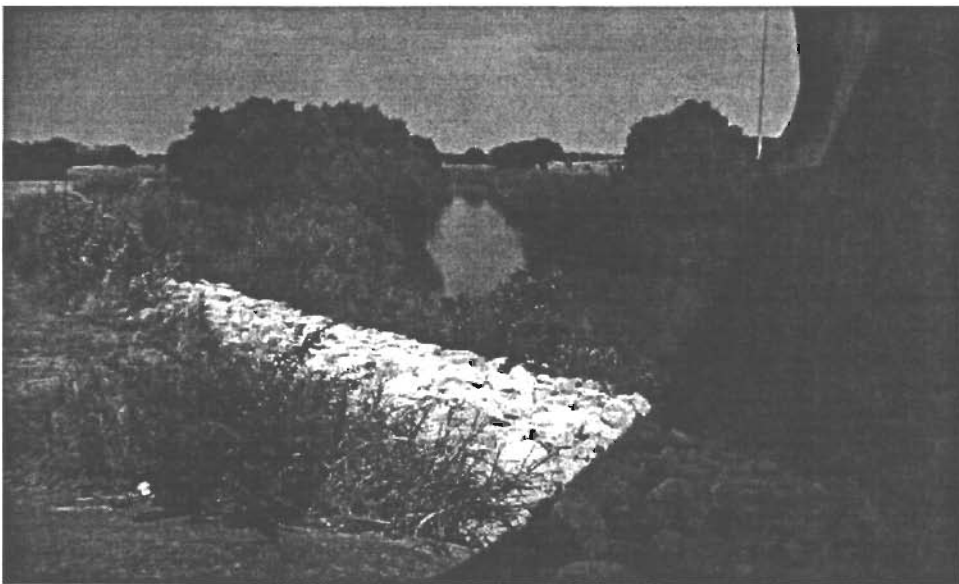
Figure 18. Picture upstream of the bridge showing the riprap and channel direction change which occurs at the bridge site.

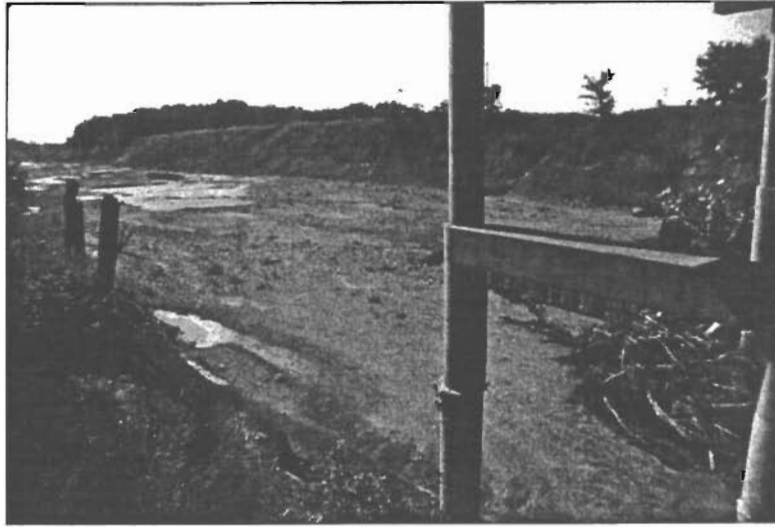
PROBLEM 7

Figure 19. This is a view looking upstream from the FM 2990 bridge crossing the North Sulfur River in Fannin County. In response to the straightening of the Sulfur River Channel, dramatic lowering of the channel bed by regional down cutting has occurred. The drop in channel bed elevation was caused by the artificial straightening of this reach of channel that resulted in the steepening of gradient. The ring shown on the concrete pier shows the level of the channel when the pier was poured.

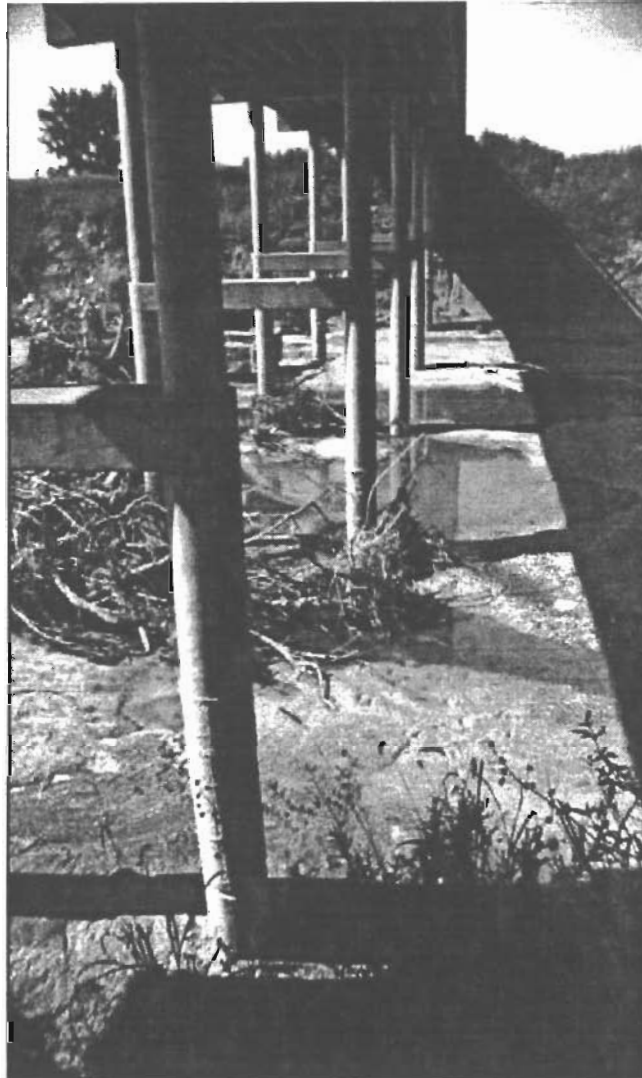
PROBLEM 7 (CONTINUED)

Figure 20. Photograph of view north to show the channel cross section at the bridge. The level of the channel at the time the piers were poured can be seen on by the markings on the two closest piers. Erosion of the channel bed is endangering all the bridge support structures and both abutments.

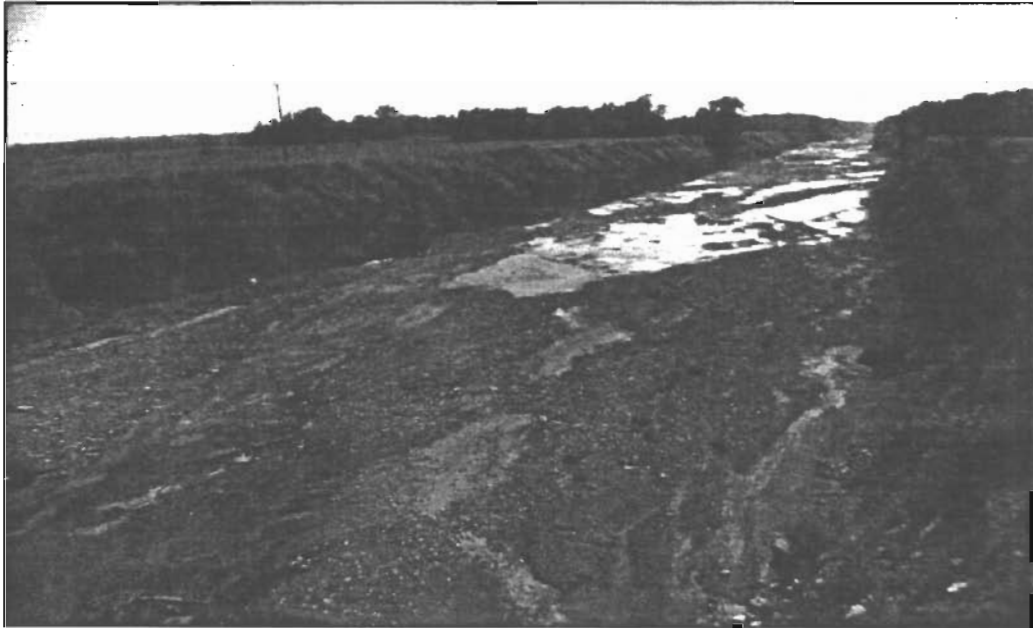
PROBLEM 7 (CONTINUED)

Figure 21. Photograph with a view east to show a view of the channel downstream from the bridge. Natural channel alluvium has been scoured away by erosion. The banks are subject to slope failure and to erosion. The channel bottom is bedrock with a few scattered gravel drifts over the surface.

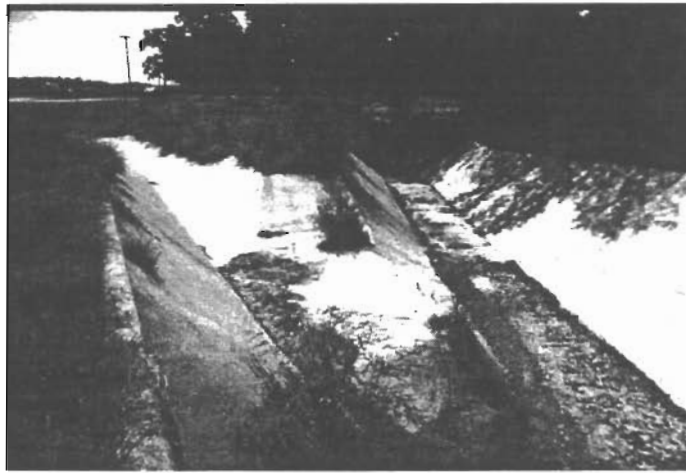
PROBLEM 8

Figure 22. Modifications to an unnamed tributary of the Navosota River near SH 6 in Brazos County. The drainage way on the left drains highway runoff toward the observer and makes a left hand turn into the drainage channel to the right which transports runoff from the watershed east of the highway. This channel flows away from the observer to a sharp curve where the concrete channel ends and an earthen channel starts at the top of the photograph.

This is among the most severe of channel modifications, and should be avoided as much as possible (Figures 22 and 23). Where no alternative is possible, the proposed new channel alignment should maintain the dimensions, slope, bed material, and meander pattern of the existing channel. If the existing channel slope cannot be maintained, grade control structures will be required as discussed above, and these may result in environmental concerns. Planning of new channel locations and alignments requires training in environmentally sensitive design procedures for both urban and rural drainage systems. Courses in river restoration and management (such as those described under Recommendation 3, above) are essential for proper development of such severe channel modifications.

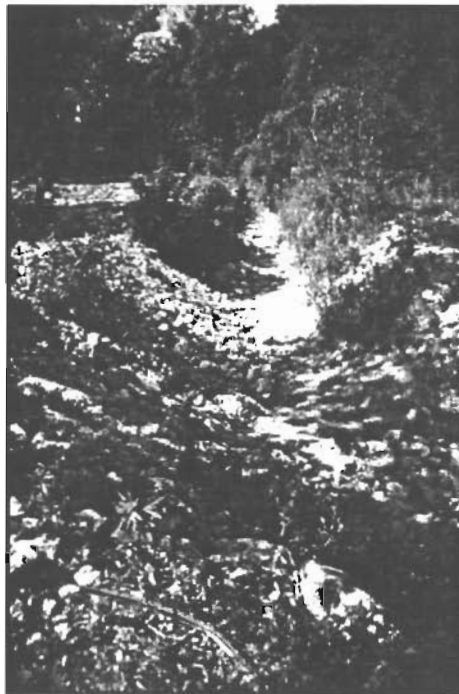
Figure 23. This shows channel conditions just downstream from the bend shown in Figure 22 to another sharp bend to the left in the earthen channel some 100 feet downstream.

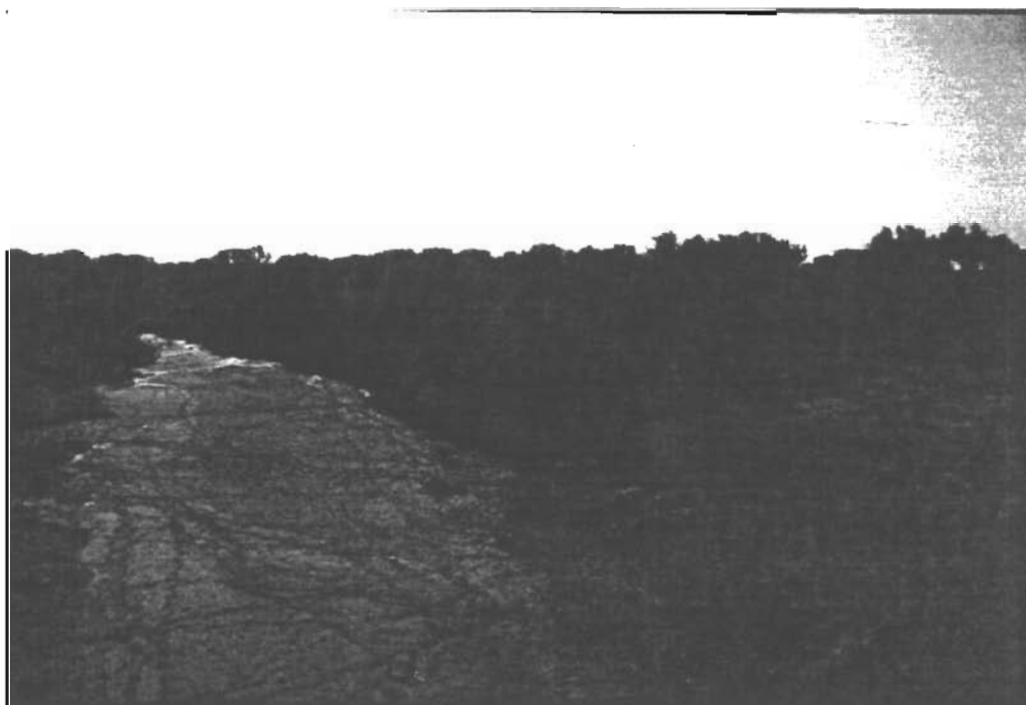
PROBLEM 9 - EXAMPLE A

Figure 24. Channel of the Pease River immediately upstream from the crossing on State Highway 6 in Hardeman County showing accelerated bank erosion by livestock entering the channel adjacent to the northern abutment.
