DATA COMMUNICATIONS CABLING INSPECTION PHOTO EXAMPLES

TEXAS TECH UNIVERSITY

This document contains examples of photographs to be provided to TTU Telecommunications following service installation for the purpose of verifying proper installation and compliance with University policies and procedures.

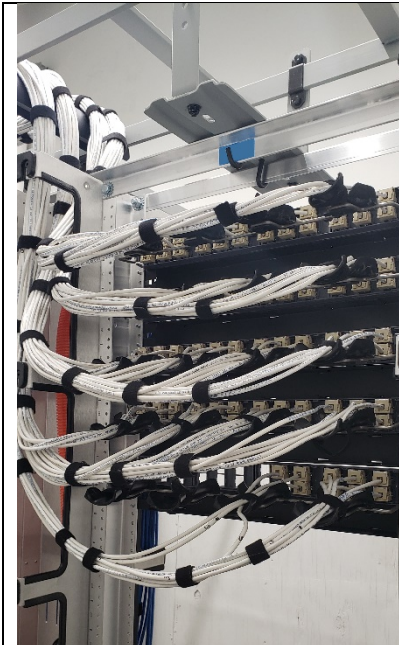
Back of patch-panel showing cables routed to vertical management.

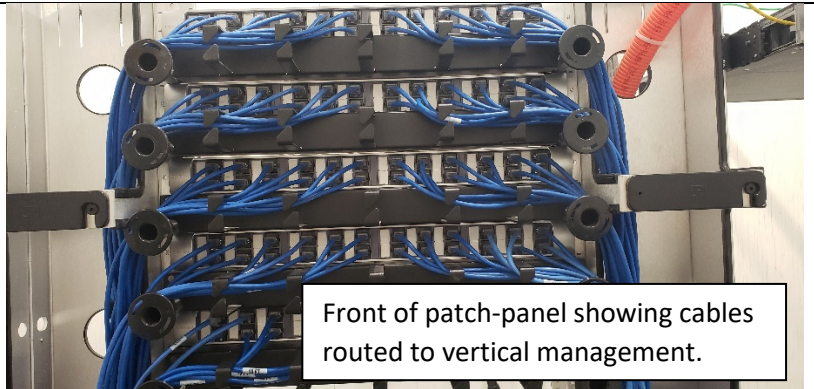
Front of patch-panel showing cables routed to vertical management.

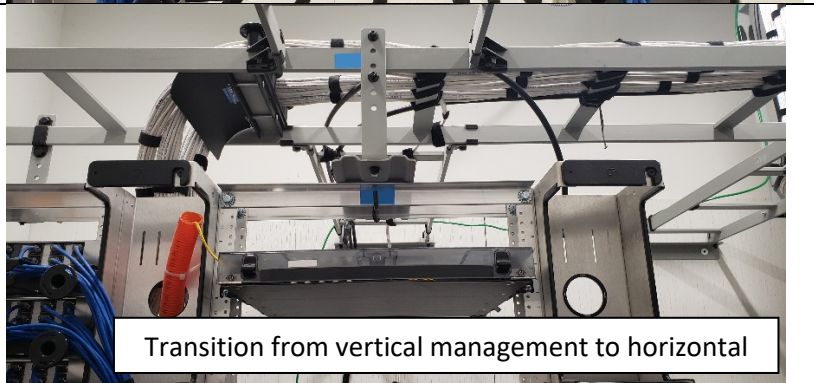
Transition from vertical management to horizontal

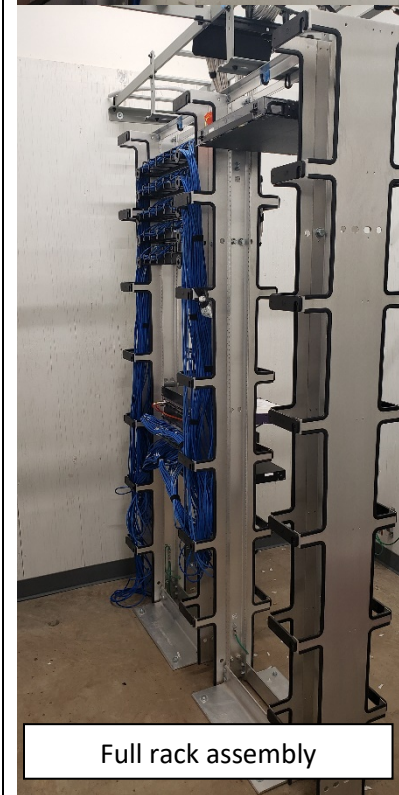
Full rack assembly

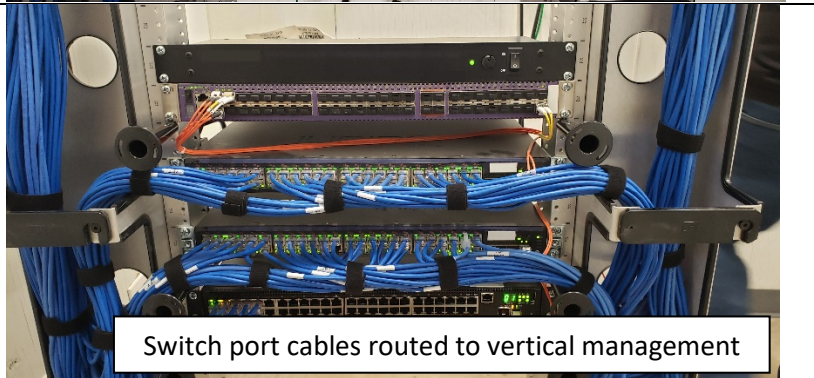
Switch port cables routed to vertical management

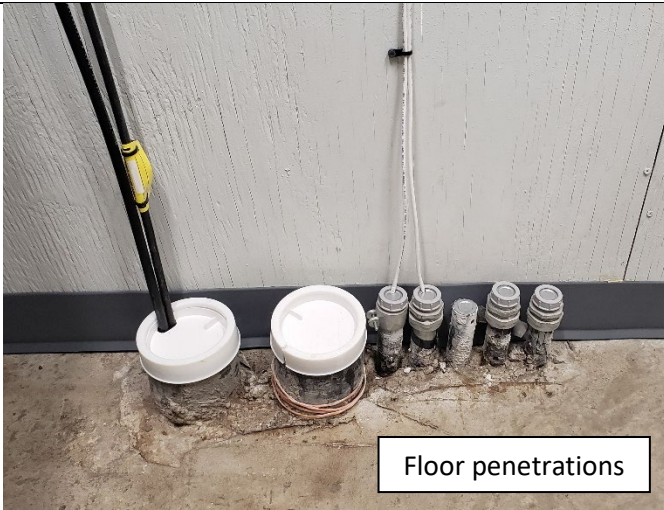
Floor penetrations

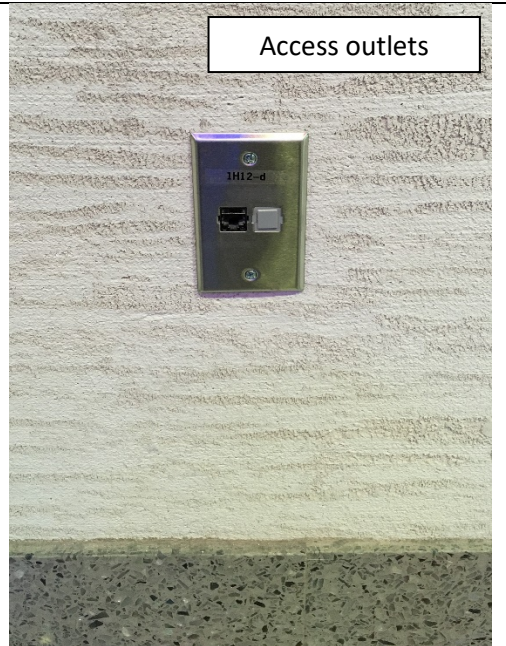
Access outlets

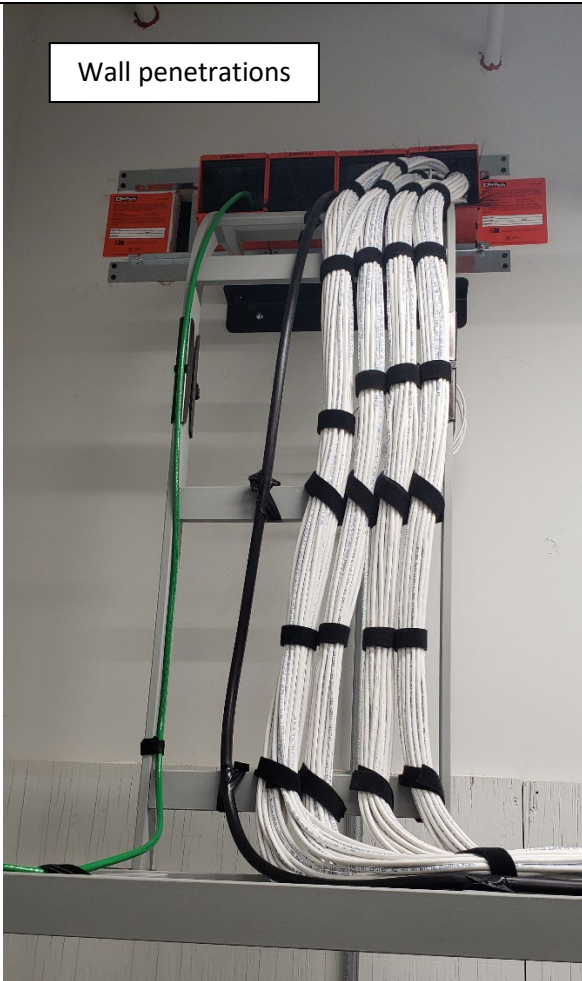
Wall penetrations

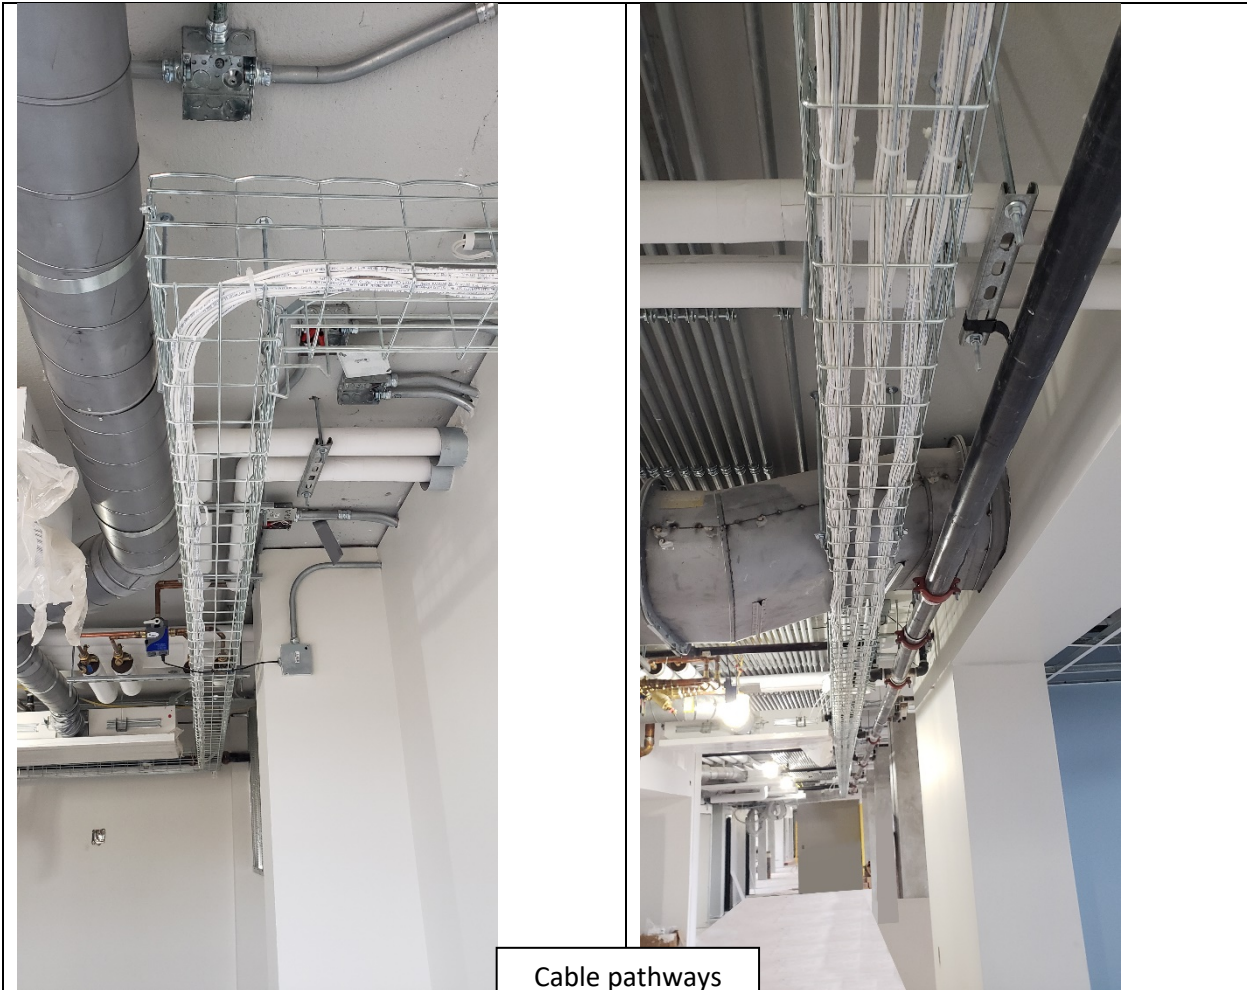
Cable pathways
