**Tornado Report**

# Evansville, Indiana November 6, 2005

## **Eastbrook Mobile Home Park**

May 30, 2006

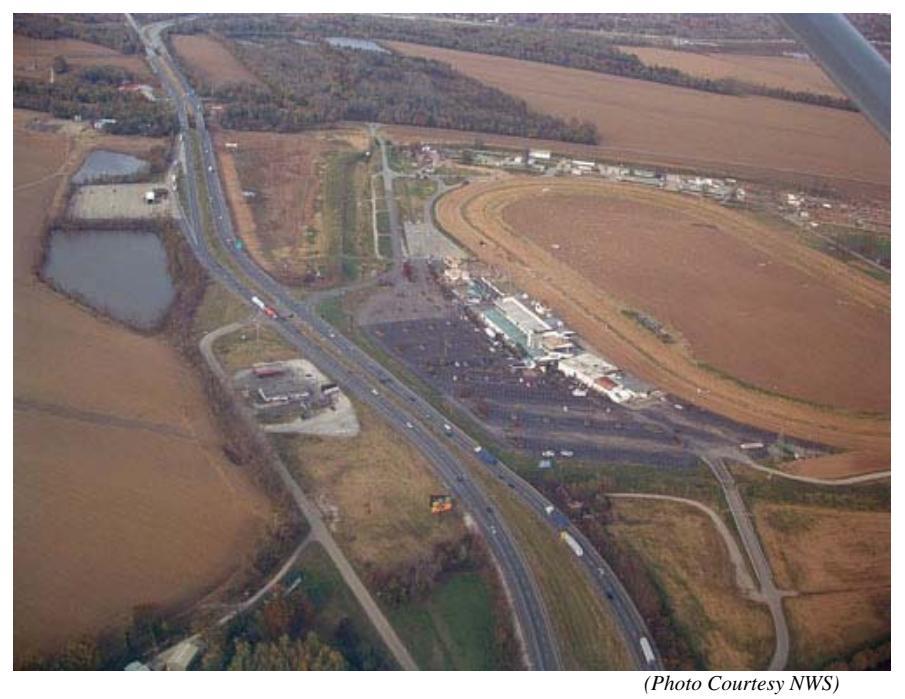
Figure 1-3. Aerial view of tornado damage at Ellis Park Raceway.

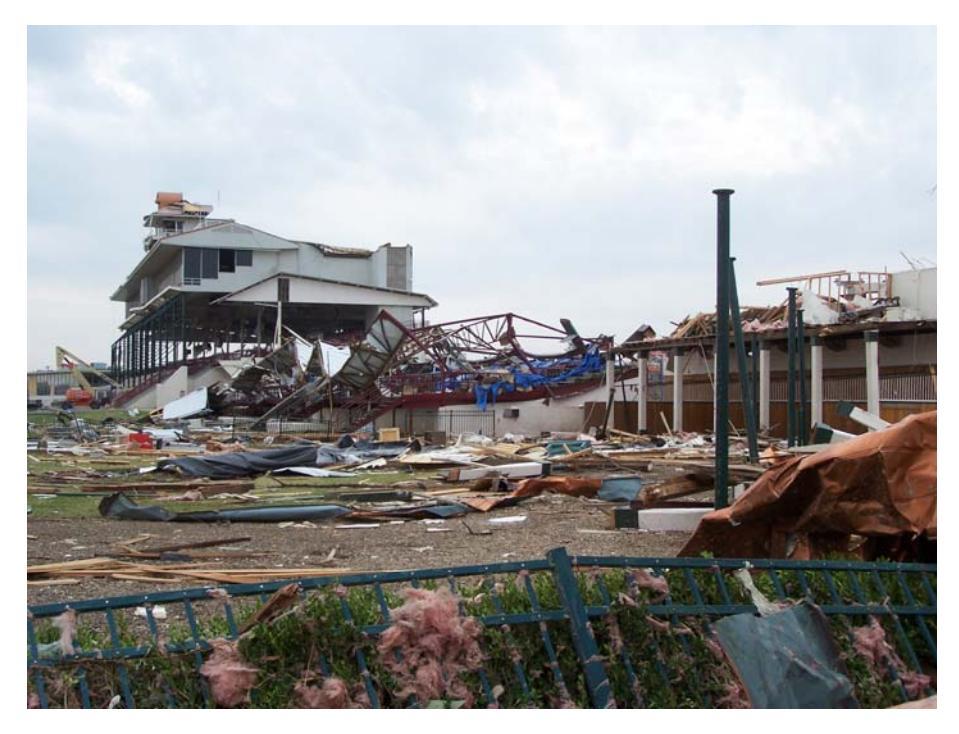
Figure 1-4. Ellis Park Raceway tornado damage.

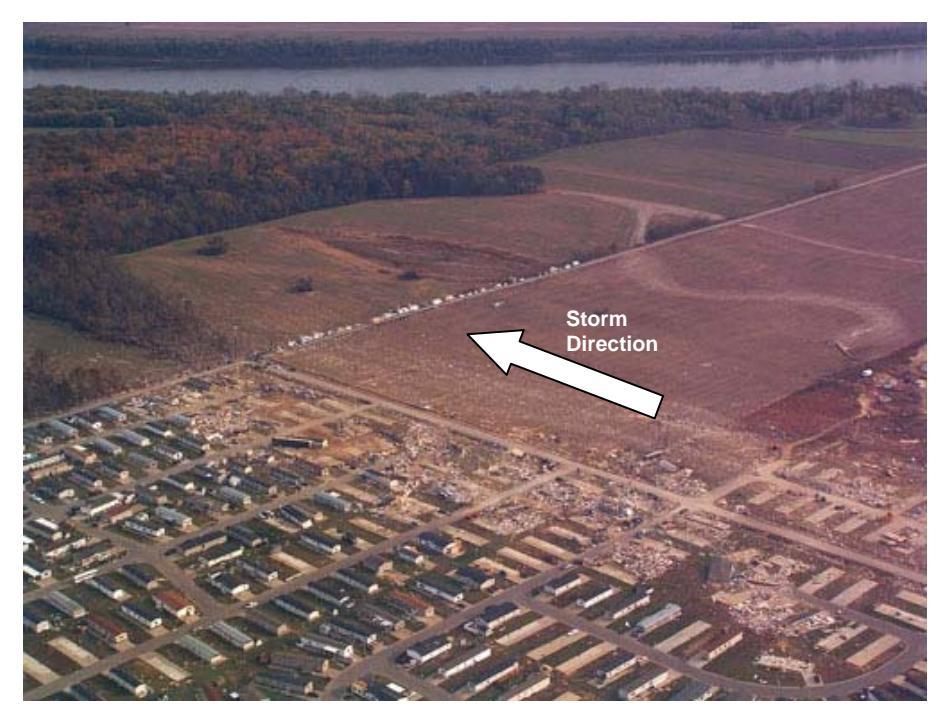
(Photo Courtesy of NWS) Figure 1-5. Aerial view of Eastbrook Mobile Home Park, Evansville, Indiana.

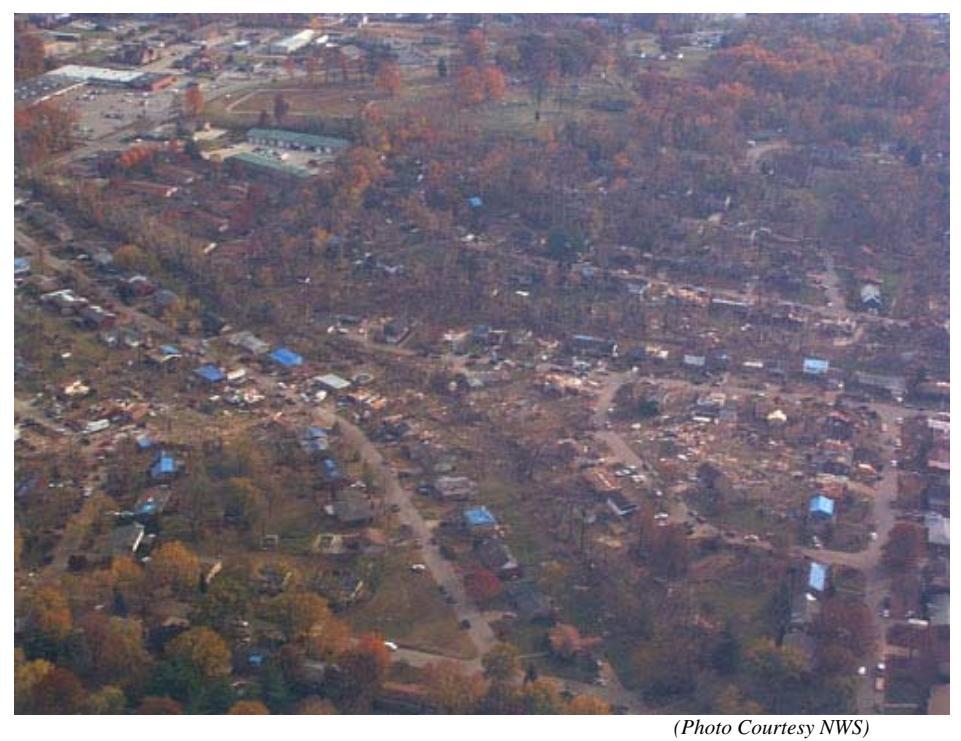
Figure 1-6. Aerial view of damage to Newburgh neighborhood.

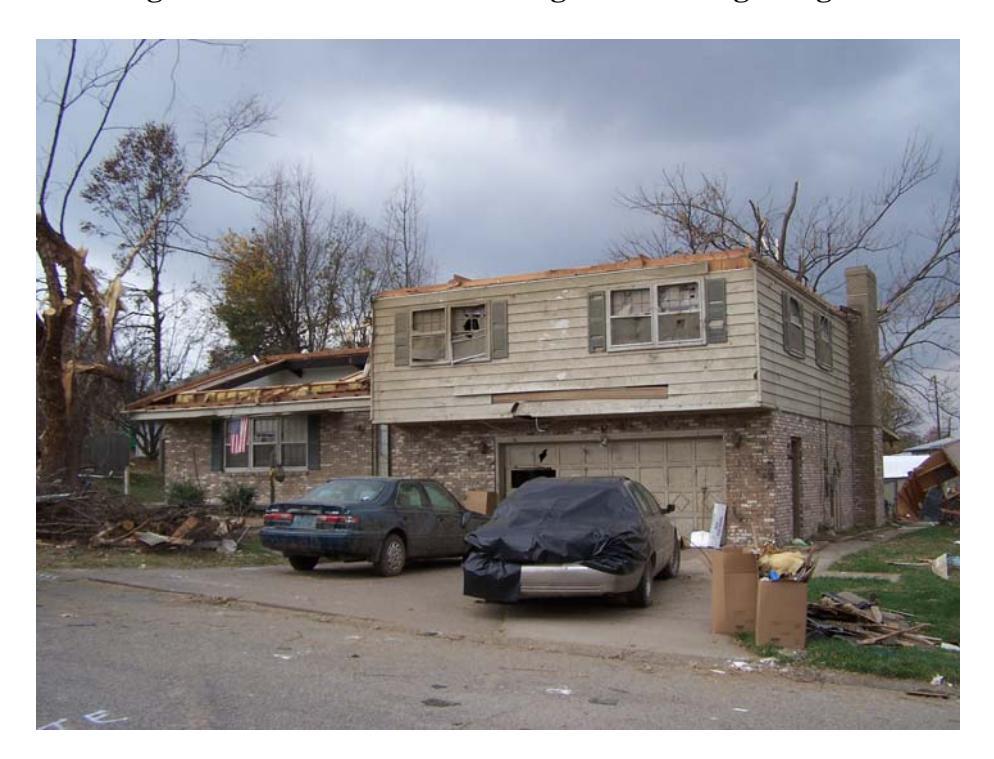
Figure 1-7. Residential damage in Newburgh, Warrick County, Indiana.

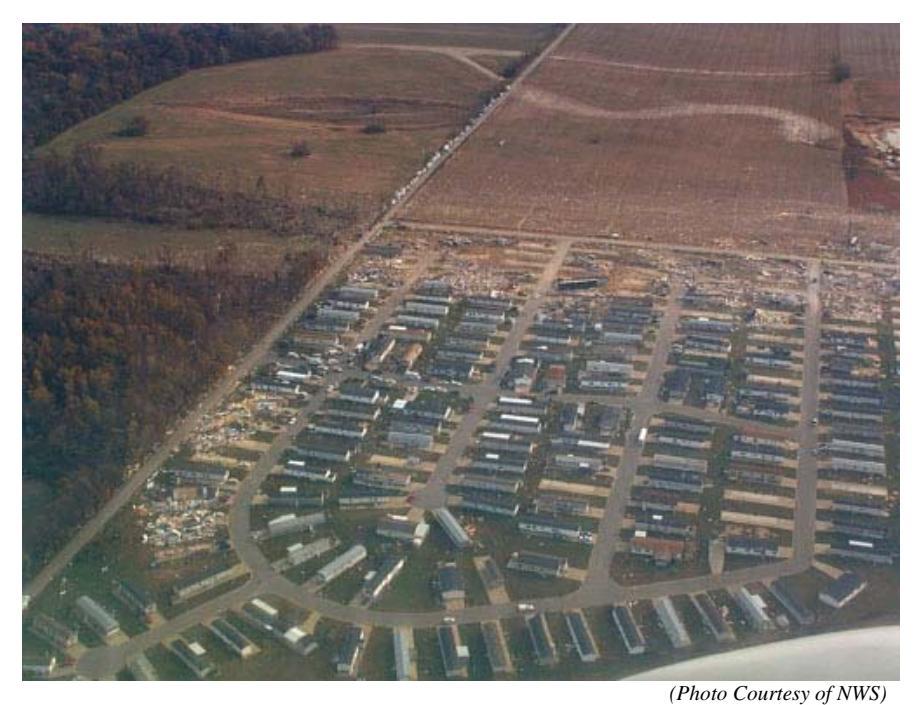
Figure 3-1. Aerial view of east half of Eastbrook Mobile Home Park.

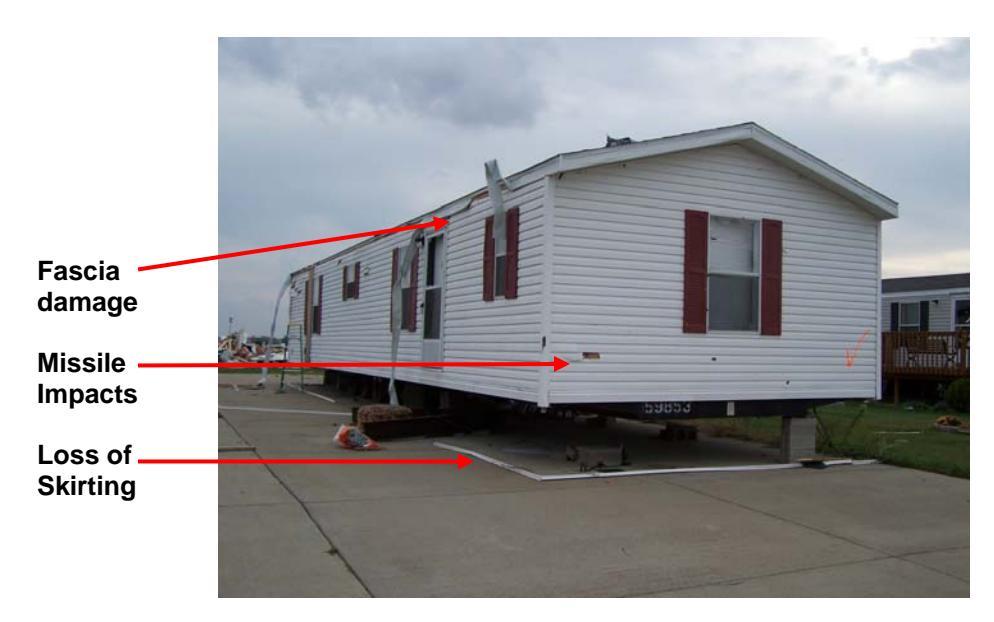
Failures produced by high wind pressures were predominant in the Evansville tornado. Minor failures are normally characterized by damage to light components and cladding elements (skirting and shutters), damage to weak attachments (awnings and patio covers), damage from debris impacts, roof damage (shingles and roof fascias), and minor sliding on supporting piers (see **Figure 3-4**). Minor damaged units often remain livable during repairs.

Figure 3-4. Minor, repairable and livable - roof, cladding and skirting damage.

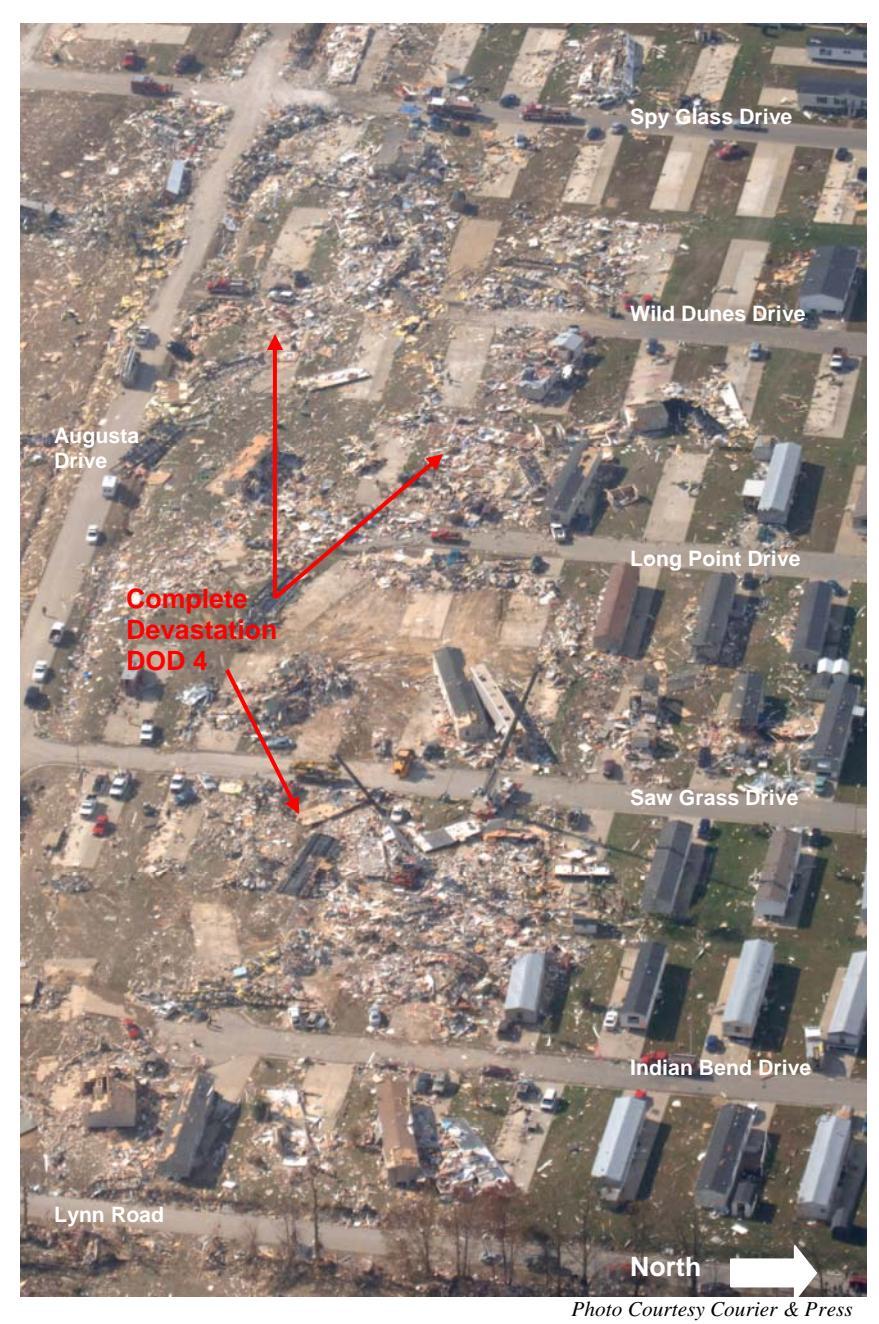
Total unit destruction was extensive, as seen in the aerial photo (**Figure 3-9**). It is estimated that approximately 110 of the 180 units were destroyed, Degree of Damage (DOD) 4. In most cases, failure was initiated by loss of the unit anchors. It should be noted that this investigation was conducted the first three days after the storm. The accumulation of debris was extensive in the areas of the greatest devastation and in-depth investigation in these areas was therefore limited. Typical modes of failure leading to unit destruction were overturning; structural racking from sliding; house separation from the under-frame (undercarriage); walls separated from the floor decking; and vaulting or tossing of the unit from its original location (see **Figures 3-10** to **3-14**). At least four units were found to have been installed without any tie-downs (**Figure 3-15**).

Figure 3-9. Southeast corner of Eastbrook Mobile Home Park.

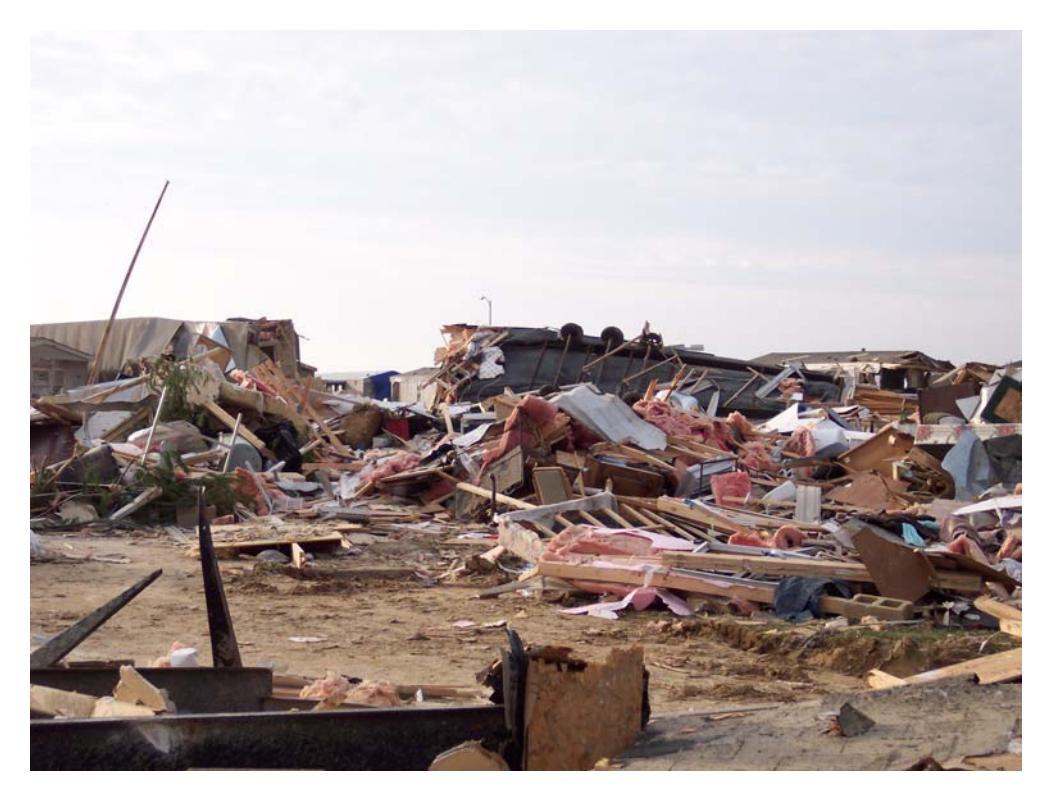
Figure 3-14. Units tumbled and tossed by the wind forces.

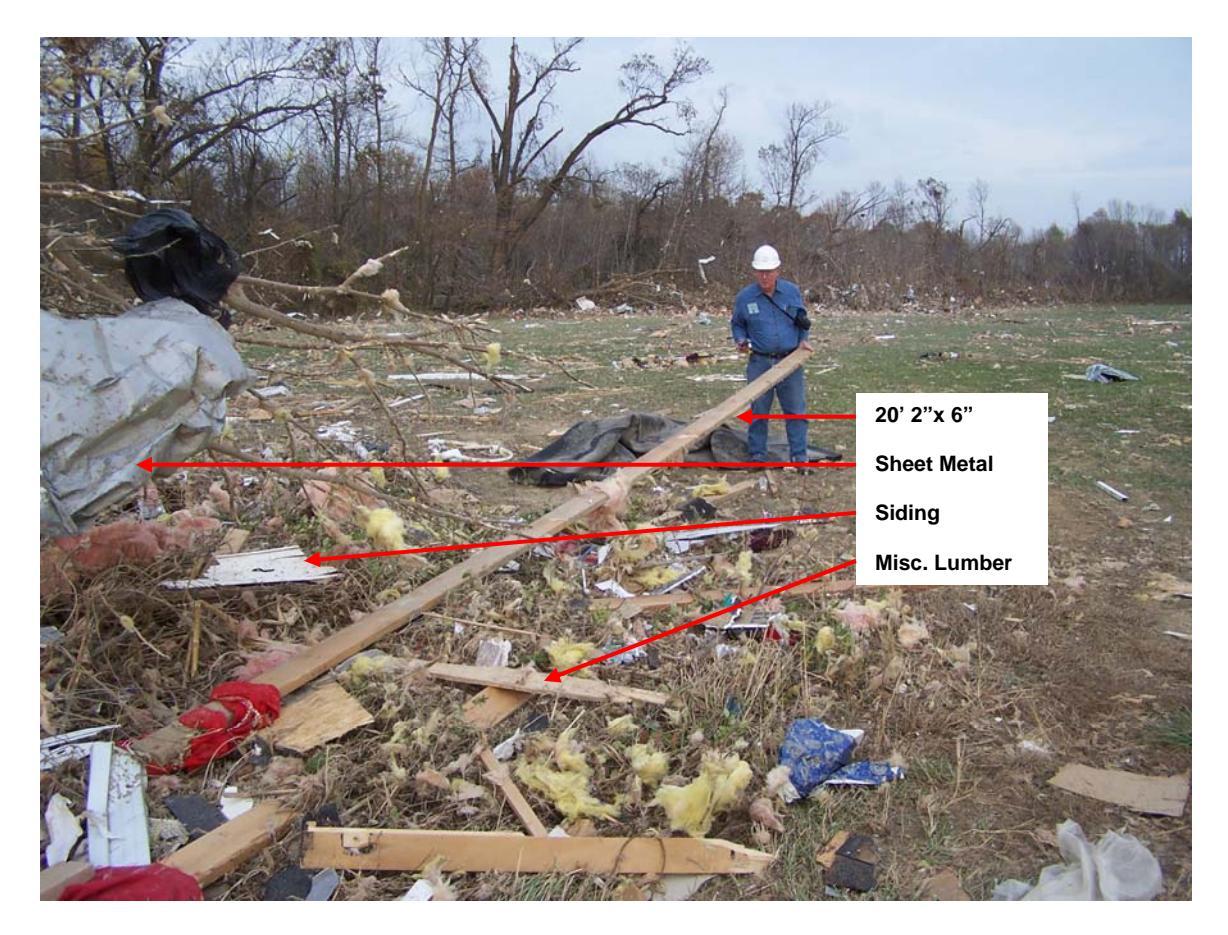
Debris and windborne missiles were abundant. **Figure 3-16** portrays the debris collected just east of the Park and includes a 20-ft. 2"x 6" piece of lumber. Small missiles such as asphalt shingles damaged and penetrated the vinyl cladding of units (**Figure 3-17**), and larger missiles completely perforated walls (see **Figure 3-18**). The largest missile observed was a truck that cut a mobile home in half (see **Figure 3-19**).

Figure 3-16. Field east of the Eastbrook Park littered with debris, including a 20-ft. long 2"x 6" piece of lumber.

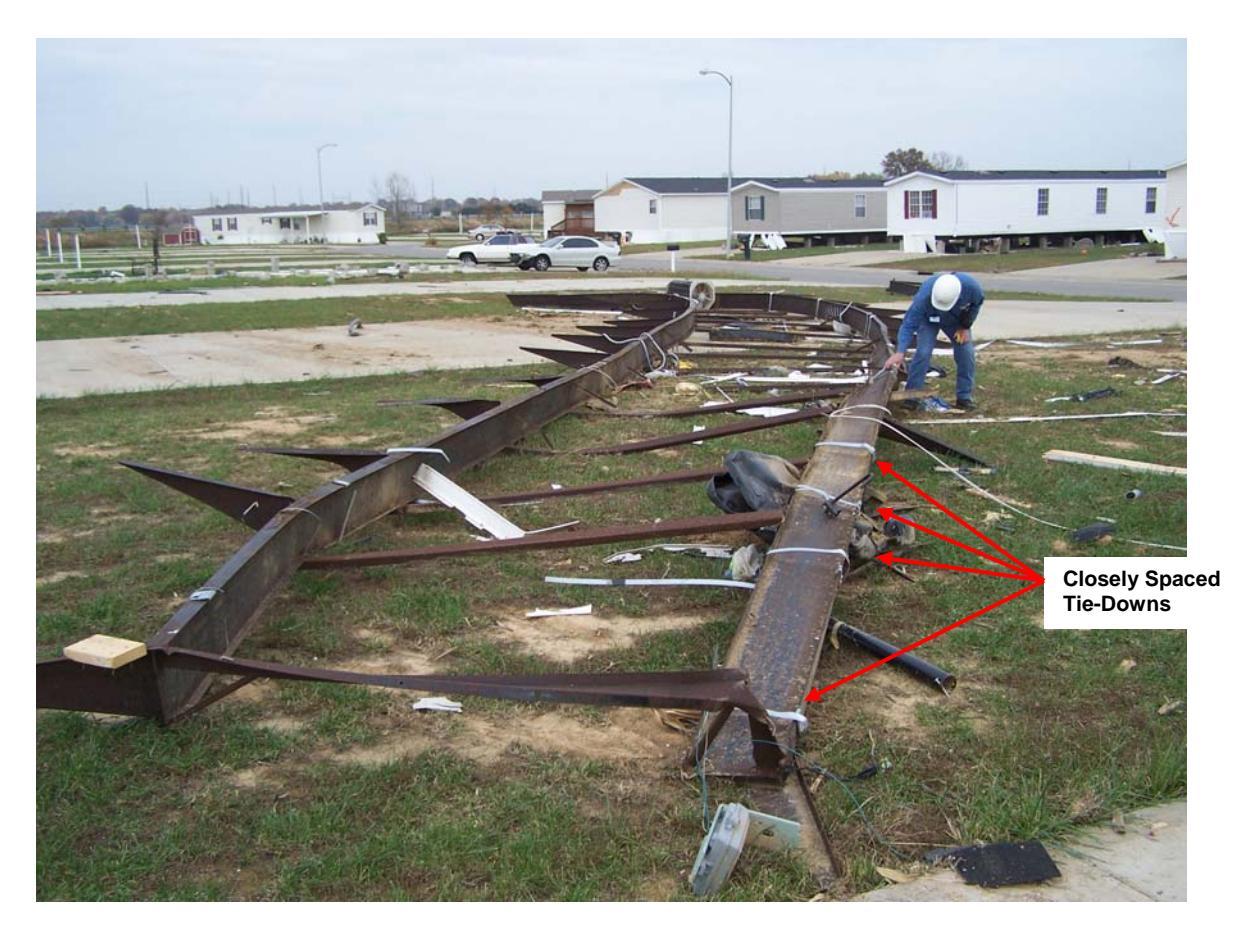
The performance of mobile homes subjected to extreme winds is directly related to unit construction and anchorage of the unit to the ground. The strength of the unit, as previously detailed, is prescribed by the HUD *Manufactured Home Construction and Safety Standards, Article 3280.* The design wind speed for a Zone I unit, typical for Indiana and non-coastal regions, is 86 mph, 3-second gust. Mobile homes at or near the vortex of the tornado that struck on November 6 experienced winds far in excess of that velocity. The unit shown in **Figure 3-20** was located very near the vortex and was structurally unable to resist the wind forces even though it had numerous, closely spaced tie-downs. Its tie-downs failed, thereby allowing the unit to be displaced from its original location and the home superstructure behaved like a "wind sail" and was separated from the structural steel frame.

Figure 3-20. Under-frame of unit from a destroyed mobile home.

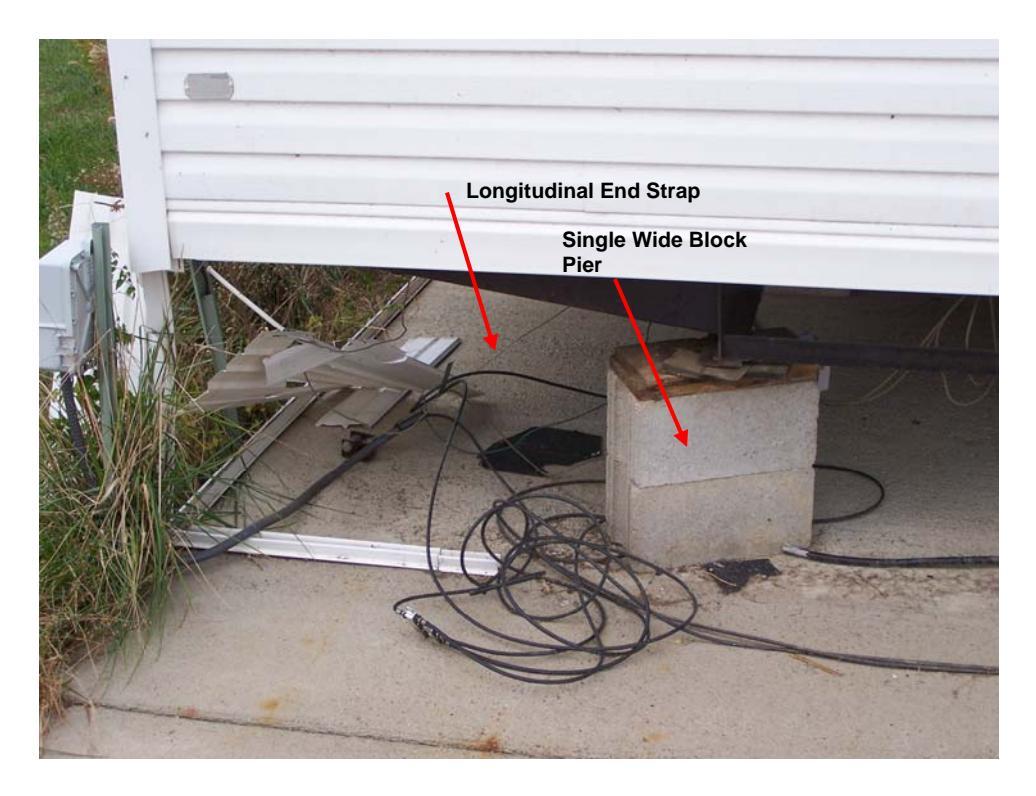
Over 20 of the 180 units were Zone II/III units with over-the-top straps; however, only 4 of these units were observed with these straps connected to ground anchors. NFPA 225 clearly states that, "If sidewall or over-the-top roof straps are installed on the home, they shall be connected to an anchoring device..."<sup>26</sup> It further states that "Manufactured homes shall have anchors to resist longitudinal forces."<sup>27</sup> Longitudinal straps, as seen in **Figure 3-23**, were seldom observed at the Eastbrook Park. The unit end-strapping typically found installed at the Eastbrook Park is shown in **Figure 3-24**.

Figure 3-23. Properly installed longitudinal unit end strap.

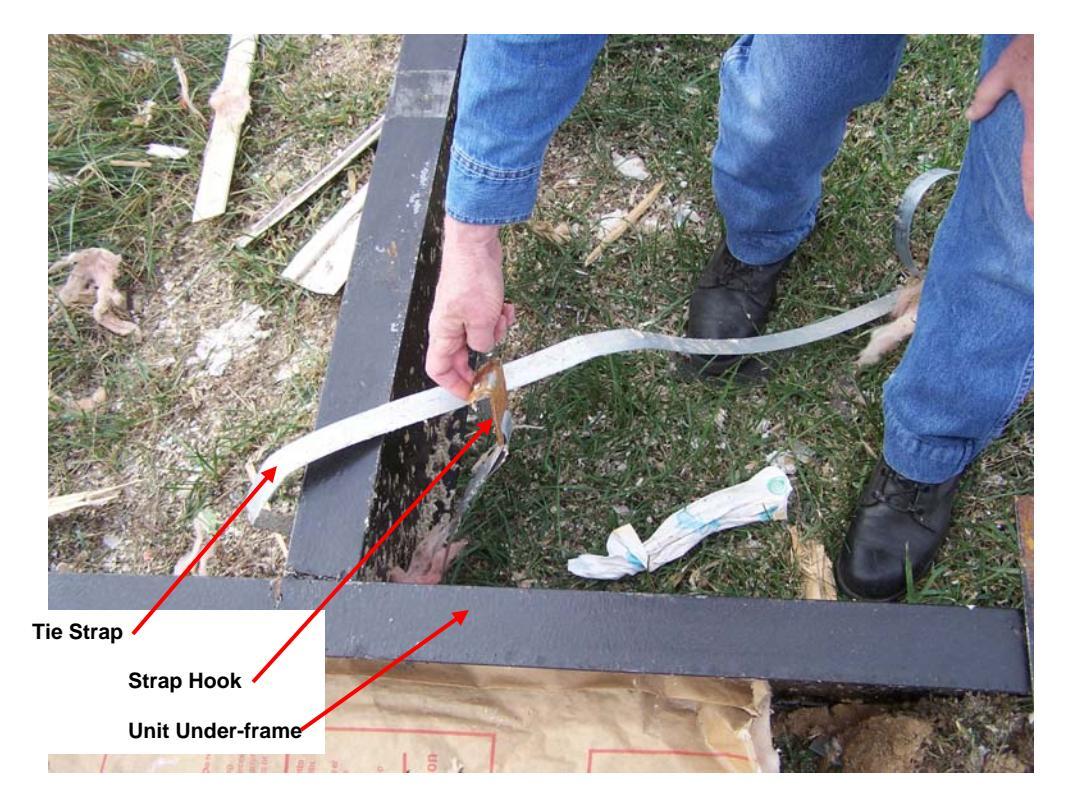
Regardless of the type of anchoring system utilized, the mechanism of failure was generally the same; the strap broke, as shown in **Figure 3-30**. The failure sequence would begin with the wind forces pushing, lifting, and sliding the unit off its piers (see **Figure 3-31**), a process facilitated by loose ties, and ultimate failure of the strap at a bend on the frame flange, (see **Figure 3-30**). The standard method of connecting the strap to the frame was to loop the strap around the frame, much like a belt and buckle or to hook the strap on one flange of the frame and then wrap the strap around the frame (**Figure 3-32**). The writers conclude from the evidence observed that the tie-down strap failure was most commonly the combined results of excessive tensile stresses from the wind forces, combined tensile and flexural stresses resulting in steel straps by shifting of the under-frame (see **Figure 4-17**), and brittle fatigue or shearing of the straps hooked around the sharp flange edges which was produced by the rocking motion of the unit (see **Figure 3-33**).

Figure 3-32. Typical installation-tie-down strap hooked and wrapped over frame.

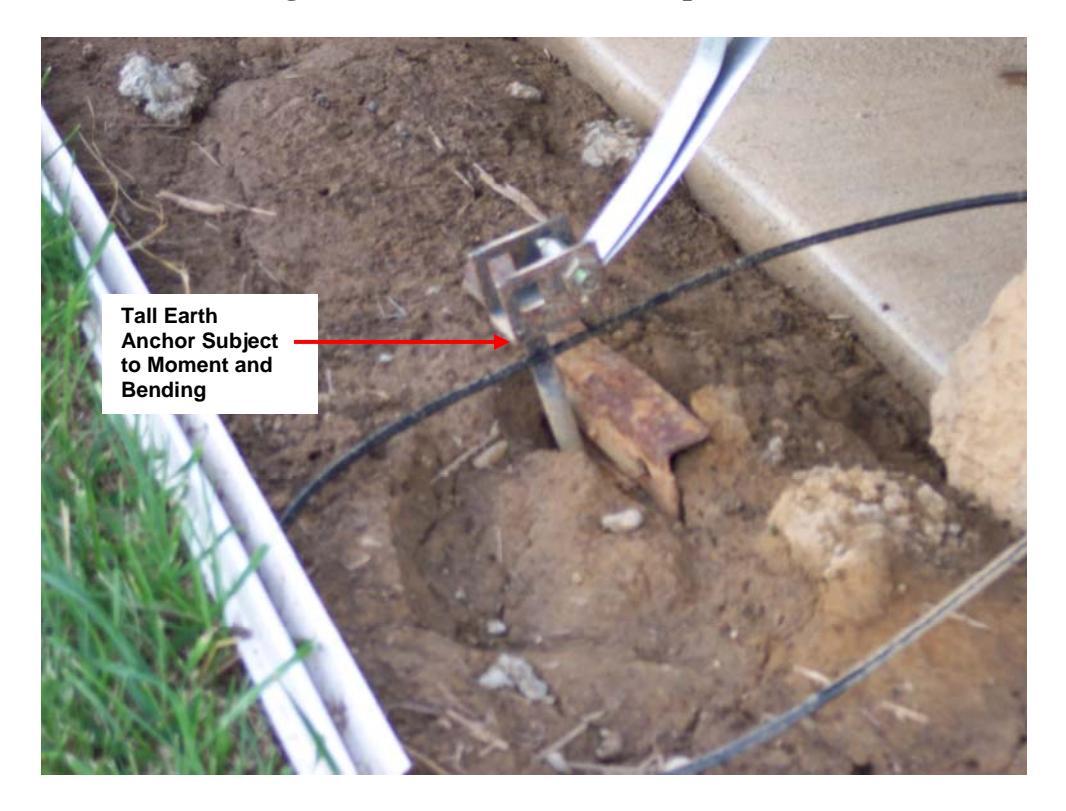
Figure 3-36. Tie-down connected to earth anchor.

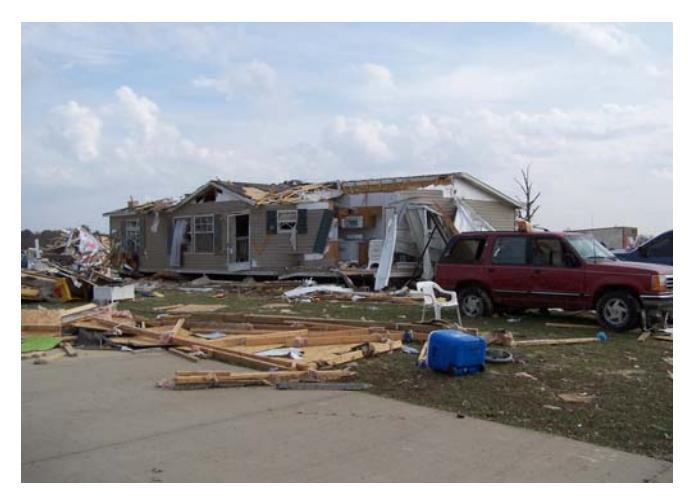
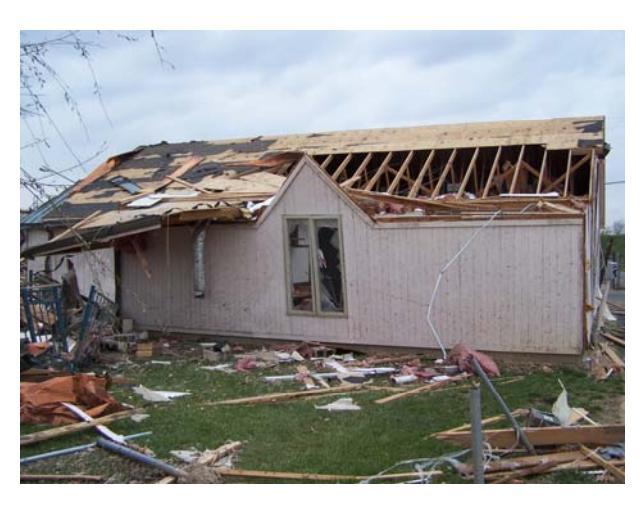
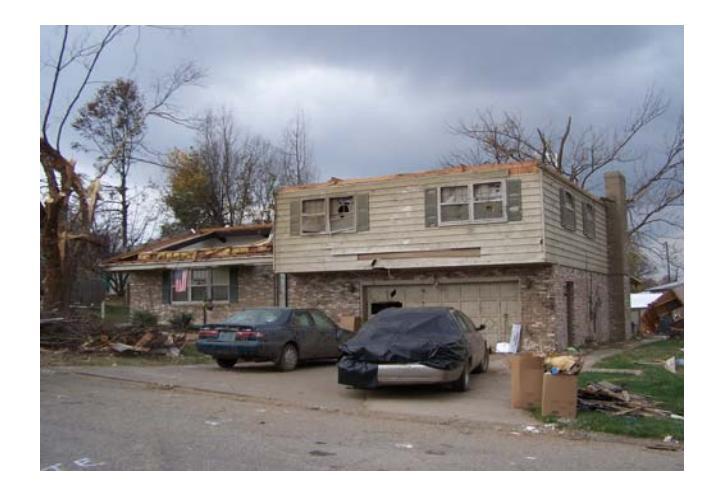
An investigation of the damage was conducted from the storm's touch down near Ellis Park horse race track to Eastbrook Mobile Home Park to Newburgh (see **Figure 4-1**). The level of damage in all three locations was similar, suggesting that each location was exposed to nearly the same wind speeds. The magnitude and intensity of damage at Eastbrook Park is probably attributable to the "mobile and temporary" nature of mobile homes and their lack or weakness of foundation systems. Virtually every home in the Eastbrook Park that was under the influence of the storm's vortex was destroyed (see **Figure 4-2**). The exceptions were those destroyed mobile homes located in the park northeast quadrant along Lynn Road. Their damage most likely resulted from "backside" winds and debris from the tornado coupled with poor anchoring.

Figure 4-1. Comparison of residential destruction at Ellis Park Raceway, Eastbrook Park and Newburgh.

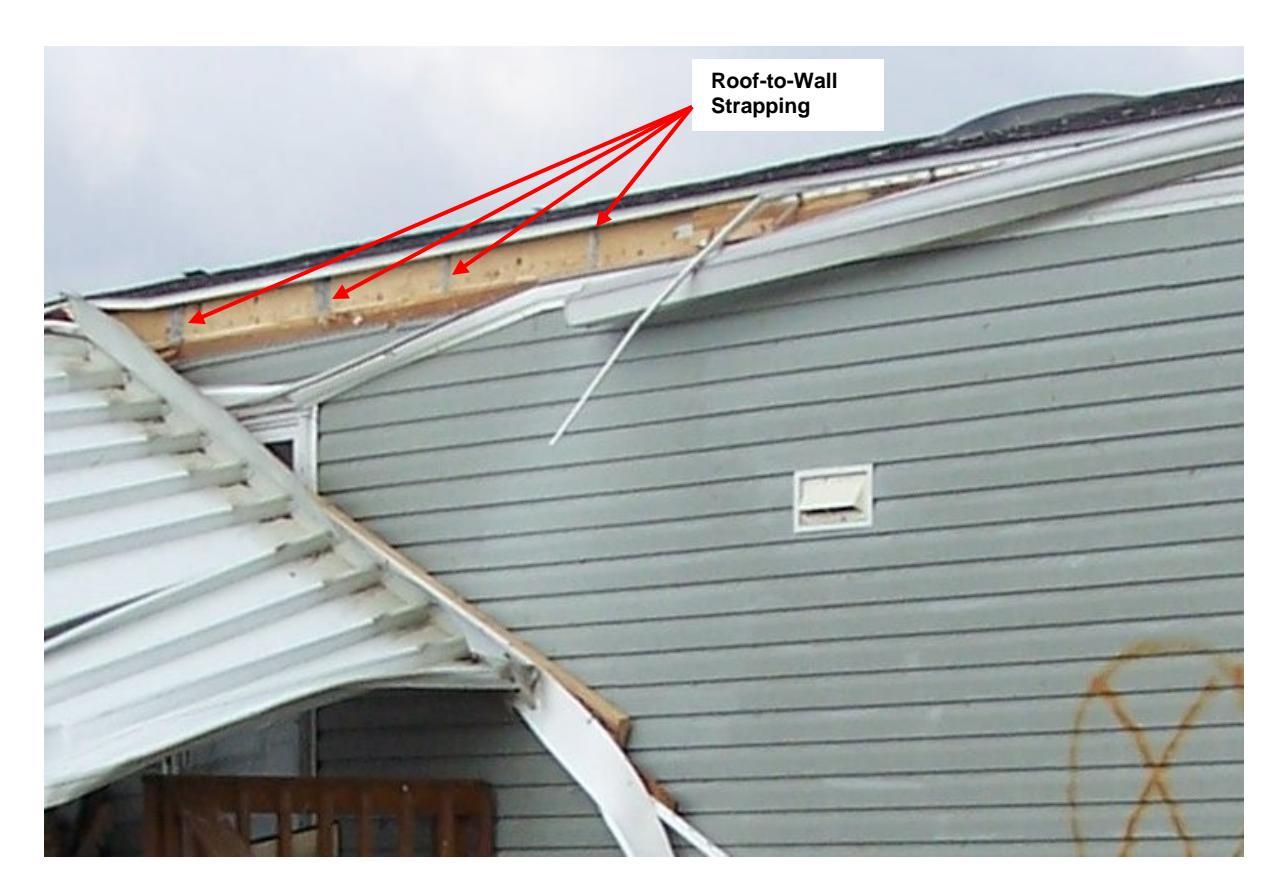
Figure 4-3. Zone II/III unit with roof-to-wall strapping.

As previously stated, Article 3280 merely requires the constructed components of the Zone I manufactured housing unit to be connected to resist the applied loads; however, no guidance to accomplish this task is provided and no maximum stud spacing is specified. Guidance is provided for the Zone II & III units by requiring roof truss-to-stud and stud-to-floor connections to be accomplished with 26 steel strapping located at 24-in. and 16-in. centers respectively. Though not specified in Article 3280, this allocation of strapping spacing would appear to coincide with the stud spacing of these high wind units. **Figure 4-3** illustrates top wall brackets included on a Zone II/III unit located in the Eastbrook Park. **Figure 4-4** shows an older Zone I unit with its roofing removed by the storm. The Zone I roof-to-wall connections are made with randomly located and poorly installed short steel straps.

- 3. Zone I units should be constructed with connecting clips at each stud as is currently required for the Zone II/III units.
- 4. The tie strap looped around the under-frame is a major source of unit failure. A better method of connecting tie-straps to the under-frame must be developed and required by Article 3280 and NFPA 501. Longitudinal strapping is essential to the stability of the unit in multi-directional winds of a windstorm and must be included in the new connection designs.

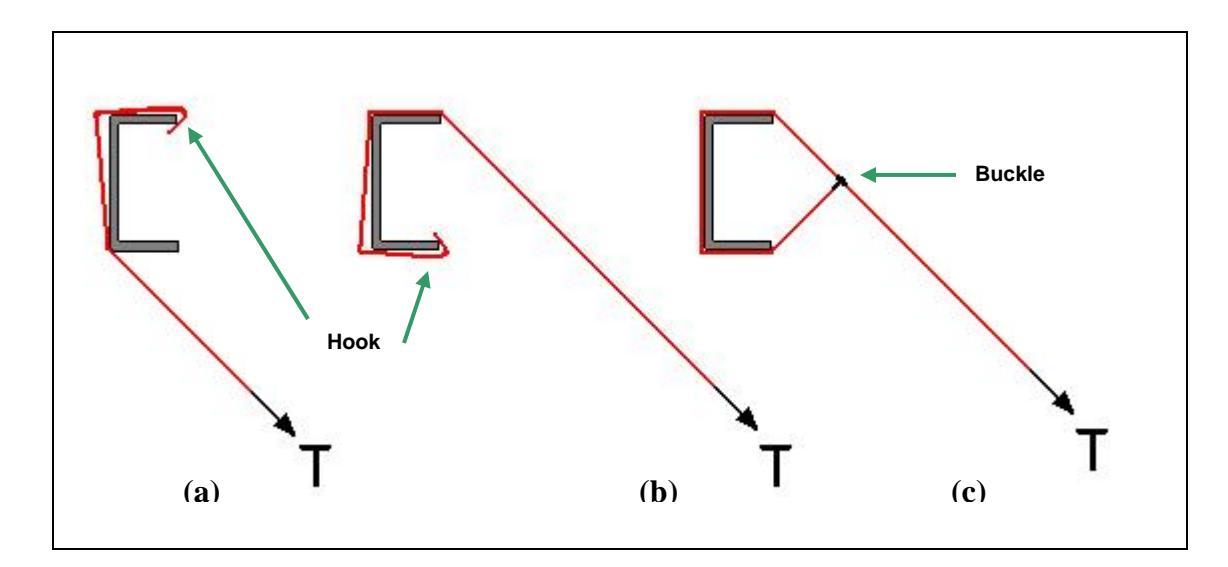
Figure 4-14. Standard installation method of tie strap to under-frame.

Design and analysis of mobile home tie-down systems presumes a near-perfect installation in which the tie-down strap is tight and remains perpendicular to the steel channel under-frame and that the anchor is installed correctly and is sufficient to carry the ultimate load of the strap. The investigators found no perfect installations. The tie-down strap was typically hooked to the under-frame and wrapped around the frame channel, as shown in **Figures 3-25** & **3-34**, and as illustrated in **Figure 4-14 (a, b, & c)**. This method of wrapping the strap creates a sharp bend in the strap that is easily fatigued by the wind buffeting the unit. Failure of tie-downs was typically found at one of these sharp bends in the tie-down strap (**Figure 4-15**).
