DAMAGE SURVEY OF THE TORNADOES NEAR ALTUS, OKLAHOMA ON MAY 11, 1982

James R. McDonald and Timothy P. Marshall

Institute for Disaster Research
Texas Tech University
Lubbock, TX
July 1983

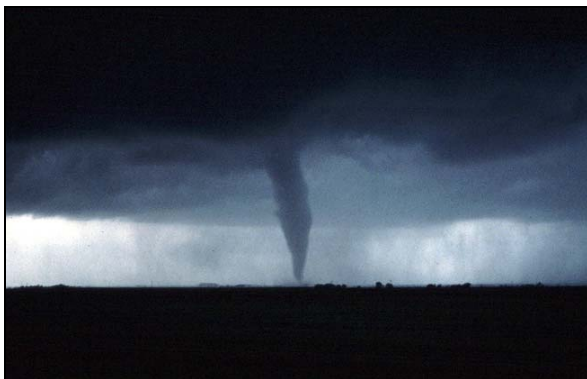
Figure 1. View looking west of the tornado that Struck the Altus Air Force Base. Photograph Courtesy of Dr. Howard Bluestein, OU-NSSL Severe Storm Intercept Project.

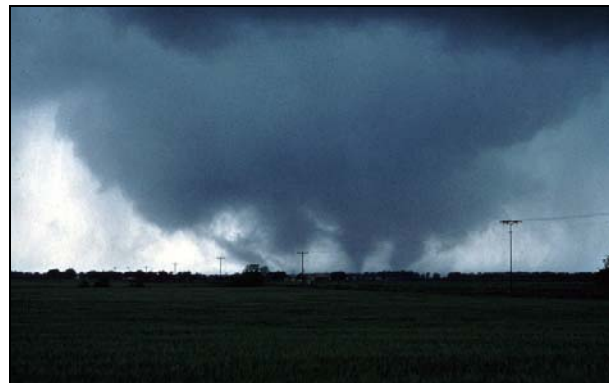
Figure 2. View looking northwest of second tornado (multi-vortex) near Friendship, Oklahoma. Photograph courtesy of Dr. Howard Bluestein, OU-NSSL Severe Storm Intercept Project.

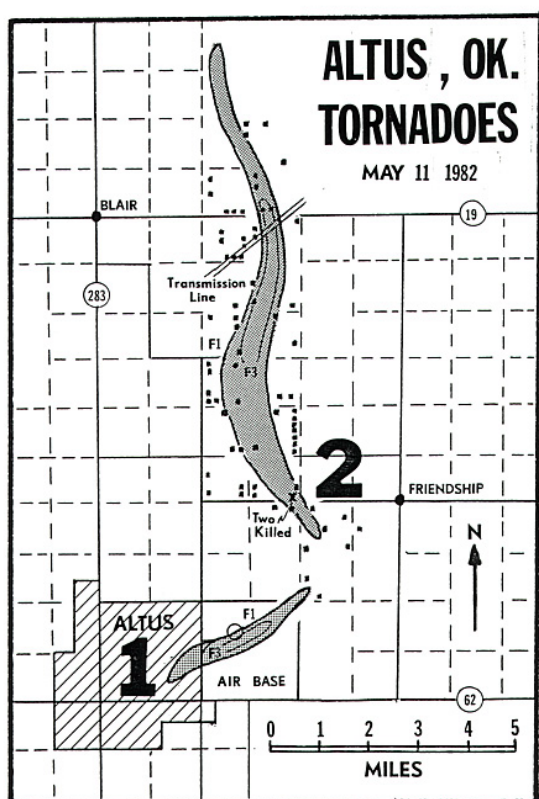
The first tornado touched down on the east side of Altus (Figure 4). There was only minor damage to trees, fences, and streetlights until the storm entered the Air Force Base. The tornado intensified and traveled northeastward from the main gate, across the center of the base and lifted just east of the main runway. Within a few minutes after the first tornado, a larger tornado touched down northeast of the Air Force Base near the community of Friendship. The tornado traveled northward for twelve miles through the countryside damaging rural homes and trees. Two people were killed by flying debris two miles west of Friendship as they were heading for an outdoor storm cellar. A 138 KV transmission line owned by Public Service of Oklahoma was downed as the tornado crossed Route 19, 3.5 miles east of Blair. F-scale classifications were assigned to rural building damage. Since no engineered structures were in the path of the Friendship tornado, wind speed estimates were not attempted. The characteristics of both tornadoes are listed in Table 2 in the Appendix.

Figure 4. Damage path of the Altus tornado and Friendship tornado (shaded areas). Small squares indicate houses. F-scale numbers also are shown.

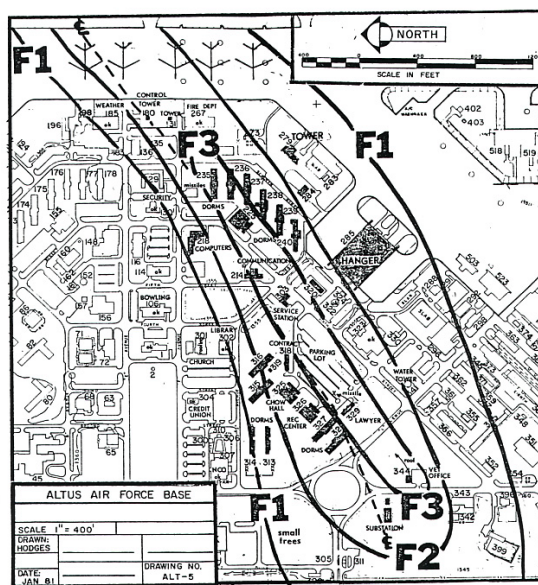
Figure 5. Detailed tornado damage path through Altus Air Force Base. Gradations in damage are depicted by F-scale.

The initial survey revealed that the damage path extended from the main gate across the center of the base and ended just east of the main (north-south) runway (Figure 5). The damage produced by this tornado was of great interest to the storm study team because it provided an opportunity to study the effects of tornadic winds on buildings that had received various degrees of engineering attention in their design. The storm also presented a unique opportunity to compare wind speed estimates from appearance of damage with wind speeds obtained from structural analysis of damaged building components.

The damage path through the Altus Air Force Base shown in Figure 5 was assembled using F-scale criteria. Buildings which sustained F1 damage or greater are shaded in Figure 5. Six buildings were heavily damaged (F3), eleven had moderate damage (F2), and seven had light damage (F1). From analysis of fallen trees and debris trajectories, the centerline of the tornado appeared to be parallel to the northern periphery of the F3 damage track. The individual performances of buildings which sustained the heaviest damage are discussed below. A rationale for the assignment of the F-scale rating also is given.
