**Storm Observations and Damage Survey
of the Tornado Outbreak Near
Pampa, Texas on May 19, 1982**

Timothy P. Marshall
James R. McDonald, P.E.

Institute for Disaster Research
Texas Tech University
Lubbock, TX

June 1983

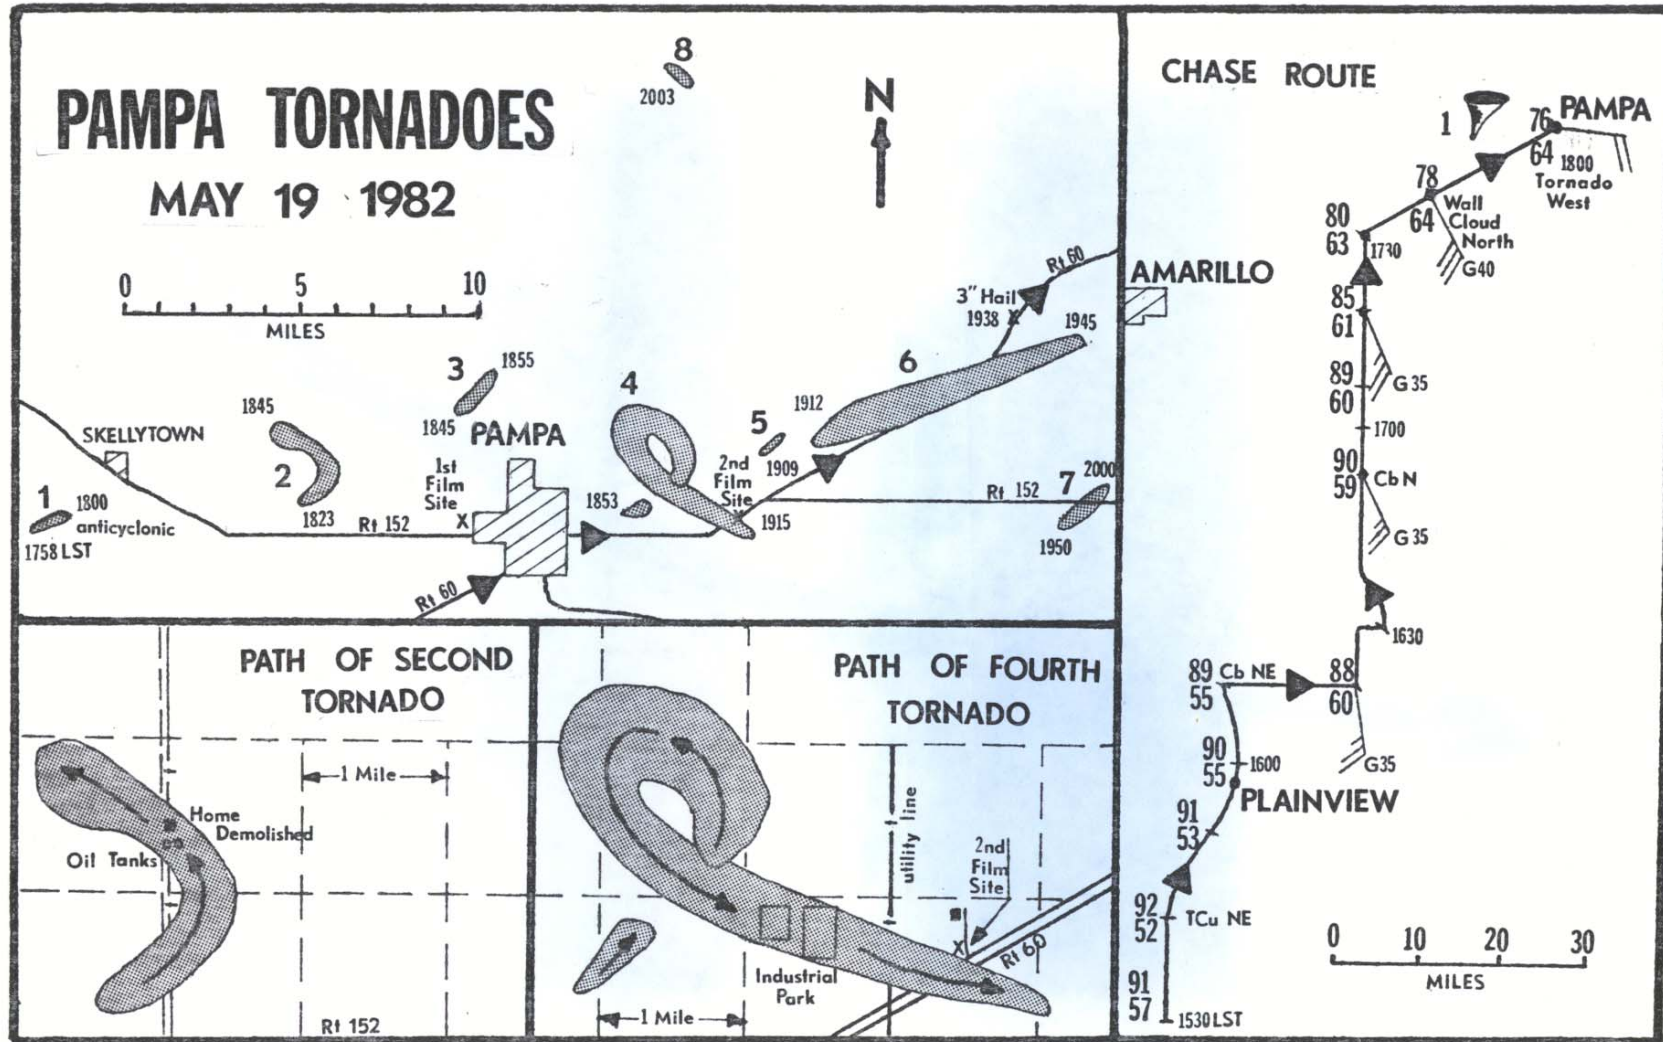
The locations of the tornado paths and positions of the tornado intercept team are shown in Figure 2. At least eight tornadoes occurred in succession lasting a total of over two hours on the ground. The actual times of tornado touchdown and lifting point are verified from transcribed information from tape recordings. An enlarged view of the damage paths of the second and fourth tornadoes is included since they were responsible for most of the damage.

Figure 2. Damage paths of the Pampa Tornadoes. The route of the Intercept Team is shown by arrows. Temperature and dewpoints are in $^{\circ}\text{F}$, wind speed in mph and local time are indicated.

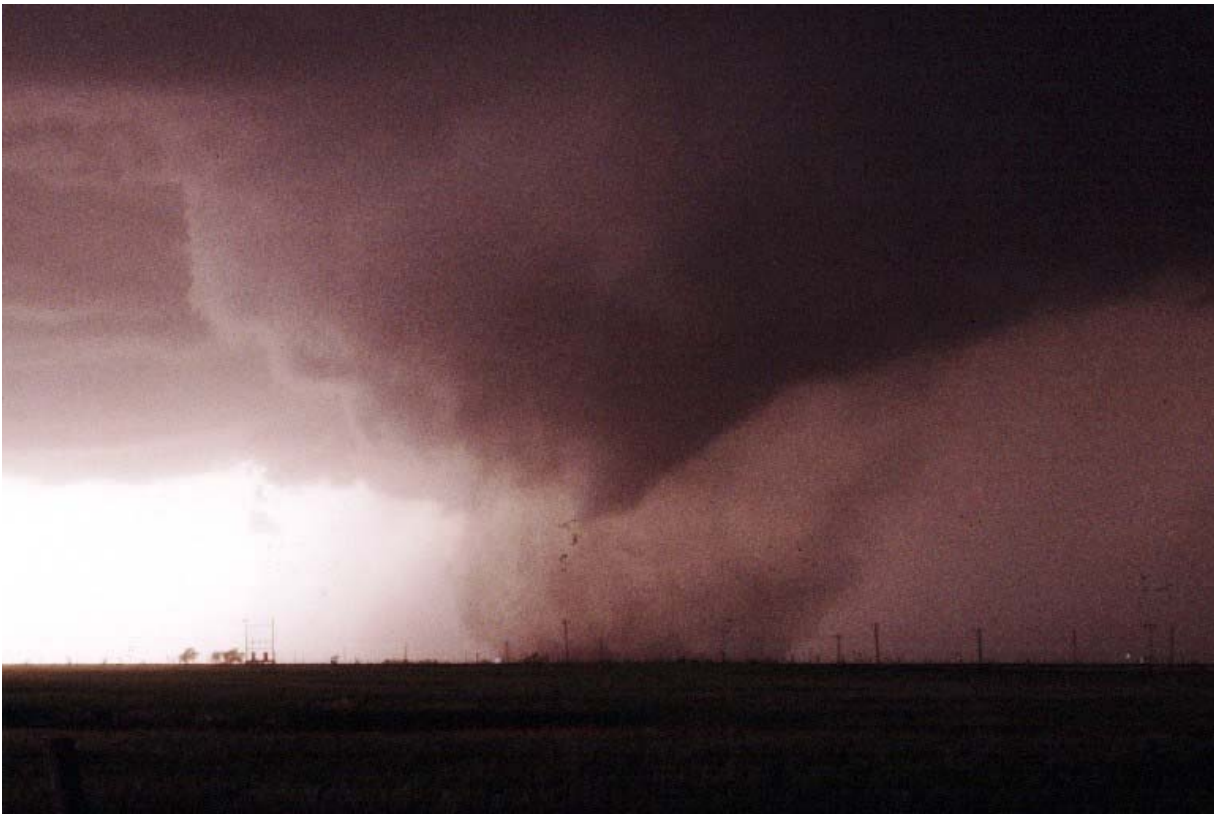
The storm appeared to go thru a transition stage as another large updraft merged into the storm from the south. Soon, the circulation at cloud base widened and intensified and a large wall cloud emerged. At 6:23 p.m., a laminar funnel protruded from the wall cloud and finally touched ground about four miles west of our location (Figure 5). As the tornado (#2) moved gradually northeastward, it widened into a V-shaped vortex and became obscured by dust.

Figure 5. The second tornado developed four miles west of Pampa. Note that the debris cloud is much larger than the condensation funnel.

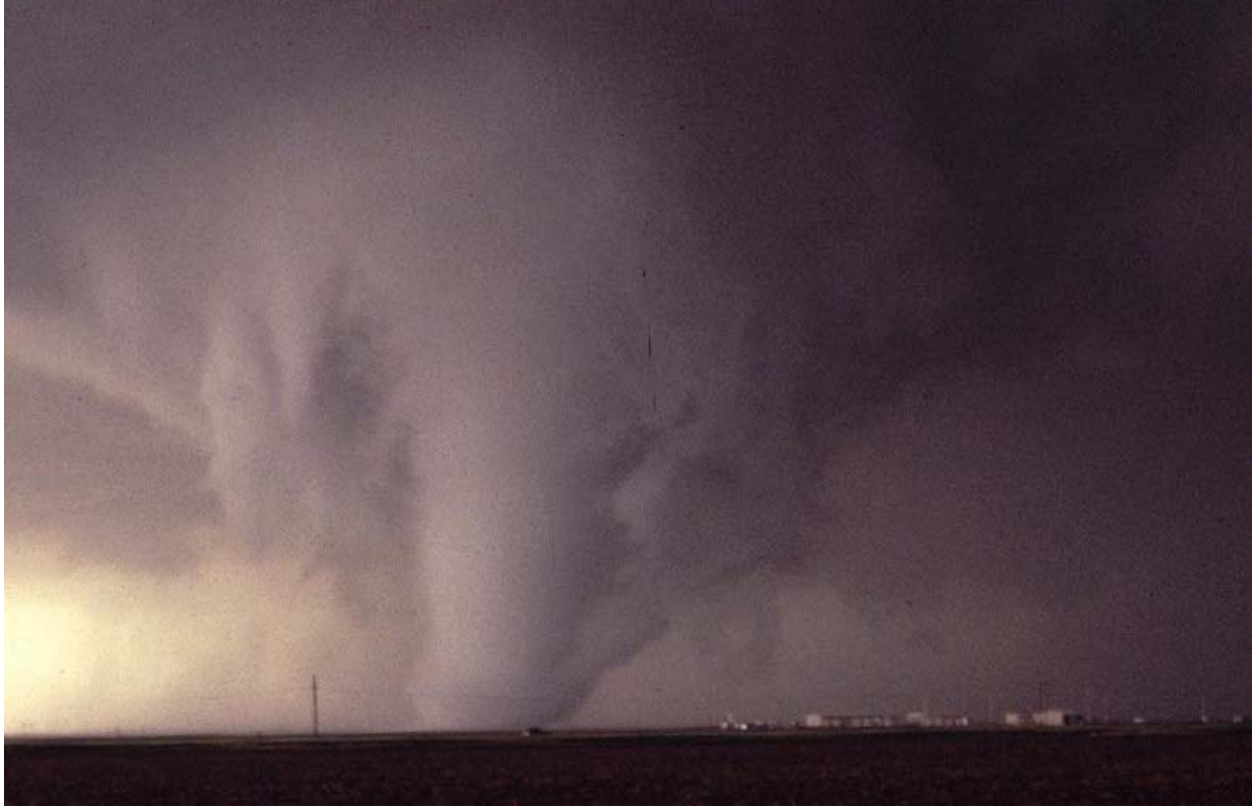
Soon a fourth circulation developed at cloud base over Pampa and moved eastward. The team followed and set up a second filming location four miles east of Pampa at 6:50 p.m. Within minutes, the fourth tornado developed and touched down two miles west of our location (Figure 6). The single-cell tornado was initially V-shaped and widened rapidly into a cylindrical-shaped vortex. After only a few minutes, the tornado dissipated and the circulation at cloud base widened. Within two minutes a large tornado with three sub-vortices developed a mile northwest of our location (Figure 7). The sub-vortices formed one at a time on the southern periphery of the circulation and moved around to the north-east side where they dissipated. The tornado traveled northward through a plowed field picking up loose soil which changed the tornado to a dark red color. At the same time, an anticyclonic funnel developed overhead and moved northward along the eastern periphery of the updraft.

Figure 6. View of the fourth tornado in the single-cell stage just before striking the Pampa Industrial Park. (Photo by Tim Marshall)

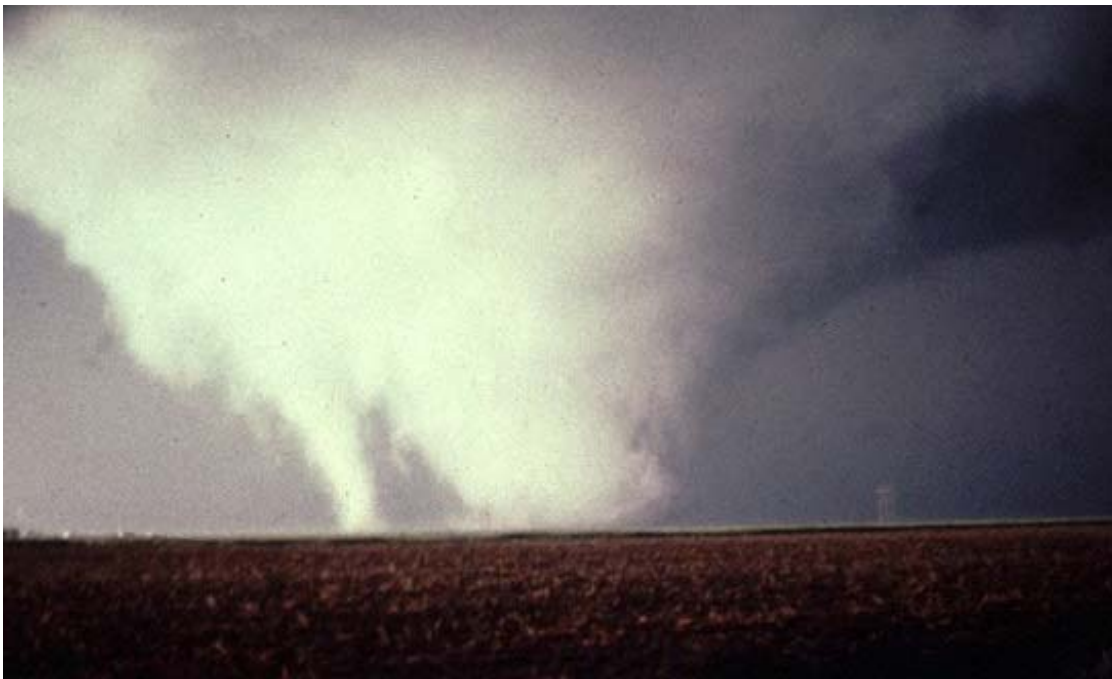
Figure 7. View of the fourth tornado two minutes later as it begins the multi-vortex stage. (Photo courtesy of Mr. Roy Britt)

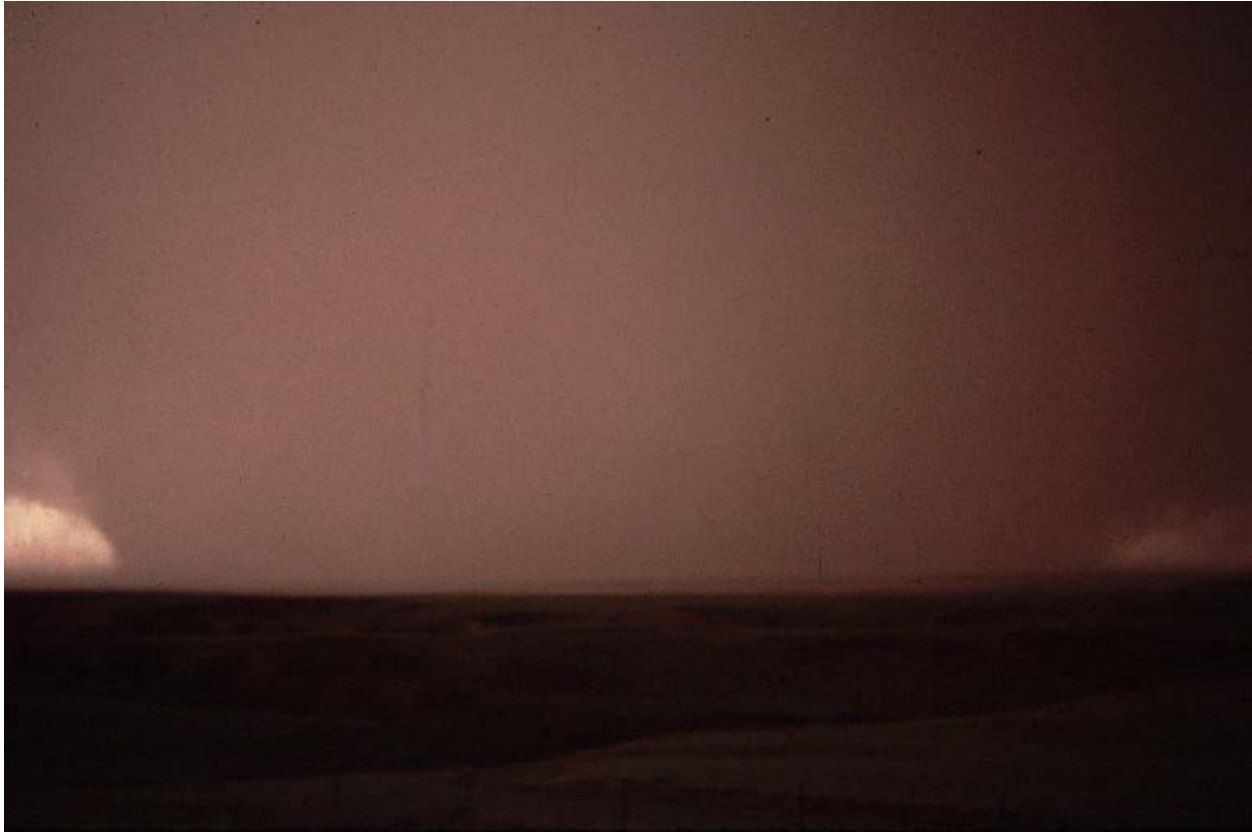
By 7:12 p.m., the wind switched to the west as the gust front passed. Soon, visibility became reduced as rain and hail began to fall. Then a dark, ominous wedge-shaped tornado emerged from the heavy precipitation about a mile away (Figure 8). This monstrous-size tornado was nearly a mile wide as it moved northeastward along Rt. 60 across sparsely populated ranchland. Baseball-size hail was encountered as the team drove eastward ahead of the advancing tornado. The tornado stayed on the ground for a half hour before dissipating near Miami, Texas.

Figure 8. The sixth tornado was nearly a mile wide. This photo was taken looking west about a mile away. (Photo by Tim Marshall)
