May 20, 2013 Moore, OK Tornado Shelter Performance Report
Larry J. Tanner, Pataya L. Scott, Joseph Dannemiller, Daan Liang

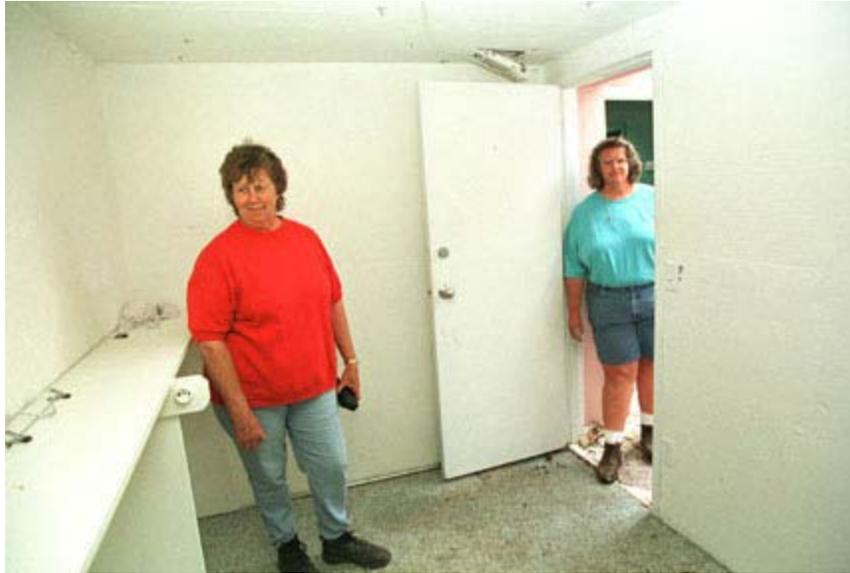
Figure 19. Beth Bartlett and her mother standing inside her above ground storm shelter where they took cover during the May 3, 1999 tornado.
