# Pressure and Impact Test Performance of Above-Ground Non-Complying Tornado Shelter Doors

A NSSA/NWI DIF Sponsored Project

<sup>1</sup>Larry J. Tanner and <sup>2</sup>Ernst W. Kiesling

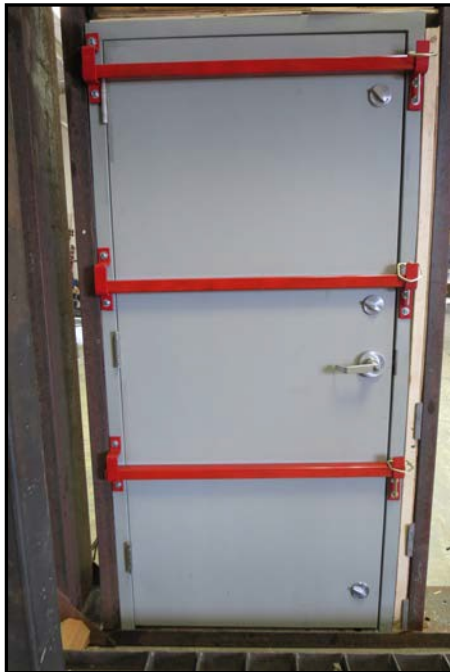
*Figure 7: Series 5 Mitigations*

- e. *Series 5*: 16 ga. HM Door, similar to Series 4, but stronger, with vertically steel stiffened core, door mounted in 18 ga. HM frame. Hardware included (3) Commercial Grade 2 deadbolts, entry lockset, and Commercial HD hinges. Door opening was mitigated with (3) 1 ½-in. x 1 ½-in. x 3/16-in. HSS tube steel hung on ¼-in. x 2-in. hangers bolted through the frame. The tube steel was further pinned with 3/8-in. shear pins. (See *Figures 7 & 8* for Series 5 mitigations.)

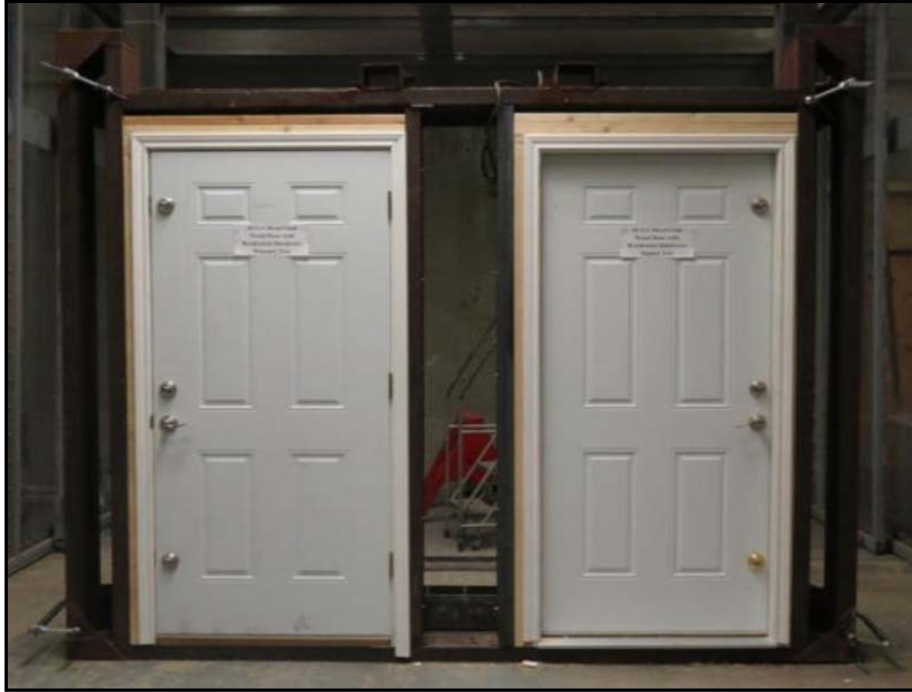
Separate doors were installed in a heavy steel channel test fixture, out-swinging to exhibit negative pressure and in-swing for impact testing. (See *Figure 9*.) Doors were bolted into the fixture with 3/8-in. bolts, seven in each jamb and three in the door head. Each door was pressure tested until the desired pressure was achieved and held 10 seconds or until failure. Pressure testing was accomplished with an air bladder installed between the door and a pressure resistant wall. (See *Figures 10 & 11*.)

*Figure 9: Series 1 Out-swing Pressure Door Left and In-swing Impact Door Right.*

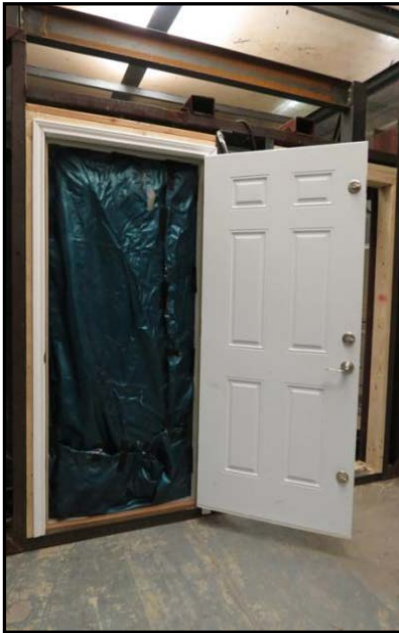
*Figure 10: Bladder Installed for Pressure Test.*

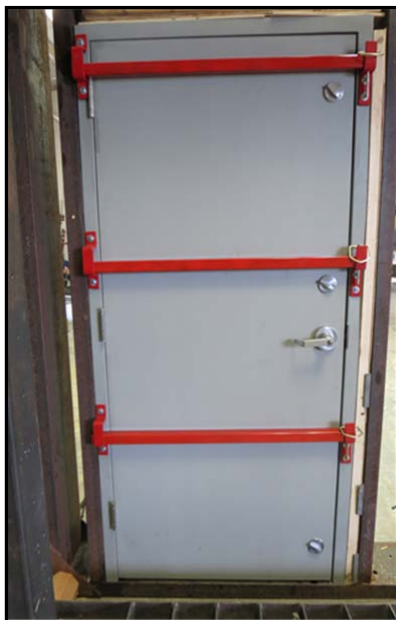
- c. The Series 5, 16 ga. HM door was vertically steel stiffened, locked with Commercial Grade 2 deadbolts, and had mitigations installed to control door deflections and lock failures. The mitigation included (3) 1 ½-in. x 1 ½-in. x 3/16-in. HSS tube steel hung on ¼-in. x 2-in. hangers bolted through the frame. The tube steel was further pinned with 3/8-in. shear pins. Safety pins were available for insertion into the shear pins, but left off, with the assumption that a panicked occupant might forget to install the pins. (See *Figures 33 & 34.*) The first impact near the top lock withdrew the shear pin and the crossbar, see *Figure 34*. A safety pin was installed in the shear pin on the center cross bar for the second impact. The safety-pinned center cross bar held the second impact. (See *Figures 35-37.*)

*Figure 33: Series 5 crossbar mitigations.*

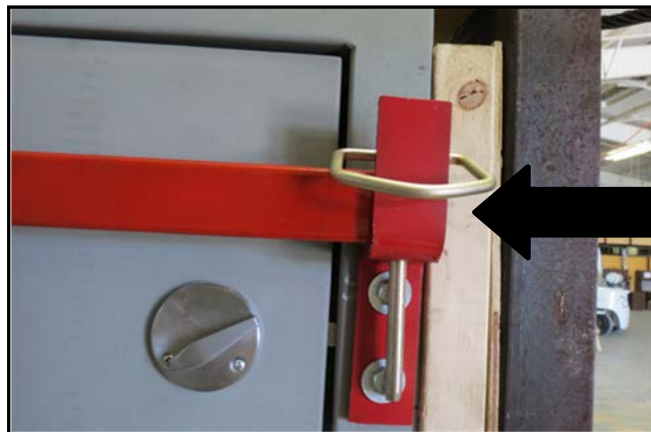
*Figure 34: Shear pin without safety pin.*

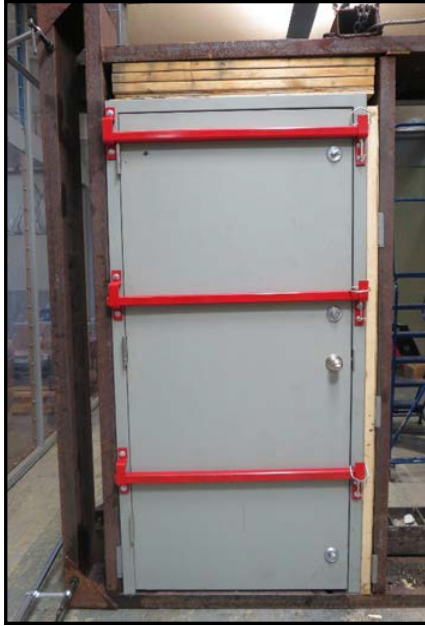
- d. The Series 6 was the same type of 16 ga. HM door and was a vertically steel stiffened door and locking hardware as Series 5. Mitigations were installed to control door deflections and lock failures. The mitigation included (3) thicker HSS (1 ½-in. x 1 ½-in. x 1/4-in.) tube steel hung on ¼-in. x 2-in. hangers bolted through the frame. The tube steel was further pinned with 3/8-in. shear pins which were restrained from withdrawal with safety pins. These mitigations represented the stronger of the two mitigation installations. Impact 1 sheared the safety pin and allowed the shear pin to withdraw and the crossbar to fall. Impact 2 produced the same behavior. (See *Figures 38-43.*)

*Figure 38: Series 6 mitigations.*

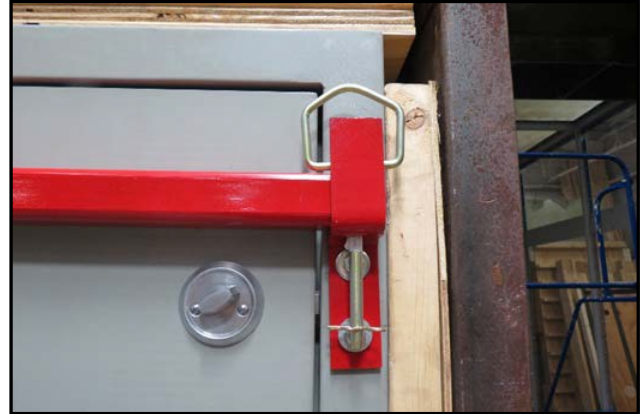
*Figure 39: Safety pins installed on all shear pins.*
