**National Wind Institute**  
**Debris Impact Facility- Texas Tech University**  
P.O. Box 43155  
Lubbock, Texas 79409-1023

**Report No. \_20140604A**  
**Specimen No. \_\_\_\_\_2\_\_\_\_\_**  
**Test Date: \_June 4, 2014\_**

- 2.0 PRODUCT TYPE:** **Series 1-FEMA 320/361 & ICC 500, Utility Brick Veneer Wall**  
**Series 2-FEMA 320/361 & ICC 500, Modular Brick Veneer Wall**
- 2.1 MODEL NUMBER:** N/A
- 2.2 CONFIGURATION:** See Article 3.0 Test Unit Description
- 2.3 SAMPLE SIZE:** See Article 3.0 Test Unit Description
- 2.4 DOOR ASSEMBLY:** See Article 3.0 Test Unit Description, see installation photos, pages 5-14.
- 2.5 DRAWINGS:** See Appendix B Drawings.

**4.1 SCOPE:** Conduct impact tests for two brick veneer wall configurations.

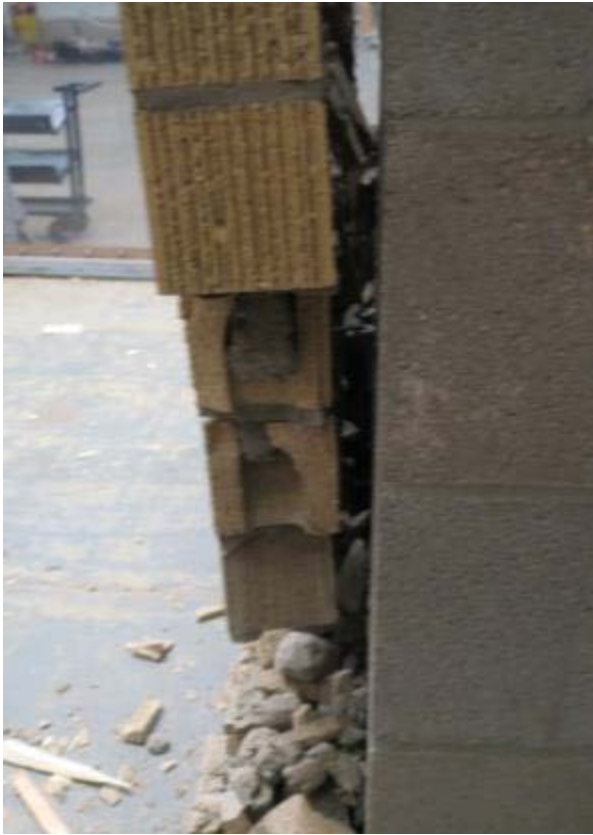
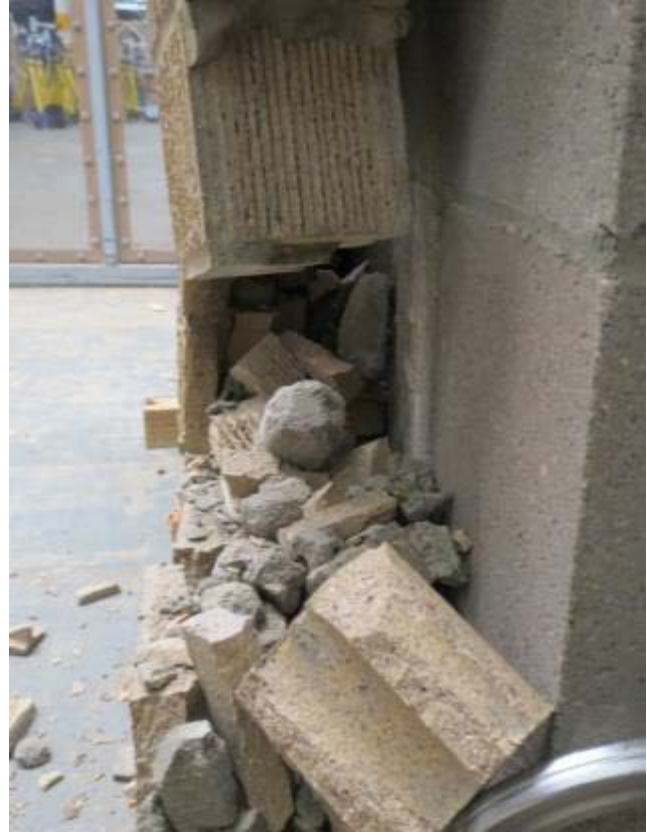
**Series 1 Impact 2 Side View**

Series/Impact	Velocity (mph)	Location	Results
1/1	100.0	Panel center.	Vertical crack from top to bottom and missile perforation of brick. No damage to CMU, front or back; see photos, pages 15-18.
1/2	100.2	Lower right over reinforced column.	Opening of vertical crack to 3/4-in. and brick destruction at impact area. No penetration of CMU; see photos, pages 19-22.
1/3	101.0	Lower left beside grouted cell.	Failure of left lower corner brick. No backside damage; see photos, pages 23-27.
2/1	102.3	Panel center.	Brick perforation with diagonal shear cracks at 22-in.; see photos, pages 28-31.
2/2	101.0	Lower right over grouted cell.	Destruction of brick at impact point; see photos, pages 32-33.
2/3	103.3	Upper left beside grouted core.	Cracking of corner; see photos, pages 34-39.
