TEXAS TECH UNIVERSITY  
**National Wind Institute™**

**MAY 20, 2013 MOORE, OK, TORNADO INVESTIGATION REPORT**

November 2014

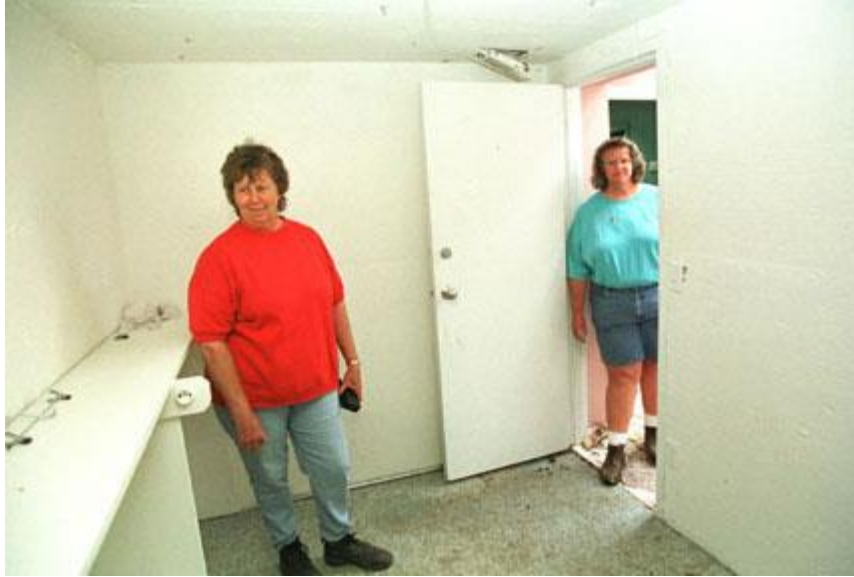
The TTU May 3, 1999 Moore, OK, storm investigation, along with the FEMA Mitigation Assessment Team, revealed the presence of numerous below-ground shelters. One above-ground shelter, shown in *Figure 19*, was observed in Dell City, OK, standing on the lawn of Beth Bartlett, the shelter owner. Following the admonitions of local media, many residents fled their homes, two of whom were killed seeking shelter under a local underpass (Miller *et al.* 1999). President Bill Clinton authorized the first FEMA Shelter Incentive Program to aid homeowners in the cost of installing a shelter. The TTU investigation of the May 8, 2003 tornado led to the finding of new below-ground and above-ground shelters constructed to the FEMA P-320 (1998) specifications.

**Figure 1.19.** Beth Bartlett and her mother standing inside her above-ground storm shelter where they took cover during the May 3, 1999 tornado.

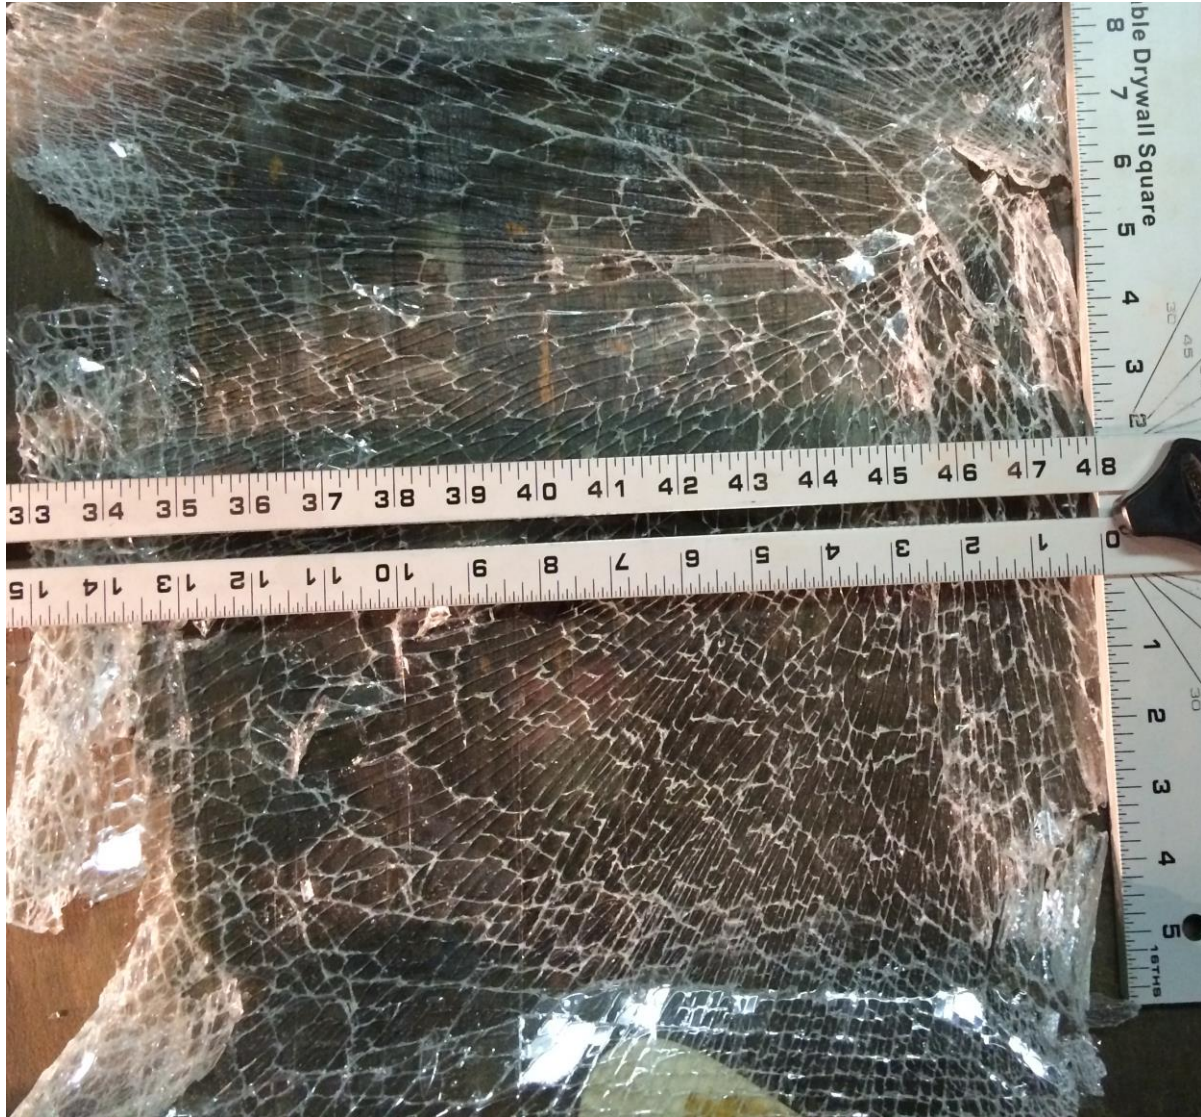
**Figure. 3.2.** 2.5 mm X 500 mm X 500 mm (3/32 in. X 20 in. X 20 in.) specimen loaded to failure in test lab.

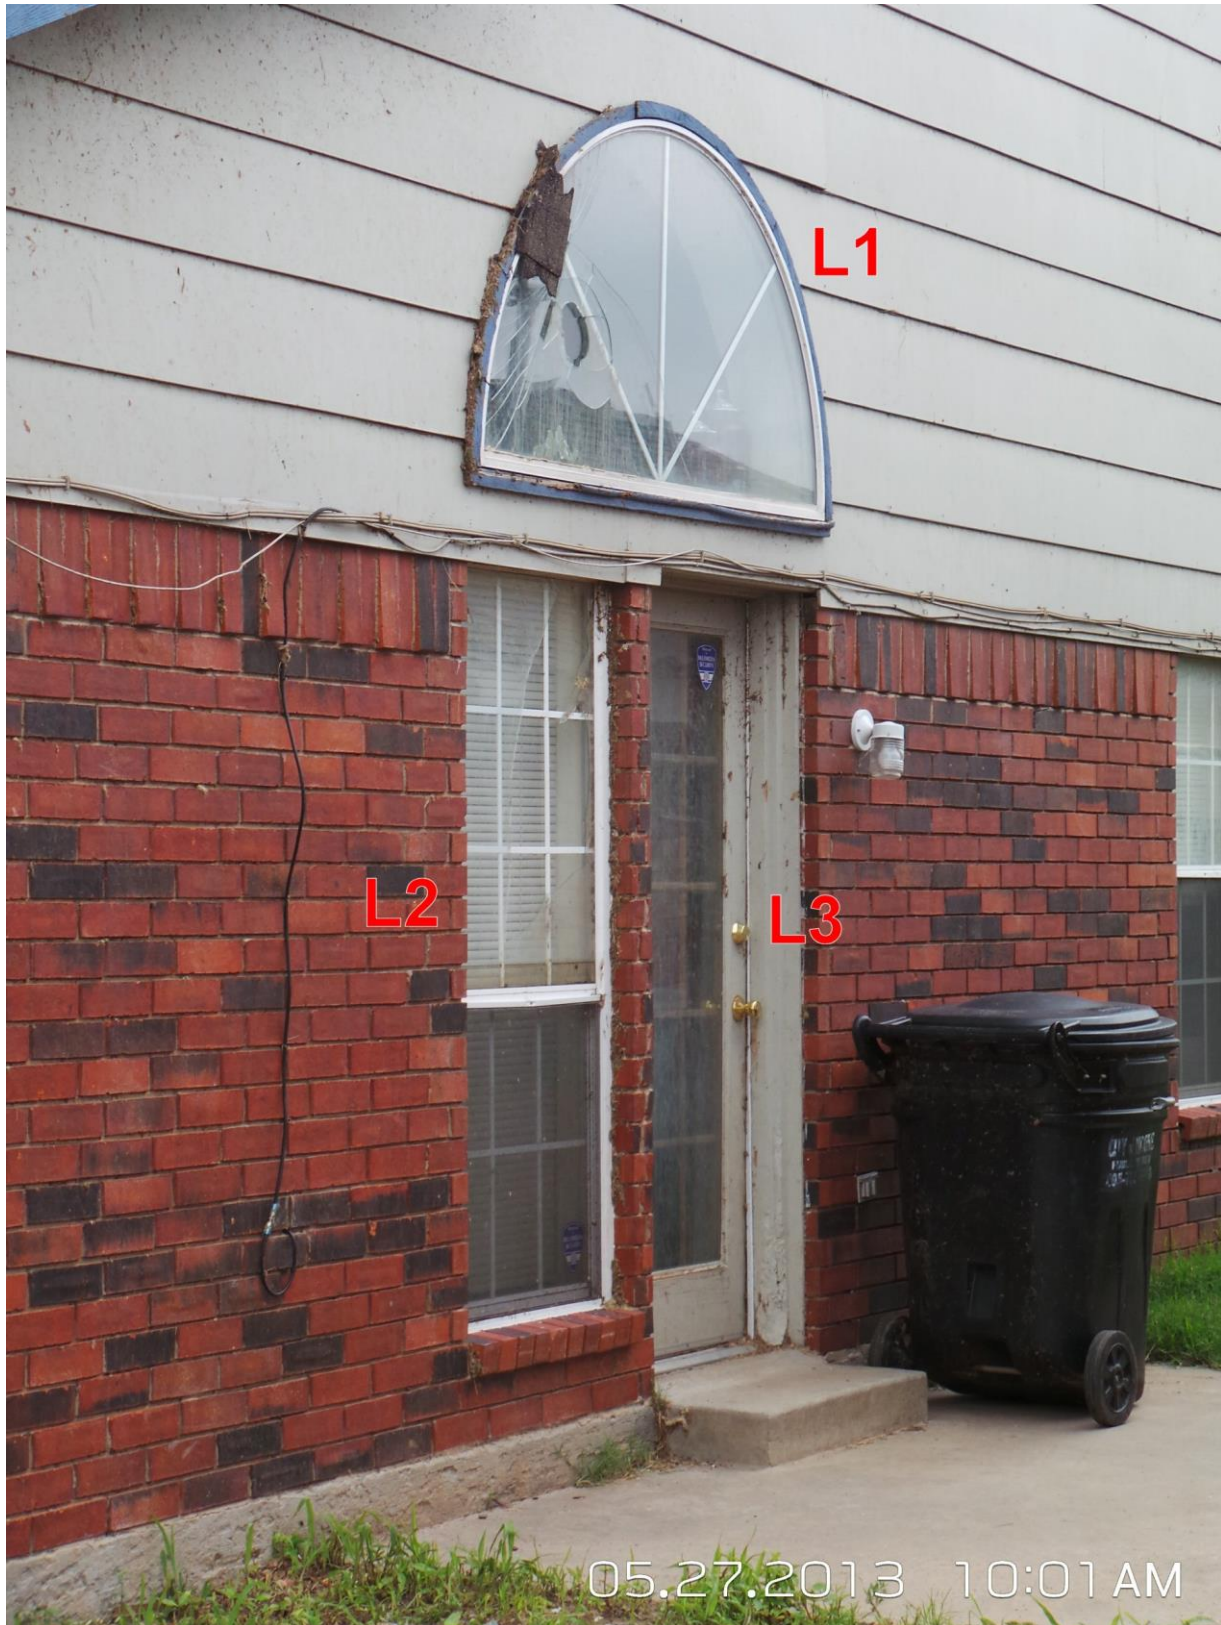
Figure B.14. Specimens L1, L2 and L3.

In contrast, *Figure 3* shows a magnified view of Specimen L1 where the shards are significantly larger with large areas of unfractured glass indicating the fracture was not due to large stresses resulting from a high uniform lateral pressure, but rather due to impact damage caused by wind borne debris impacting the window. Using the assessment criteria, it was determined that all 15 fractured specimens fractured due to debris impact. *Table A.3* lists the criteria for each fractured specimen with a justification for determining the specimens fractured due to debris impact damage.
