Tornado Damage in Happy, Texas,

May 5, 2002

A report prepared by Larry J. Tanner, P.E.

Submitted to NIST

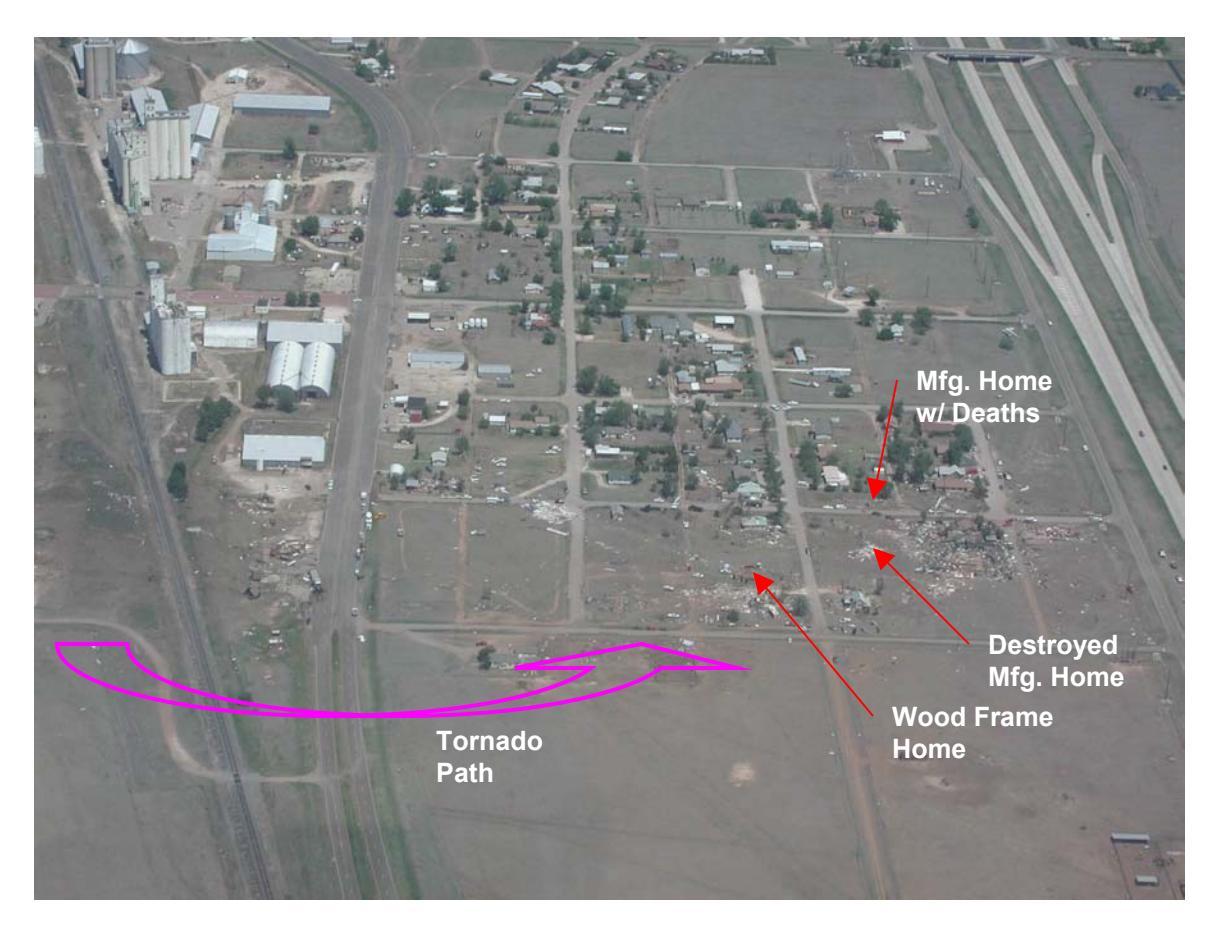
Figure 12. Happy, Texas, southeast corner

Figure 12 indicates the path of the storm re-entering the southeast corner of the town of Happy, Texas. At this point the tornado was organized into a funnel as shown in Figure 13, a photograph taken by engineer and storm chaser Tim Marshall, as the storm crossed US Hwy 87.
