Water Intrusion in Base/Subgrade Materials at Bridge Ends: Final Report

Texas Department of Transportation

Report No. 0-5096-1

October 2005

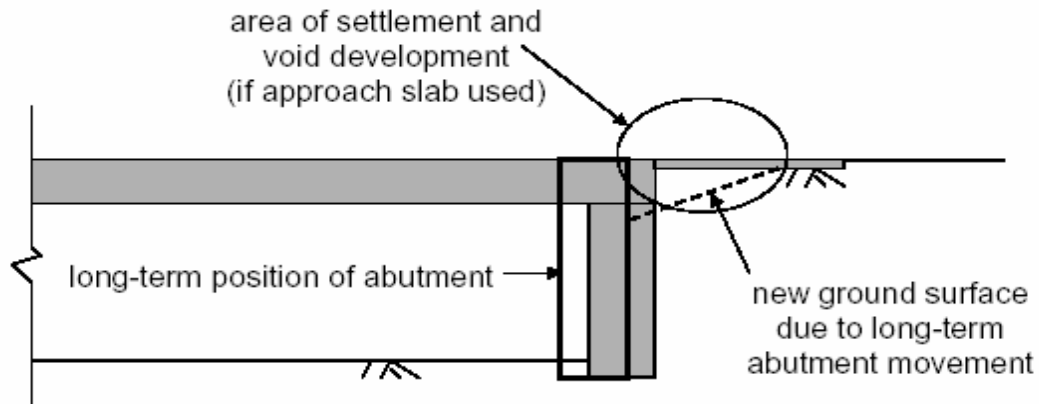
During the winter contraction of the bridge structure, a wedge shaped portion of the retained soil moves towards the abutment. However, this soil wedge is not pushed back to its original position during the summer expansion. This is mainly due to the non-linear behavior of soil. This effect tends to accumulate over the years and the net result of this accumulation is the creation of a void just behind the abutment. Figure 2.5 shows the void development behind the abutment.

Figure 2.5: Void development behind abutments in IAB's (same source as above)

There have been several strategies, suggested to fix the above mentioned problem, associated with integral abutment bridges. One earlier complete structural approach was to reduce the height of each abutment considerably. Although the lateral earth pressure acting on the abutment still increased every summer, the total resultant force and flexural stresses that the abutment should be designed to resist, reduced significantly because of the smaller span. Another more geotechnical approach involved the concept of placing a compressible inclusion (i.e. a material placed in the ground, which is significantly more compressible than the material adjacent to it). One example of a commonly used compressible inclusion is expanded polystyrene (EPS) geofoam. Recycled tire fragments have also been tried as compressible inclusions, but their behavior has been found to be unpredictable and they have been found to be environmentally problematic. Figure 2.6 demonstrates the application of compressible inclusions behind the bridge abutment.

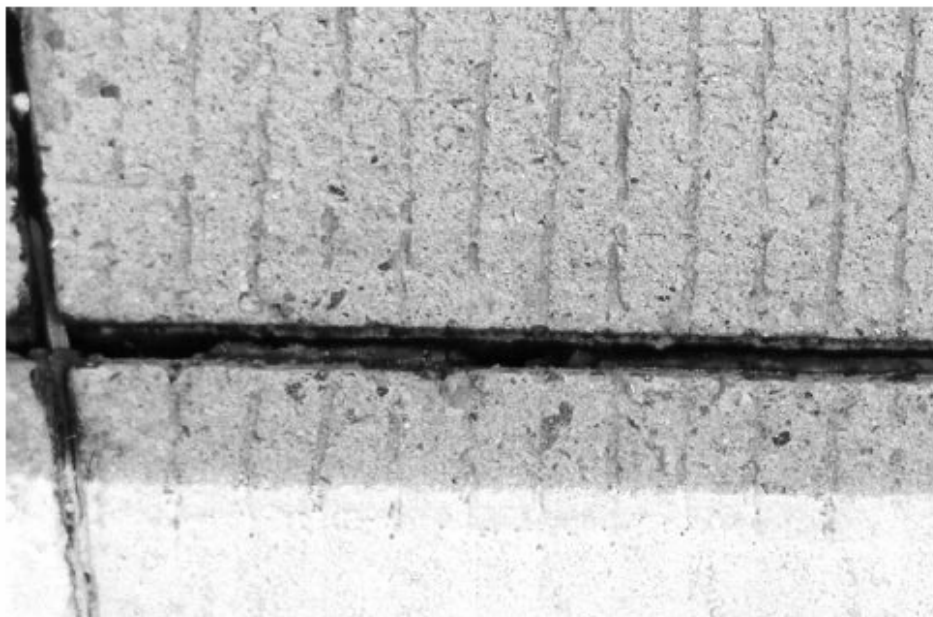
Joint sealants split open either by losing bond with the sidewalls of the joint reservoir (Figure 2.9), by losing internal bonding (Figure 2.10) spalling and torn/missing sealant. Case studies have shown that the predominant distresses in pavement joints sealants are adhesion loss and spall failure.

Figure 2.10: Full Depth Cohesion Failure
(Taken from FHWA Report No. FHWA-RD-99-146)
