## 14. AUTOMOBILE SERVICE BUILDING (ASB)

### General Description

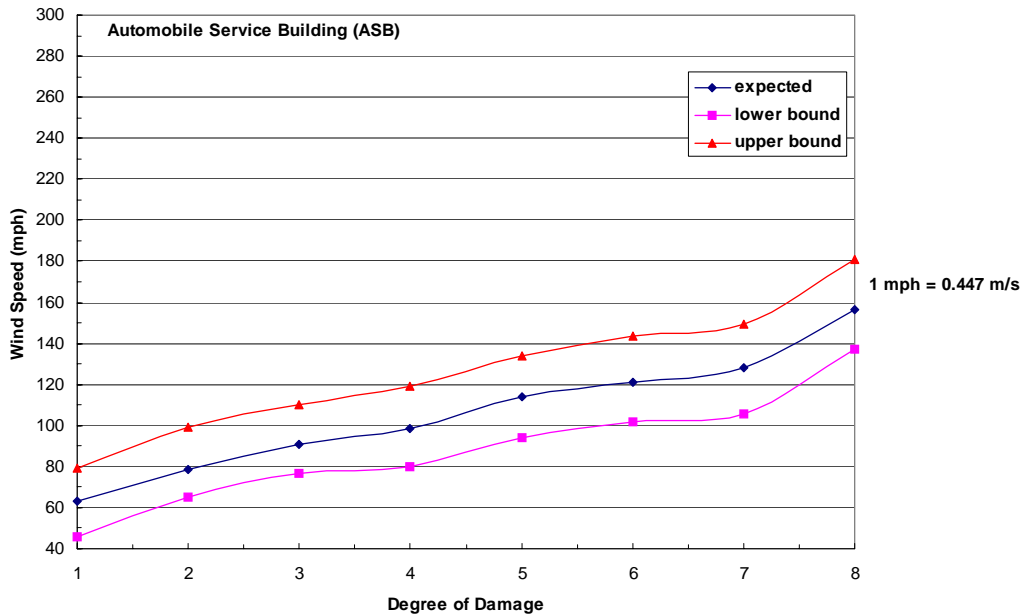
Figure 14. Wind Speed vs. Degree of Damage

DOD*	Damage description	EXP	LB	UB
1	No visible damage	63	46	79
2	Loss of some roofing material ( $\leq 20\%$ )	78	65	99
3	Uplift of metal roof decking; significant loss of roof covering ( $>20\%$ ); loss of rooftop HVAC equipment	91	77	110
4	Failure of overhead doors	98	80	119
5	Uplift or collapse of roof structure	114	94	134
6	Collapse of non-bearing masonry or tilt-up walls	121	102	143
7	Collapse of load-bearing walls	128	106	149
8	Complete destruction of all or a large section of the building	157	138	181
