19. HIGH-RISE BUILDING: GREATER THAN 20 STORIES (HROB)

General Description

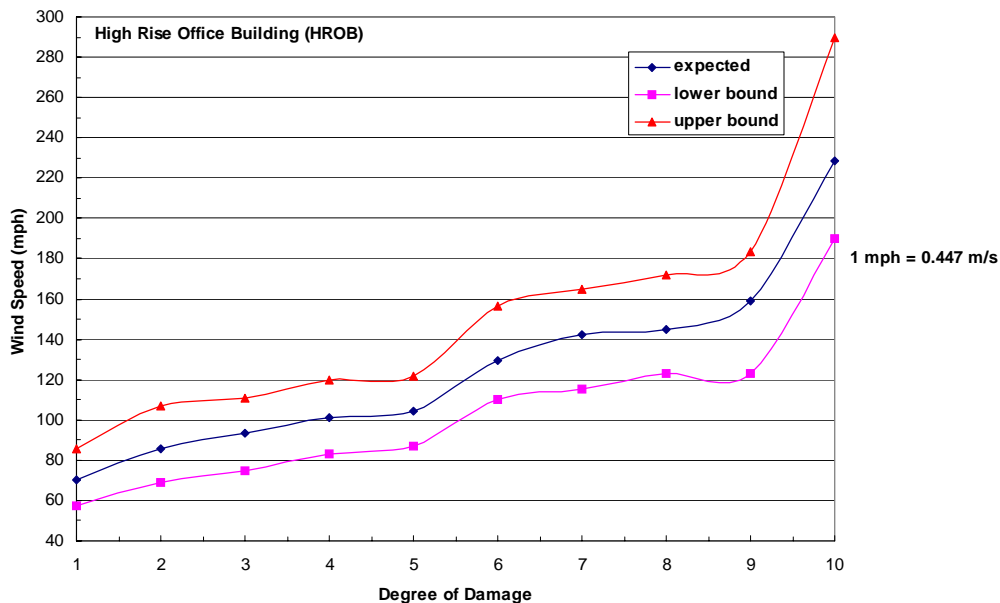
Figure 19. Wind Speed vs. Degree of Damage

DOD*	Damage description	EXP	LB	UB
1	No visible damage	70	58	86
2	Damage to penthouse roof and/or walls; loss of rooftop HVAC equipment	86	69	107
3	Loss of roof covering (<20%)	93	75	111
4	Broken curtain wall panel anchors	101	83	120
5	Broken glass in curtain walls; glass in entryways; significant damage to building interior	104	87	122
6	Uplift of roof decking; significant loss of roofing material (>20%)	129	110	157
7	Damage to parapet wall or coping	143	115	165
8	Uplift or collapse of roof structure	145	123	172
9	Failure of exterior walls at top story	159	123	183
10	Significant structural deformation or collapse of building	228	190	290

* DOD is degree of damage
