1. Report No. FHWA/TX-12-5-9045-05-1	2. Government Accession No.:	3. Recipient's Catalog No.:	
4. Title and Subtitle: Just in Time Technology Transfer for Portland Cement Concrete Pavement Construction and Rehabilitation		5. Report Date: August 2012

**Just in Time Technology Transfer for Portland Cement Concrete Pavement
Construction and Rehabilitation**

Project Report 5-9045-05-1

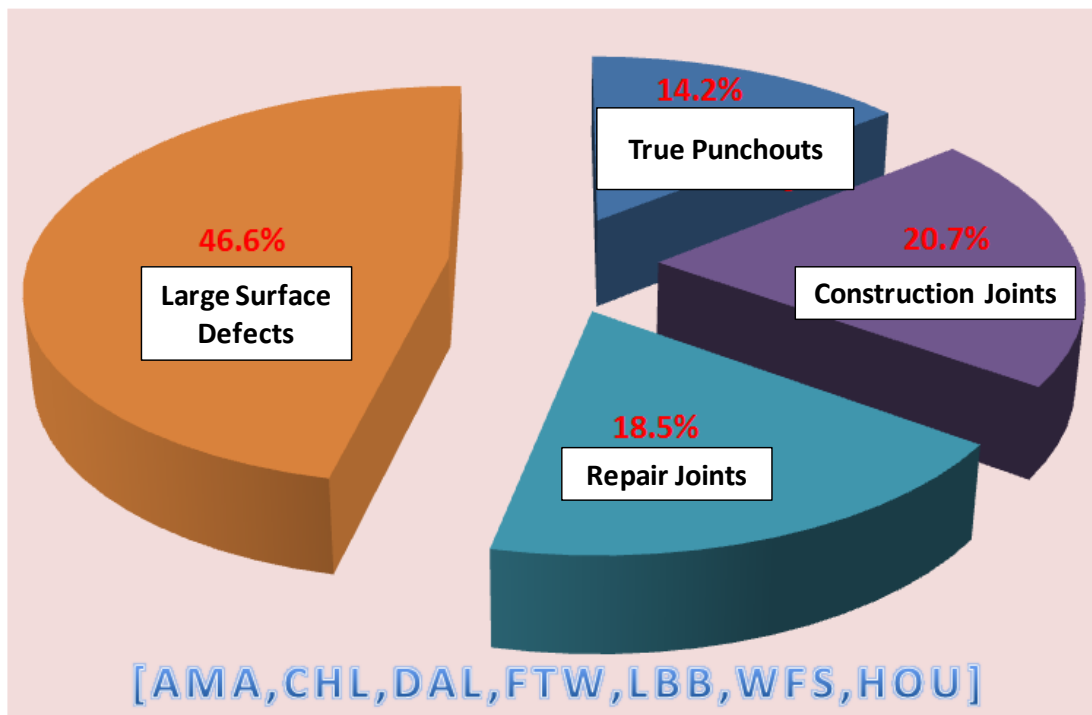
Figure 1 Classification of CRCP distresses in Texas

Figure 1 shows that about half of all the punchouts recorded in TxDOT PMIS are actually large surface defects. These defects, shown in Figure 2, are primarily due to the use of a specific coarse aggregate type, or poor finishing practices. The distress in Figure 2-(a) is due to poor workmanship during the finishing operations. Large spalling and subsequent repairs as shown in Figure 2-(b) are due to the use of a coarse aggregate with high coefficient of thermal expansion (CoTE). Efforts are currently underway in TxDOT to address the coarse aggregate issue.

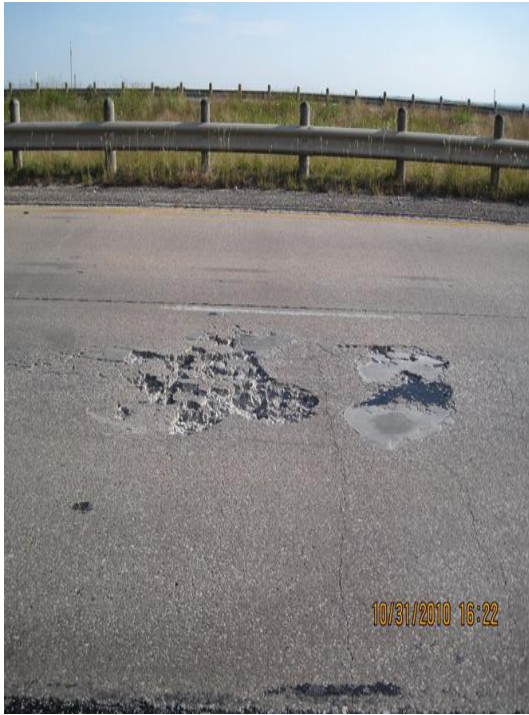
Figure 2-(a) Large surface defect

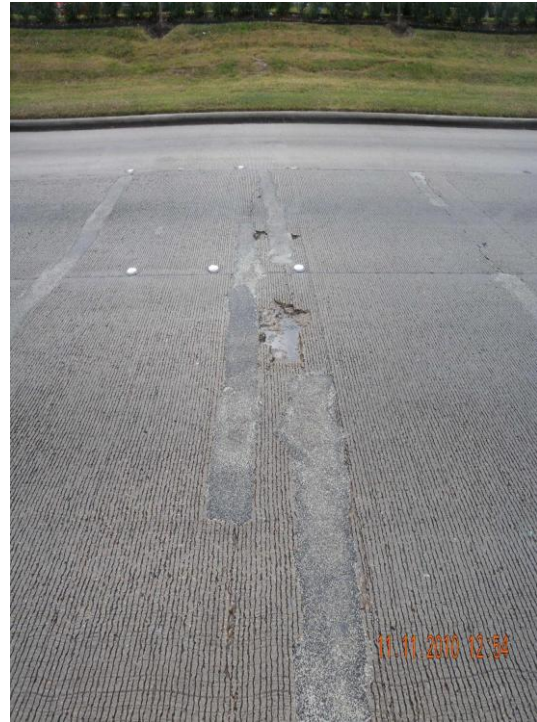
Figure 2-(b) Spalling and repairs

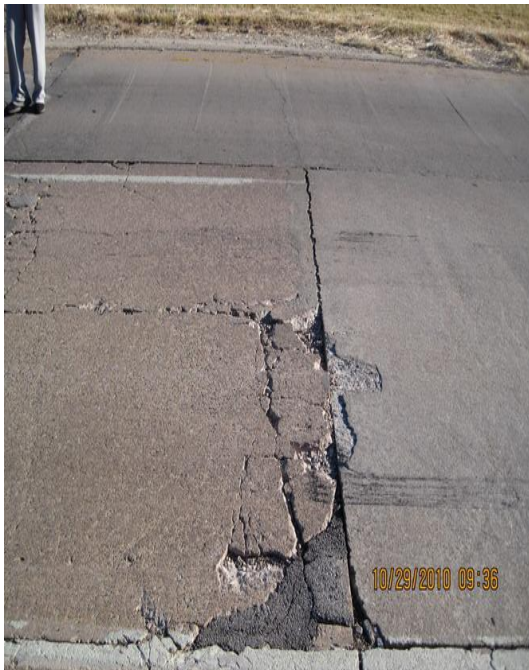
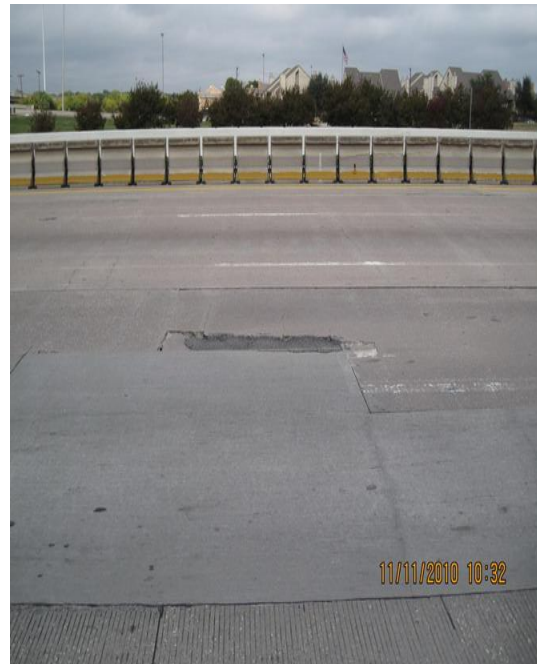
Figure 3-(a) Distress at repair joint

Figure 3-(b) Distress at repair joint

About 19 percent of punchouts recorded in TxDOT PMIS are actually distresses related to previously repaired joints. Figure 3 shows the distresses next to the repair joints.

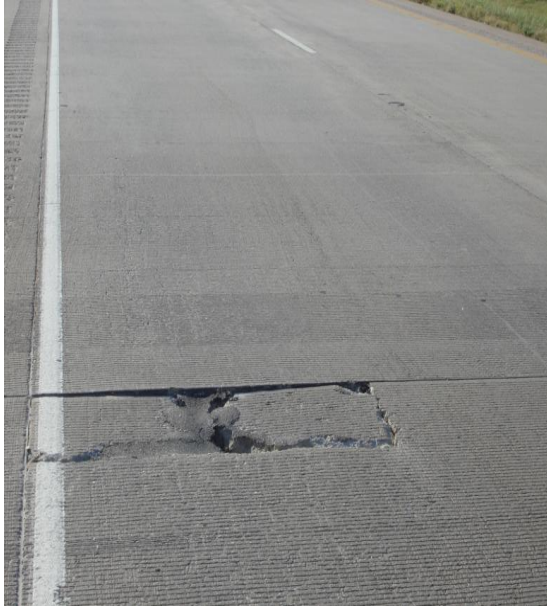
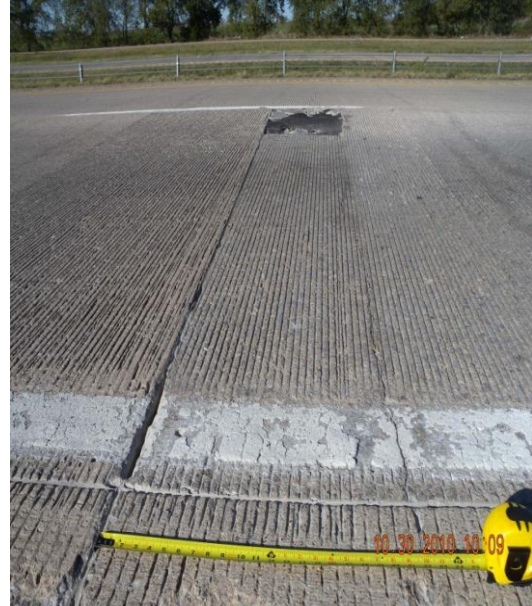
Figure 4-(a) Distress at transverse construction joint

Figure 4-(b) Distress at transverse construction joint

About 21 percent of the punchouts recorded in TxDOT PMIS occur at transverse

construction joints, as shown in Figure 4. This could be due to the materials or construction practices in the joint area. Currently, research efforts are under way to identify the causes of this type of distress.
